Project Dragon SAF  
Production Facility

**Table A1. Summary of the findings of the Preliminary (Bat) Roost Assessment of Buildings**

| Table 1 – Preliminary Roost Assessment (PRA) conducted on 25/07/2023 | |

## Bryophyte survey and assessment of land at Port Talbot Docks

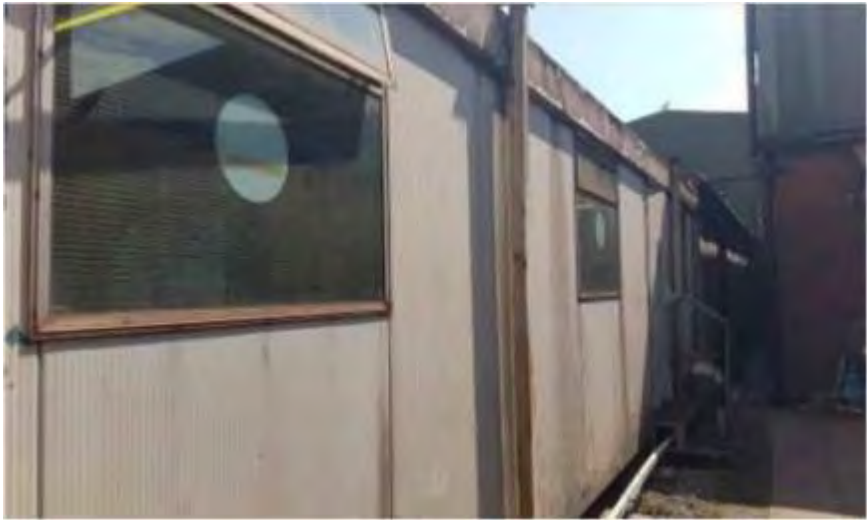
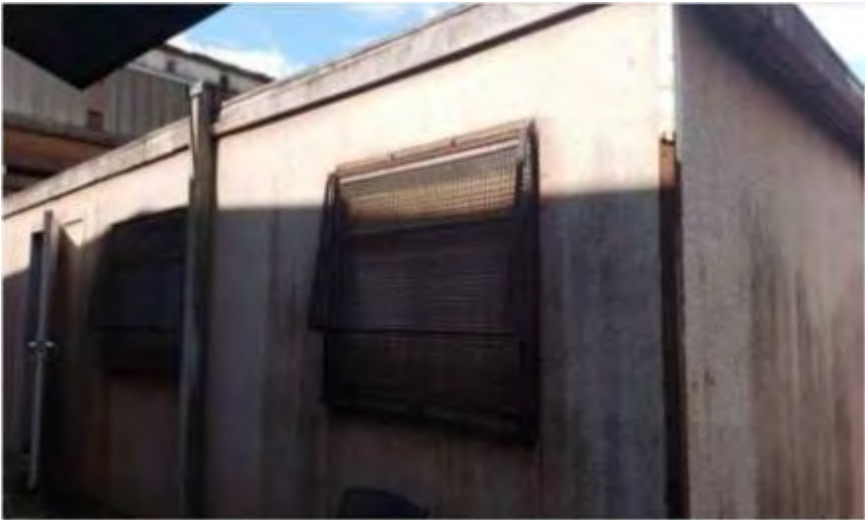
| Table 1 – Preliminary Roost Assessment (PRA) conducted on 25/07/2023 | |
|---|---|
| Building 3A-D | |

| Table 1 – Preliminary Roost Assessment (PRA) conducted on 25/07/2023 | |
|---|---|
| <p><b>Negligible</b></p> <p>Series of portacabins, in use. No features apart from a round hole into roof but thick with cobwebs. 3D has a flap of roofing felt at the edge but unlikely to be suitable.</p> | |

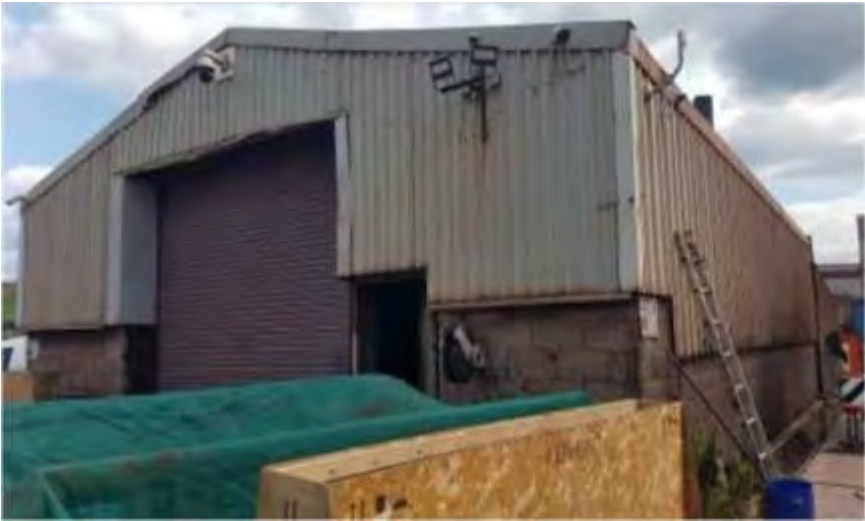
| Table 1 – Preliminary Roost Assessment (PRA) conducted on 25/07/2023 | |
|---|---|
| Building 9 | |

| Table 1 – Preliminary Roost Assessment (PRA) conducted on 25/07/2023 | |
|---|---|
| <b>Negligible</b><br>In use by Davies Crane Hire, corrugated metal shed structure with bright lighting | |

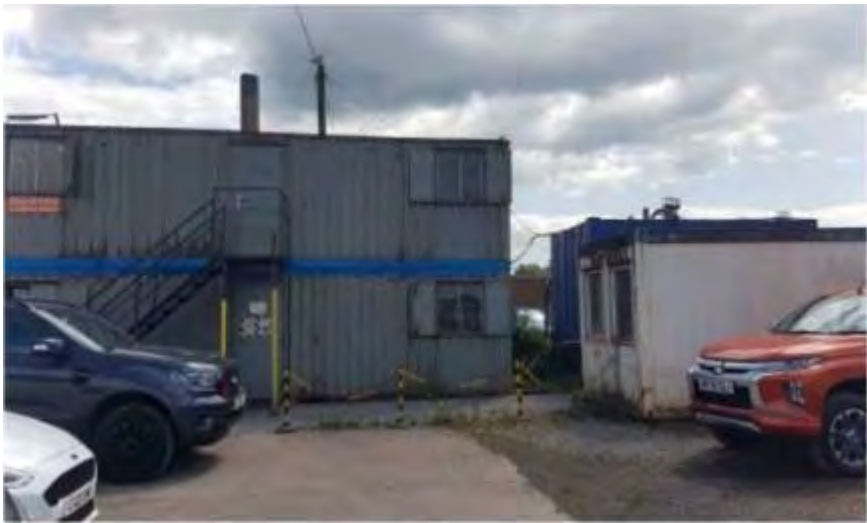
| Table 1 – Preliminary Roost Assessment (PRA) conducted on 25/07/2023 | |
|---|---|
| Building 10 | |

| Table 1 – Preliminary Roost Assessment (PRA) conducted on 25/07/2023 | |
|---|---|
| <p><b>Negligible</b><br/>Stacked container buildings in use. Lighting from 9 spills onto this area.</p> | |

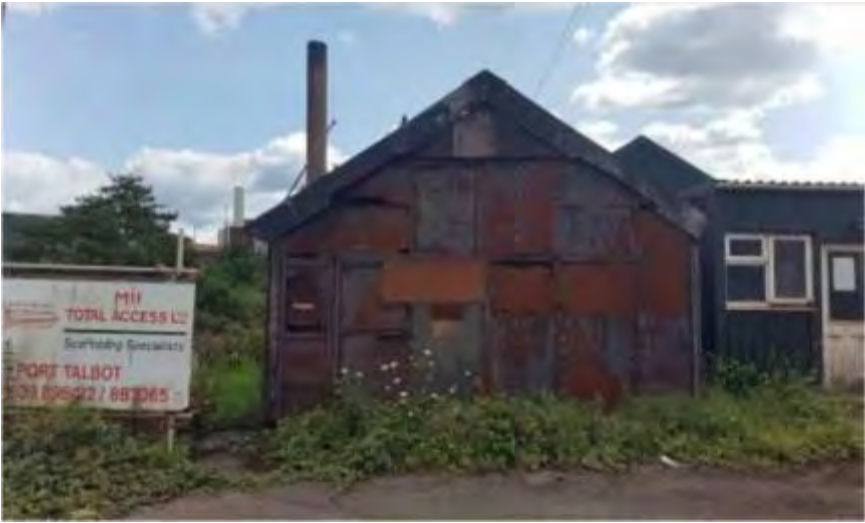
| Table 1 – Preliminary Roost Assessment (PRA) conducted on 25/07/2023 | |
|---|---|
| Building 12 | |

| Table 1 – Preliminary Roost Assessment (PRA) conducted on 25/07/2023 | |
|---|---|
| <p><b>Negligible</b><br/>Old metal shed, no longer in use, very corroded, holes in walls, but cobwebs across them.</p> | |

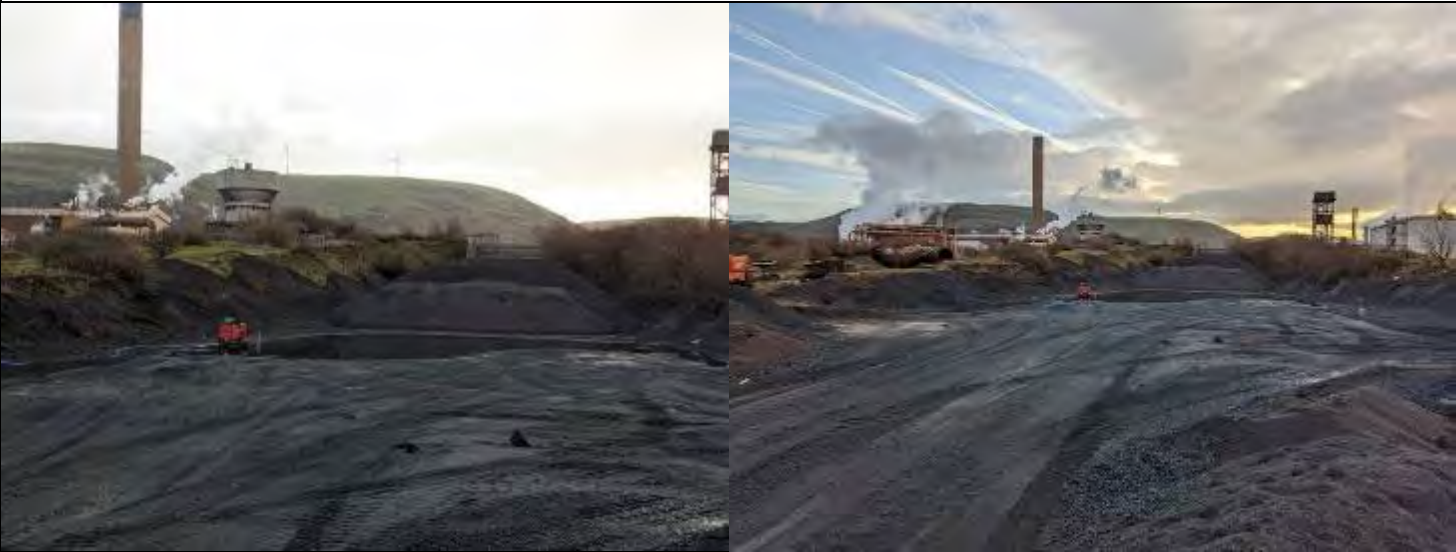
| Pond ID | Photo | Description |
|---|---|---|
| W1 | | <p>Standing surface water in raw materials storage area.</p> <p>Permanence: Temporary pooling during heavy rainfall.</p> <p>Water quality: Low and it is highly trafficked area.</p> <p>Depth in winter: 2-5cm maximum depth</p> |

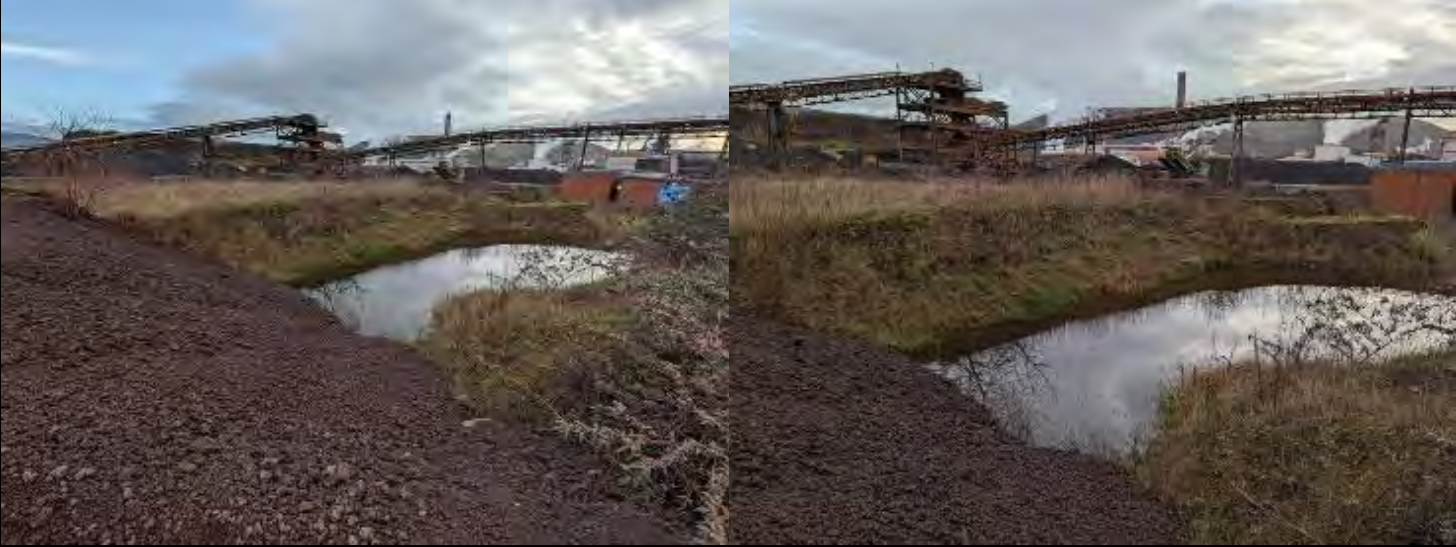
| Pond ID | Photo | Description |
|---|---|---|
| W2 | | <p>As above, standing surface water in raw materials storage area.</p> <p>Permanence: Less transient than W1 but is not present all year round</p> <p>Water quality: contaminated with iron ore stocks .</p> <p>Depth in winter: 2-5cm maximum</p> |
