**LanzaTech UK Limited**

**Project Dragon – Sustainable Aviation Fuel  
(SAF) Production Facility:  
Temporary Construction Area at Margam  
Wharf**

Desk Study

| ISSUE RECORD | | | | | |
|---|---|---|---|---|---|
| Report Reference: 2111006.006.01 | | | | | |

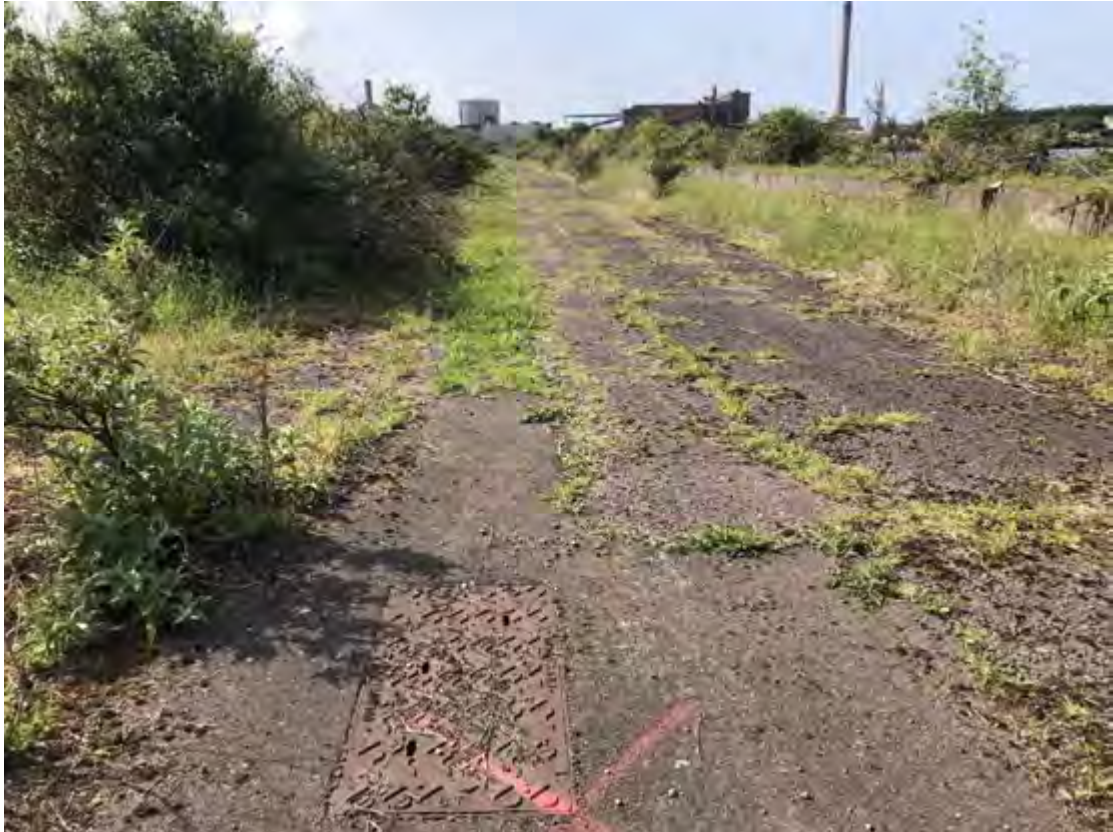
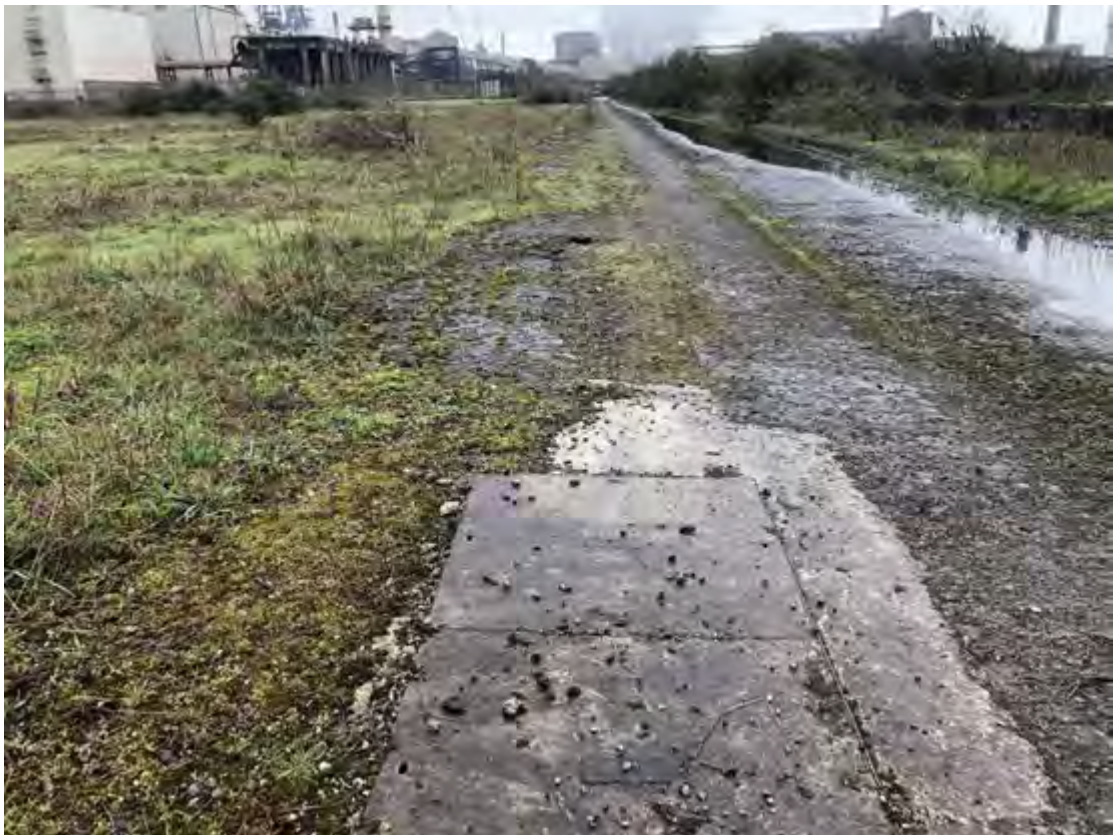
Photograph 3: View facing south, towards BT service cover located parallel to existing access road.

Photograph 4: View facing south, towards BT service cover located parallel to existing access road.

| Feature | Description |
|---|---|
| <b>General</b> | BT Services with marked service covers were recorded parallel to the entire access road starting from the north and ending at the southern site boundary ( <i>Appendix A - Photographs 3 &amp; 4</i> ).<br><br>A number of recently filled in gullies were observed within the site reconnaissance, generally filled with concrete and slag.<br><br>Located immediately offsite within the north-eastern site area, large interlocking concrete blocks, forming a former access road, have been observed which ran parallel to the site boundary and connected to the northernmost site boundary at a former entry/egress gate ( <i>Appendix A - Photographs 5 &amp; 6</i> ). |

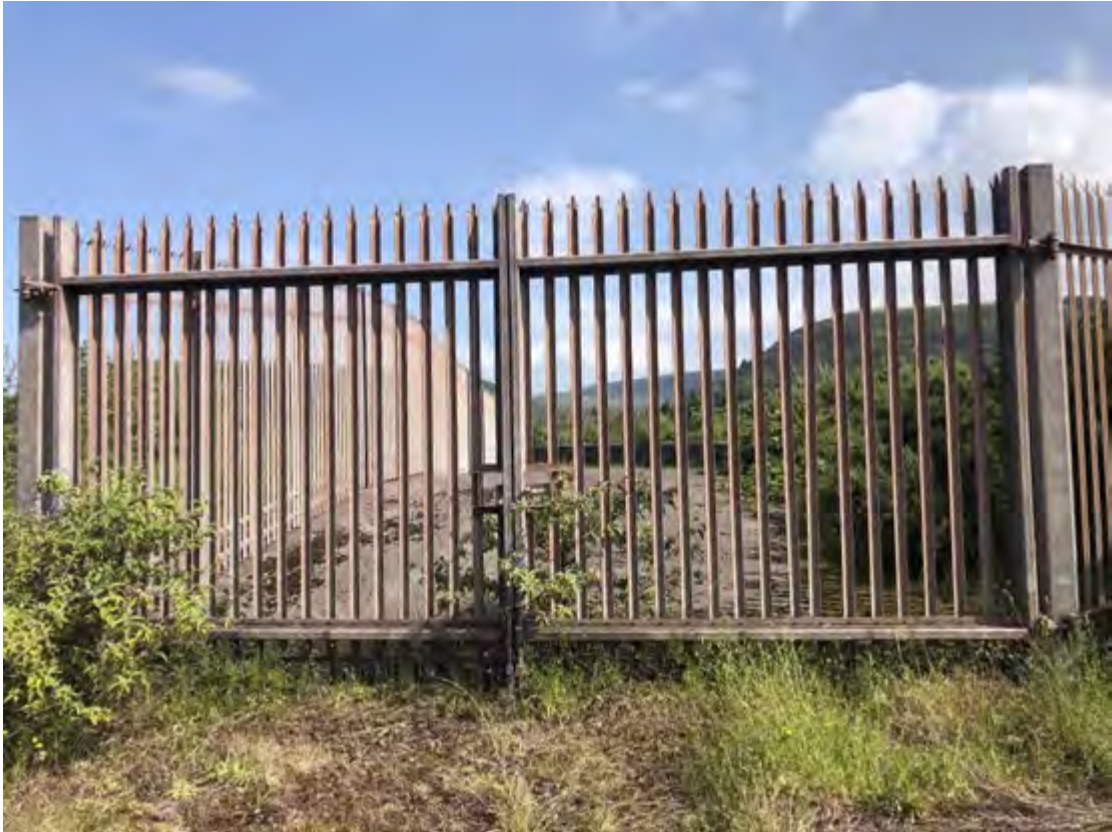
Photograph 5: View facing north, towards a gated entrance of a former access road.

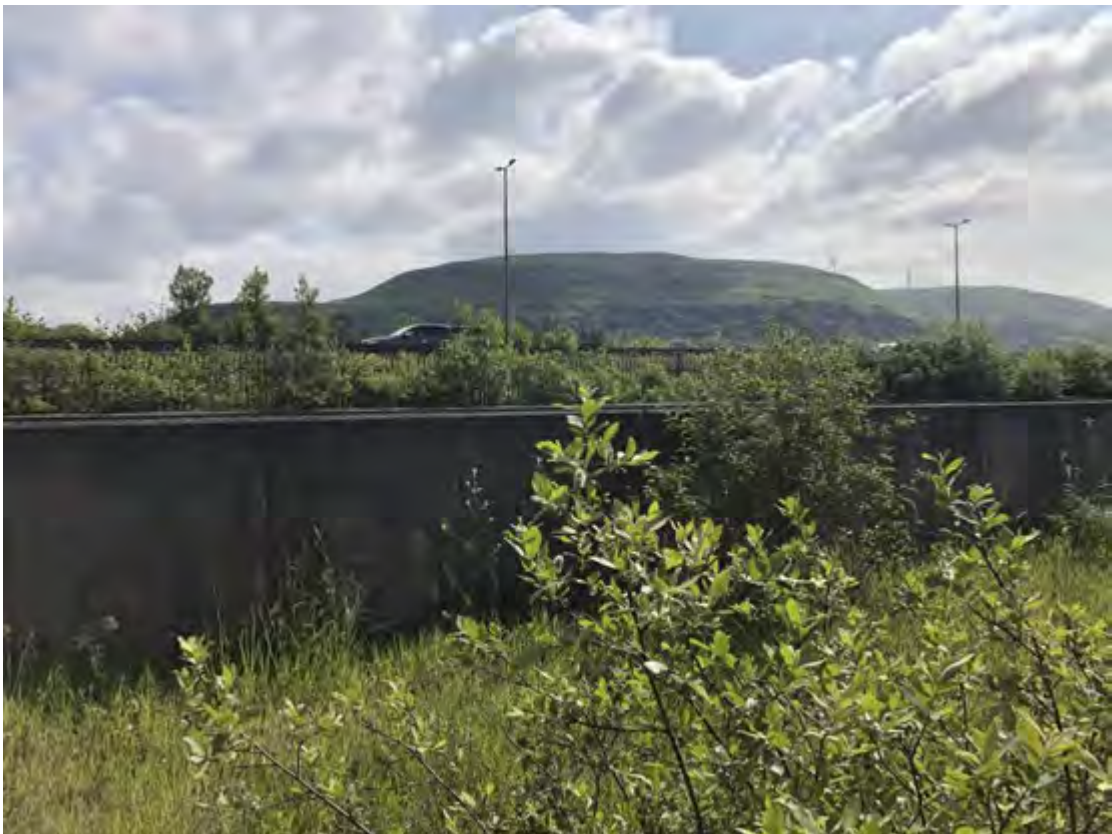
Photograph 6: Interlocking concrete blocks, located north and north-east of the site, formally used as an access road leading to the northern gate.

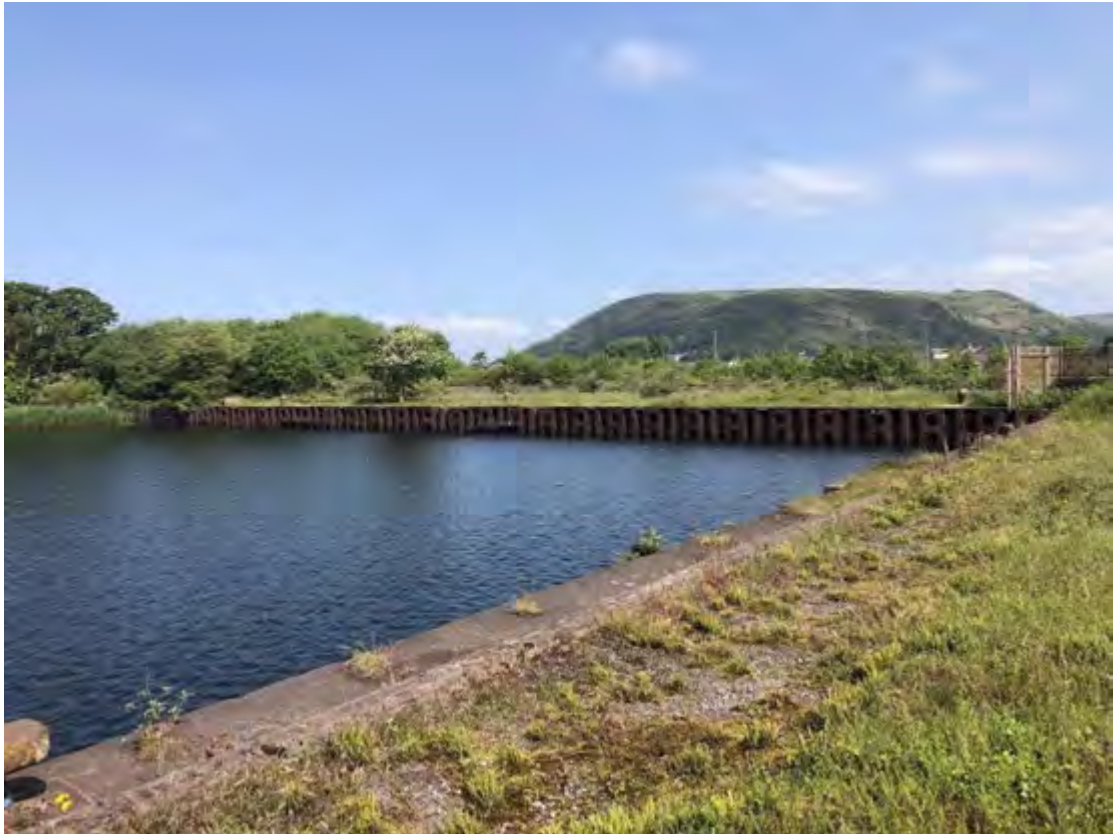
Photograph 7: View facing north-west towards neighbouring harbour wall made up of combined sheet piled wall.

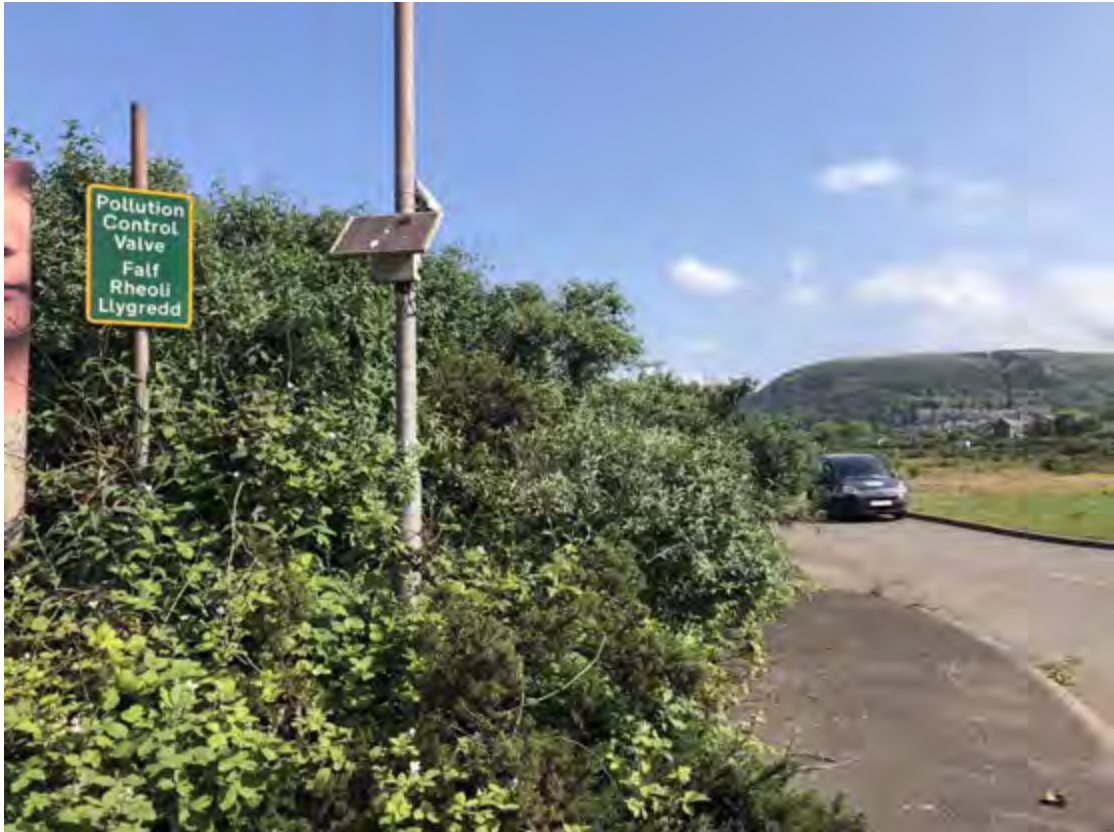
Photograph 9: A pollution control valve situated at the south-western site boundary.

| Feature | Description |
|---|---|
| <b>Site Drainage</b> | Surface water drains have been recorded within the road located south-west of the site. This was observed to merge to the south-western site boundary towards a pollution control valve also located at the south-western site boundary which flows through to a cofferdam immediately north-west ( <i>Appendix A - Photographs 9 to 12</i> ).<br><br>Within the central site area, an area observed to have been fenced off with heras fencing comprised large metal manhole covers, which suggests the presence of a large drainage/service chamber - National Grid Reference: 277059, 188726 ( <i>Appendix A - Photograph 13</i> ).<br><br>Located within the south-eastern site area, an exposed plastic pipe was noted, generally being above ground level and running the south-eastern onsite boundary. Furthermore, the entire western site boundary was observed to boarder a harbour wall forming the wharf ( <i>Appendix A - Photograph 14</i> ). |

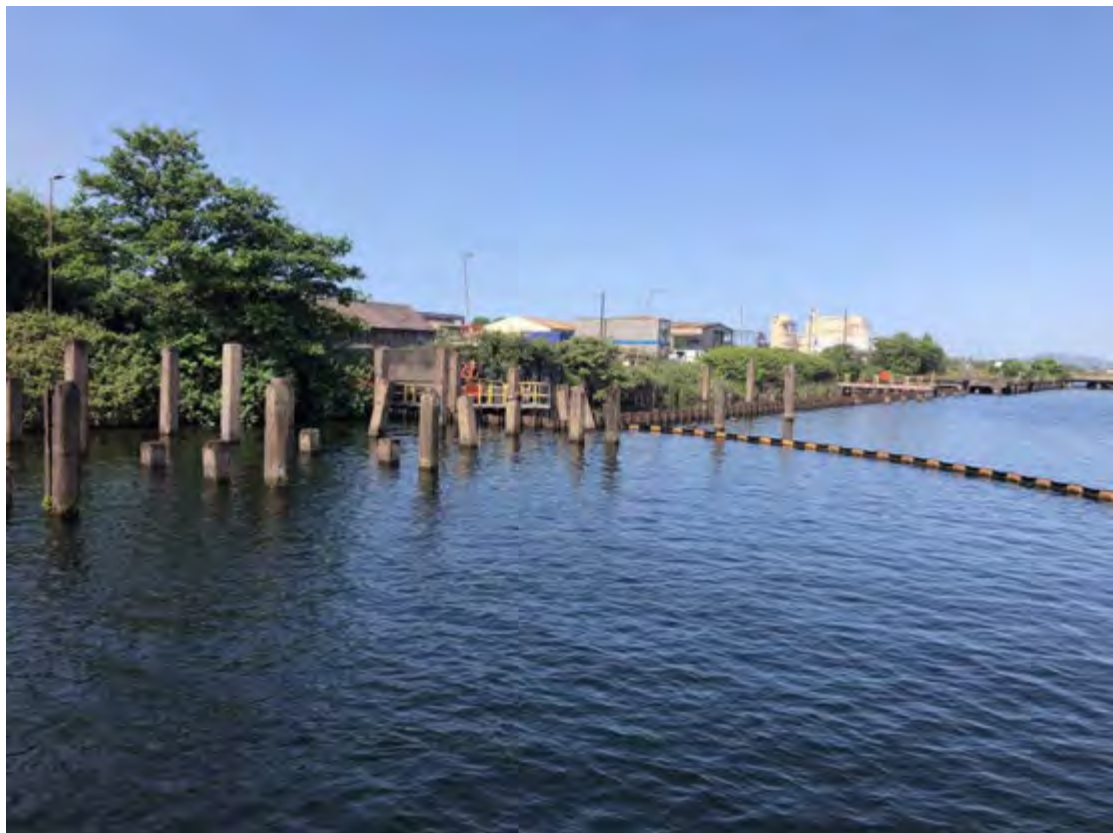
Photograph 10: View from southern site area, facing south-west towards existing cofferdam and remaining stone columns.

| Feature | Description |
|---|---|
| <b>Ground Stability Hazards</b> | No visual evidence of ground subsidence/ movement observed or any areas of sunken ground noted / cracks in retaining walls/ landslip evidence/ creep etc. note on the site itself.<br><br>In addition, located south-west offsite, the retaining wall of the wharf were observed to have a partial collapsed retaining wall and gradual tilting of remaining stone columns within the cofferdam ( <i>Appendix A - Photographs 10 to 12</i> ). |

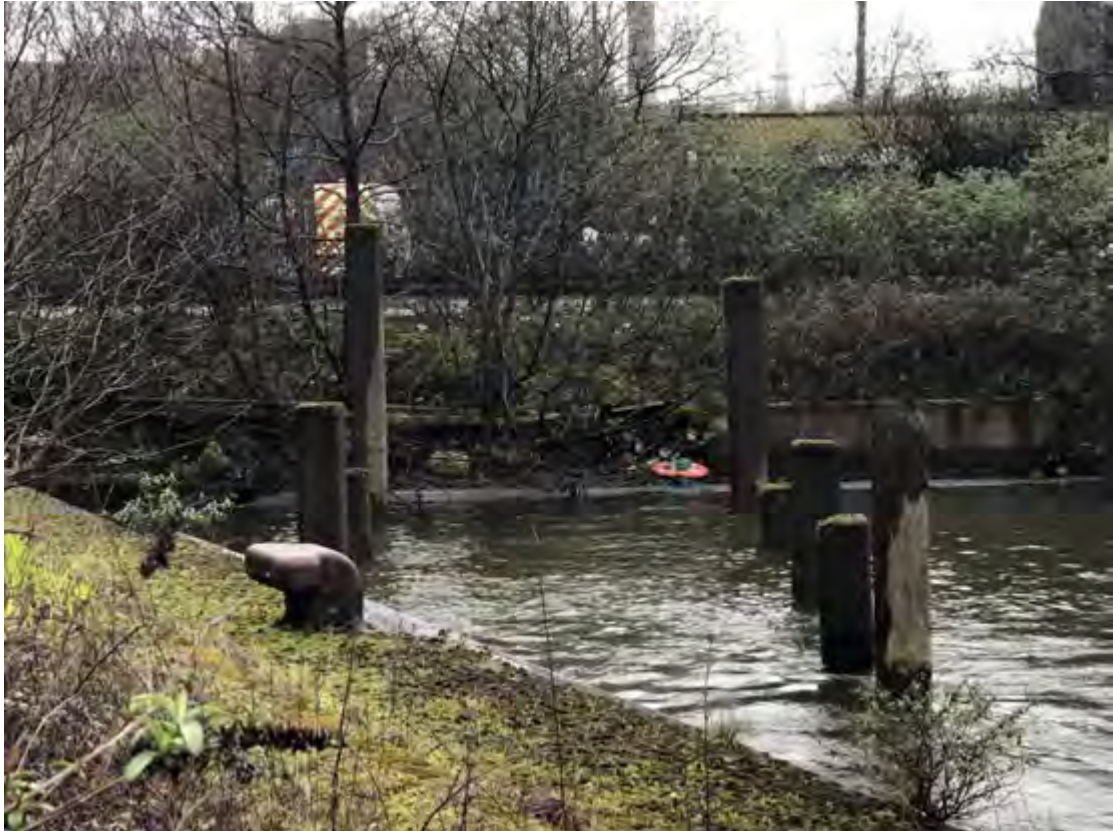
Photograph 11: View from harbour wall, facing south-west towards damaged retaining wall – *Photograph taken 29 April 2023.*

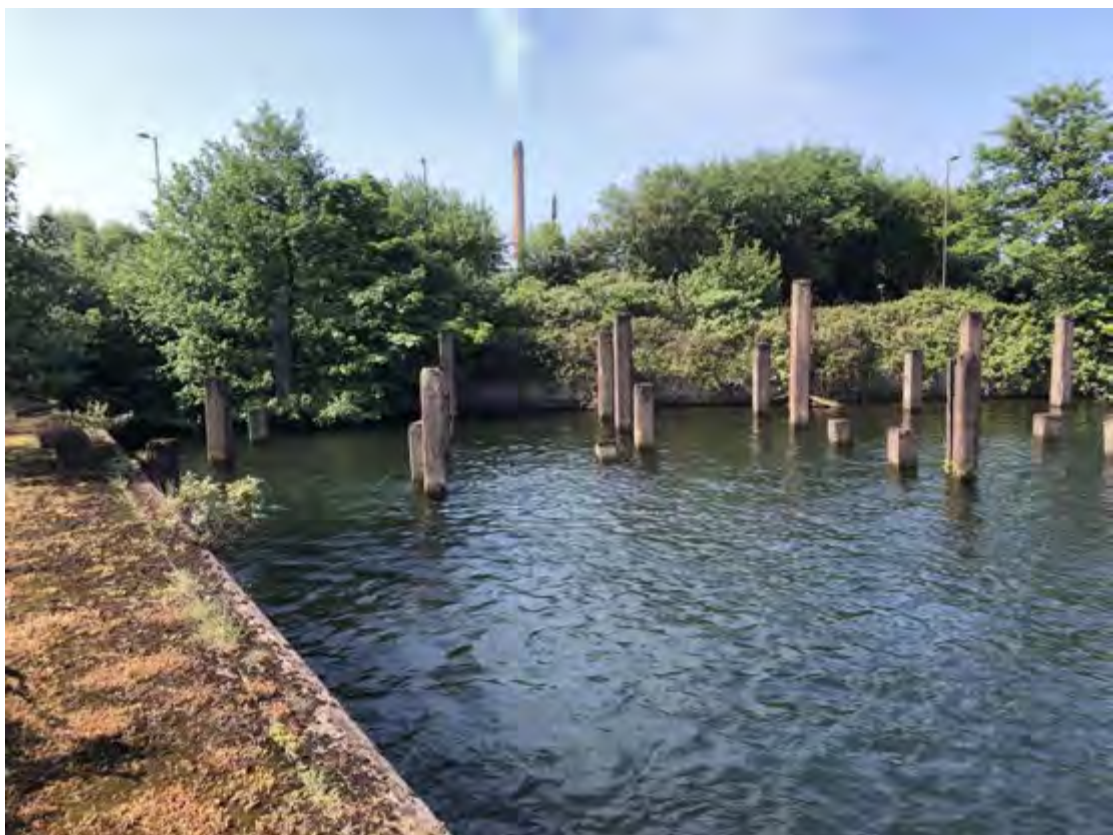
Photograph 12: View from harbour wall, facing south-west towards damaged retaining wall (now covered with dense vegetation) – *Photograph taken 25 May 2023.*

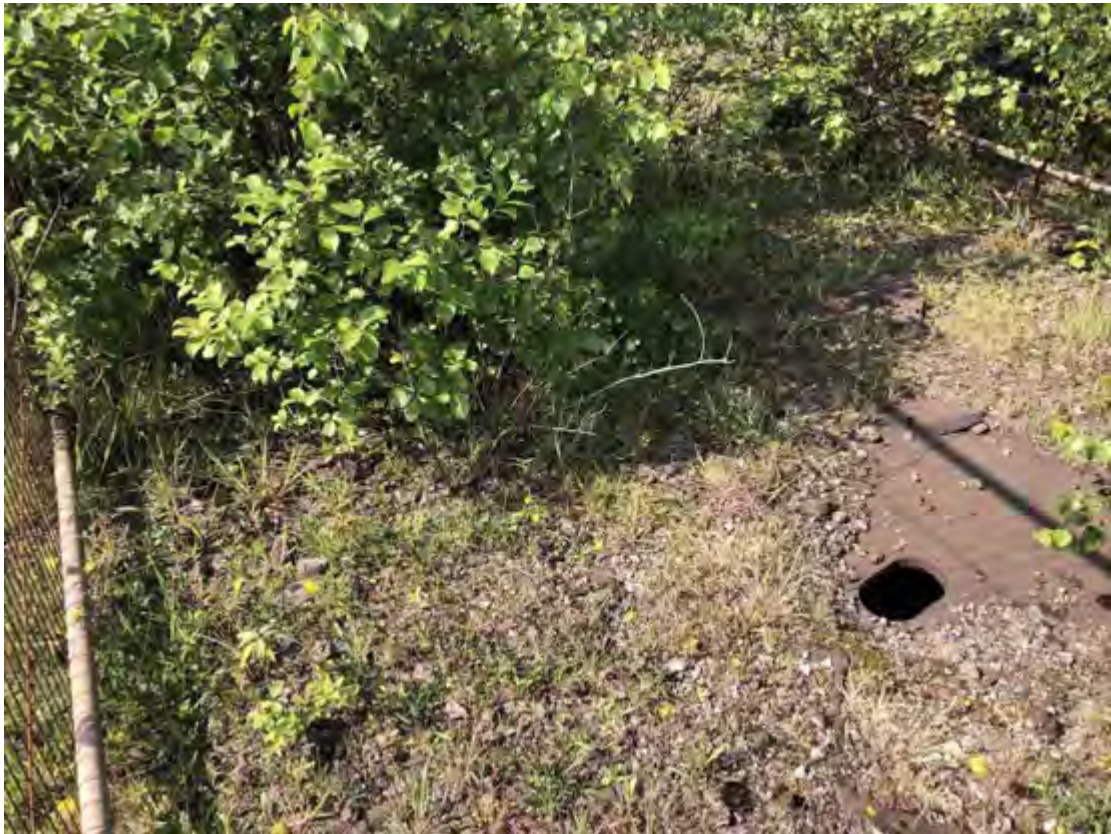
Photograph 13: View of large metal covers currently fenced off and located within the western site area.

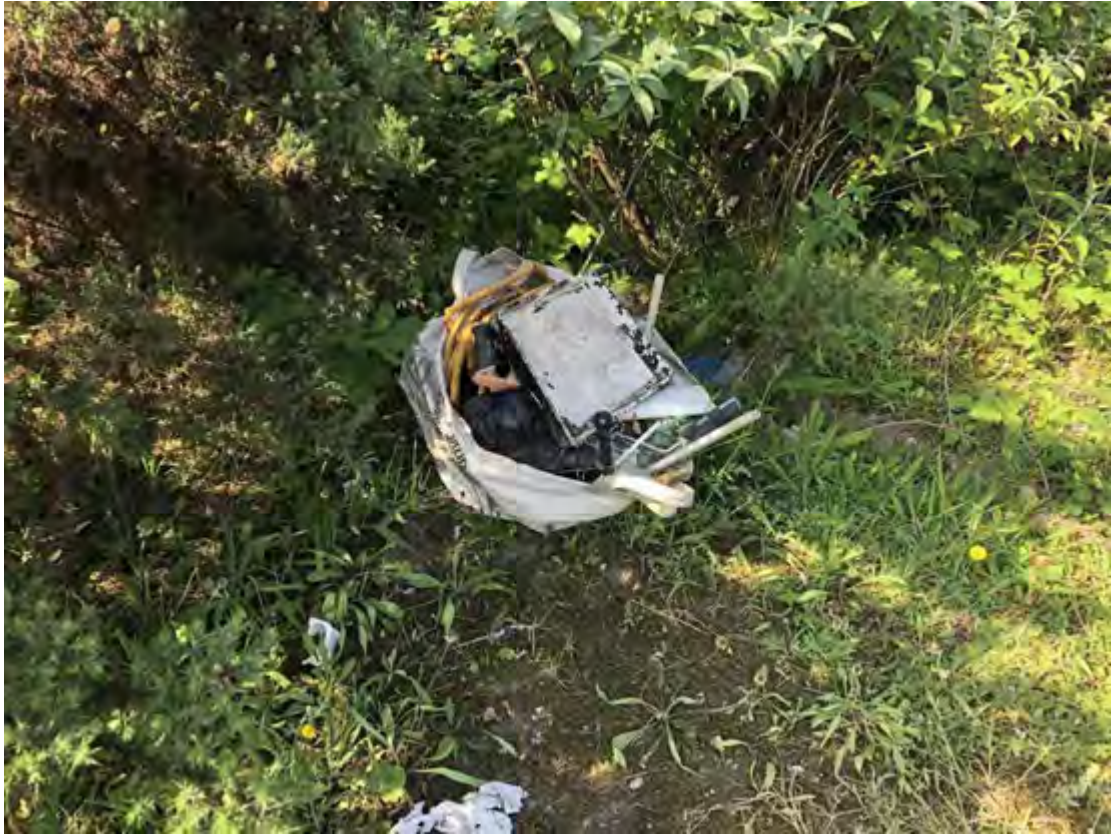
Photograph 15: Observed fly tipping within the southern site area.

| Feature | Description |
|---|---|
| <b>Evidence of Potential Contamination</b> | No visual/olfactory evidence of gross contamination (stressed vegetation, stained ground etc) has been observed. However, localised areas have been observed to comprise materials from recent fly tipping ( <i>Appendix A - Photograph 15</i> ). |

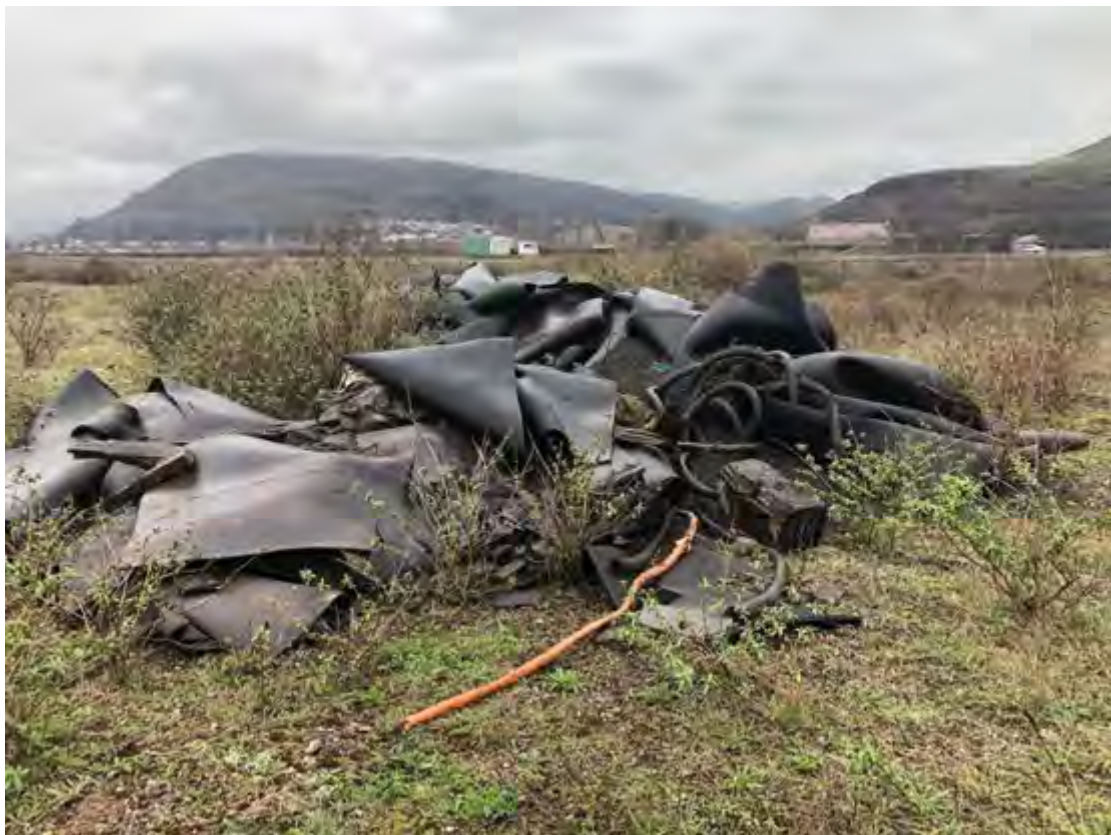
Photograph 16: Stockpiles of waste materials observed close to the access road along the front of the wharf.

| Feature | Description |
|---|---|
| <b>Fuel, Hazardous Chemicals and Waste Materials Storage</b> | No AST, USTs, contents, or containers etc. has been observed on site.<br>A number of stockpiles, comprising building rubble and other waste materials have been observed close to the access route along the front of the wharf. In addition, to a lesser extent localised areas have been observed to comprise materials from recent fly tipping. ( <i>Appendix A</i> ) |
