# Figures: 1 - 7

Project Dragon, Port Talbot

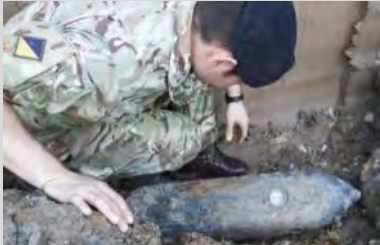
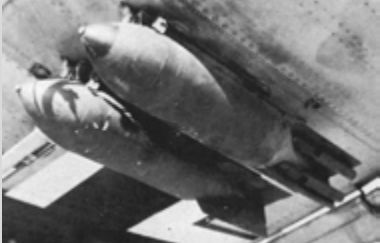
Variants:

8 x variants. Additional fittings: Kopfring nose for limited penetration and Stabbo nose for dive-bombing.

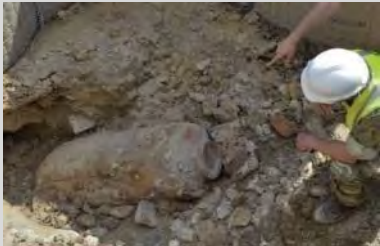
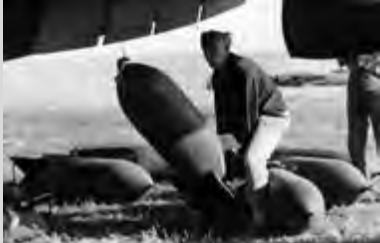
SC 250

Variants:

8 x variants. Kopfring nose for limited penetration. Stabbo nose for dive-bombing.

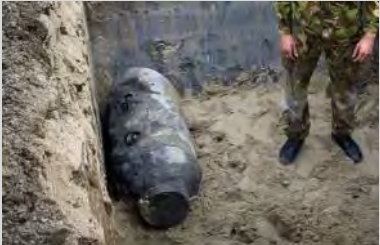
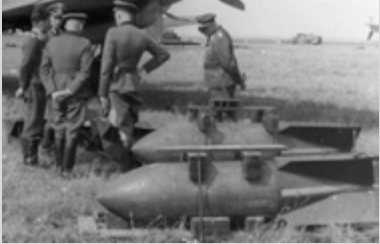
SC 500

Variants:

3 x variants. Kopfring nose for limited penetration.

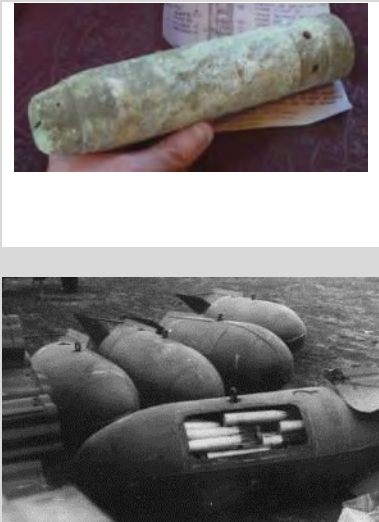
**Operation:** Small percussion charge ignites Thermite (>1,000°C burn).

**Variants:** Most common variant: B 2EZ (2kg) included a small HE charge

**Remarks:** Drop containers varied in size. The smallest cluster bomb held 36 x B-1Es and the largest 620 x B-1Es.

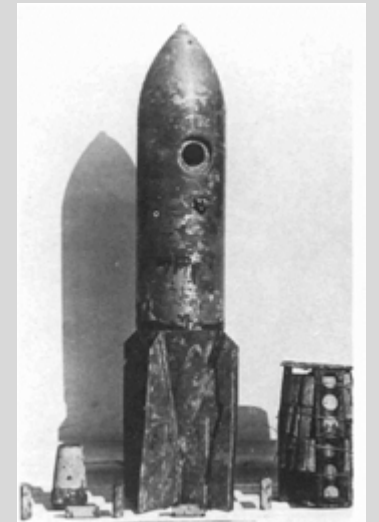
Spreng-Brand C50 - Fire Pot

**Bomb Weight:** 34kg (75lb)

**Appearance:** Bomb body and tail painted grey/green or pale blue with red base plug and red or green incendiary markings. Steel construction.

**Operation:** A charge blows off the base plate, firing a plume of incendiary mixture 100 yds. Approx 1 second later the HE charge detonates.

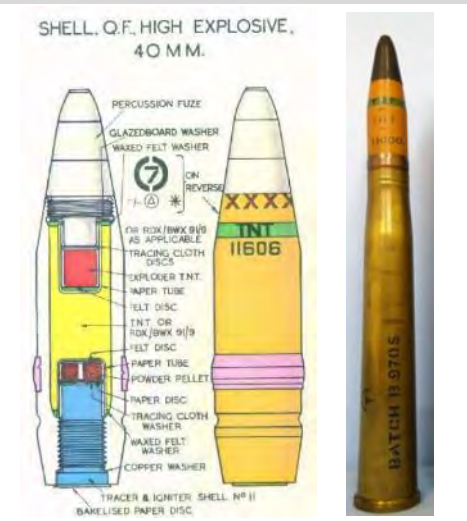
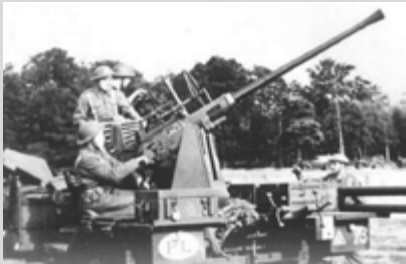
LAA Battery - 40mm Bofors Shell

Shell Weight: 0.84kg

Ceiling: 7,000m

Variants: HE or AP shells. Both with rear tracer compartment

The 40mm Bofors gun could fire 120 x HE shells / minute to a ceiling of 1,800m. Each shell was designed to self-destruct if it didn’t strike an aircraft, however, inevitably some failed and fell back to earth.

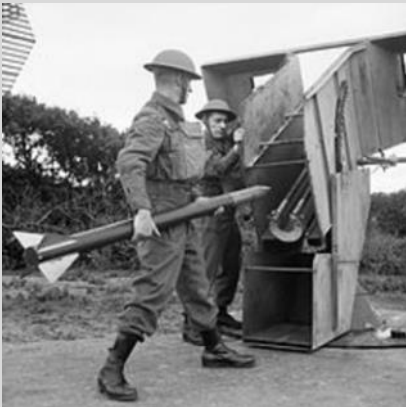
Z Battery - 3” U.P Rocket

Rocket Weight: 24.5kg

Ceiling: 6,770m

Operation: Fired from single, tandem and (later) 36 x rail launchers (Z Batteries). Limited use throughout the UK.
