**Regener8 Power**

# **Rhigos Road Solar Farm** **Historic Environment** **Assessment**

**Final report**

April 2023

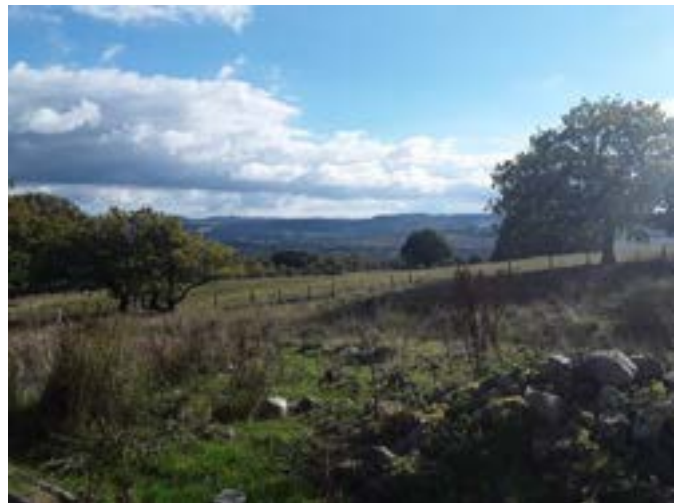
*Plate 1: View south-west towards the Site from East Fforest Fawr and Mynydd-y-Glog historic landscape, near Nant Moel reservoir*

**4.25** Although visible from this asset, the Site is located 2.6km away and perceived as part of the wider area of industrial development within which it sits. Furthermore, the topography of the Site and the orientation of the solar panels (facing south) are factors that will contribute to the view of the Site as part of the developed landscape. Therefore, the Site will not represent a distraction for the understanding and appreciation of the historic asset and its significance will not be affected.

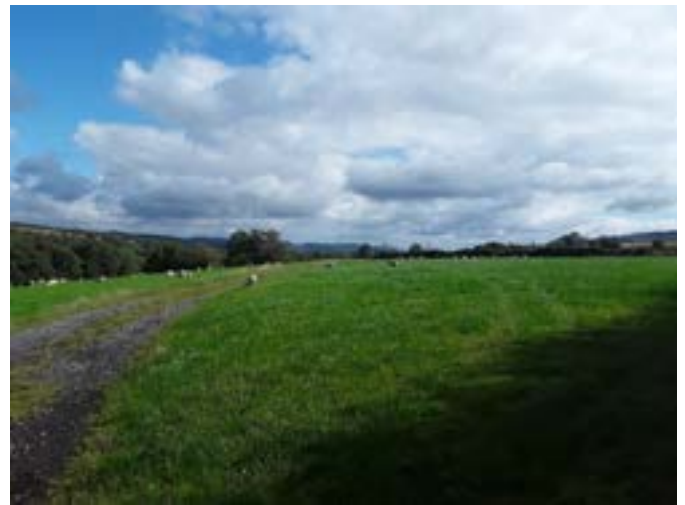
*Plate 2: View looking east towards the Site from north-west from public path near the cluster of Bronze Age Cairns.*

**4.33** During operation, the Proposed Development would be perceptible in eastern views from these historic assets, it would be seen within the context of an existing industrialised landscape. In addition, the elements of the historic asset's setting which contribute most to their heritage significance, including their relationship to each other, would not be affected.
