# Rhigos Road Solar Farm Scheme

Preliminary Risk Assessment

315223 R01 (04)

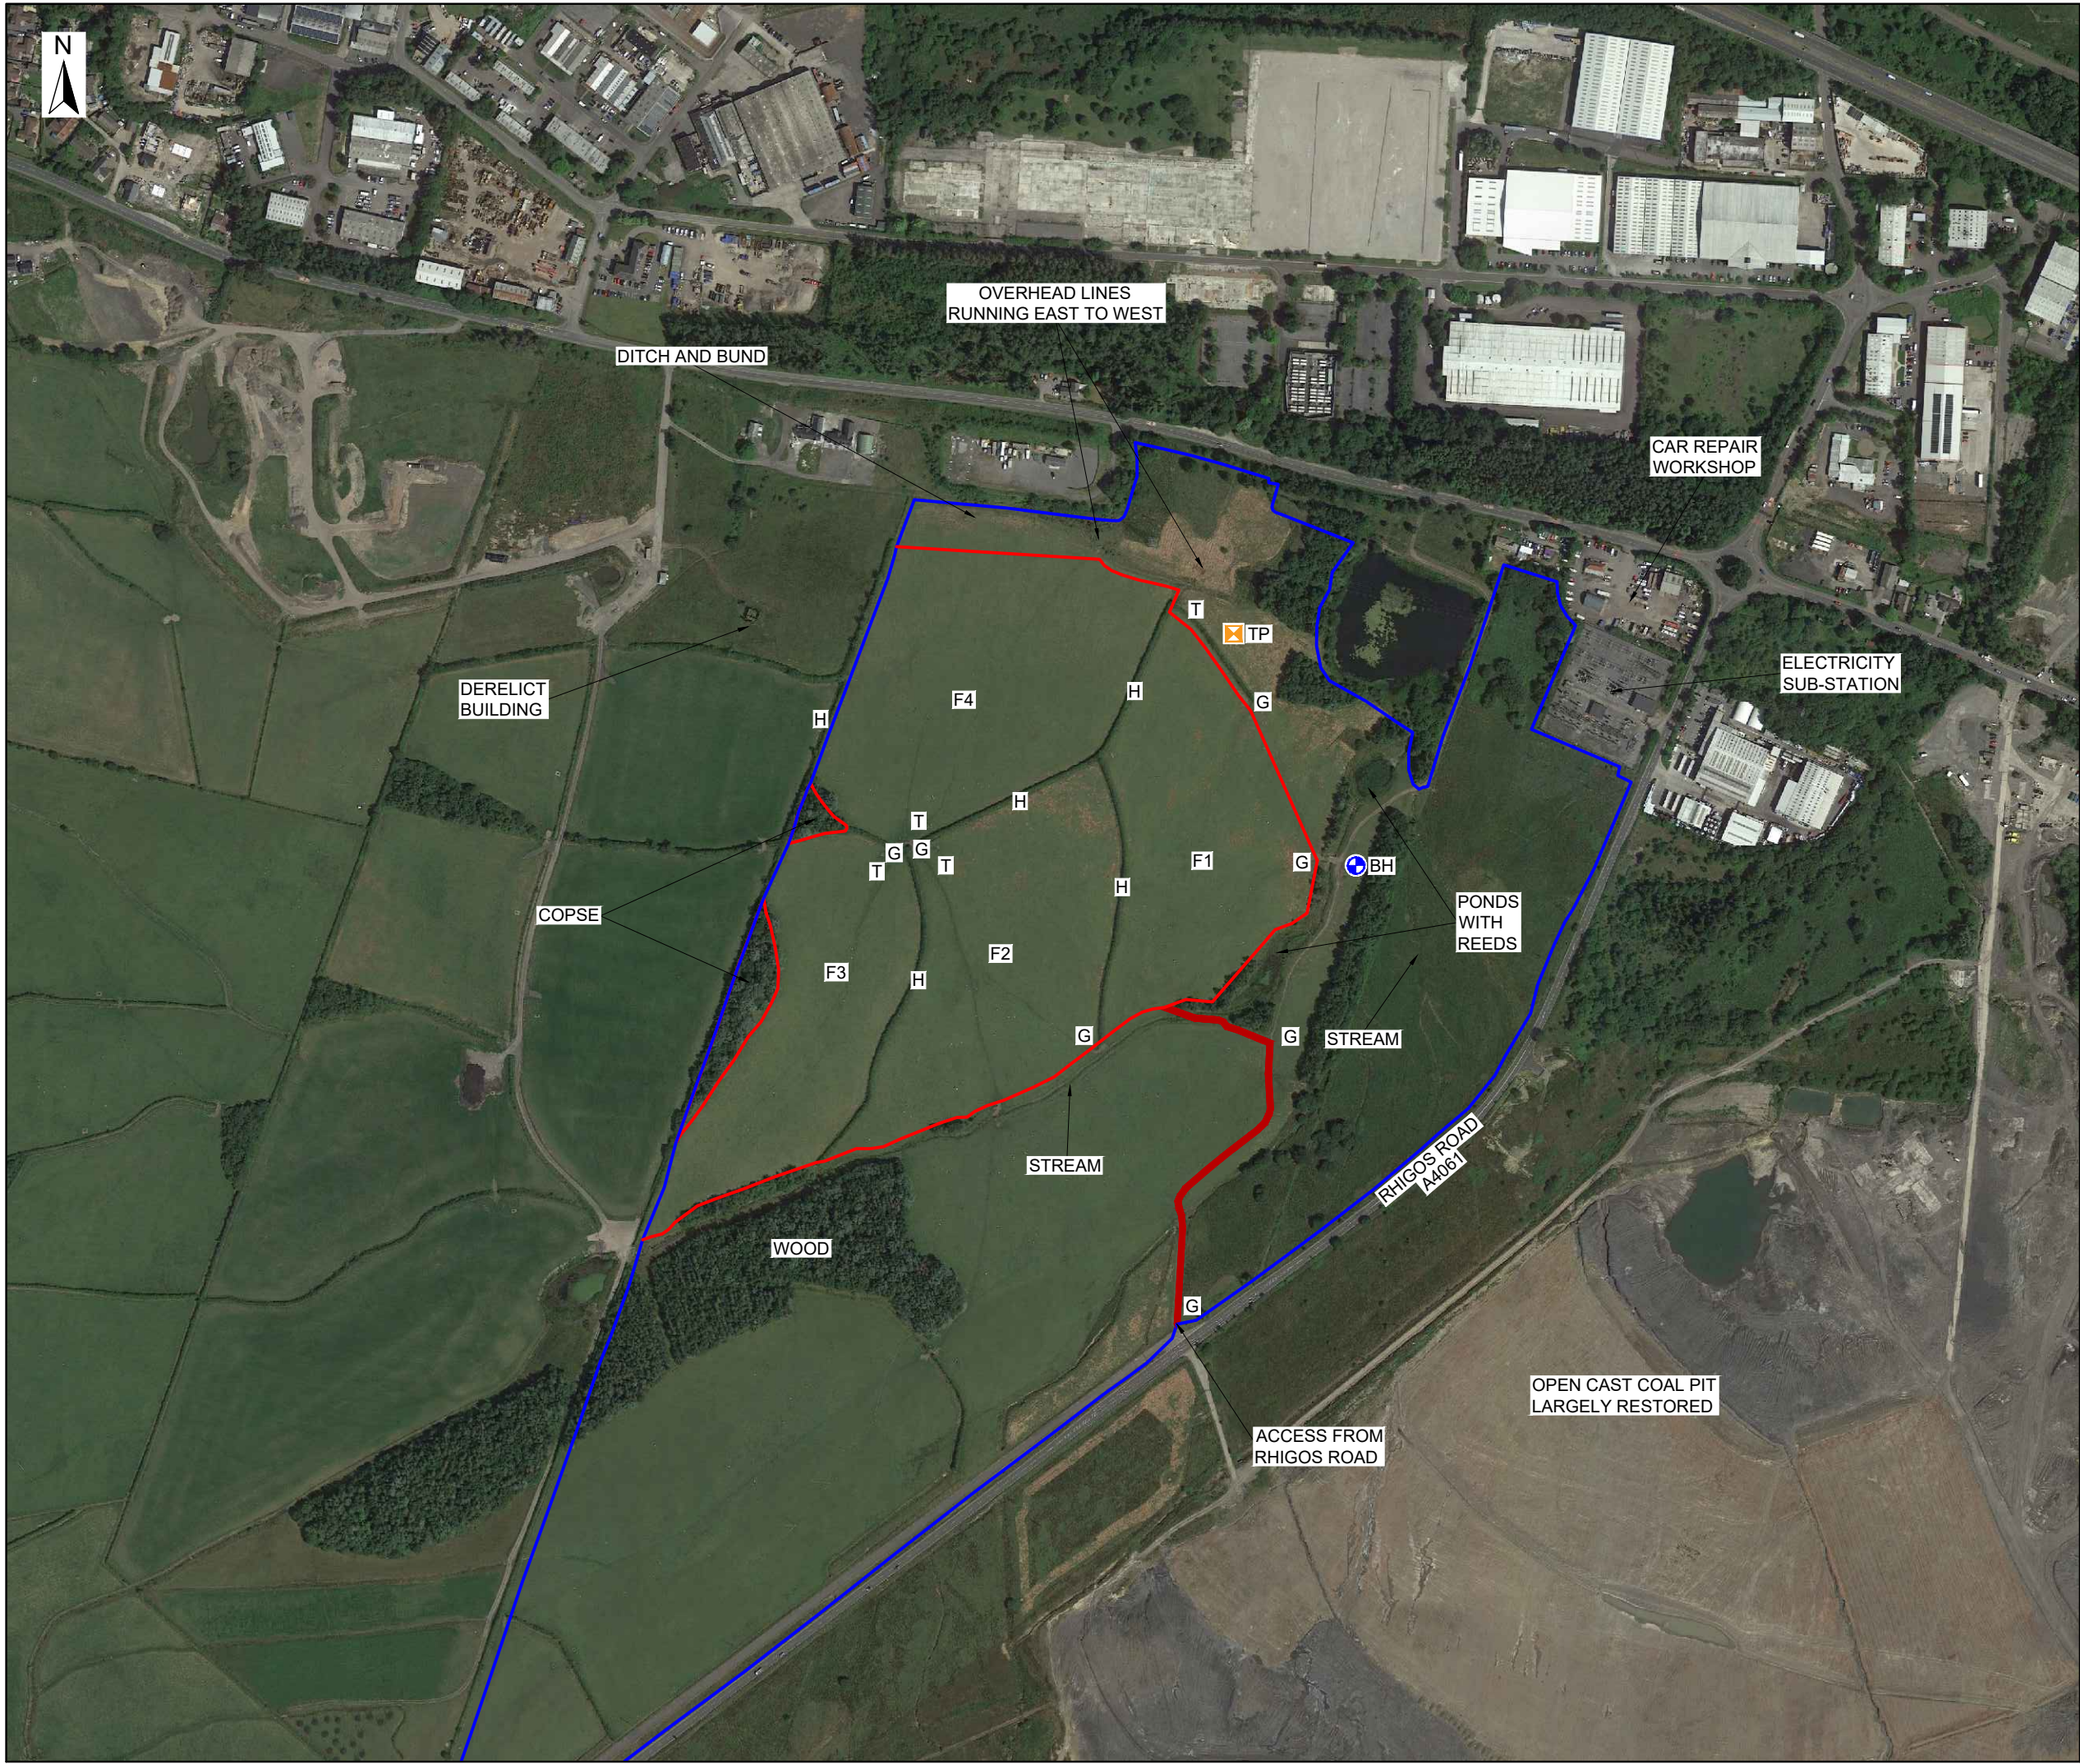
- Site Boundary
- Land Ownership
- Access Track - 5m width
- Historical Trial pit location
- Historical Borehole location
- F Field
- T Trough
- G Field Gate
- H Hedge
