# **Rhigos Road Solar Farm Scheme**

Preliminary Coal Mining Risk Assessment

315223 R02 (03)

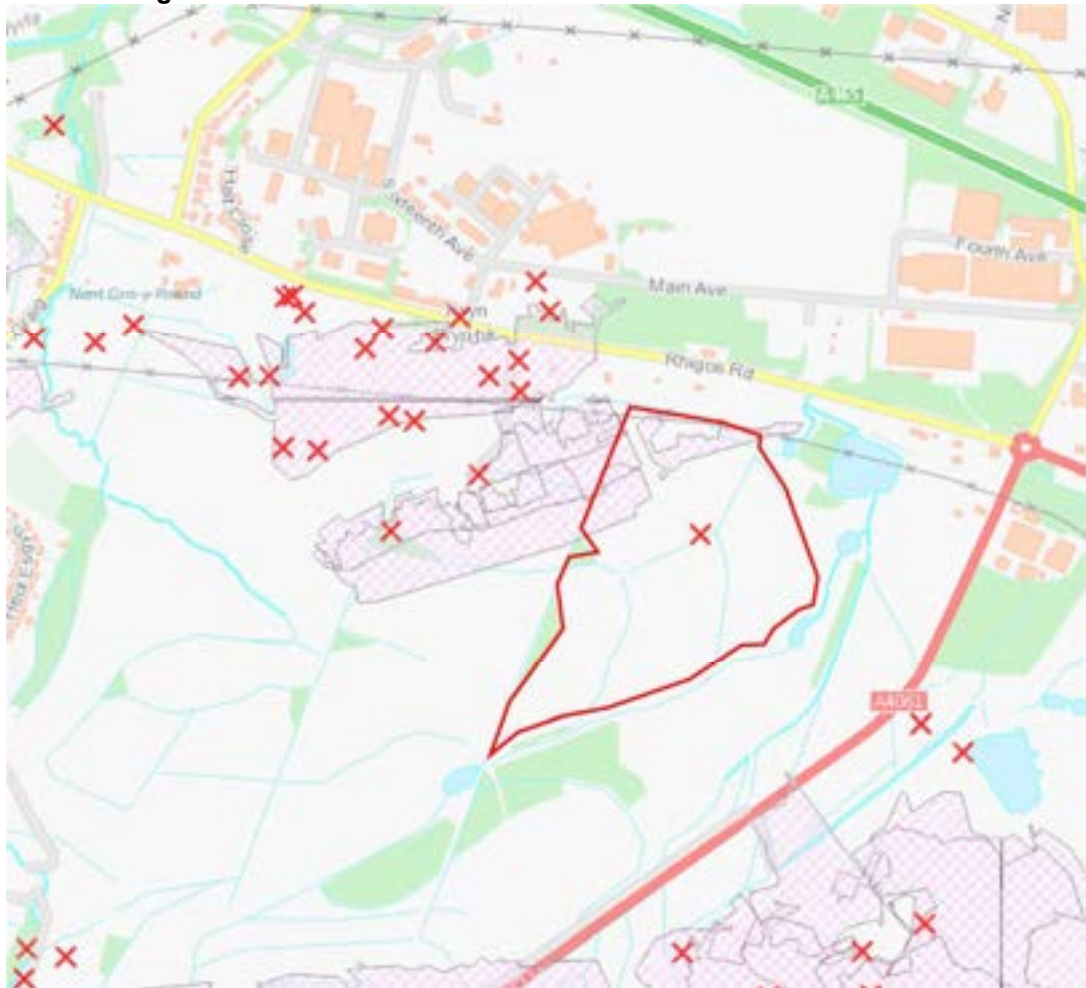
**Plate 1: Coal Authority interactive viewer extract showing the extent of underground mineworkings in relation to the site area**

Comparing the overlay image presented in Plate 1, overleaf, and opencast plan 16617 presented in Appendix D, it is interpreted that the majority of region of the site subject to underground mining will have been excavated during opencast workings. However, a small region in the far north of the site appears to have been undermined and not excavated during opencast workings, indicating that mining voids and ground stability hazards may still be active in this area.

*Note: Active filters included in the extract comprise: Mine Entry, Parent Phase, and Underground Working.*

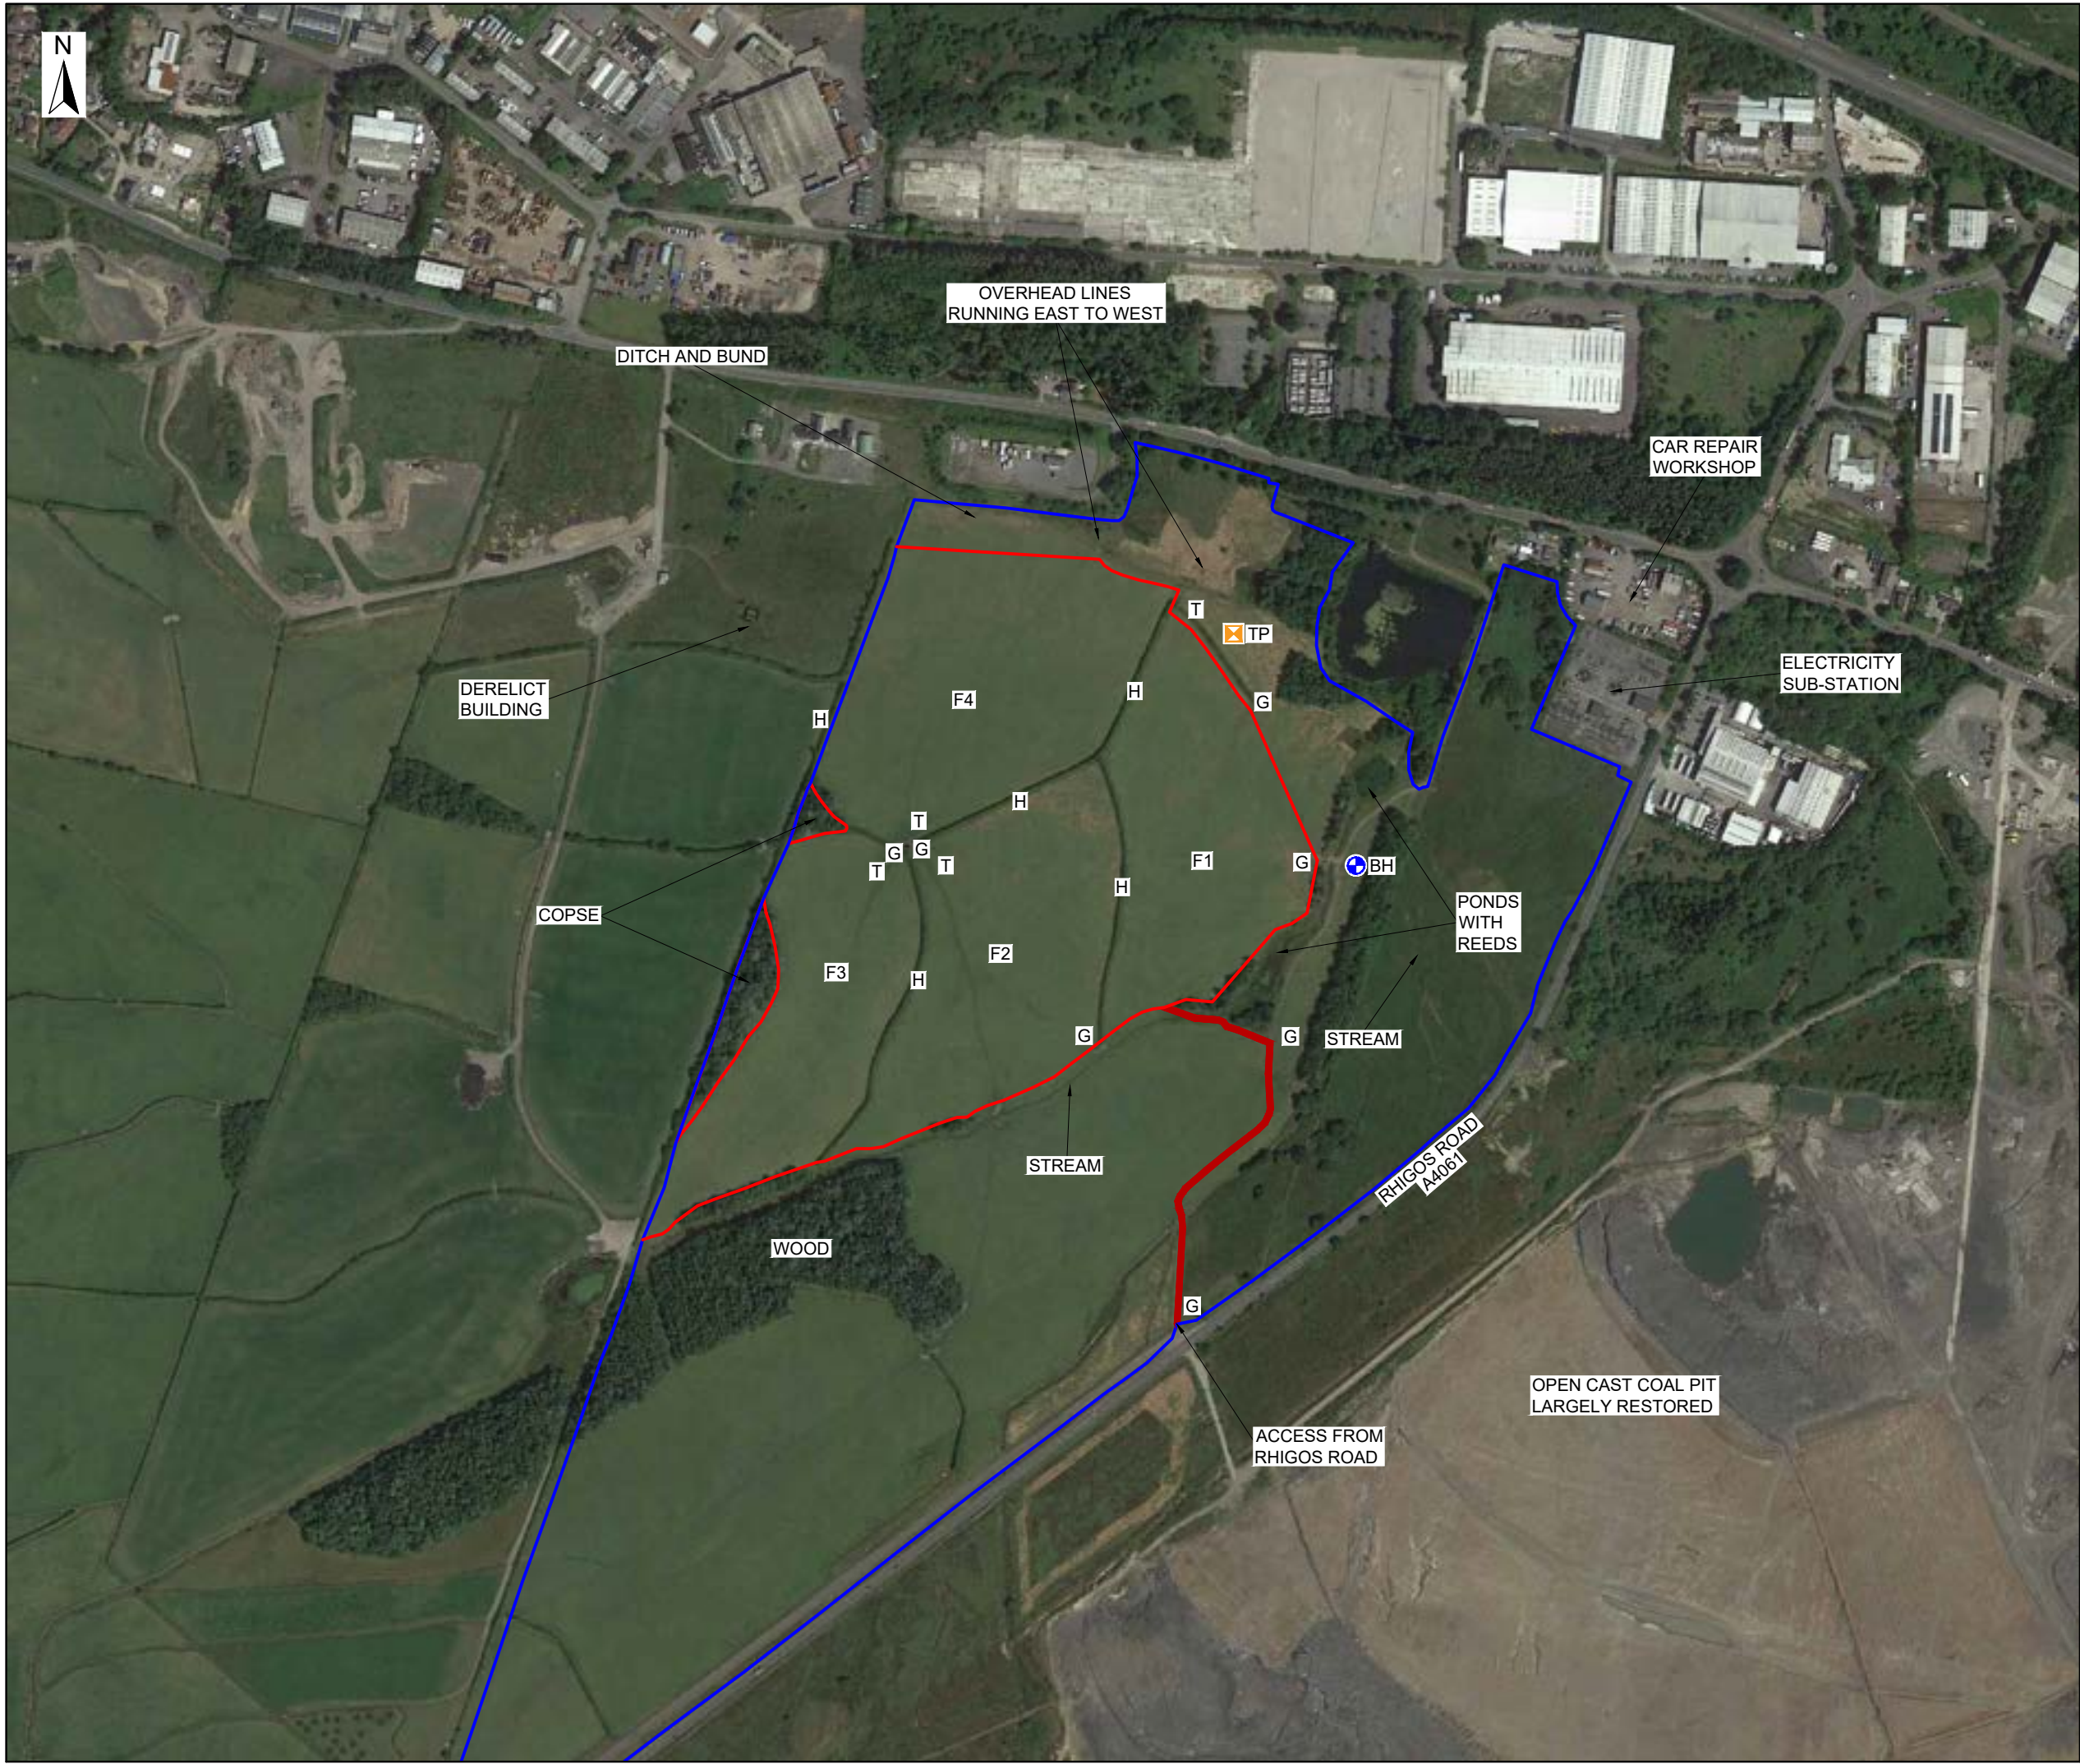
| Drawing Number |
|---|
| FIGURE 1 |

Site location details are presented in Table 1, below, and a site location plan is presented in Figure 1.

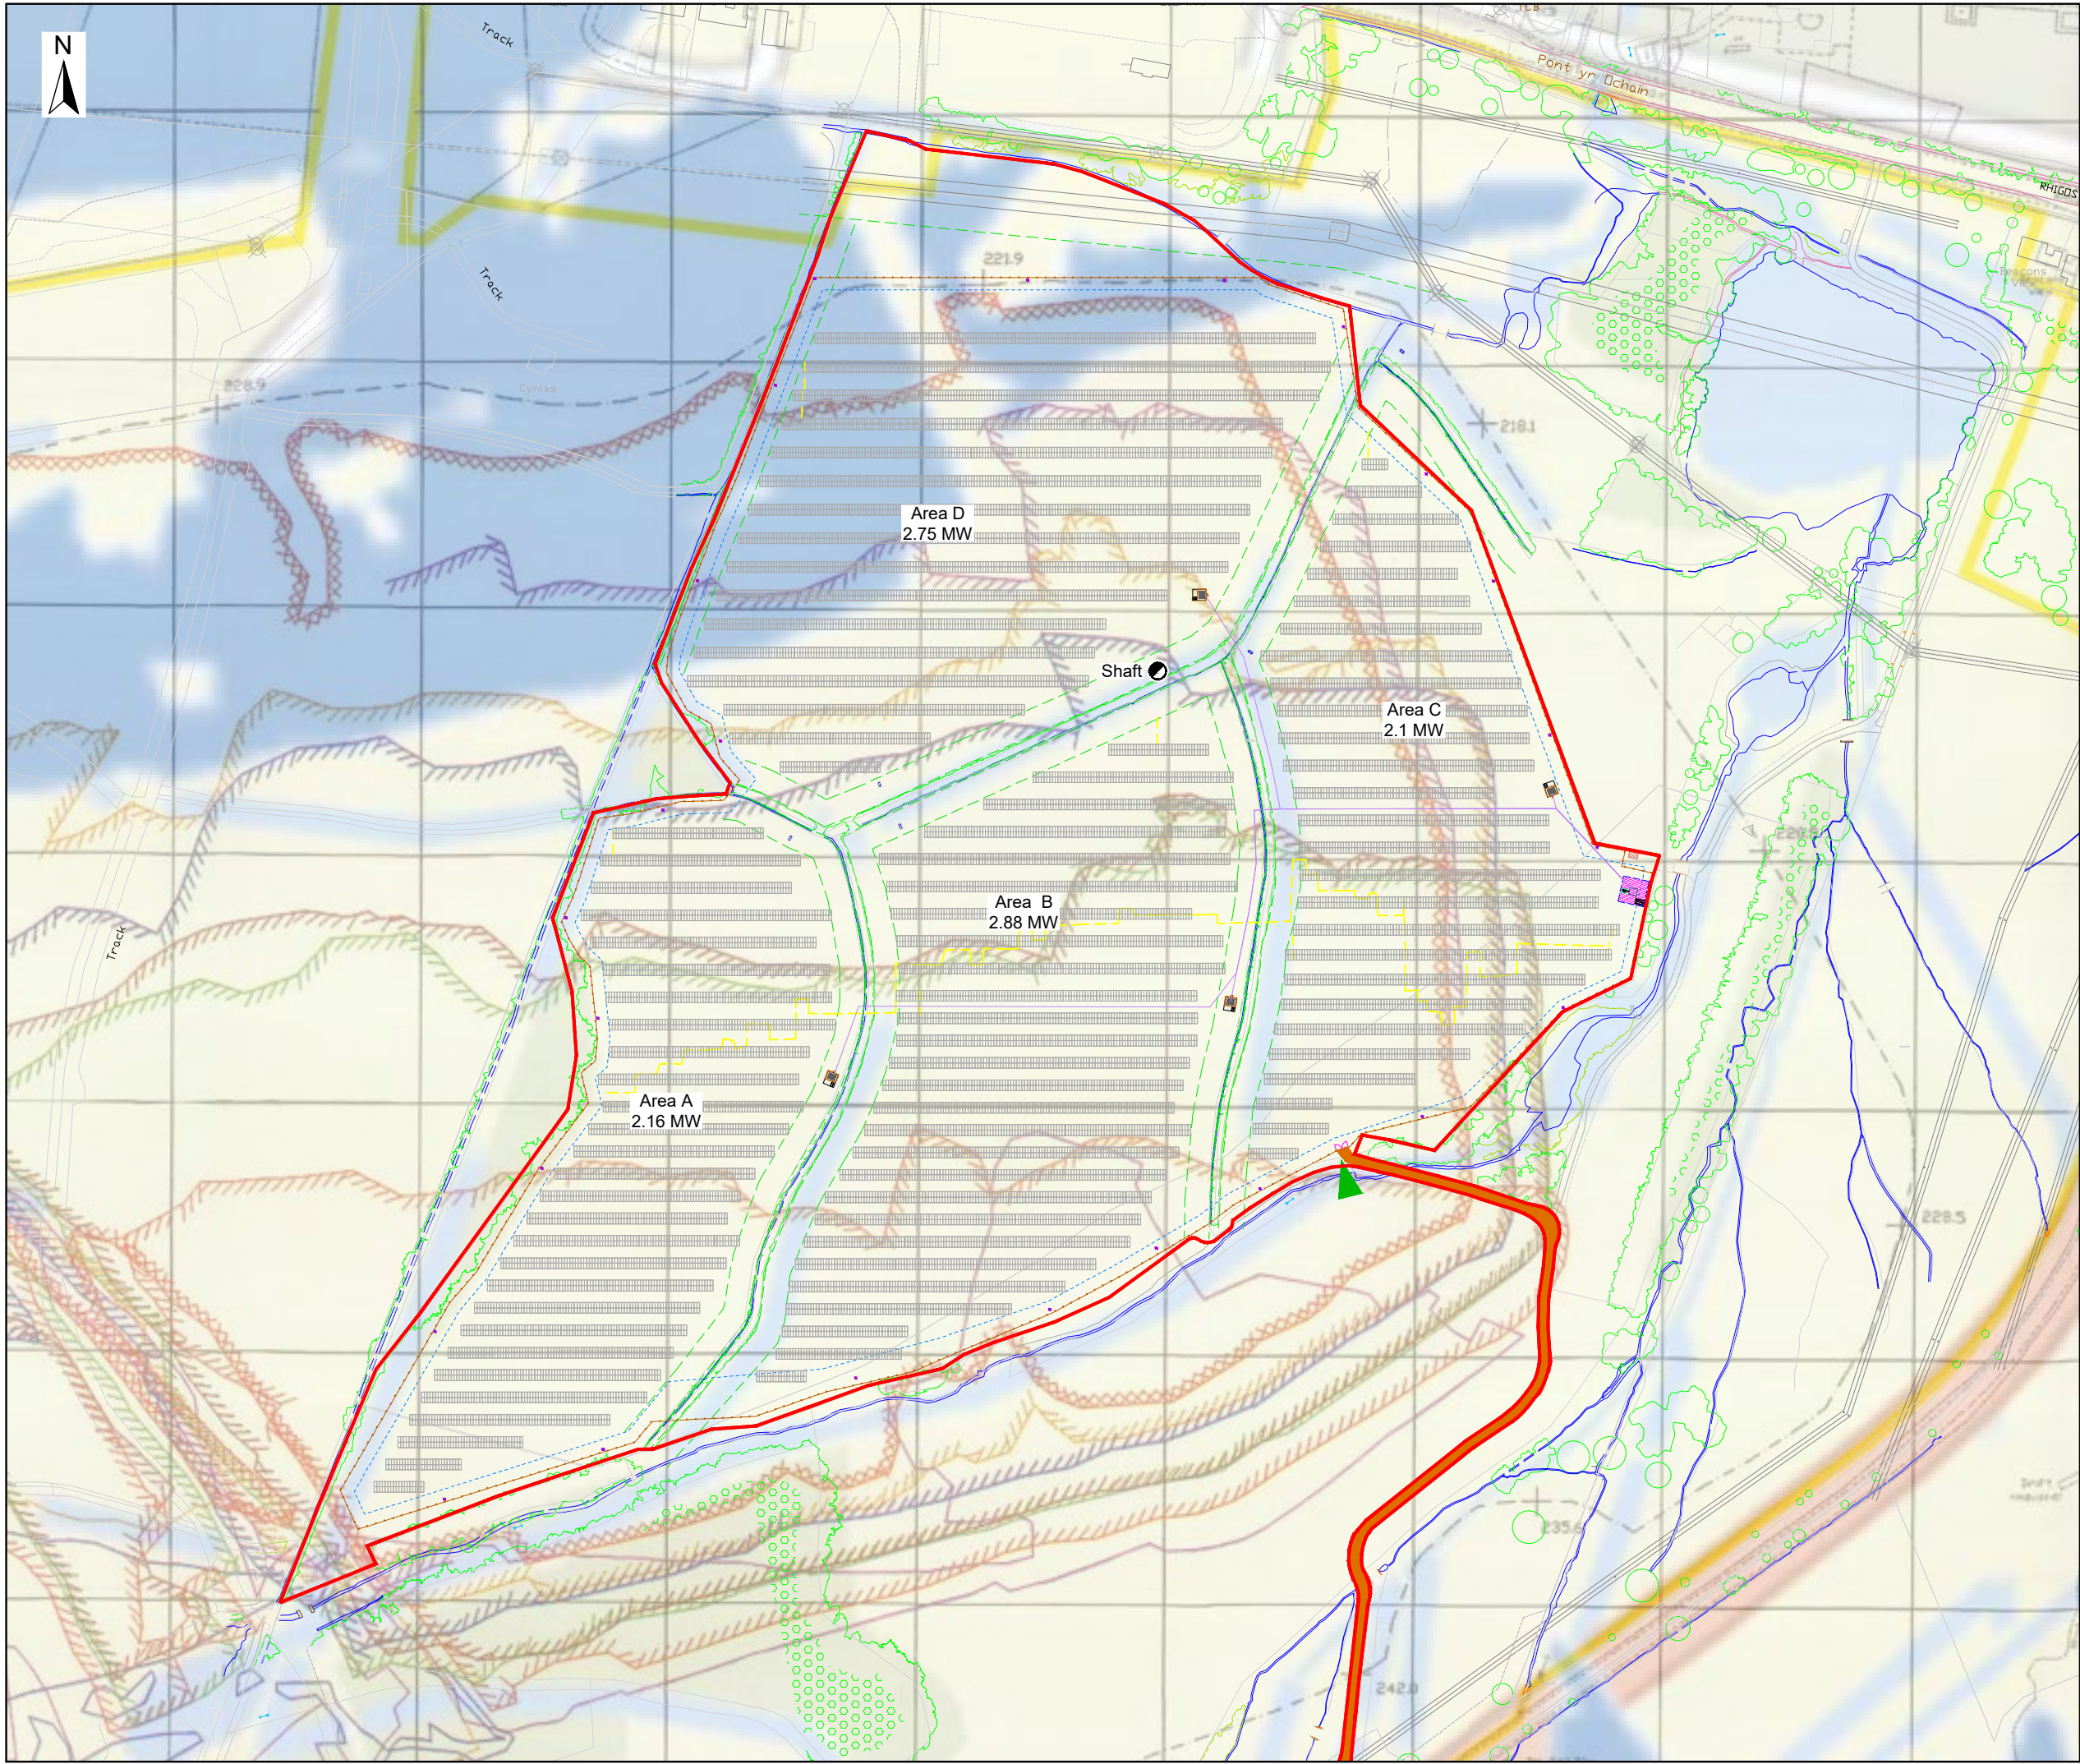
| Drawing 32404/C01 | Combined Ffyndaff (1981-1989) Opencast and Underground Mineworkings over Proposed PV Development Plan |

- Extent of underground mineworkings
- Site boundary
- Perimeter fence (1637m)
- Maintenance track
- Customer substation
- DNO
- 20ft. Power Station (3000 kVA)

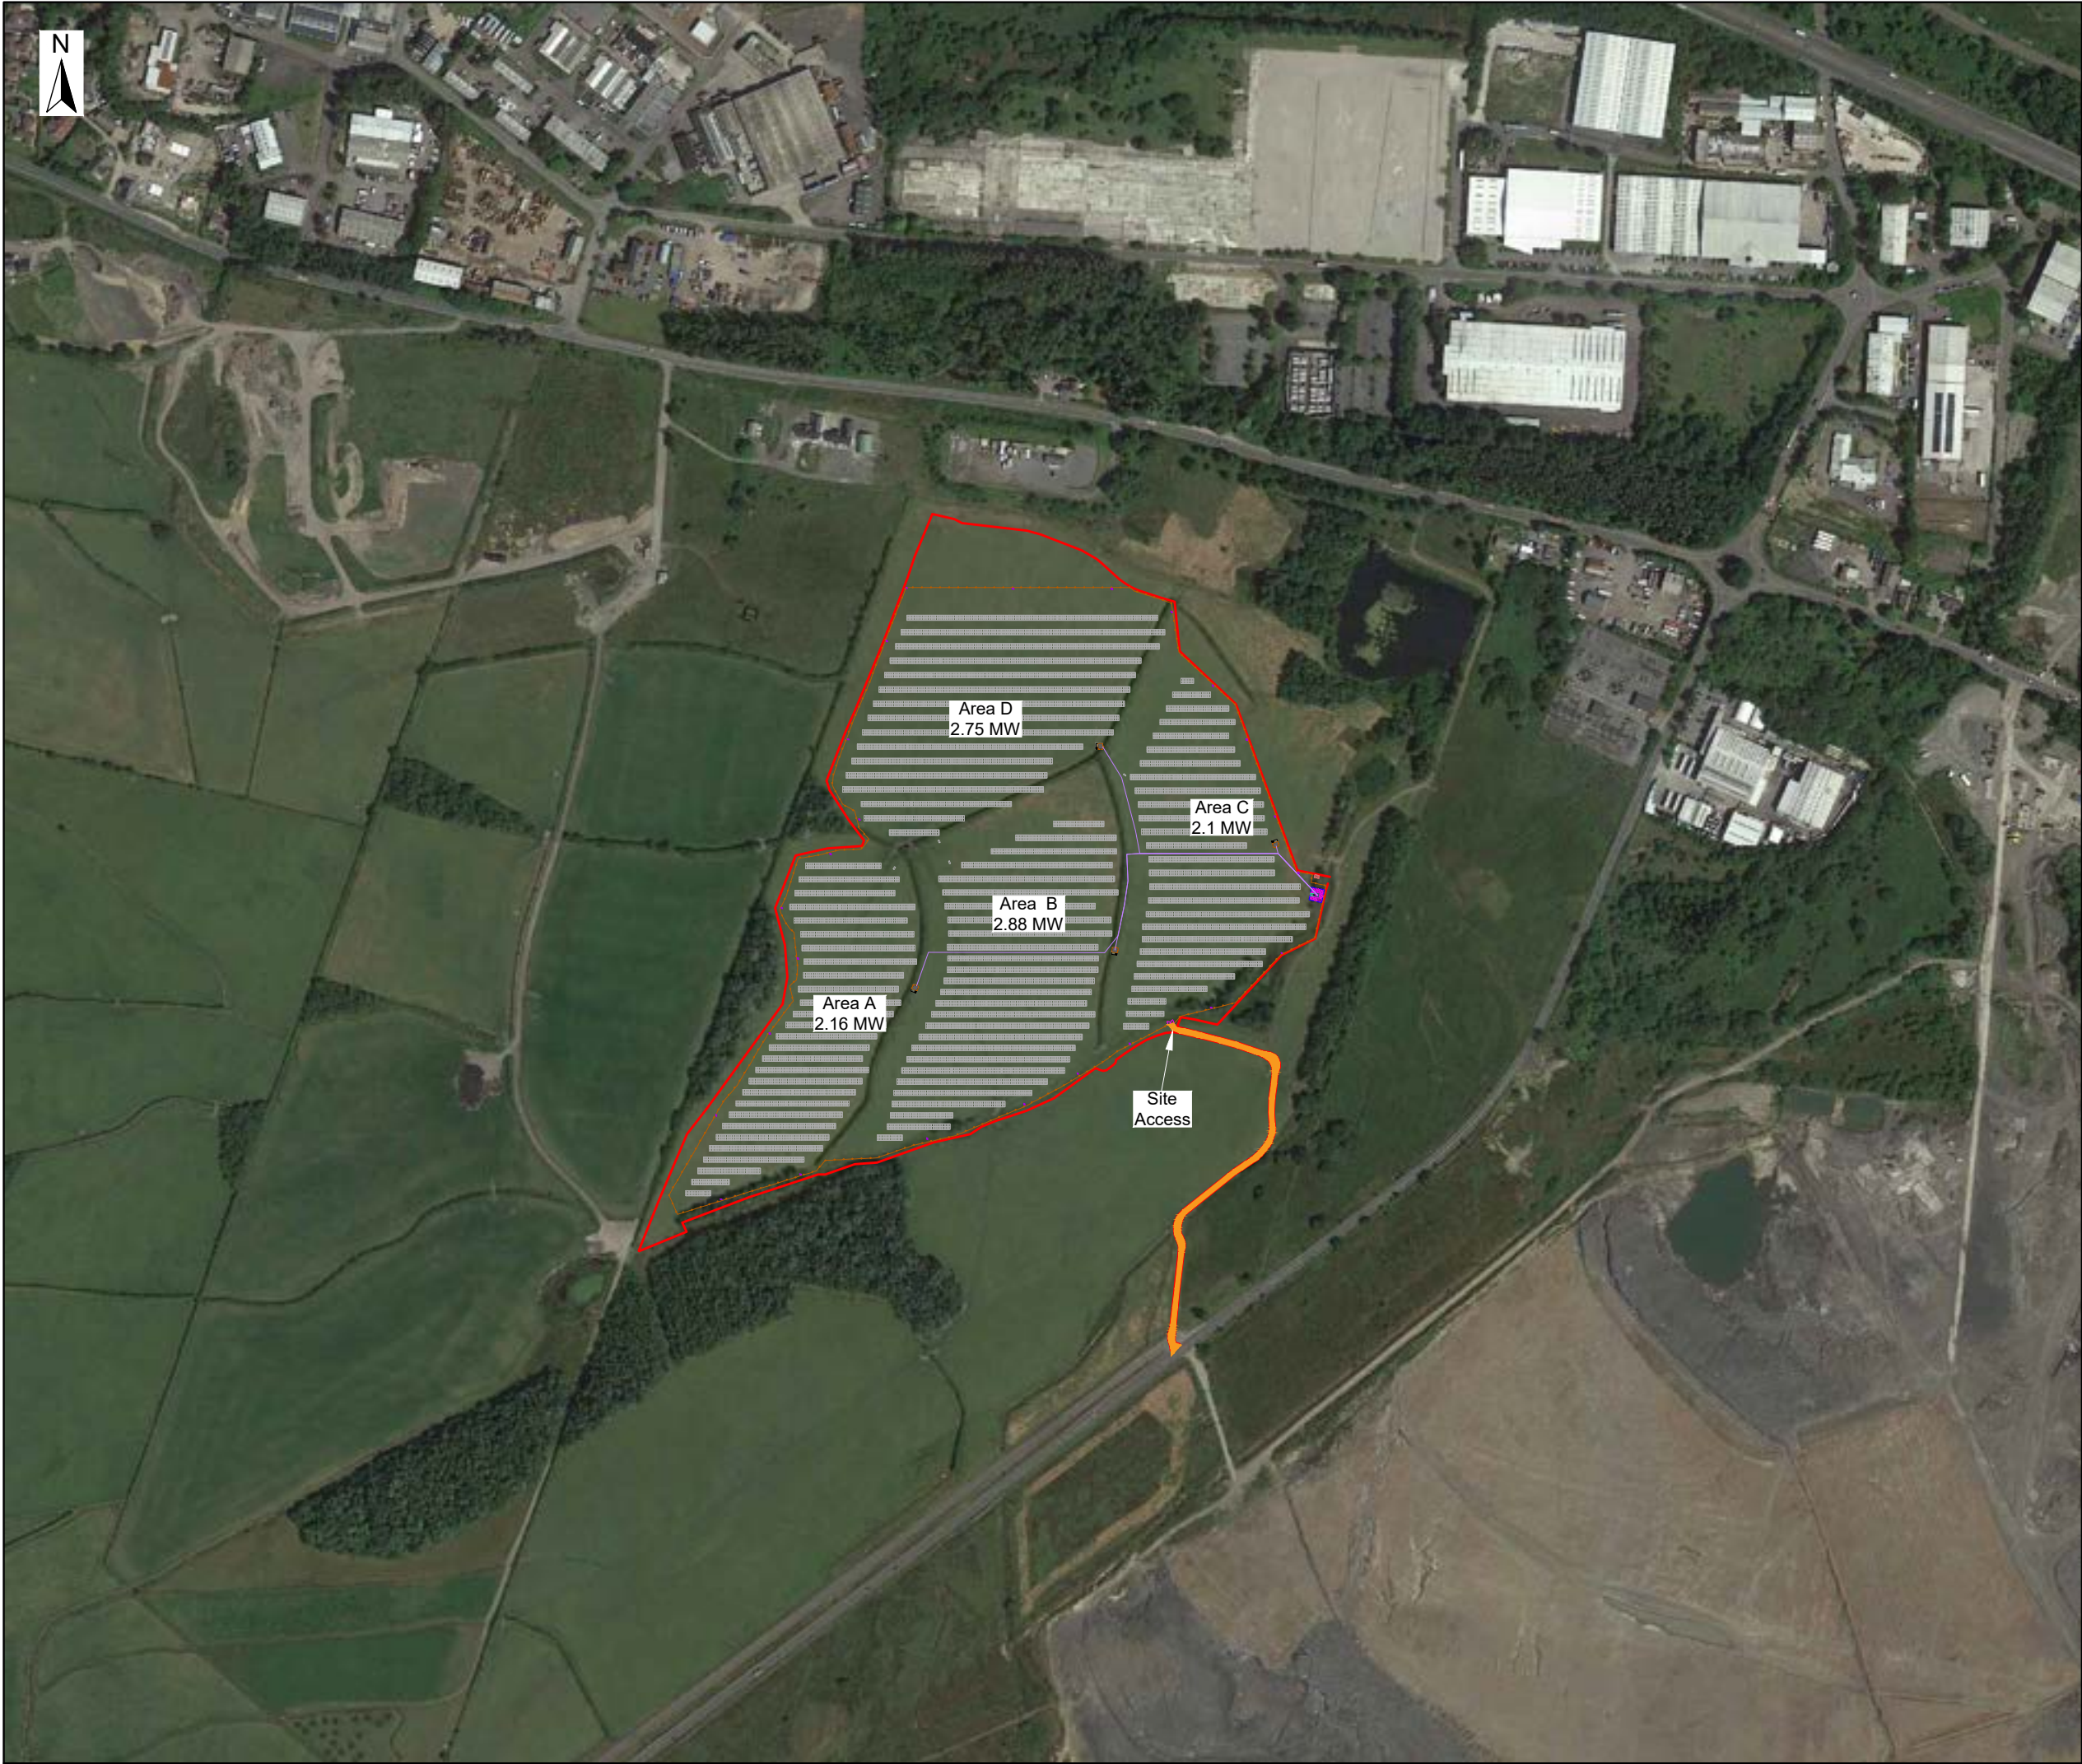
# **PROPOSED DEVELOPMENT LAYOUT PLAN**

- Site Boundary
- Security Fence
- DNO Enclosure
- Customer Switchgear Enclosure
- LV Transformer Station
- CCTV cameras
- Gate
- Access Road
- MV cable

RSK understands that the site is being considered for development as a solar farm. The current planned layout of the site is shown in Appendix B.

The development will include two main elements; the solar arrays and the on-site power and customer stations and substations, which are surrounded by perimeter fencing. The two main elements of the development are outlined below.

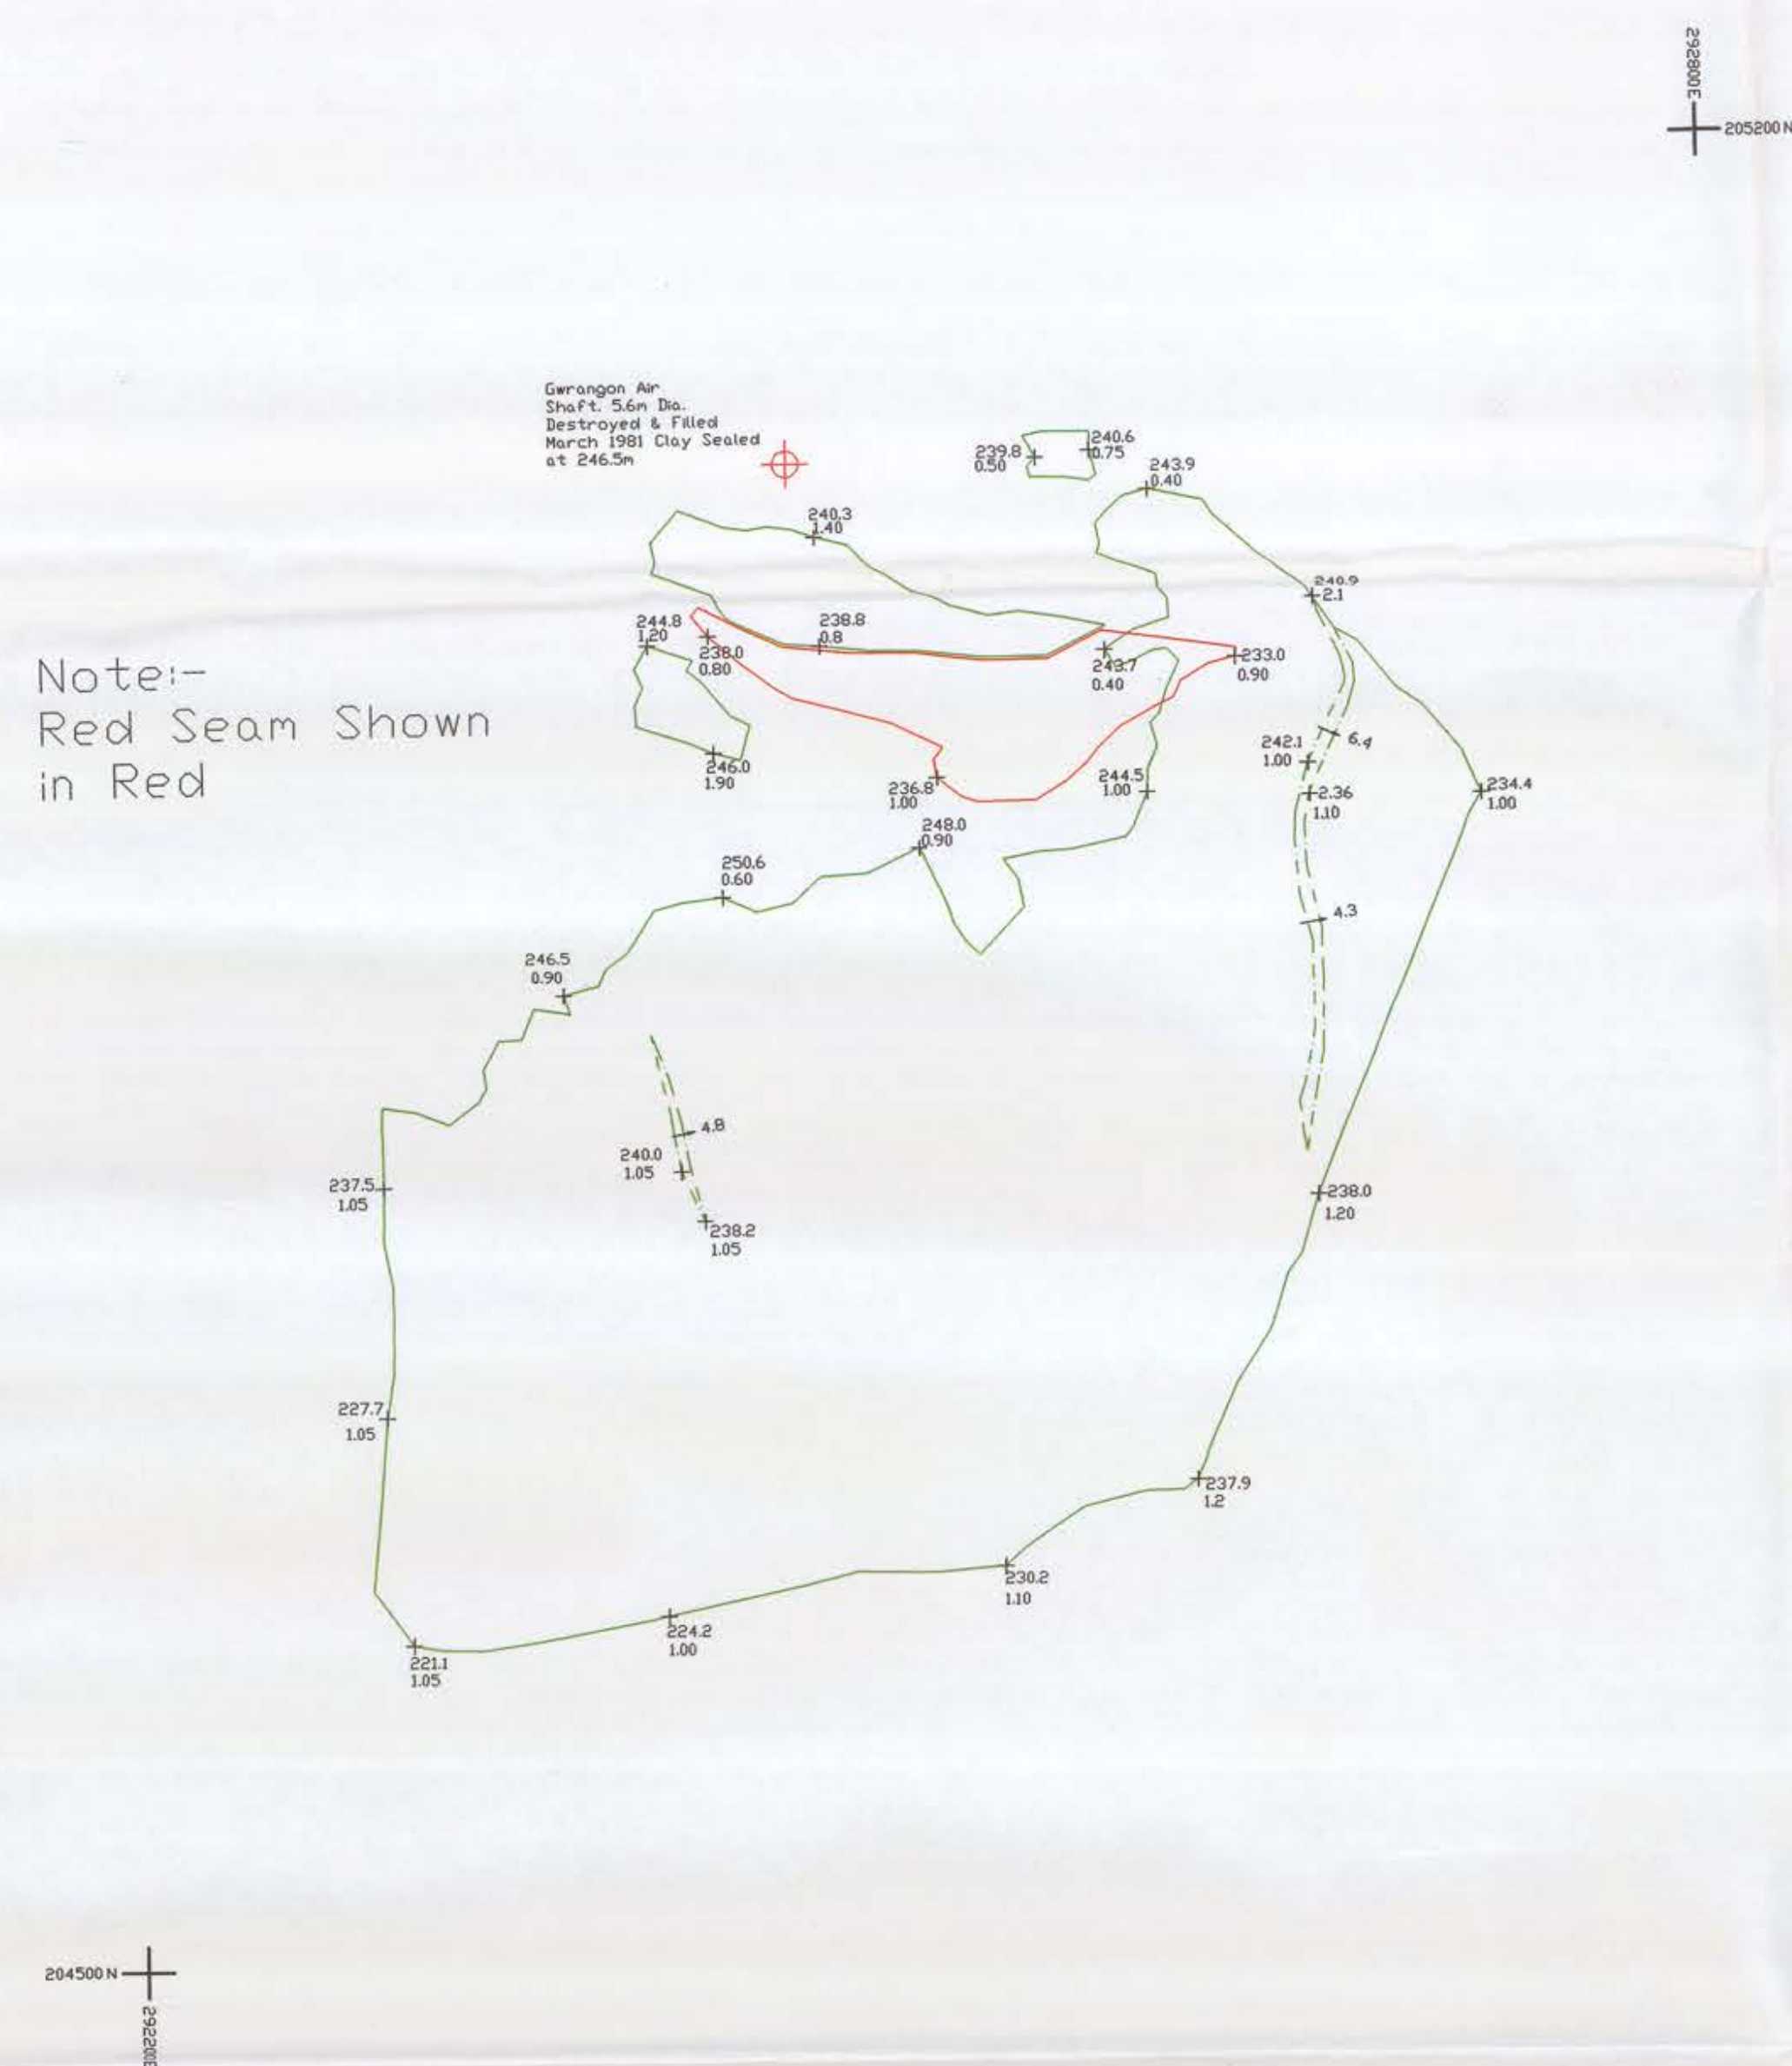
RED + SIX FEET(UPPER) SEAM

Note:-  
Red Seam Shown  
in Red

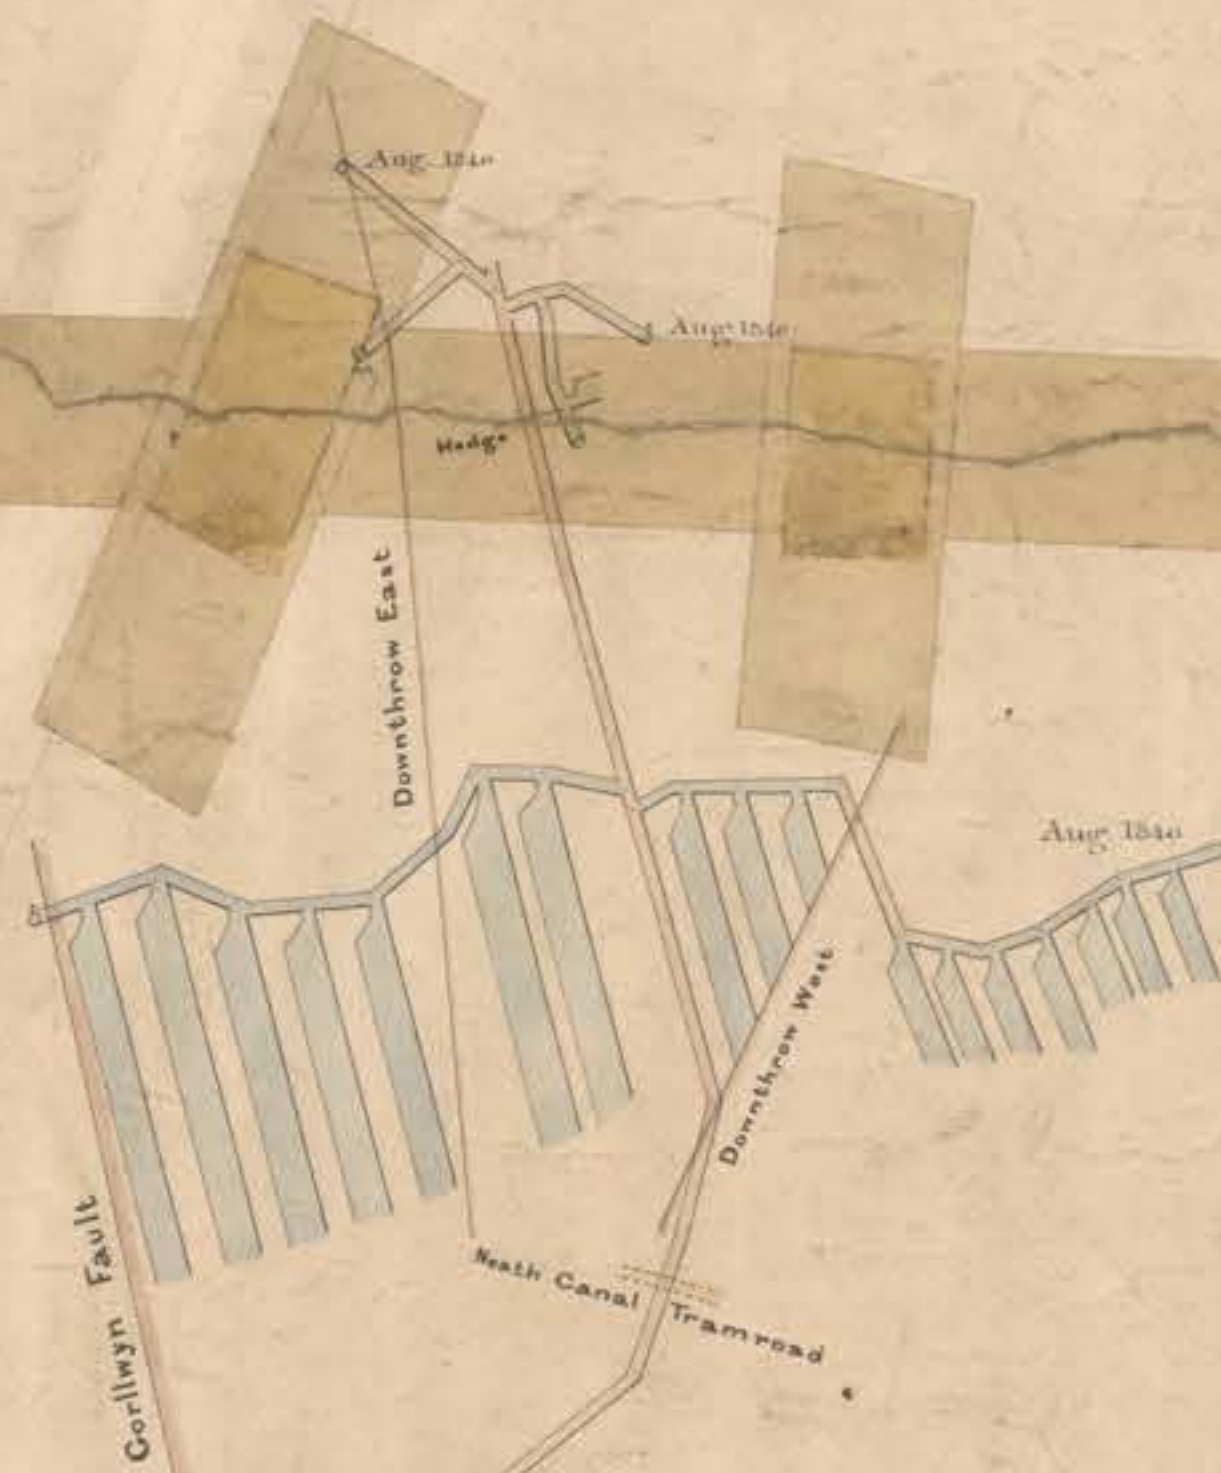
The Drains and the Mines are colored  
The Workings on the Blue Vein Ironstone  
The Workings on the Black Vein Ironstone

Red  
Blue  
Green
