## **APPENDIX F      ADDITIONAL DESK BASED DATA**

**Site at Rhigos Road, Cefn Rhigos, Rhigos, Rhondda Cynon Taf,  
Wales, CF44 9UG (nearest postcode)**

**ENVIRONMENTAL INFORMATION REPORT**

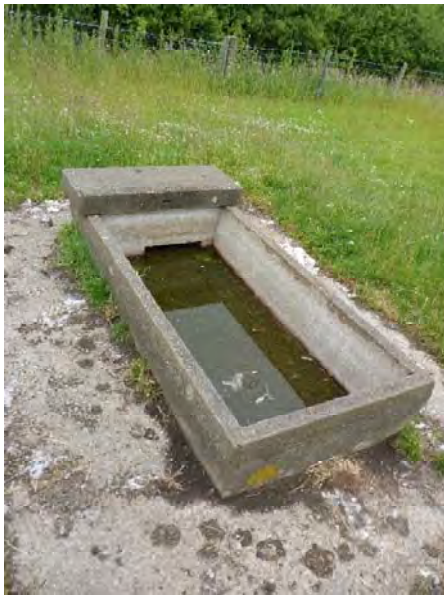
| <b>Photo No.</b><br>7 | <b>Date:</b><br>28 June 2022 | |

| <b>Description:</b><br>Animal water trough in Field 2. | | |

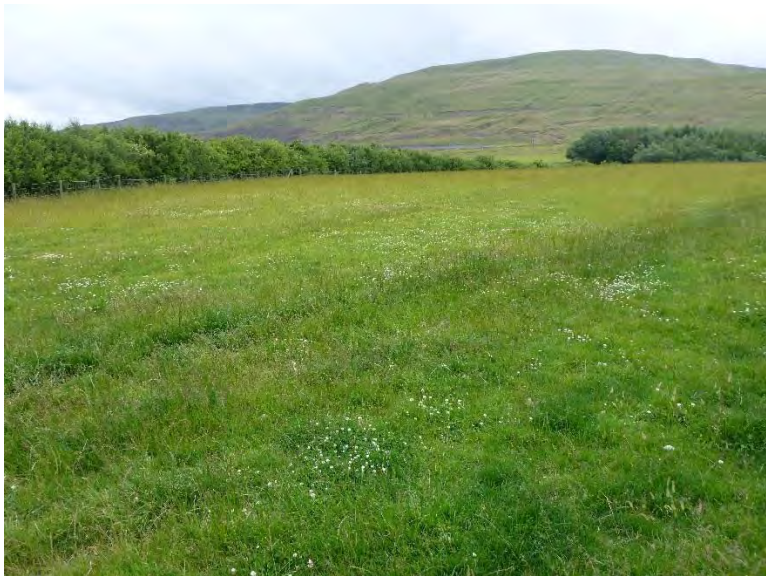
| <b>Photo No.</b><br>8 | <b>Date:</b><br>28 June 2022 | |

| Looking South | | |
| <b>Description:</b><br>Field 3 | | |

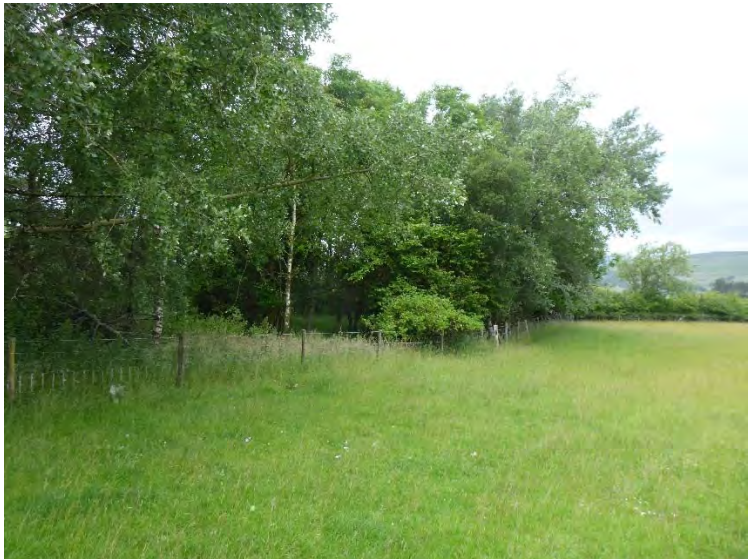
| <b>Photo No.</b><br><b>9</b> | <b>Date:</b><br>28 June 2022 | |

| Looking North | | |
| <b>Description:</b><br>Copse to the west of Field 3 | | |

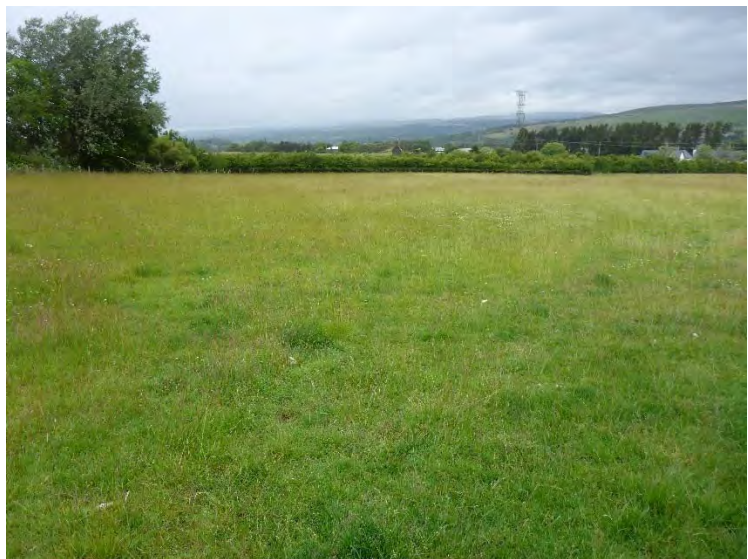
| <b>Photo No.</b><br><b>10</b> | <b>Date:</b><br>28 June 2022 | |

| Looking North-West | | |
| <b>Description:</b><br>Field 4 | | |

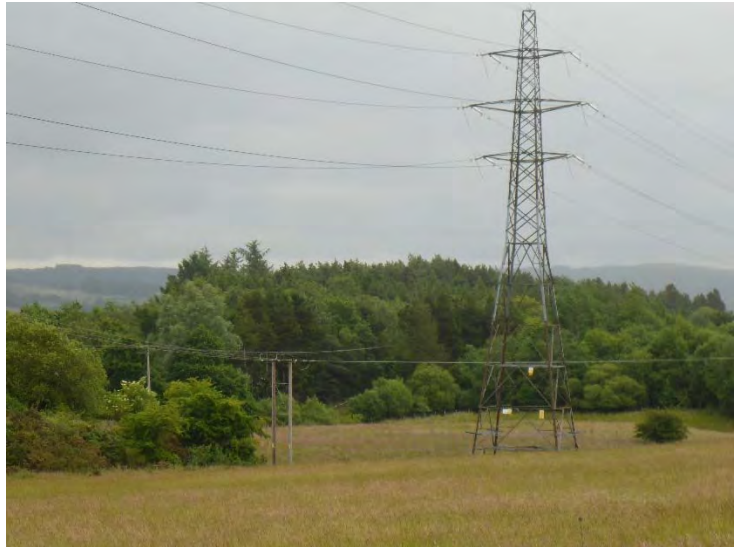
| <b>Photo No.</b><br><br>11 | <b>Date:</b><br><br>28 June 2022 | |

| <b>Description:</b><br><br>Overhead lines off-site to the north of Field 4 | | |

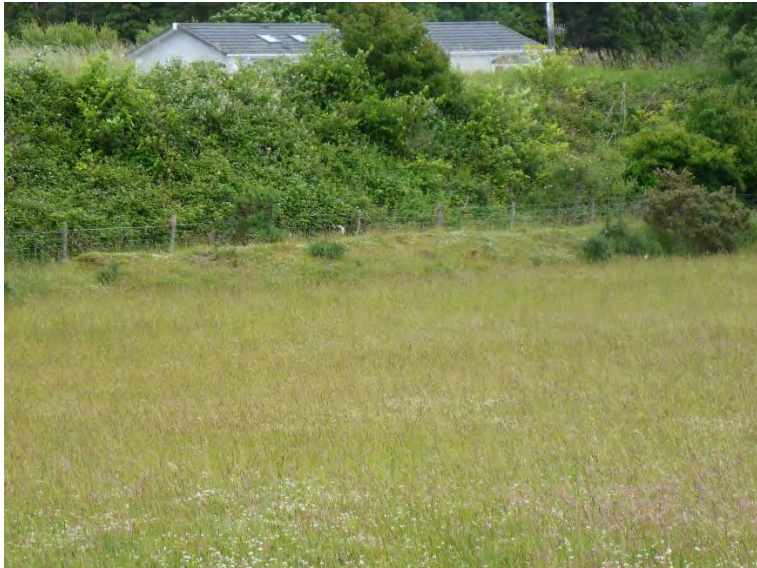
| <b>Photo No.</b><br><b>12</b> | <b>Date:</b><br>28 June 2022 | |

| <b>Description:</b><br>Bund beyond northern boundary of Field 4 creating a field ditch | | |

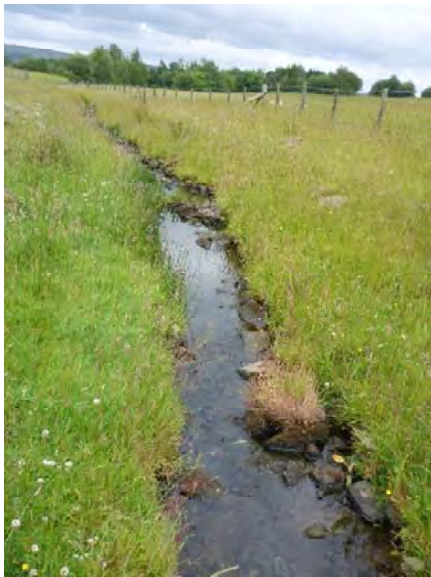
| <b>Photo No.</b><br><b>13</b> | <b>Date:</b><br>28 June 2022 | |

| <b>Description:</b><br>Stream forming southern boundary | | |

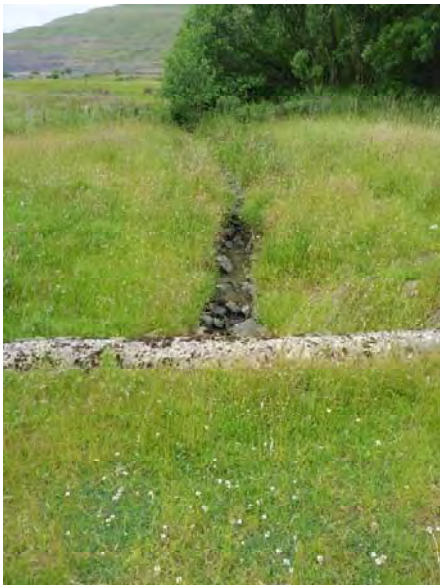
| <b>Photo No.</b><br><b>14</b> | <b>Date:</b><br>28 June 2022 | |

| <b>Description:</b><br>Off-site stream culverted beneath access and cable route. | | |

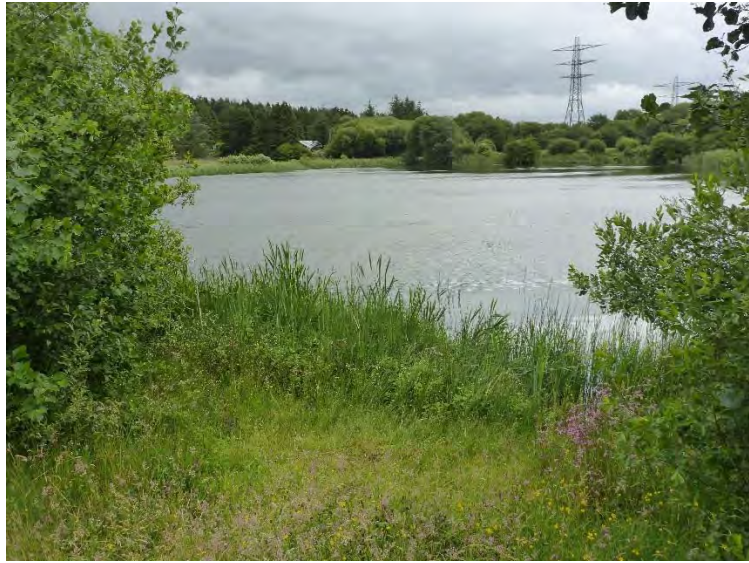
| <b>Photo No.</b><br><b>15</b> | <b>Date:</b><br>28 June 2022 | |

| <b>Description:</b><br>Large pond to north-east of site | | |

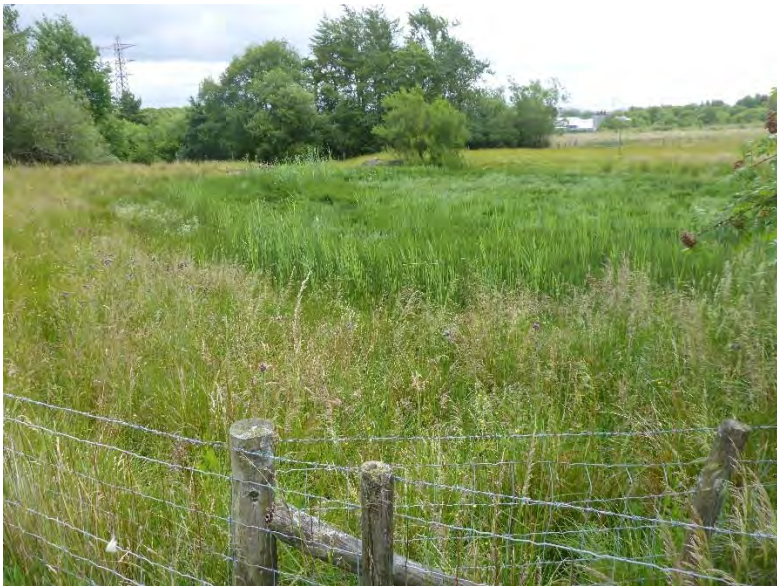
| <b>Photo No.</b><br><br><b>16</b> | <b>Date:</b><br><br>28 June 2022 | |

| <b>Description:</b><br><br>Pond to east of Field 1.<br>Over-grown with reeds | | |

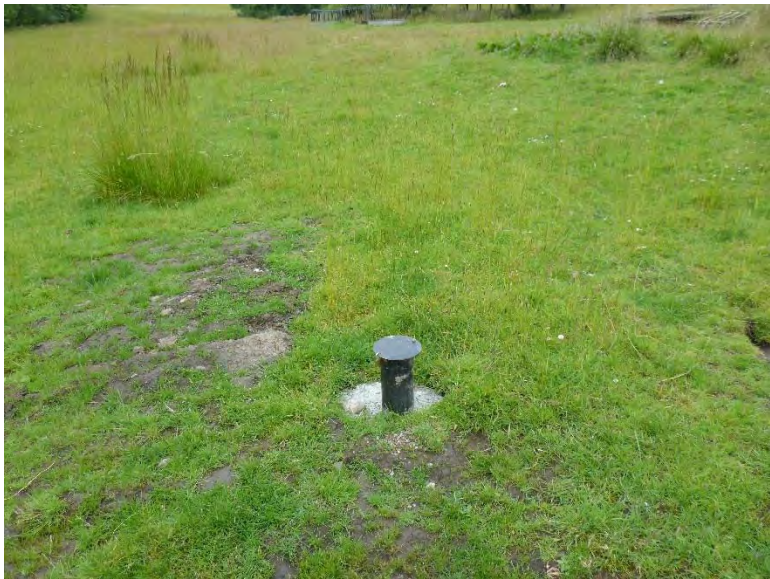
| <b>Photo No.</b><br><b>17</b> | <b>Date:</b><br>28 June 2022 | |

| <b>Photo No.</b><br><b>17</b> | <b>Date:</b><br>28 June 2022 | |
| - | | |
| <b>Description:</b><br>Borehole (locked cover)<br>noted to the east of Field 1 | | |

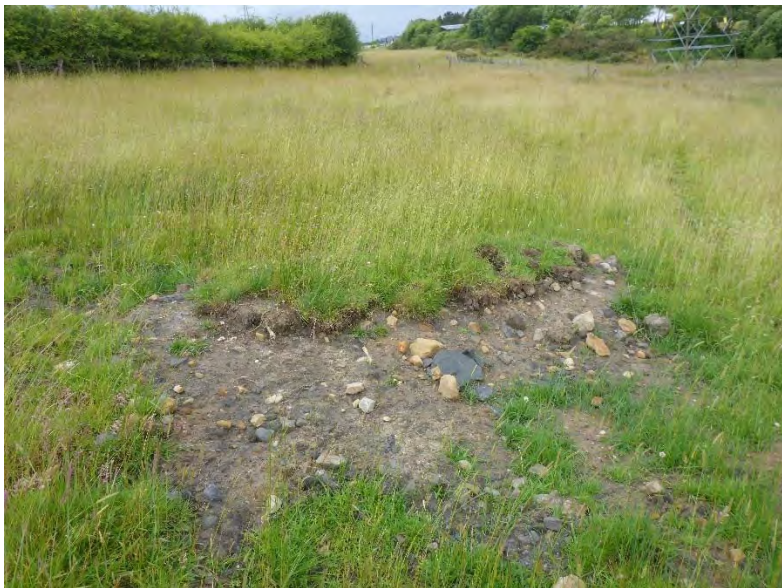
| <b>Photo No.</b><br><b>18</b> | <b>Date:</b><br>28 June 2022 | |

| <b>Photo No.</b><br><b>18</b> | <b>Date:</b><br>28 June 2022 | |
| - | | |
| <b>Description:</b><br>Possible back filled trial pit<br>to the north-east of Field 1. | | |

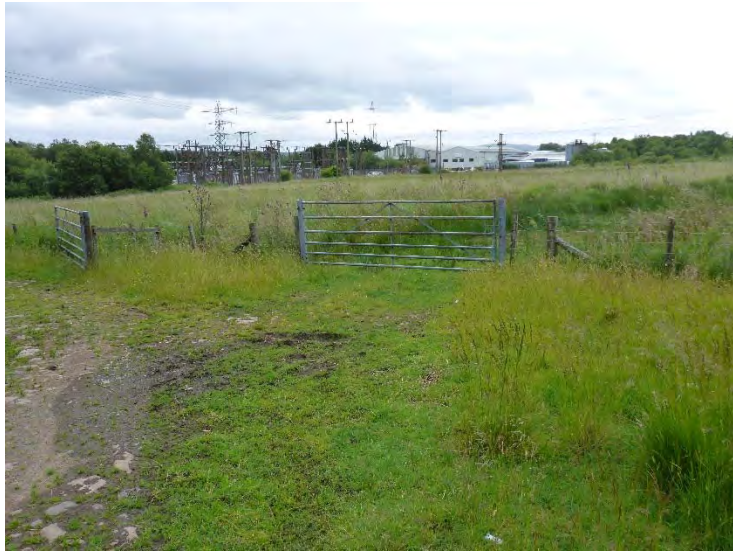
| <b>Photo No.</b><br><br><b>19</b> | <b>Date:</b><br><br>28 June 2022 | |

| <b>Description:</b><br>Access to adjacent field for cable route | | |

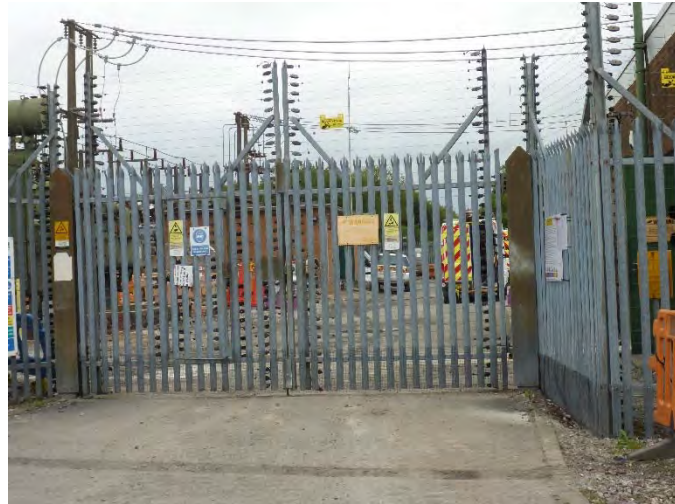
| <b>Photo No.</b><br><br>20 | <b>Date:</b><br><br>28 June 2022 | |

| <b>Description:</b><br><br>Access to electricity sub-station from Rhigos Road | | |
