RHONDDA  
GEOTECHNICAL  
SERVICES

CONTAMINATED LAND ASSESSMENT

FOUR INDUSTRIAL UNITS (SINGLE BUILDING)

UNIT 19/20 MARDON PARK

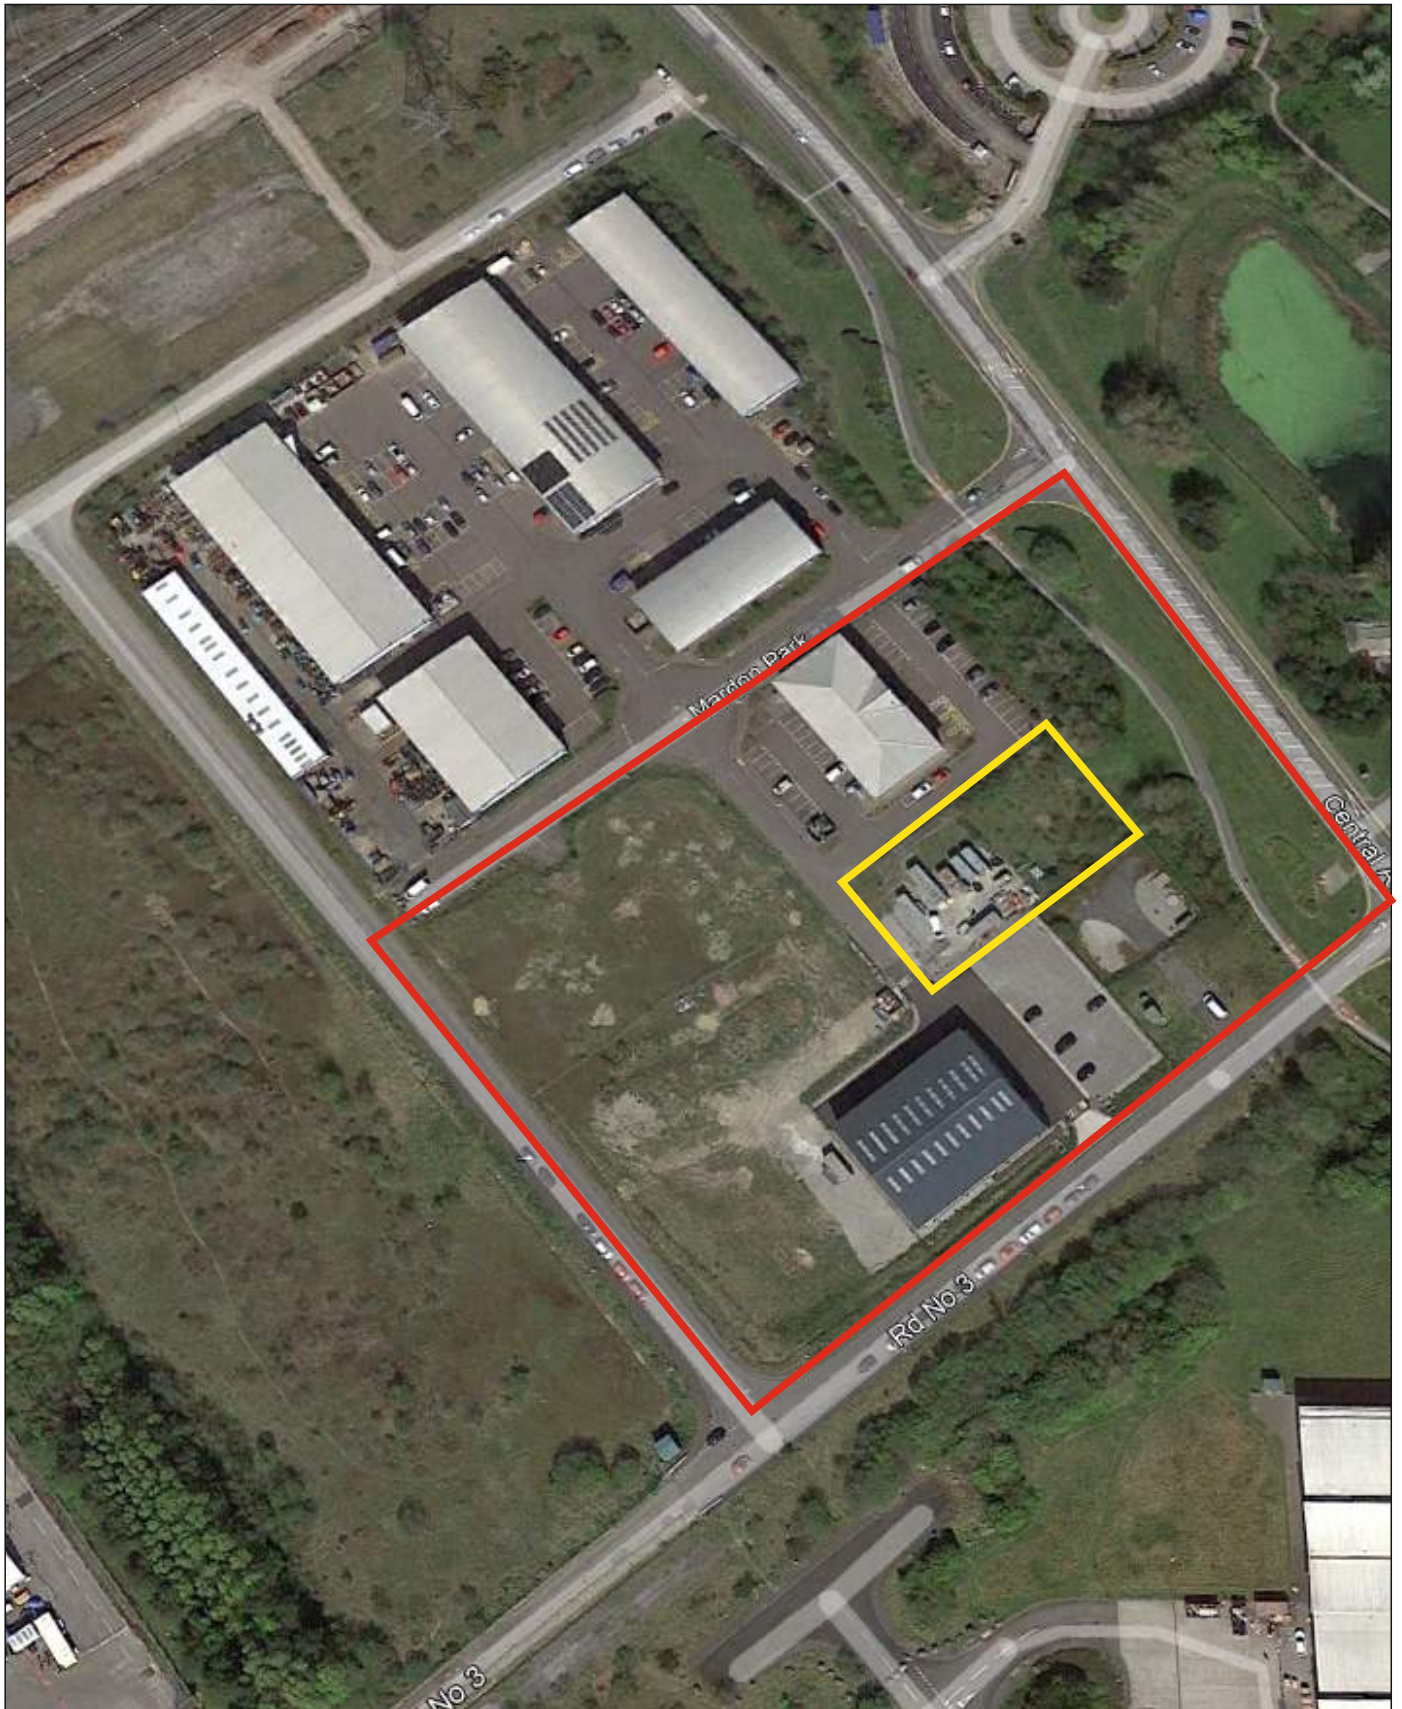
FIGURE 2

AERIAL VIEW FROM GOOGLE EARTH PRO. THE RED BOUNDARY DELINEATES THE AREA COVERED BY THE IAN FARMER ASSOC. DESK STUDY (PHASE 1). THE YELLOW BOUNDARY DELINEATES THE AREA COVERED BY THE RHONDDA GEOTECHNICAL SERVICES INTRUSIVE INVESTIGATION (PHASE 2).

The site is situated on Baglan Energy Park, Port Talbot. The site is rectangular, measuring approximately 50m x 45m (0.23 Ha). Centred on grid reference 274020,192650 the site is a featureless expanse of flat land adjacent to the existing Unit 19/20. There are no surface watercourses. The site location is shown in Figure 1, with an aerial photo from Google Earth Pro showing the site boundary in Figure 2.

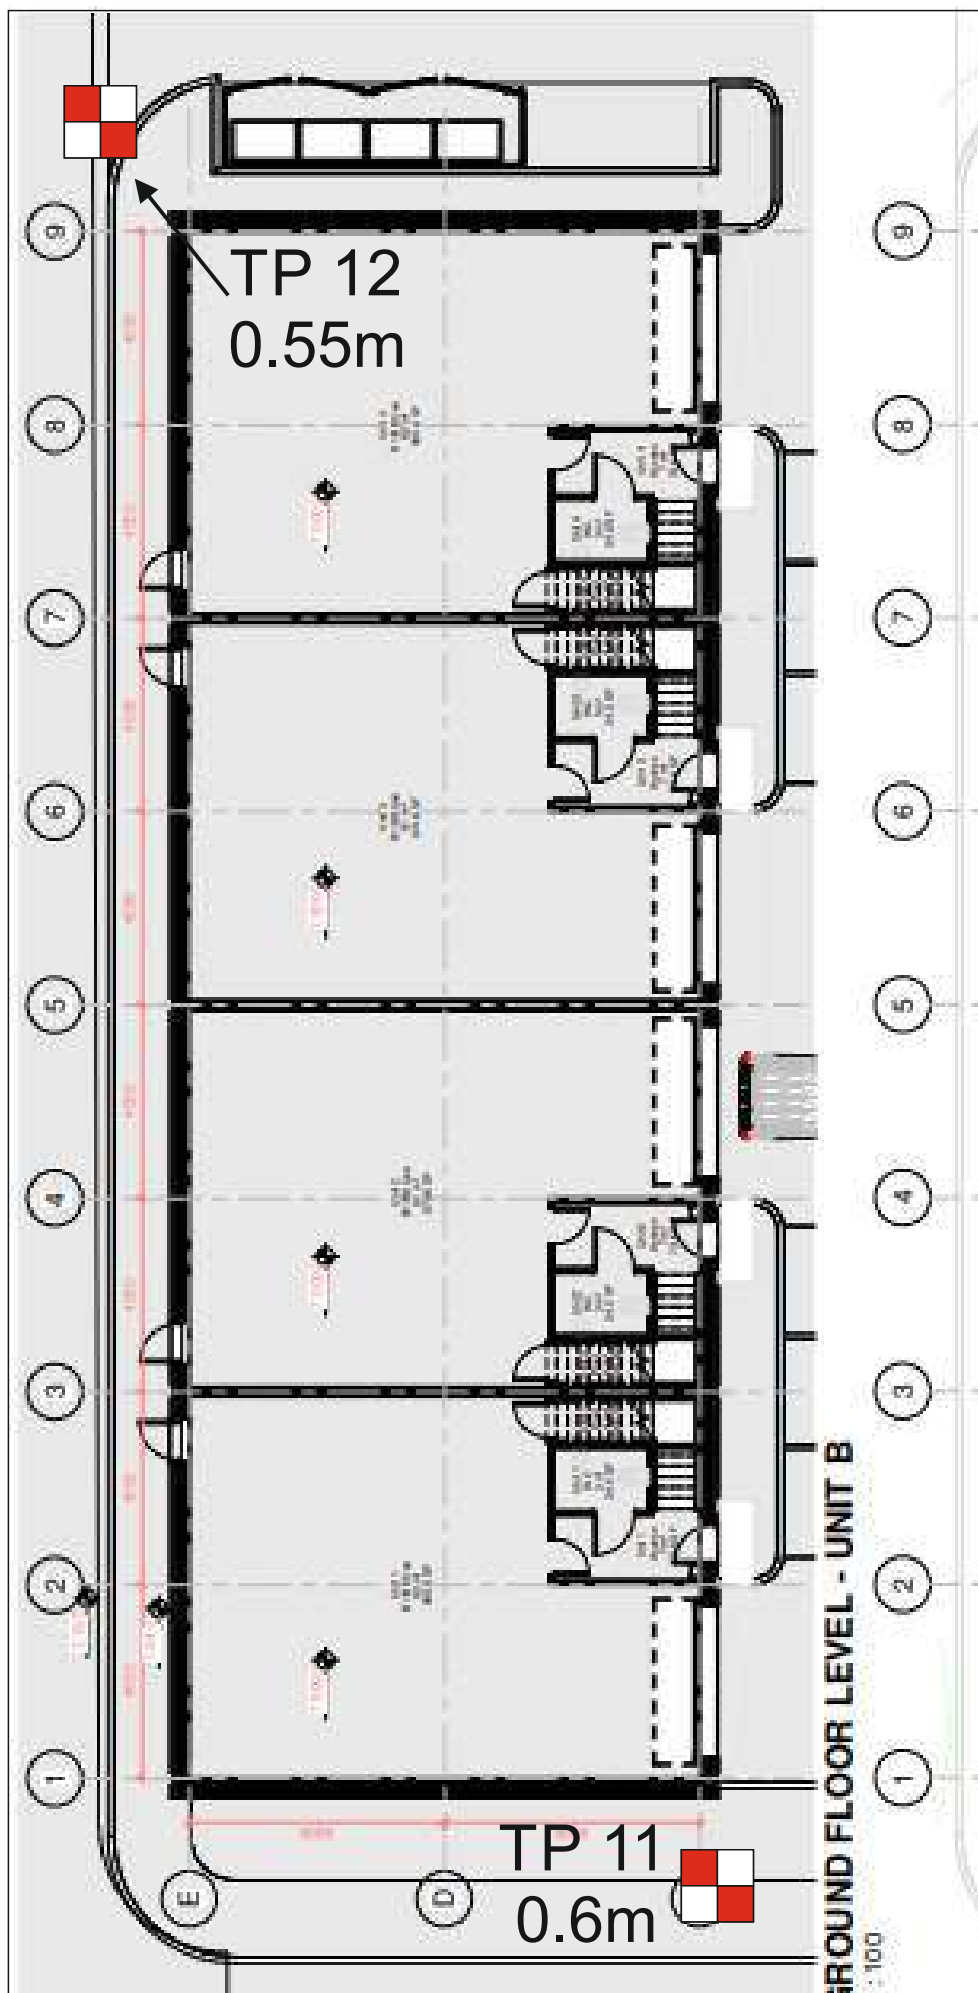
FIGURE 3  
TRIAL PIT POSITIONS AT MARDON PARK.

Intrusive site investigations were carried out on 16/03/2021 under the supervision of Richard Davies. This was done at the same time as a larger intrusive investigation into an adjacent site. Works consisted of the digging of two trial pits with a tracked excavator. The trial pit locations are shown in Figure 3 together with the depth of the samples taken. The site was flat and featureless. Previous desk studies had suggested no specific areas of contamination. Most of the site will be occupied by the new building. The two trial pit locations were situated outside the building footprint. Two soil samples were taken, one from each trial pit. This was considered reasonable and proportionate for an initial investigation of a site of this size. Because of the fused nature of the steelworks slag forming the Made Ground it was not possible to reach the underlying natural ground. This is assumed to be sand as the site could be effectively characterised by the other ten trial pits on adjacent land. There was no sensory field evidence of contamination detected anywhere on site. Groundwater was not encountered in either trial pit. Groundwater samples had been taken and tested on the larger adjacent site on the same day. Since the groundwater was clearly in hydraulic connectivity across the larger adjacent site, the results from the groundwater analysis for that site were considered suitably representative of the site now under discussion.

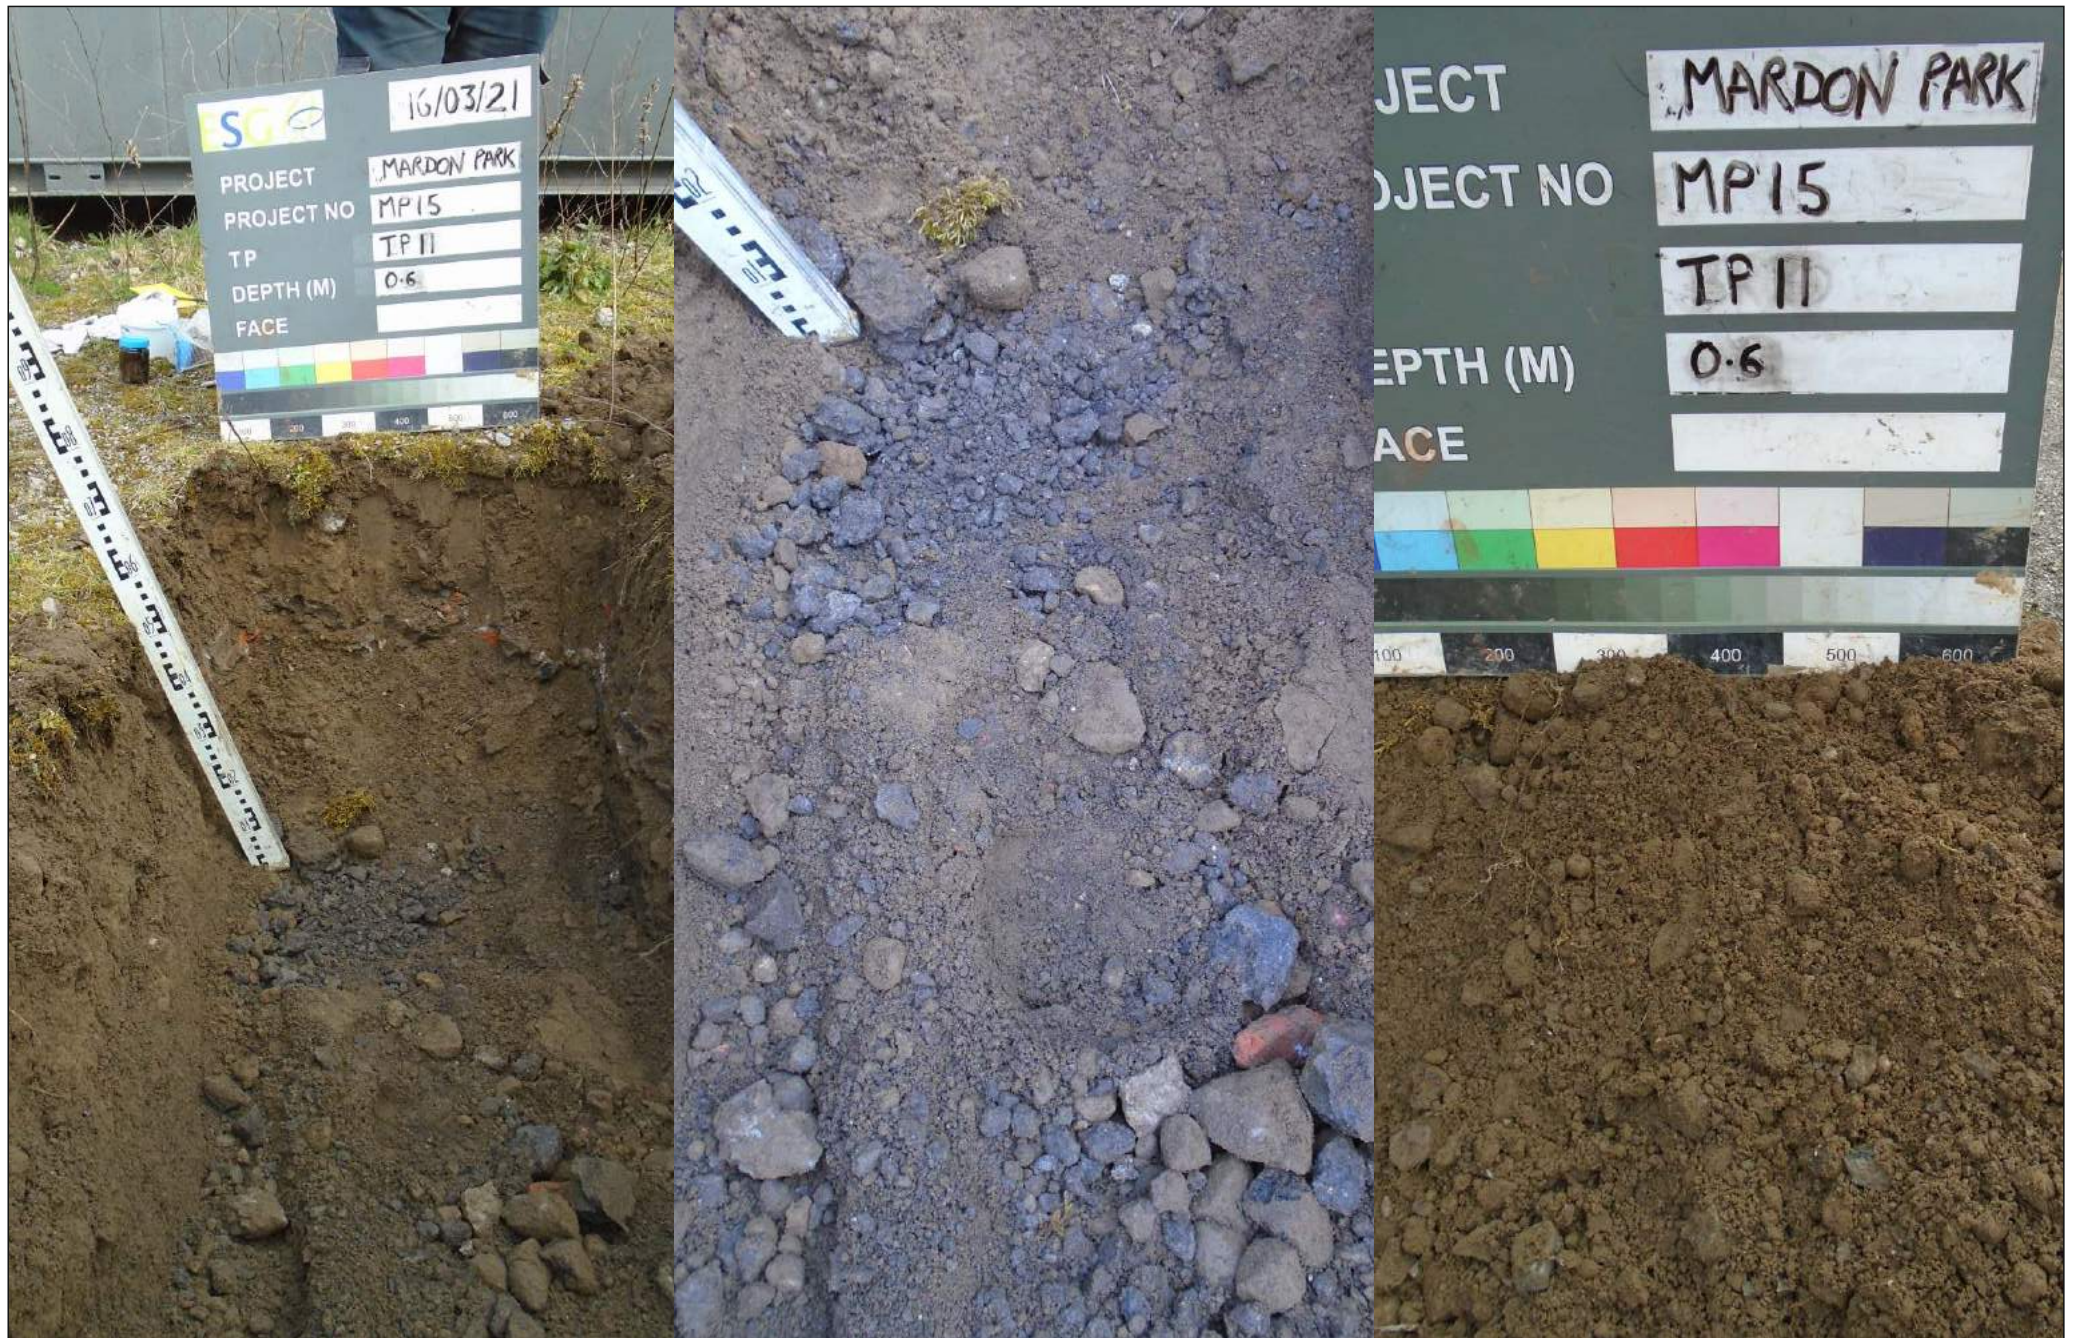
FIGURE 4 TP 11

TRIAL PIT NUMBER  
**TP11**

The full trial pit logs to BS5930:2015 together with photographs of the pits can be found in Appendix A. In summary, both trial pits encountered a layer of fused slag that the excavator could not break up to reach the underlying sand. The samples were taken from this layer.

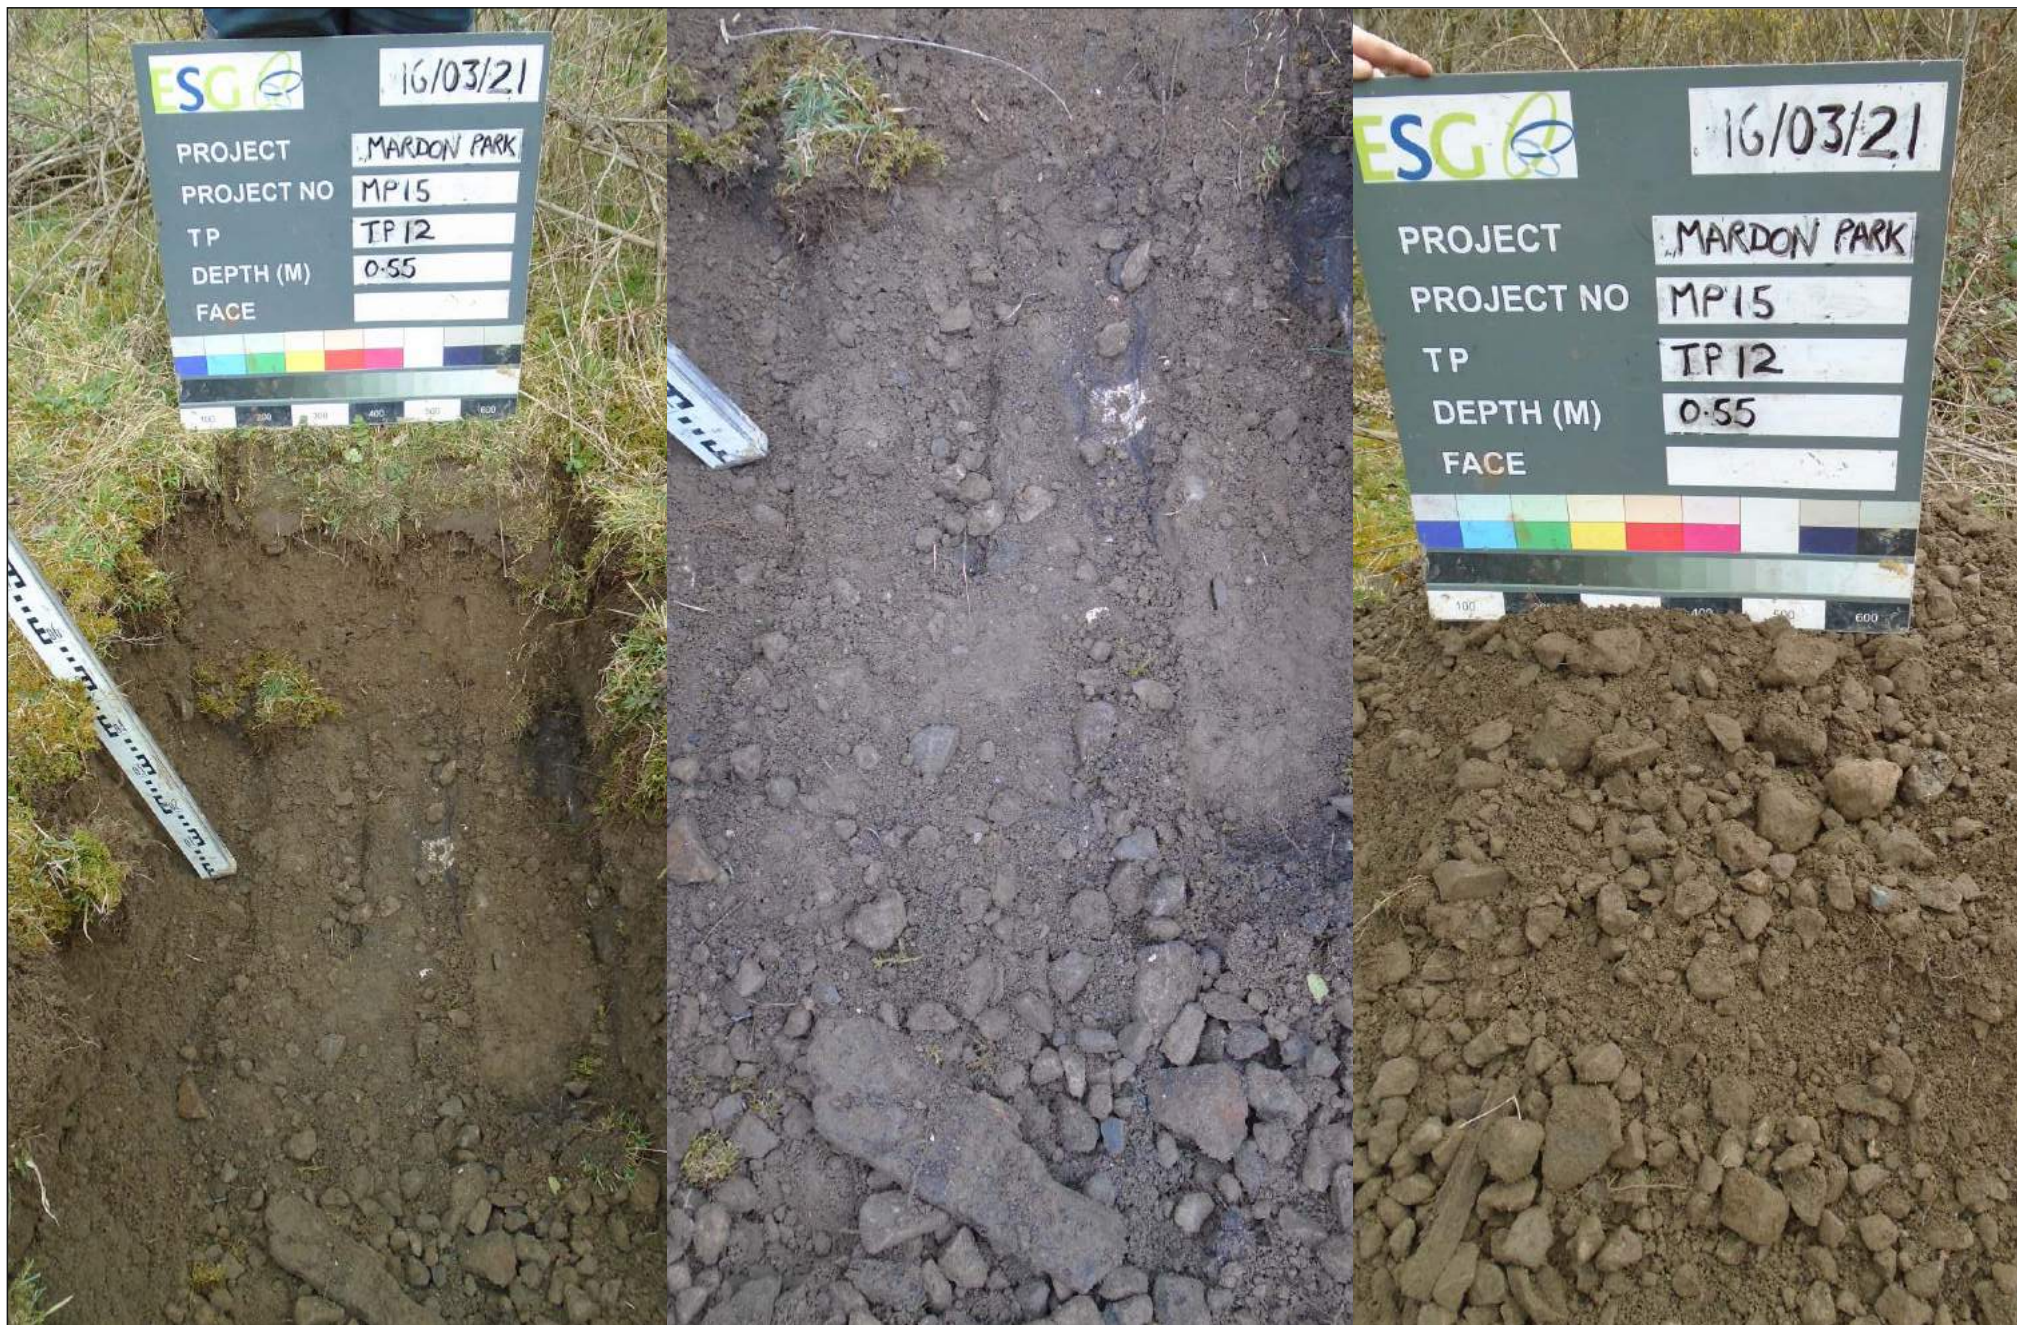
FIGURE 5 TP 12

TRIAL PIT NUMBER  
**TP12**
