**Global Centre of Rail Excellence**  
Phase 1A and 2A

2022/23 Bat Survey Report

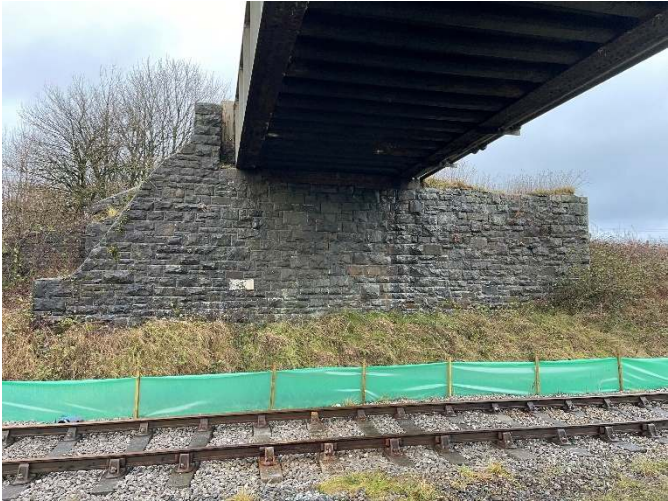
- 3.1 The Northern Bridge was assessed as having a 'Low' suitability to support roosting bats.
- 3.2 The structure is a high bridge over a rail line. Stone-block walls are in a generally good condition with intact mortar. Two drain gaps between blocks on the southern wall are present at approximately 1 m above ground. Narrow gaps are present between the top of the wall and steel bridge. The drain gaps were considered to be suitable for hibernating bats.
- 3.3 The assessment and description of the Southern Bridge, Brick Structure, Western Wall and Eastern Wall are presented in the 2022 bat survey report for the Phase 2A site (BSG Ecology, 2022b).
- 3.4 Photographs are provided in **Appendix 2**.

| Building / structure ID<br>Refer to Figure 1 for location. | Photograph |
|---|---|
| Northern Bridge<br>View of northern wall | |

- 4.6 It is unlikely that works to the Northern Bridge (assessed as having low suitability for bat roosts) will have a significant negative impact on the favourable conservation status of the local bat population. However, these structures should be inspected by a suitably experienced ecologist immediately prior to works taking place to confirm likely absence of roosting bats.

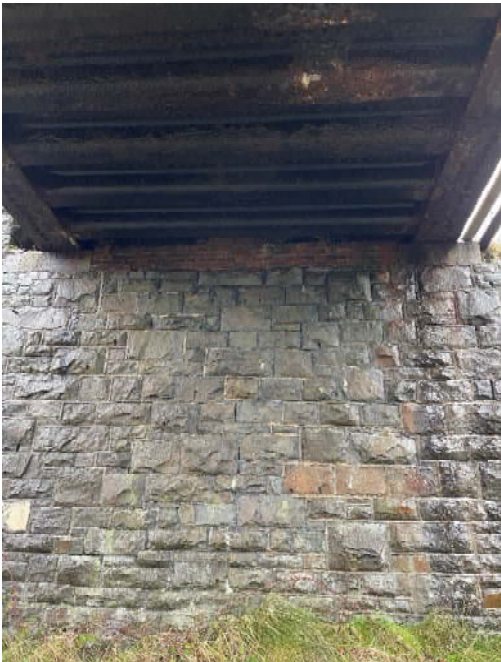
| Building / structure ID<br>Refer to Figure 1 for location. | Photograph |
|---|---|
| Northern Bridge<br>View of southern wall | |

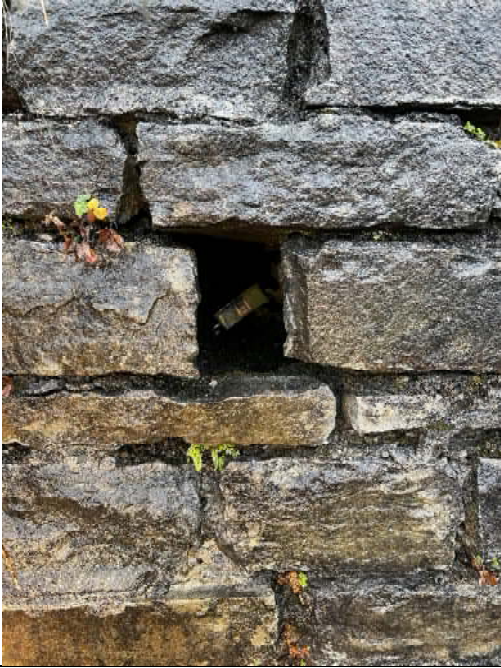
| <p>Northern Bridge</p> <p>Drainage cavity on southern wall.</p> | A close-up photograph of a stone wall made of large, irregular grey stones. A small, dark, rectangular opening is visible in the center, which is a drainage cavity. Some small green plants are growing from the cracks in the masonry. |

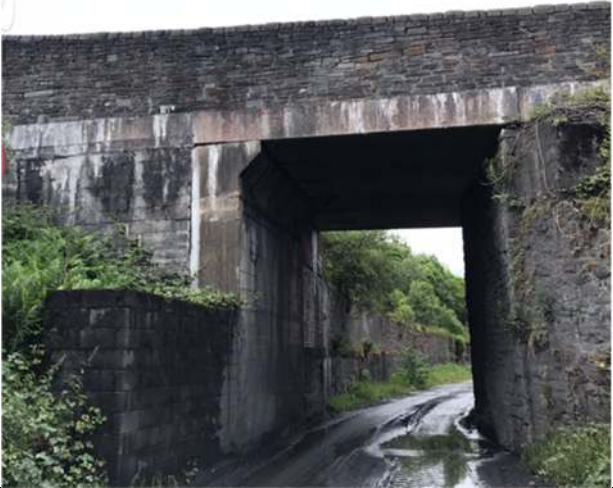
| <p>Southern Bridge</p> | A photograph showing a view through a large, dark, rectangular opening in a stone wall. The opening is part of a bridge structure. A paved road leads through the opening, and green foliage is visible on the sides and in the background. |

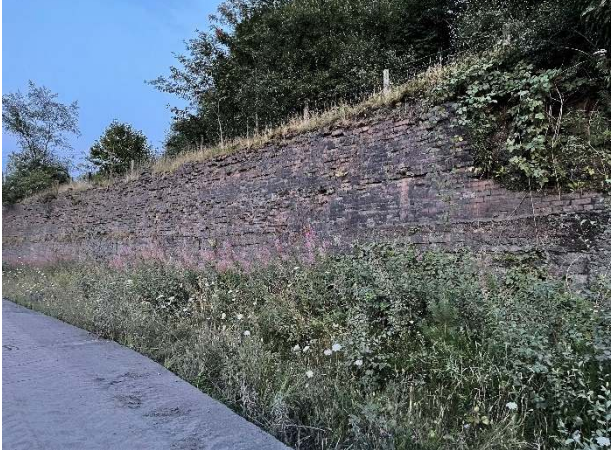
| <p>Western Wall</p> | A photograph of a stone wall, likely a retaining wall, made of large, irregular stones. The wall is covered with green vegetation, including grass and small plants. The wall is situated on a hillside, and a paved road is visible in the foreground. |

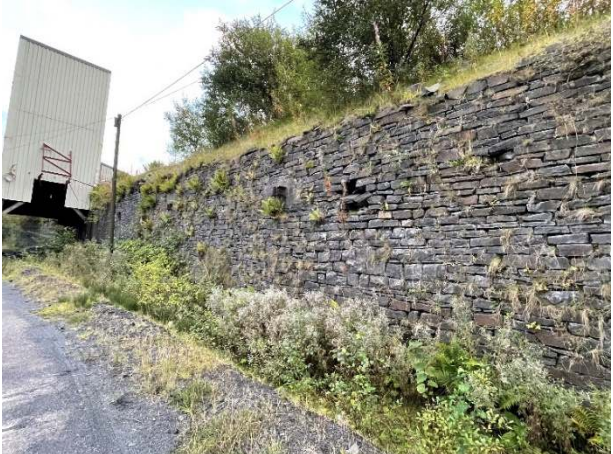
| <b>Building / structure ID</b><br><b>Refer to Figure 1 for location.</b> | <b>Photograph</b> |
|---|---|
| Eastern Wall | A photograph showing a stone wall constructed from dark, rectangular stones. The wall is situated on a grassy slope. To the left of the wall, a portion of a light-colored building with a dark roof is visible. The foreground is covered with green and yellow vegetation. |

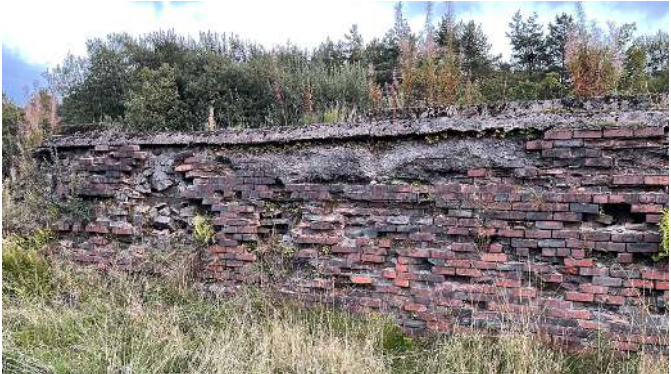
| <b>Building / structure ID</b><br><b>Refer to Figure 1 for location.</b> | <b>Photograph</b> |
|---|---|
| Brick Structure | A photograph of a brick wall made of red bricks. The wall is partially covered with dark, possibly moss or lichen, and is surrounded by tall grass and some shrubs. The background shows a line of trees under a blue sky. |
