# **Y Bryn Wind Farm Borrow Pit Assessment Appendix 10.3**

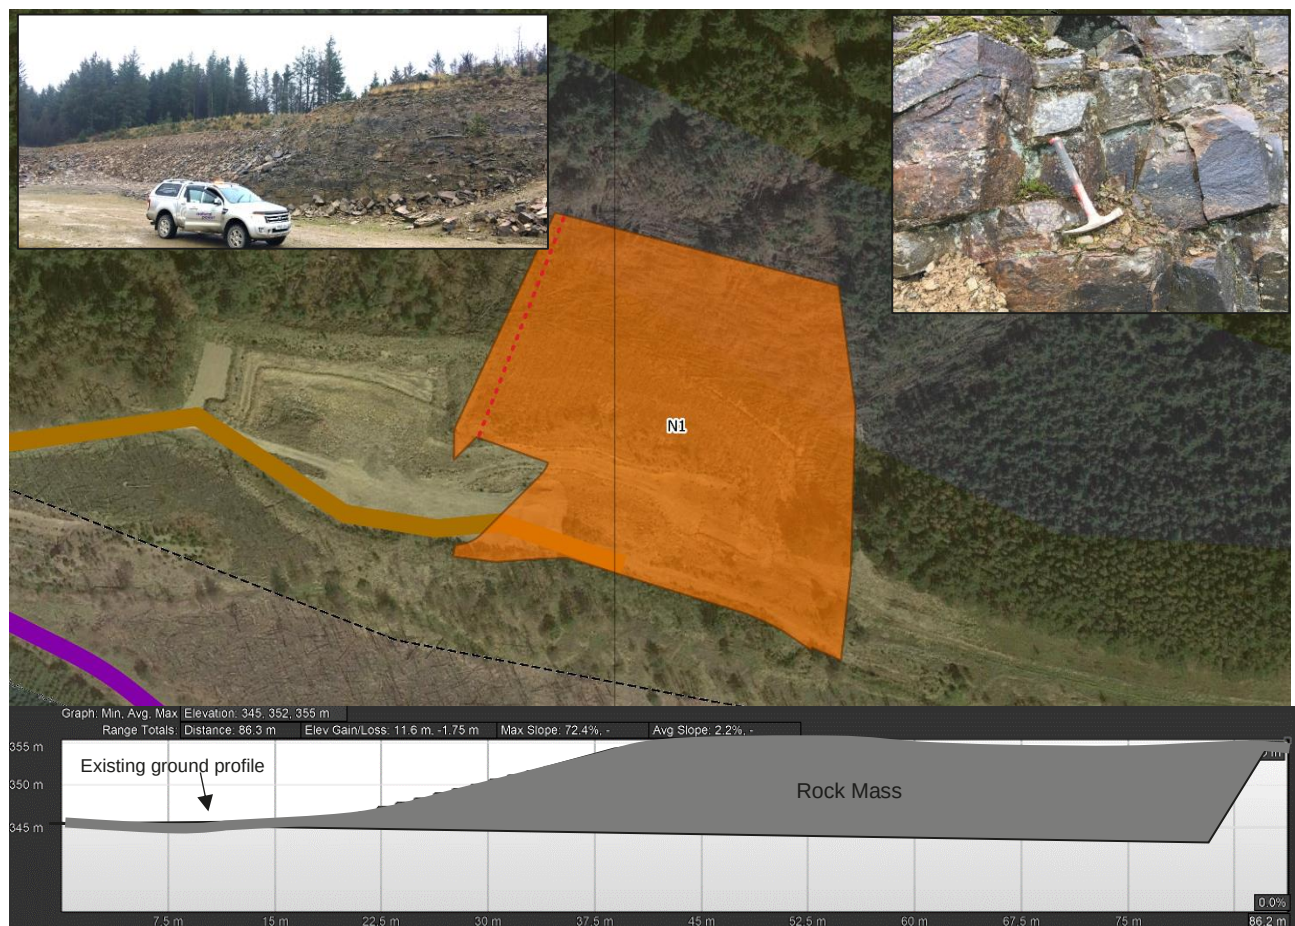
**Figure 3.1: Proposed Borrow Pit N1 Location**

This location is a large existing/active borrow pit location with plentiful reserves of extracted and processed material. The borrow pit is located close to the site entrance of the northern area of the development. The outcropping rock is good quality sandstone, slightly weathered. The back face of the existing borrow pit is approximately 8.0 m high and this backwall can be extended north if greater quantities of material are required. Bedrock is visible at the surface suggesting thin overburden thickness.

Bedrock is anticipated to comprise the: The Llynfi Member Sandstone with Mudstone and Siltstone indicated sub-cropping the northern limits of this search area.

At Borrow Pit N1 The dominant bedrock geology is identified from the British Geological Survey BGS online database<sup>1</sup> to comprise the Llynfi Member Sandstone. Described as: green-grey and blue-grey, feldspathic, micaceous, lithic arenite of southerly provenance, with thin mudstone/siltstone and seatearth interbeds and mainly thin coals; the lithologies are commonly arranged in fining upwards channel-fill sequences. South from N1; the bedrock is indicated to comprise of the South Wales Upper Coal Measures Formation described as a grey (productive) coal-bearing mudstones/siltstones with seatearths and minor grey, quartz-rich sandstones, coals and ironstones. Beyond this, further south, the South Wales Middle Coal Measures Formation is seen to dominate, described as a grey, (productive) coal-bearing mudstones/siltstones, with seatearths and minor sandstones. Figures 3.7 & 3.8 depict the geological units present across the borrow pit search areas.

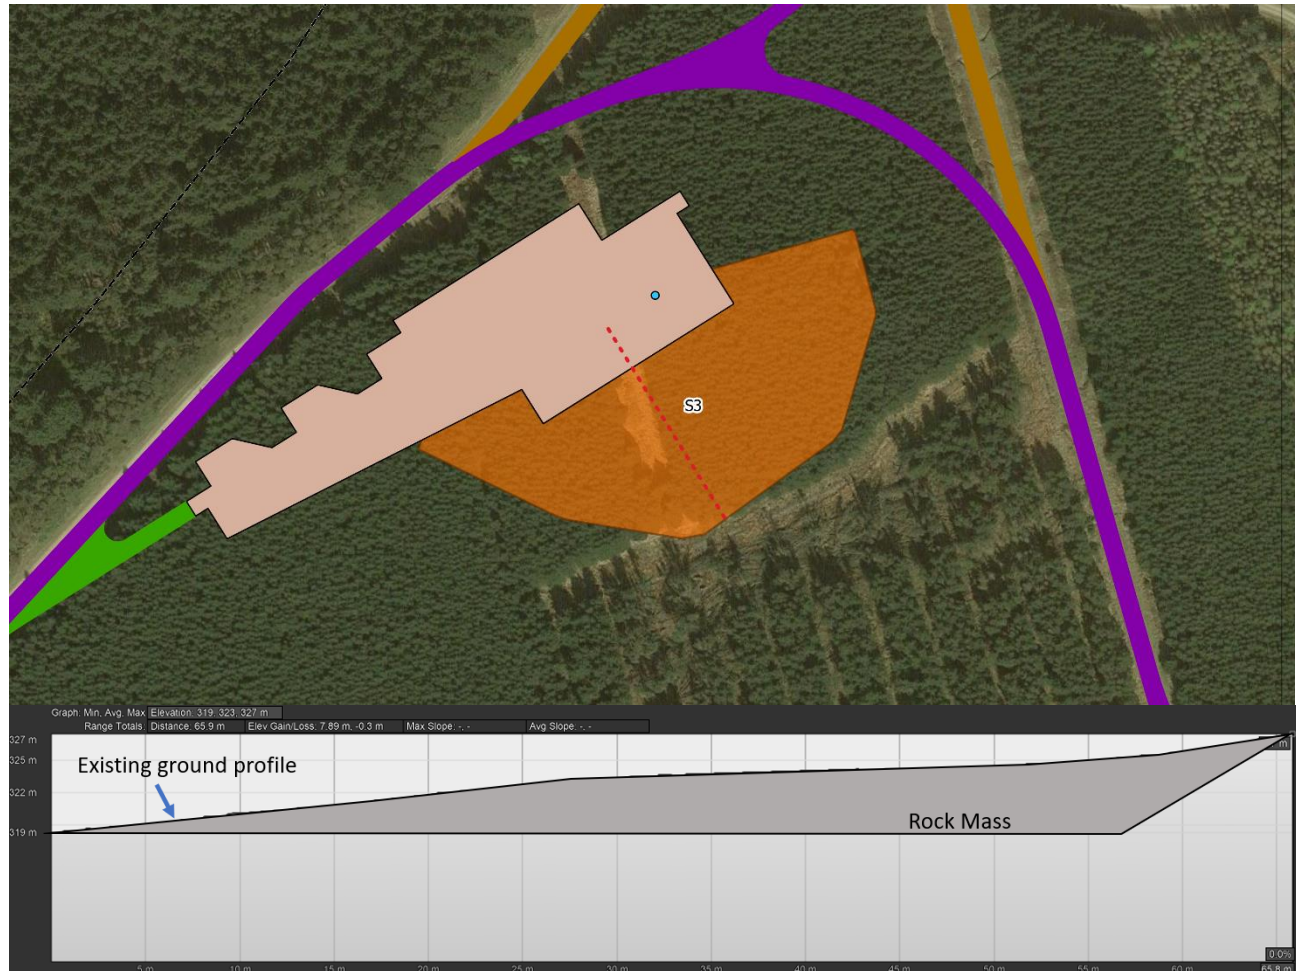
**Figure 3.4: Proposed Borrow Pit 'S3' with indicative working profile**

Located within productive forestry no rock outcrops are visible on the aerial photography. Turbine 10 and associated hardstanding is directly down-slope of the proposed borrow pit search area. The developer is seeking to optimise earthworks at Turbine 10 and extend excavations south to create BP S3. Expanding areas of cut south to form this borrow pit will require a robust design to ensure long term stability of any remaining rock cut slopes.

Bedrock is anticipated to comprise the: Brithdir Member Sandstone.

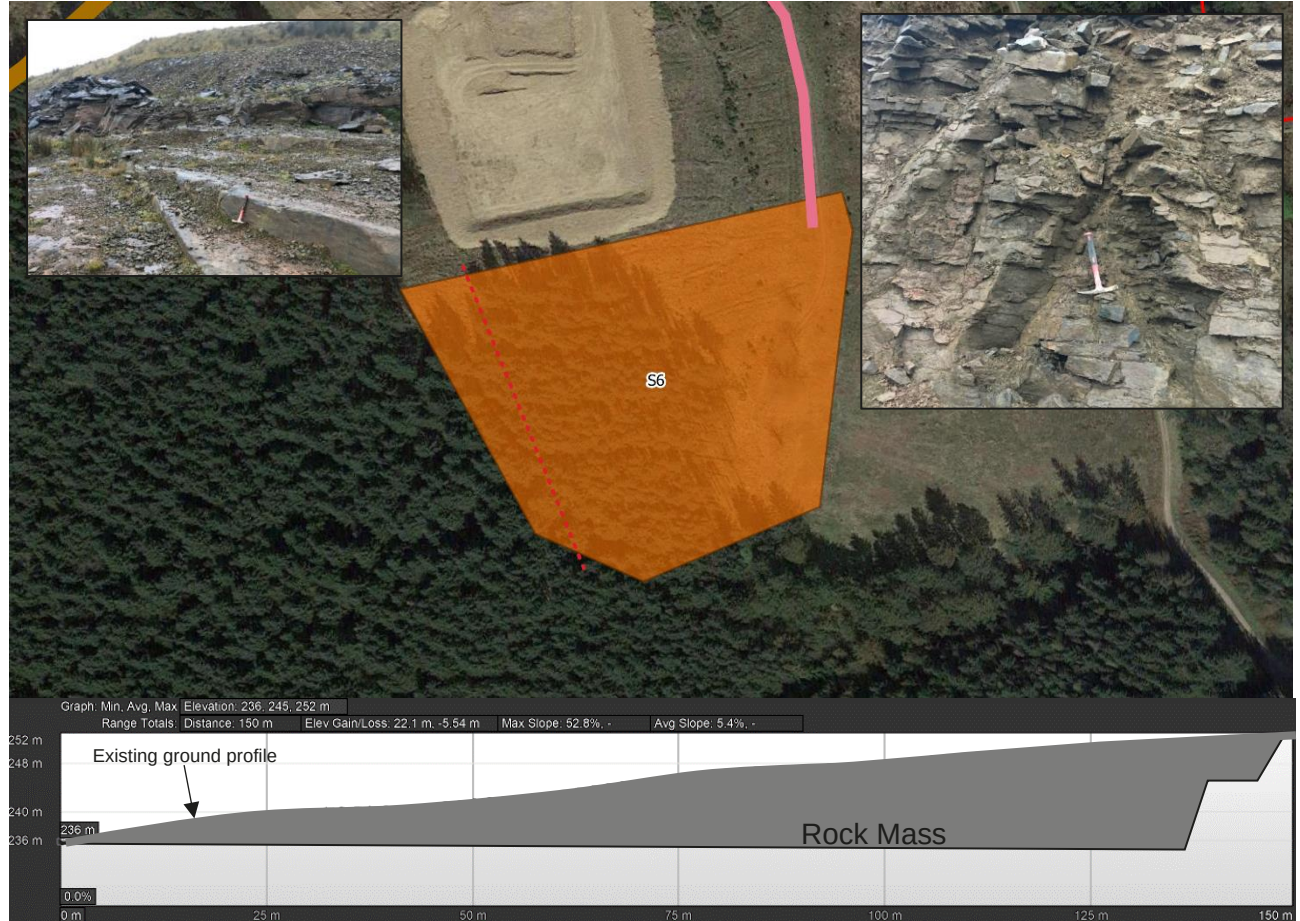
**Figure 3.6: Proposed Borrow Pit 'S5' Location**

The existing borrow in front of search area 'S5' has numerous mechanically exposed faces of sandstone of variable quality. The rock is generally moderately strong to strong with x4 different joint sets. Occasionally silty with slight weathering but predominantly fresh. On visual inspection it appears the borrow pit may be extended south into the back wall. Bedrock exposure at the surface is indicative of reduced overburden thickness.

Bedrock is anticipated to comprise the: The Brithdir Member Sandstone. A shallow dipping coal seam should be anticipated beneath the southern half of the borrow pit search area.

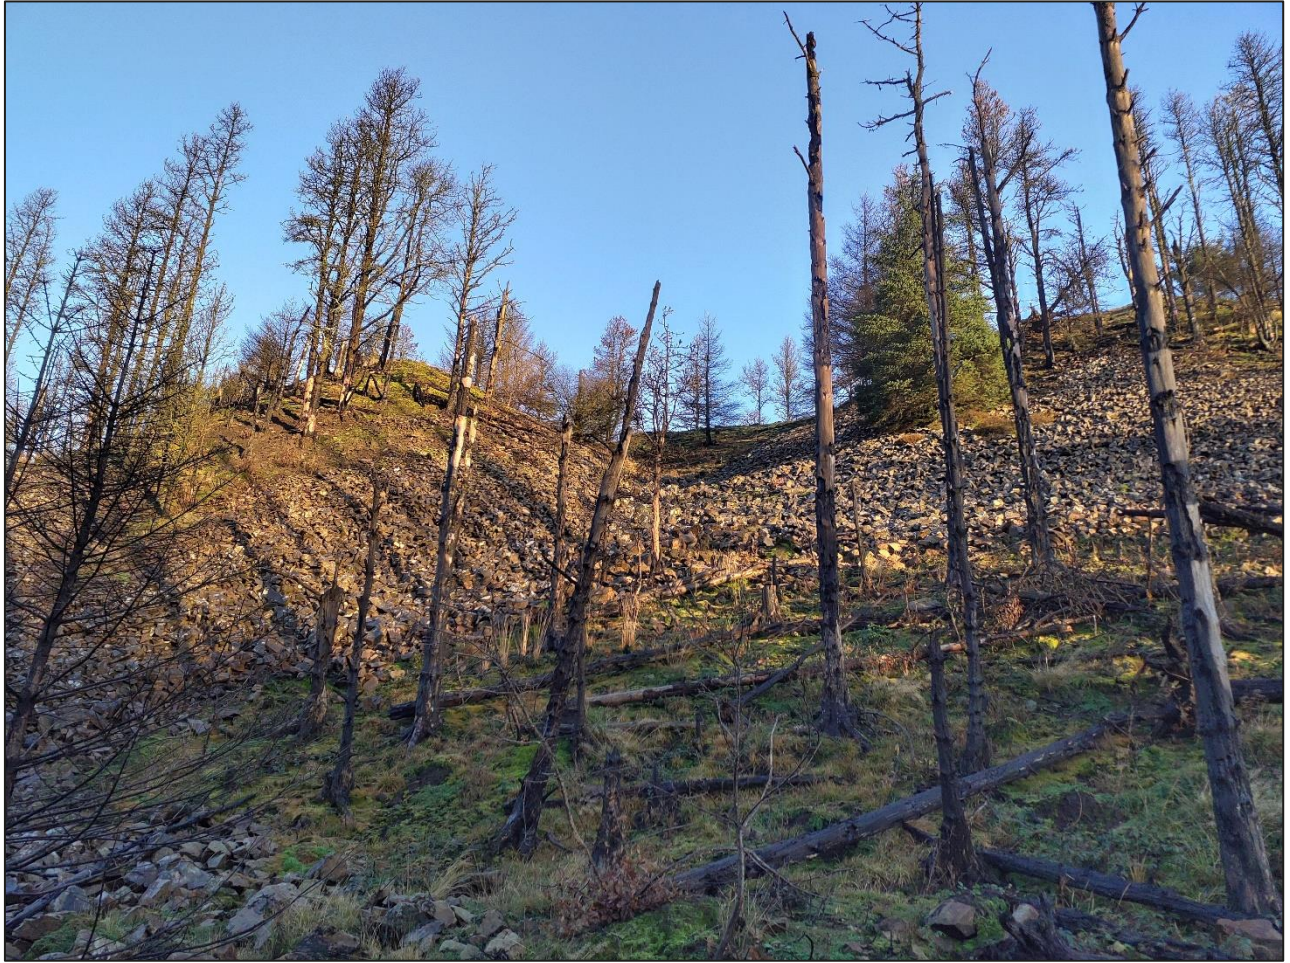
Figure 4.4: Steep terrain of 'N1' Vicinity with blocky scree evident at surface

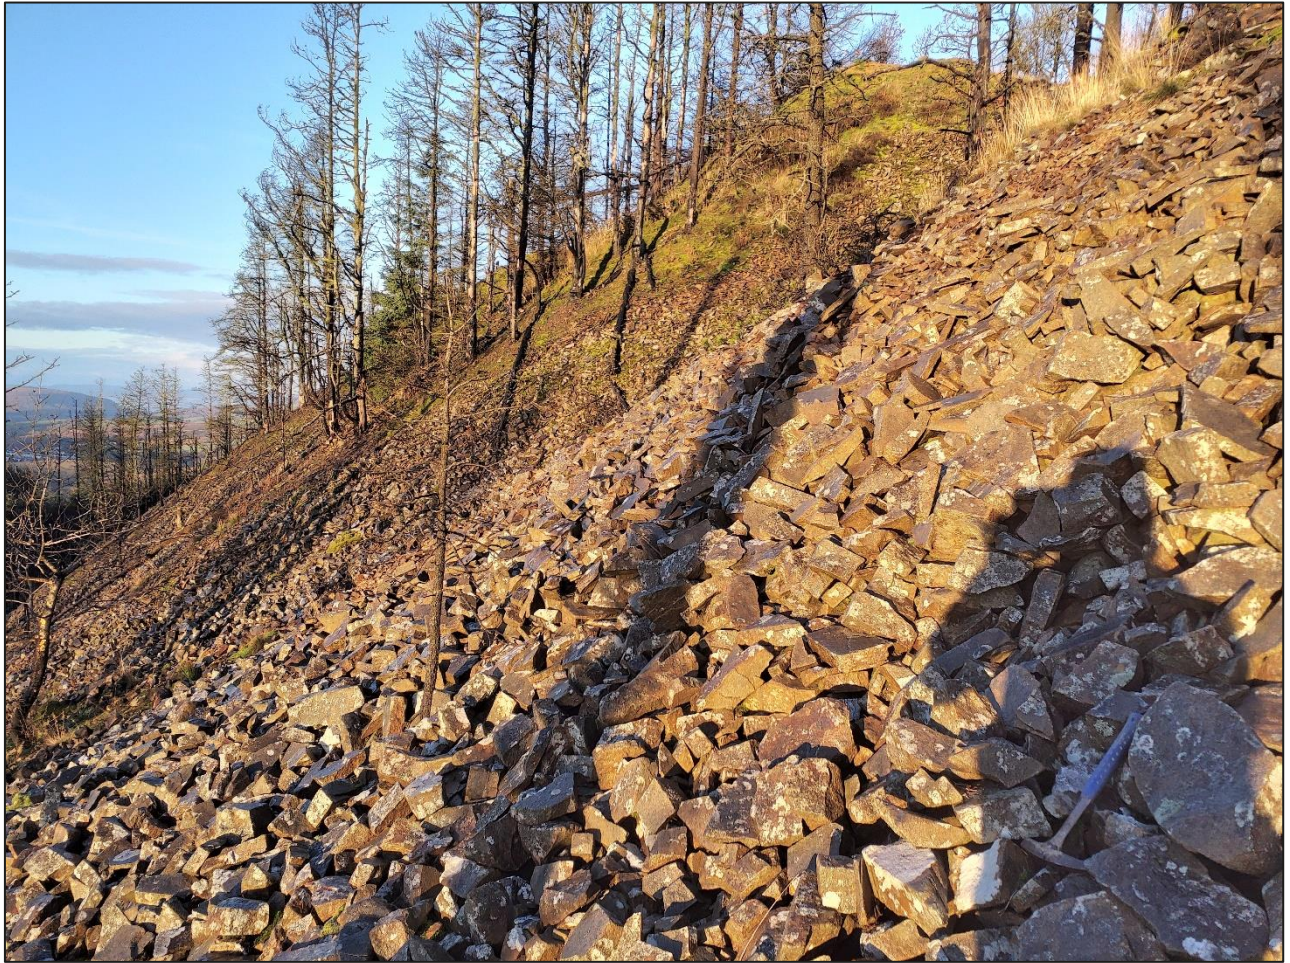
Figure 4.5: Detailed view of surface material at Borrow Pit 'N1' Vicinity

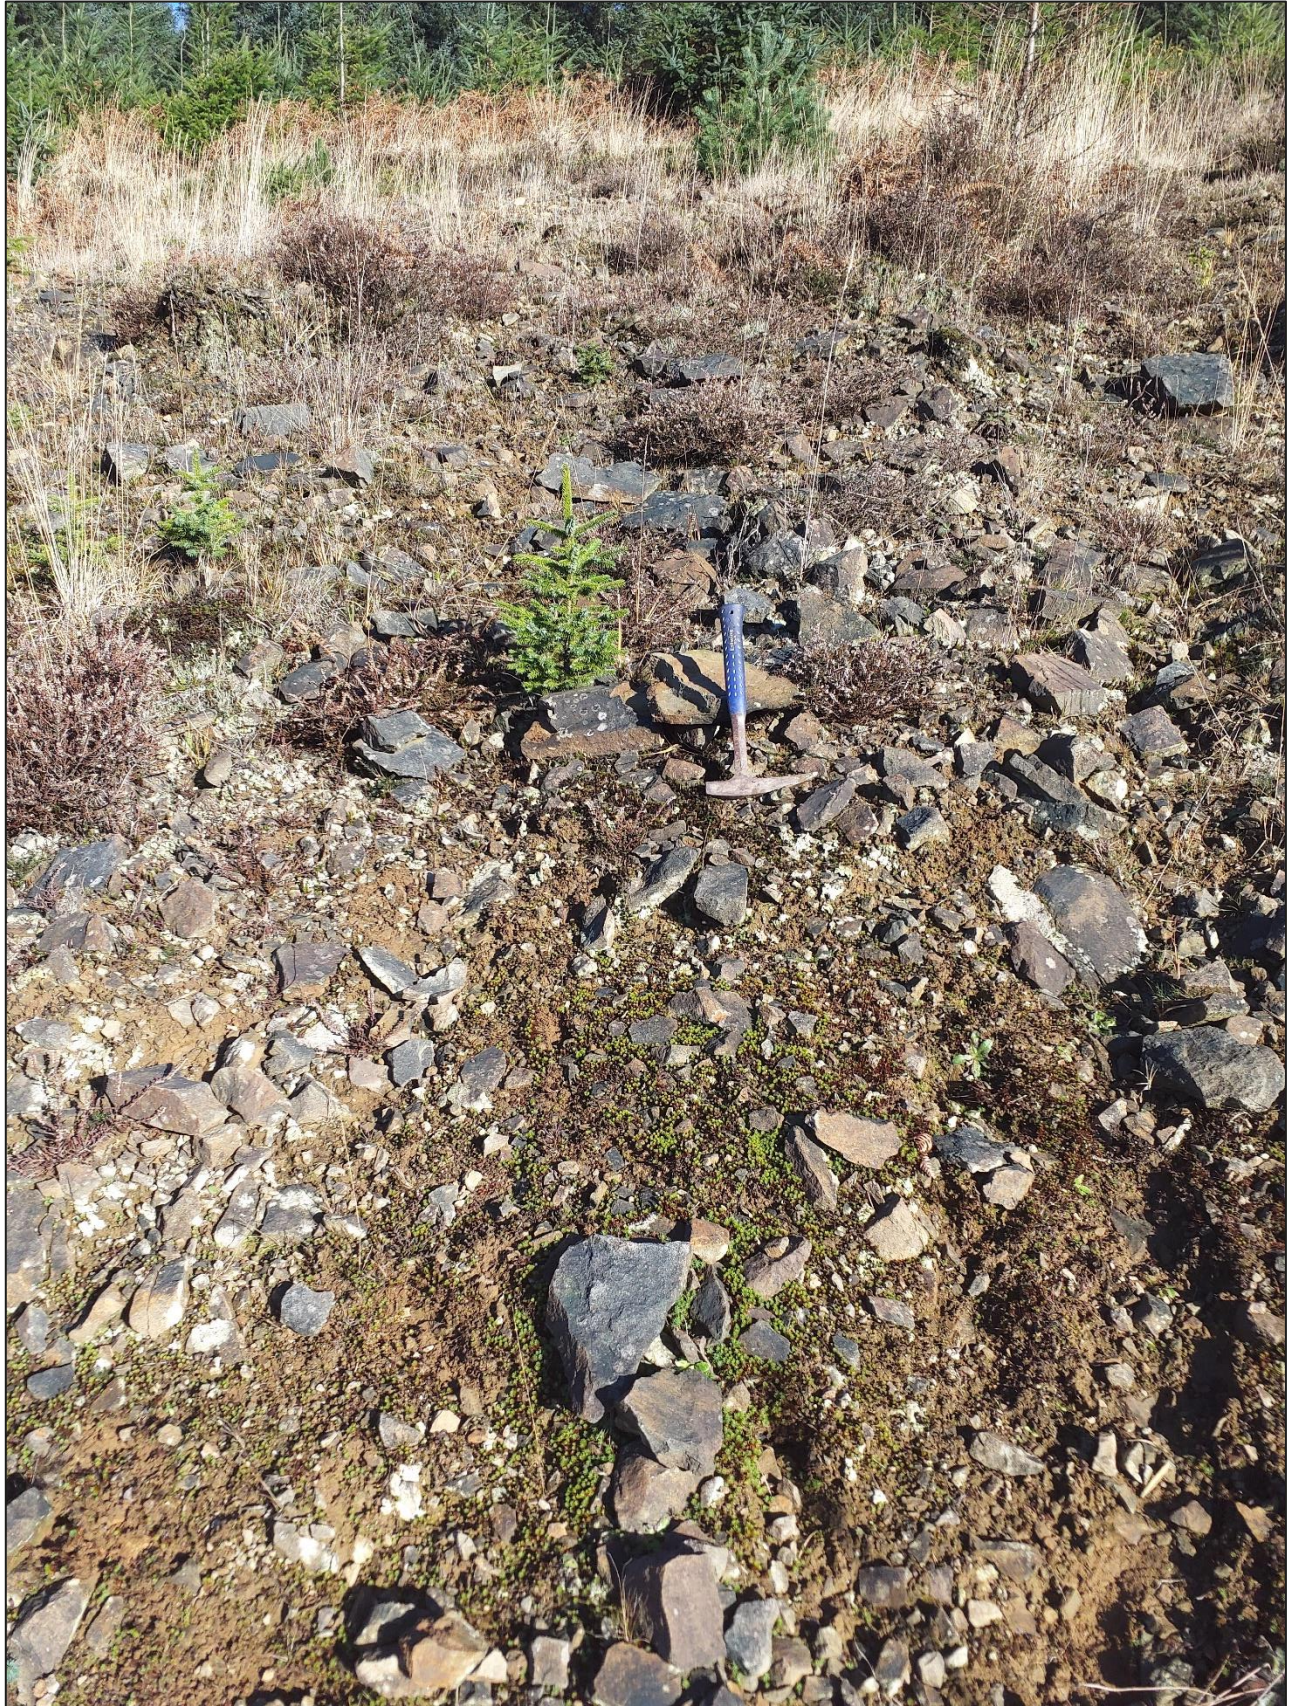
**Figure 4.7: Surface material at Borrow Pit BP 'S1'**

Visible material likely to excavate as brown to light brown subangular very (~30-40%) fine to coarse sandy COBBLES with fine to coarse subangular gravel and boulders of medium strong light brown medium sandstone. Possible high fines.
