# Technical Note

**Project:** Crymlyn Tip, Coed Darcy

**Subject:** Hydrock Lower Tip Works 2014/2015

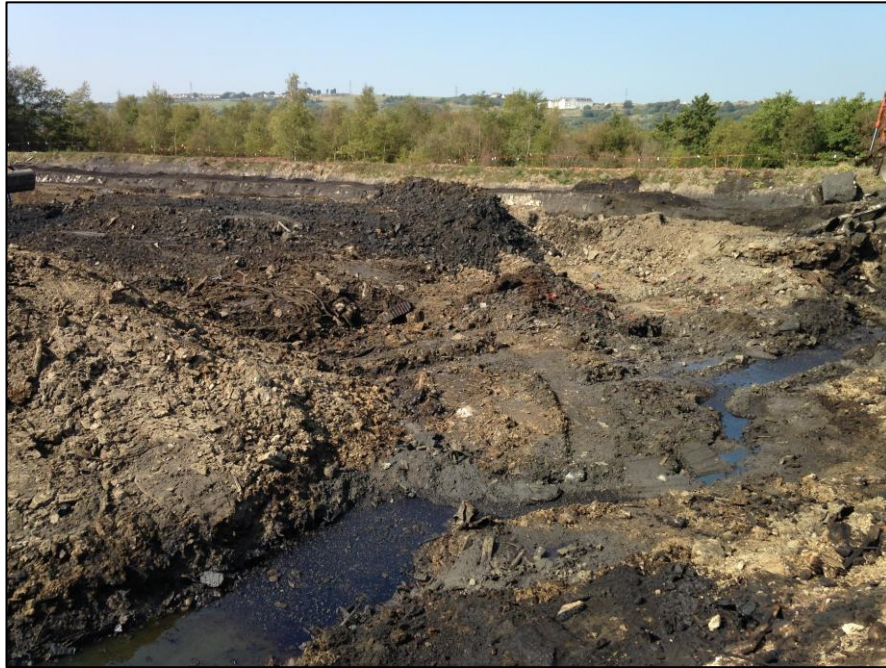
Photograph 1: Excavation in Zone 1

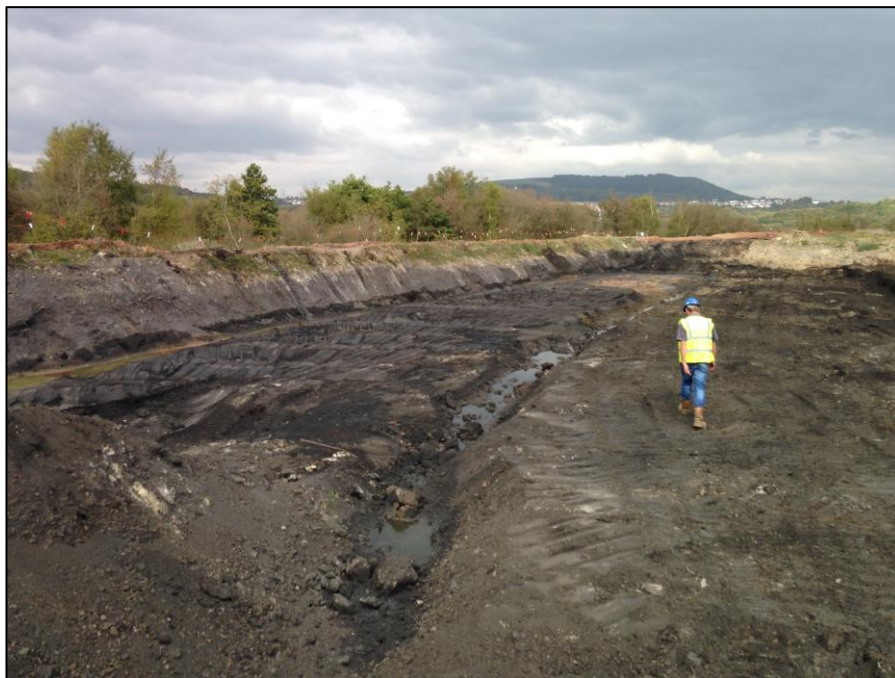
Photograph 2: Base of Excavation North of Zone 1

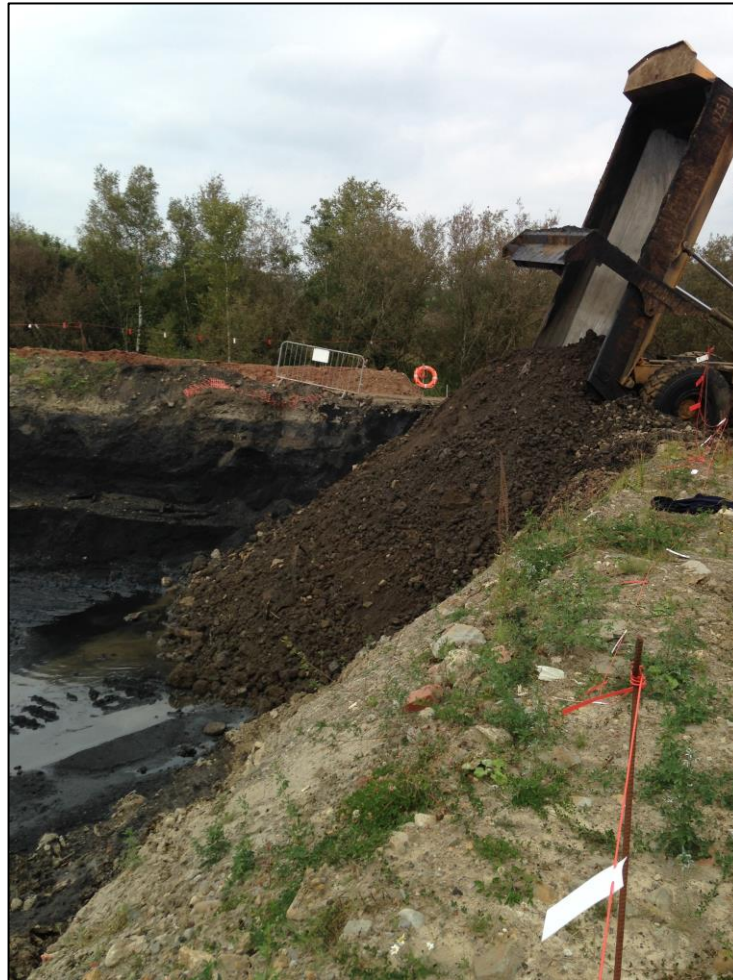
Photograph 3: Backfilling of drained soils into Zone 1 (north east corner)

The turnover comprised excavation of waste fill and removal of identified sources of oil. Oil was skimmed from standing water in the base of the excavations and excavated soils were left to drain before being replaced in layers.

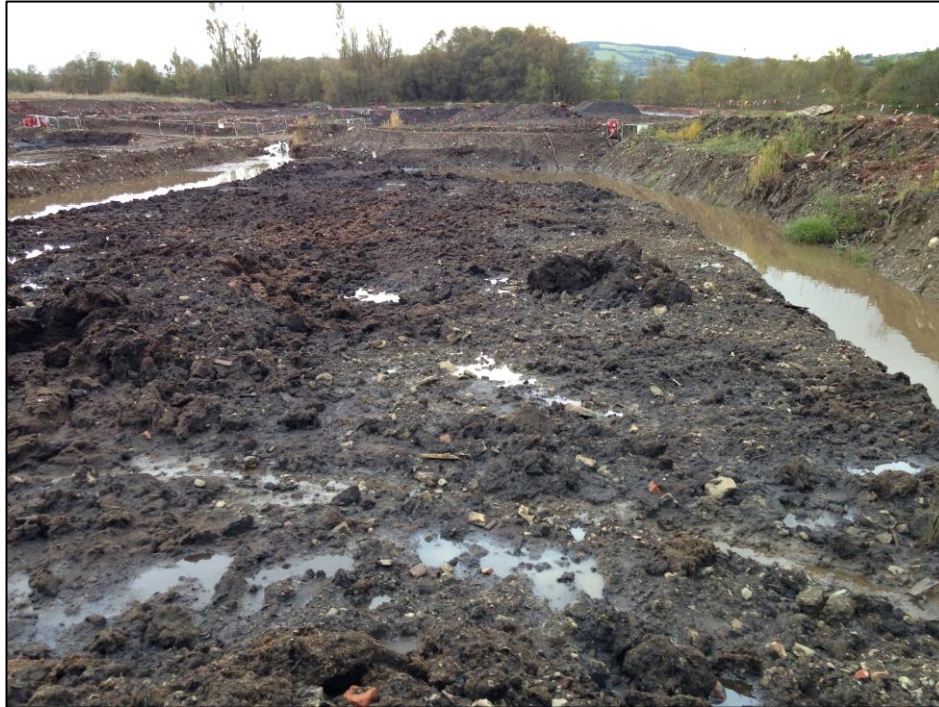
Photograph 4: Peat at base of excavation in northern part of Zone 2

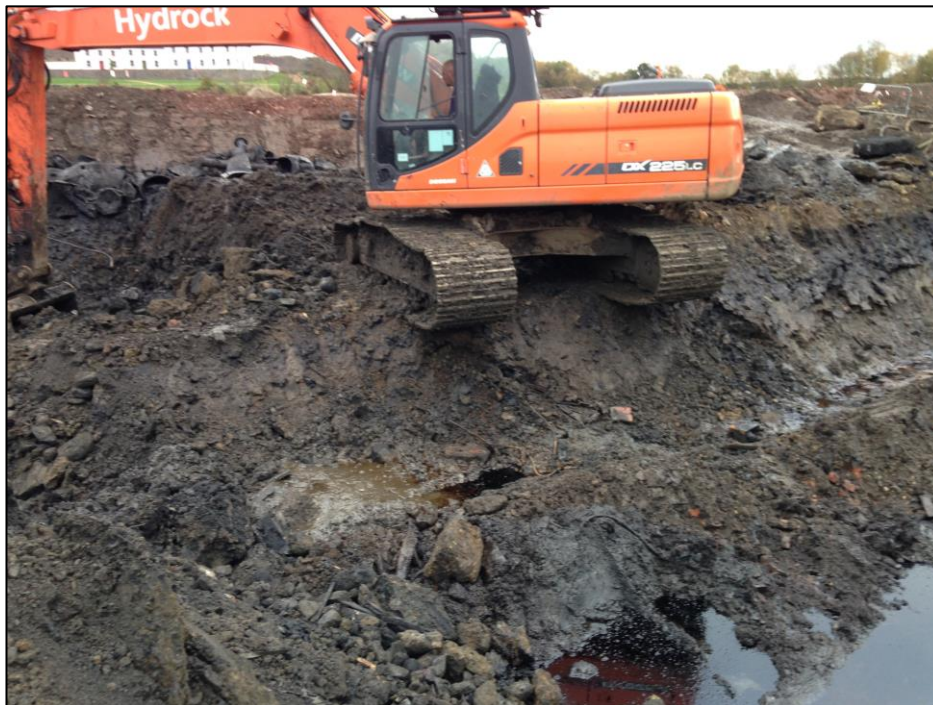
Photograph 5: Excavation of waste deposits in Zone 2

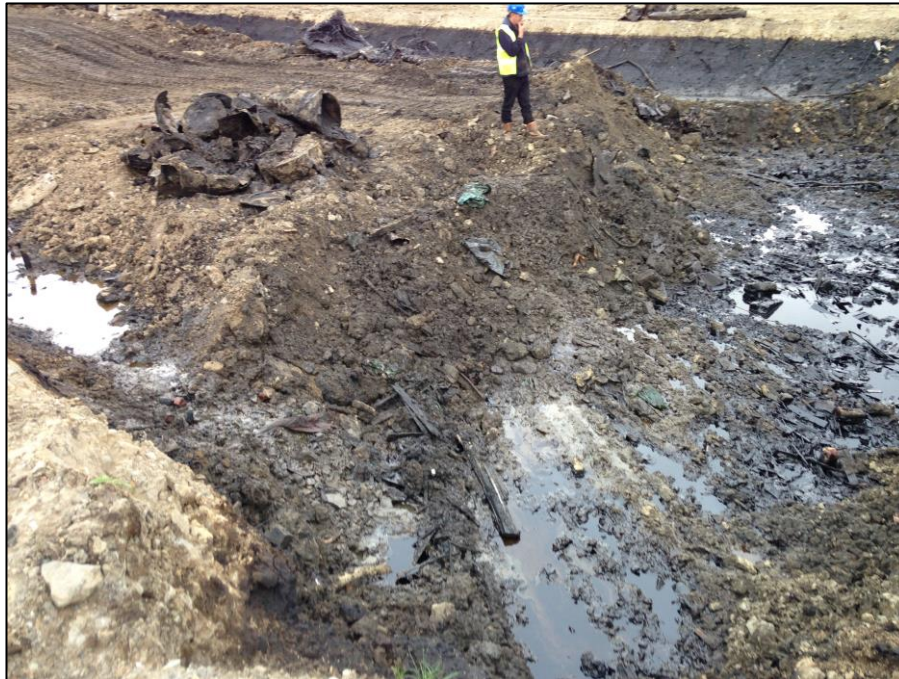
Photograph 6: Base of excavation and partial backfilling in the southern part of Zone 2

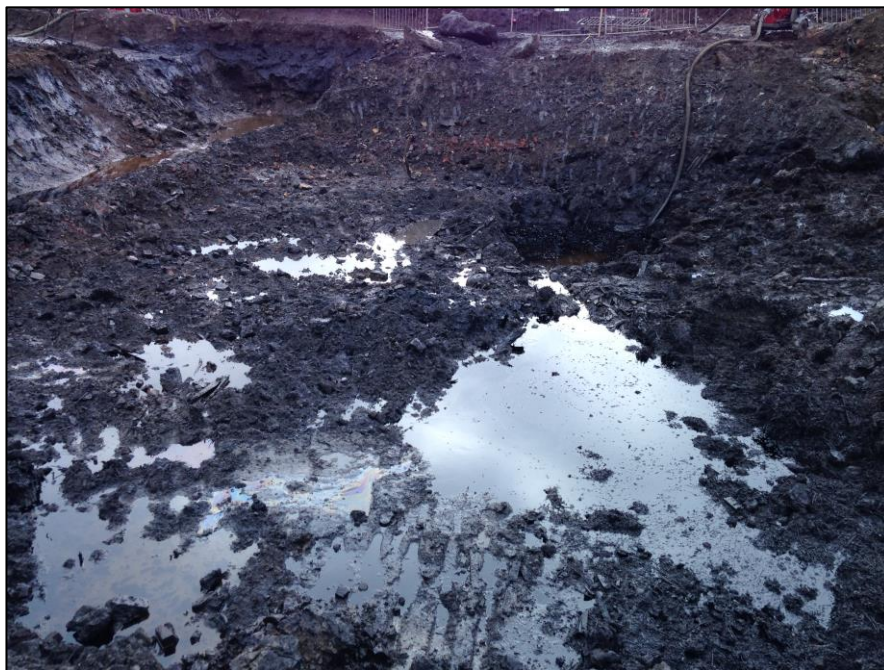
Photograph 7: Oil Recovery from the excavation in Zone 3

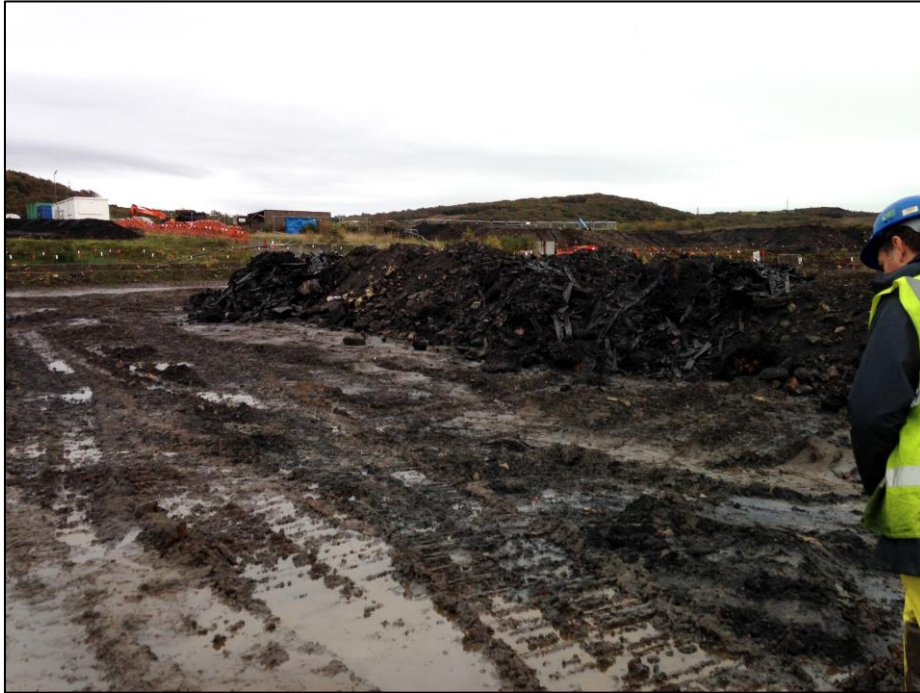
Photograph 8: Arisings from excavations
