23086/R1

**WALL COLMONOY, PONTARDAWE – GROUND INVESTIGATION REPORT**

**Wall Colmonoy**

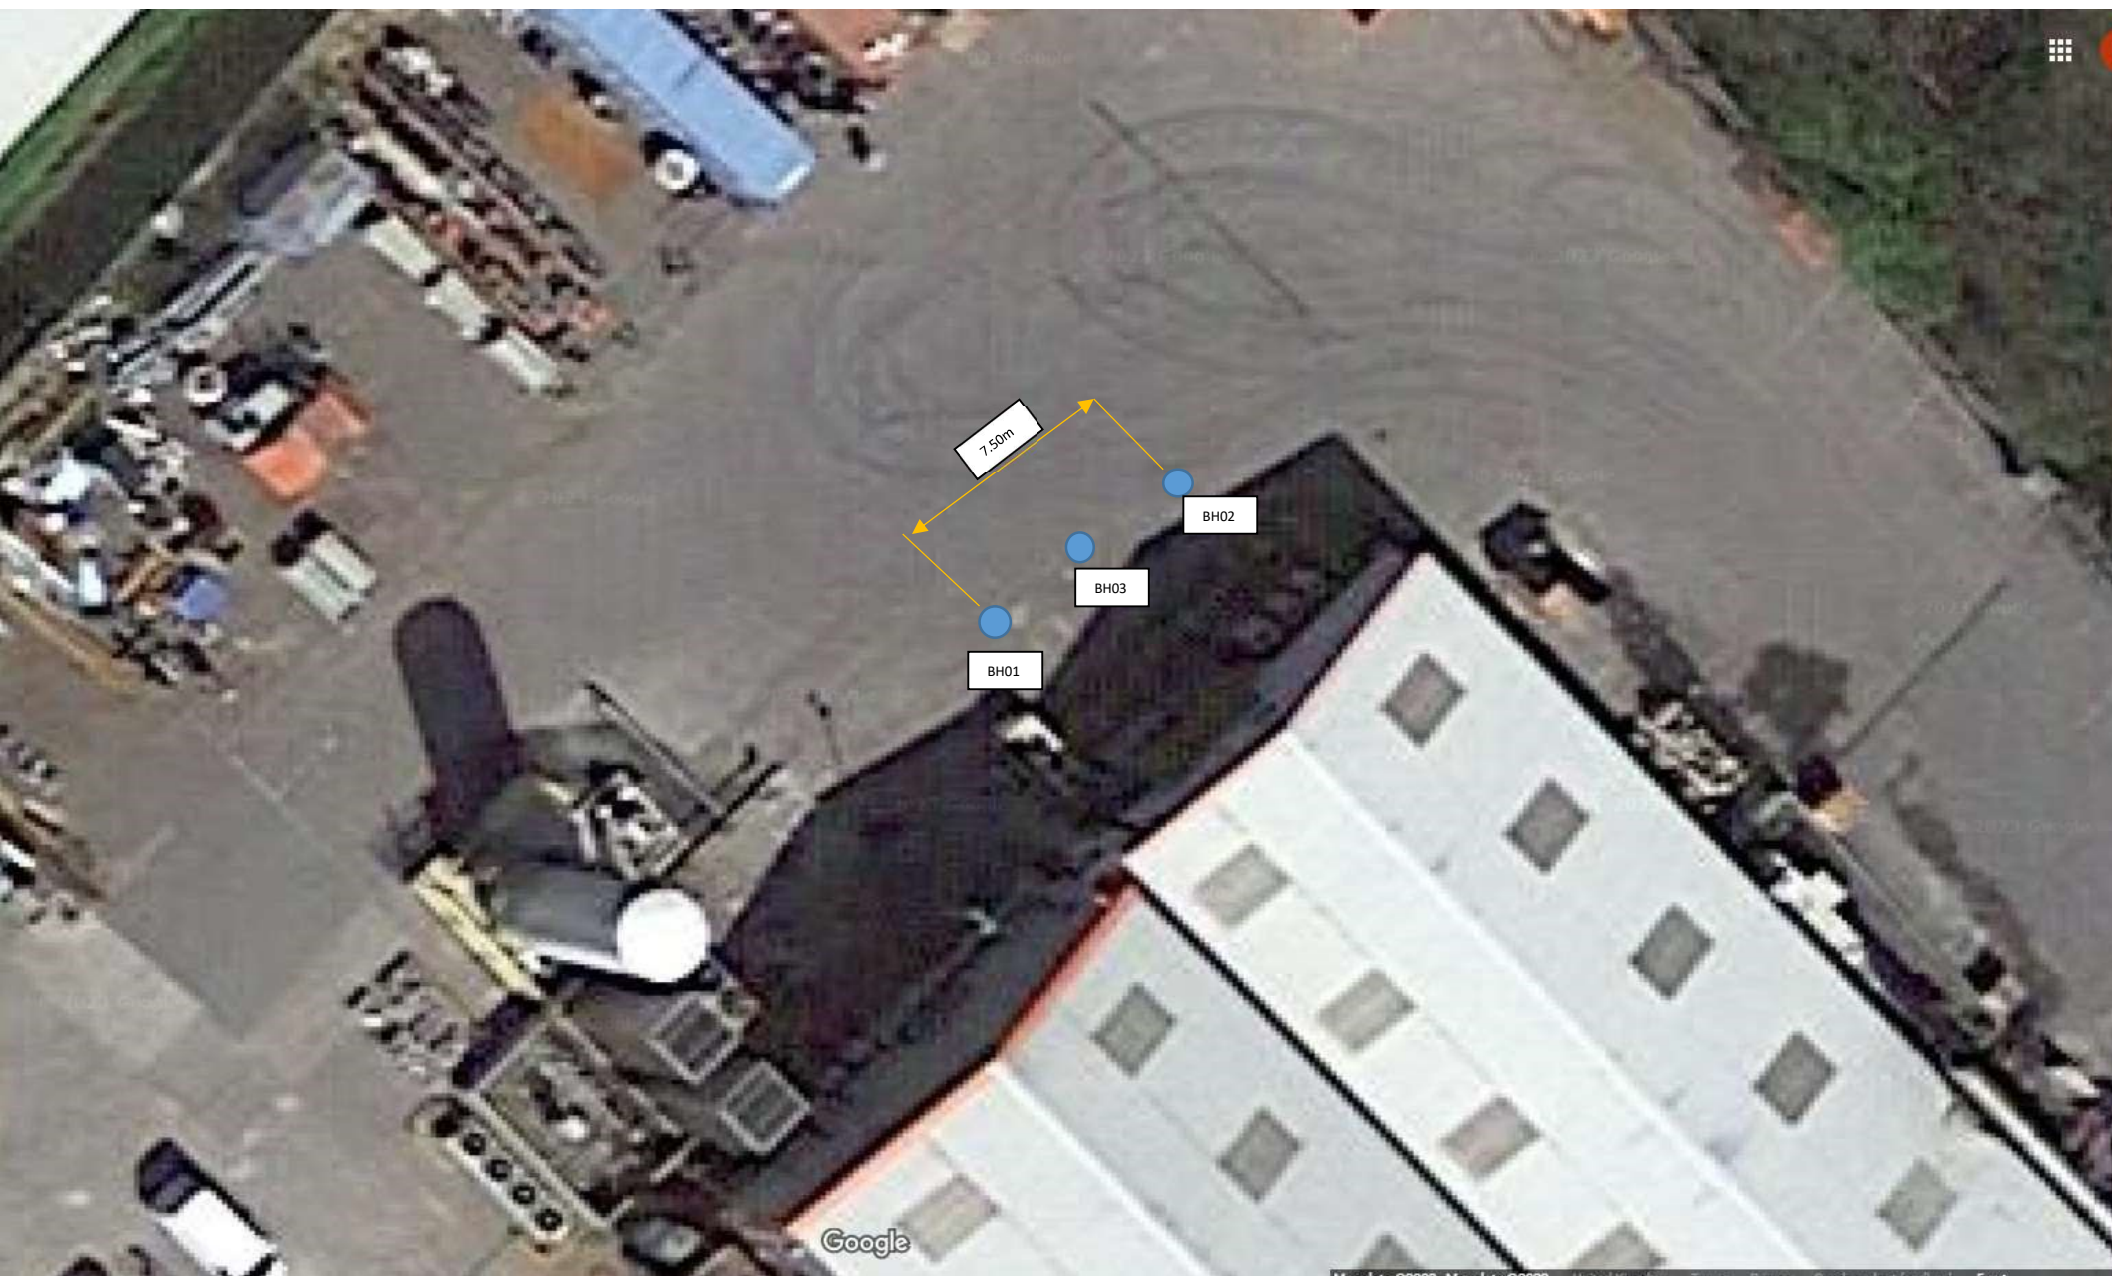
Drawing SGS/23086/Locs

Exploratory Hole Location Plan

Site works comprised 2No dynamic/rotary boreholes, which encountered difficult drilling conditions, which resulted in the requirement for a Cable Percussion borehole. Works were undertaken during the period 24 October to 08 November 2023.
