# Gnoll Country Park, Neath

**Title** Ground Conditions Assessment Report

Andrew Scott Limited working on behalf of the local council is proposing infrastructure enhancements at specific sections of the Gnoll Estate Country Park in Neath, including the construction of a new visitor centre. To assist with the development of the site proposals, Jubb Consulting Engineers (Jubb) have been appointed to undertake a geotechnical and geo-environmental assessment of the ground conditions for the proposed site use.

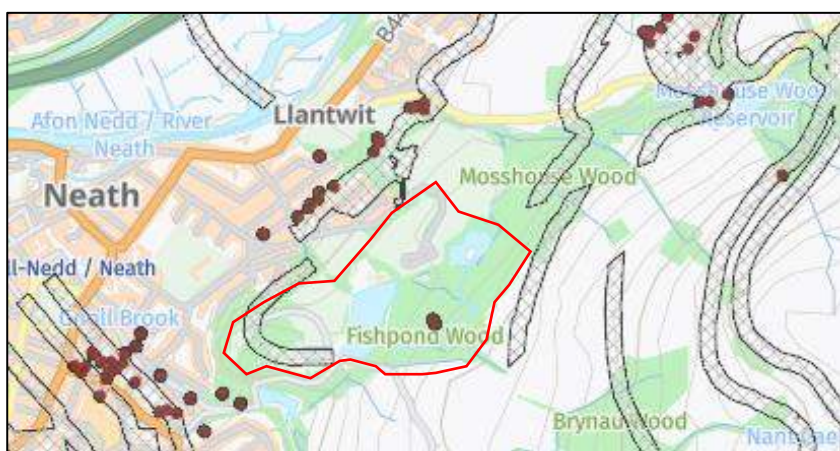
Figure 4: Extract from Coal Authority website, showing Zones of 'Development High Risk' and Mine Shaft Entries

The areas to the north of the reservoir around Areas 2 and 5 appears to be at less of a risk from mining. The probable Brithdir Rider coal seam is shown to crop out in a south-west to north-east orientation some 240m to the north-west, in the area of the former mine entries identified on historical maps. The conjectural outcrop of the Glyngwilym coal seam is shown some 360m to the east. Given the distance from the site and the fact this area of the site is shown to be underlain by *massive sandstone*, the risk of shallow mining activities in these areas is considered low.

It should be noted that the CMRA does not include the mine entry data sheets for the recorded mine shafts within the wooded area. We therefore recommend that these are obtained as part of any additional works and the CMRA updated accordingly with the findings.

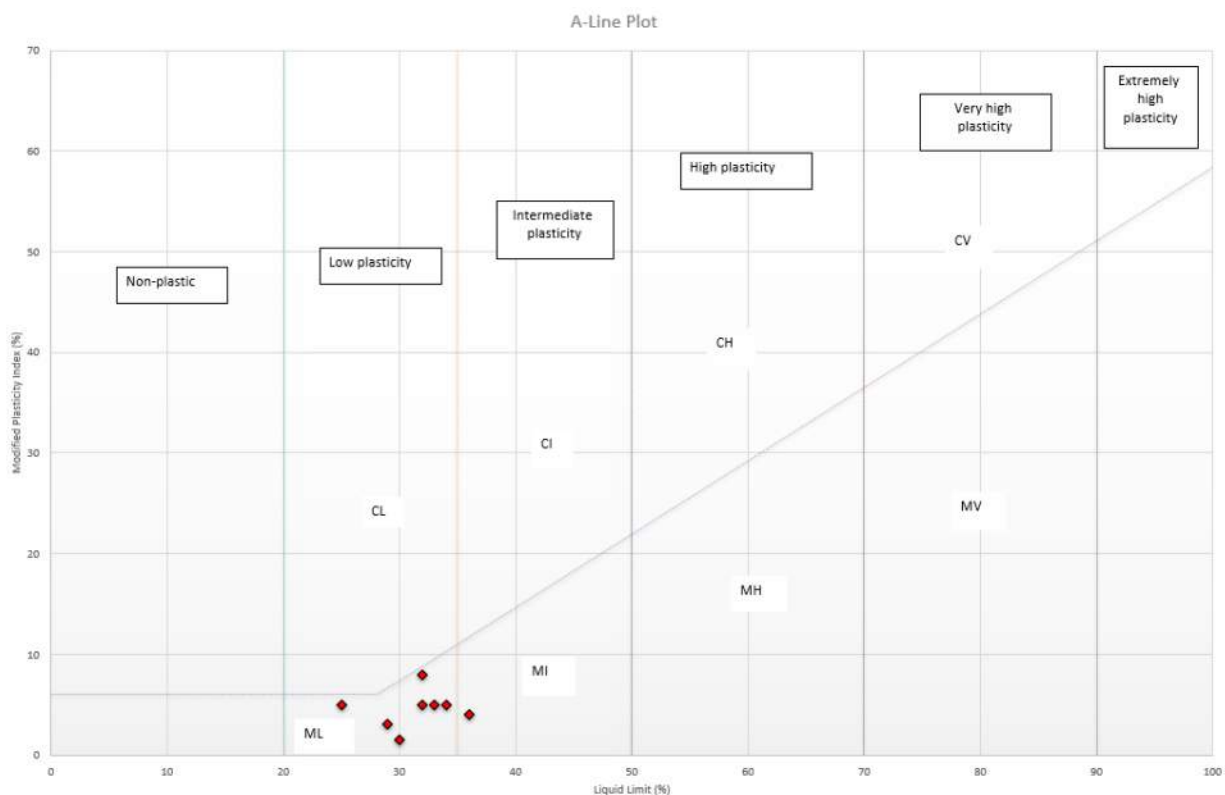
Figure 5: Summary of Plasticity Tests for Pennant Sandstone Formation

The samples of cohesive soil had natural moisture contents between 9% and 22% and a modified plasticity index of between 1% and 8% indicating the soil to be non-shrinkable. The sample comprised between 11% and 62% clay/ silt content.

Taking into account the portion of the sample passing the 425  $\mu\text{m}$  sieve, the reported plasticity index values can be modified in accordance with NHBC standards Chapter 4.2 'Building Near Trees'. Based on this the samples all have a non-shrinkable potential and so no requirement on a minimum foundation depth when building near trees, when foundations are placed within the shallow cohesive residual soils.

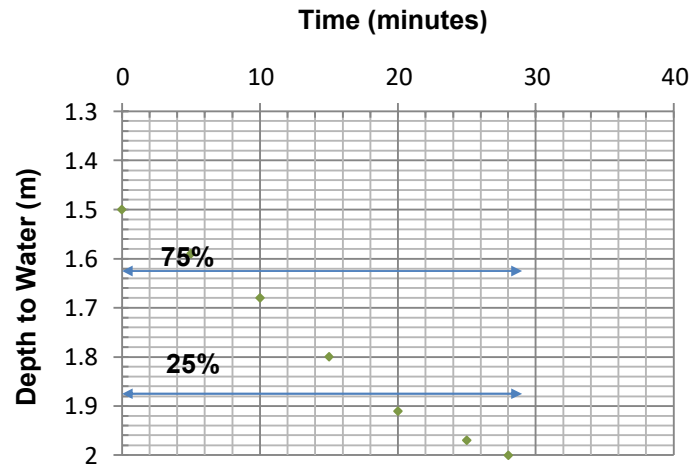
Soil Infiltration Rate,  $f$  2.14E-04 ms<sup>-1</sup>

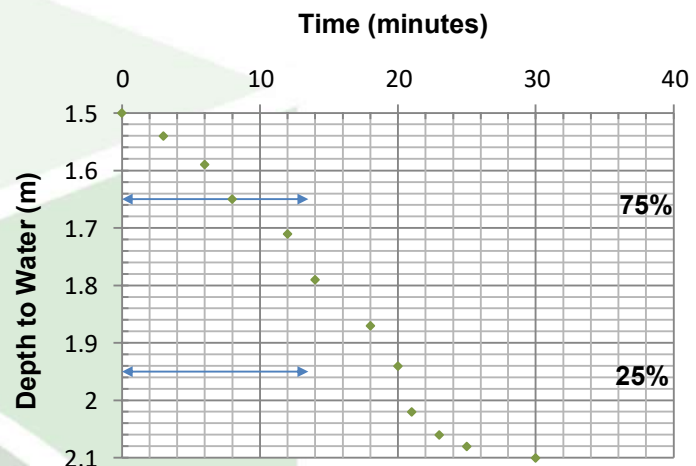
Length 2.00 m  
 Width 0.60 m  
 Depth 2.10 m  
 Fill Level 0.50 m

Soil Infiltration Rate,  $f$  1.74E-04 ms<sup>-1</sup>

| <b>Drainage</b> | Infiltration drainage will likely be suitable in areas where the base of the soakaways is within the weathered bedrock where infiltration rates of between $1.74 \times 10^{-4}$ m/s and $7.69 \times 10^{-5}$ m/s were recorded. Soakaways were carried out with the base within the residual and failed to infiltrate therefore soakaways within the clays will not be suitable, although they could potentially be extended down to the weathered granular bedrock subject to further testing. |

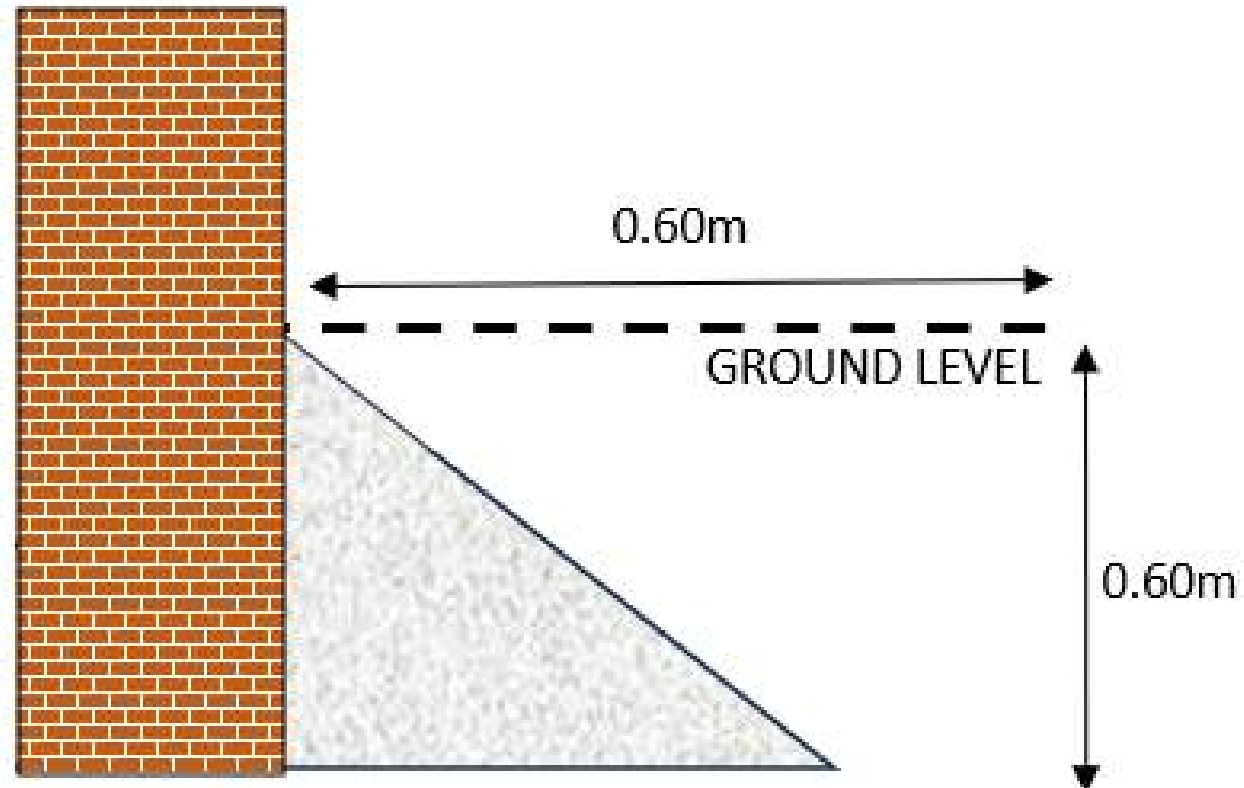
# HP03 *NOT TO SCALE*

Site Name: Gnoll Park  
Project Number: 17887  
Drawing Title: HP03 Foundation Sketch  
Drawing Number:  
Scale: Not to scale

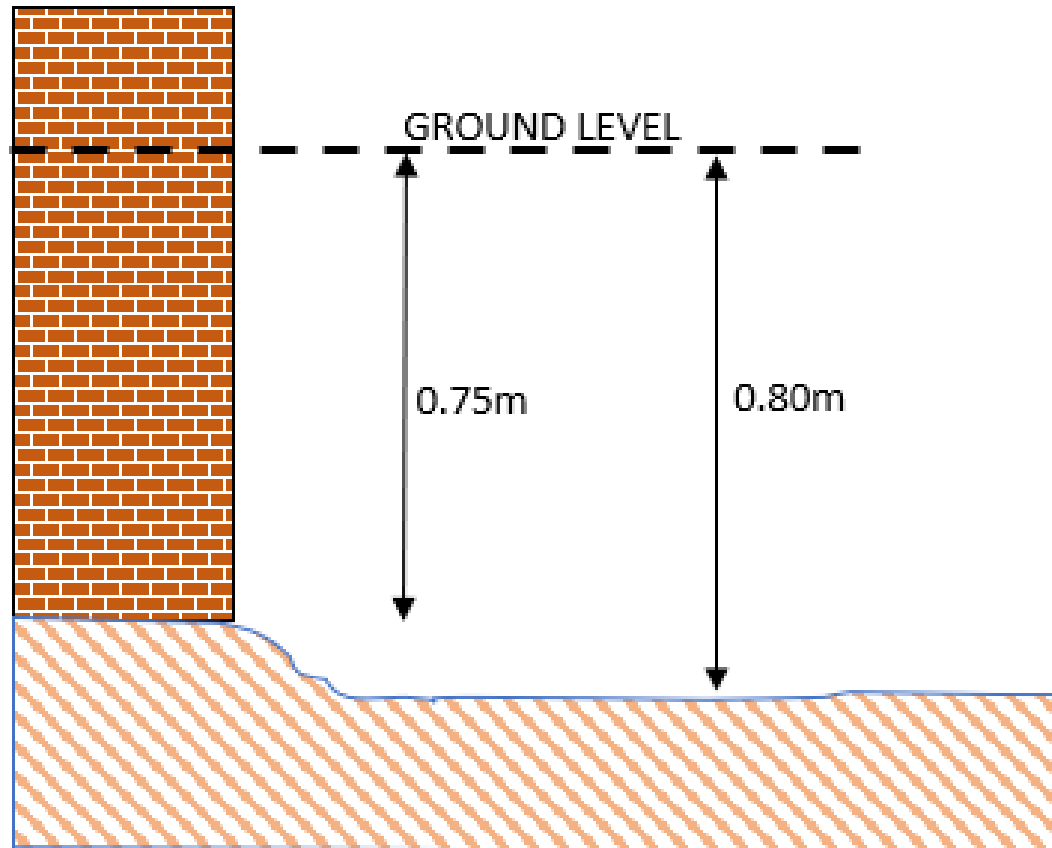
# HP04 *NOT TO SCALE*

Site Name: Gnoll Park  
Project Number: 17887  
Drawing Title: HP04 Foundation Sketch  
Drawing Number:  
Scale: Not to scale

Made Ground was encountered in HP04 during foundation exposure of Pond Cottage. The material comprised a 80mm thick crushed concrete gavel at surface, overlying a brown sandy gravelly ashy clay with anthropogenic components of clinker, coal, ash, glass and brick fragments. The depth of the material could not be proven beyond 0.80m below ground level. This fill material likely used a backfill for the foundation excavations during the construction of Pond Cottage.

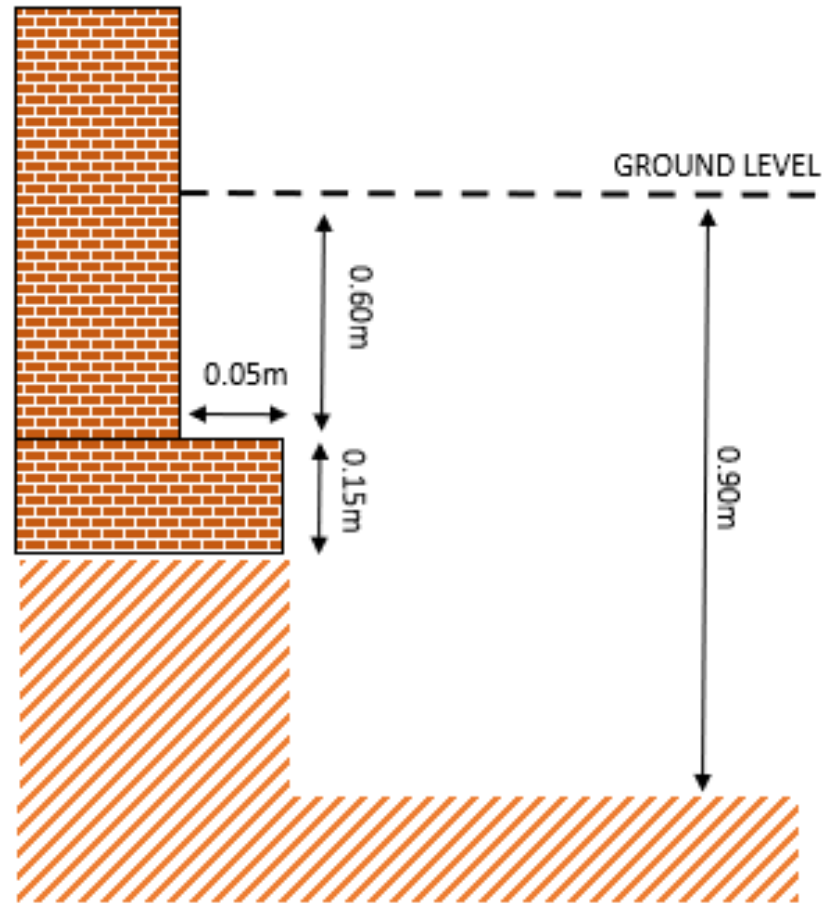
**HP05**

Site Name: Gnoll Park  
Project Number: 17887  
Drawing Title: HP05 Foundation Sketch  
Drawing Number:  
Scale: Not to scale
