## Zone 01 – Gnoll Ruins

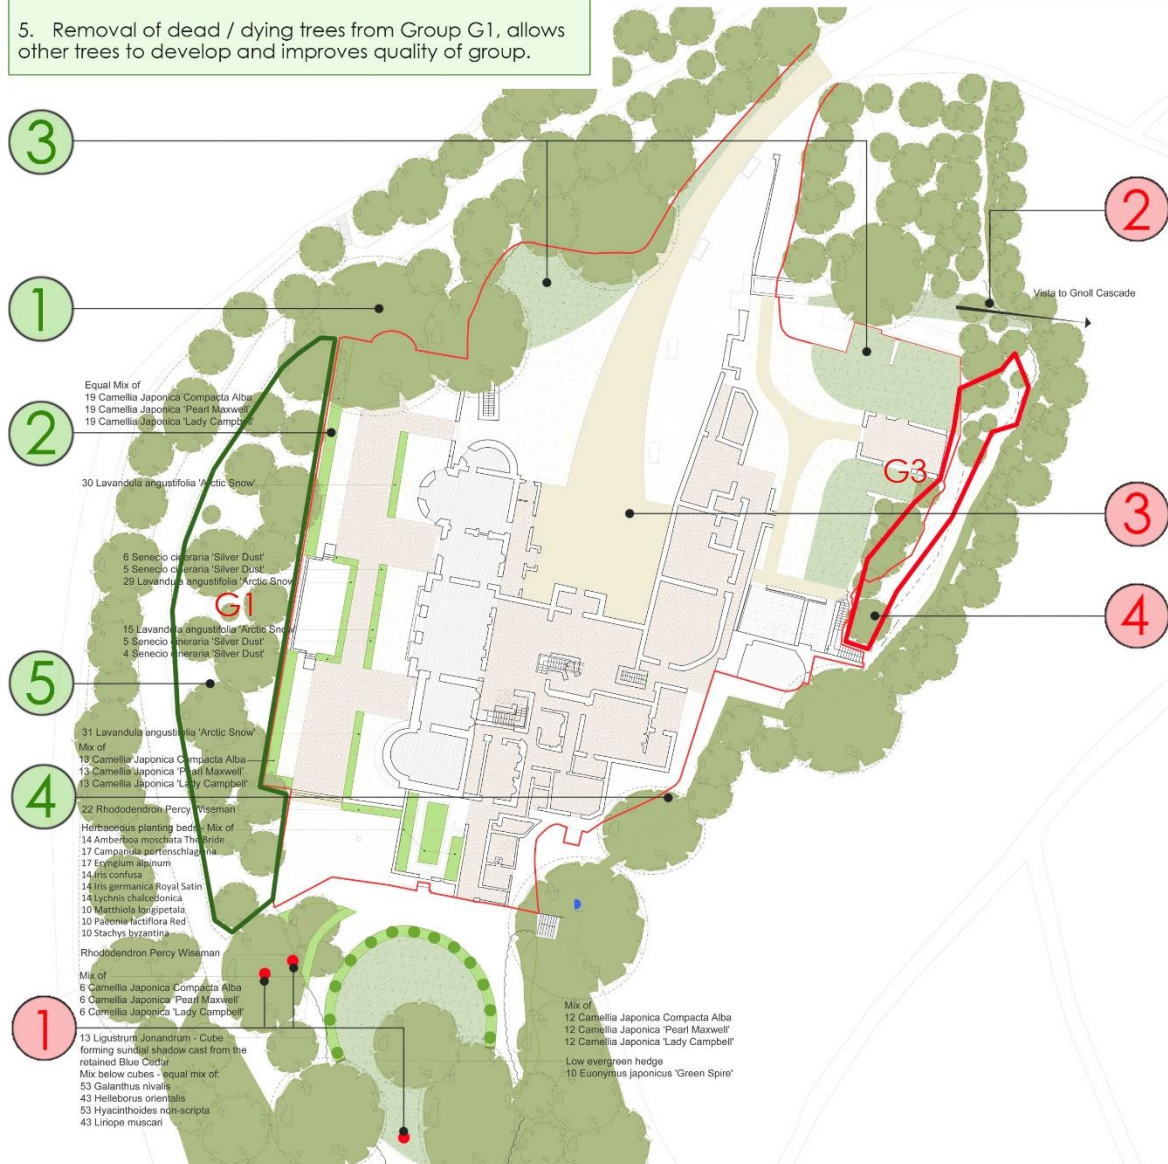
1. Existing vegetation / scrub to be retained where possible to benefit wildlife.
2. Ornamental shrub planting to new soft landscaped areas including species known to be good for pollinators. This creates an attractive external environment and provides ecological benefits.
3. New wildflower meadow areas to be created around the edges of the ruins. This enhances the site and provides more biodiversity than the existing amenity grass.
4. Bat boxes to be included around the ruins to further enhance site ecology.
5. Removal of dead / dying trees from Group G1, allows other trees to develop and improves quality of group.

1. Removal of existing trees 162, 163 and 166 for reasons noted in the Tree Report.
2. Removal of lower branches and lifting of canopies to achieve vista to Gnoll Cascade.
3. Removal of existing grassed areas to create more hard surfacing, improve access and create stage feature.
4. Removal of group of trees G3 for reasons noted in the Tree Report.

The Gnoll Ruins site involves the removal of a small number of poor quality trees as well as the loss of some areas of species poor amenity grass. The introduction of new shrub planting, wildflower meadow areas and bat boxes will enhance biodiversity and provide an appropriate level of mitigation for the site.
