**Level 2 Building Recording:**  
**Former Dyffryn Lower School, Port Talbot**

March 2024

Report No. 2278

Prepared for KEW Planning  
By  
Susan Stratton PhD

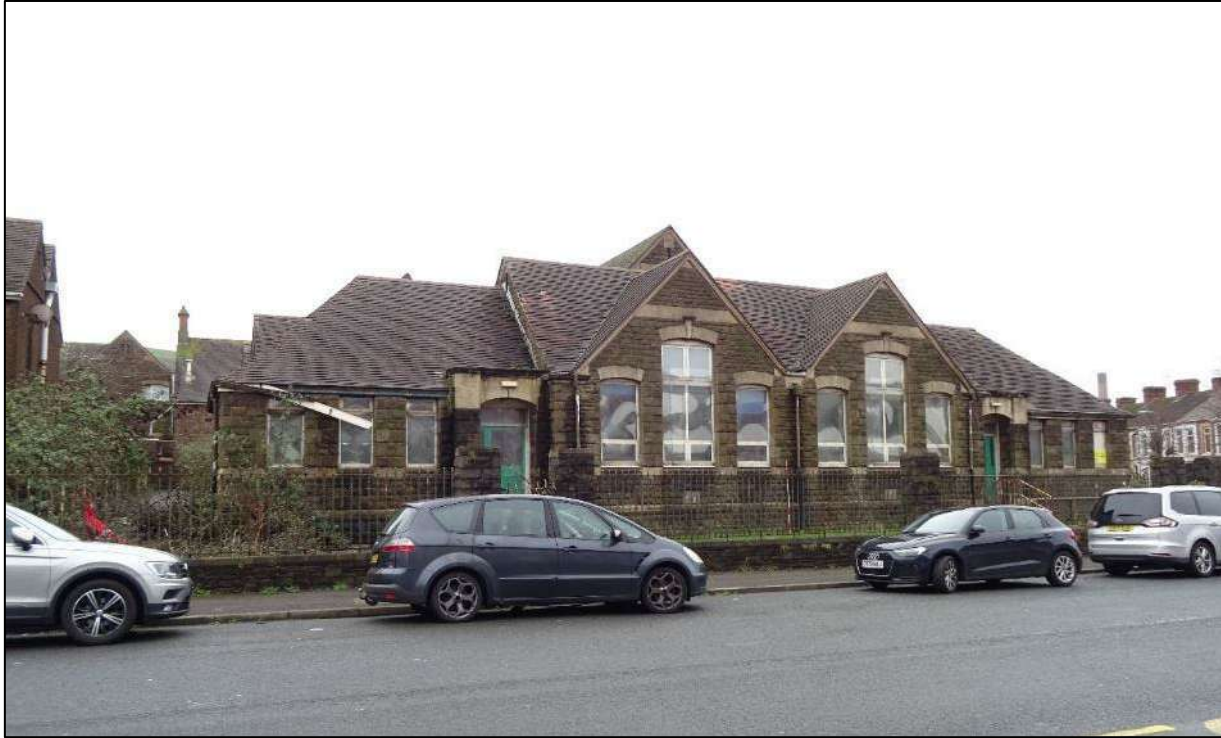
*Plate 3. Building 1, front (north-west) facing elevation, looking south. Scale 2m.*

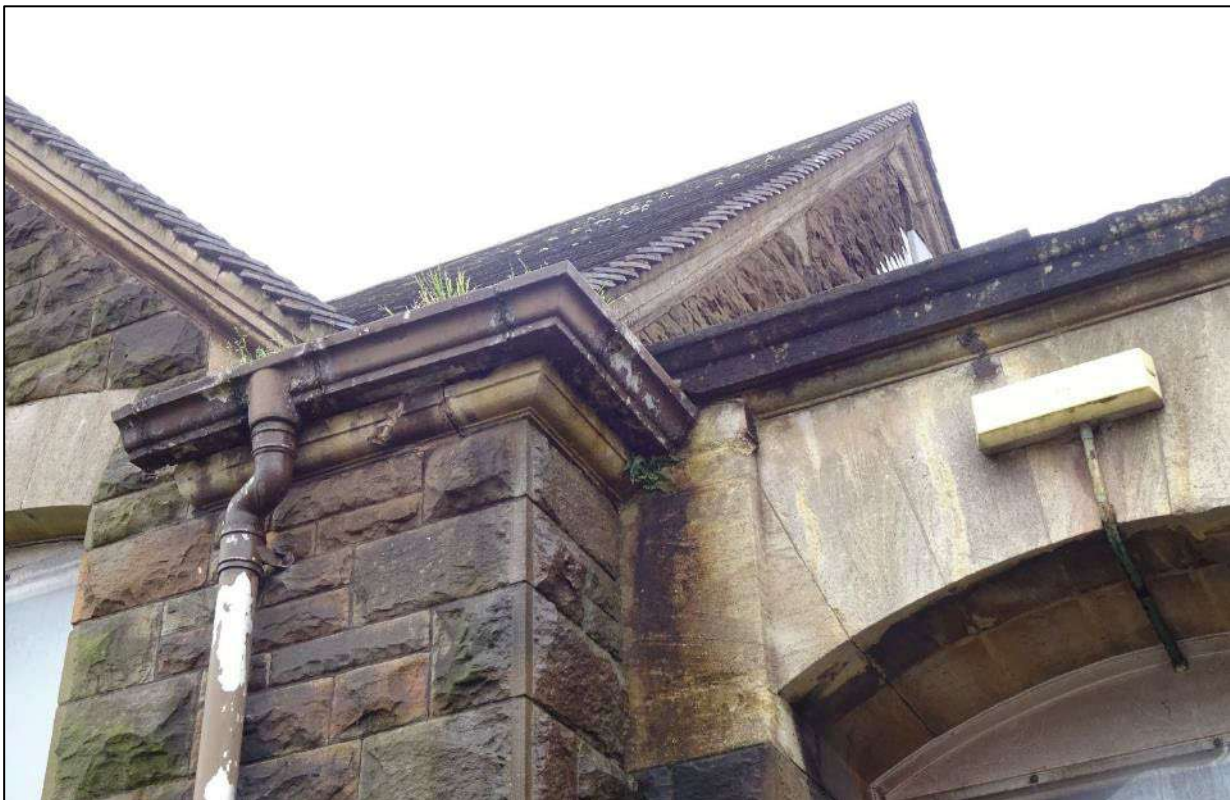
*Plate 4. Detail of cornice and guttering to front elevation, looking east.*

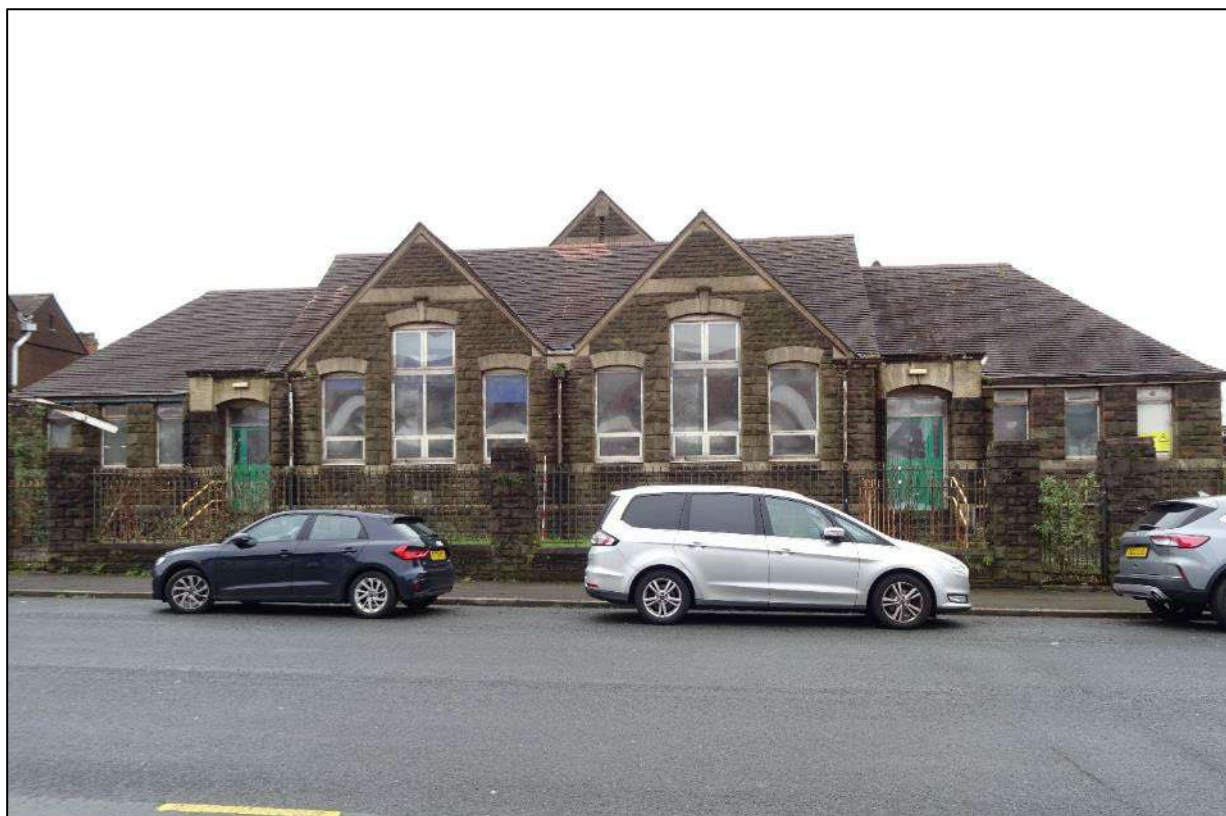
*Plate 5. Building 1, front (north-west) facing elevation, looking south. Scale 2m.*

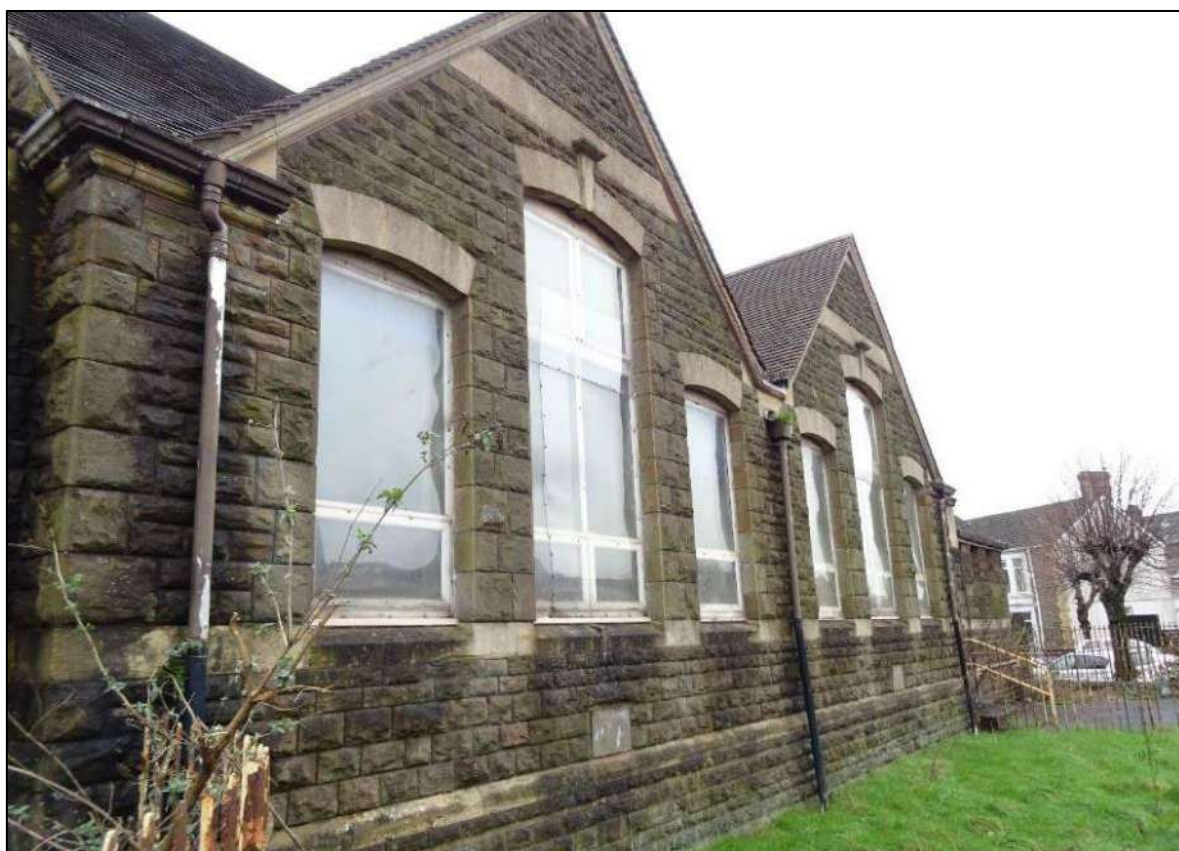
*Plate 6. Oblique view of central cross-gables to the front elevation of Building 1, looking south.*

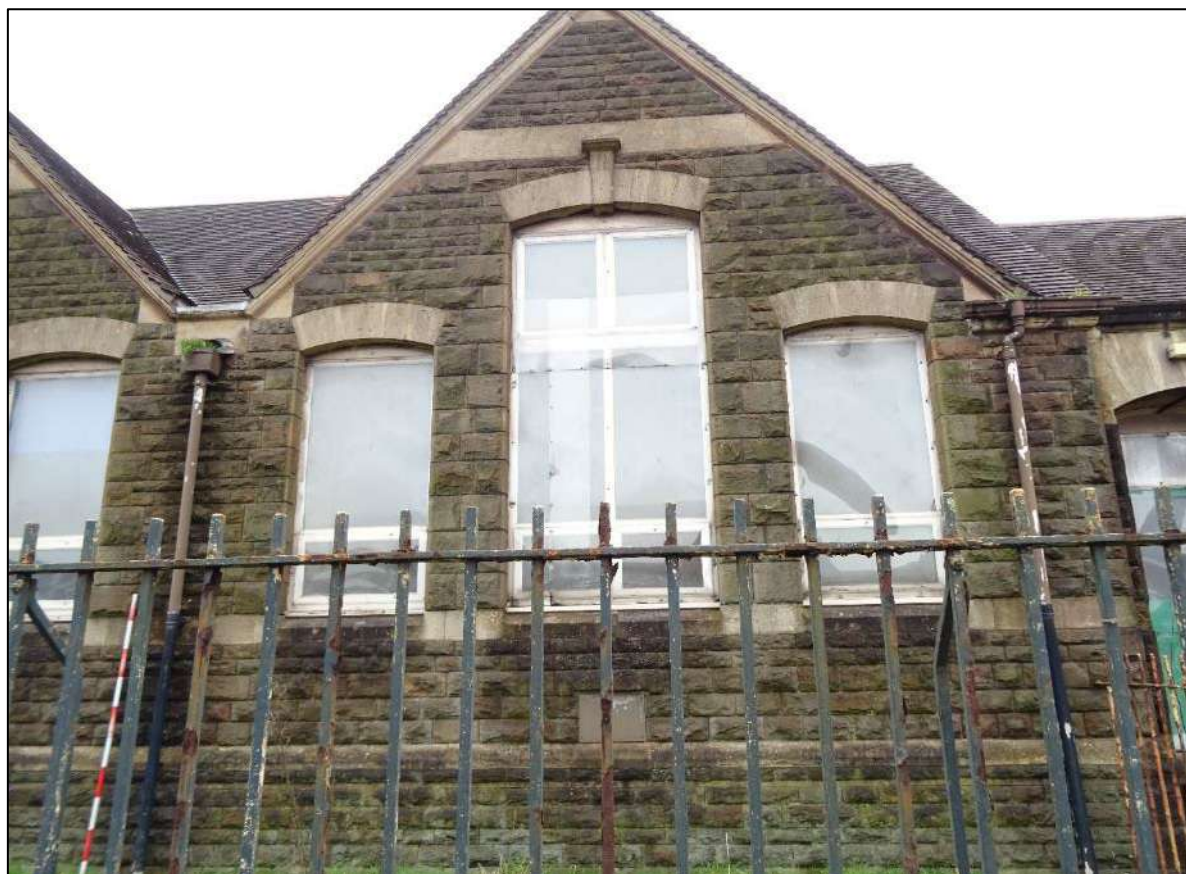
- 5.3.3. Each cross-gable has three windows. The central window is taller and wider, while the two outer windows reach the height of the eaves (Plate 7). The windows are segmental arched, with smooth-finished limestone voussoirs. The central window has an elongated keystone. They are slightly recessed, and the sills are canted and form part of the band course (Plate 8). The central sill has a stub to the centre, indicating a former mullion. The original windows have been replaced with uPVC framed windows, now covered with protective Perspex sheeting. There are quoins of large rock-faced ashlar blocks to the sides.

*Plate 7. Right-hand central cross-gable to the front elevation of Building 1, looking south-east.*

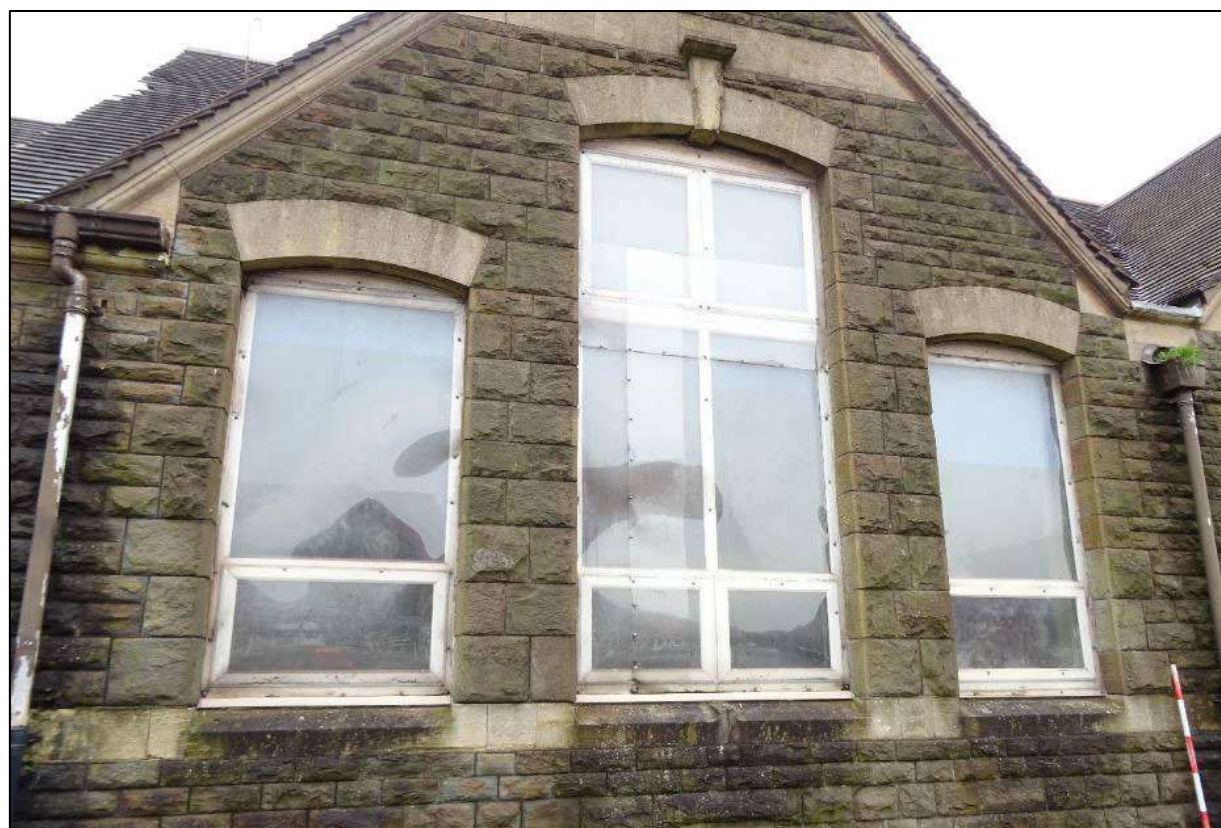
*Plate 8. Windows of left-hand central cross-gable to the front elevation of Building 1, looking south-east. Scale increment 0.2m.*

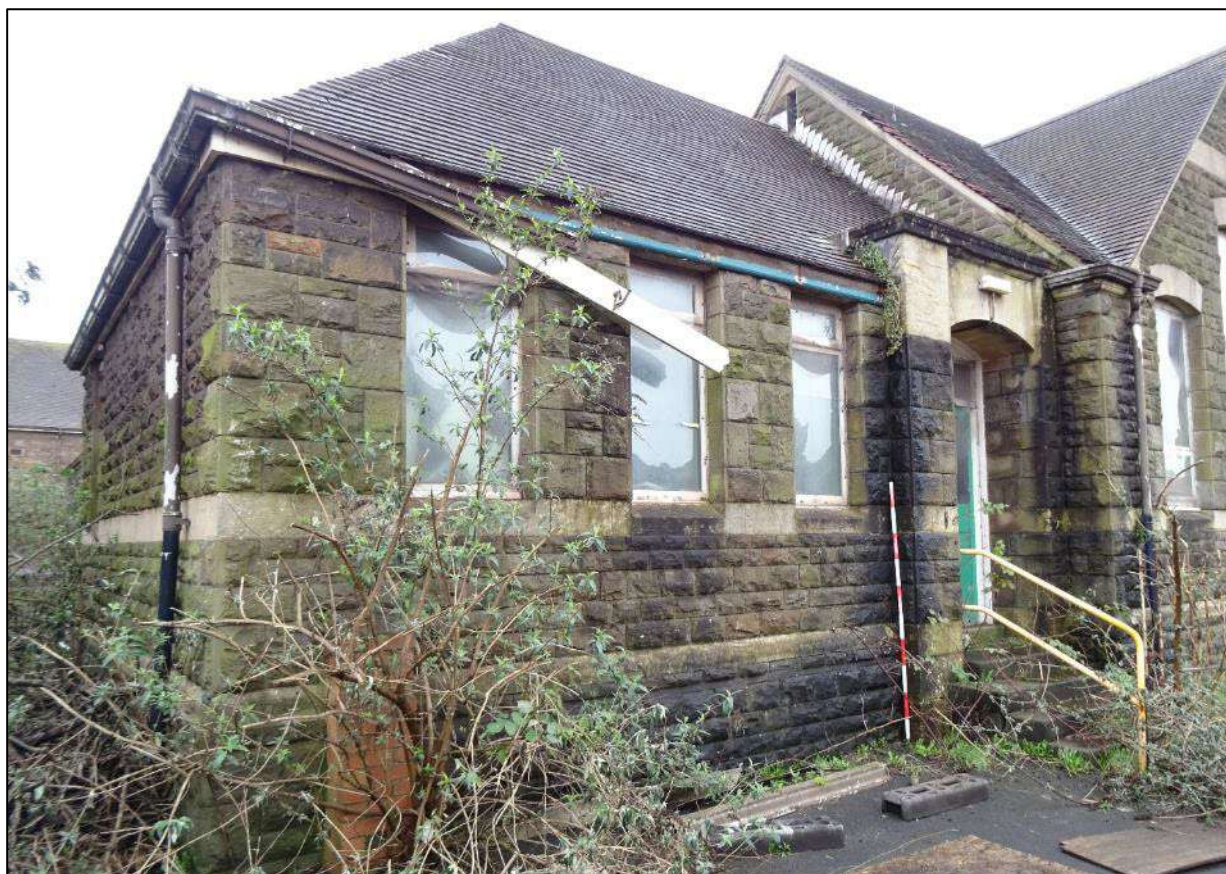
*Plate 9. Left-hand hipped section of north-west facing elevation, looking south. Scale 2m.*

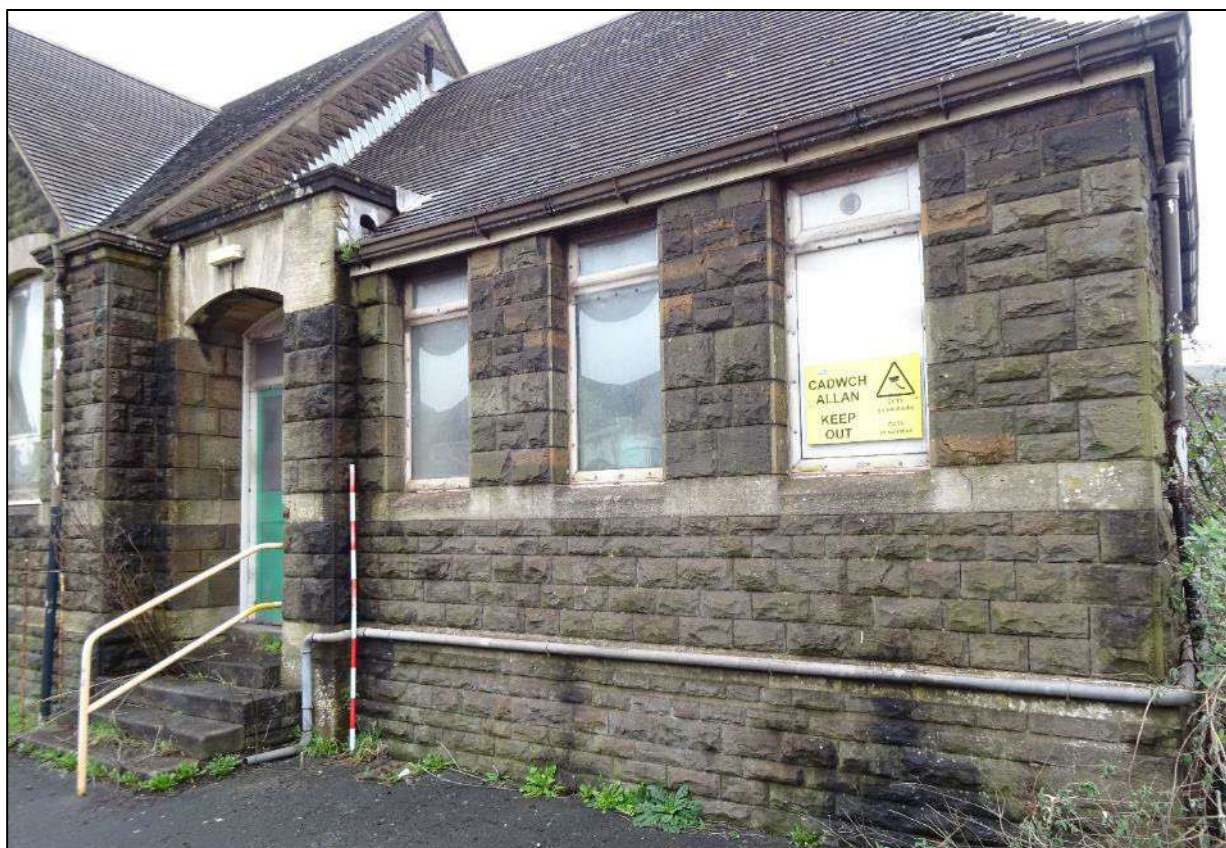
*Plate 10. Right-hand hipped section of north-west facing elevation, looking east. Scale 2m.*

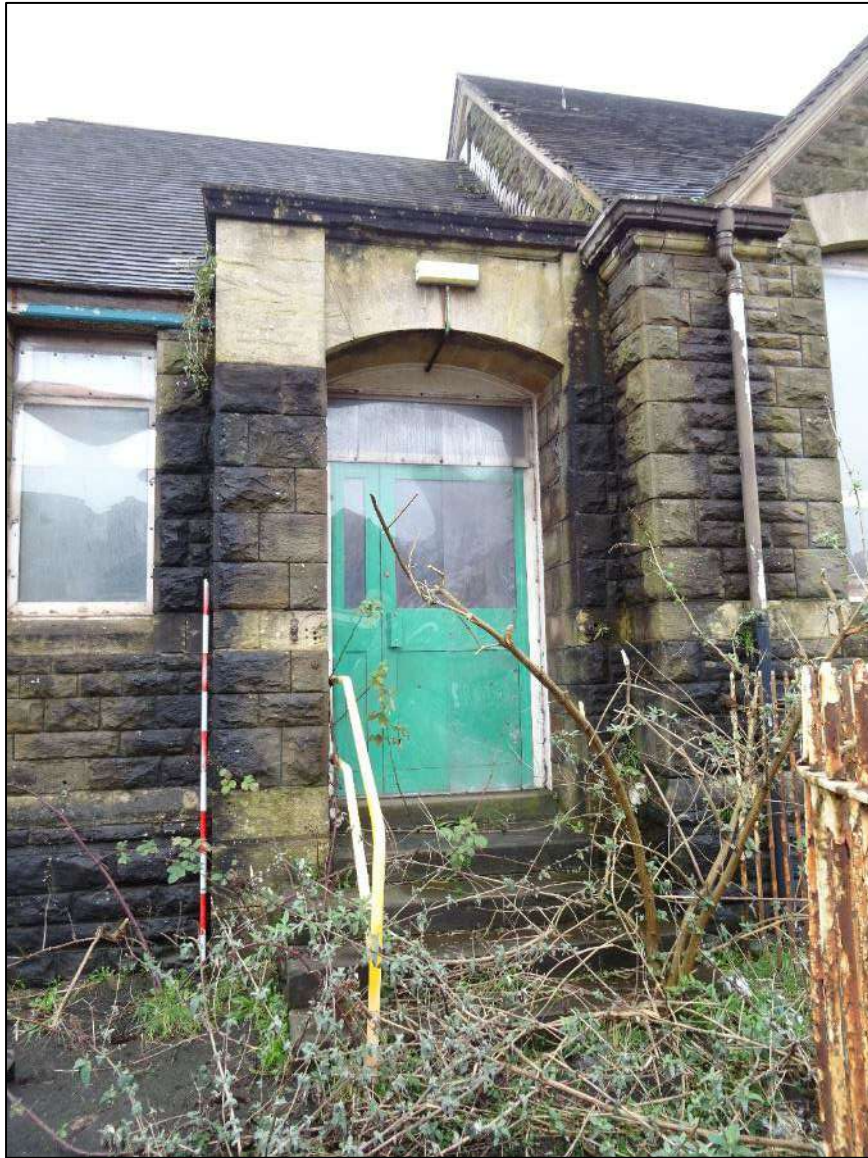
*Plate 11. Entrance porch to left-hand hipped section of north-west facing elevation, looking south-east. Scale 2m.*

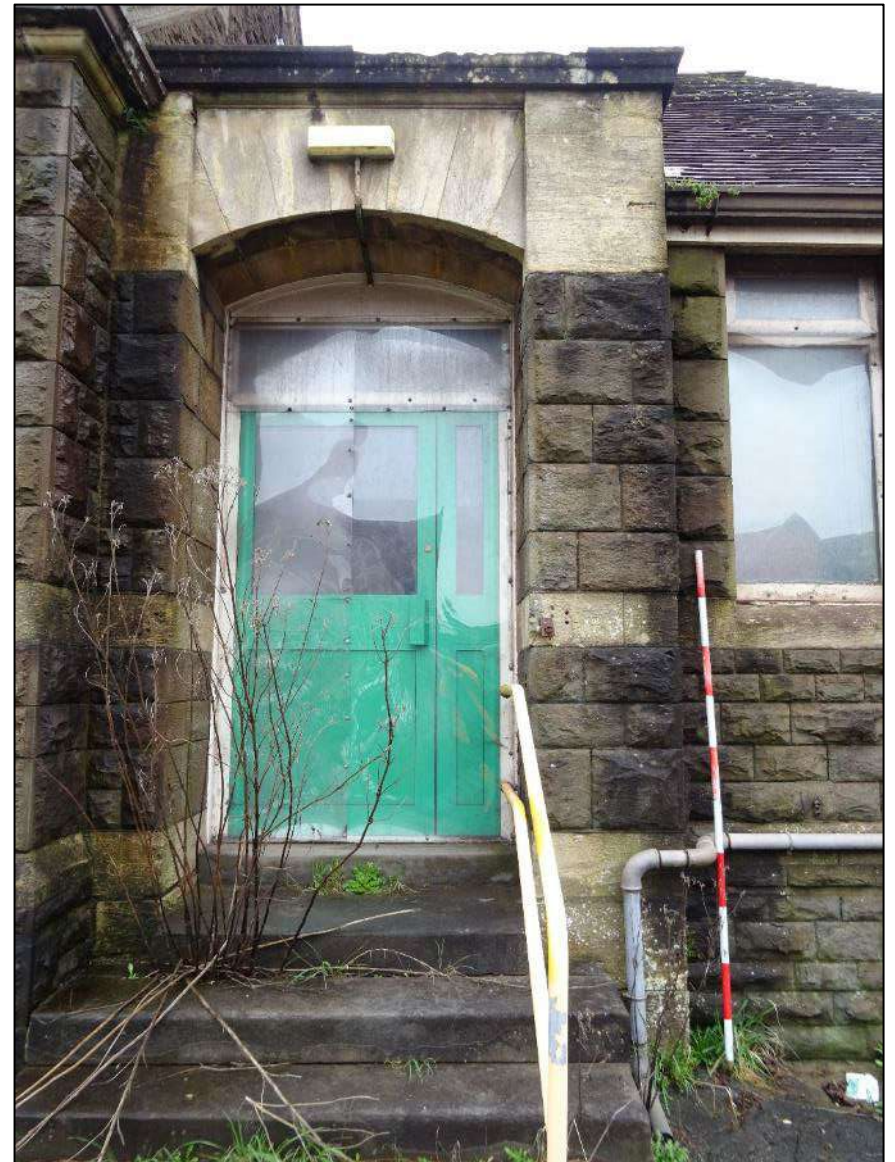
*Plate 12. Entrance porch to right-hand hipped section of north-west facing elevation, looking south-east. Scale 2m.*

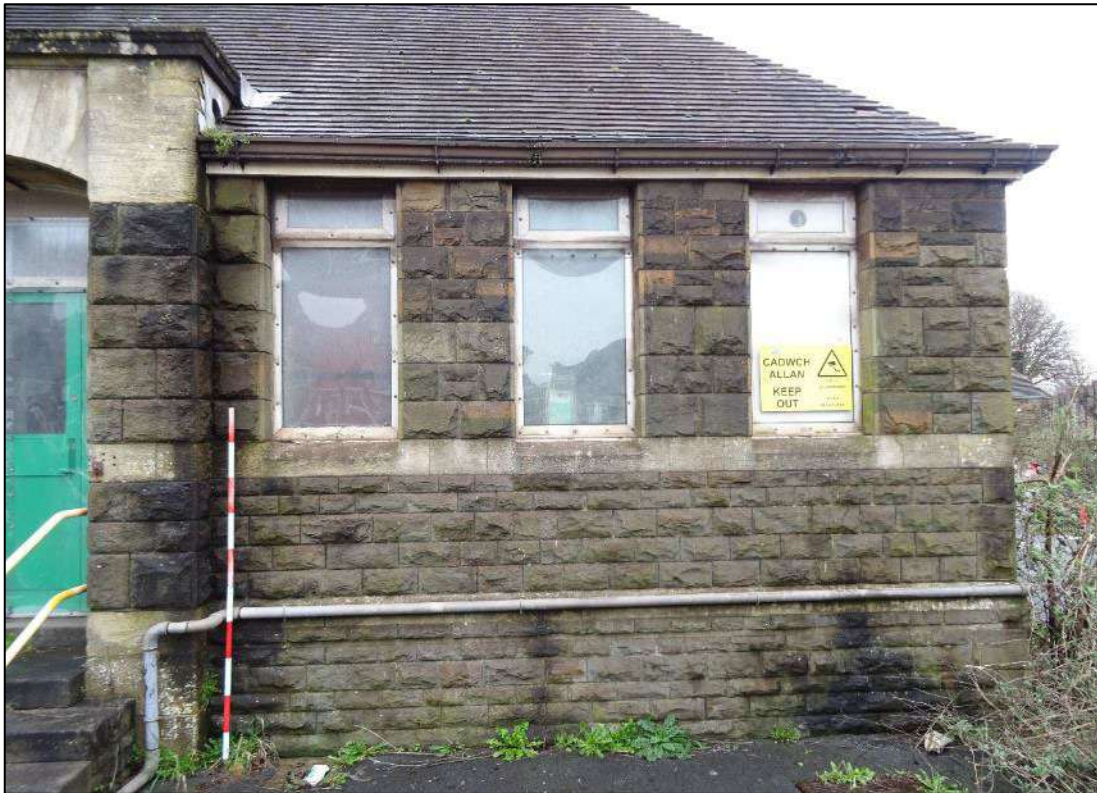
*Plate 13. Windows to right-hand hipped section of north-west facing elevation, looking south-east. Scale 2m.*

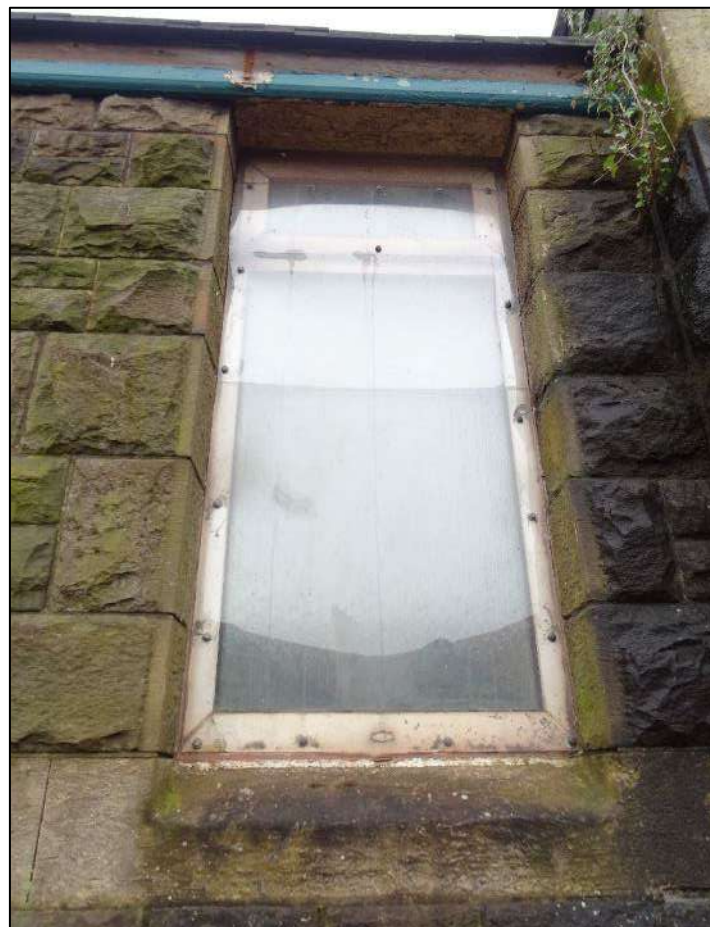
*Plate 14. Window to hipped section of north-west facing elevation, looking south-east.*

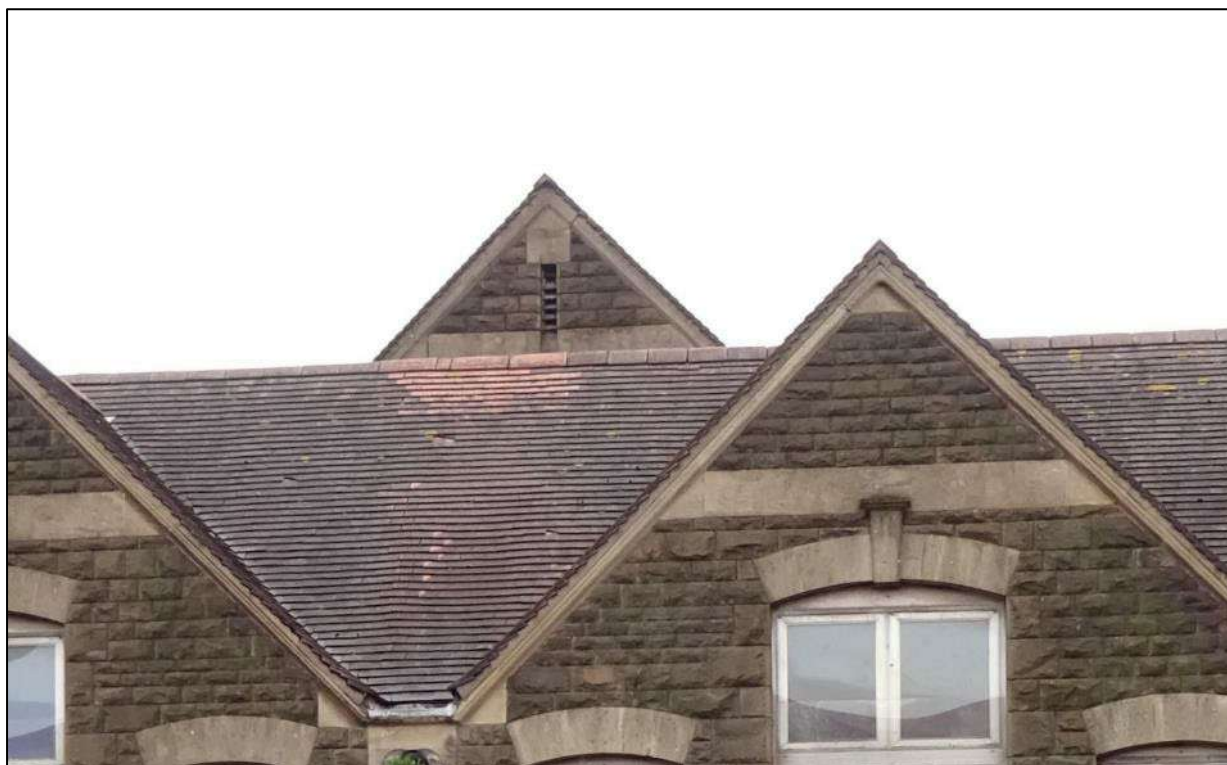
*Plate 15. Gable end of the central cross-wing, Building 1, looking south-east.*

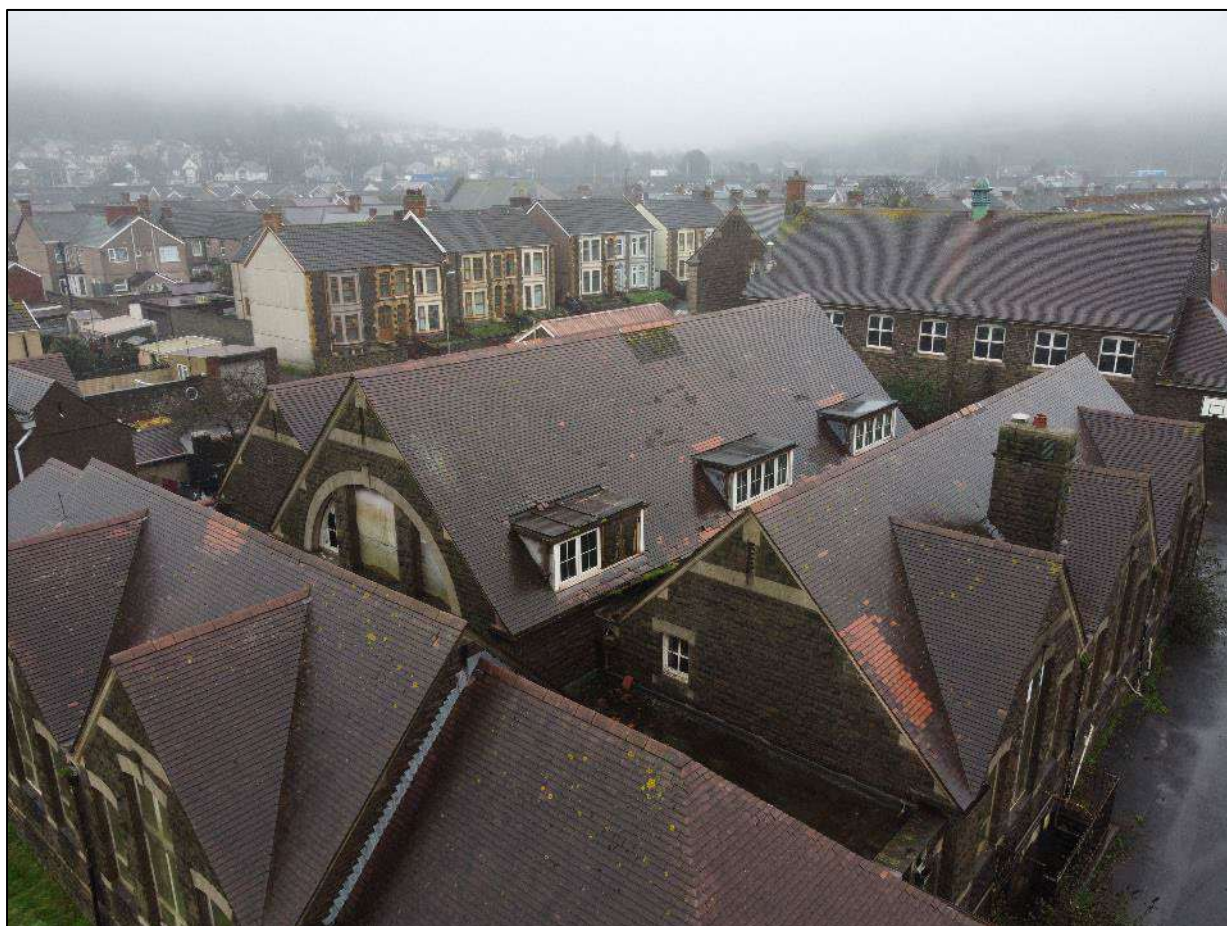
*Plate 16. Drone shot showing the south-west facing gable ends of the cross-gable ranges, Building 1, looking east. Photo courtesy of Roberts Limbrick.*

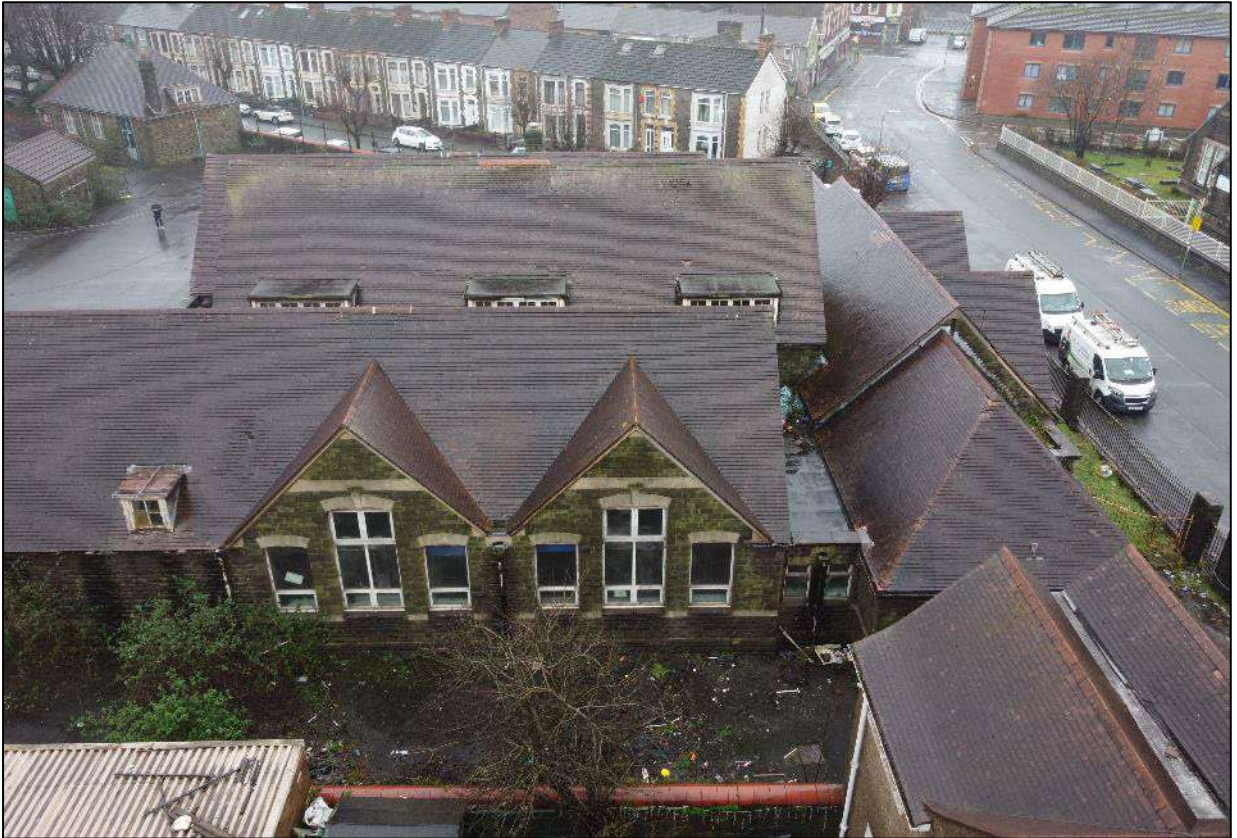
*Plate 17. Drone shot of north-east facing elevation of Building 1, looking south-west. Photo courtesy of Roberts Limbrick.*

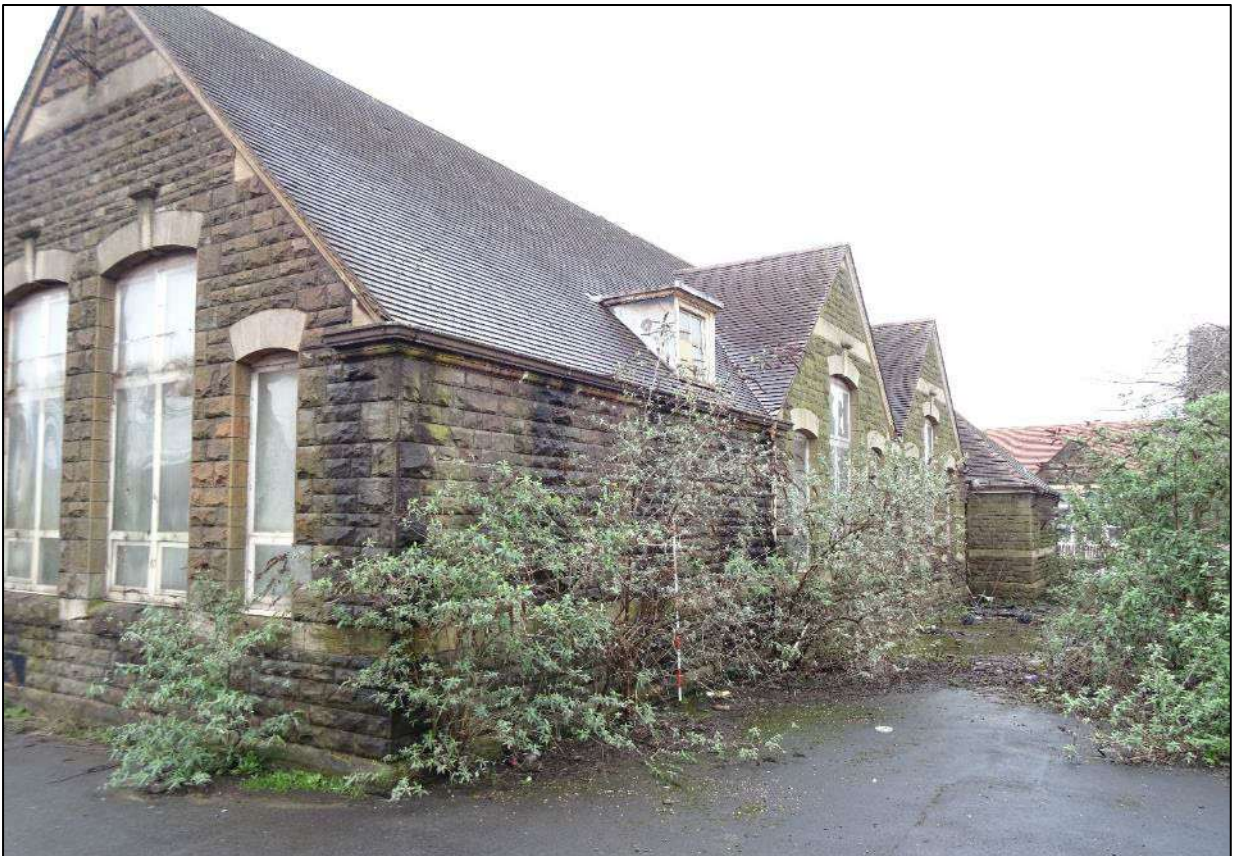
*Plate 18. Oblique shot of north-east facing elevation, looking west. Scale 2m.*

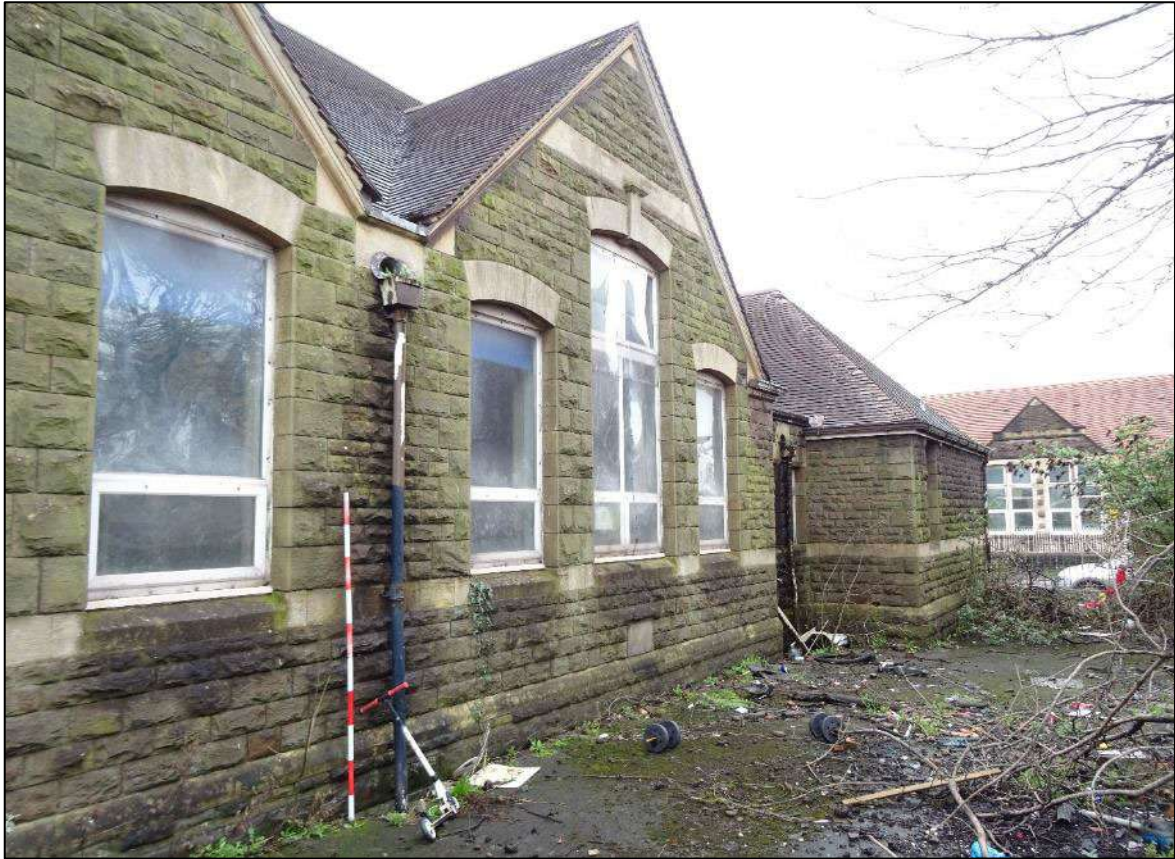
*Plate 19. Oblique shot of right-hand cross-gable to north-east facing elevation, looking west.  
Scale 2m.*

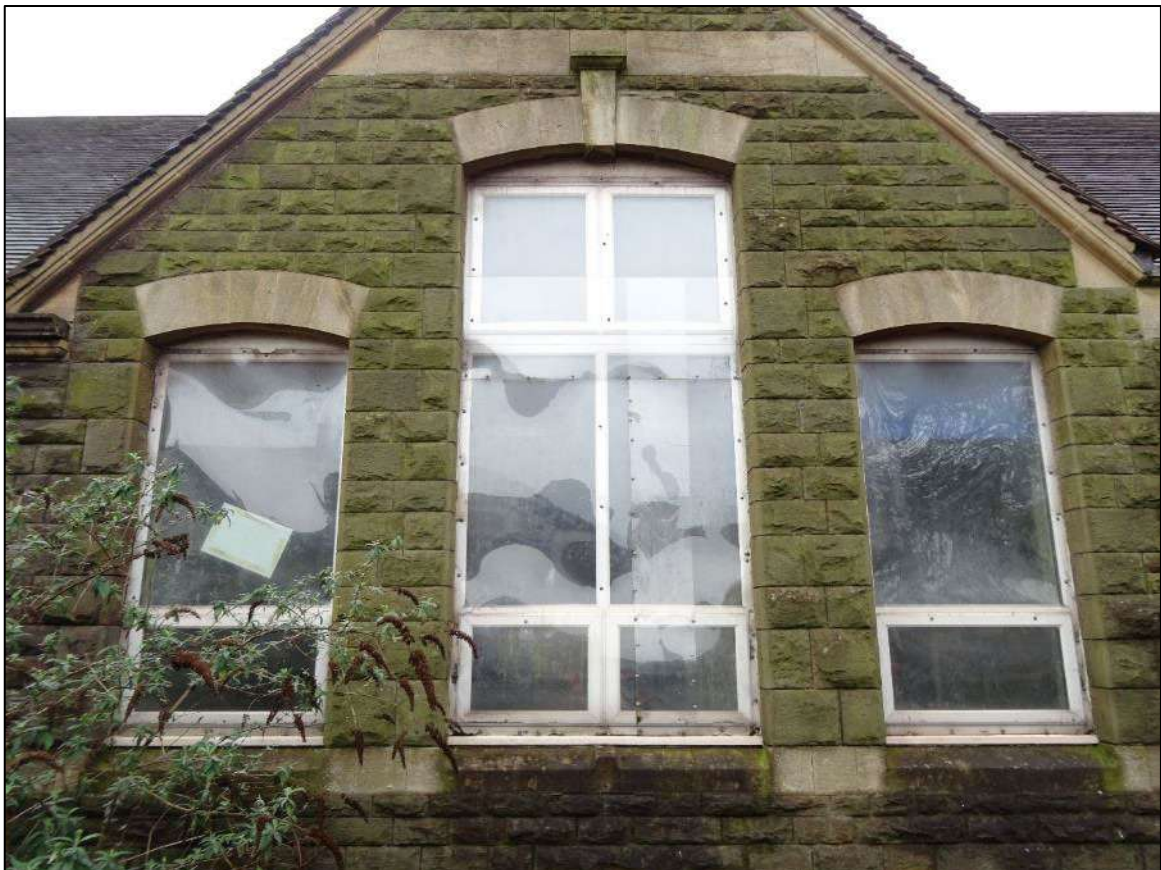
*Plate 20. Windows to left-hand cross-gable to north-east facing elevation, looking south-west.*

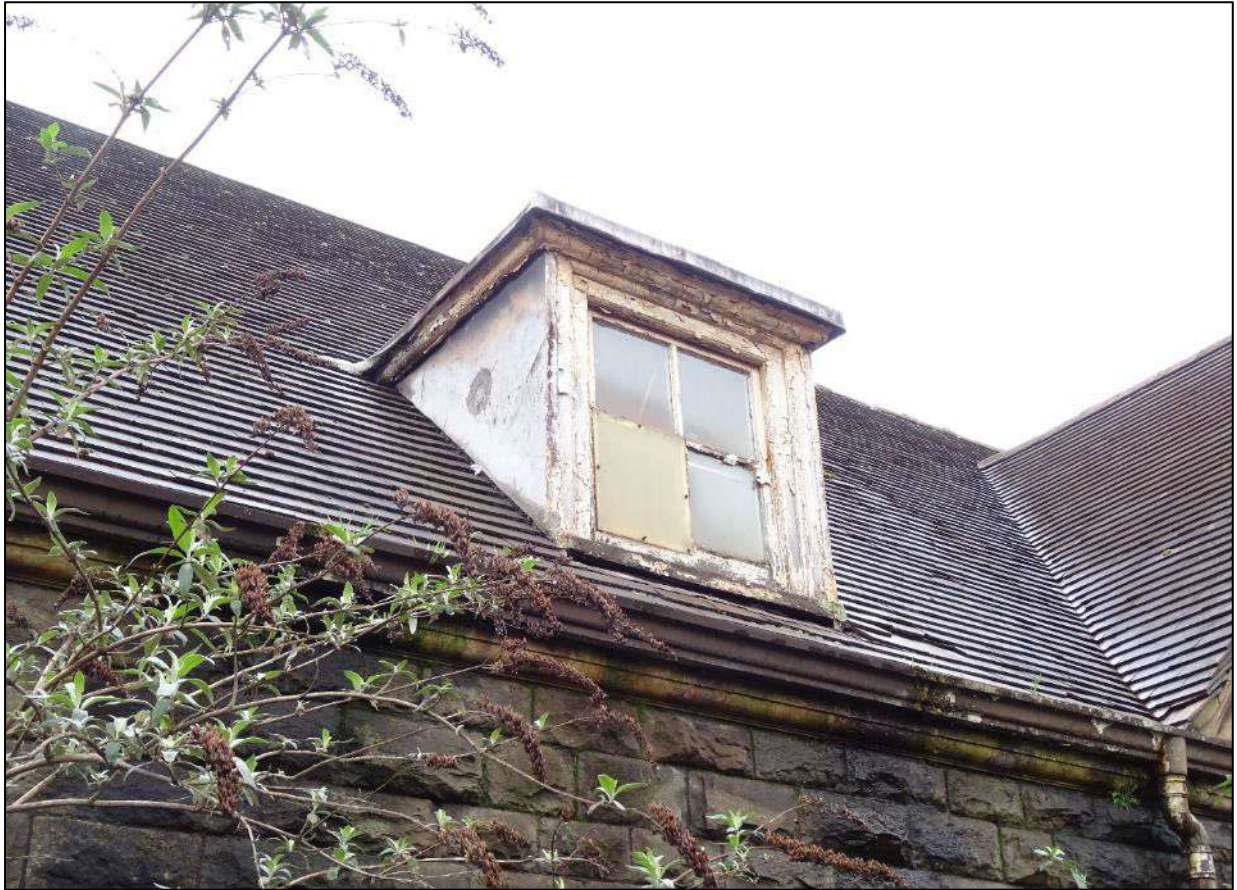
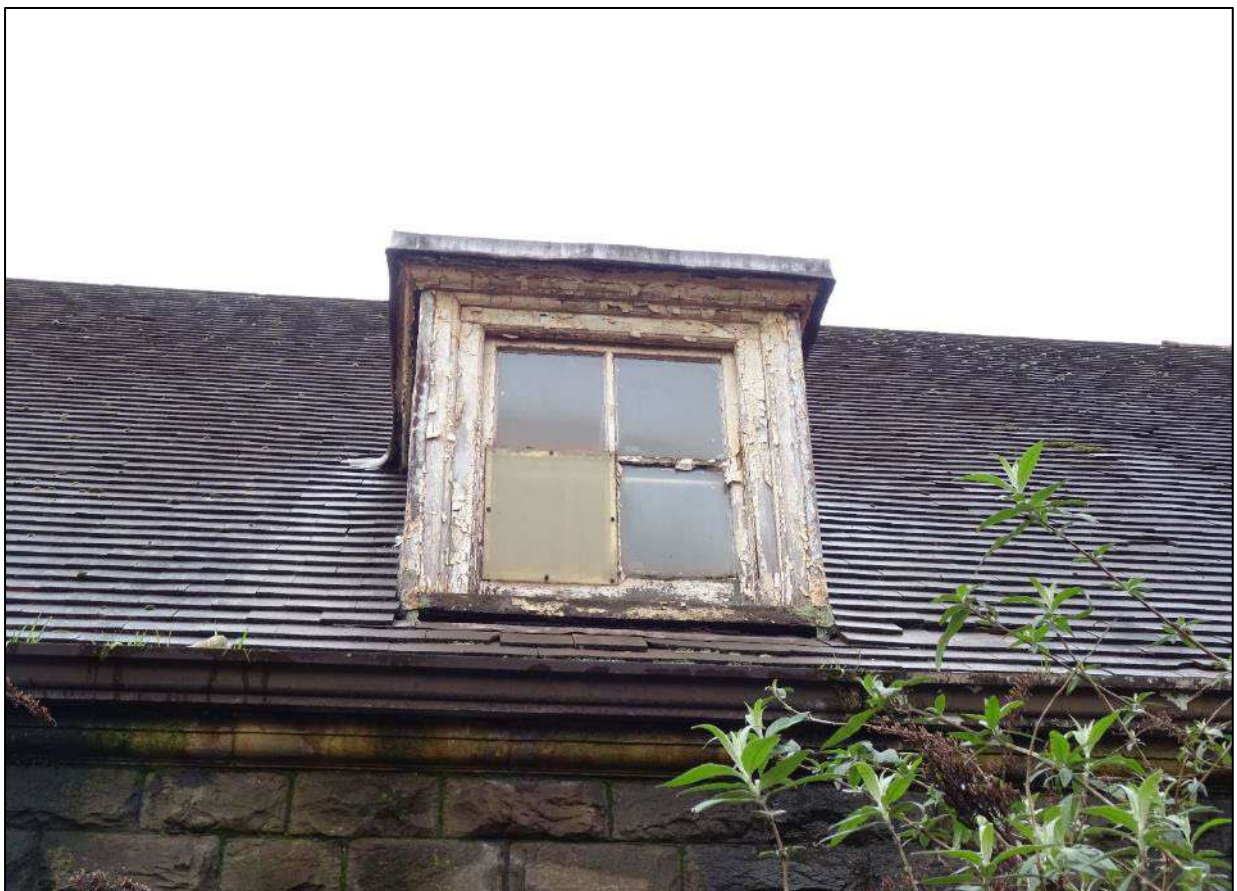
- 5.4.2. To the left of the cross-gables is a small, flat-roofed dormer window (Plates 21 and 22). The sides and frame are all of white painted wood, in poor condition. The window is four-light. The roof appears to be lead-covered.

*Plate 21. Dormer window to north-east facing elevation of Building 1, looking west.*

*Plate 22. Dormer window to north-east facing elevation of Building 1, looking south-west.*

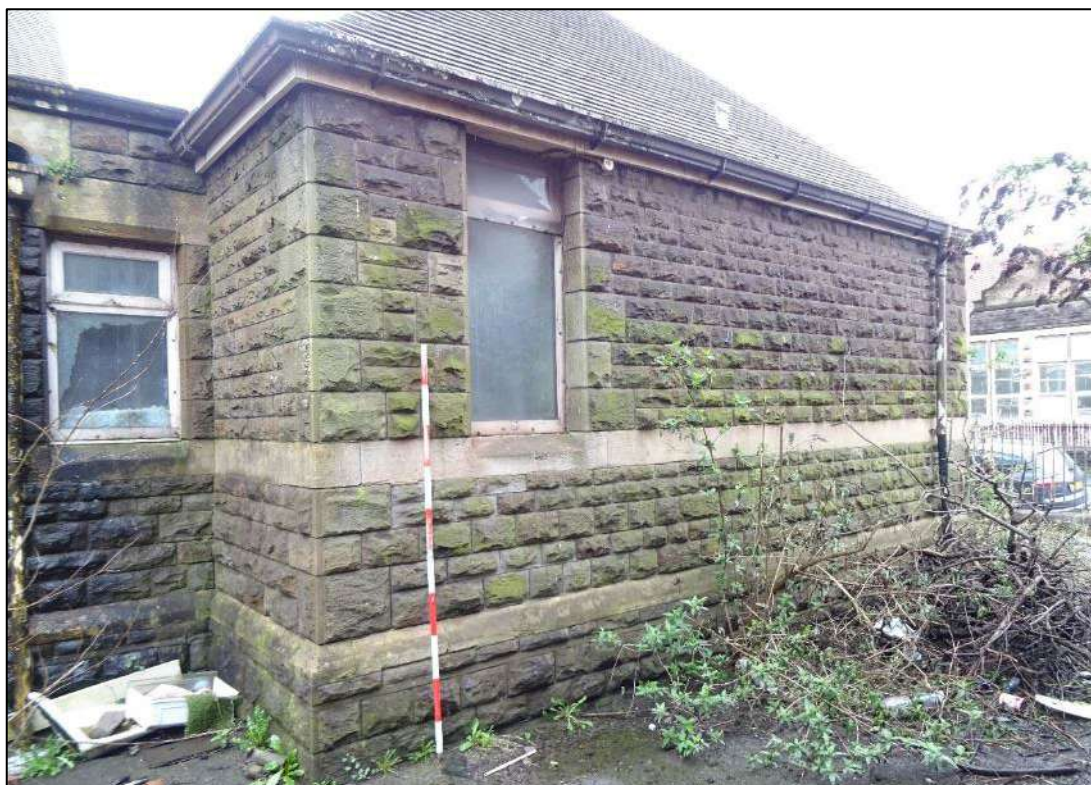
*Plate 23. North-east facing elevation, hipped end of front range of Building 1, looking west.  
Scale 2m.*

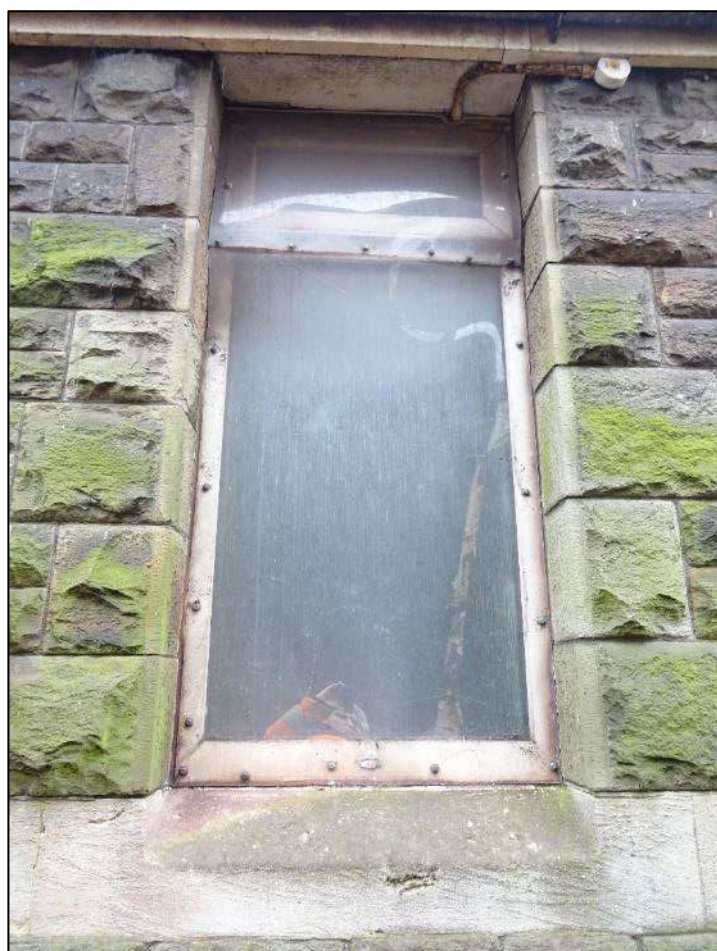
*Plate 24. Window to left side of hipped end of front range of Building 1, looking south-west.*

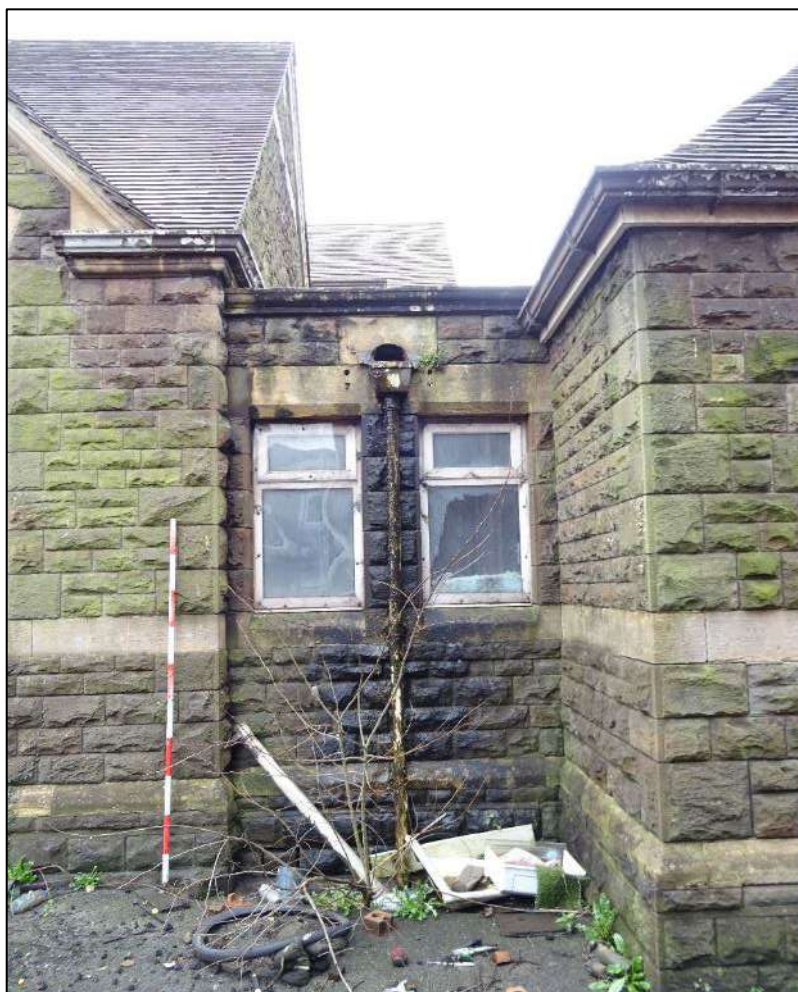
*Plate 25. North-east facing elevation between ranges, looking south-west. Scale 2m.*
