**Level 2 Building Recording:**  
**Former Dyffryn Lower School, Port Talbot**

March 2024

Report No. 2278

Prepared for KEW Planning  
By  
Susan Stratton PhD

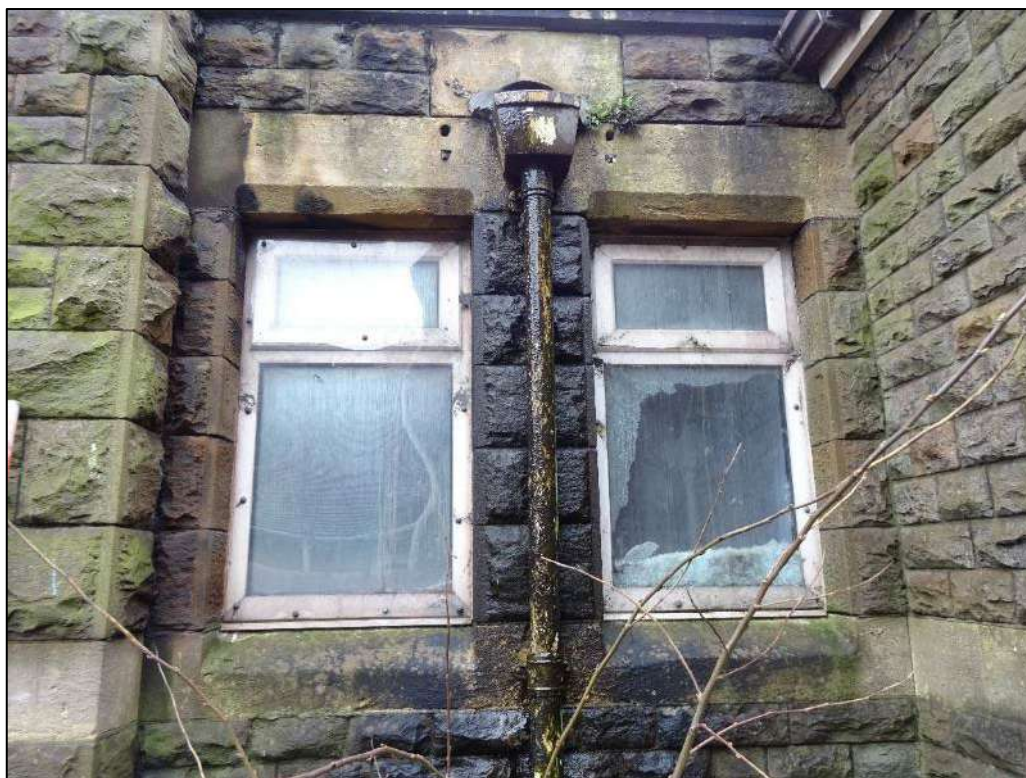
*Plate 26. Windows to north-east facing elevation between ranges, looking south-west.*

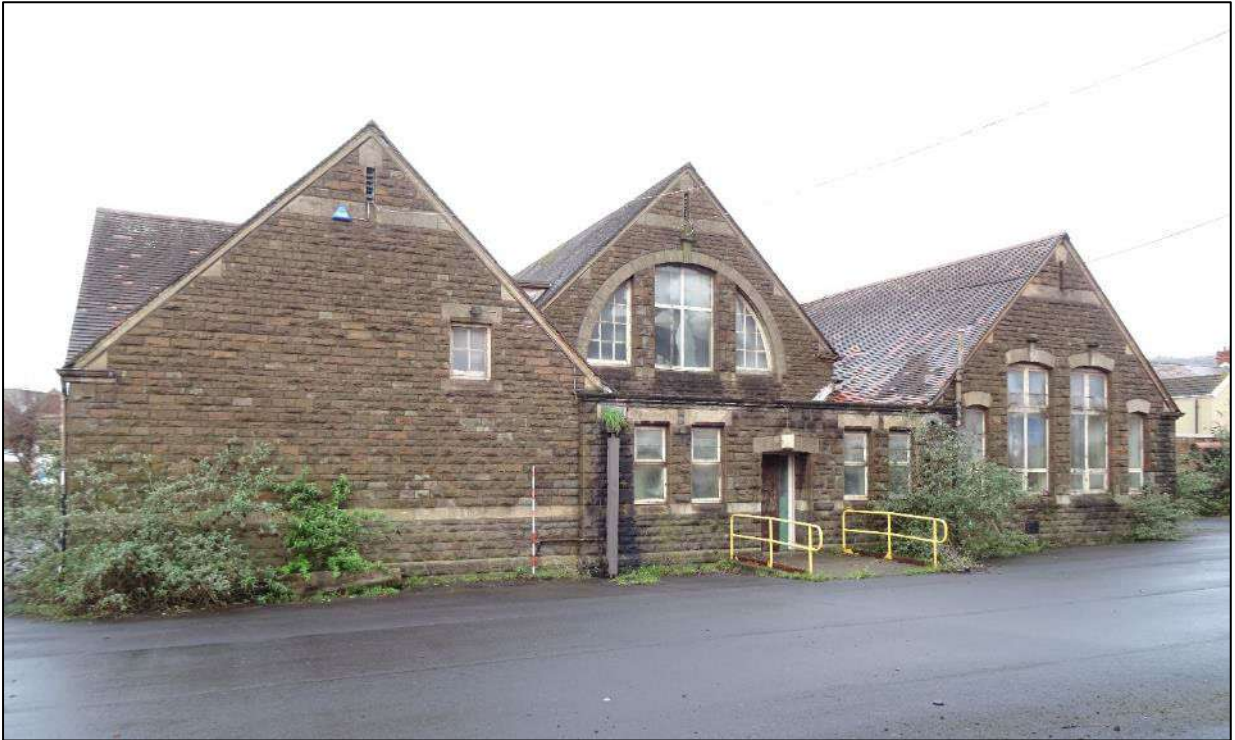
*Plate 27. South-east facing elevation of Building 1, looking north. Scale 2m.*

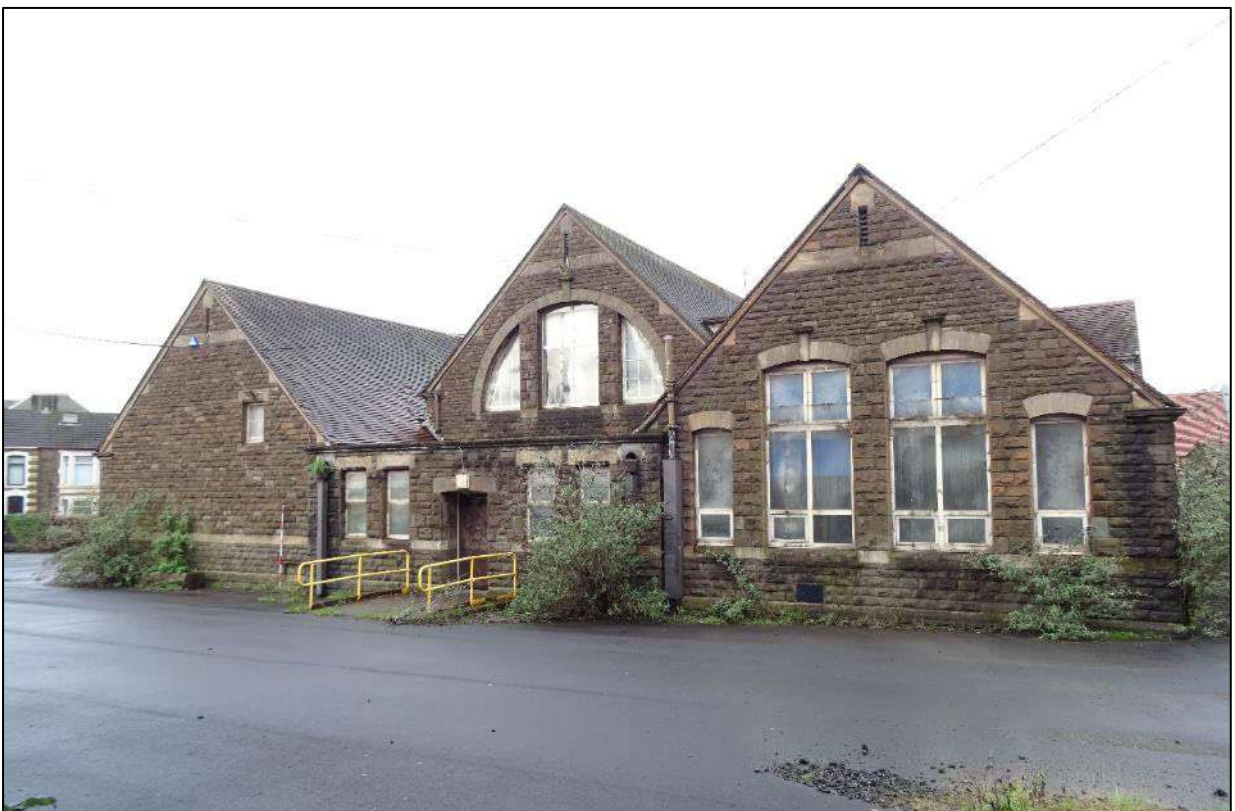
*Plate 28. South-east facing elevation of Building 1, looking west. Scale 2m.*

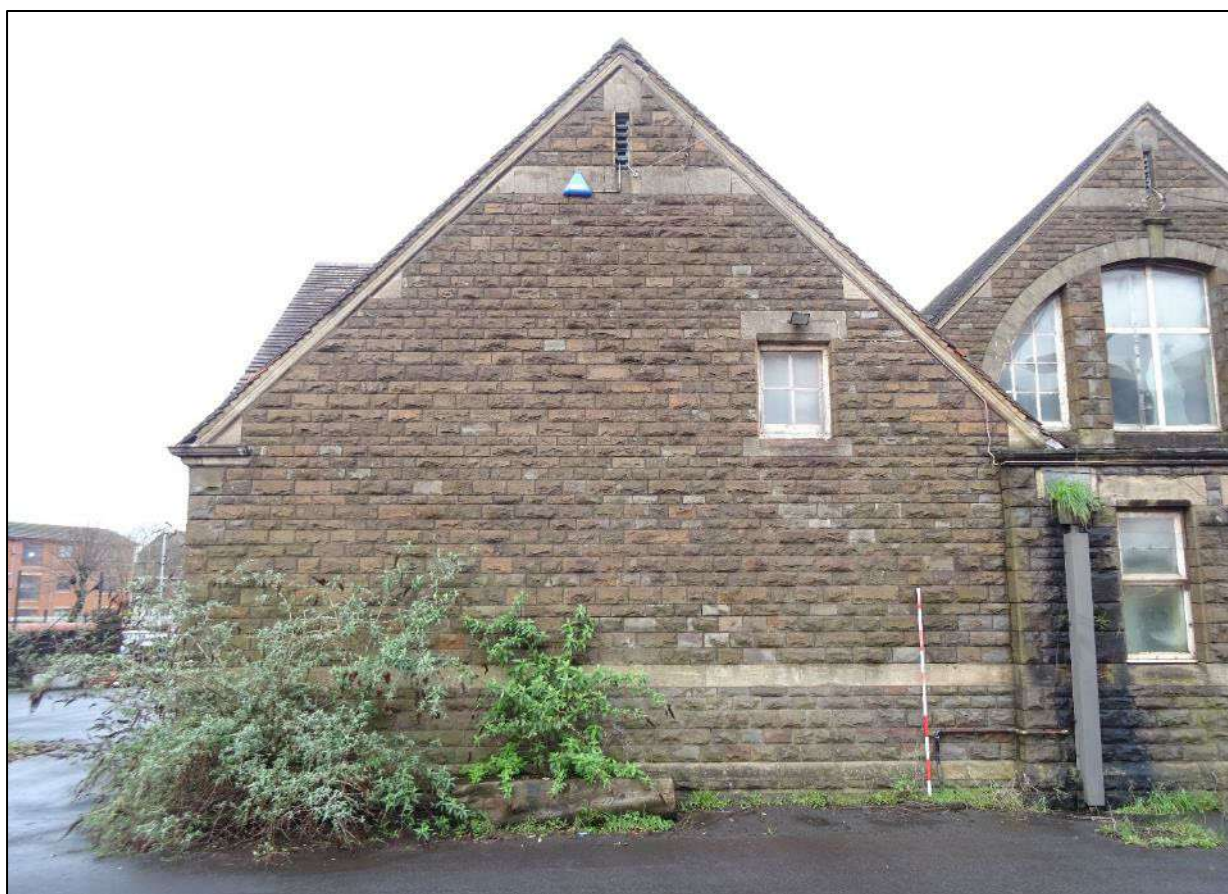
*Plate 30. Left-hand gable end of south-east facing elevation of Building 1, looking north-west.  
Scale 2m.*

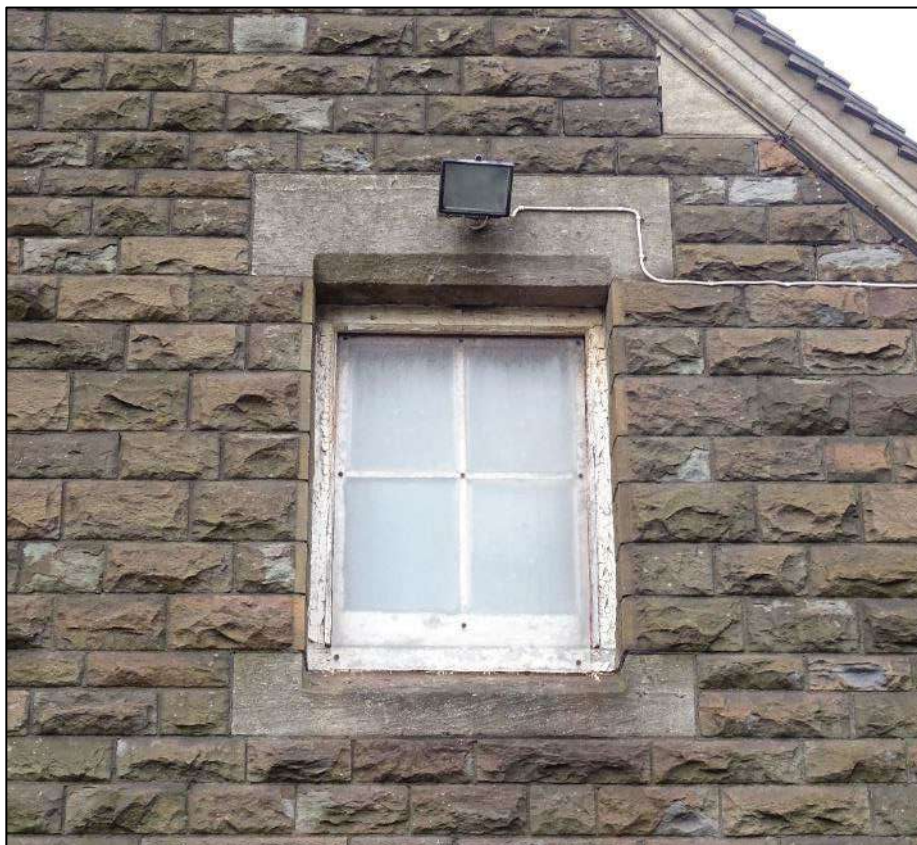
*Plate 31. Window to upper right of left-hand gable end of south-east facing elevation of Building 1, looking north-west.*

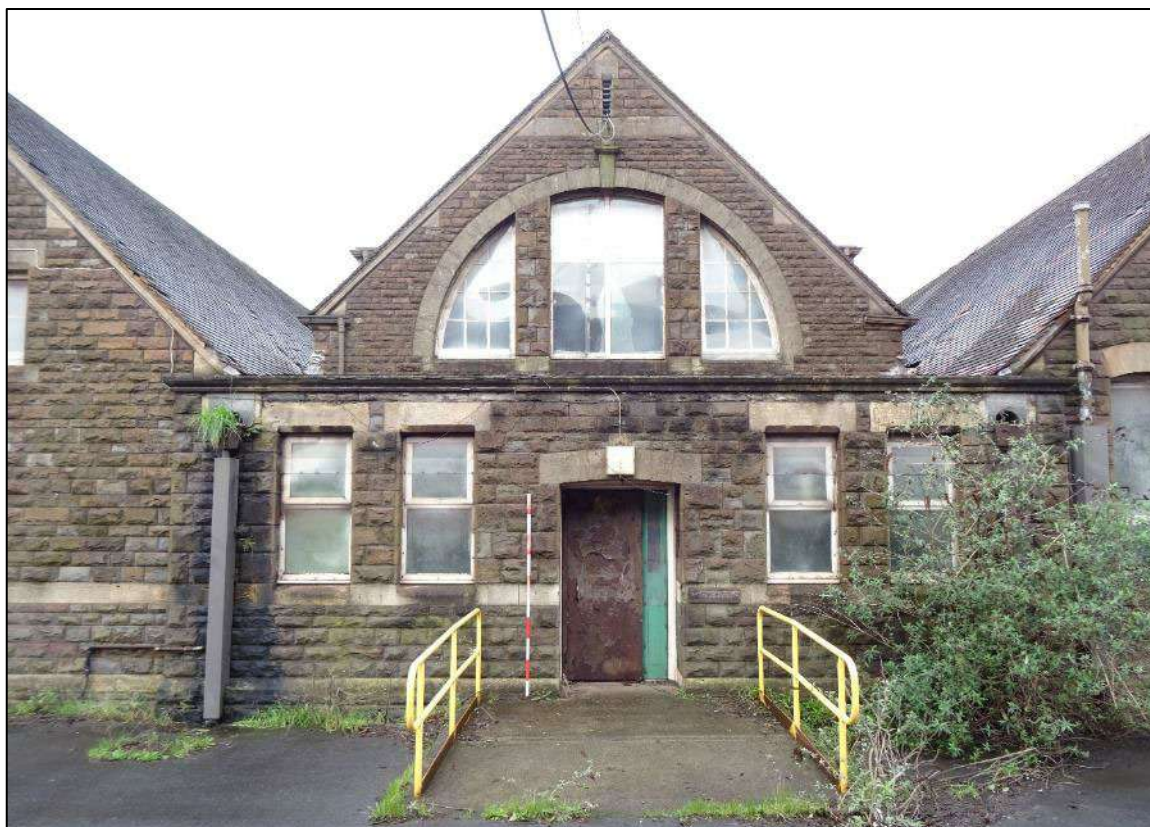
- 5.5.3. The central gable end sits back from the front of the elevation, with a flat roofed element the height of the outer gable eaves in front (Plate 32). To the centre of this is an entrance with metal security door and a  $\frac{1}{4}$  side panel of the same type as the doors on the front elevation (Plate 33). It has a segmental arched lintel of smooth-finished limestone voussoirs. The door is deeply recessed, with brush-hammered ashlar to the reveals (Plate 34). To the right of the door is a degraded wooden sign saying "Renrhys" (Plate 35). The doorway is approached by a shallow concrete ramp with modern handrails to either side.

*Plate 32. Central gable end of south-east facing elevation of Building 1, looking north-west.  
Scale 2m.*

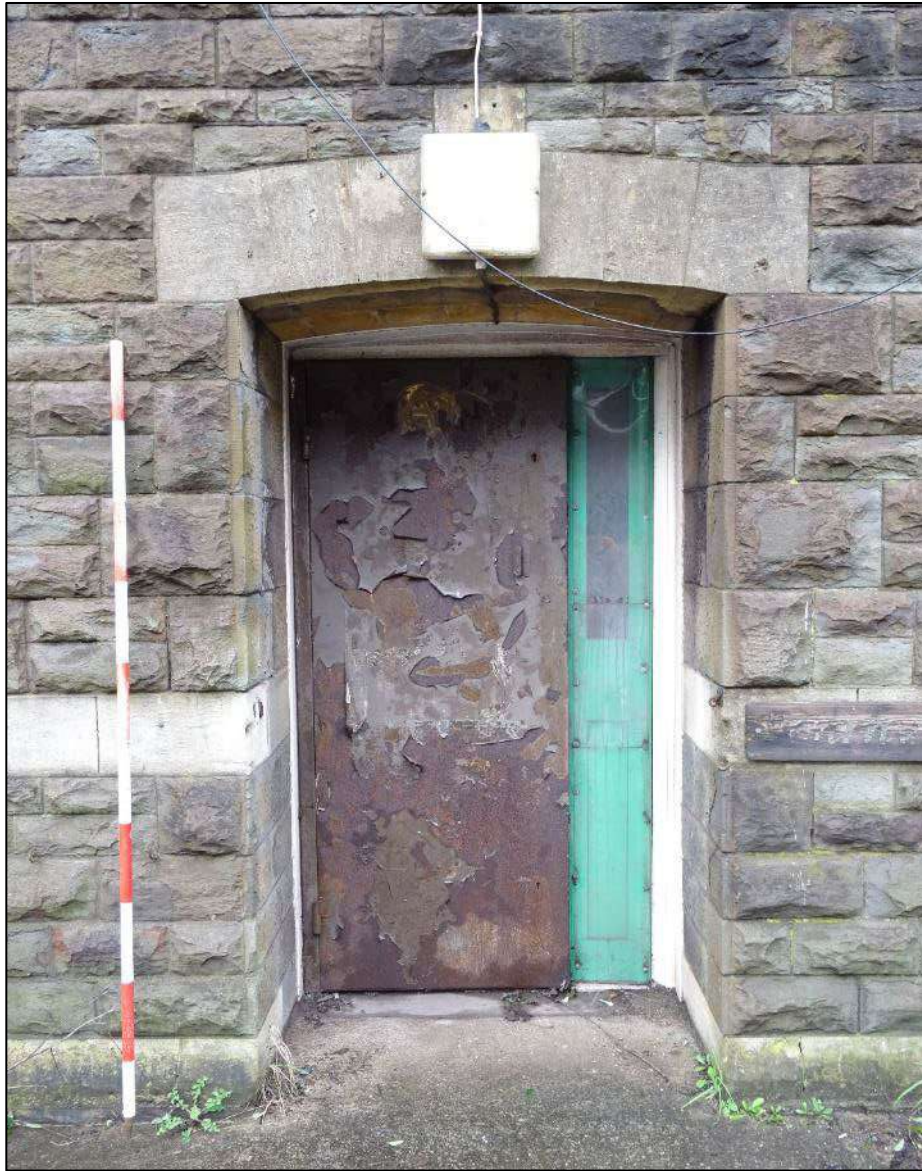
*Plate 33. Entrance to centre of south-east facing elevation of Building 1, looking north-west. Scale 2m.*

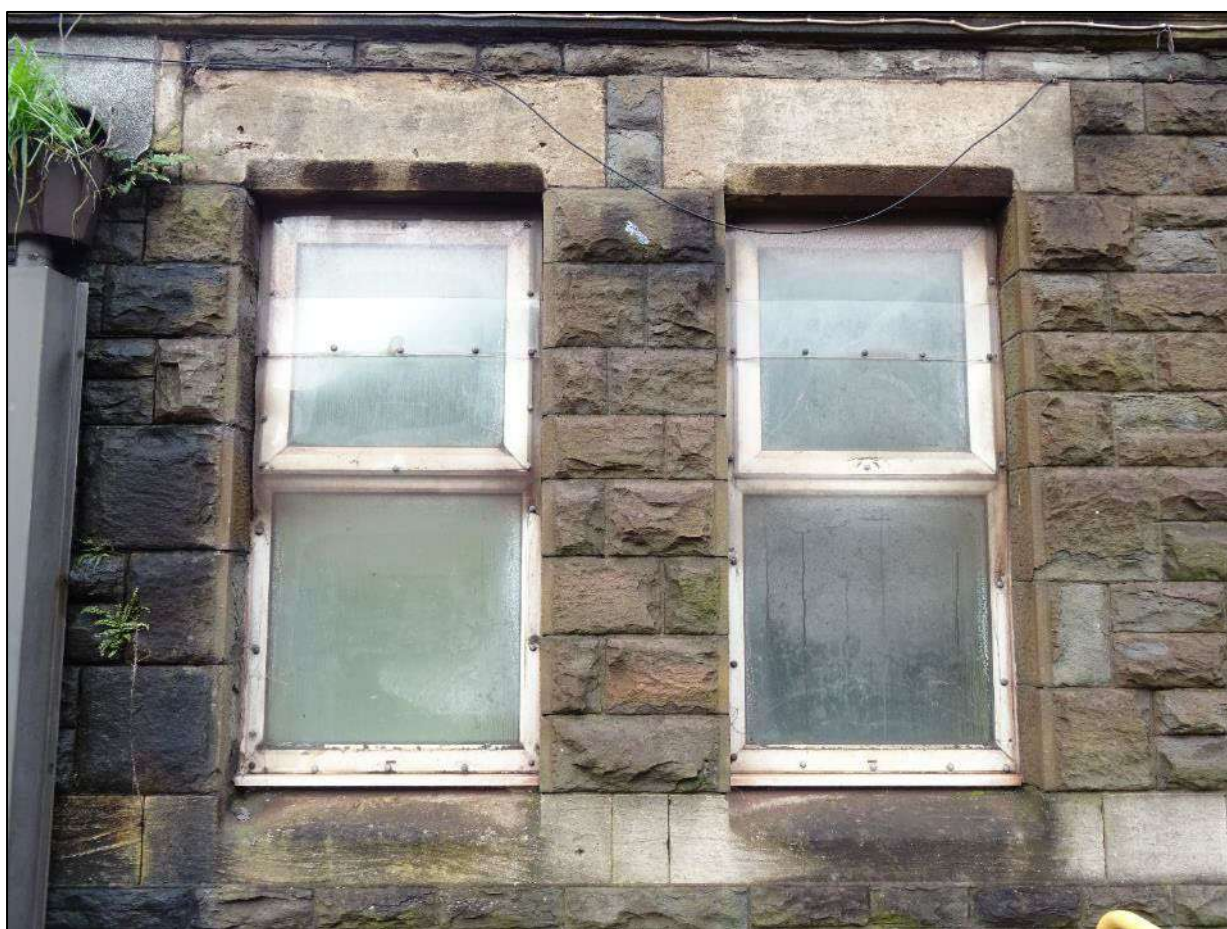
*Plate 36. Windows to left of entrance, south-east elevation of Building 1, looking north-west.*

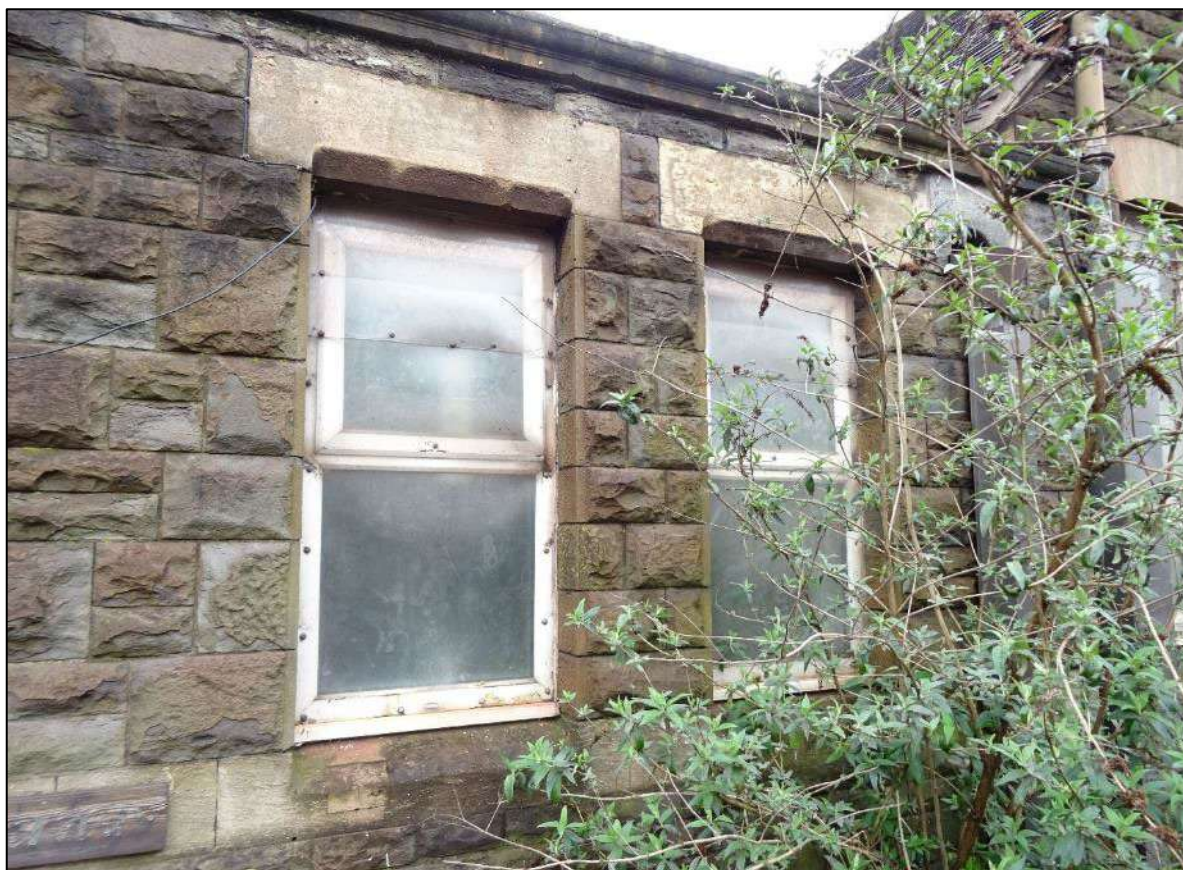
*Plate 37. Windows to right of entrance, south-east elevation of Building 1, looking north.*

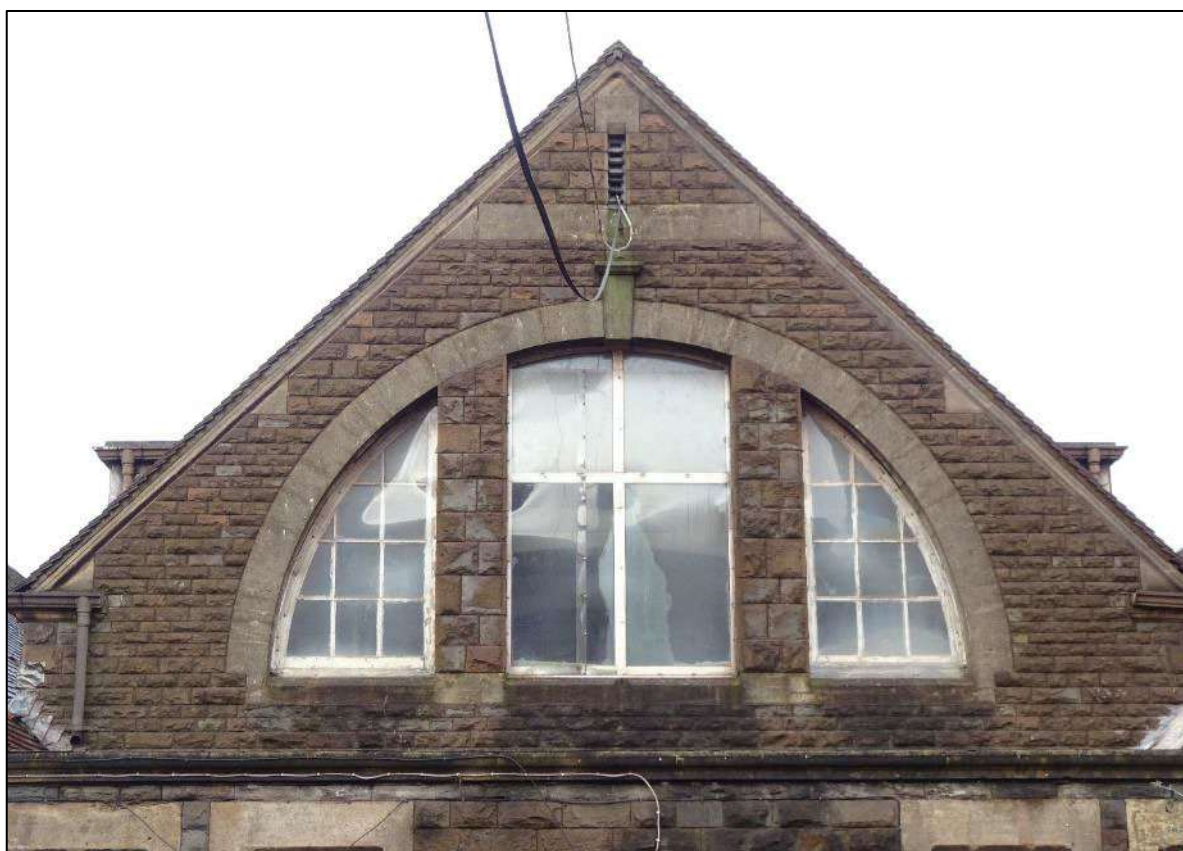
*Plate 38. Semi-circular window to central gable end, south-east facing elevation, looking north-west.*

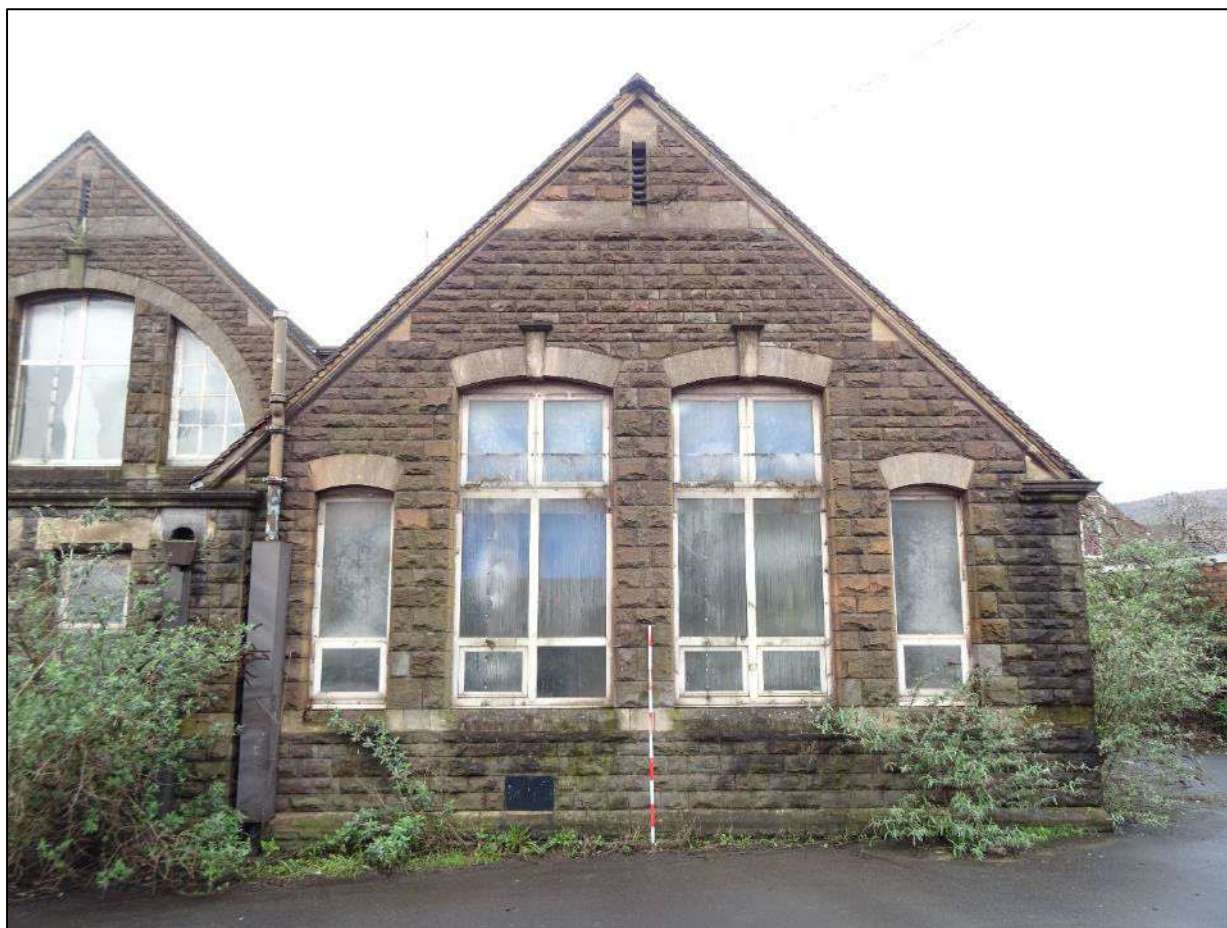
*Plate 39. Right-hand gable of south-east facing elevation, looking north-west. Scale 2m.*

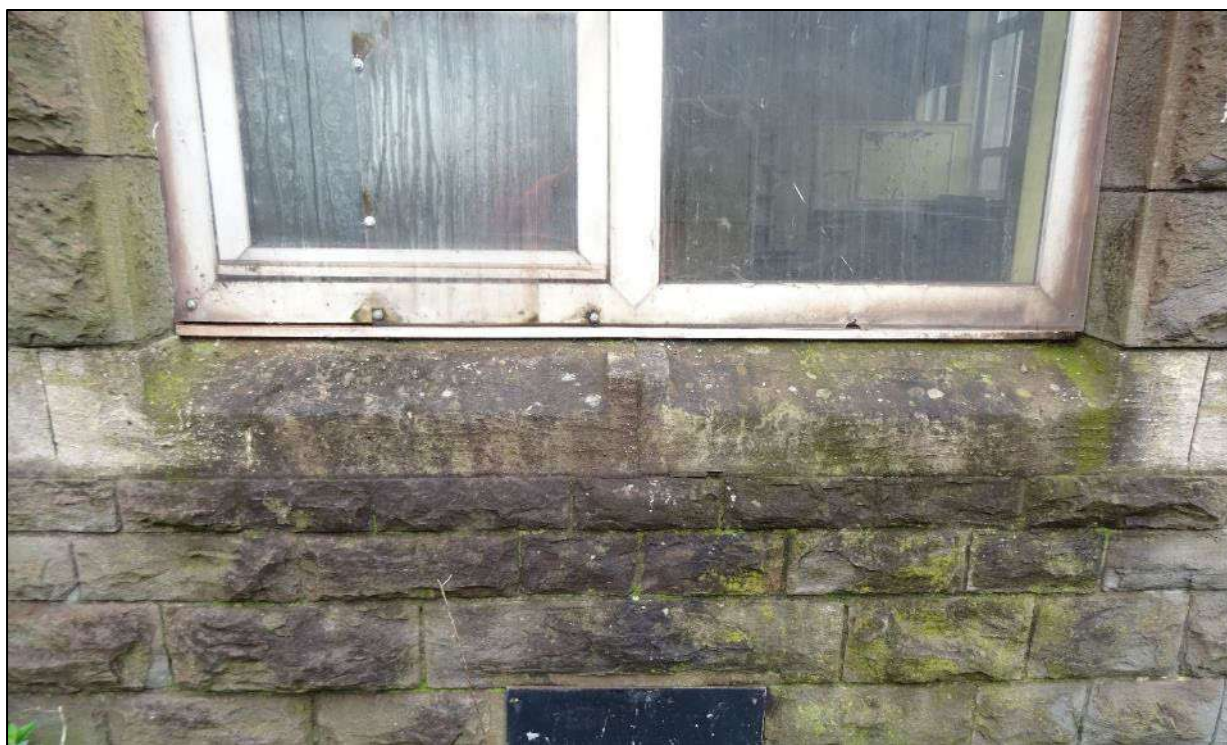
*Plate 40. Sill of left-hand of two larger windows to right-hand gable, south-east facing elevation, looking north-west.*

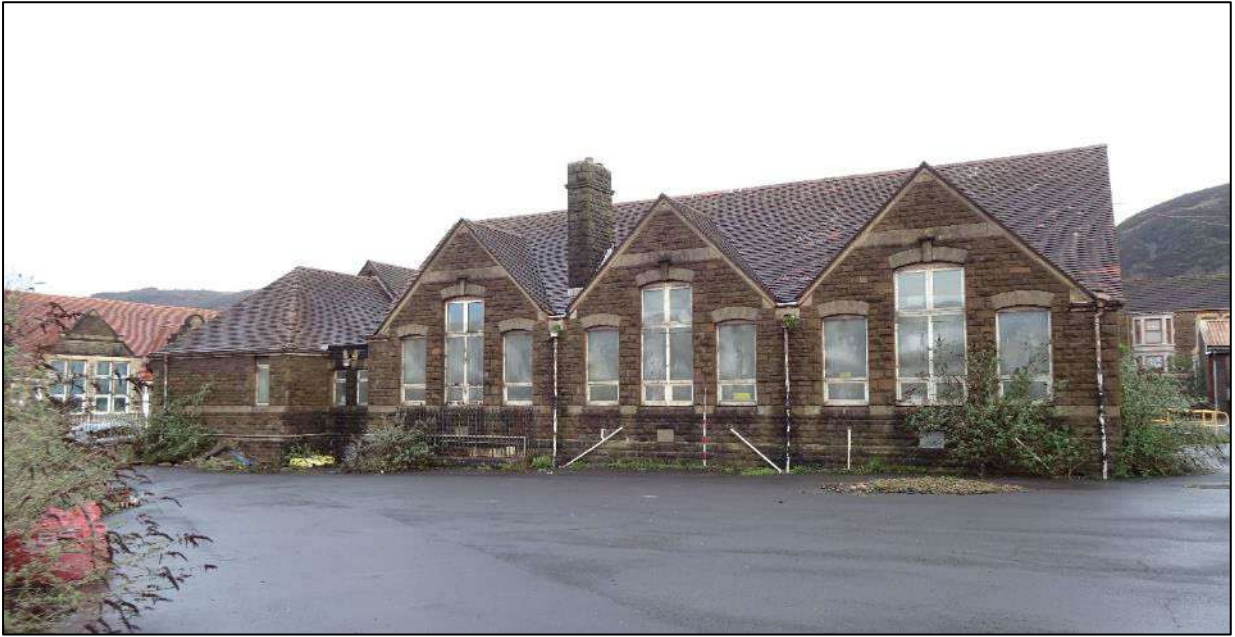
*Plate 41. South-west facing elevation of Building 1, looking north. Scale 2m.*

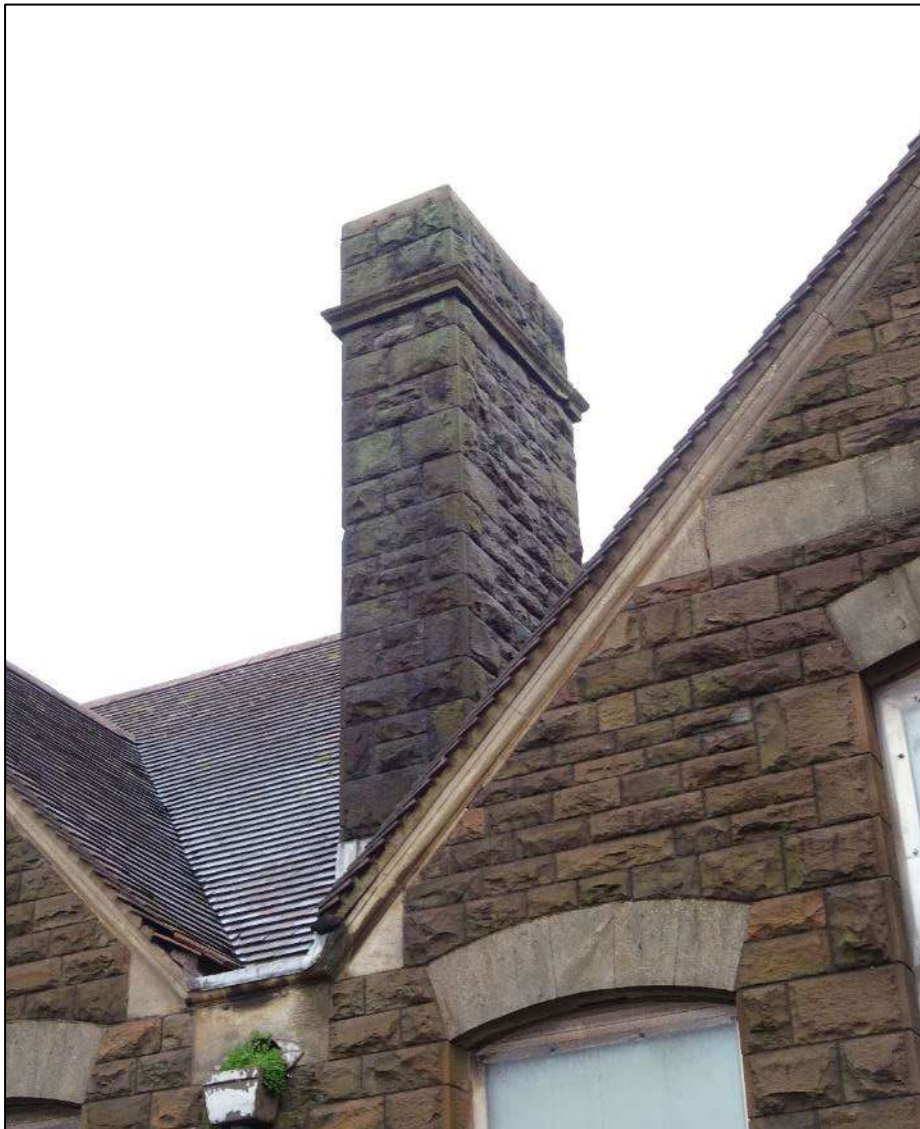
*Plate 42. Chimney stack to south-west facing elevation, looking north.*

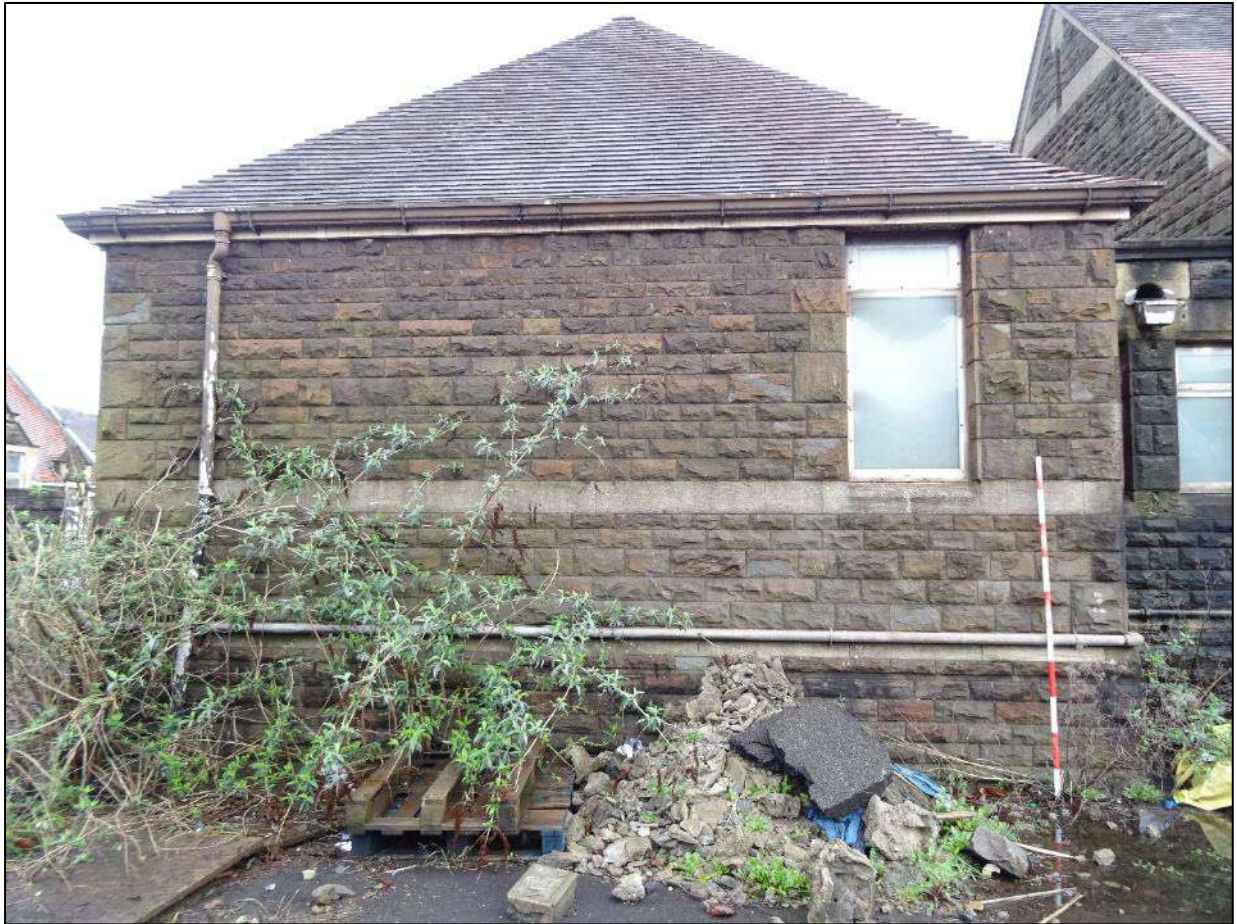
*Plate 43. Hipped end of front range, south-west facing elevation of Building 1, looking north-east. Scale 2m.*

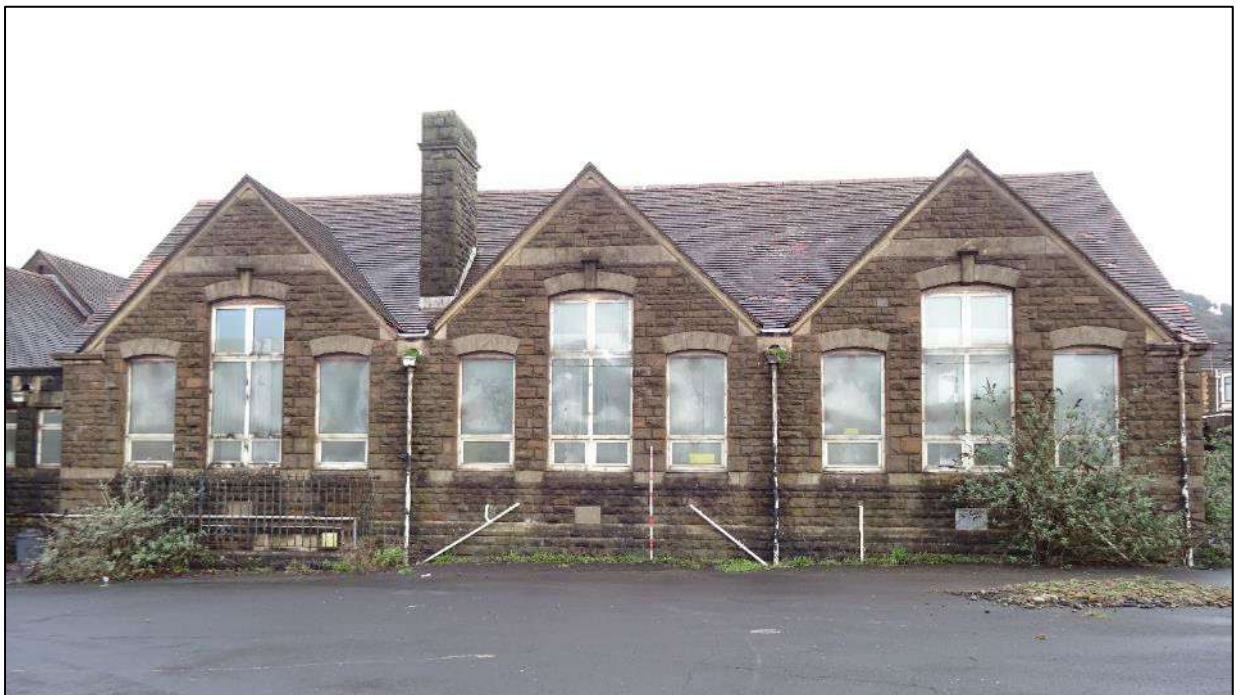
*Plate 44. Cross-gables to south-west facing elevation of Building 1, looking north-east. Scale 2m.*

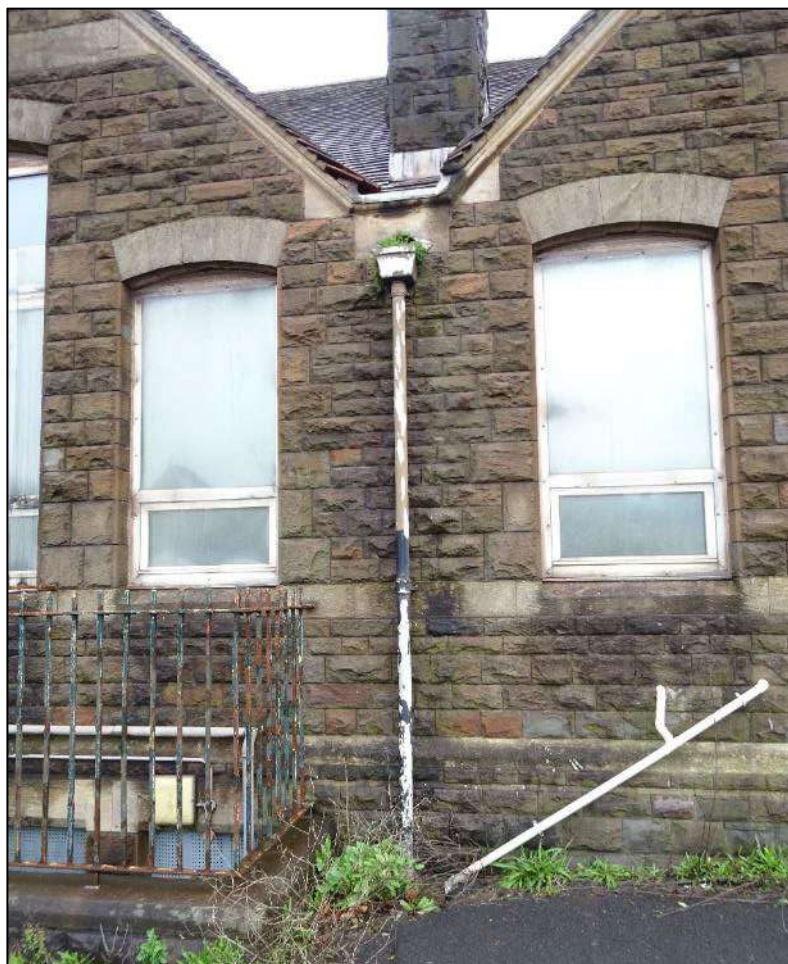
*Plate 45. Drain and downpipe between cross-gables, south-west facing elevation, Building 1, looking north-east.*

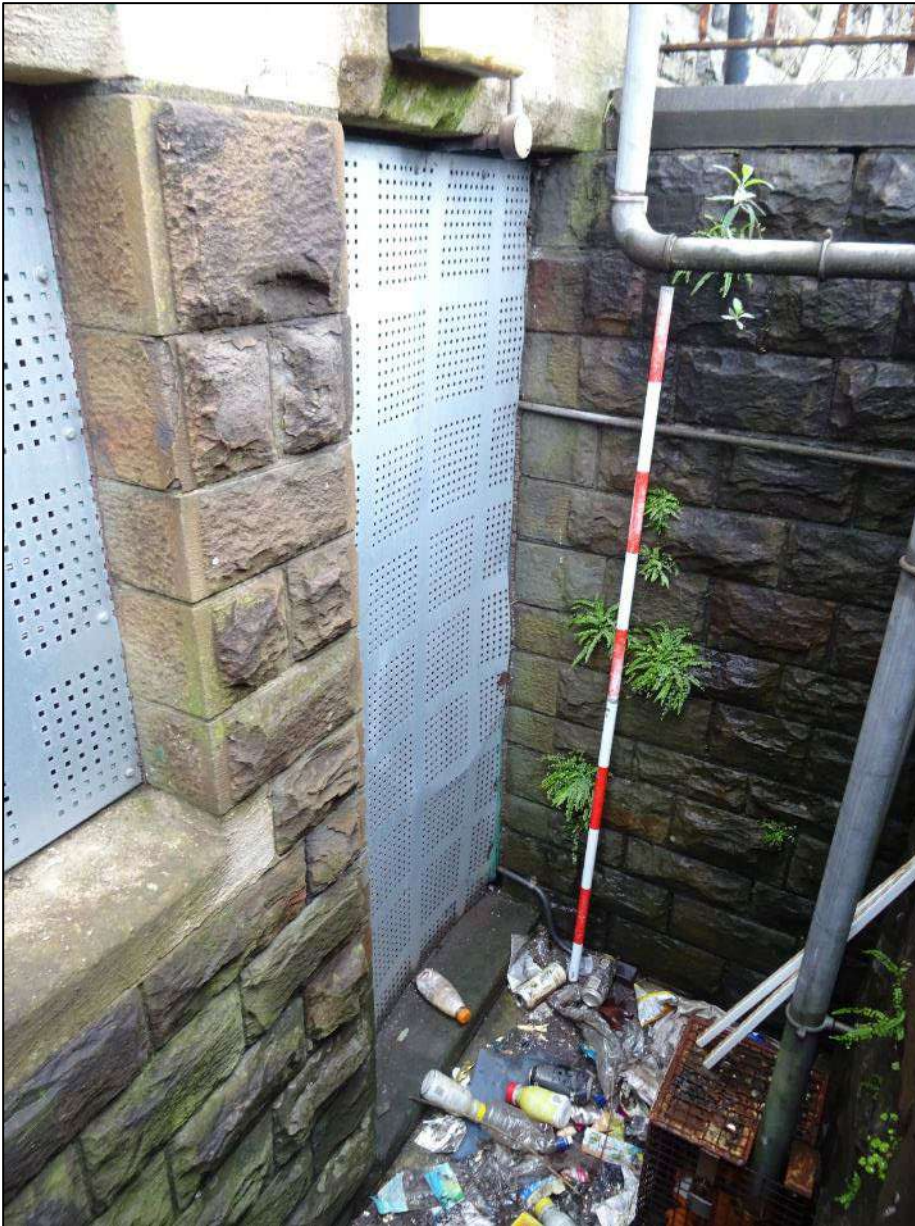
*Plate 49. Door to basement, south-west facing elevation of Building 1, looking east. Scale 2m.*

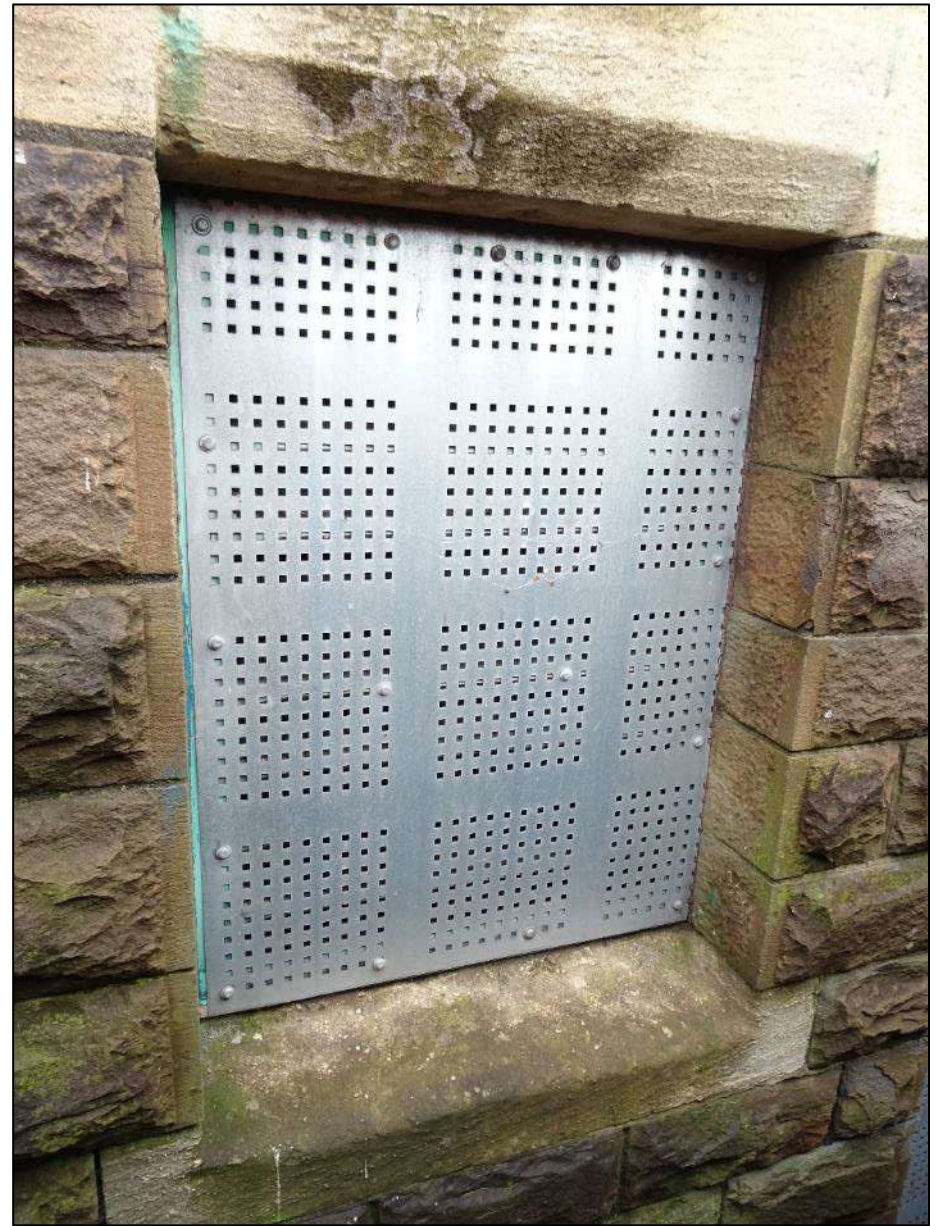
*Plate 50. Window to basement, south-west facing elevation of Building 1, looking east.*

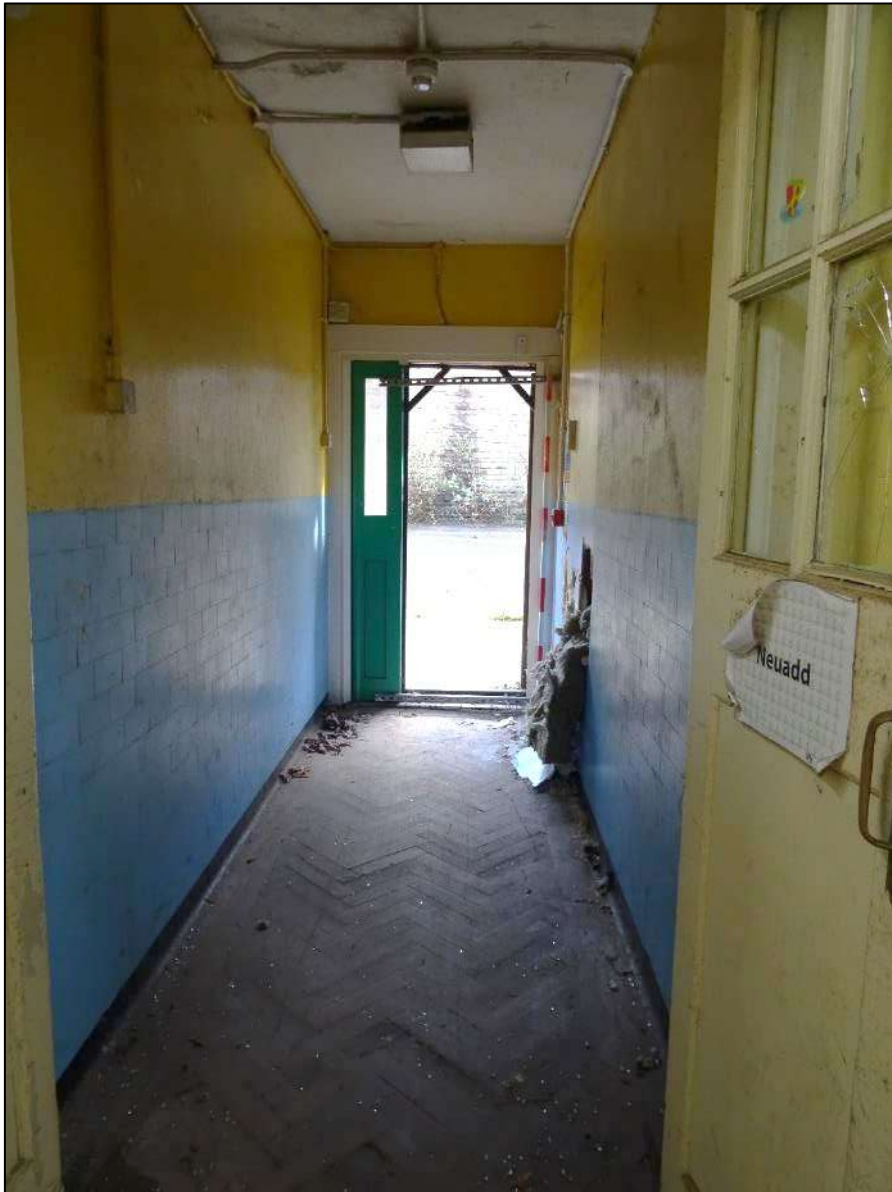
*Plate 54. Room 1, Building 1, entrance corridor, looking north-west.  
Scale 2m.*

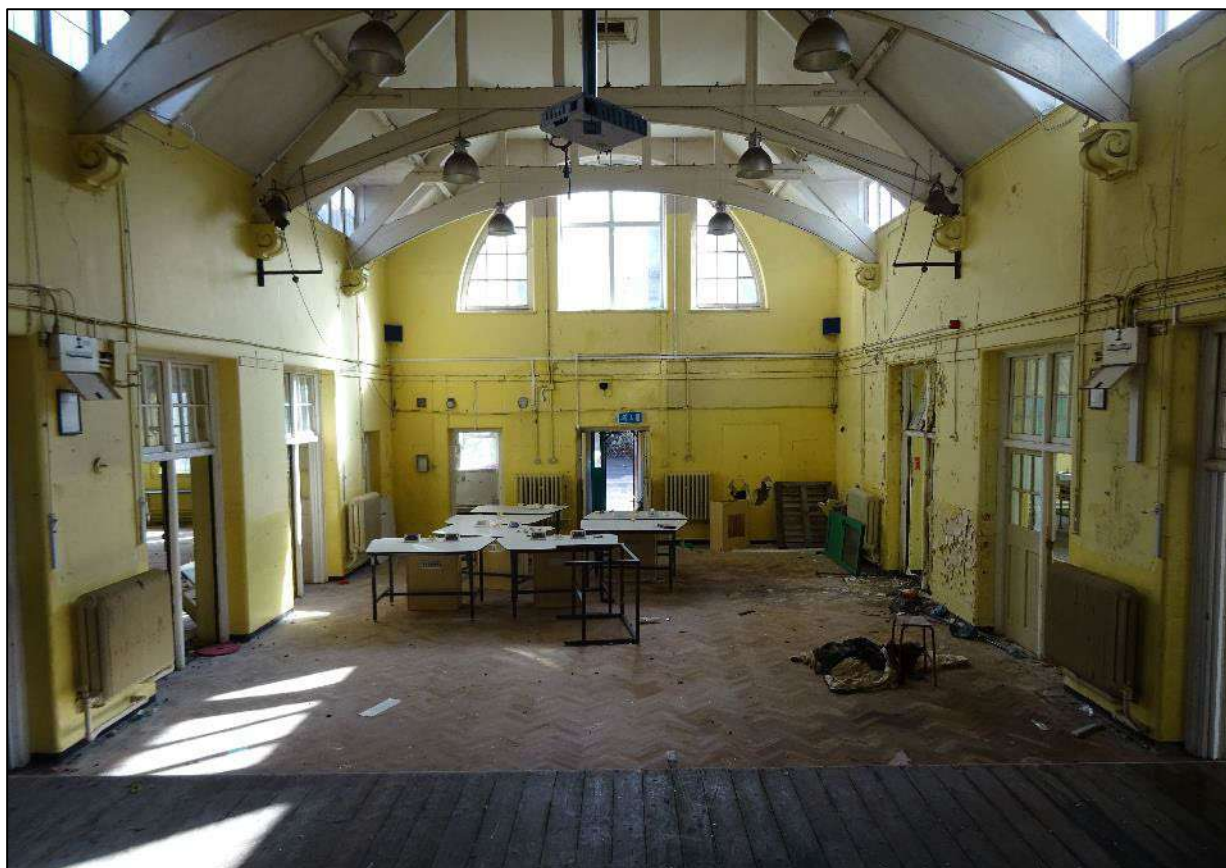
is recessed with rounded corners. On the opposing, south-west wall, a gap in the tiling and difference in appearance of the plaster indicates there was formerly a matching door, since blocked (Plate 70). On the south-east wall, to the left of the main door, is a door to a small room, Room 16, in the same style. The outline of a mirroring door, now blocked, to the right of the entrance, is clearly visible (Plate 57).

*Plate 57. Hall, Room 1, Building 1, looking south-east.*

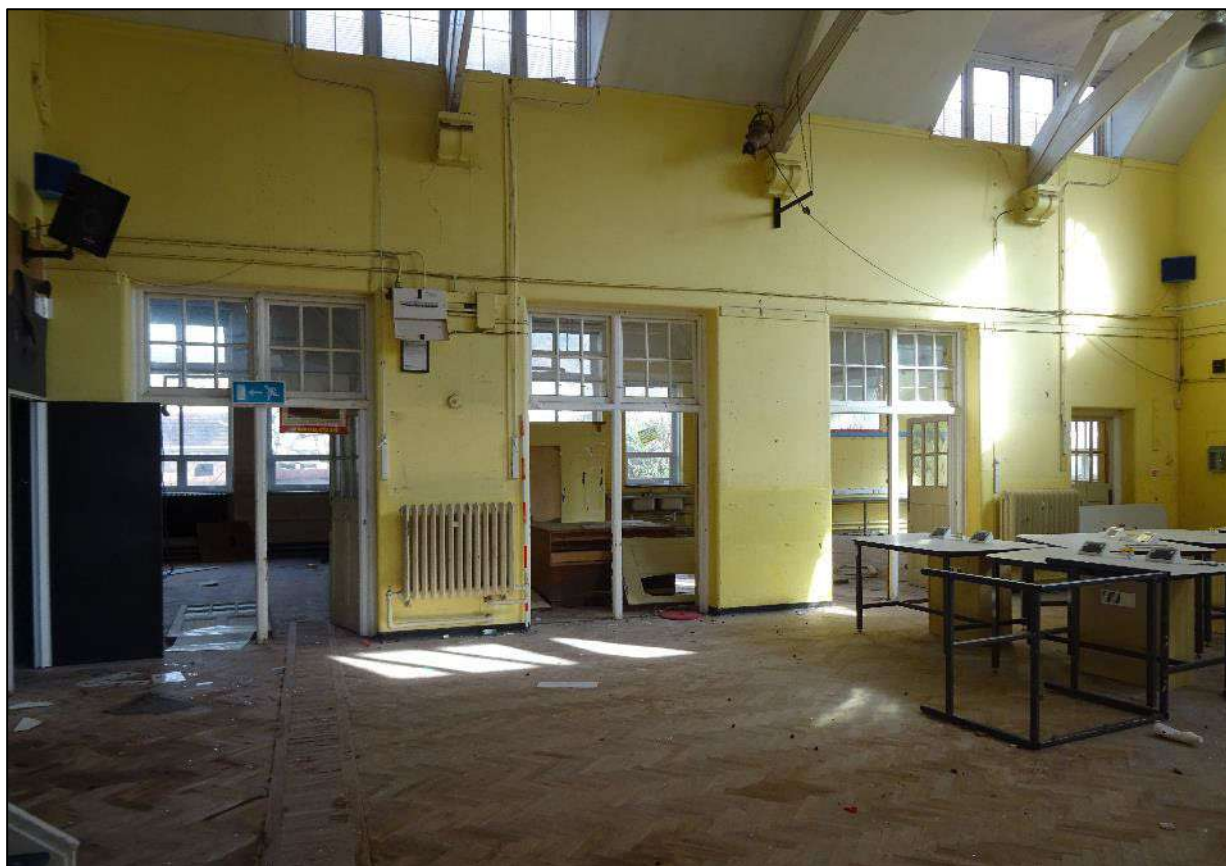
- 5.7.7. The side walls both have four doorways that open onto two classrooms (Rooms 3 and 5 to the south-west (Plate 64) and 14 and 15 to the north-east (Plate 59)). The doors have two fielded panels to the lower half and a six-pane glazed upper, and are paired with an identical, non-opening panel to the side (Plate 66). Above door and side panel are six-pane hopper-opening fanlights. The dividing mullion and transom and surrounding frame are all plain wood, painted white. The doorways are slightly recessed with rounded corners. The two within the backstage area have been blocked and radiators have been fitted within the recess (Plate 66).

*Plate 59. Hall, Room 1, Building 1, looking east. Scale 2m.*
