**Level 2 Building Recording:**  
**Former Dyffryn Lower School, Port Talbot**

March 2024

Report No. 2278

Prepared for KEW Planning  
By  
Susan Stratton PhD

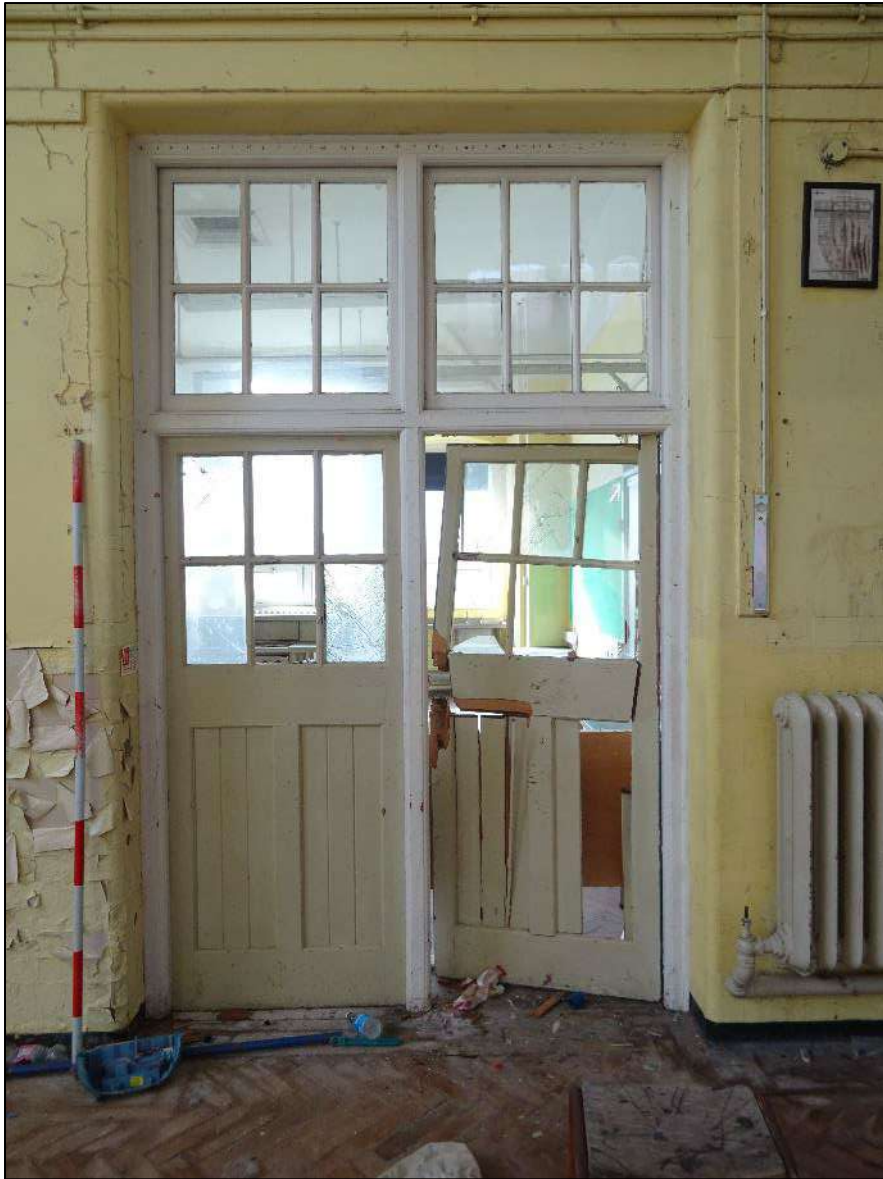
*Plate 65. Doorway on south-west wall of hall to Room 3, looking south-west. Scale 2m.*

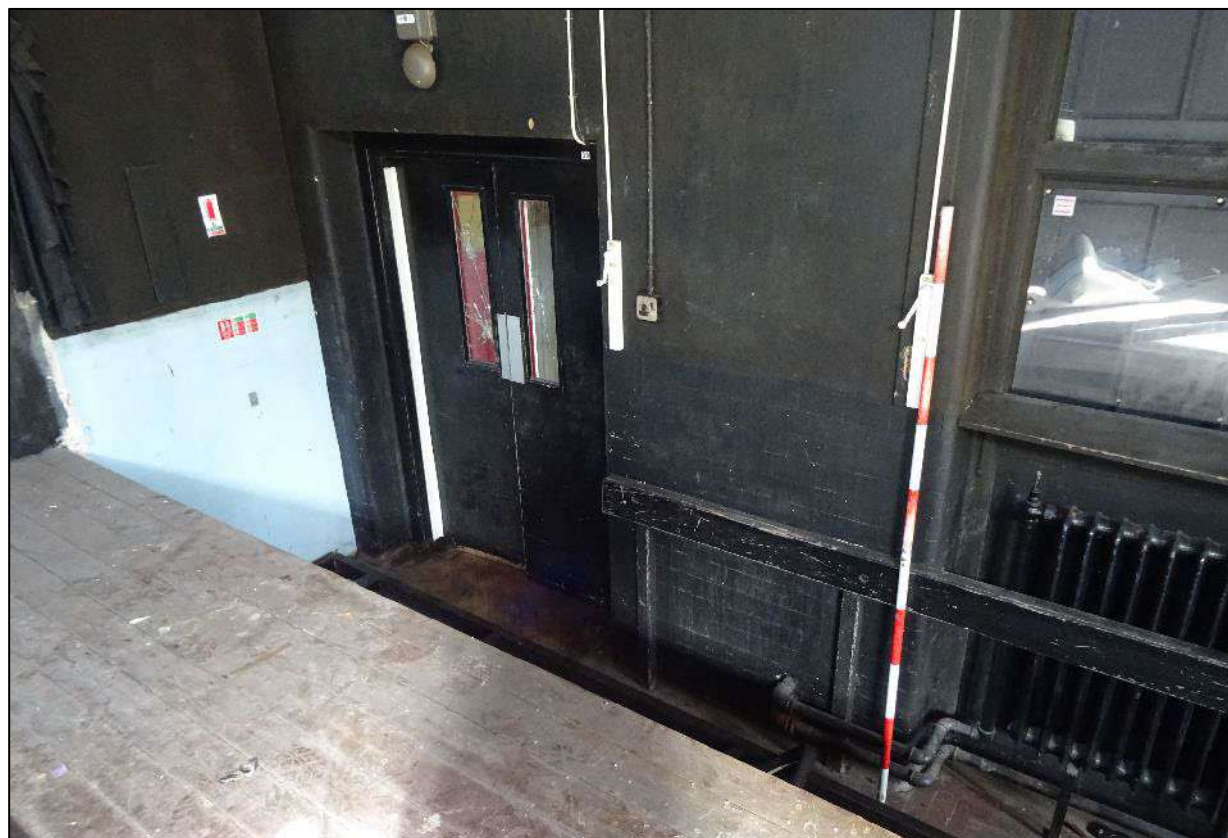
- 5.7.8. At the north-west end of the room, there are also doorways on both side walls to the corridors to the front entrances. That to the south-west wall is a wooden double door with fielded panel bottom half and four-pane light upper (Plate 67). That to the north-east is a modern replacement of solid double doors with narrow vertical off-centre lights (Plate 68). Both are recessed with rounded corners.

*Plate 68. Door to corridor Room 10, from stage, looking north. Scale 2m.*

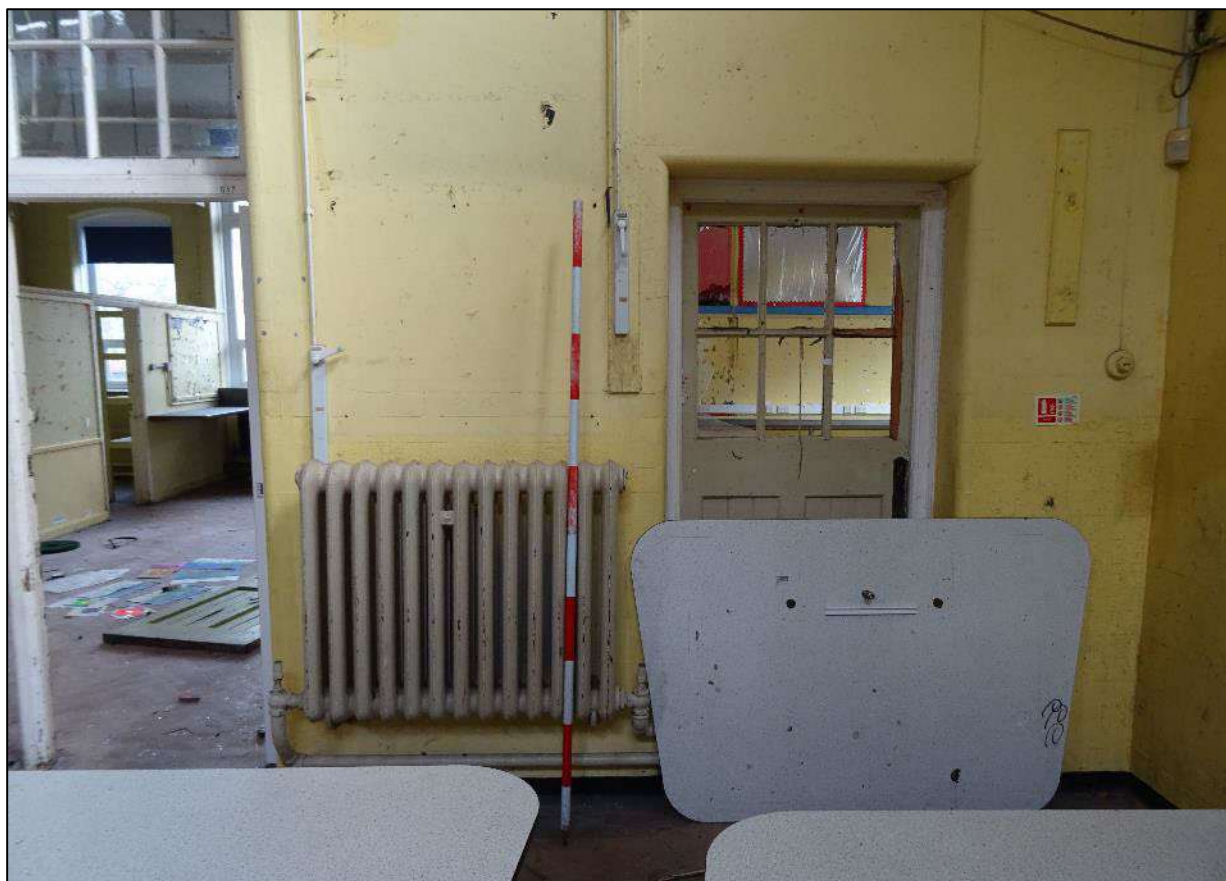
- 5.7.9. There is another door to Room 15 at the south-east end of the north-east wall. It is the same style as the other doors, two fielded panels to the lower half and a six-pane glazed upper, but without the side panel or fan lights (Plate 69). It

*Plate 69. Door to Room 15 from hall, looking north-east. Scale 2m.*

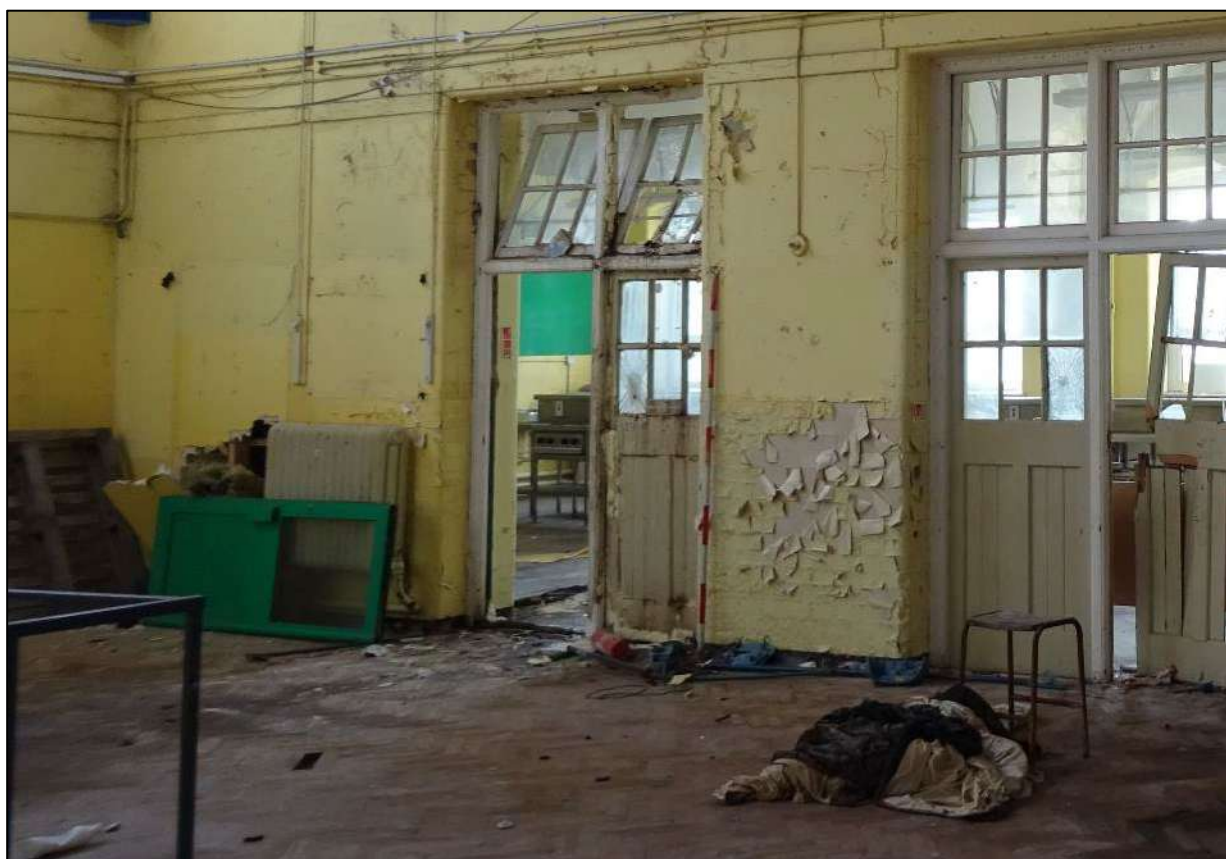
is recessed with rounded corners. On the opposing, south-west wall, a gap in the tiling and difference in appearance of the plaster indicates there was formerly a matching door, since blocked (Plate 70). On the south-east wall, to the left of the main door, is a door to a small room, Room 16, in the same style. The outline of a mirroring door, now blocked, to the right of the entrance, is clearly visible (Plate 57).

*Plate 70. South-west wall of hall, blocked doorway visible to left of shot.*

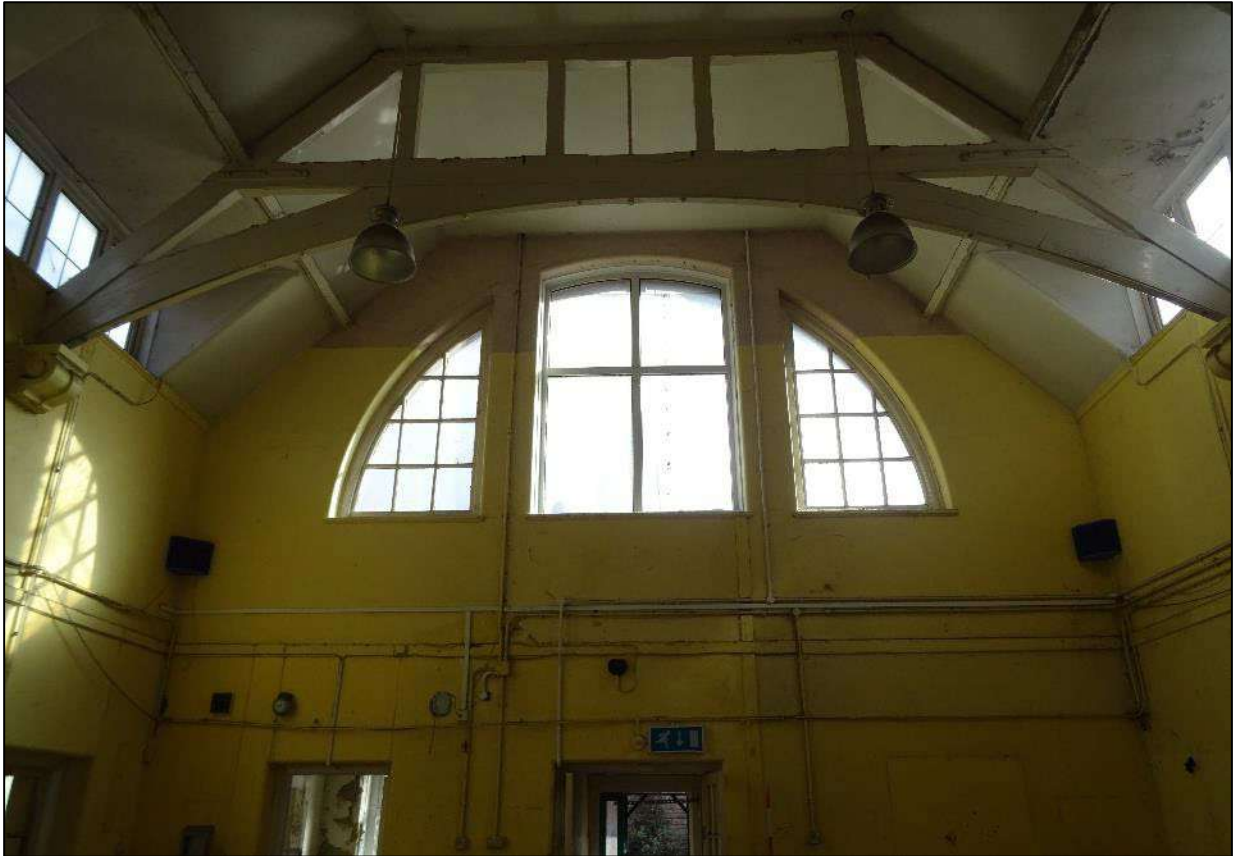
- 5.7.10. To either end of the room are large, semi-circular three-light windows (Plate 71). That to the north-west end has been blocked, painted black, and is largely obscured by the stage lighting rig and rear curtain (Plate 72). All the lights of the north-west window appear to be multi-pane wooden framed, while to the south-east the central light is a modern uPVC framed window. They are recessed with rounded edges and have wooden sills.
- 5.7.11. There are three full dormer windows along both long walls of the hall. Each is a uPVC framed four-light mullion window (Plate 73). They have wooden sills.
- 5.7.12. There are cast iron column radiators on the north-east, south-east and south-west walls (Plate 74).

*Plate 71. Large semi-circular window to the south-east gable end of Room 1, looking south-east.*

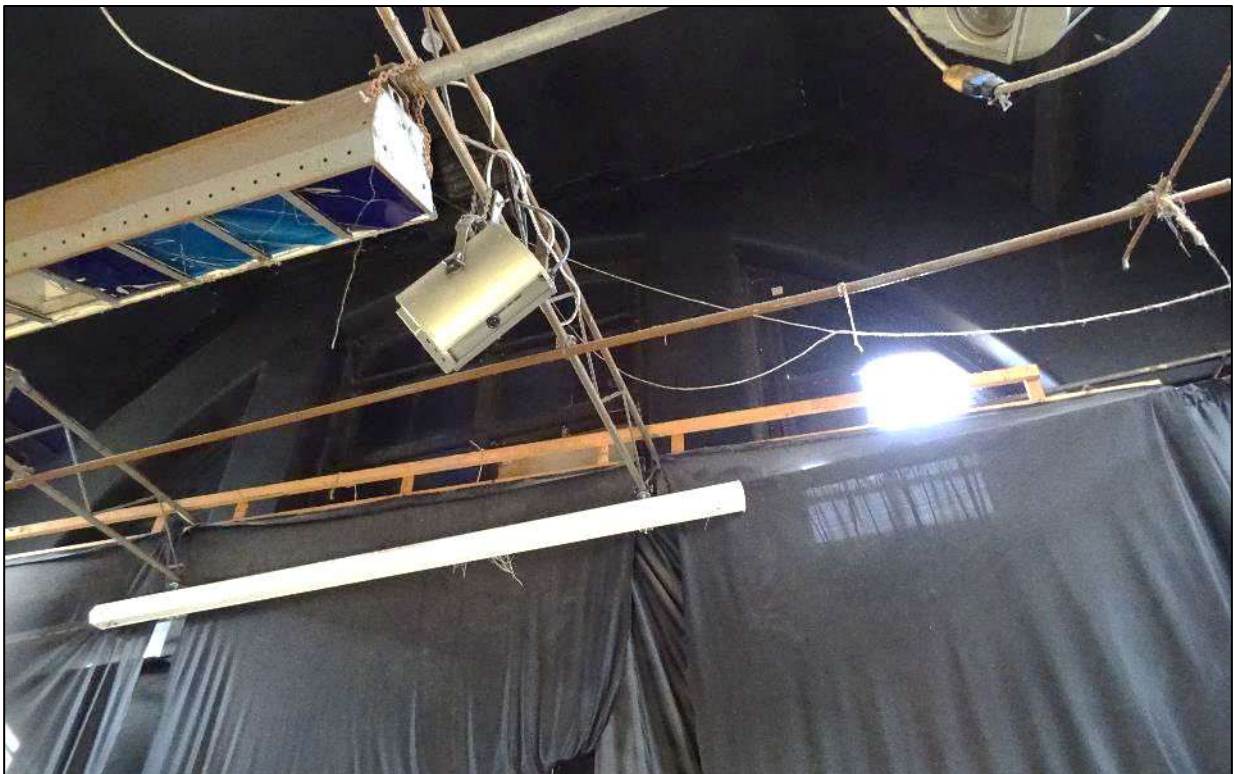
*Plate 72. Large semi-circular window to the north-west gable end of Room 1, just visible behind stage equipment, looking north-west.*

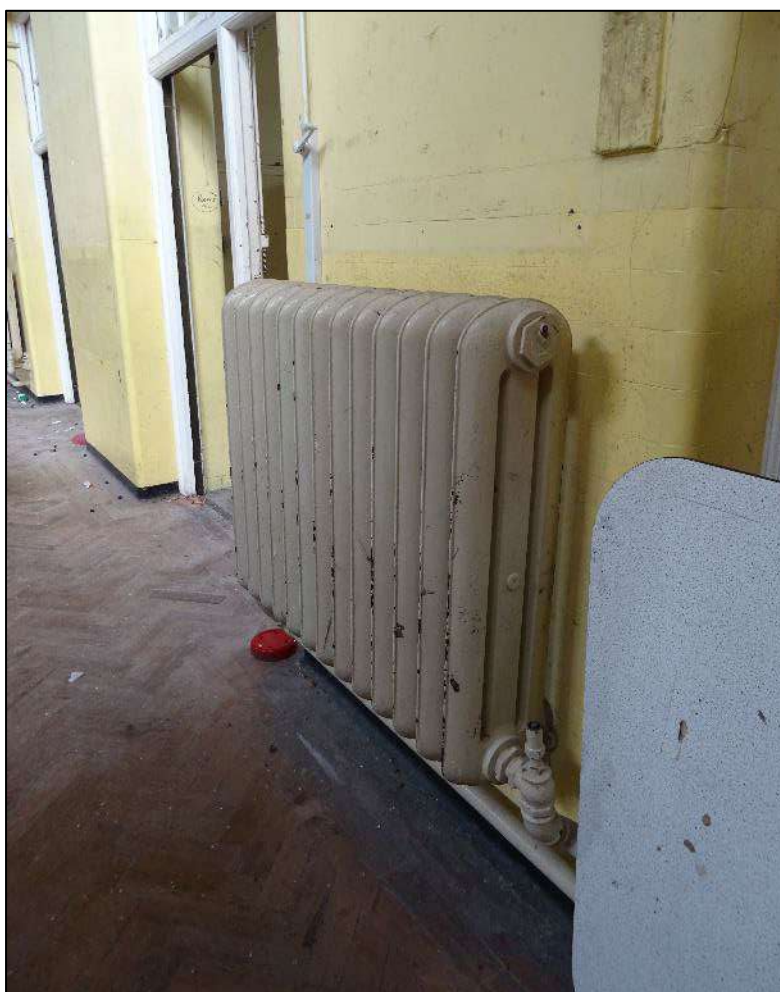
*Plate 74. Radiator on north-east wall of hall, looking north.*

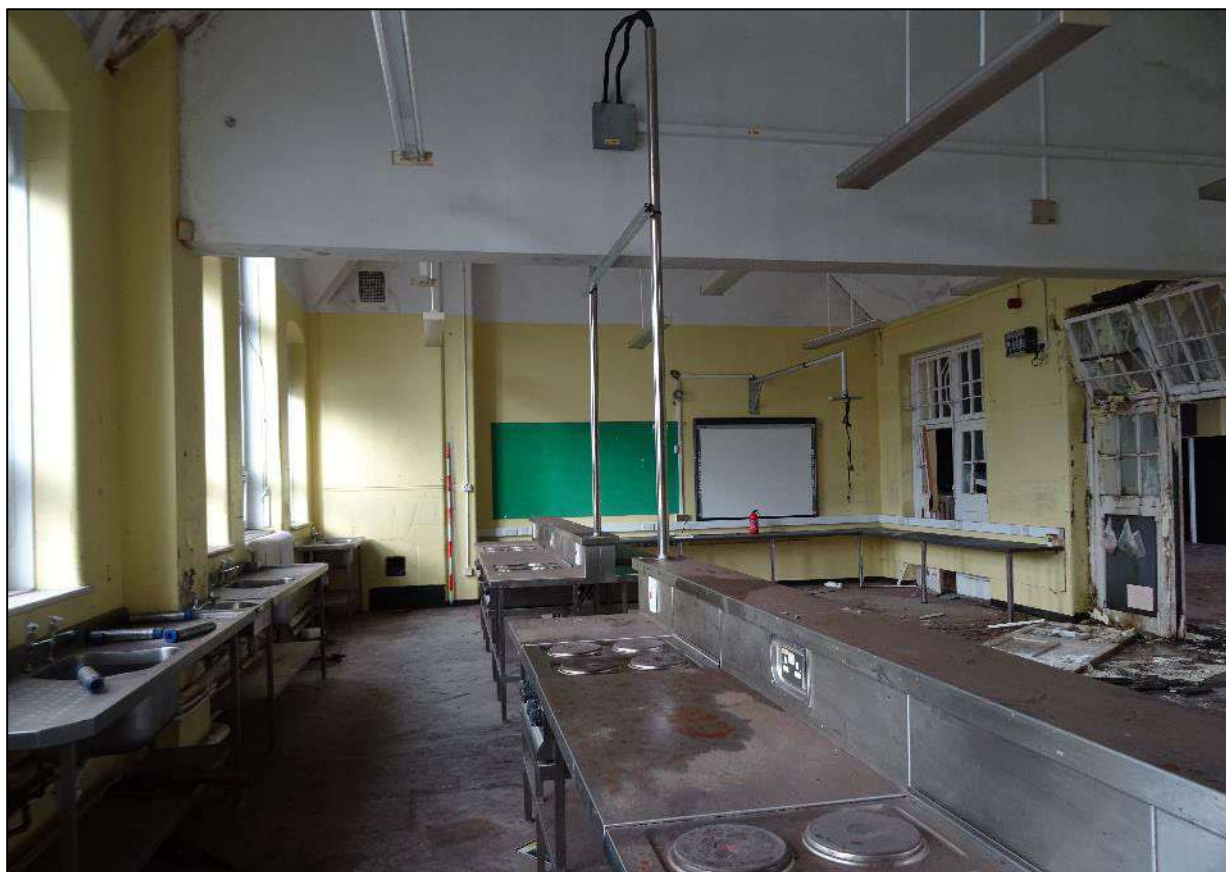
- 5.7.13. Room 3 is in the southern corner of the building, occupying the south-east end of the south-west cross-gable. It has a herringbone parquet floor (Plates 75 and 76). The walls are pale yellow painted plaster, and the ceiling is white painted plaster. The ceiling slopes down to the south-west and north-east and a boxed-in section in the centre of the room indicates a formerly exposed roof truss (Plate 76). Various modern, stainless-steel kitchen fixtures remain.
- 5.7.14. The two doorways from the hall on the north-east wall are as described in Paragraph 5.7.6, although the lower half of the left-hand doorway is blocked by a modern fitted work surface (Plate 77). Also on the north-east wall, at the south-eastern end, is a modern doorway through to Room 4 (Plate 78). The door is solid wood in a plain wooden frame, all painted white.

*Plate 75. Room 3, looking north-west. Scale 2m.*

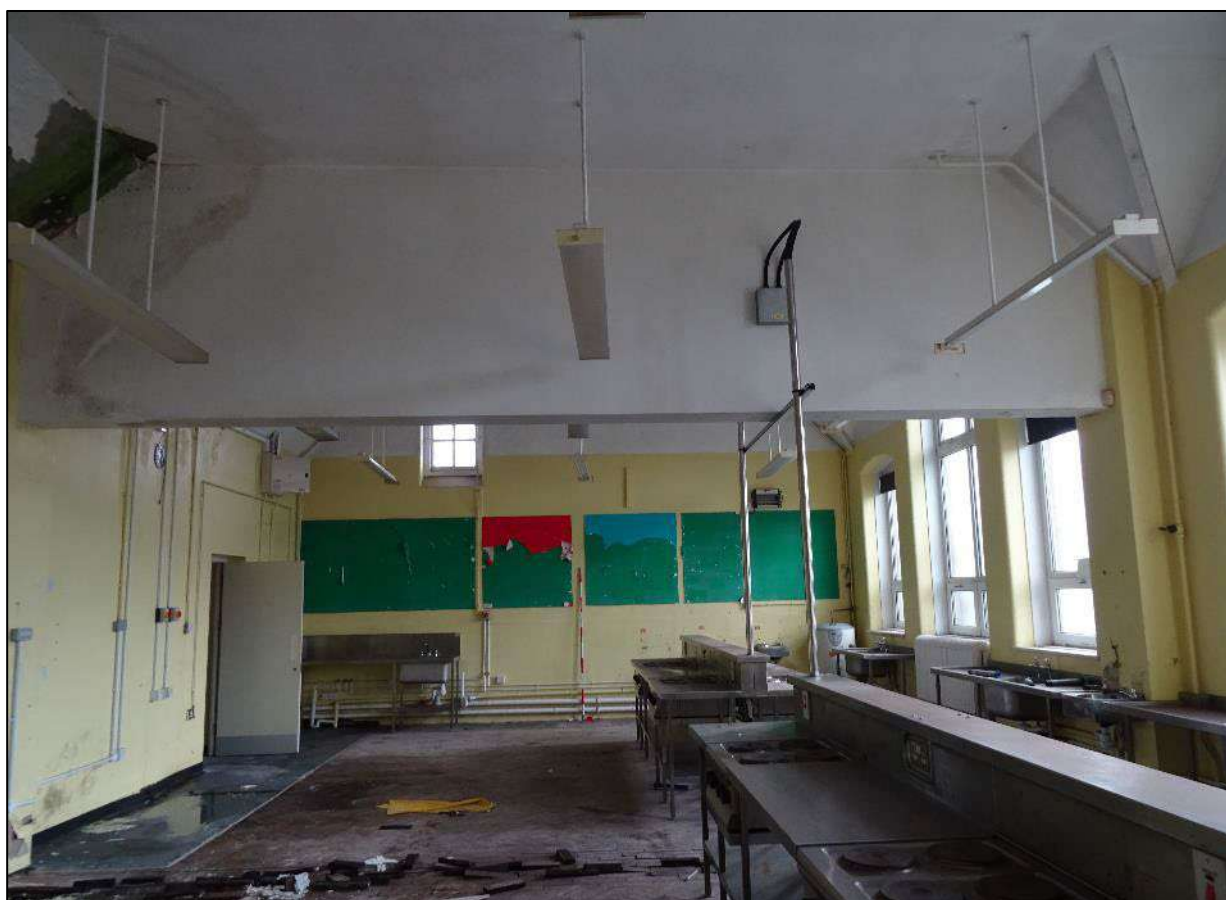
*Plate 76. Room 3, looking south-east. Scale 2m.*

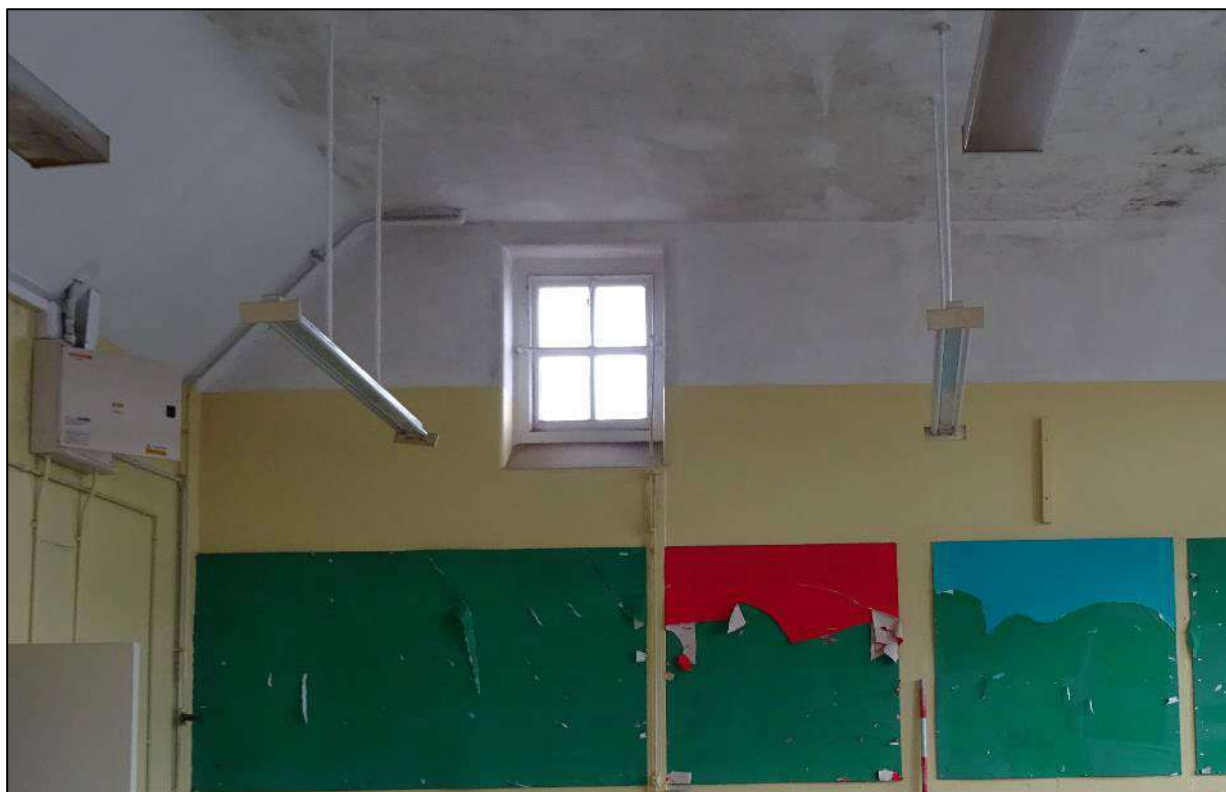
- 5.7.15. To the upper left of the south-east wall is a small, wooden framed, four-pane, hopper window (Plate 79). It is recessed, with rounded edges to the recess and a canted sill.

*Plate 79. Window on south-east wall of Room 3, looking south-east.*

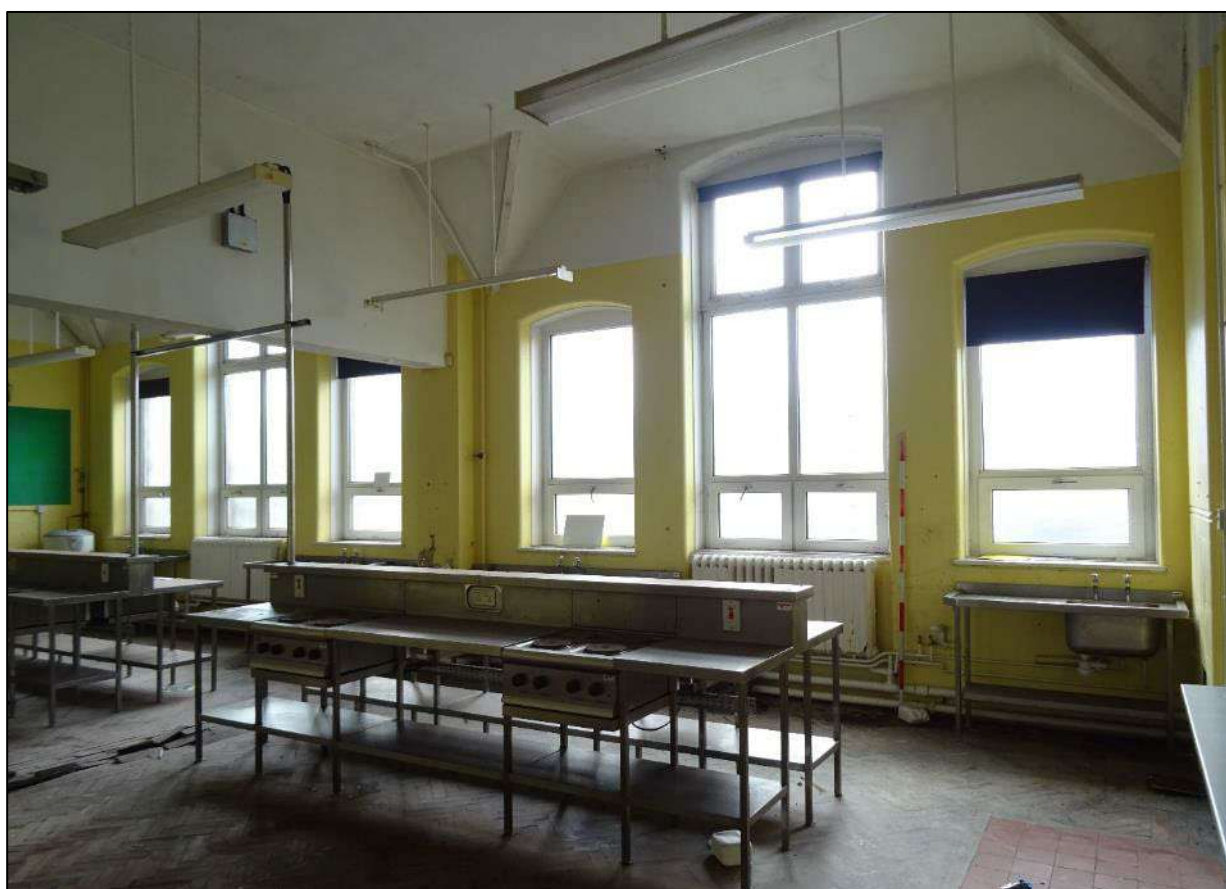
- 5.7.16. The south-west wall has two bays of three windows, separated by the boxed-in roof truss, with the ceiling sloping at the ends following the line of cross-gable ends (Plate 80). The central window of each bay is taller, extending to the top of the ceiling (Plate 81). The windows are all modern uPVC framed windows. They are in segmental arched recesses with rounded edges and wooden sills. Below the central window of each bay is a cast iron column radiator (Plate 82).

*Plate 80. Room 3, Building 1, looking south. Scale 2m.*

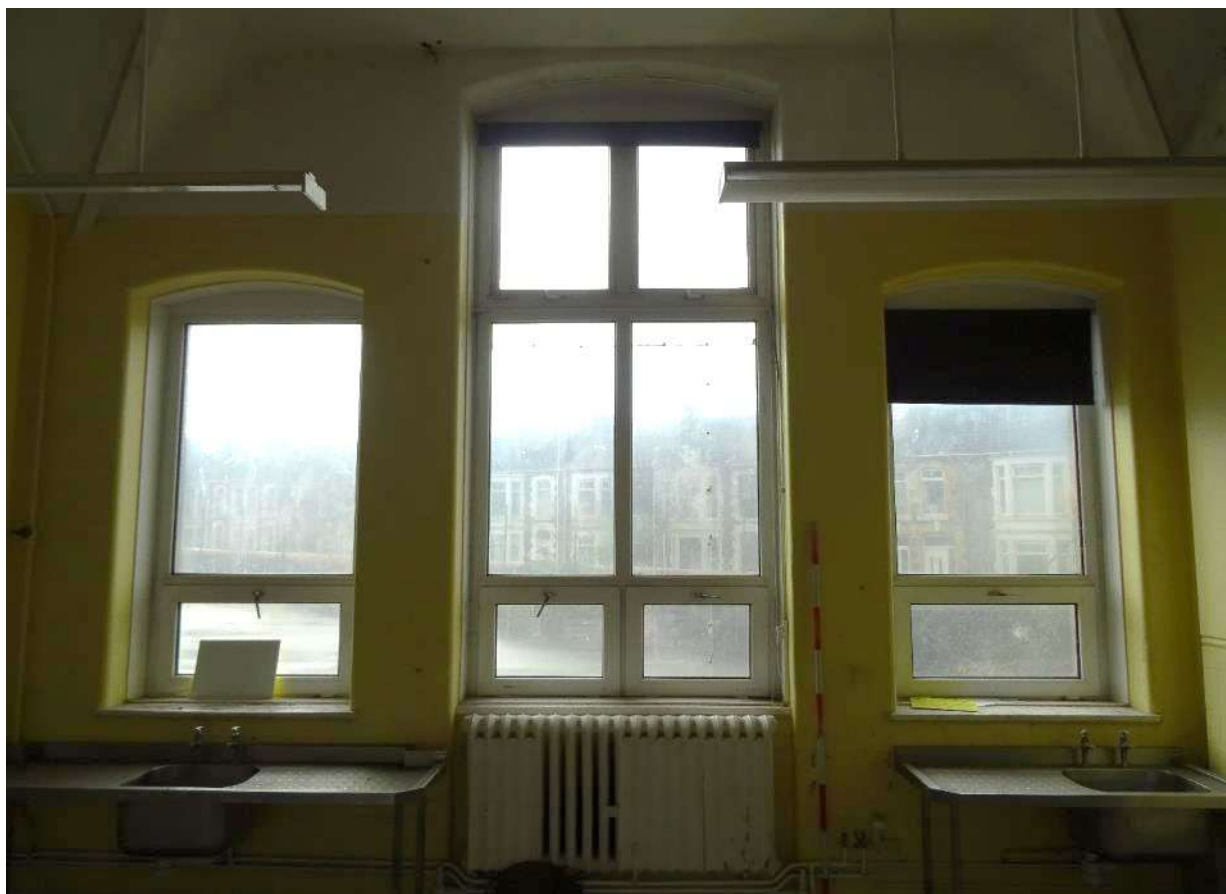
*Plate 81. Windows to right-hand bay of south-west wall, Room 3, looking south-west. Scale 2m.*

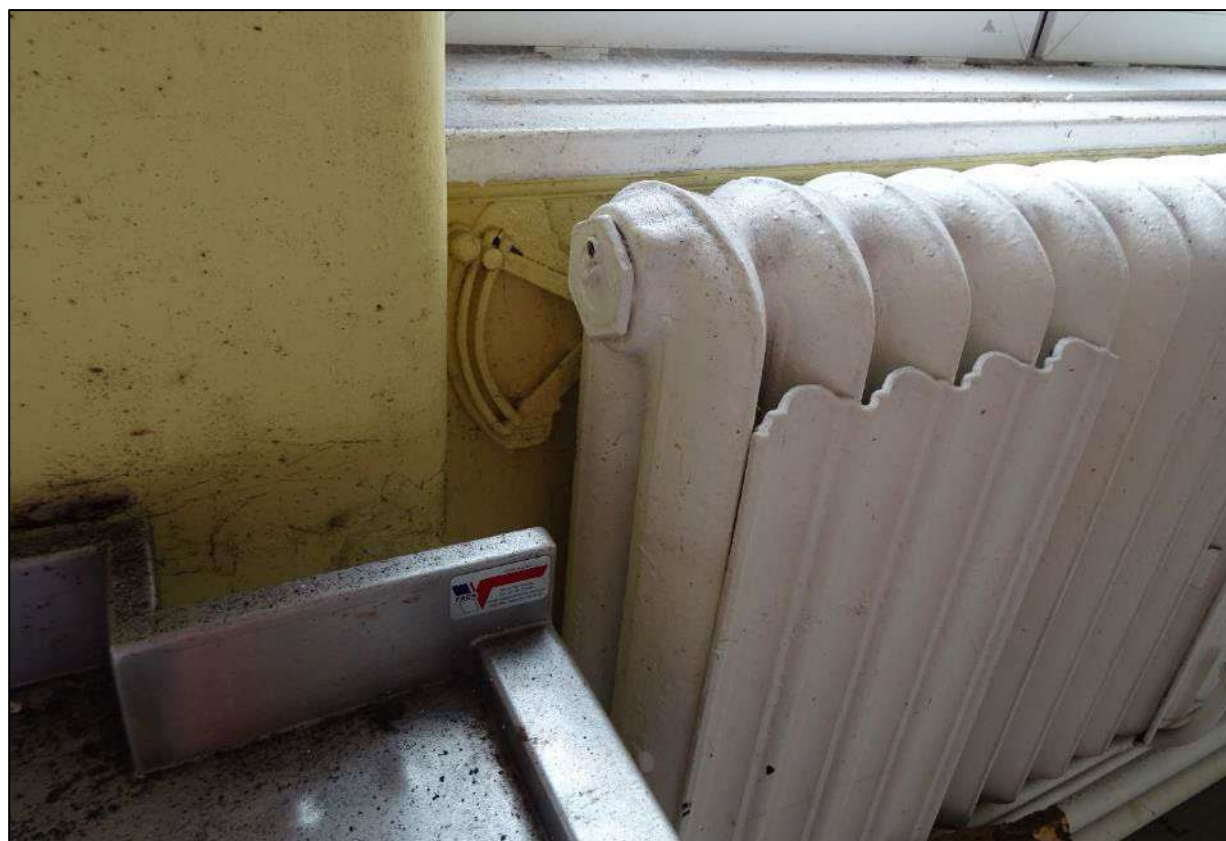
*Plate 82. Detail of radiator in right-hand bay of south-west wall, Room 3, looking west.*

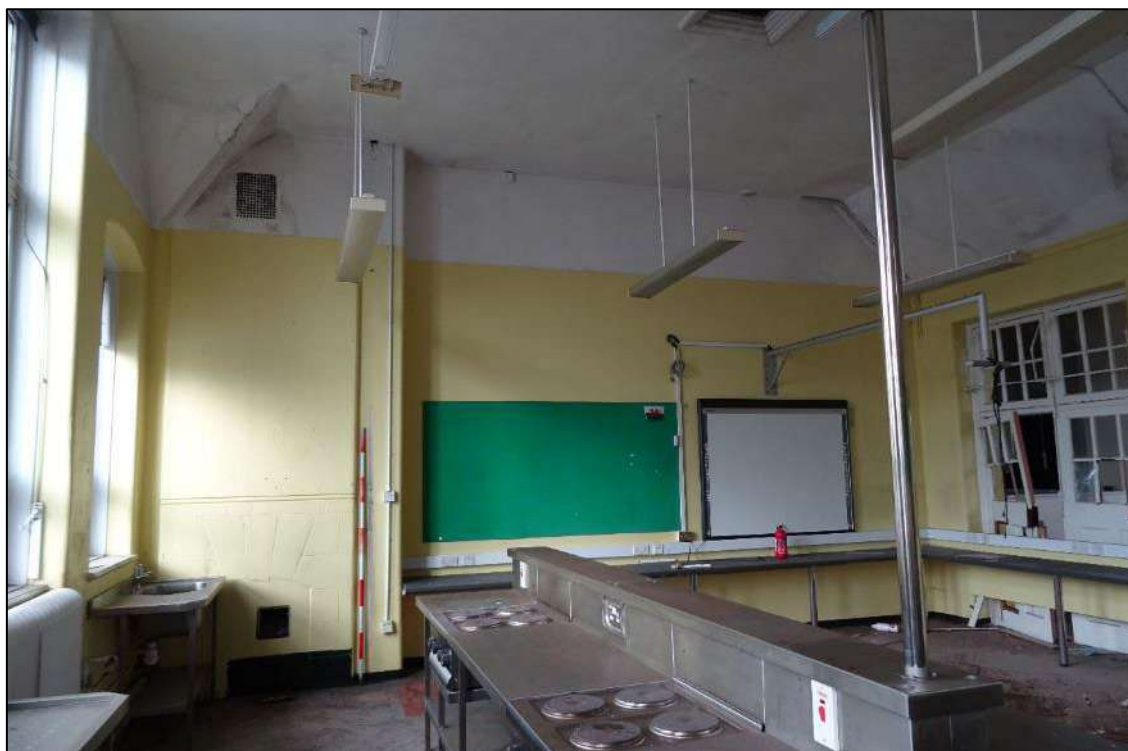
- 5.7.17. There is a projecting chimney breast on the left side of the north-west wall (Plate 83). The fireplace has been blocked and the surround painted over, but it is possible to make out the arrangement of the ceramic tiles, including elongated keystone and voussoirs (Plate 84). A moulded plaster band runs above the tiled area. There is a stone hearth in front of the fireplace.

*Plate 83. North-west wall with chimney breast to left, looking north-west. Scale 2m.*

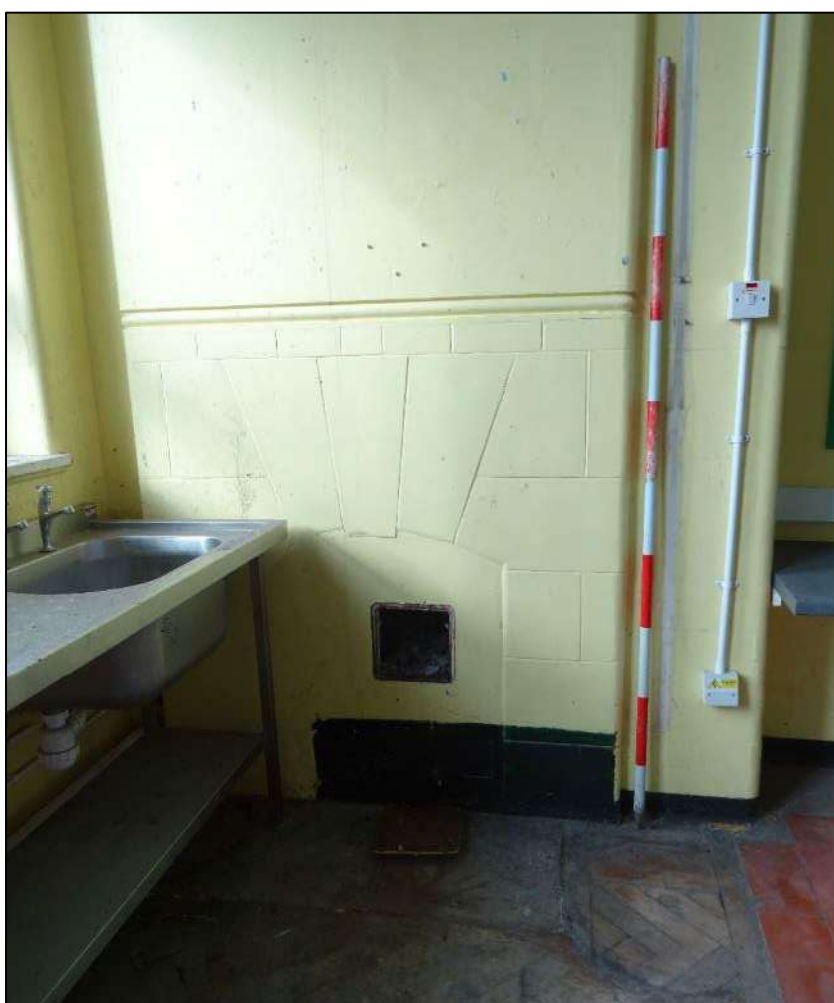
*Plate 84. Fireplace in west corner of Room 3, Building 1, looking north-west. Scale 2m.*

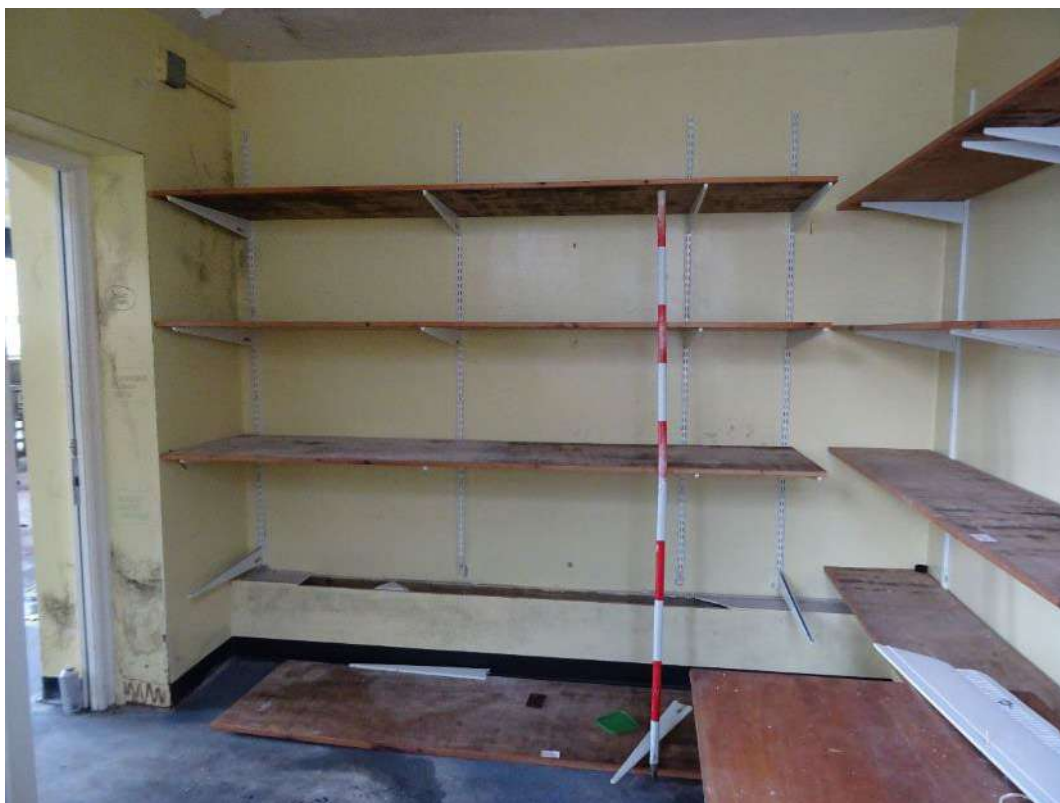
- 5.7.18. Room 4 is a small storeroom accessed from Room 3, located at the south-east of the building, between Rooms 1 and 3. It has blue linoleum flooring, cream painted plaster walls and white painted plaster ceiling (Plate 85). The door to Room 3 is on the south-west wall.
- 5.7.19. There are two windows on the south-east wall. Both are modern uPVC framed windows. They are recessed, with painted plaster to the reveals. The left-hand window has a uPVC sill, while this has been removed on the one to the right, revealing a ceramic tile sill (Plate 86).
- 5.7.20. There are modern shelves fitting to the north-west and north-east walls, and there is a fitted cupboard with modern solid wood doors in a plain wooden frame on the south-west wall (Plate 87).

*Plate 85. Room 4, Building 1, looking north-west. Scale 2m.*

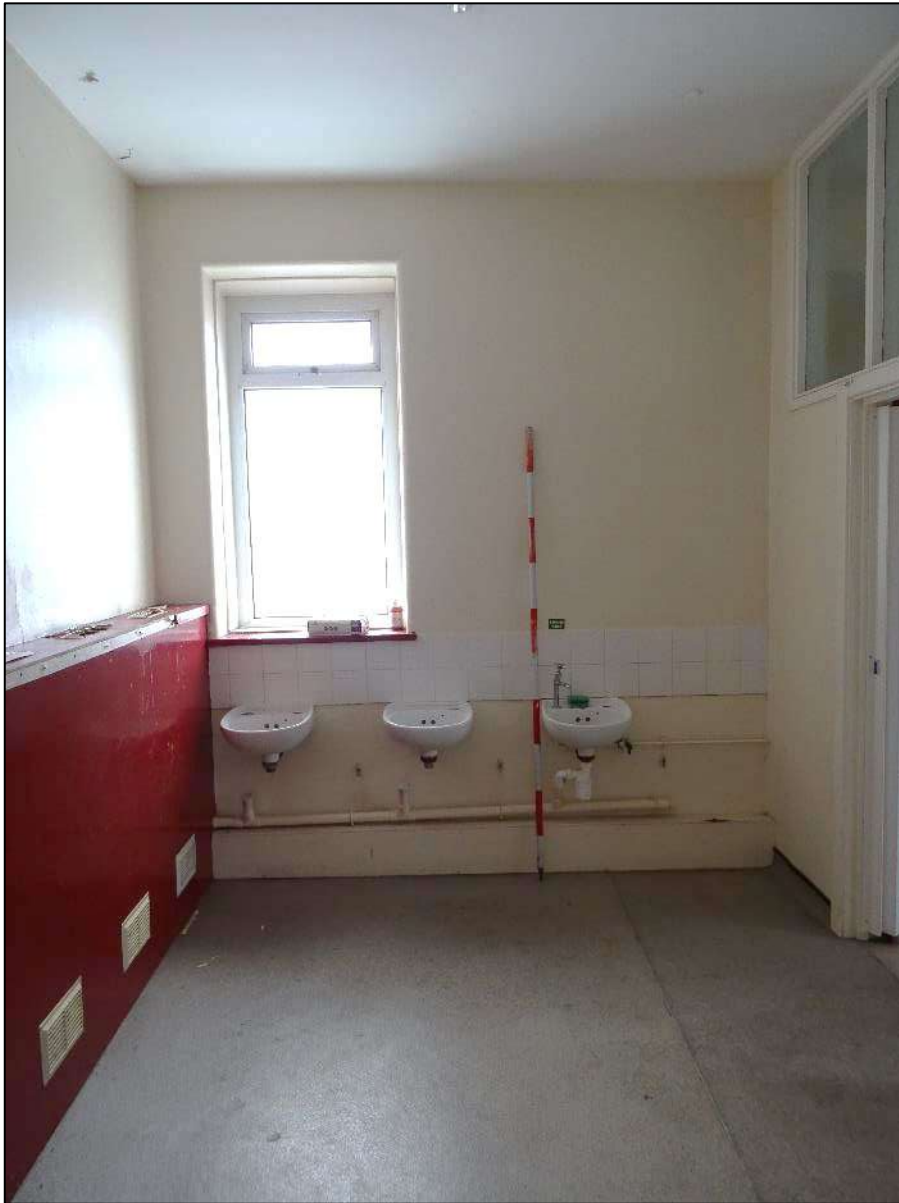
*Plate 106. Left hand window to south-west wall of Room 7, looking south.*

5.7.40. There is a single window in the same style to the left of the south-west wall (Plate 107). Under the window is a row of three modern sinks with a narrow band of white ceramic tiles.

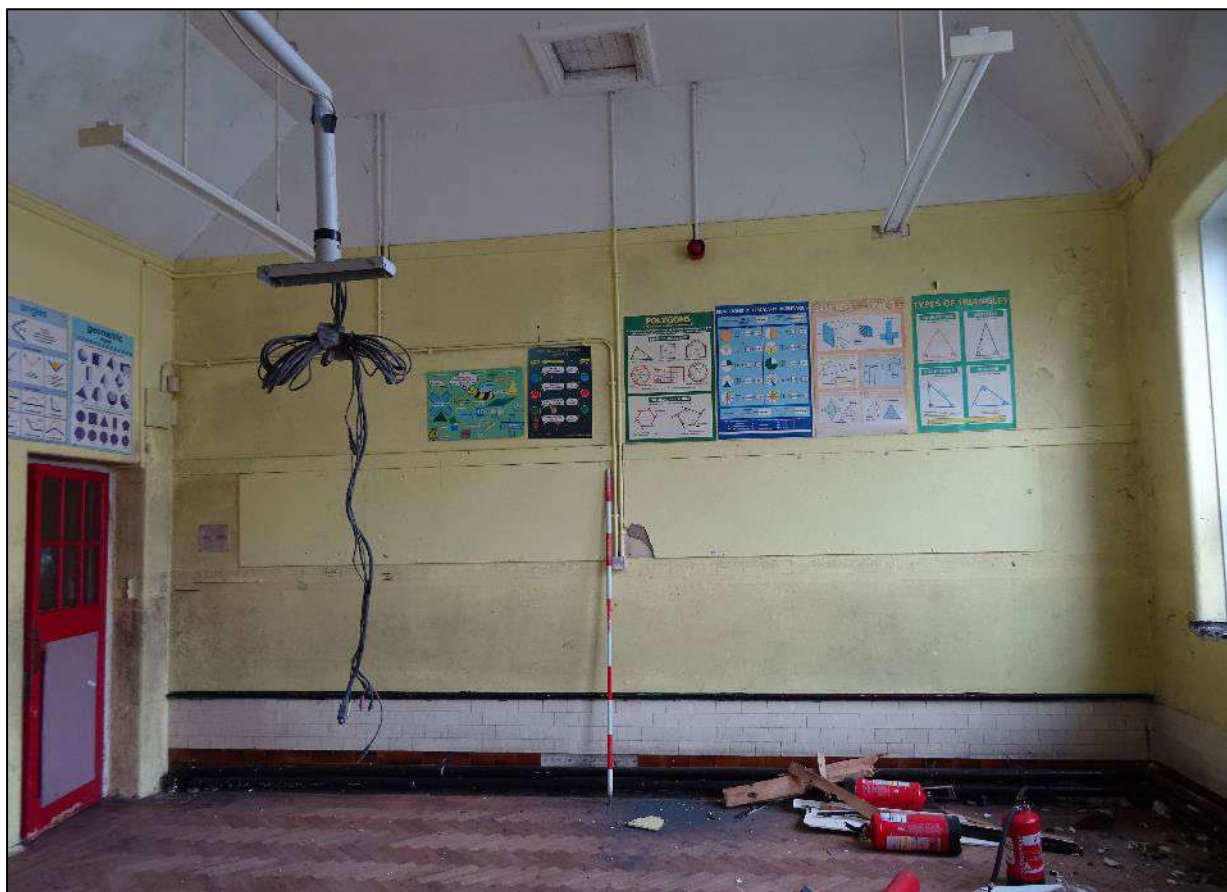
*Plate 111. Room 9, Building 1, looking south-west. Scale 2m.*

5.7.42. Room 9 is located in the front range of the building and is accessed from the corridor, Room 6. It has a herringbone parquet floor (Plate 111). A band of brown and white ceramic tiling runs around the bottom of the walls to a height of 0.6m. The rest of the walls are magnolia painted plaster. The ceiling is white painted plaster and slopes down in line with the gable end of the range at the south-east, south-west and north-west sides. Additionally, either side of the north-west wall slopes in line with the cross-gable (Plate 112).

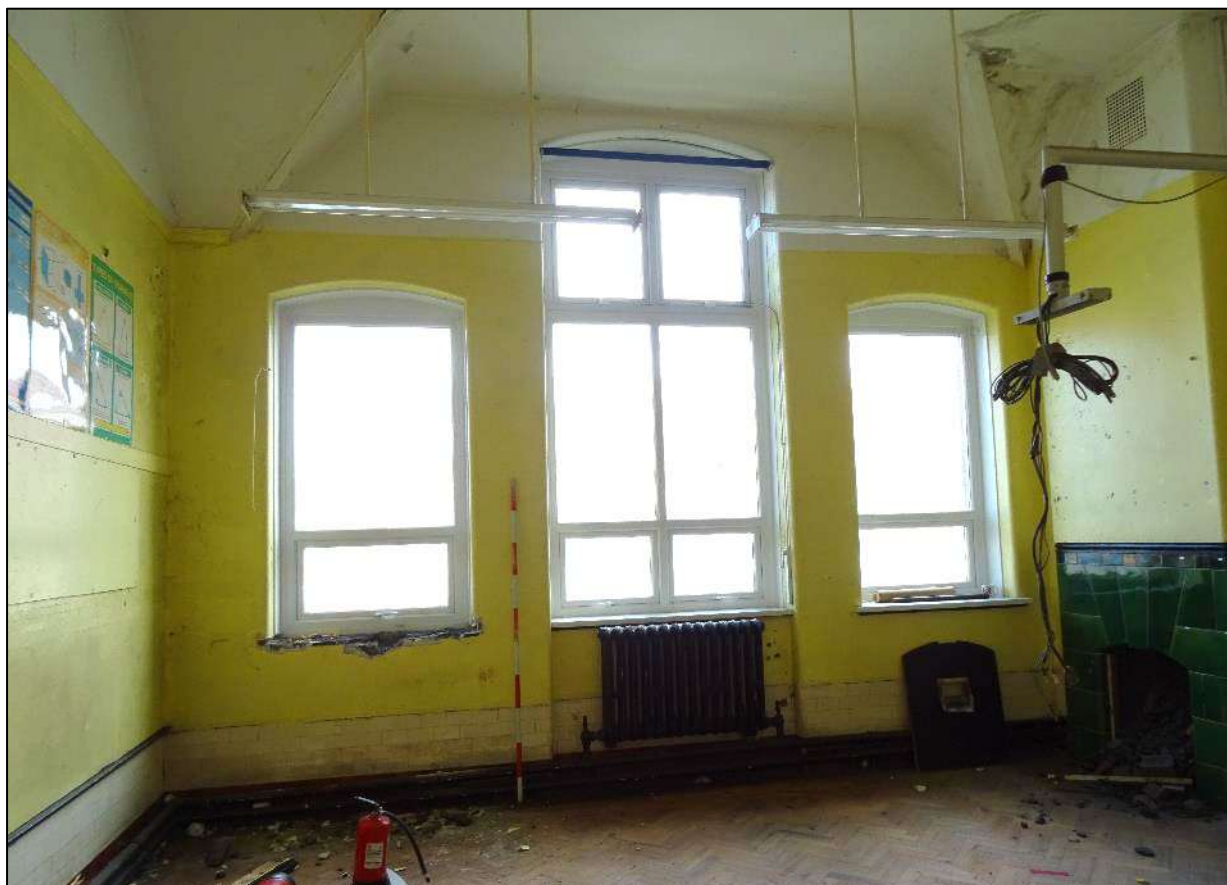
*Plate 112. Room 9, Building 1, looking north-west. Scale 2m.*

5.7.44. There are three windows to the south-west wall (Plate 112), which are the same as those in Rooms 3 and 5 (Paragraph 5.7.16).

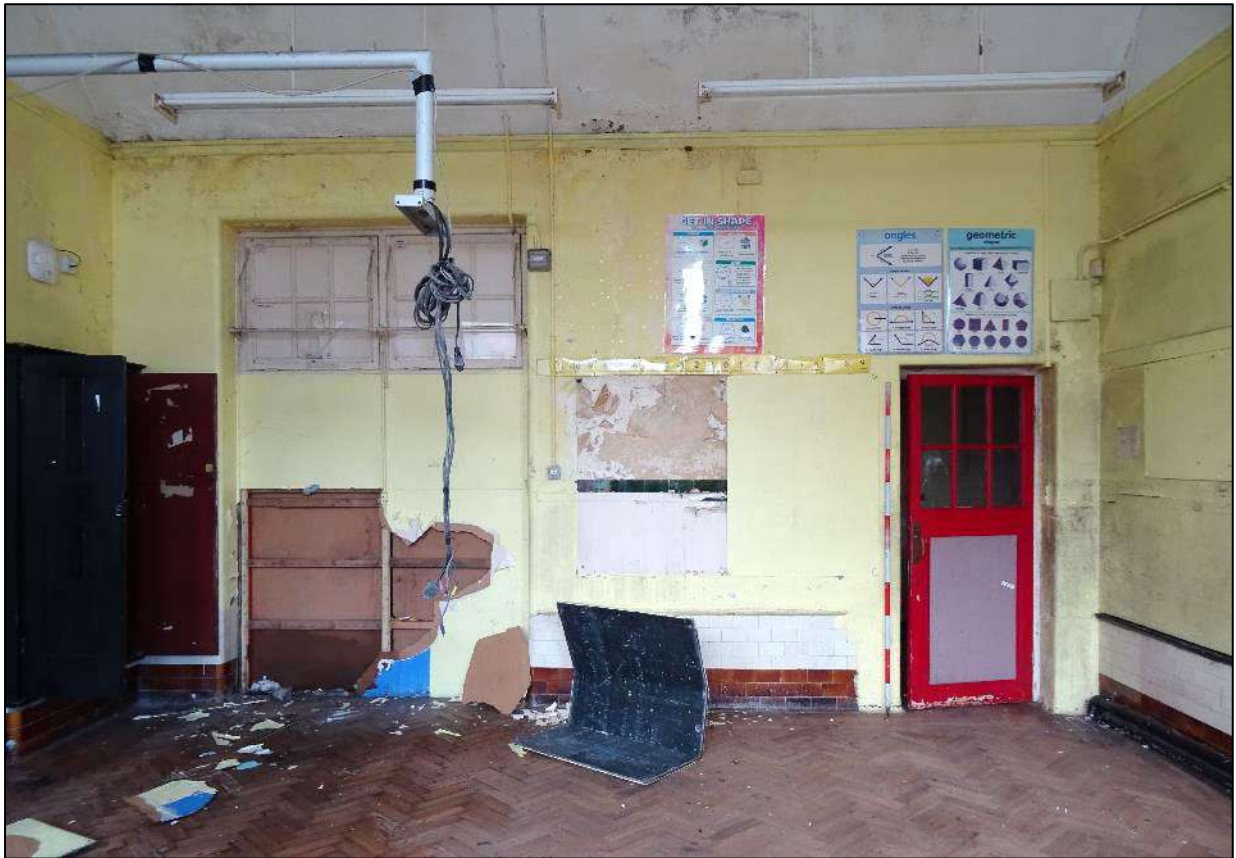
*Plate 113. Room 9, Building 1, looking south-west. Scale 2m.*

5.7.43. The door from the corridor is to the right of the south-east wall (Plate 113) and is as described in Paragraph 5.7.31. There is also a blocked doorway to the rear of the hall (Room 2), which from the exposed upper windows appears to have been the same as those on the long wall of the hall (Paragraph 5.7.7).
