**Level 2 Building Recording:**  
**Former Dyffryn Lower School, Port Talbot**

March 2024

Report No. 2278

Prepared for KEW Planning  
By  
Susan Stratton PhD

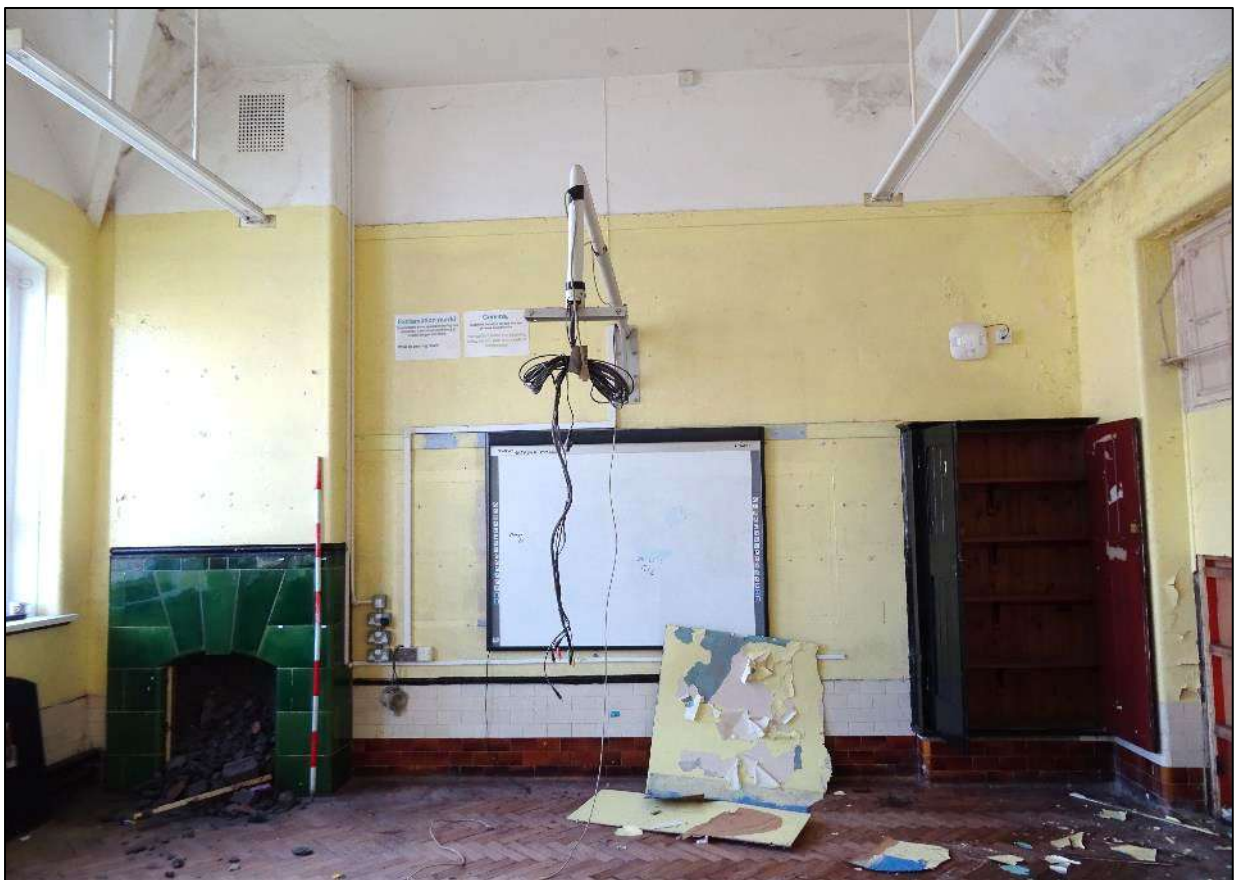
*Plate 114. Room 9, Building 1, looking north-east. Scale 2m.*

5.7.45. The north-east wall has the same fireplace and built-in cupboard as the north-west wall of Room 5 (Paragraphs 5.7.24 and 5.7.26). The only differences are that the moulded band to the top of the fire surround is painted black, as are the cupboard doors (Plate 114).

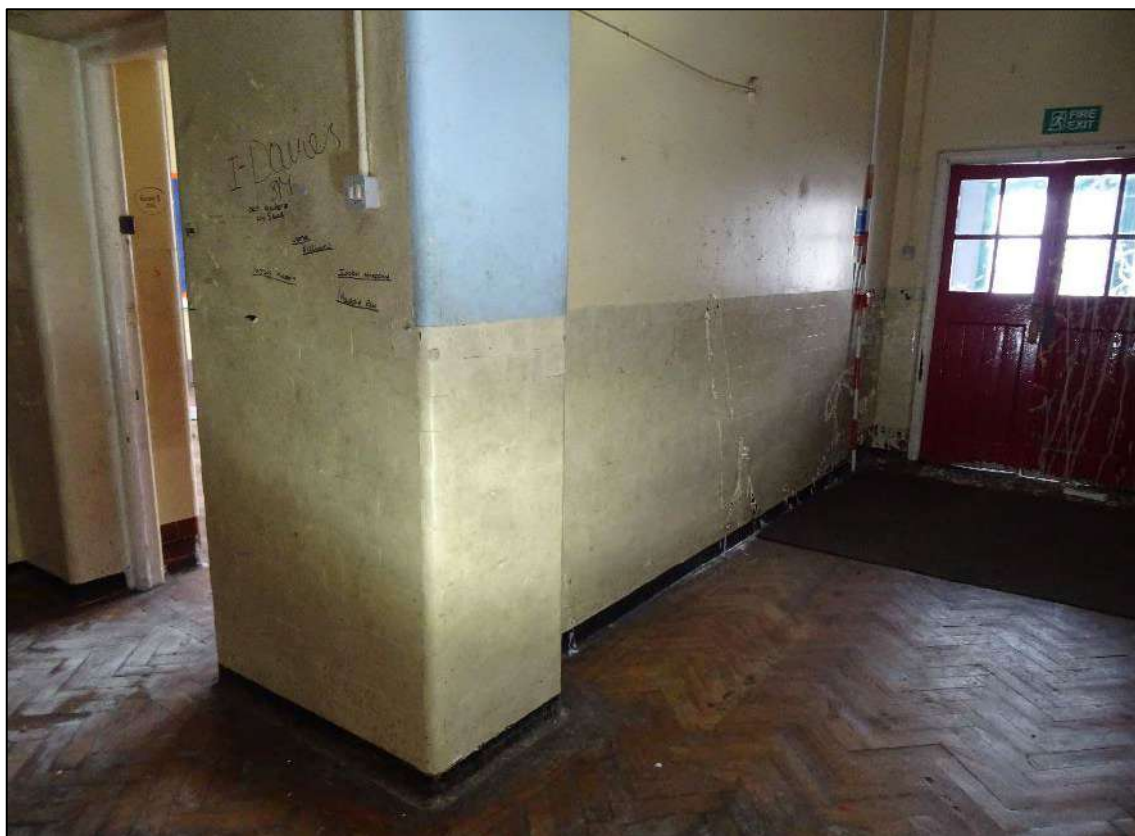
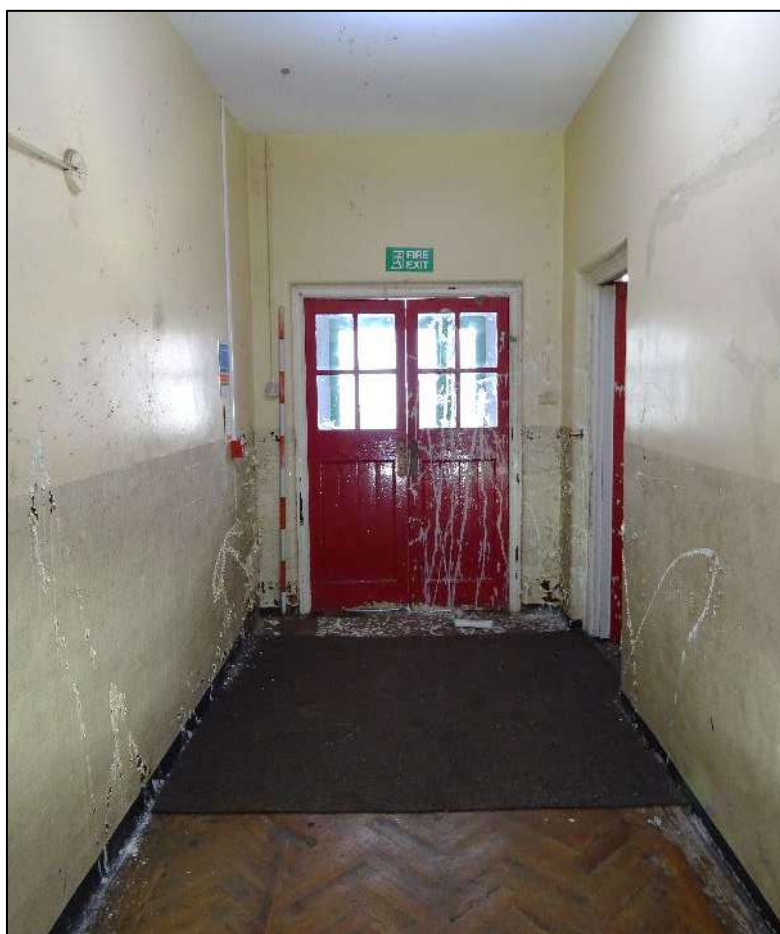
*Plate 115. Room 10, Building 1, looking west. Scale 2m.*

5.7.46. Room 10 is the mirror of Room 6, linking the north-west end of the hall (Room 2) with the entrance to the north-east of the front of the building (Plates 115 and 116).

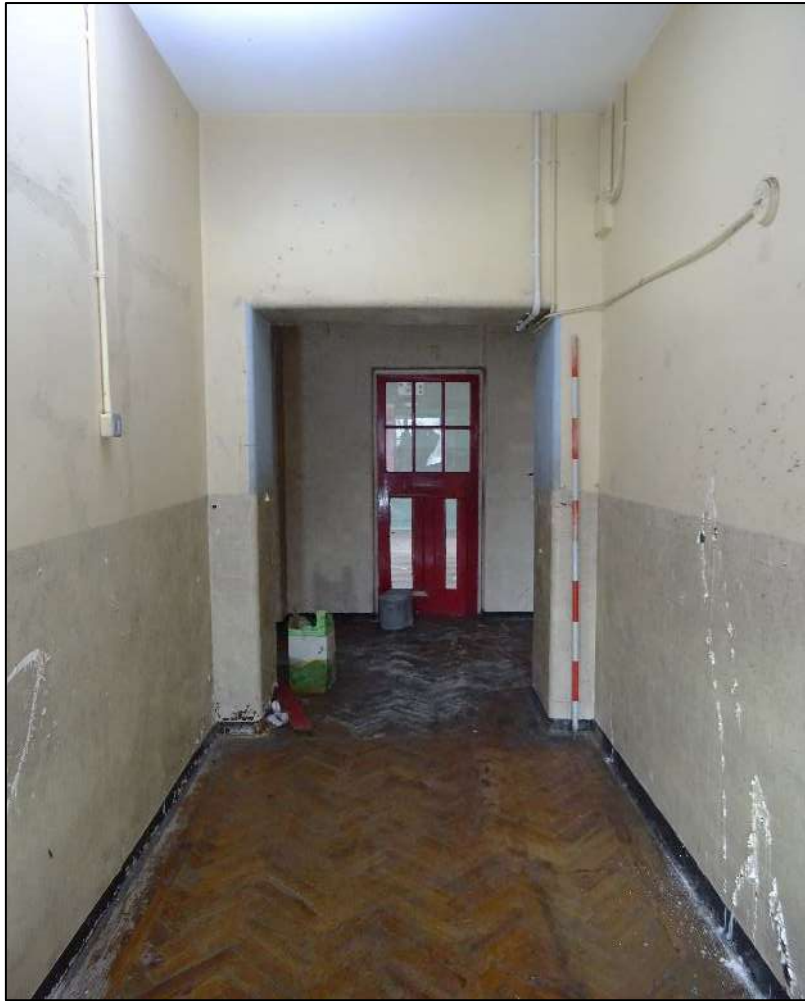
*Plate 117. Room 10, Building 1, looking south-east. Scale 2m.*

on the south-east wall (Plate 117). It is a wooden door, painted red, with two fielded panels to the bottom half (now missing some panels) and a six-pane glazed panel to the top (Plate 118). It is recessed, with painted plaster to the reveals and rounded edges.

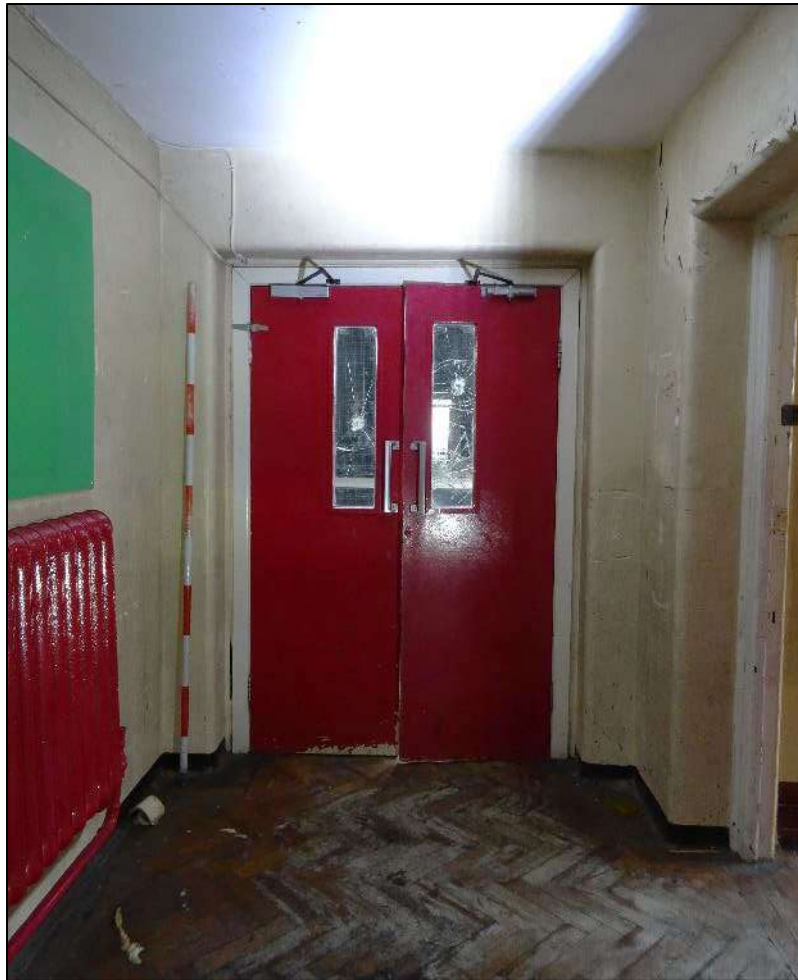
*Plate 119. Door to hall from Room 10, looking south-west. Scale 2m.*

- 5.7.48. The door to the hall (Plate 119) is a modern double door in the original rounded edge doorway (see Paragraph 5.7.8).

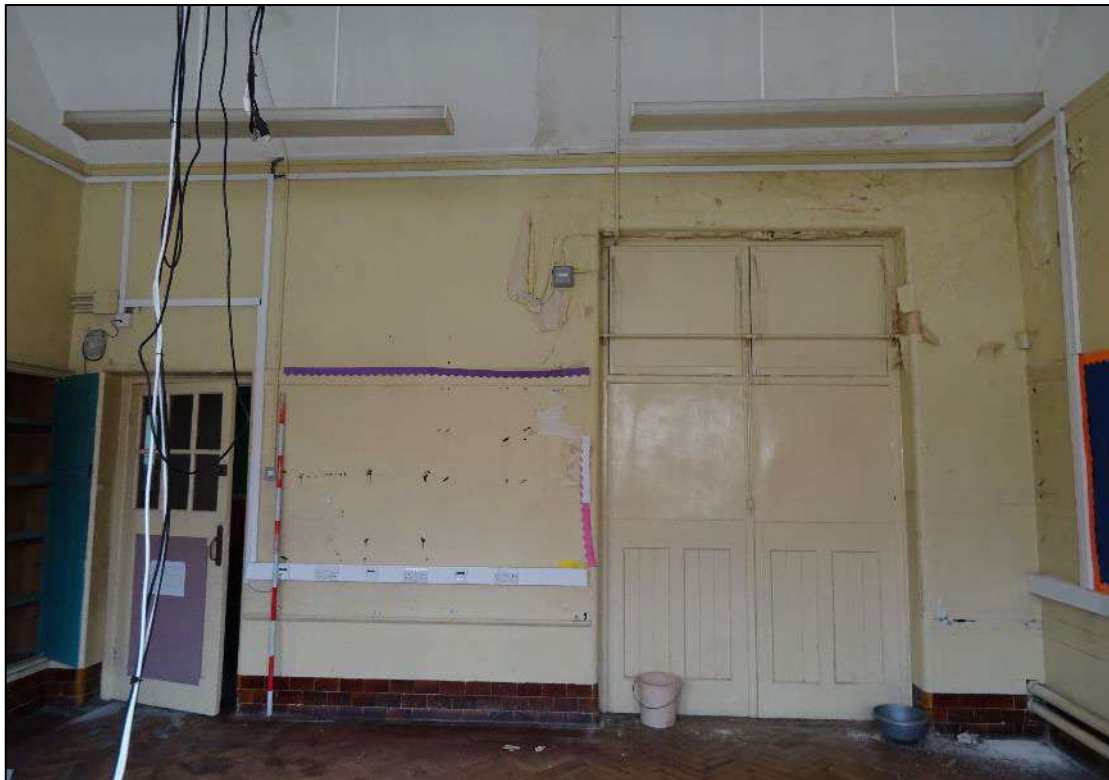
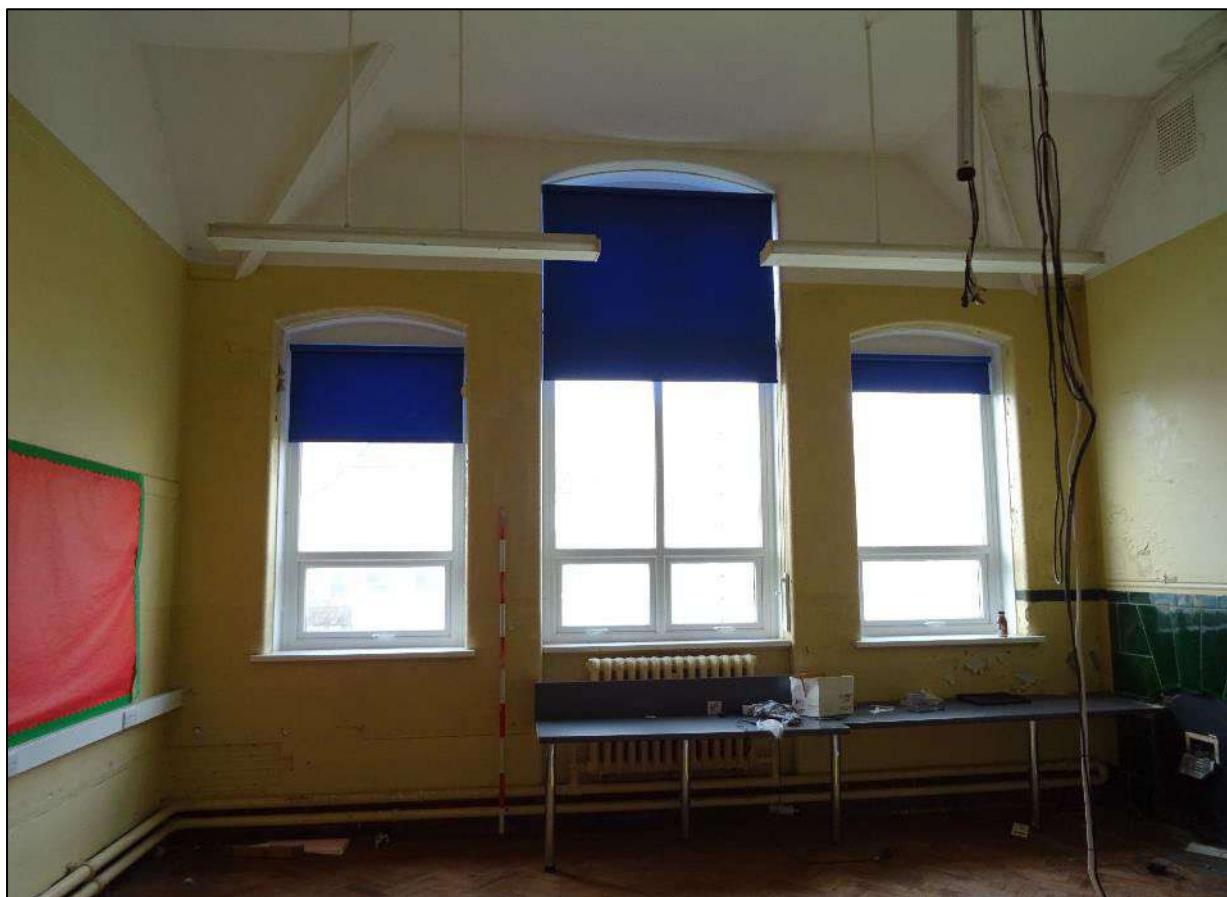
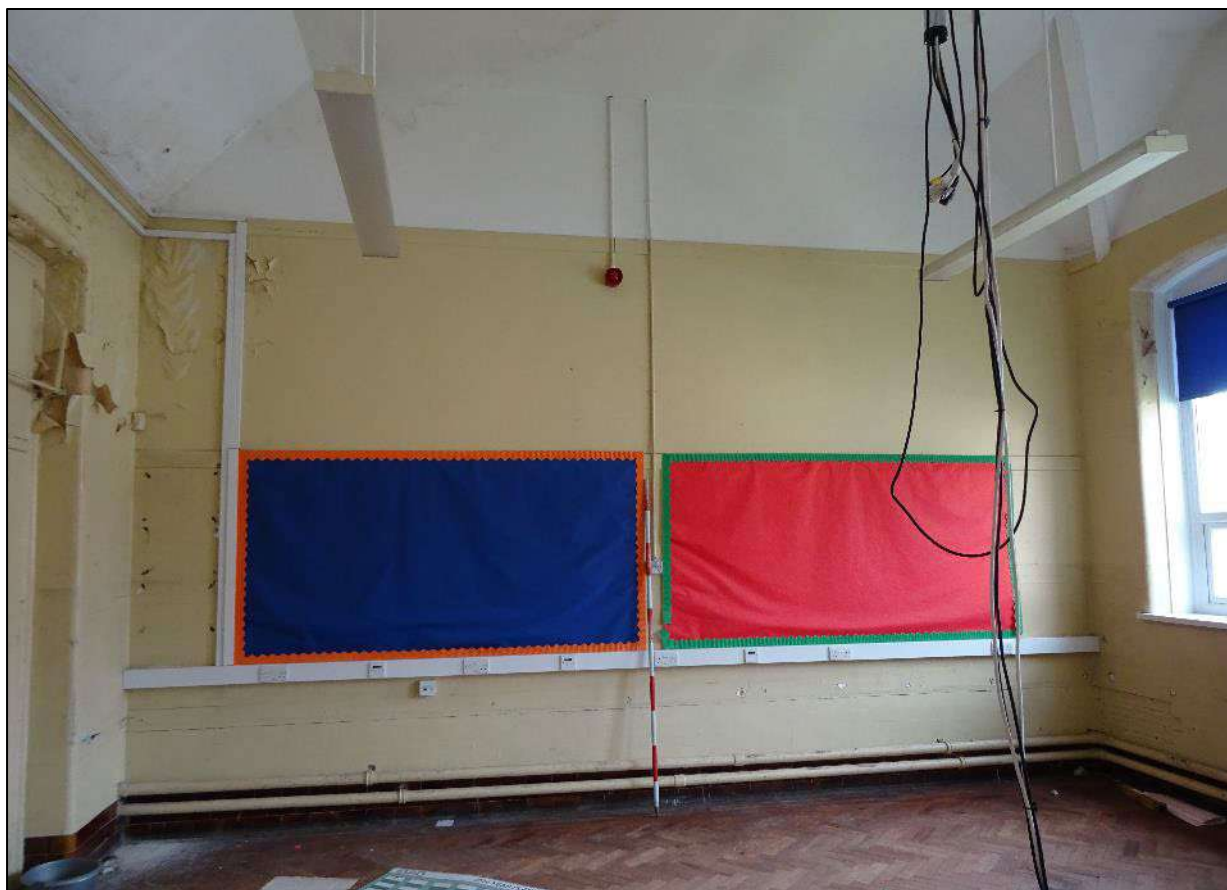
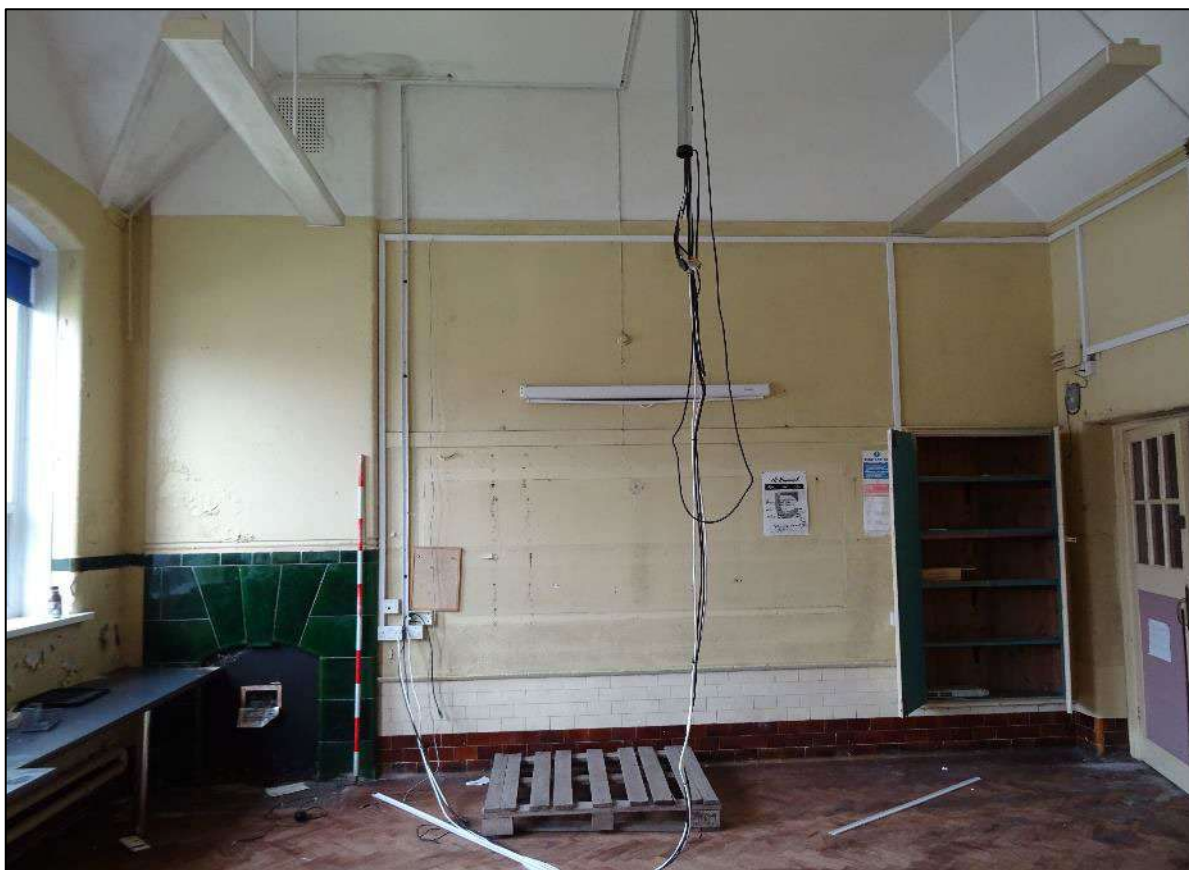
*Plate 120. Room 11, Building 1, looking south-east. Scale 2m.*

- 5.7.49. Room 11 is at the front of the building and is broadly a mirror of Room 9, which it is adjacent to. While the south-east (Plate 120) and north-west walls (Plate 121) mirror Room 9, the south-west (Plate 122) and north-east (Plate 123) are copies, meaning the fireplace and recessed cupboard are on the north-east wall in both rooms. The white tiles around the bottom of the walls have been painted over on all but the north-east wall, but the brown ones remain exposed.

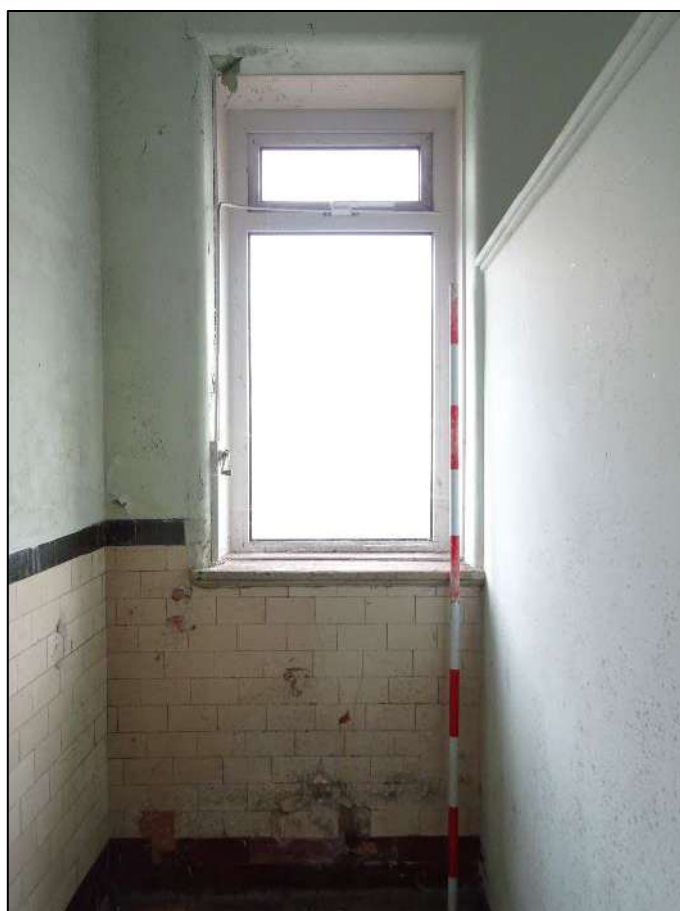
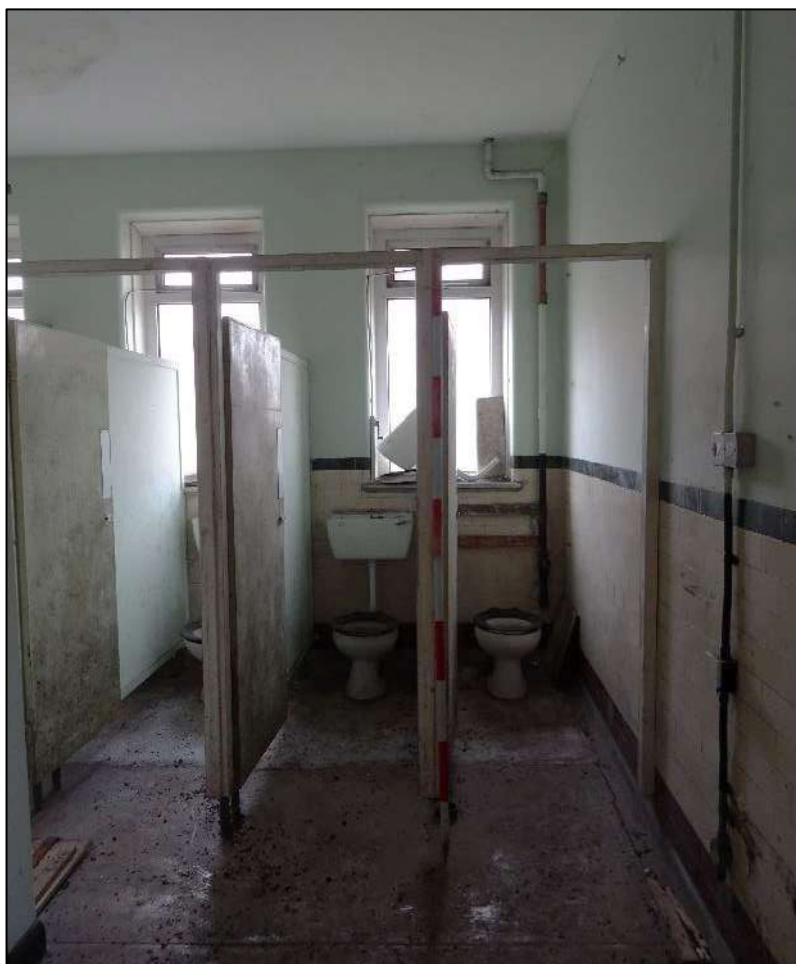
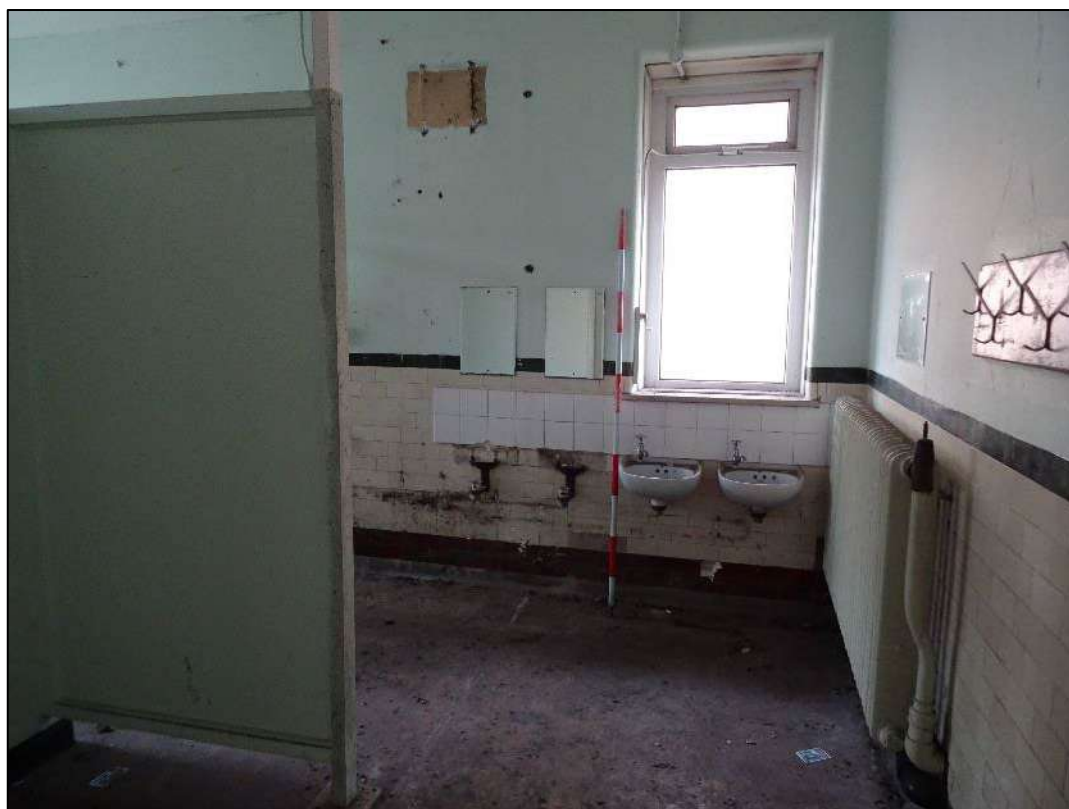
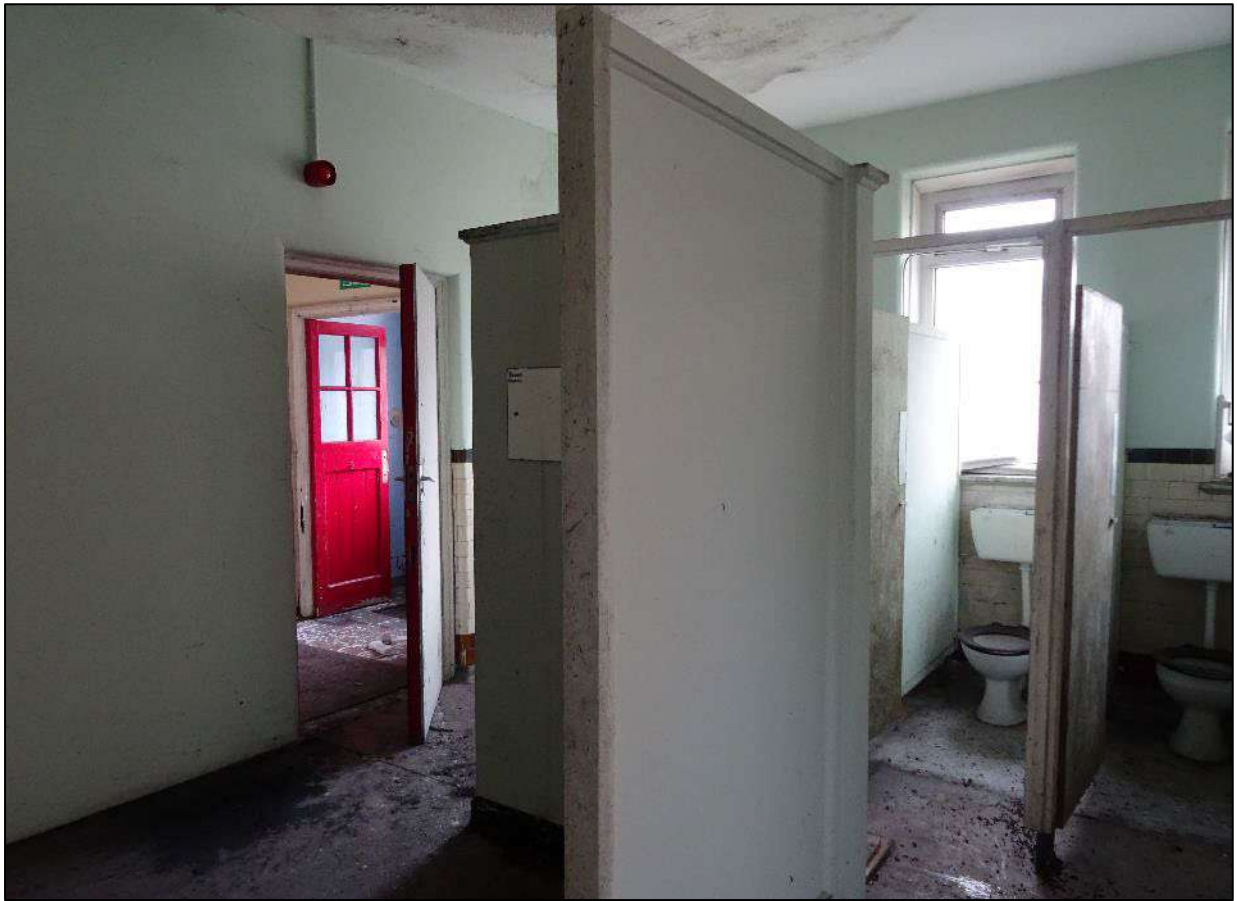
*Plate 124. Left-hand window to north-west wall of Room 12, looking north-west. Scale 2m.*

- 5.7.50. Room 12 is at the north-corner of the building, in the hipped end of the front range. It is a mirror of Room 8, and the main features of the room are the same, including the three windows on the north-west wall (Plates 124 and 125), single window on the north-east wall (Plate 126), the door to the right side of the south-west wall (Plate 127), and the lower ceiling height.
- 5.7.51. However, the internal appearance is significantly different. The room retains the original 1/3 height white ceramic tiles with a brown band to the bottom and green band to the top (Plate 128). The room has three toilet cubicles of 2/3 height wooden partitions, probably of mid-20th century date (Plates 125 and 127).

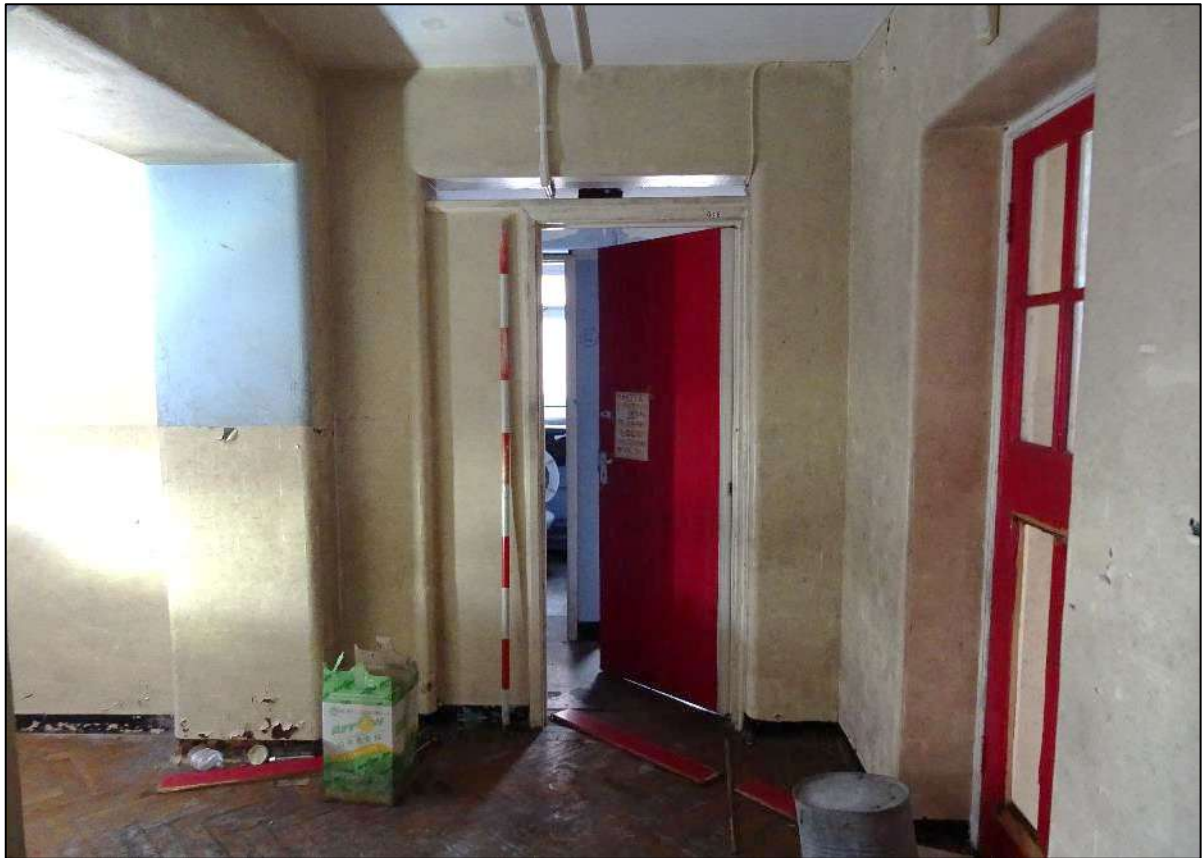
*Plate 129. Door to Room 13 from corridor Room 10, looking north-east. Scale 2m.*

mirroring the storeroom, Room 7. The door from the corridor is a modern plain wooden door with a filled half-panel to the left side (Plate 129). The height of the frame does not fully fill the original doorway, leaving a narrow gap at the top.

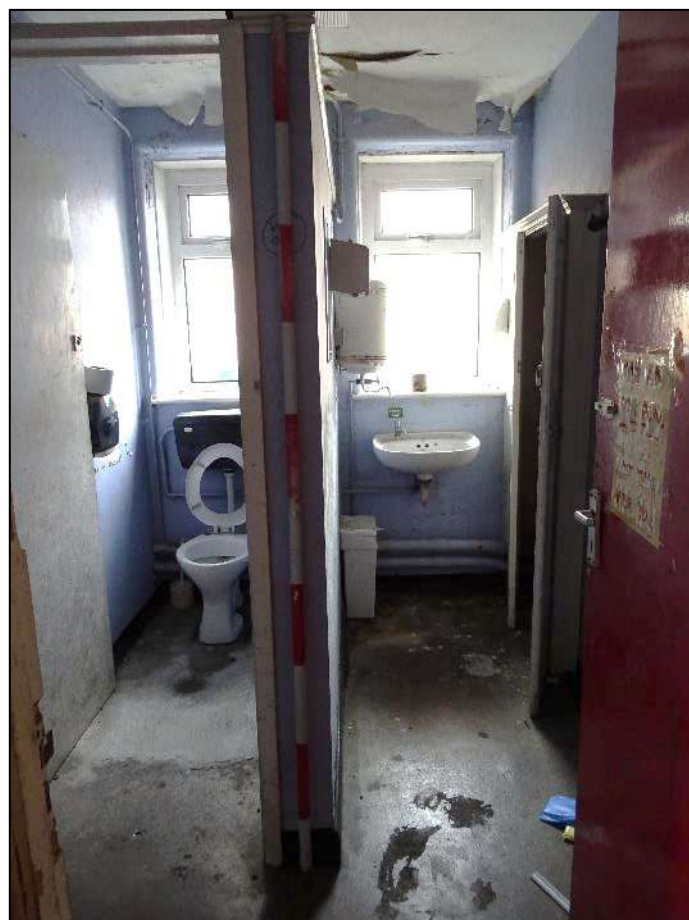
*Plate 130. Room 13, looking north-east. Scale 2m.*

5.7.53. The room has an exposed concrete floor, blue painted plaster walls and white painted plaster ceiling (Plate 130). The windows on the north-east wall are uPVC units. They are recessed, with painted plaster reveals with rounded edges, and have wooden sills. There is a 3/4 height partition in the centre of the room, oriented north-east to south-west, creating a cubicle to the north corner of the room.

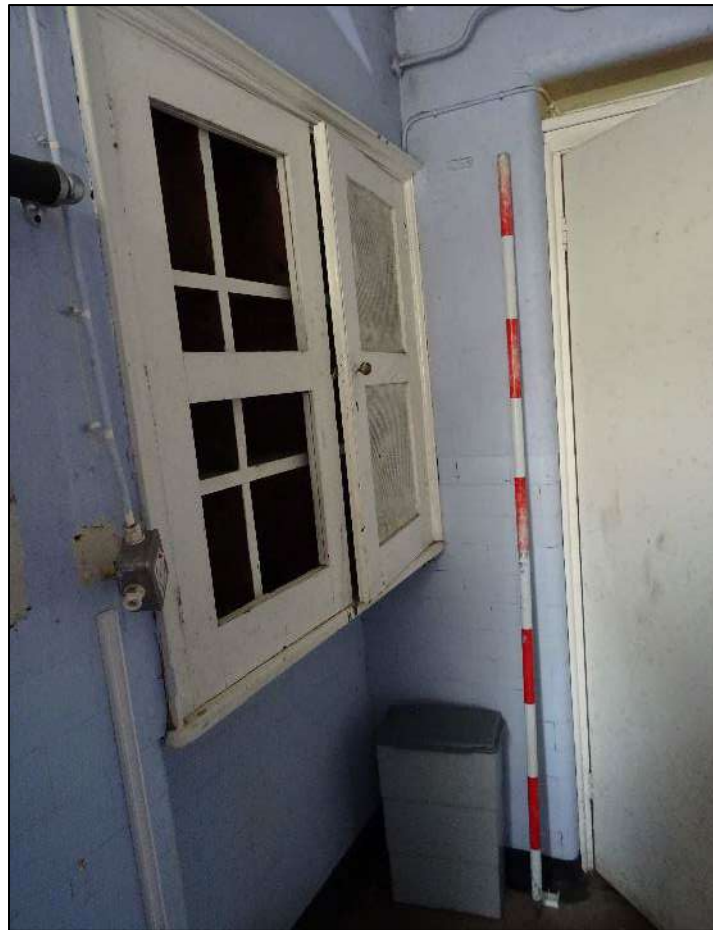
*Plate 131. Cupboard to right of south-east wall, Room 13, looking south. Scale 2m.*

5.7.54. There is a wooden cupboard fitted in a recess to the right side of the south-east wall (Plate 131).

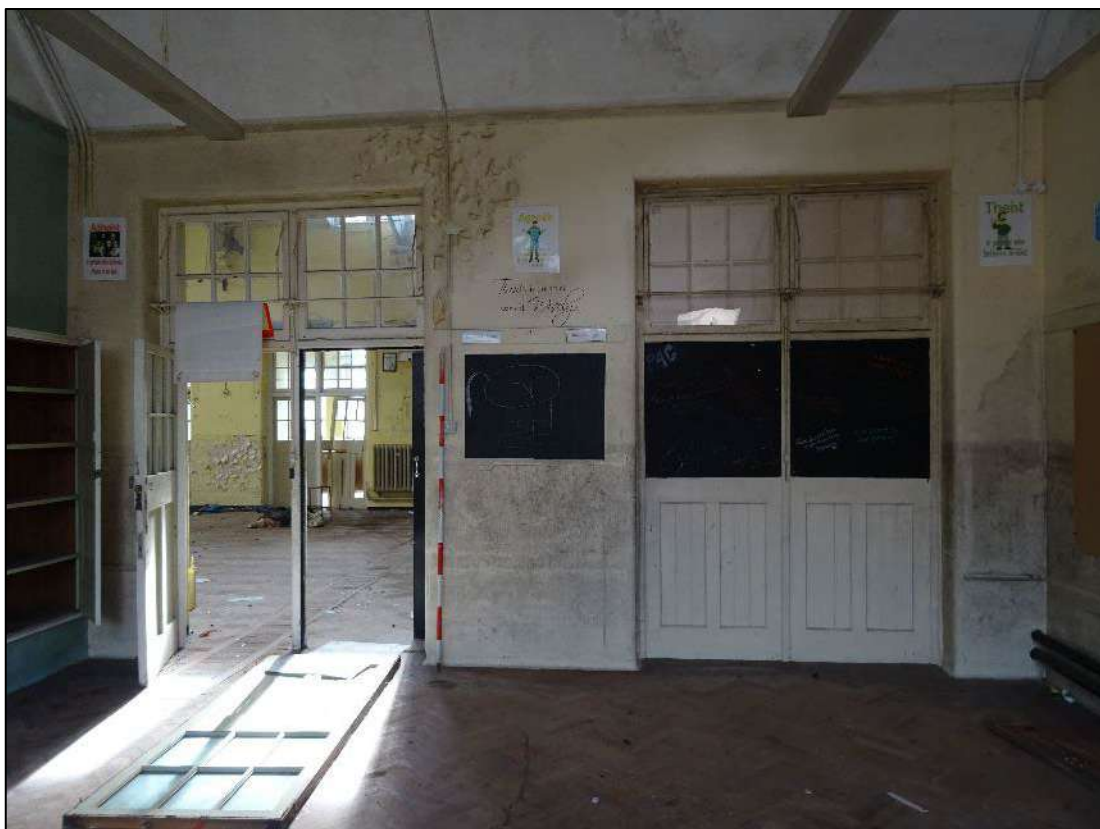
*Plate 132. Room 14, Building 1, looking south-west. Scale 2m.*

5.7.55. Room 14 is to the north-east side of the building and broadly mirrors Room 5 (Plates 132 and 133). The main differences are on the north-west and south-east walls.

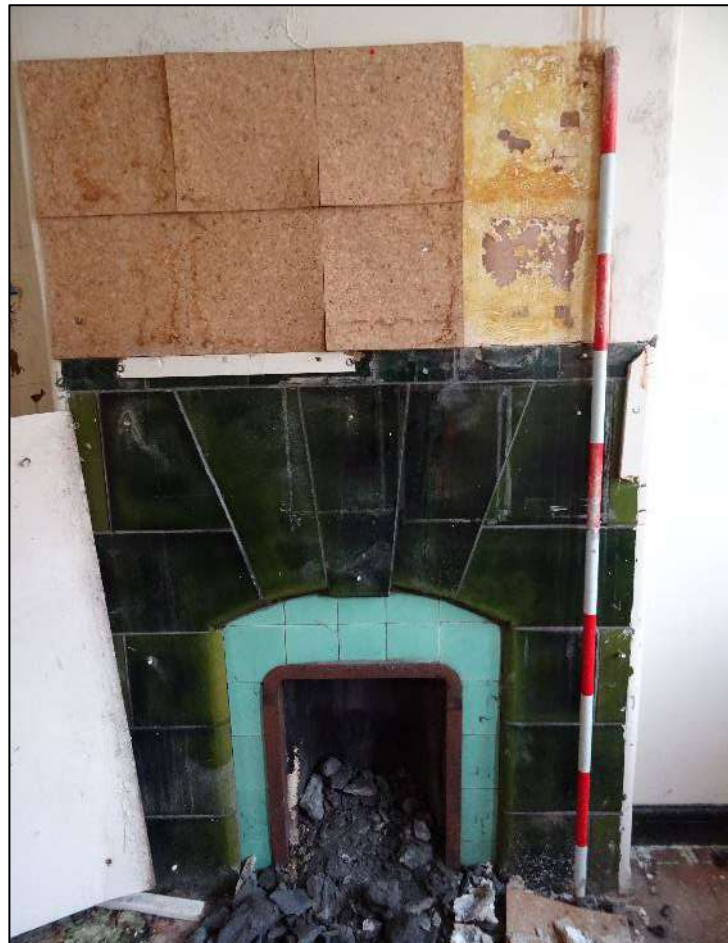
*Plate 151. Room 16, Building 1, looking north-west. Scale 2m.*

north-west wall (Plate 151) and is as described in Paragraph 5.7.9.

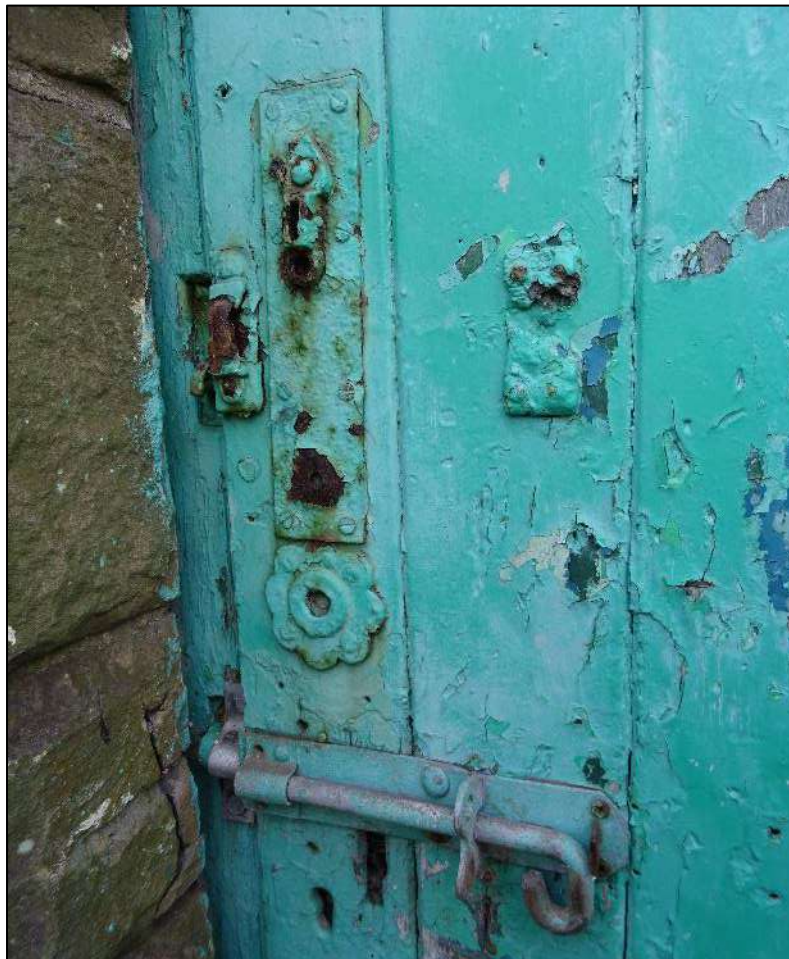
*Plate 155. North-east facing elevation of Building 2, looking south-west. Scale 2m.*

- 5.9.1. The north-east facing elevation is a gable end (Plate 155). To the centre is a doorway with single concrete step. The door is a wooden batten and ledged door, painted green, with former handles painted over (Plate 156). It has a concrete lintel and quoins of rock-faced ashlar Pennant stone.
- 5.9.2. There are also quoins of rock-faced ashlar Pennant stone to the corners of the elevation. It has a wooden bargeboard, painted green.
- 5.9.3. Part of the lower right side of the elevation has been re-mortared or rebuilt, using a ribbon mortar finish.

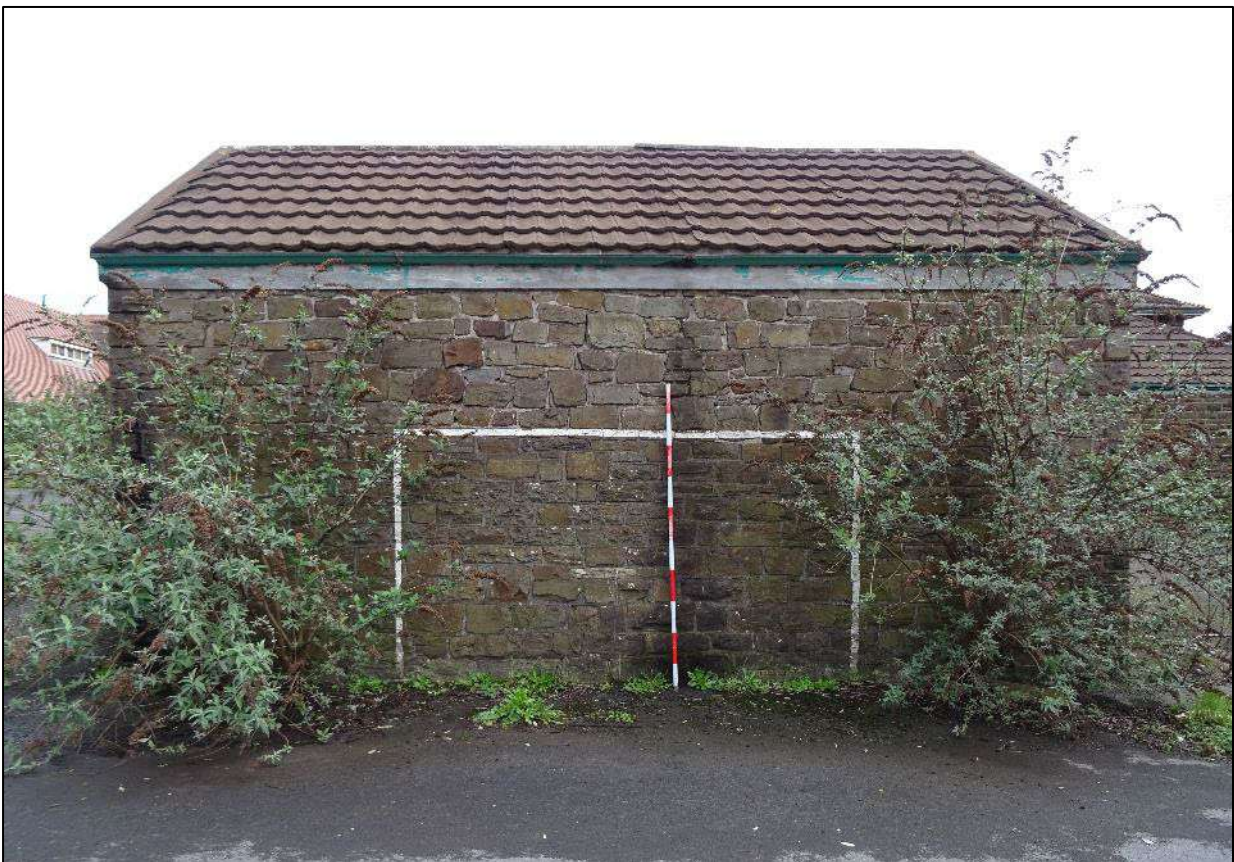
*Plate 159. South-west facing elevation of Building 2, looking north-west. Scale 2m.*

5.11.1. The south-west facing elevation is the same as the north-east facing elevation, although missing a bargeboard (Plate 159).

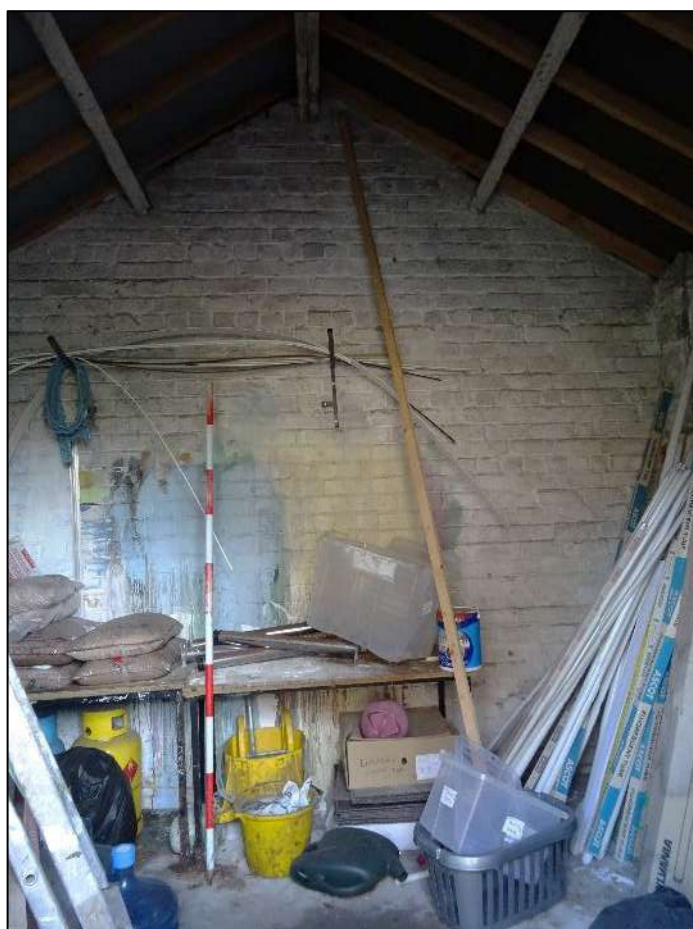
*Plate 161. South-west wall of Room 1, Building 2, looking south-west.*

5.13.1. Room 1 is to the north-east half of the building. It has an exposed concrete floor. The north-west, north-east, and south-east walls are white-washed rubblestone (Plate 161). The south-west wall, which is the dividing wall with Room 2, is whitewashed brickwork in an English garden wall bond (Plate 162). The ceiling is the exposed underside of the modern roof structure (Plate 163).

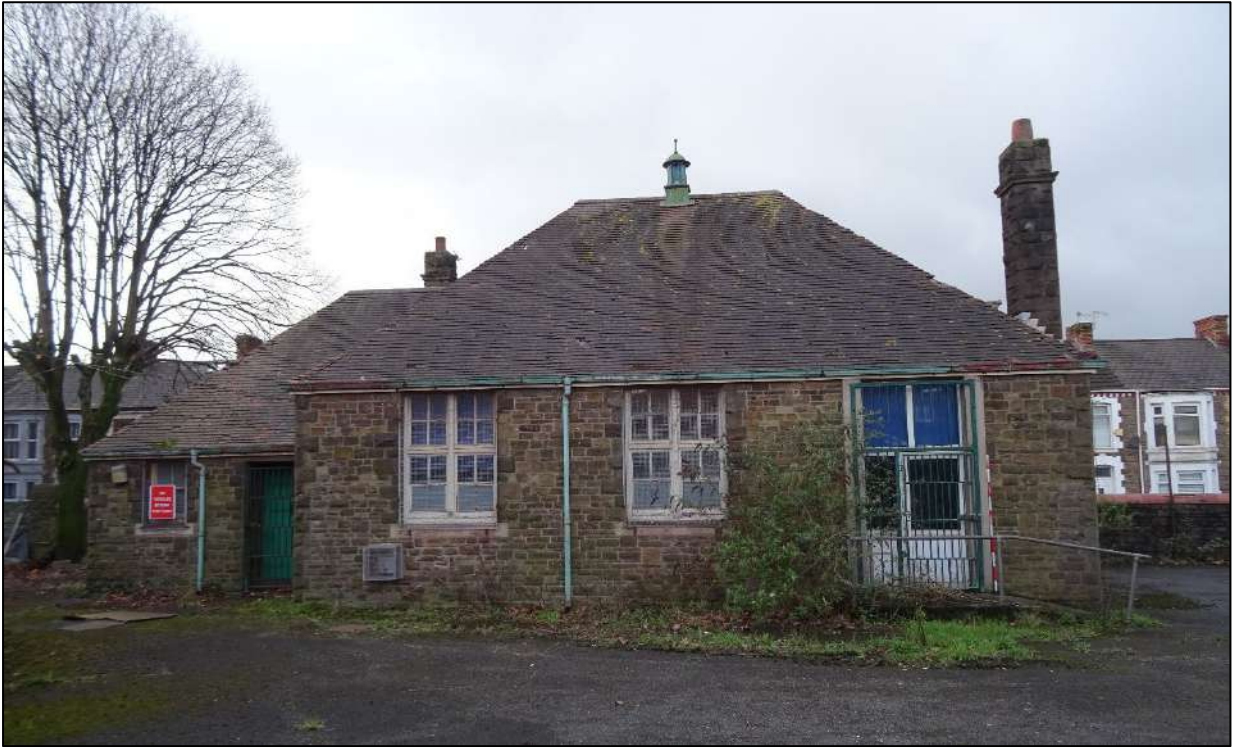
*Plate 166. Drone shot of Former Dyffryn Lower School, looking east. Building 3 to centre of shot along Devonshire Place, Building 2 to the left, and Building 6 to the rear. Photo courtesy of Roberts Limbrick.*

- 5.14.1. Building 3 is located on the south-west boundary of the school, and the south-west wall of the building is integrated into the site boundary wall (Plate 166). It is a single storey, hipped roofed building with a smaller, hipped section to the south-east (Plate 167).
- 5.14.2. It is constructed from squared rubblestone, brought-to-course, with flush cement mortar. There are rock-faced Pennant stone ashlar quoins to all corners. The roof is ceramic tile with ceramic ridge tiles. It has moulded stone guttering, painted green (Plate 168).

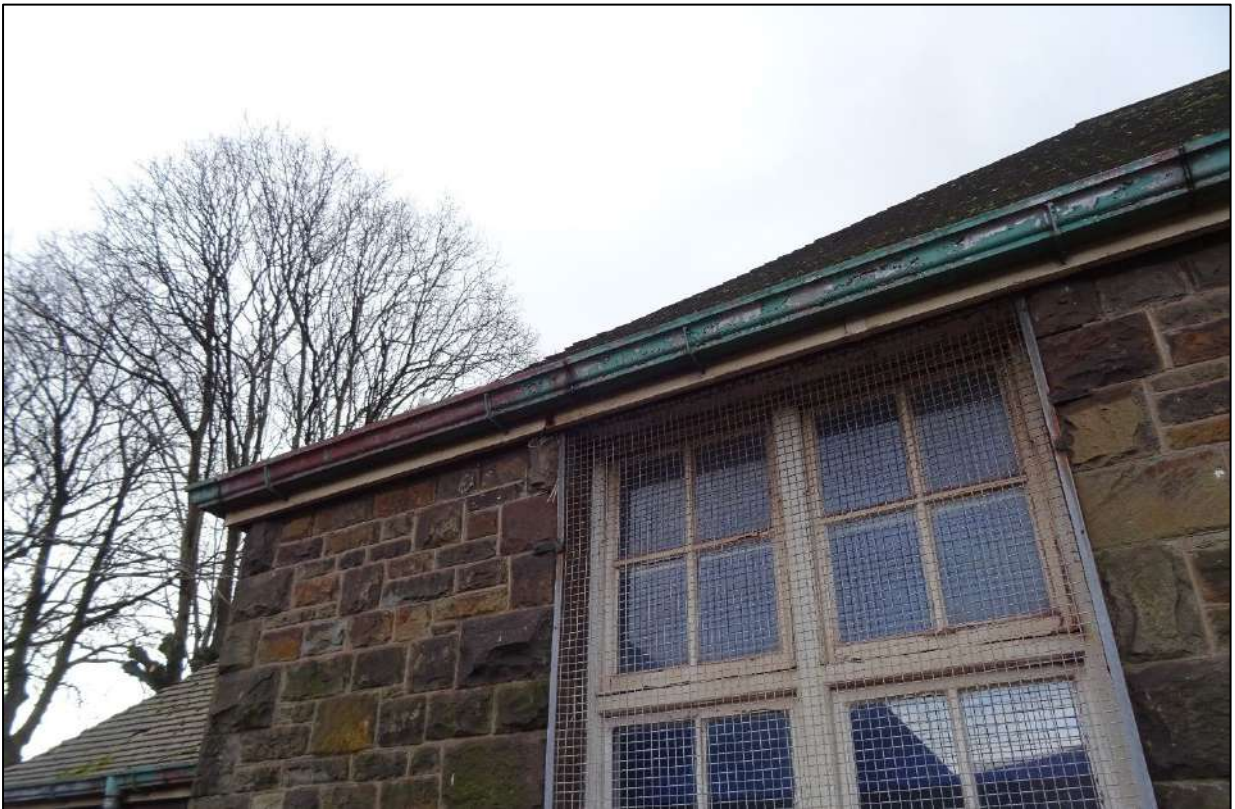
*Plate 167. North-east facing elevation of Building 3, looking south-west. Scale 2m.*

- 5.15.1. The north-east facing elevation consists of the long side of the main hipped roofed section and the smaller element to the left (Plate 167). The main section is three bay.
- 5.15.2. There is a modern metal door with upper glazed panel, a side panel and two lights above to the right-hand bay (Plate 169). It extends to the height of the eaves and has cement surrounds. There is a modern concrete access ramp with handrail leading to it from the right of the elevation. It is covered by a metal security gate.
- 5.15.3. The left and central bays both have four-light mullion and transom wooden framed windows, with four panes to each light (Plate 170). They have smooth

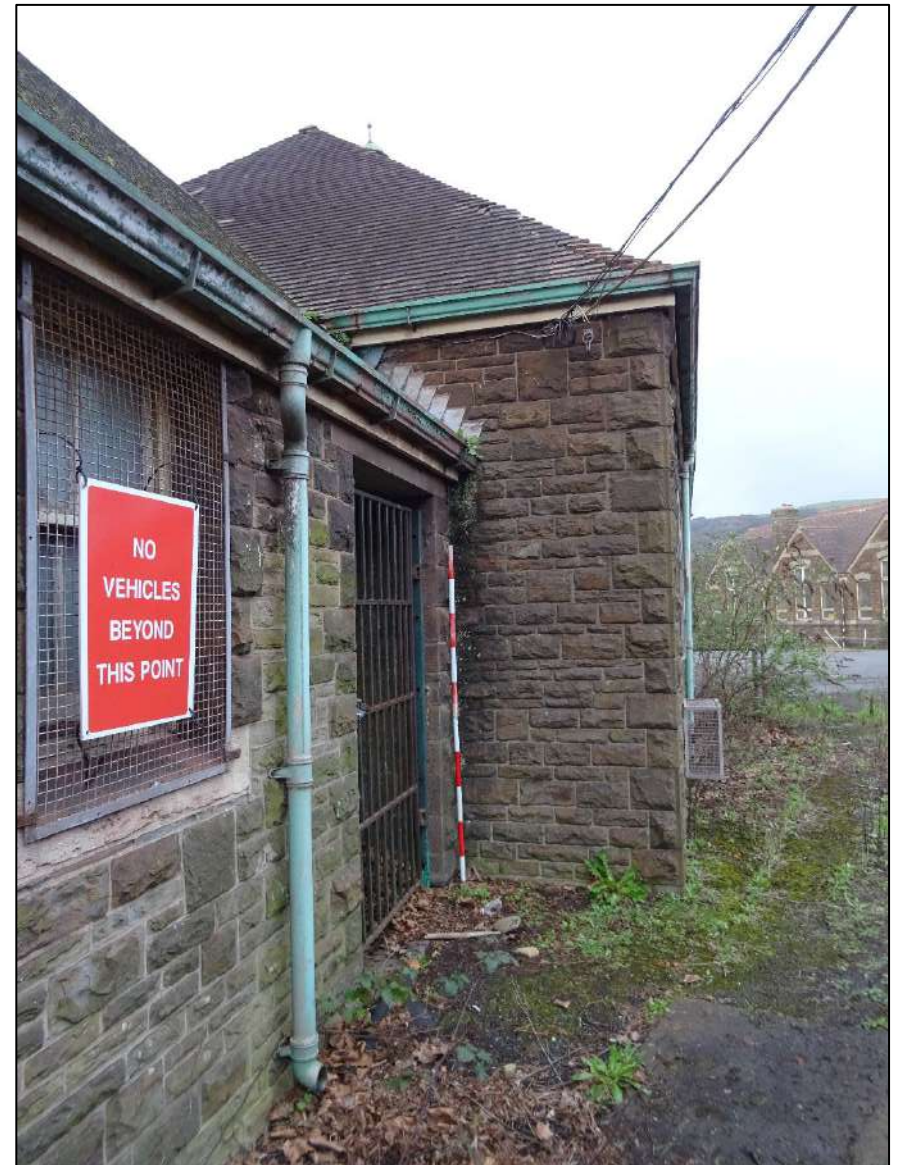
*Plate 175. Window to left of north-east facing elevation of Building 3, looking south.*

5.15.6. To the left side is a small, four-light wooden framed sash window (Plate 175). It has a smooth finished limestone sill and rock-faced Pennant stone ashlar quoins to the sides. It extends to the height of the eaves. It is covered by a modern security grill.
