**Level 2 Building Recording:**  
**Former Dyffryn Lower School, Port Talbot**

March 2024

Report No. 2278

Prepared for KEW Planning  
By  
Susan Stratton PhD

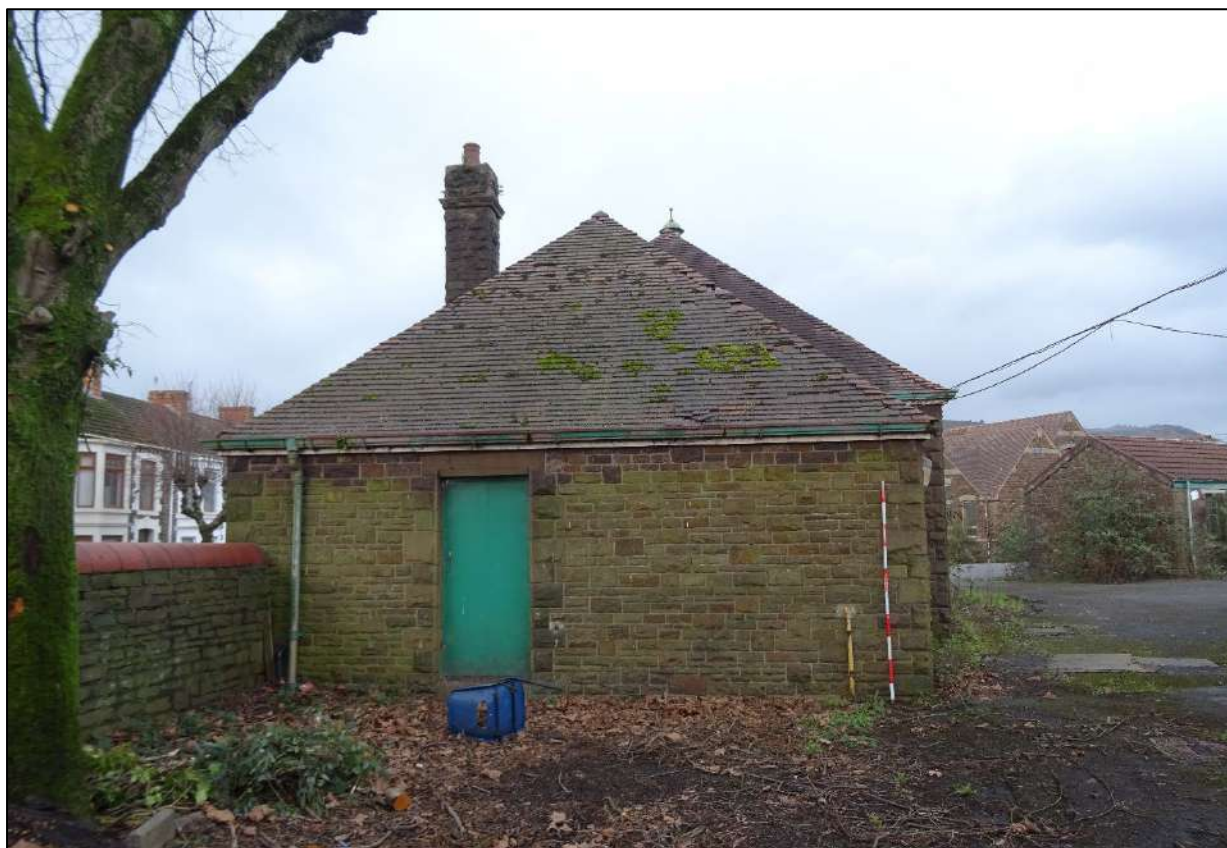
*Plate 176. South-east facing elevation of main section of Building 3, looking north-west. Scale 2m.*

5.16.1. The south-east facing elevation consists of the hipped end of the main section (Plate 176) and the hipped end of the smaller section to the south-east (Plate 177).

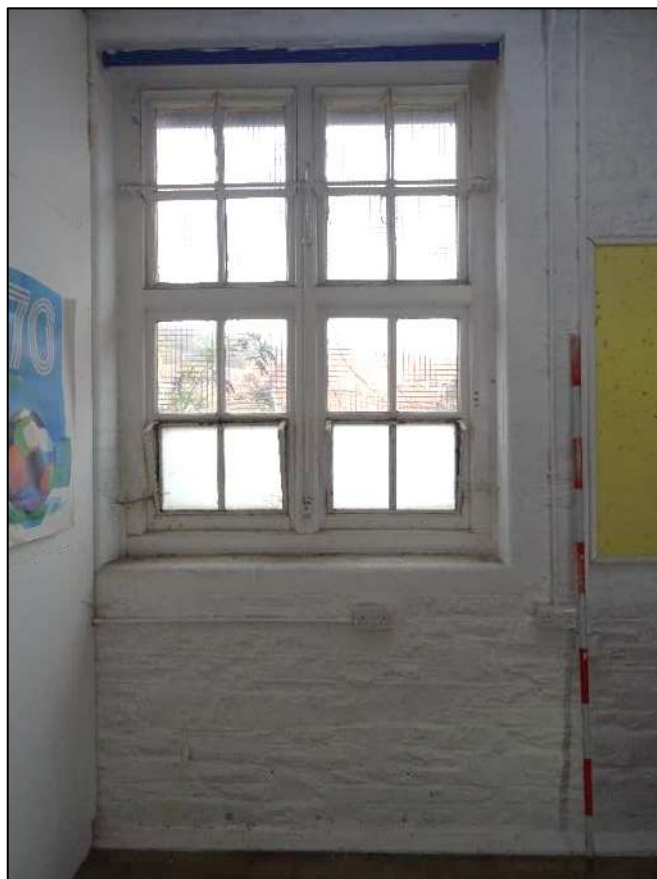
*Plate 212. Central and right windows to north-east elevation, Room 5, Building 3, looking north. Scale 2m.*

5.19.23. There are two windows to the north-east elevation (Plate 212). They are the same as those on the south-west elevation (Paragraph 5.19.18).

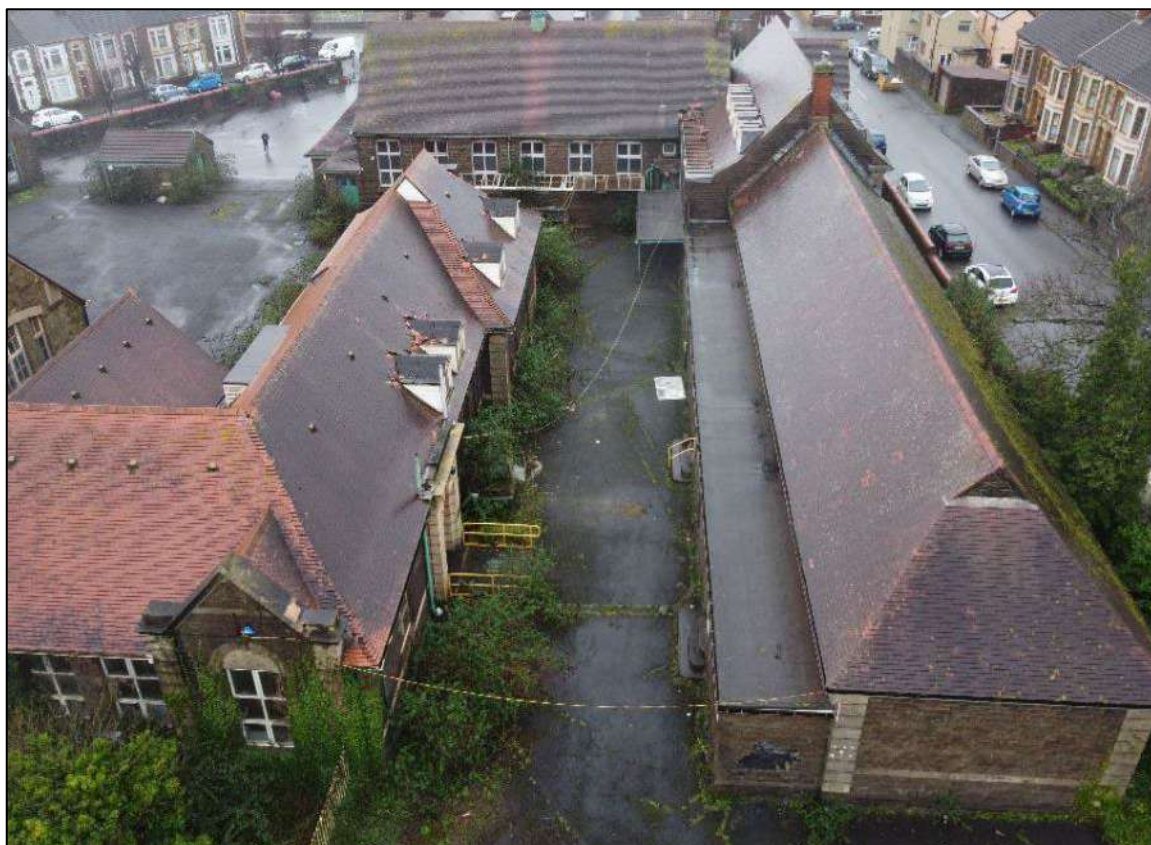
*Plate 214. Drone shot showing Building 4 to left, Building 5 to bottom left, Building 6 to top right, and Building 2 to bottom right, looking south-east. Photo courtesy of Roberts Limbrick.*

- 5.20.1. Building 4 is not one of the original school buildings, first appearing on the 1947 map. The building is L-shaped in plan, with the radiating arms being single storey and a taller central body of over two-storeys. The north-west to south-east orientated range fronts onto York Place, with the north-east to south-west range extending from its north-west end towards the centre of the site (Plate 214).

- 5.27.1. Building 5 is a small building on the north-west site boundary, attached to the north-west corner of Building 4 by a modern covered section (Plates 214 and 372). It is a north-west to south-east oriented gable ended building with a flat roofed element to the south-west.
- 5.27.2. It is constructed from squared rubblestone, brought-to-course and the pitched roof is modern corrugated panelling.

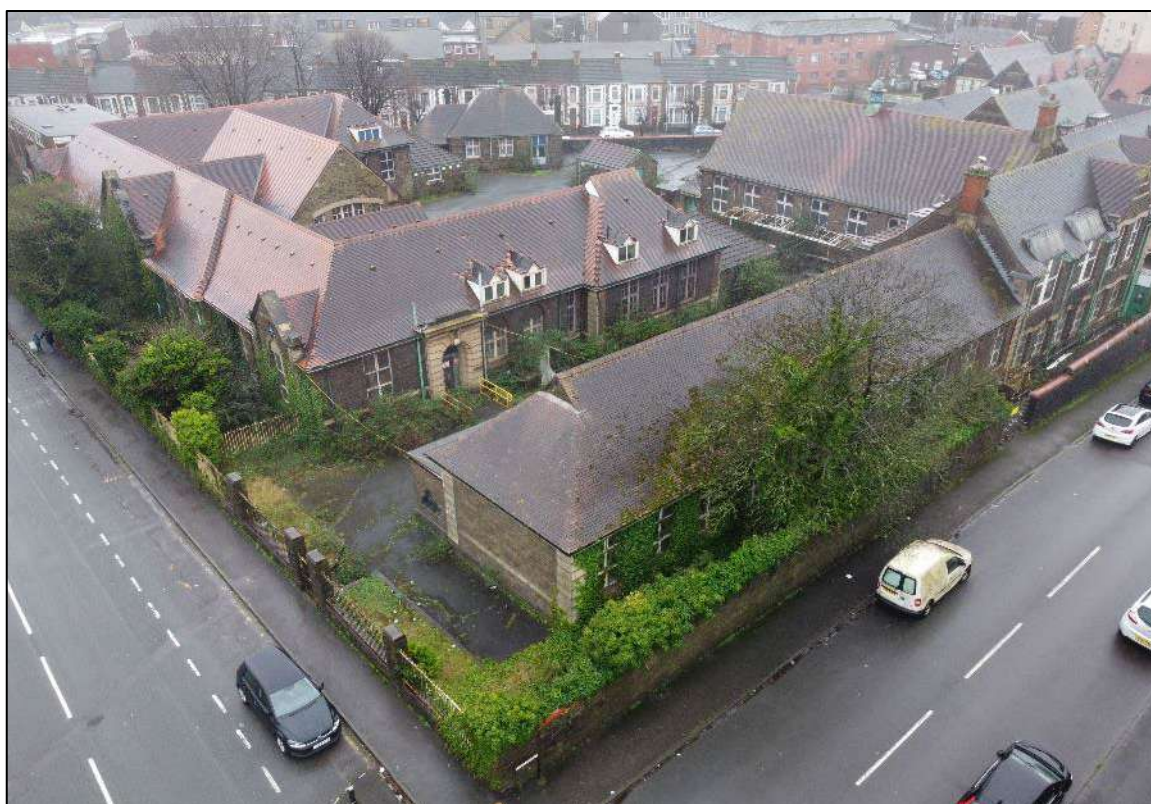
*Plate 215. Drone shot showing Building 4 to centre and right, Building 6 to left, and Building 2 to top right, looking north-west. Photo courtesy of Roberts Limbrick.*

- 5.20.2. The longer north-west to south-east orientated range has a hipped combination roof with a Dutch gable end and flat roofed extension running along its southern elevation (Plate 215). The shorter arm is gable ended with a combination roof and a brick chimney at its north-eastern gable and a low double cross-hipped lean-to at its south-western. The central two-storey structure has a gabled roof with small cross-gable and two 'through-the-cornice' dormers on its to the north-east elevation and a series of four flat roofed dormer windows to its southern. A brick chimney extends from the lower single-storey up through the roofline of the adjacent two-storey section.

- 5.22.1. The south-east facing elevation consists of the long side of the shorter south-west wing with the lean-to cross-hipped element to the south-west and the end of the longer main wing (Plate 215).

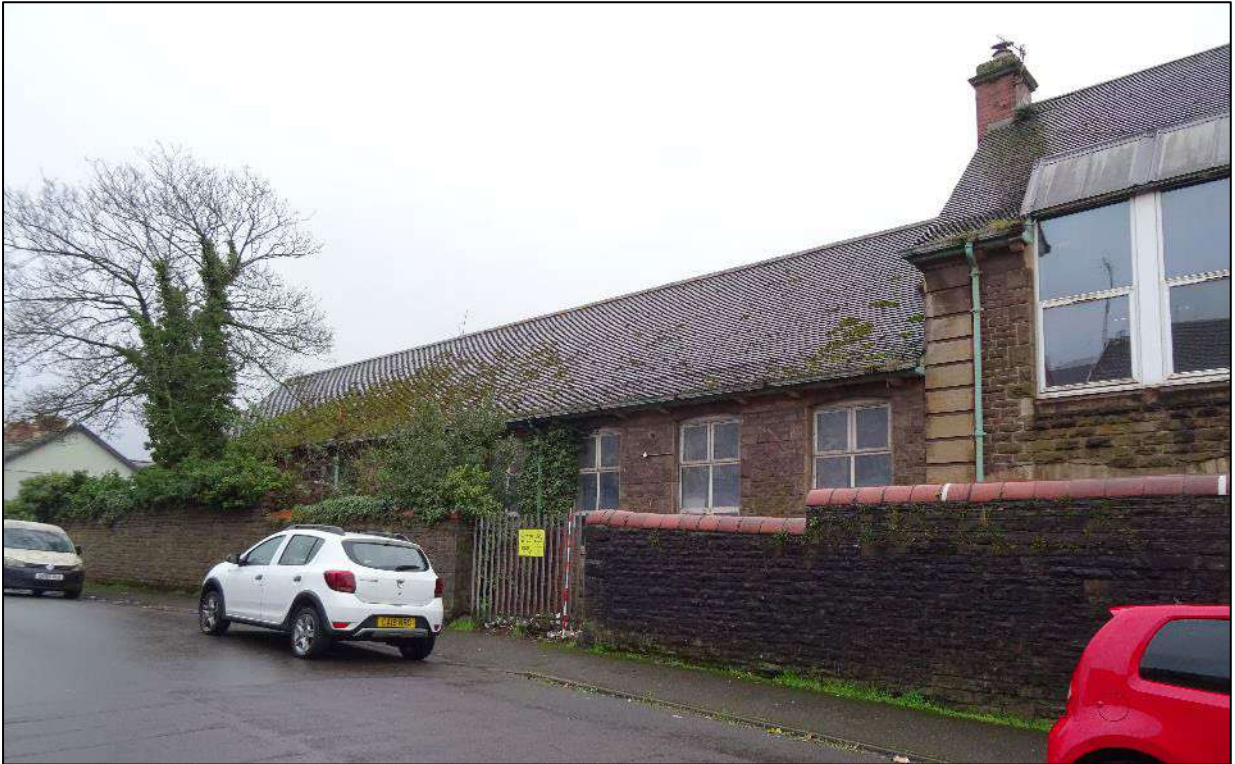
*Plate 216. Drone shot showing Building 4 to front and right, Building 6 to left, and Buildings 2 and 3 to centre top, looking west from corner of York Place and Talcannau Road. Photo courtesy of Roberts Limbrick.*

- 5.21.1. The north-east facing elevation consists of the single storey longer arm of the 'L' and the accompanying two-storey section, comprising the main range, and the gable end of the short arm or south-west wing (Plate 216).

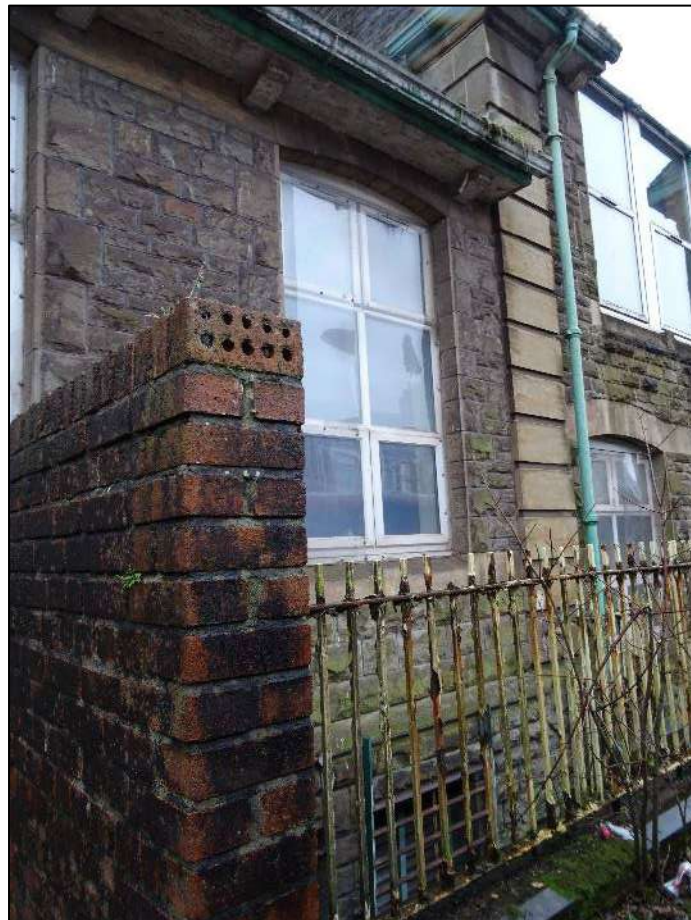
*Plate 217. Single storey wing of north-east facing elevation, Building 4, looking south from York Place. Scale 2m.*

- 5.21.2. The single storey wing is largely covered by vegetation and visibility was also limited by the closeness of the perimeter wall (Plate 217). Only the north-western end was clearly visible. It is of rock-faced ashlar with an upper smooth-

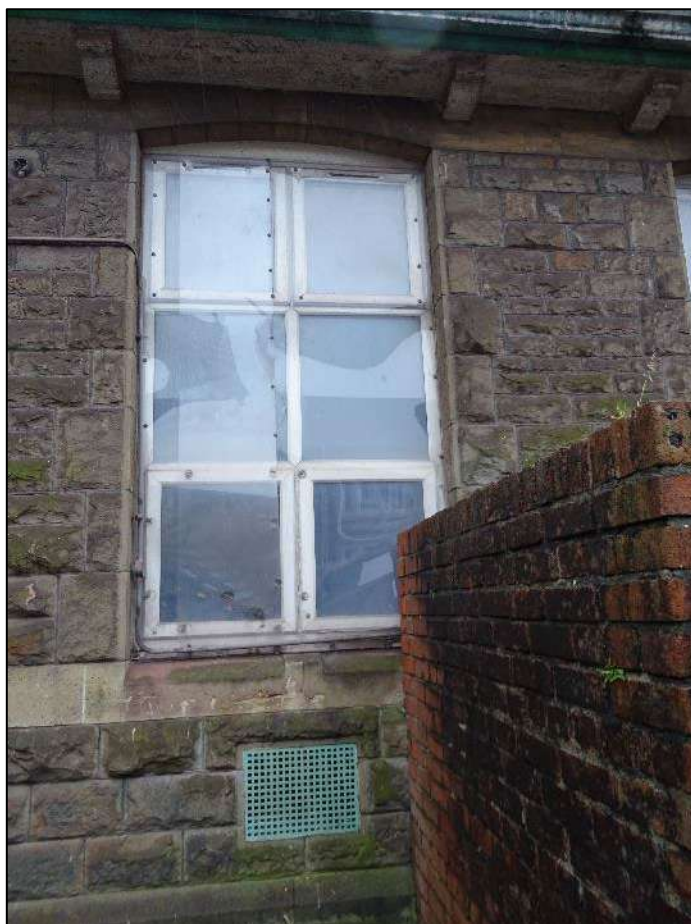
*Plate 218. North-west end of single storey wing of north-east facing elevation, Building 4, looking west.*

finished limestone band that arches over the windows. Extending out from this band is a series of soffit corbels to the projecting eaves (Plate 218). A second limestone band runs beneath the windows and is chamfered where it touches to form sills (Plate 219).

- 5.21.4. In front of the north-western bays, a set of steps extends along the wall and descends to the boiler house (Plate 218). The steps are protected by wrought iron railings set into bevelled coping stones along the north-east and a red brick wall to the south-east. The boiler house doorway, now blocked with perforated metal sheeting, has a stone doorstep and bevelled lintel in smooth-finished limestone. The edge of the stonework to the side has chiselled margins. A window to the left is in the same style and is now blocked by horizontal metal bars.

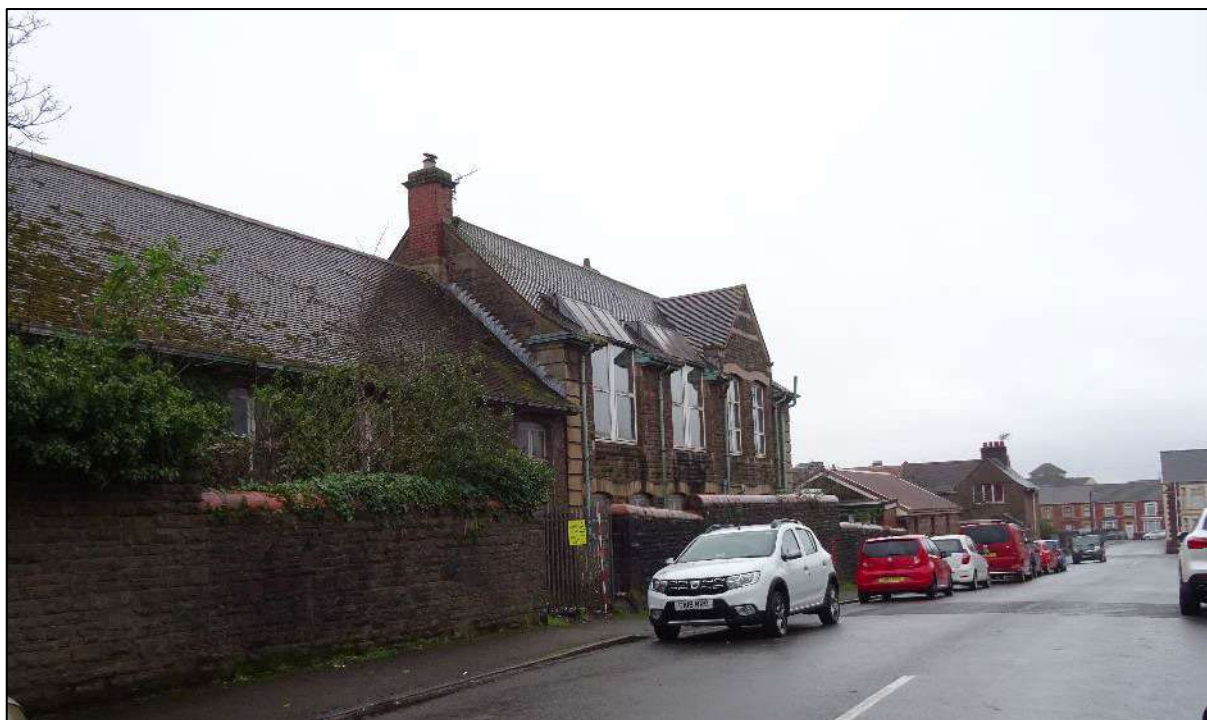
*Plate 219. Window to north-west end of north-east facing elevation of single storey wing, Building 4, looking south-west.*

- 5.21.3. The wing has 11 bays, each with a segmental arch headed, now covered with semi-opaque plastic sheeting (Plate 219). All the windows are slightly recessed, with brush-hammered reveals and rock-faced toothed surrounds with chiselled margins. The sills, formed from the band course, have central stubs indicating that the windows originally had central stone mullions.

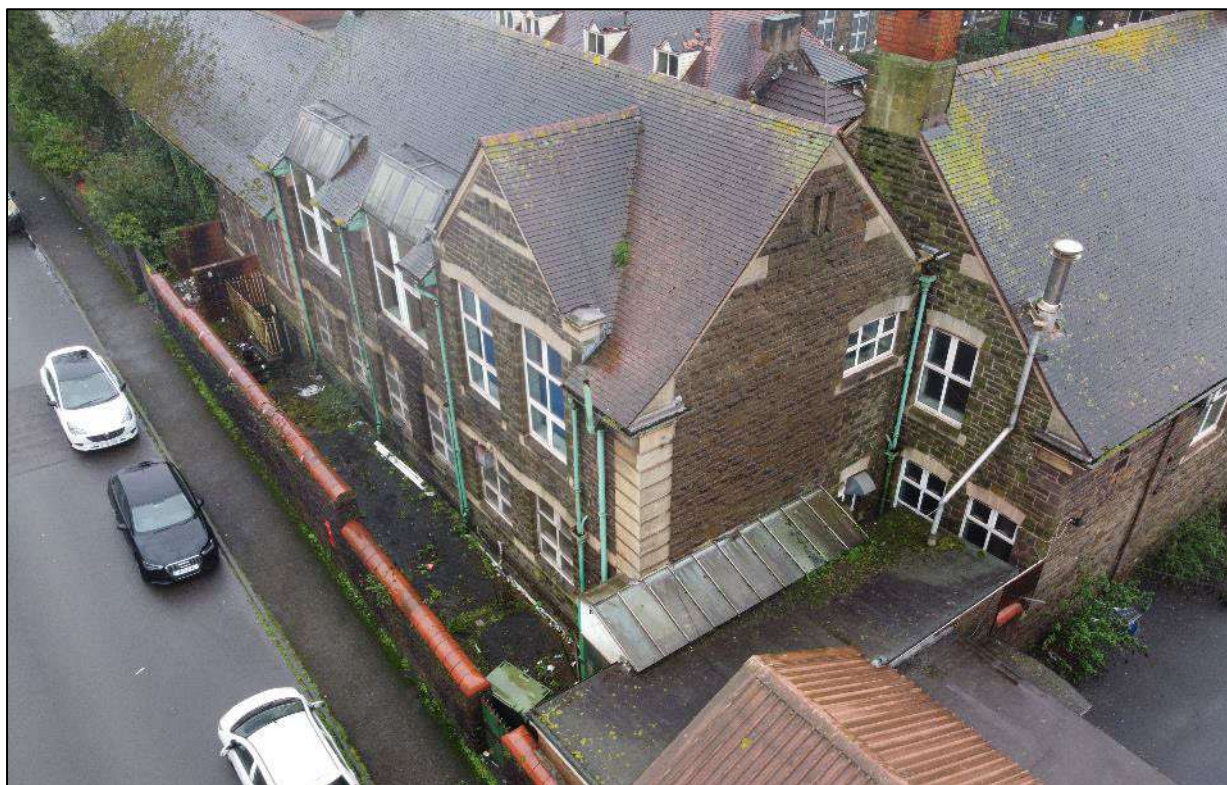
*Plate 222. Two-storey wing of north-east facing elevation, Building 4, looking south-west from York Place. Scale 2m.*

- 5.21.7. The right-hand bay is cross-gabled with a triangular pediment (Plate 222). It has a moulded limestone cornice and two limestone bands with a pair of small lancet vents between.

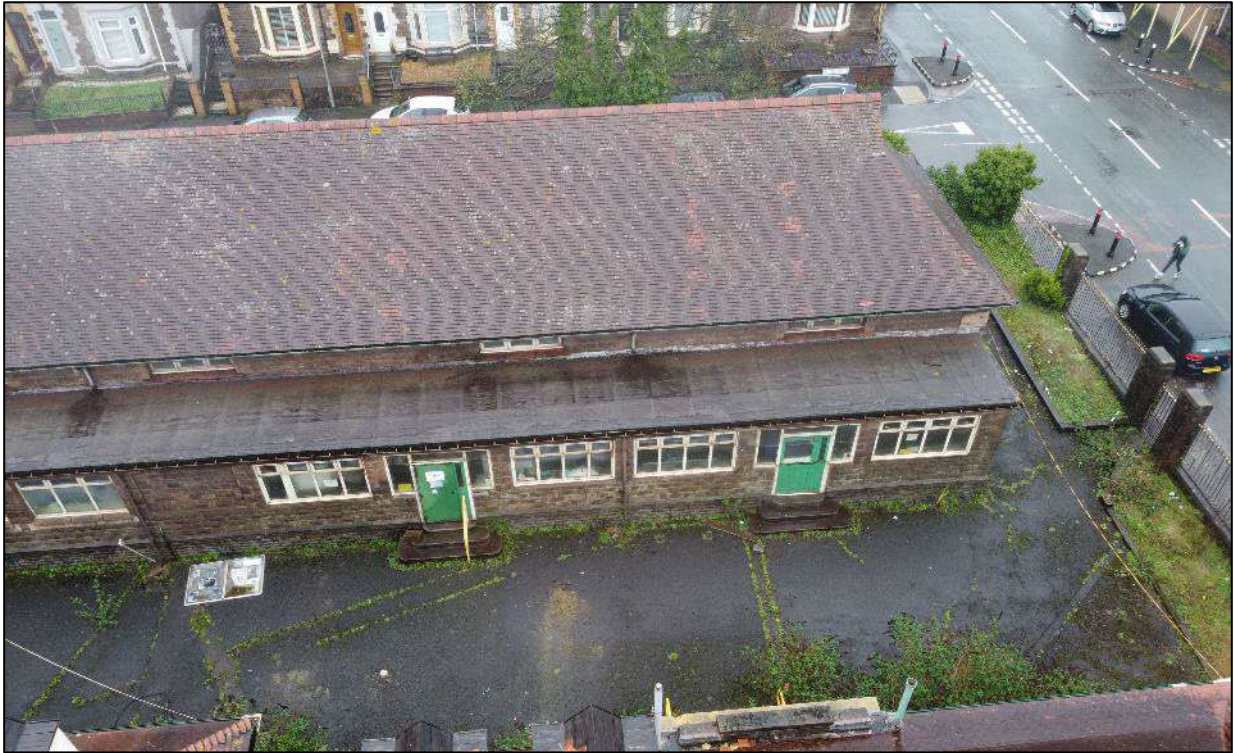
*Plate 242. Drone shot showing south-west elevation of main range and south-east elevation of the south-west wing, Building 4, looking north. Photo courtesy of Roberts Limbrick.*

- 5.23.9. There are four, flat roofed dormers to the roof (Plate 242). They have lead roofs and sides, with a moulded wood cornice.
- 5.23.10. The single storey section of the main range is of coursed, rock-faced ashlar Pennant stone (Plate 249). It has toothed rock-faced Pennant stone quoins. The projecting base course continues from the south-east facing elevation. A limestone band course runs below the eaves and there is a moulded stone gutter.

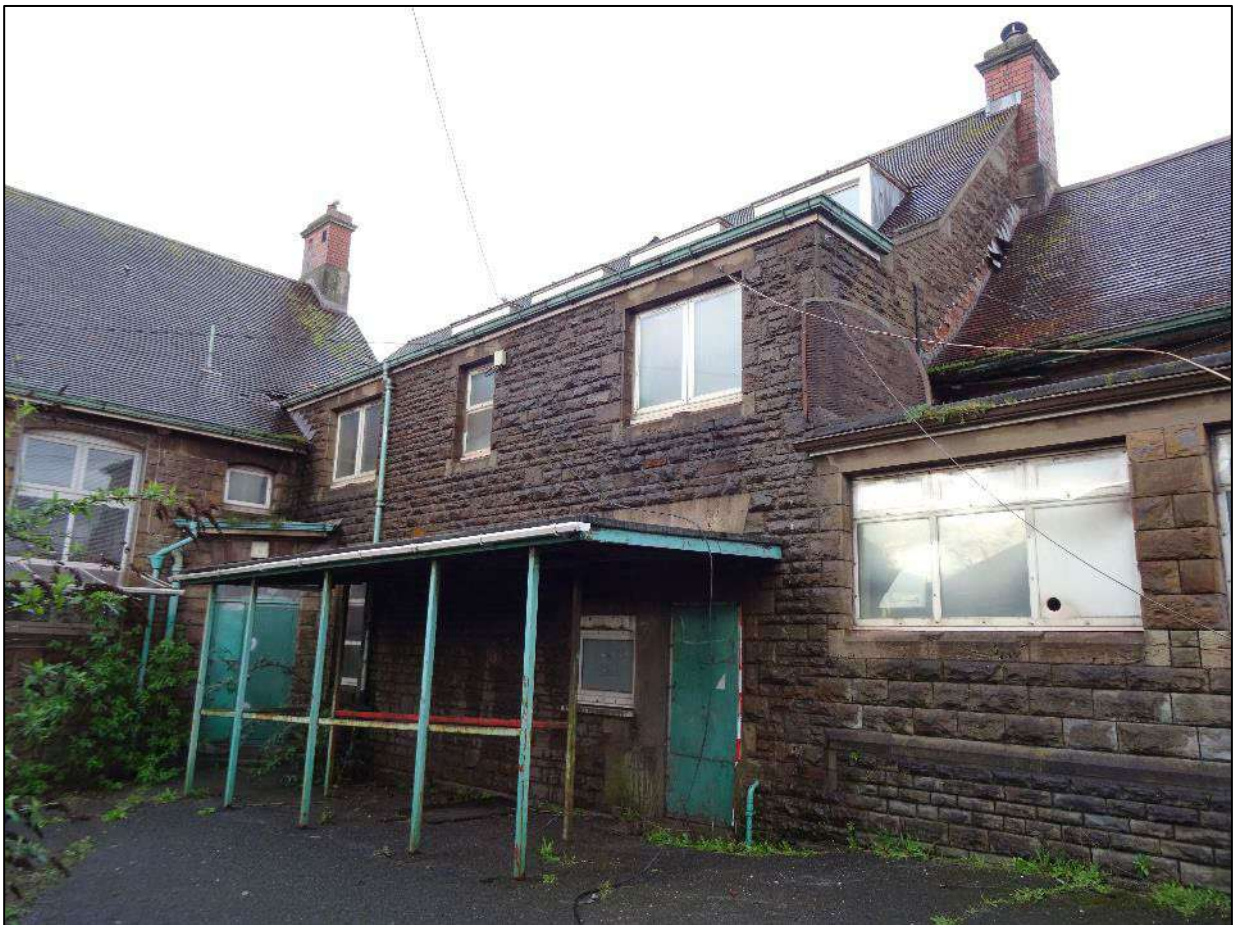
*Plate 244. South-west facing elevation of two-storey section of main range, Building 4, looking north. Scale 2m.*

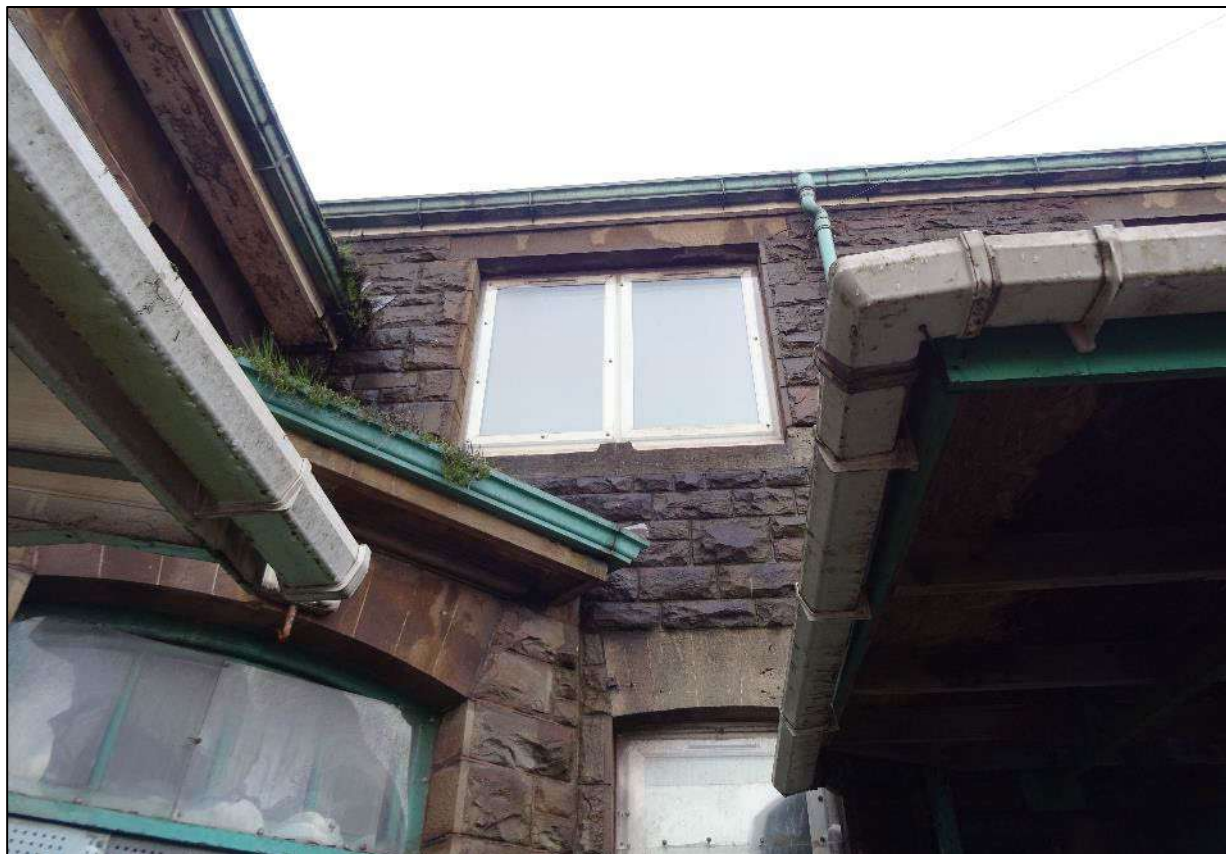
*Plate 247. South-west facing elevation of two-storey section of main range, Building 4, looking north-east. Scale 2m.*

- 5.23.8. The second storey has three windows, the central one being half the width of the outer two (Plate 247). They are in the same style as the left-hand first storey window (Plate 248).

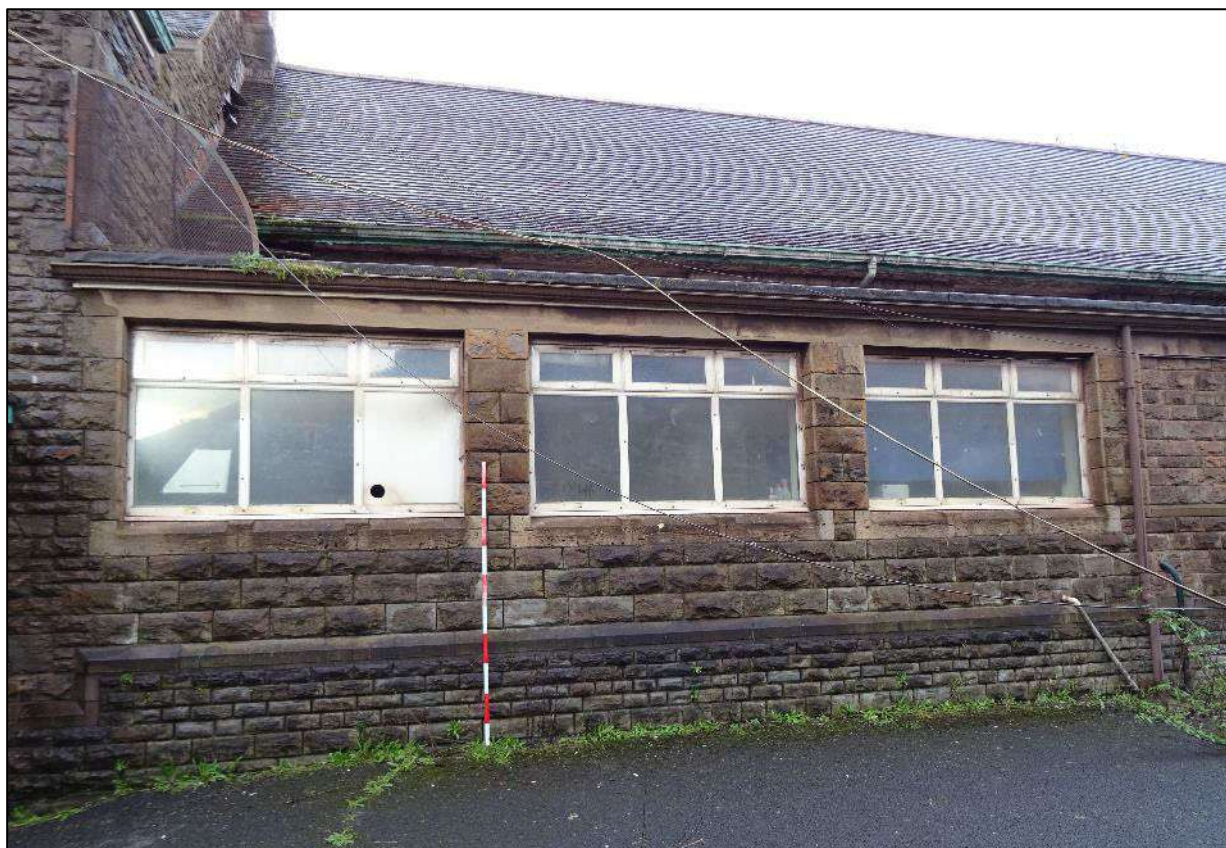
*Plate 250. Entrance to bay six of single storey section, south-west facing elevation of main range, Building 4, looking north-east. Scale 2m.*

- 5.23.11. The elevation has ten bays. Bays six and nine are entrances. They have three wide, rounded cornered steps up to the door (Plate 250). The doors are metal security doors with modern side panels with a narrow light. They have a narrow fanlight above and two windows to the sides at the same height as the rest of the windows on the elevation. These have narrow cement sills.

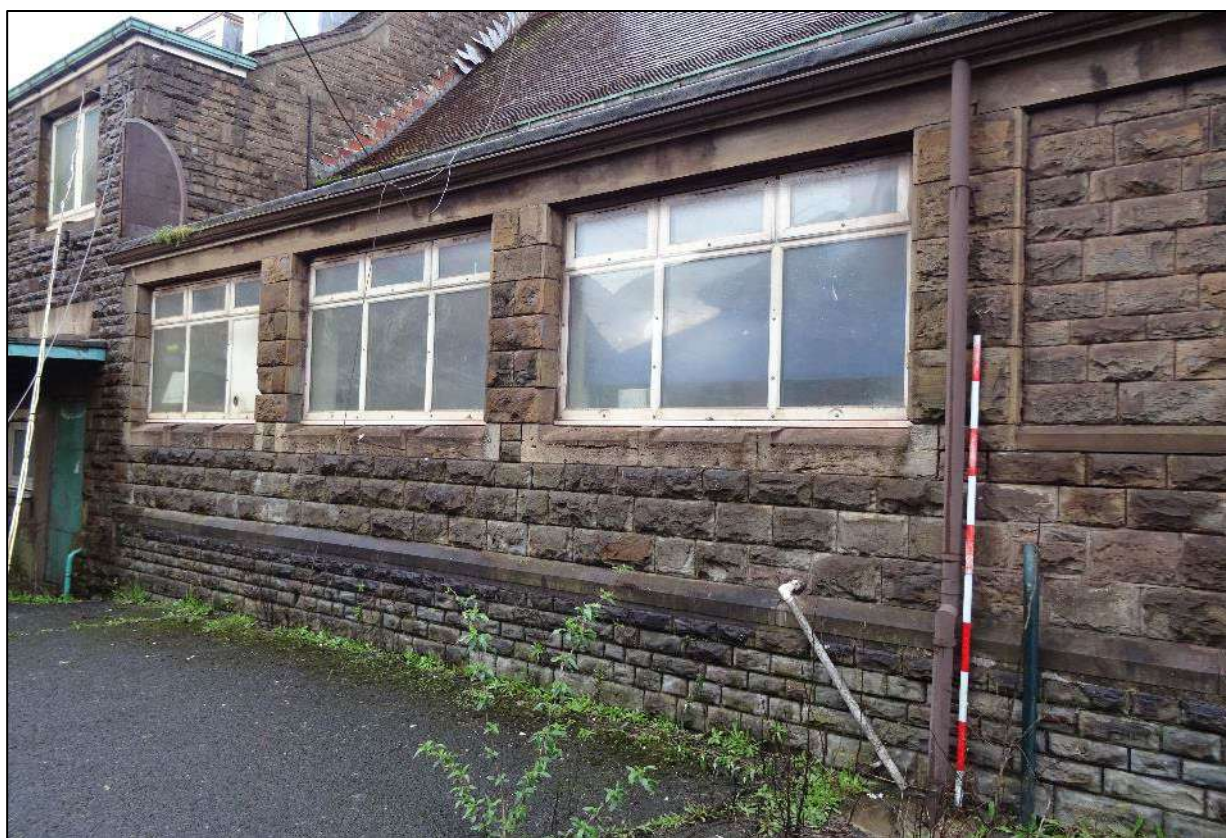
*Plate 251. Bays one to three of single storey section, south-west facing elevation of main range, Building 4, looking north-east. Scale 2m.*

- 5.23.12. The first to third bays have wide windows immediately beneath the eaves (Plate 251). They have bevelled limestone sills in three sections, with stubs between (Plate 252). They are recessed, with brush-hammered reveals and chiselled margins.

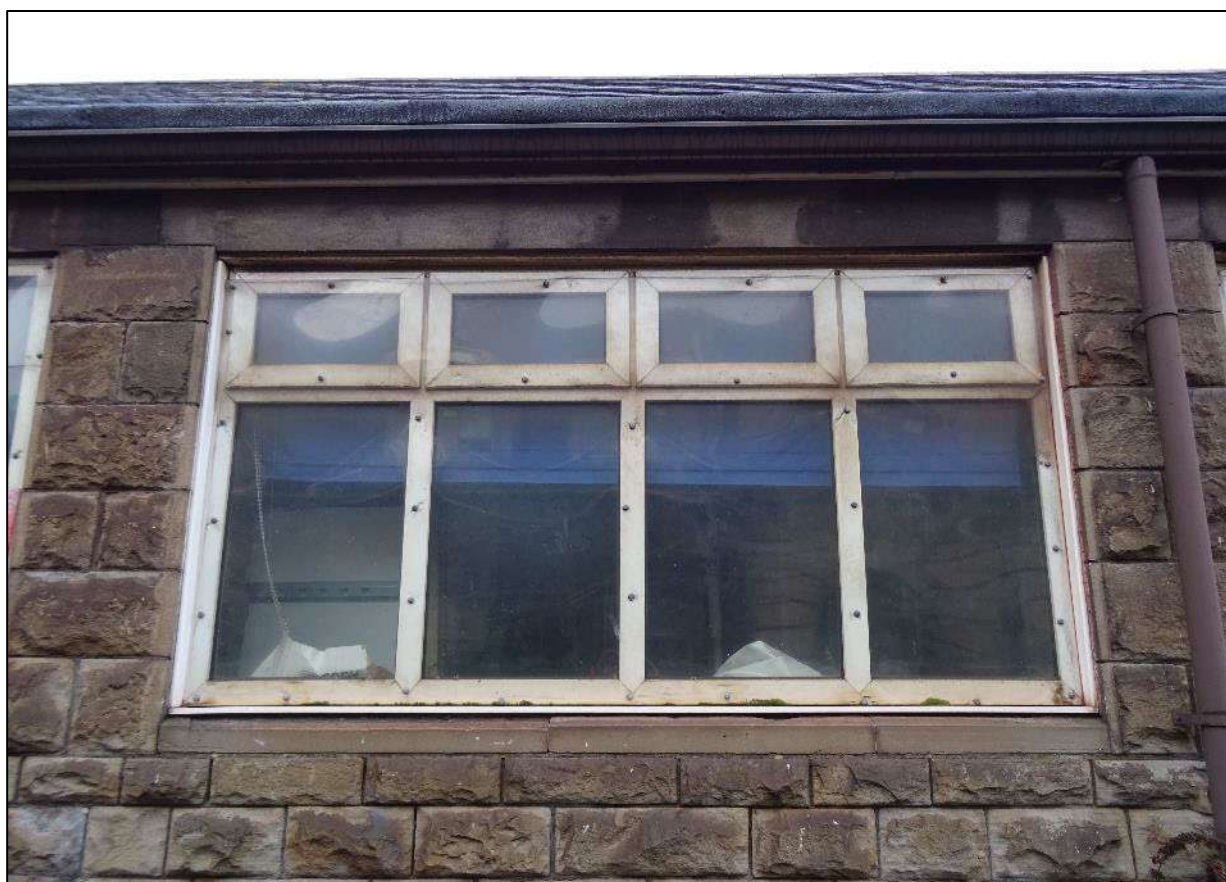
*Plate 253. Blind window to fourth bay of single storey section, south-west facing elevation of main range, Building 4, looking north-east. Scale 2m.*

- 5.23.13. Bay four is a blind window, with a narrow, bevelled sill and chiselled margins to the sides (Plate 253).
- 5.23.14. The remaining bays have windows in the same style. They have narrow cement sills and chiselled margins to the rock-faced ashlar to the sides (Plate 254).

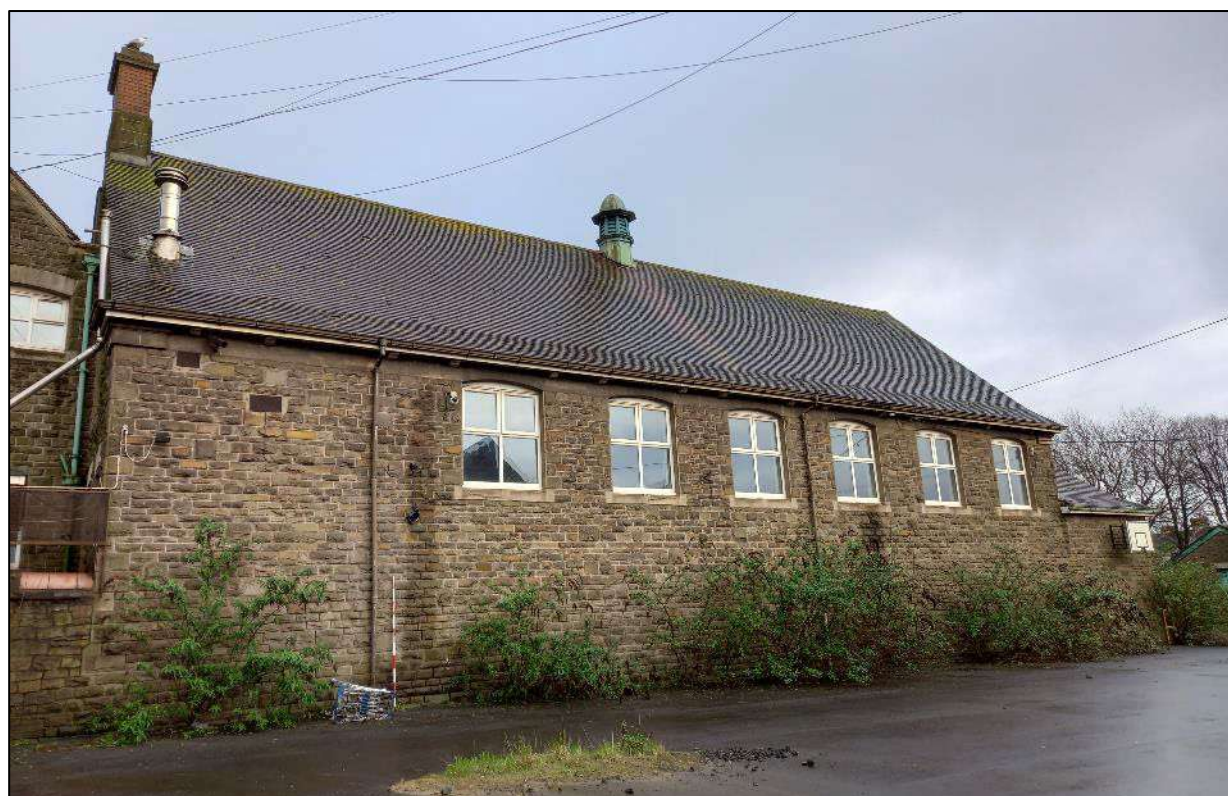
*Plate 255. North-west facing elevation of Building 4, main range to left, looking south-east. Scale 2m.*

- 5.24.2. The gable end of the main range is of rock-faced ashlar Pennant stone, brought-to-course (Plate 255). It has smooth finished rusticated limestone quoins to the left. The gable has a moulded limestone cornice. Towards the top of the gable are two lancet vents with toothed rock-faced surrounds with chiselled margins, and a rock-faced sill and lintel. The left side of the first storey is covered by the modern lean-to walkway (Plate 233).
- 5.24.3. There is a small window to the right side of the first storey and a larger one to the right of the second storey. Both have segmental arched limestone voussoirs, bevelled limestone sills, brush-hammered reveals and rock faced

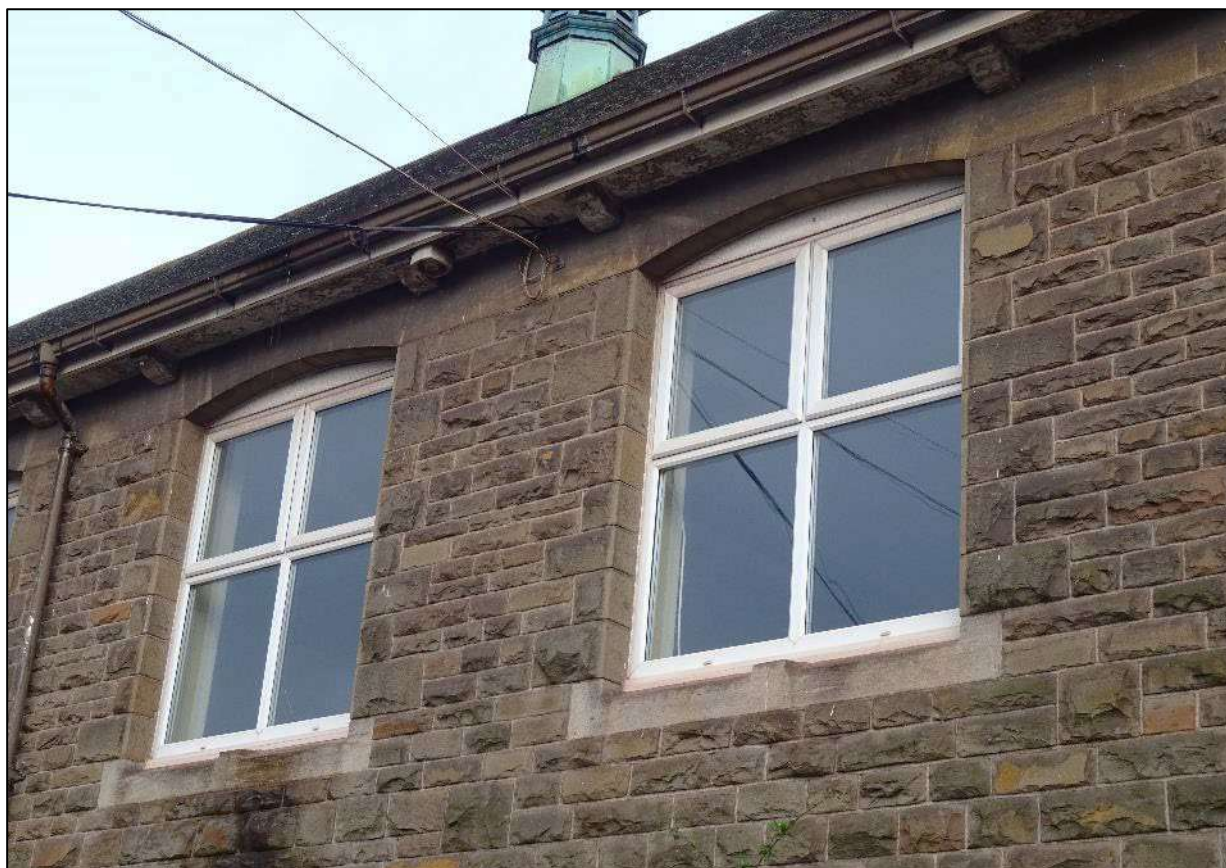
*Plate 256. North-west elevation of south-west wing, Building 4, looking south. Scale 2m.*

- 5.24.4. The gable-ended section of the south-west wing is of rock-faced ashlar Pennant stone, brought-to-course, with toothed quoins (Plate 256). There is a smooth finished limestone band course immediately below the eaves. It has limestone corbels supporting the projecting soffits (Plate 257).
- 5.24.5. There are six evenly spaced windows towards the south-west of the elevation (Plate 256). They are segmental arched windows with smooth-finished limestone voussoirs rising from the band course below the eaves. The windows are slightly recessed, with brush-hammered reveals and rock-faced toothed surrounds with chiselled margins. The sills are bevelled limestone with a central stub.
- 5.24.6. The lean-to cross-hipped section to the south-west of the wing has no features (Plate 258).

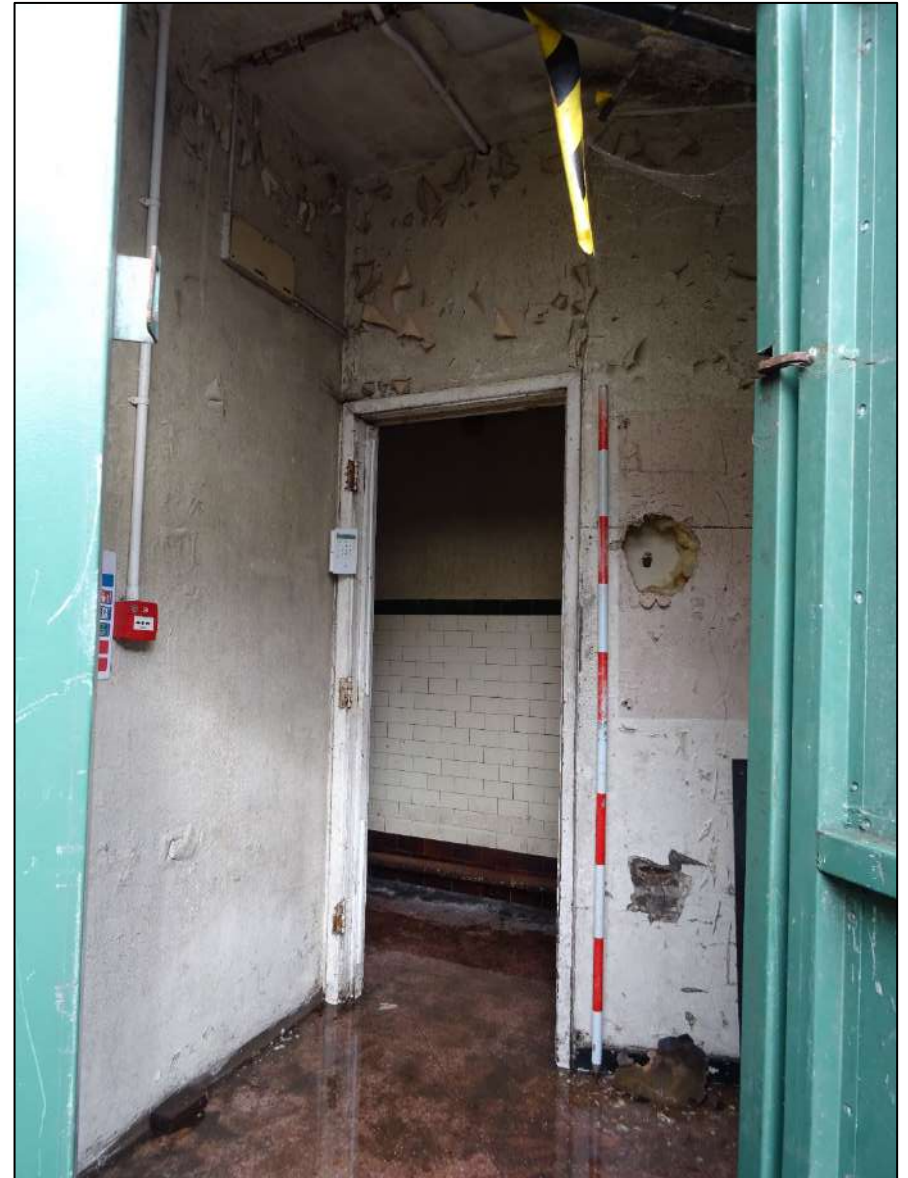
*Plate 259. Door to Room 1, Building 4, looking south. Scale 2m.*

- 5.25.1. The north-western end of the building is accessed by the angled porch between the main range and south-west wing. It has a red terrazzo floor and painted plaster walls and ceiling, except to the lower south-east wall which has white tiles with a brown band to the bottom and green to the top (Plate 259).
- 5.25.2. The external doorway has a moulded wood segmental arch surround, painted white, with a four-light fanlight (Plate 259). The door has been replaced with a metal security door. The doorway through to Room 2 has lost its door. It has a plain white painted wooden frame (Plate 260).
- 5.25.3. The stairs to the first floor are to the south-east (Plate 261). The tiling to the lower south-east wall runs up the outside of the half turn stairwell, all the way to the first-floor landing (Room 16). The stairs are concrete. They have a

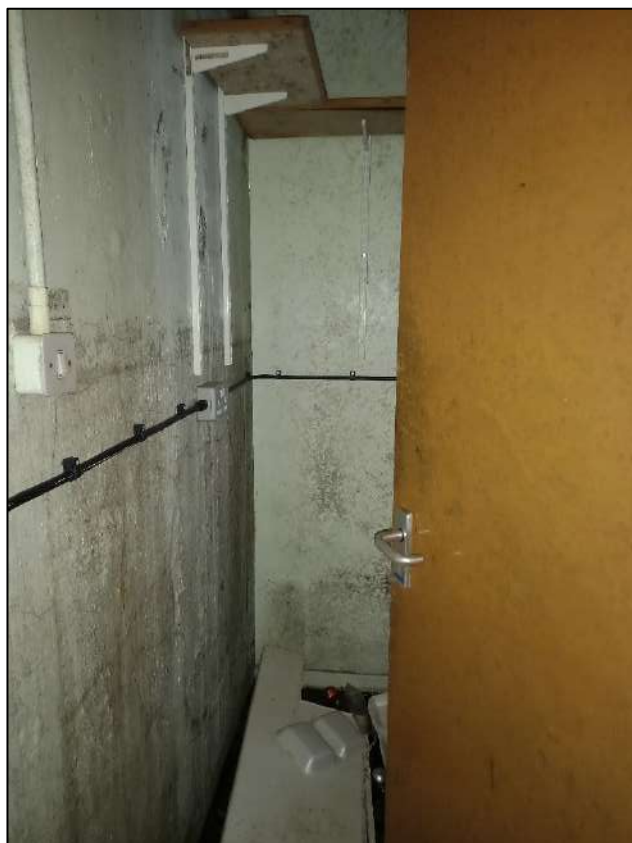
*Plate 283. Room 6, Building 4, looking south-east.*

5.25.17. Room 6 is a small storeroom at the south-east end of corridor Room 2. It was not possible to fully access the room, but it has painted plaster walls and ceiling (Plate 283).

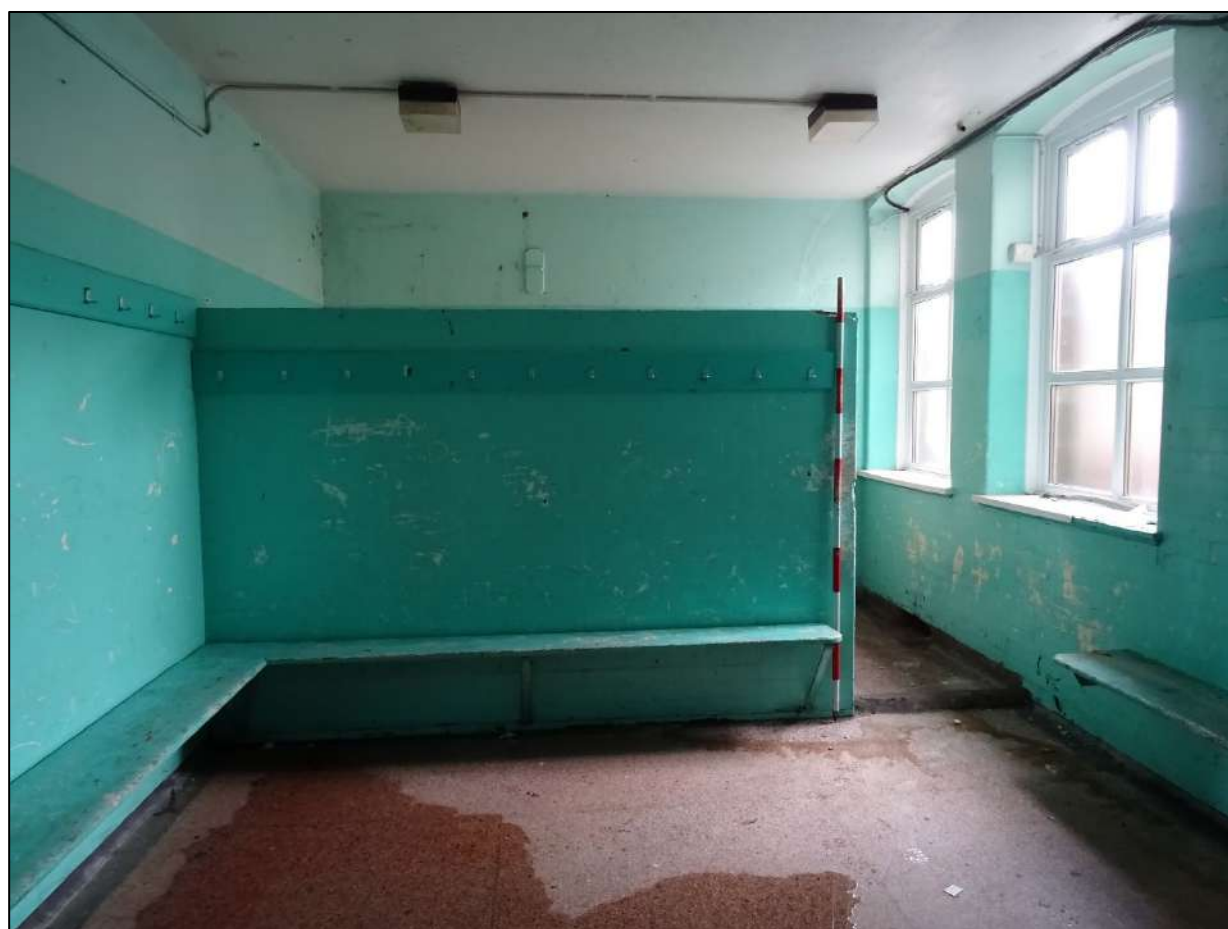
*Plate 284. Room 7, Building 4, looking north-west.*

5.25.18. Room 7 is accessed from corridor Room 2. It is at the north-east end of the south-west wing. It has a red terrazzo floor. The south-west wall is painted plaster, while the other three walls have are tiled to two-third height, painted over, with painter plaster above (Plate 284). The ceiling is painted plaster.

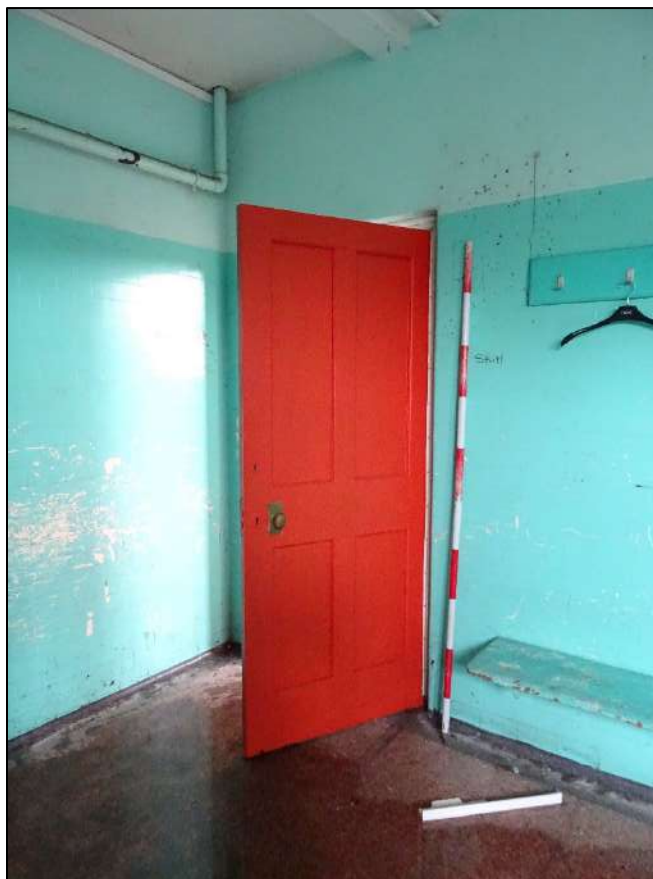
*Plate 285. Door to Room 8 from Room 7, looking south. Scale 2m.*

5.25.19. The door from Room 2 is at the right of the north-east wall, with a door to Room 8 opposite on the south-west wall (Plate 285). They are four fielded panel wooden doors, painted red, in a moulded wooden frame, painted white. The surround is rounded to the wall, including the tiled section.
