**Level 2 Building Recording:**  
**Former Dyffryn Lower School, Port Talbot**

March 2024

Report No. 2278

Prepared for KEW Planning  
By  
Susan Stratton PhD

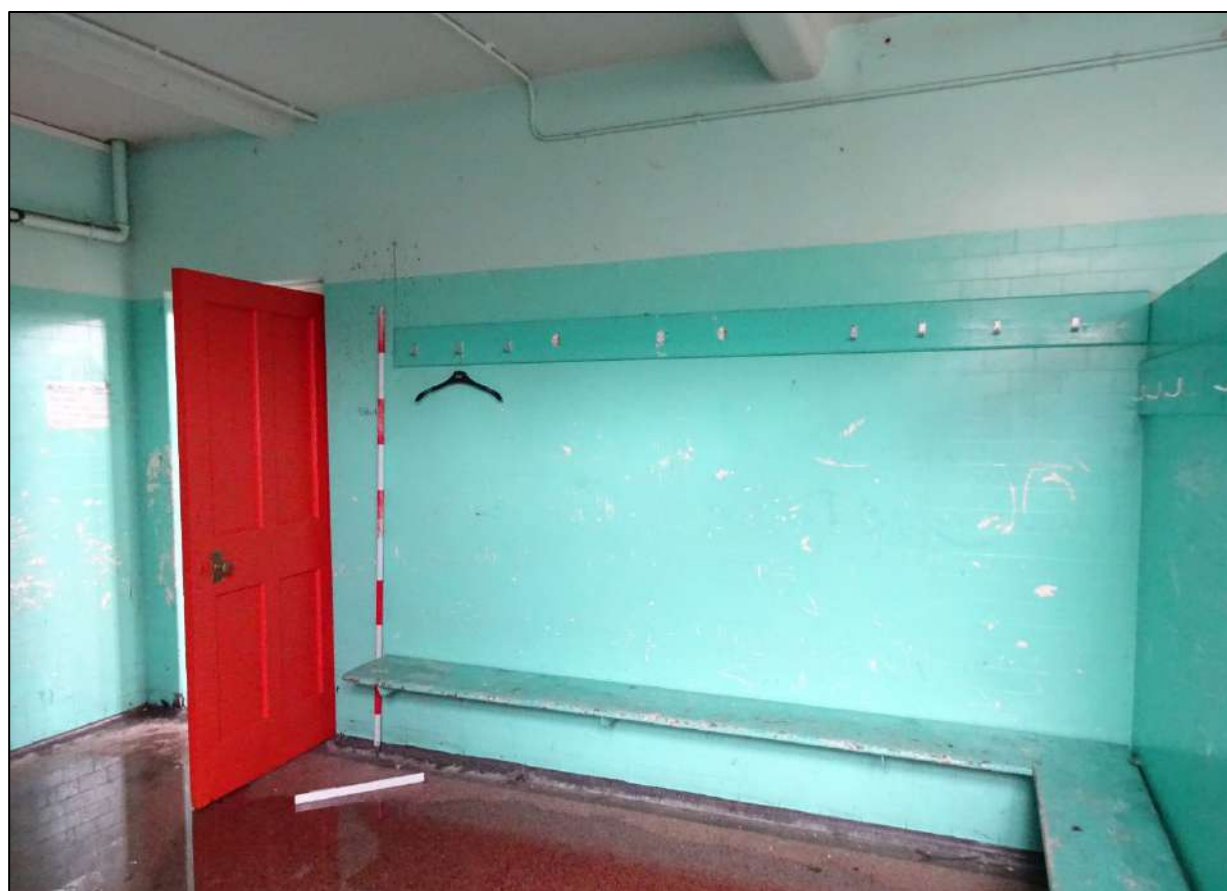
*Plate 286. Room 7, looking south-west. Scale 2m.*

5.25.20. To the south-east half of the room is a changing area with low wooden benches and a wooden band with hooks above (Plate 286). The north-west of the room is the shower area with a central concrete dividing wall. There are narrow wooden bands with hooks along this and the south-east and south-west walls.

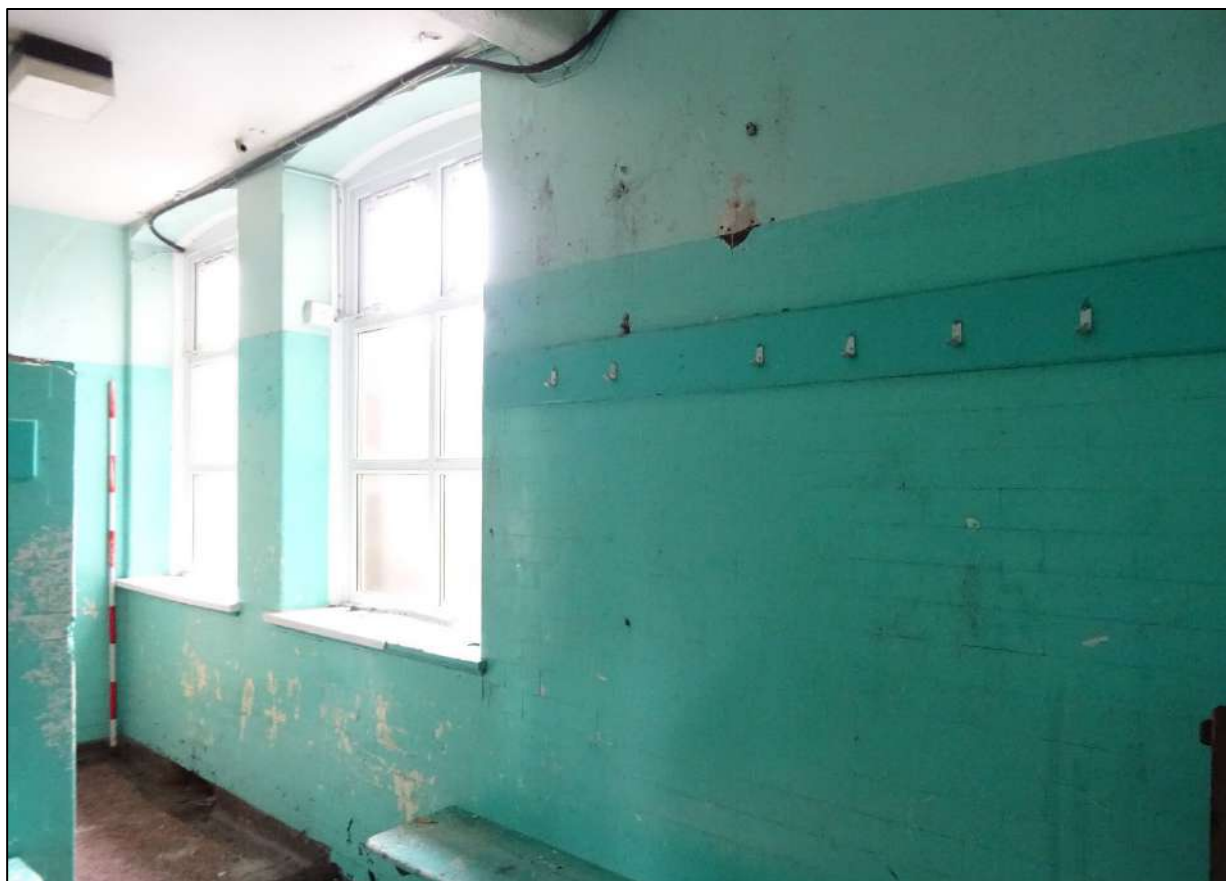
*Plate 288. North-east wall of Room 7, looking north. Scale 2m.*

5.25.21. To the left half of the north-east wall are two windows (Plate 288). They are

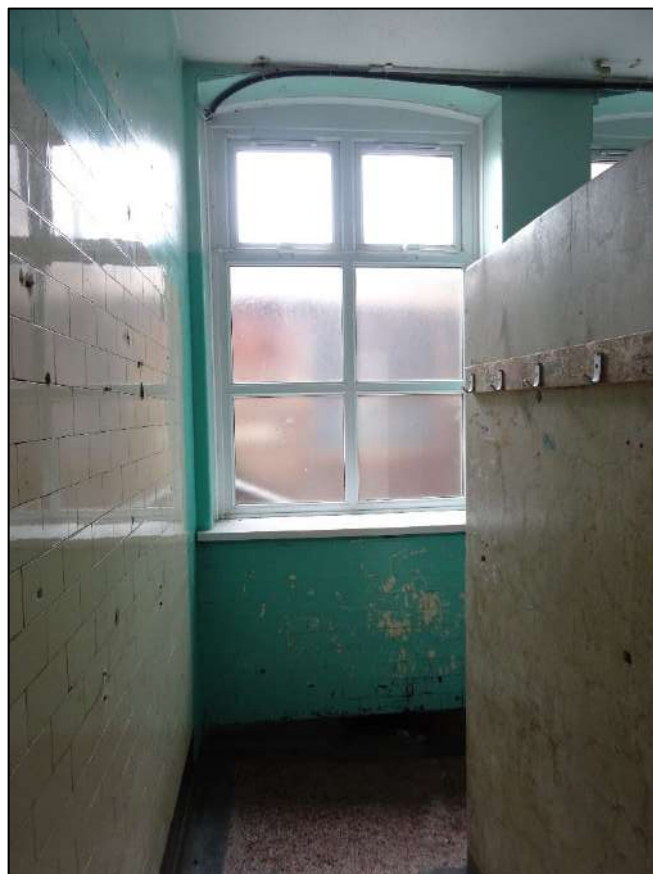
*Plate 289. Left-hand window to north-east wall of Room 7, looking north-east.*

recessed with segmental arches, painted tiles and plaster reveals as the wall, rounded edges to the walls, and uPVC sills over the original wooden sills (Plate 289). At the base of the wall between the windows is a concrete-lined drain (Plate 290).

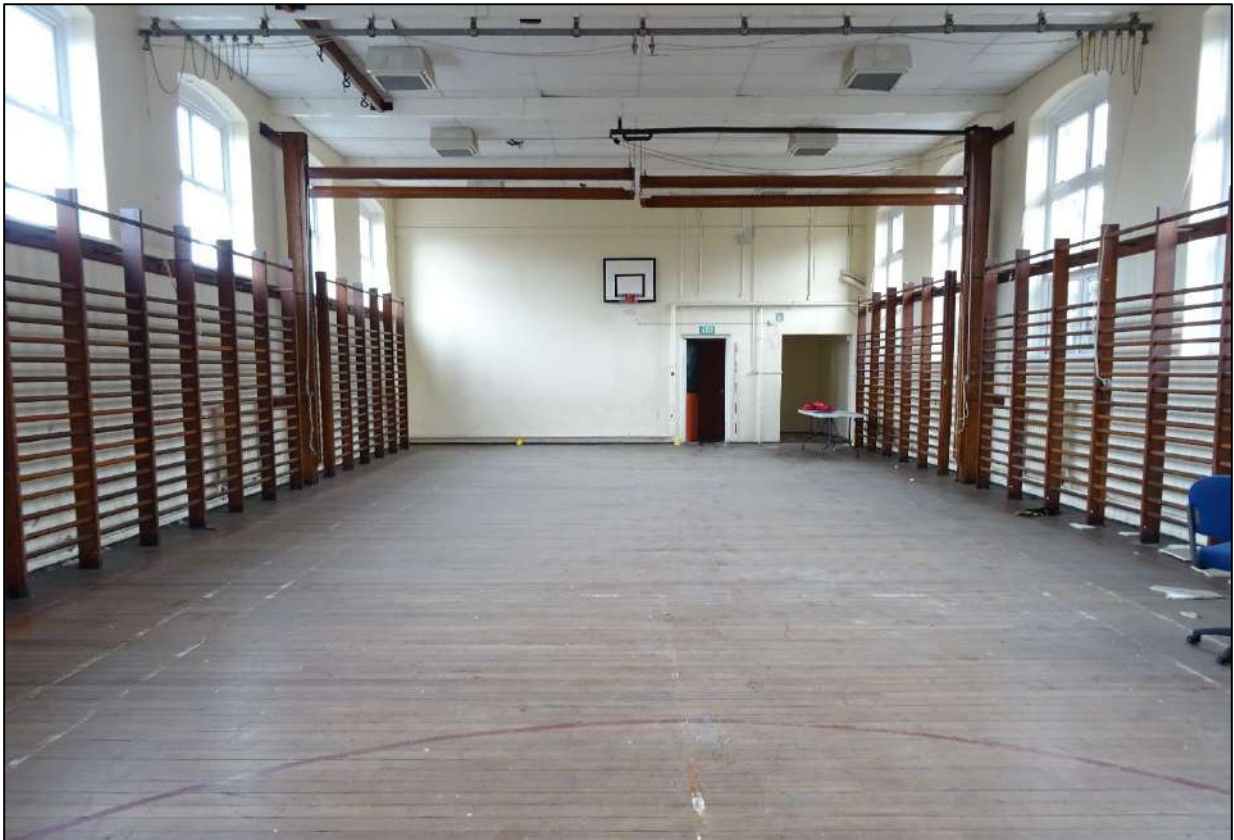
*Plate 291. Gymnasium, Room 8, Building 4, looking north-east. Scale 2m.*

5.25.22. Room 8 is a gymnasium hall that occupies the rest of the gabled section of the south-west wing. It has a wooden board floor, painted plaster walls, and a suspended tiled ceiling (Plate 291).

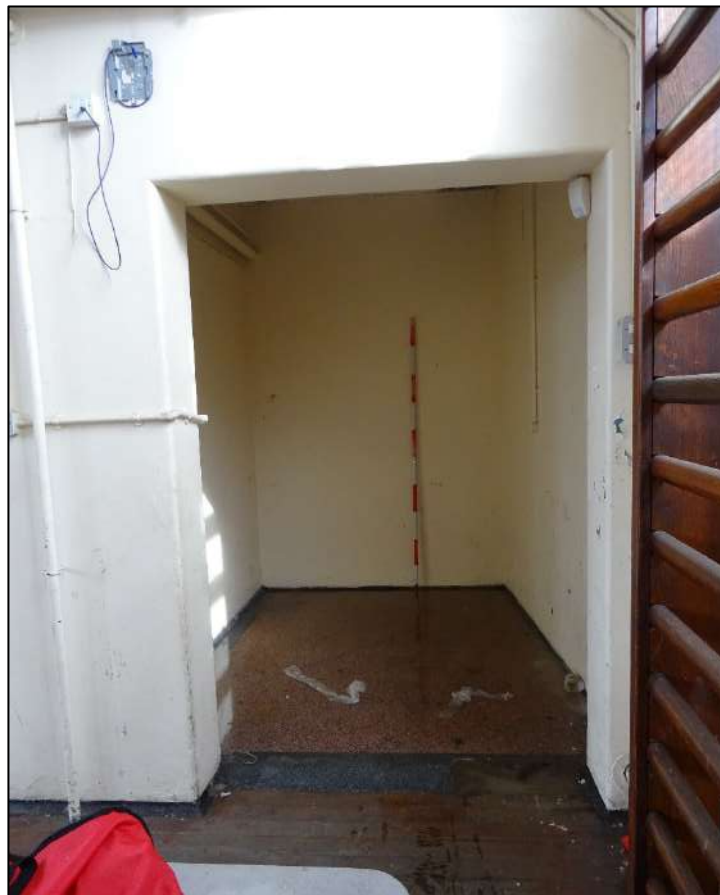
*Plate 292. Small room opening off the north-east wall of Room 8, looking north-east. Scale 2m.*

5.25.23. The door from Room 7 (described above, Paragraph 5.25.19) is to the right side of the north-east wall. To the right of this is a wide flat arched opening to a small room with a terrazzo floor and painted plaster walls and ceiling (Plate 292). On left side of the south-west wall is a door to Room 9 (Plate 293). It is a four fielded panel wooden door, painted orange, with a moulded wooden frame painted white (Plate 294). It is recessed, with painted plaster reveals with rounded edges to the walls.

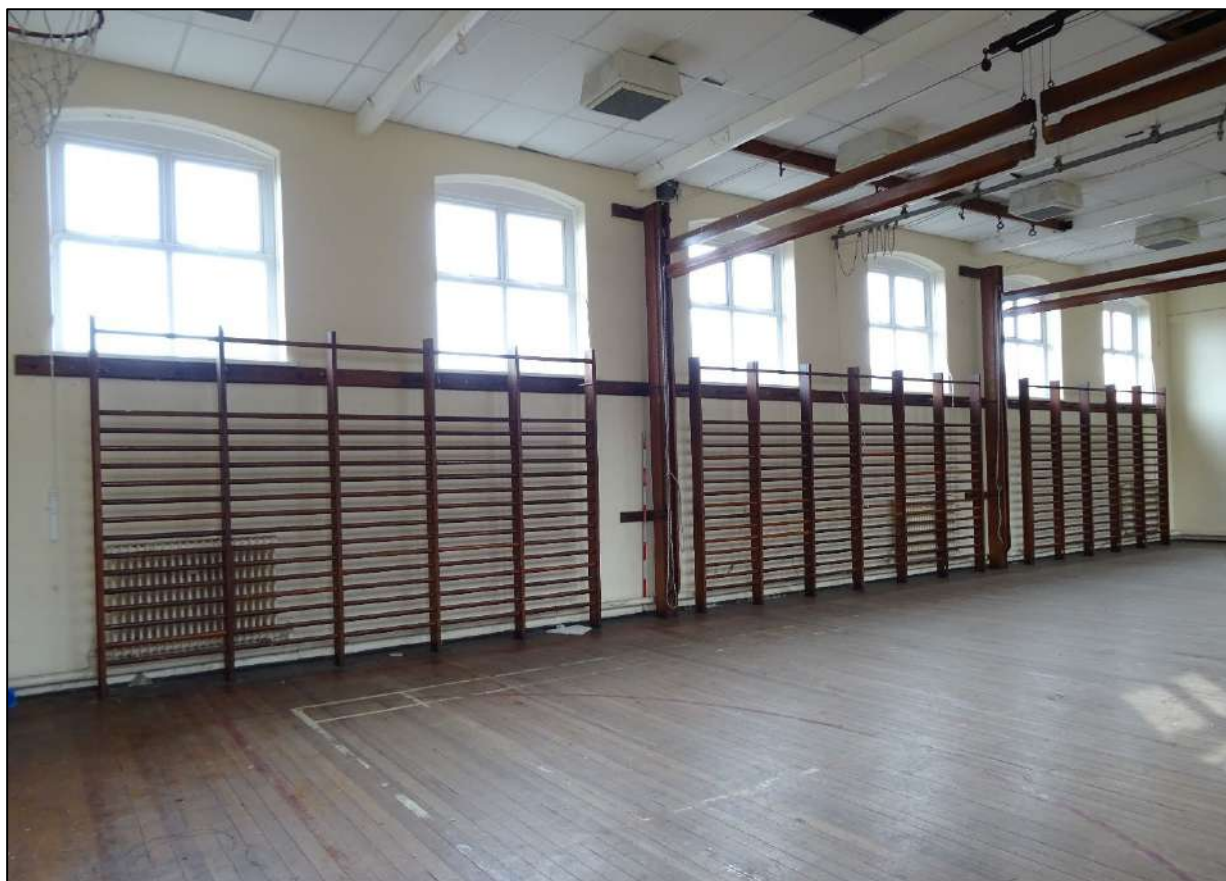
*Plate 295. North-west wall, Room 8, looking north. Scale 2m.*

5.25.24. To the upper half of the north-west and south-east walls are six large windows (Plates 295 and 296). Those to the south-east wall are taller, but they are all segmental arch headed, slightly recessed with painted plaster reveals and rounded edges to the walls, and uPVC sills (Plates 297 and 298). There are cast-iron column radiators below some of the windows.

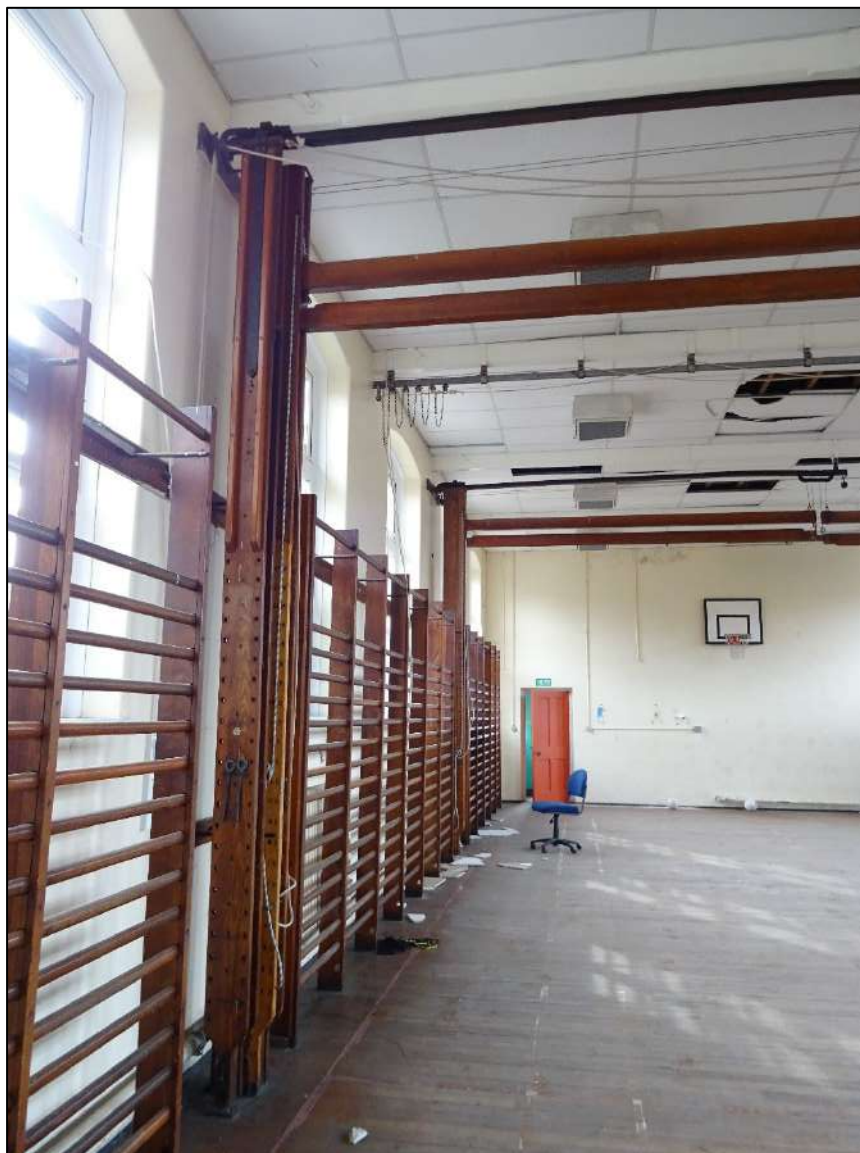
*Plate 299. Gym equipment along north-west wall of Room 8, looking north-east.*

5.25.25. Along both long walls is retractable wooden gym equipment (Plates 299 and 300).

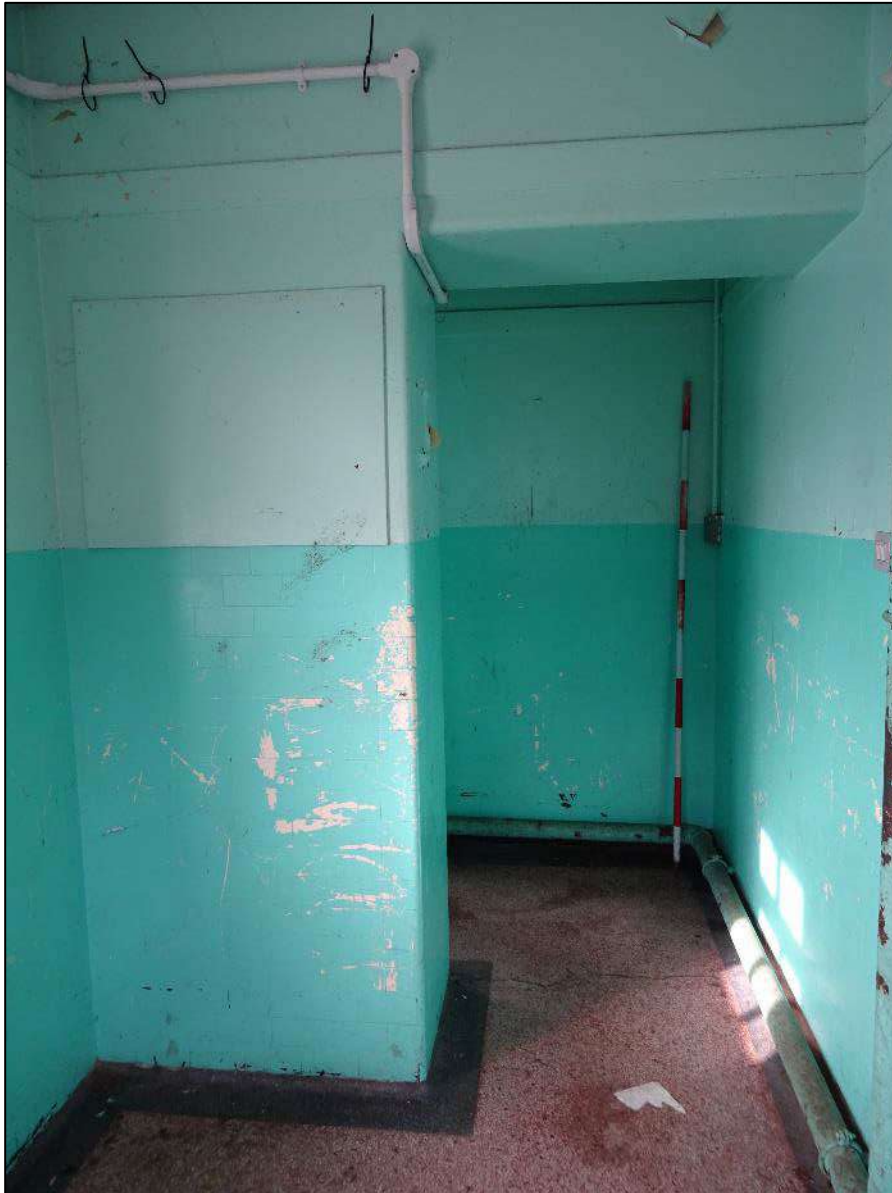
*Plate 301. Room 9, Building 4, looking north-west. Scale 2m.*

5.25.26. Room 9 is a small entrance vestibule in the lean-to element to the south-west end of the south-west wing, opening onto the boy's changing room (Room 10). It has a red terrazzo floor, tiles to the lower half of the wall and plaster above, all painted, and a painted plaster ceiling (Plate 301).

5.25.29. There is a flat arched opening to the north-west of the room, with the door to Room 10 to the south-west of the dividing wall (Plate 301). The door is missing but the frame is white painted moulded wood (Plate 305).

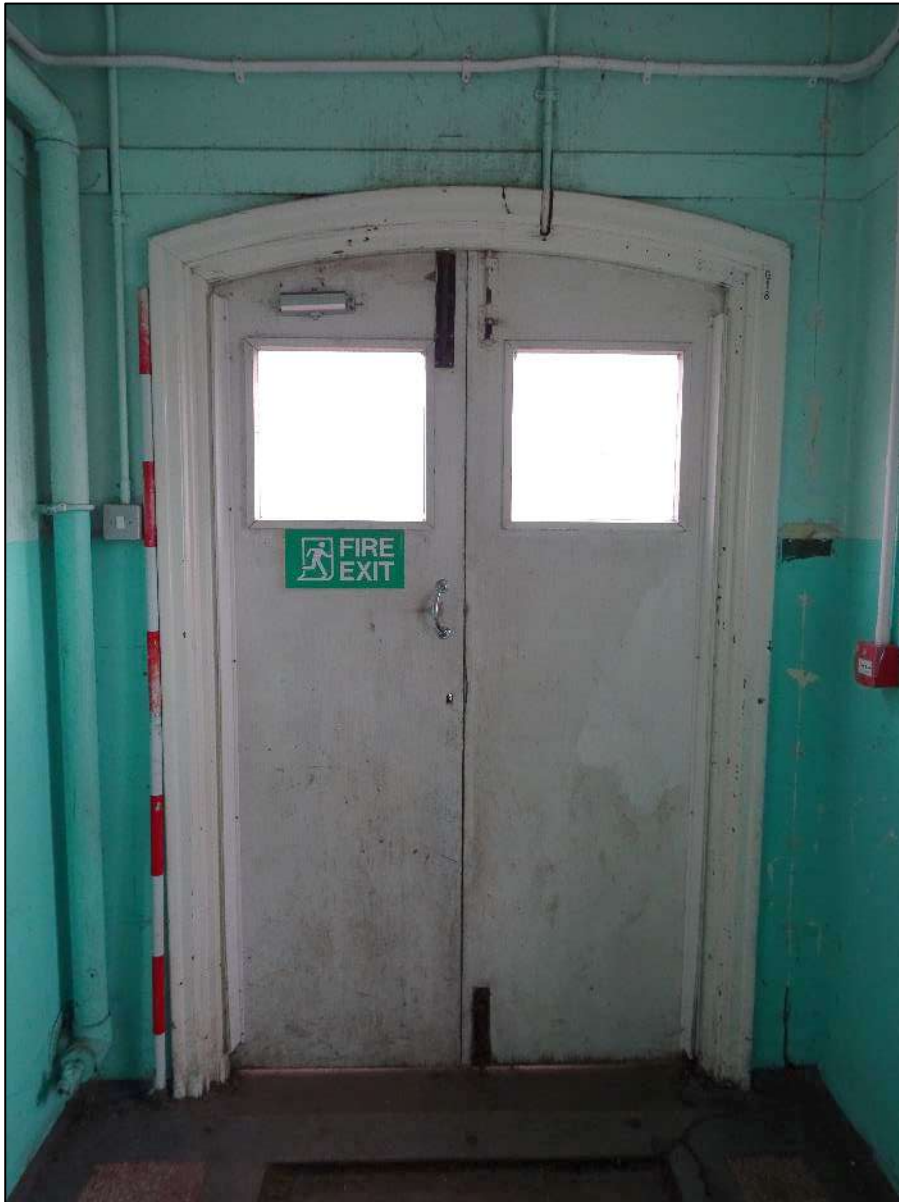
*Plate 304. Exterior door on south-east wall of Room 9, looking south-east. Scale 2m.*

5.25.27. The door from Room 8 is on the north-east wall, as described above in Paragraph 5.25.23. There is an exterior door to the south-east wall. It is a solid wood double fire door with single light to each side (Plate 303). The surround is a segmental arch headed moulded wooden frame, painted white.

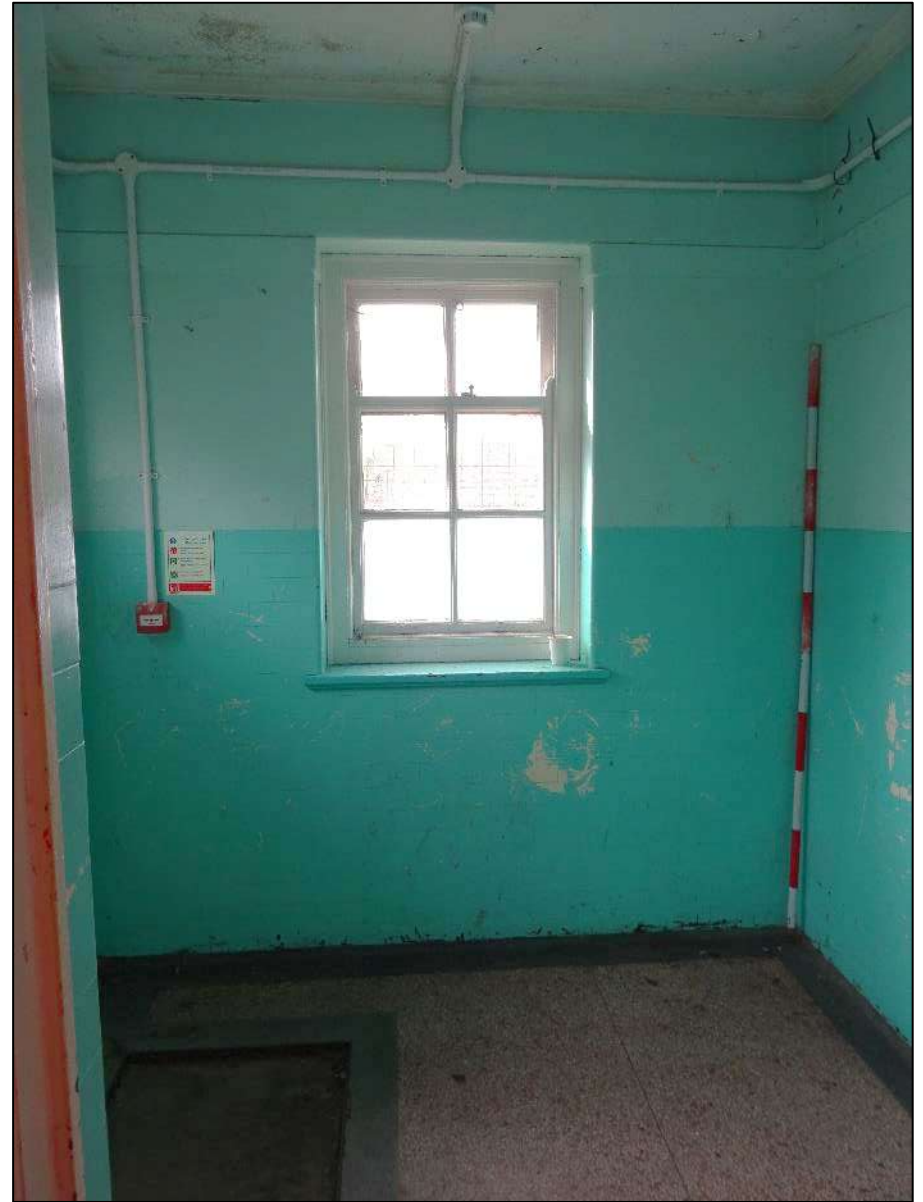
*Plate 303. South-west wall of Room 9, looking south-west. Scale 2m.*

5.25.28. On the south-west wall is a six-light wooden framed sash window. It is recessed in a flat arch with tiles and painted plaster to the reveals as the walls, and a painted wooden sill (Plate 304).

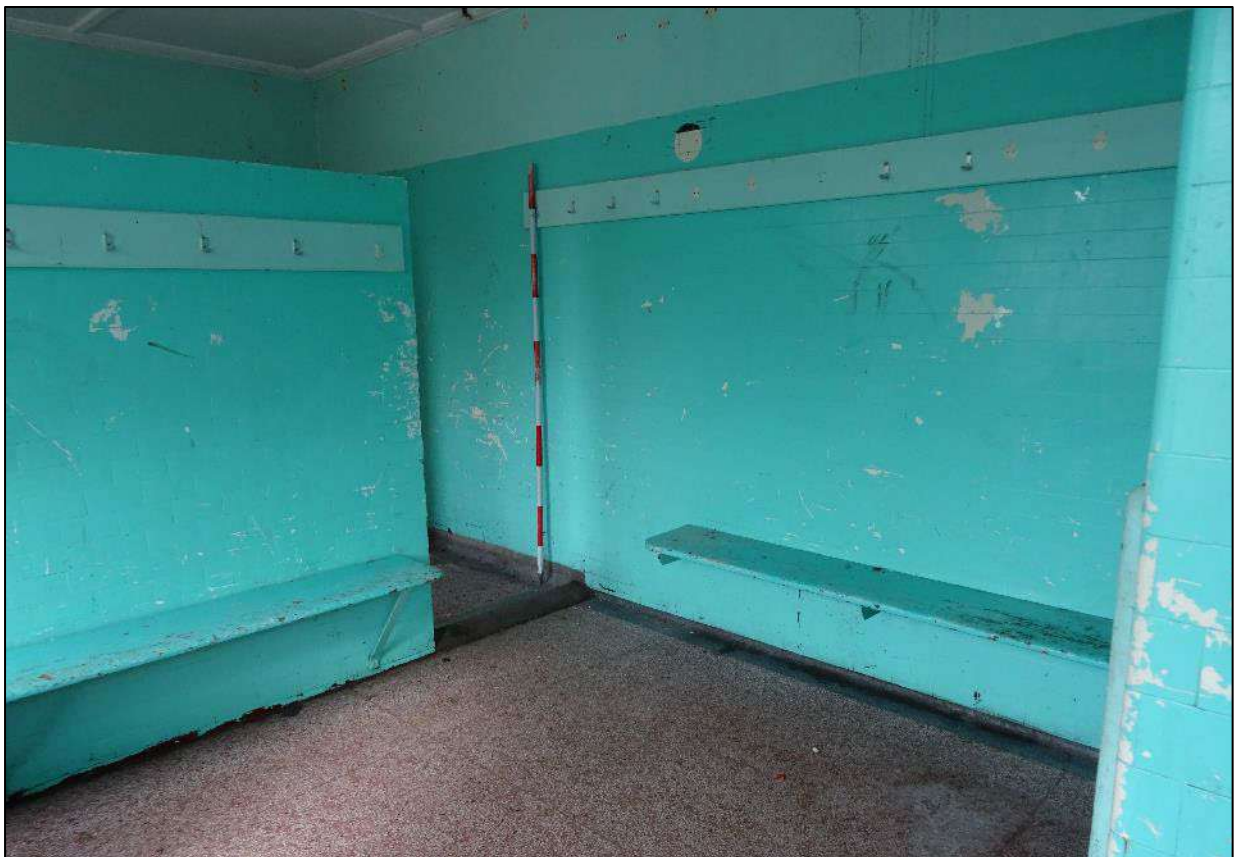
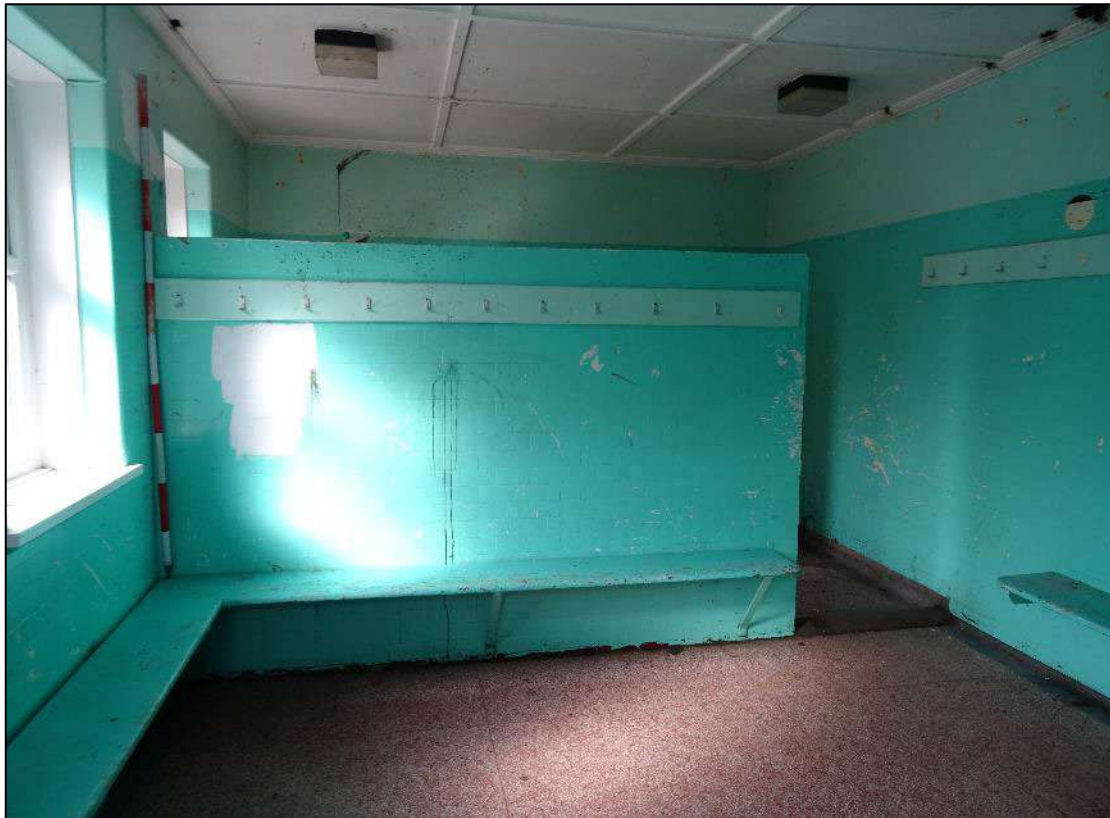
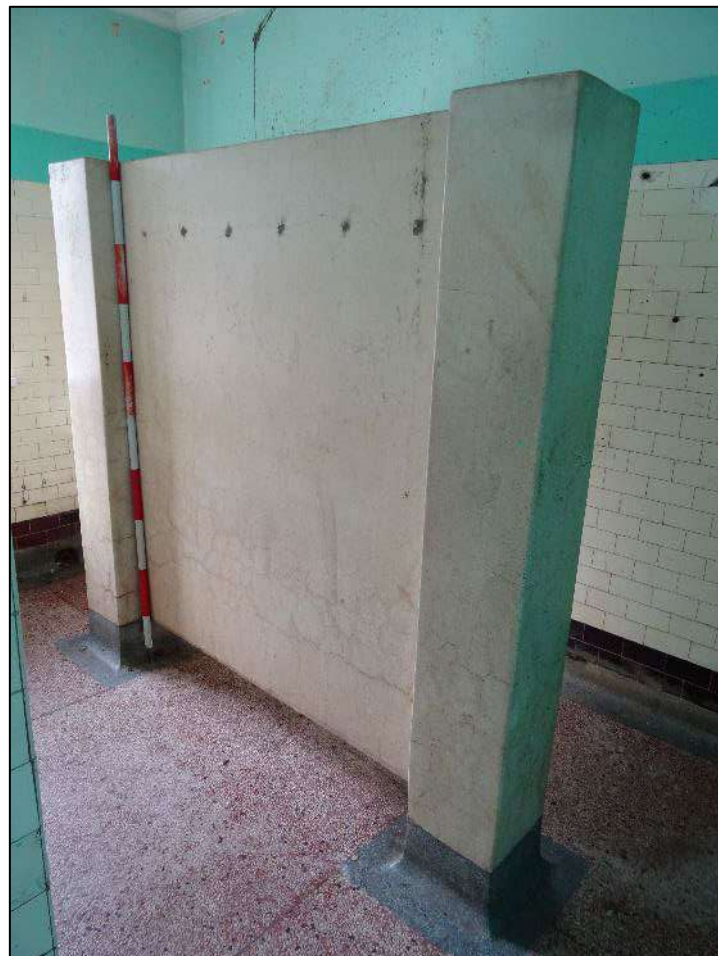
5.25.30. Room 10 is a changing room located at the south-west end of the south-west wing, within the cross-hipped element. The internal layout and decoration are a mirror of Room 7 (Paragraphs 5.25.18 to 5.25.20), with the exception that the ceiling is wooden panel, painted white (Plates 306, 207 and 308).

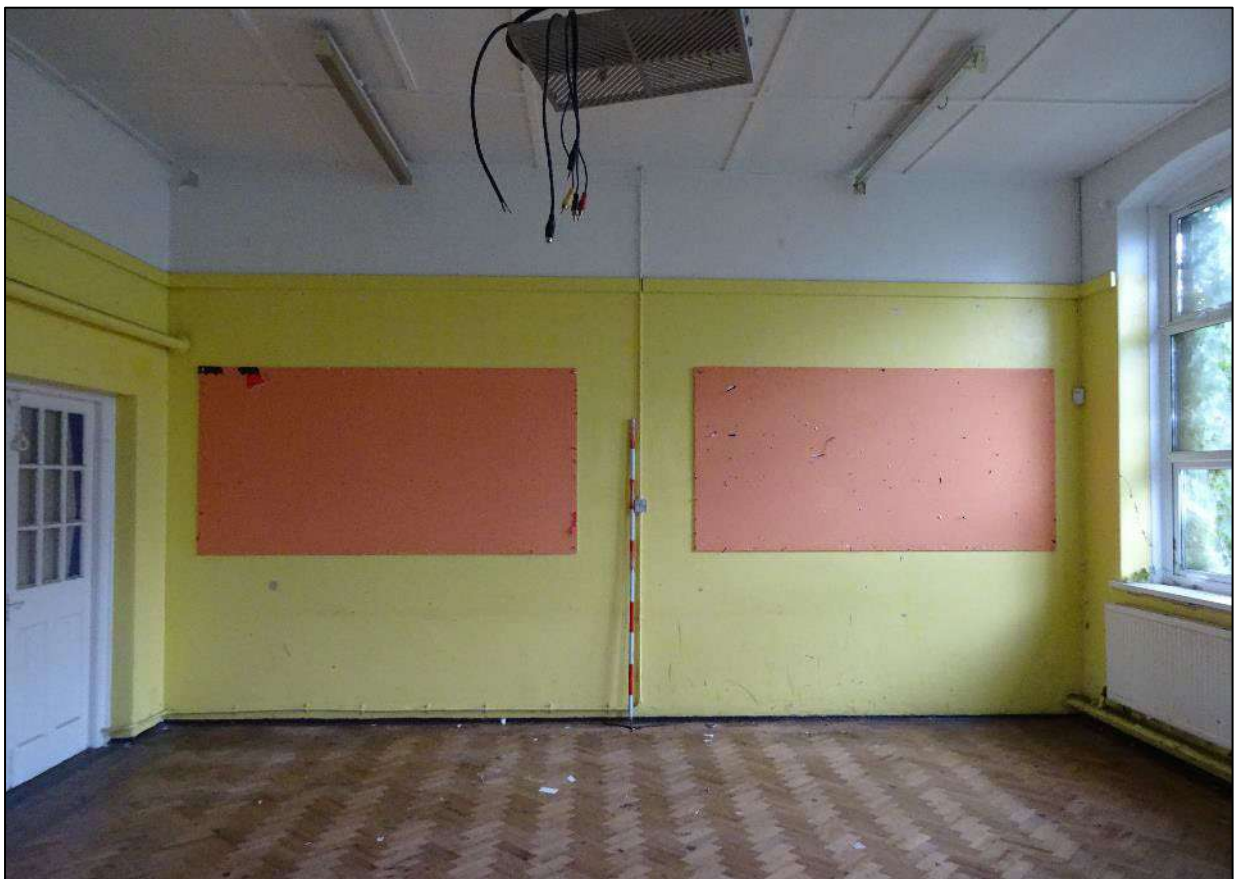
5.25.38. Room 12 is a classroom at the south-east end of the main range. It has a herringbone parquet floor, painted plaster walls and a wooden panelled ceiling (Plate 322).

*Plate 322. Room 12, Building 4, looking north-west. Scale 2m.*

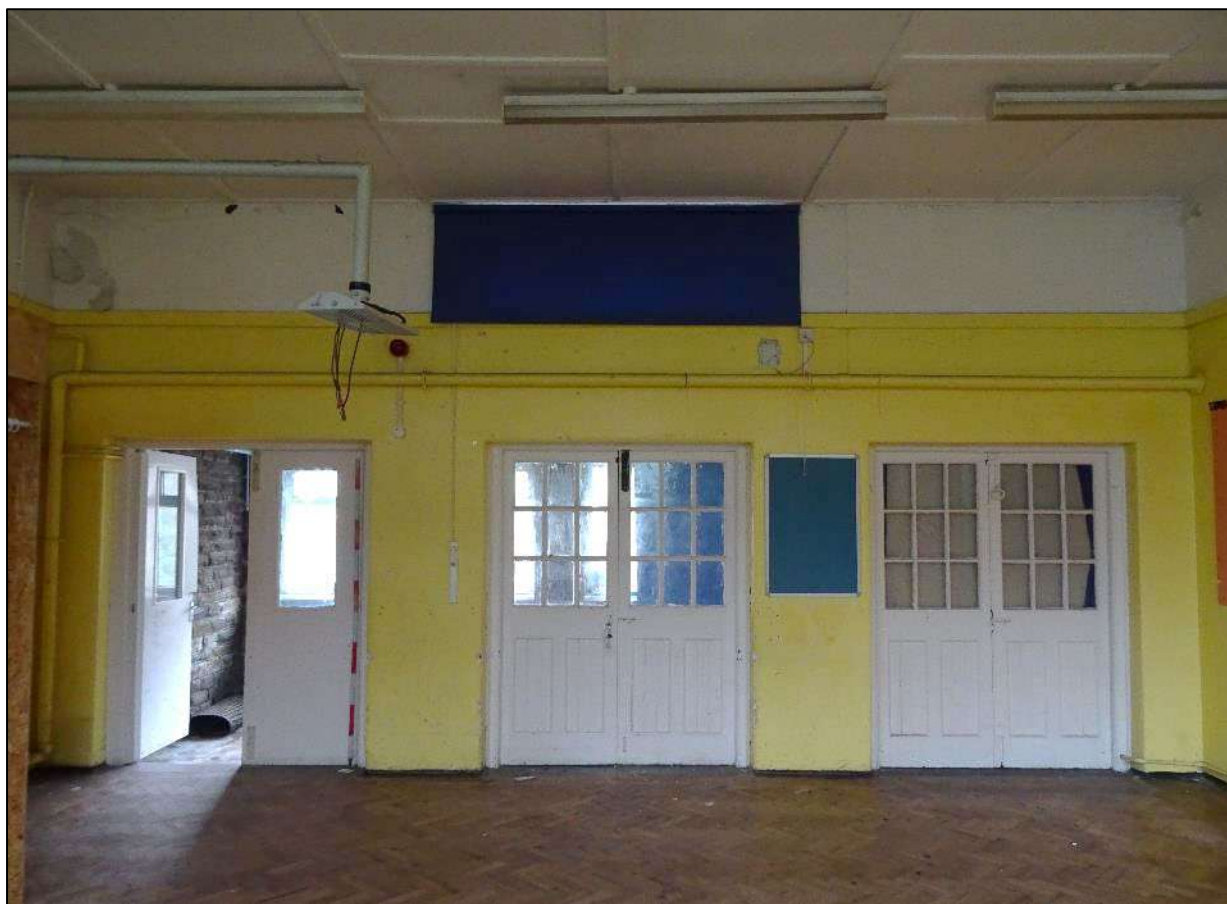
5.25.39. There are three double doors to the south-west walls, as described for bays five to seven in Room 11 (Paragraph 5.25.37) (Plate 323). The centre of the top of the wall is a three-light mullion window (Plate 324). It is recessed, with painted plaster reveals, rounded edges to the surround, and a moulded wooden sill.

*Plate 323. Room 12, Building 4, looking south-west. Scale 2m.*

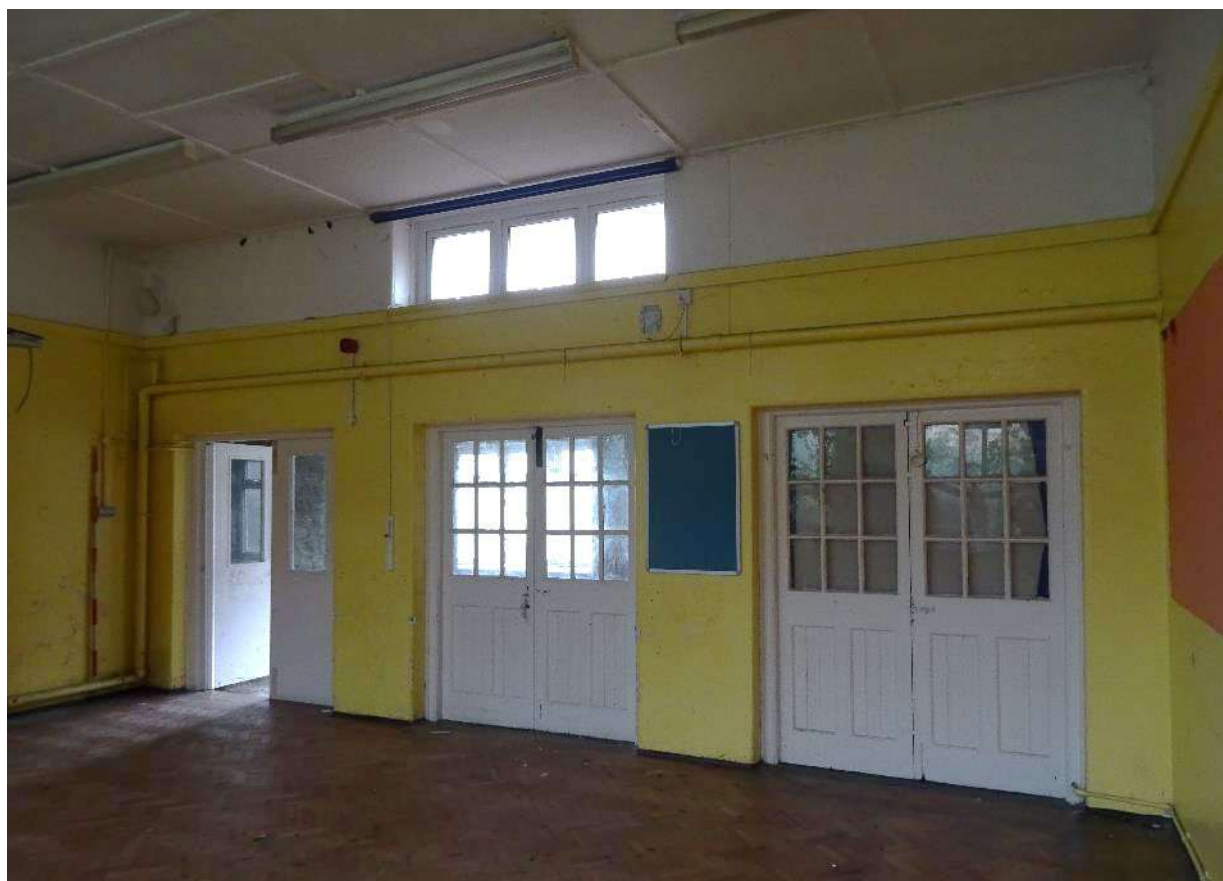
*Plate 324. Room 12, Building 4, looking south. Scale 2m.*

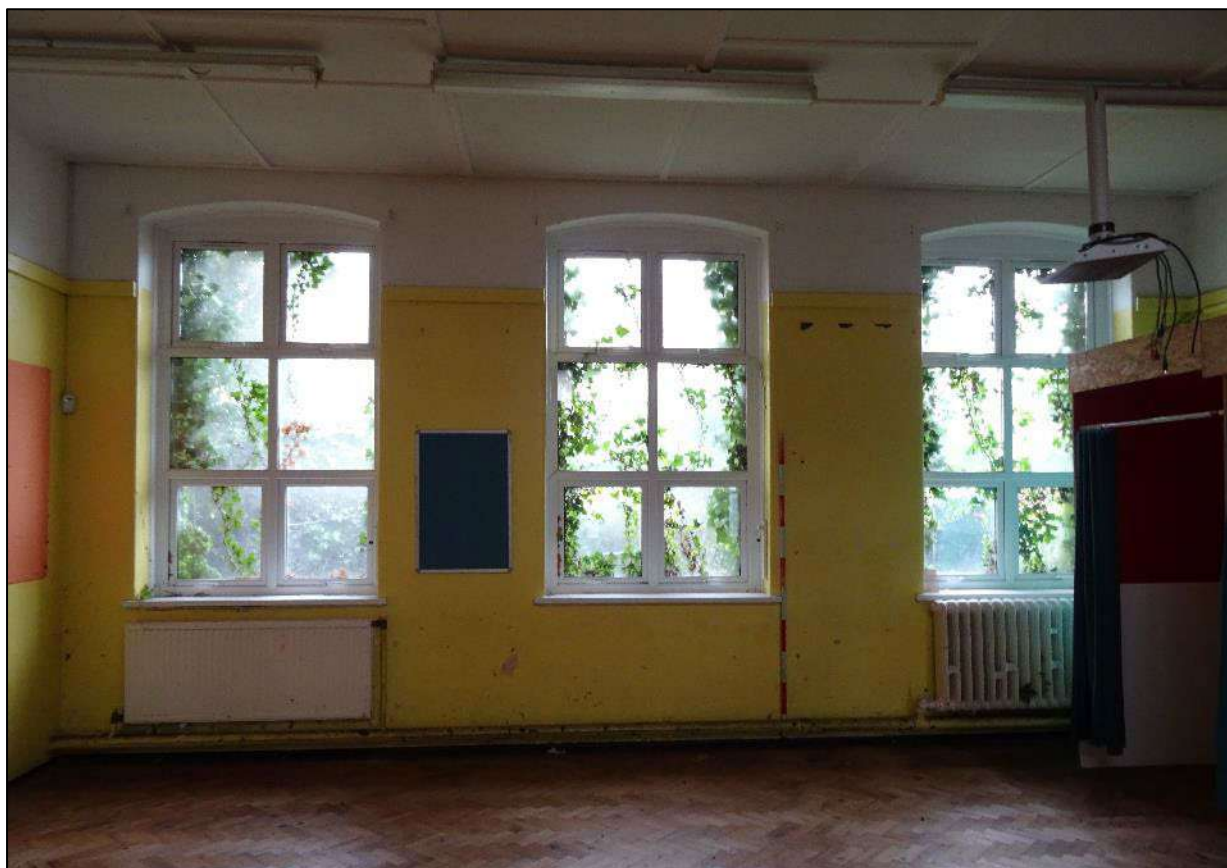
5.25.40. There are three, large segmental arch headed windows to the north-east wall (Plate 325). They have painted plaster reveals and uPVC sills over the original moulded wood. There is a modern panel radiator below the first window and a cast-iron column radiator under the third.

*Plate 325. Room 12, Building 4, looking north-east. Scale 2m.*

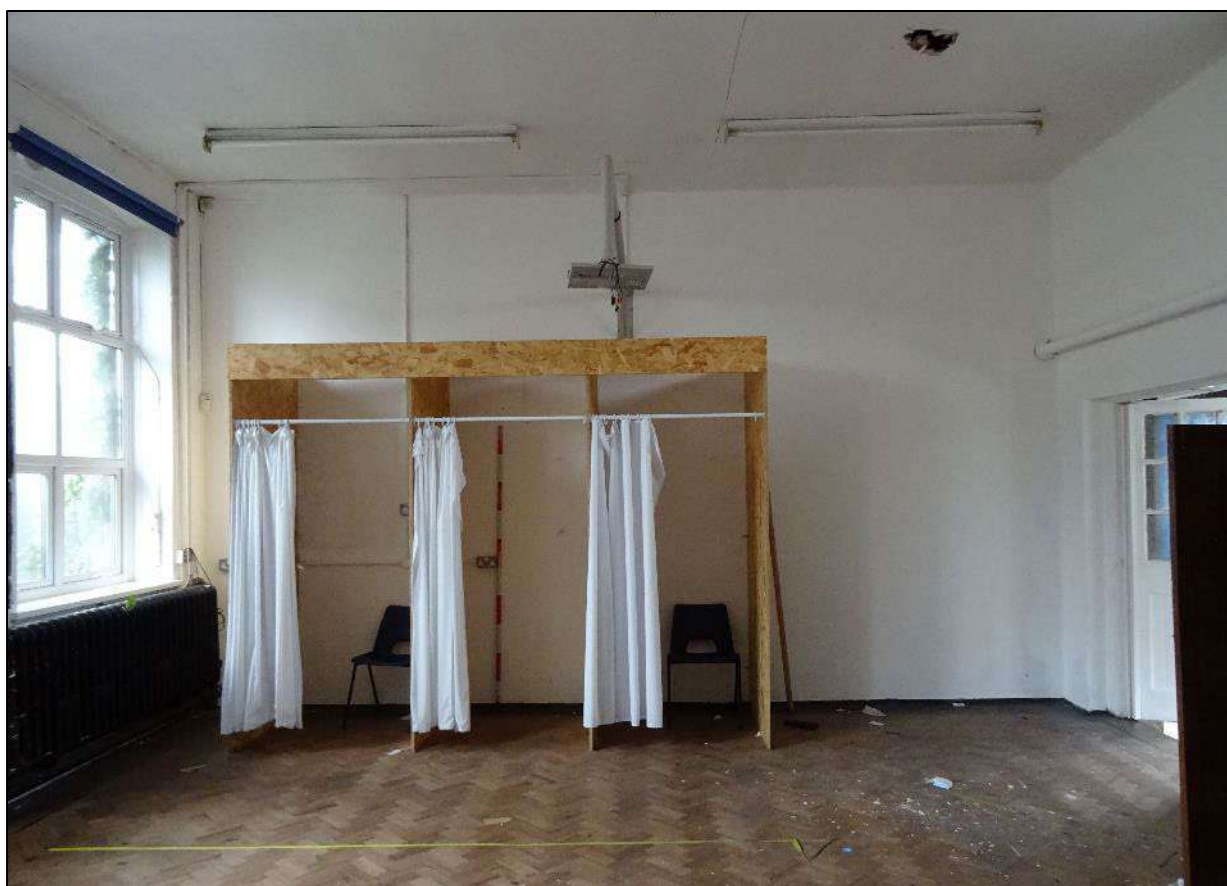
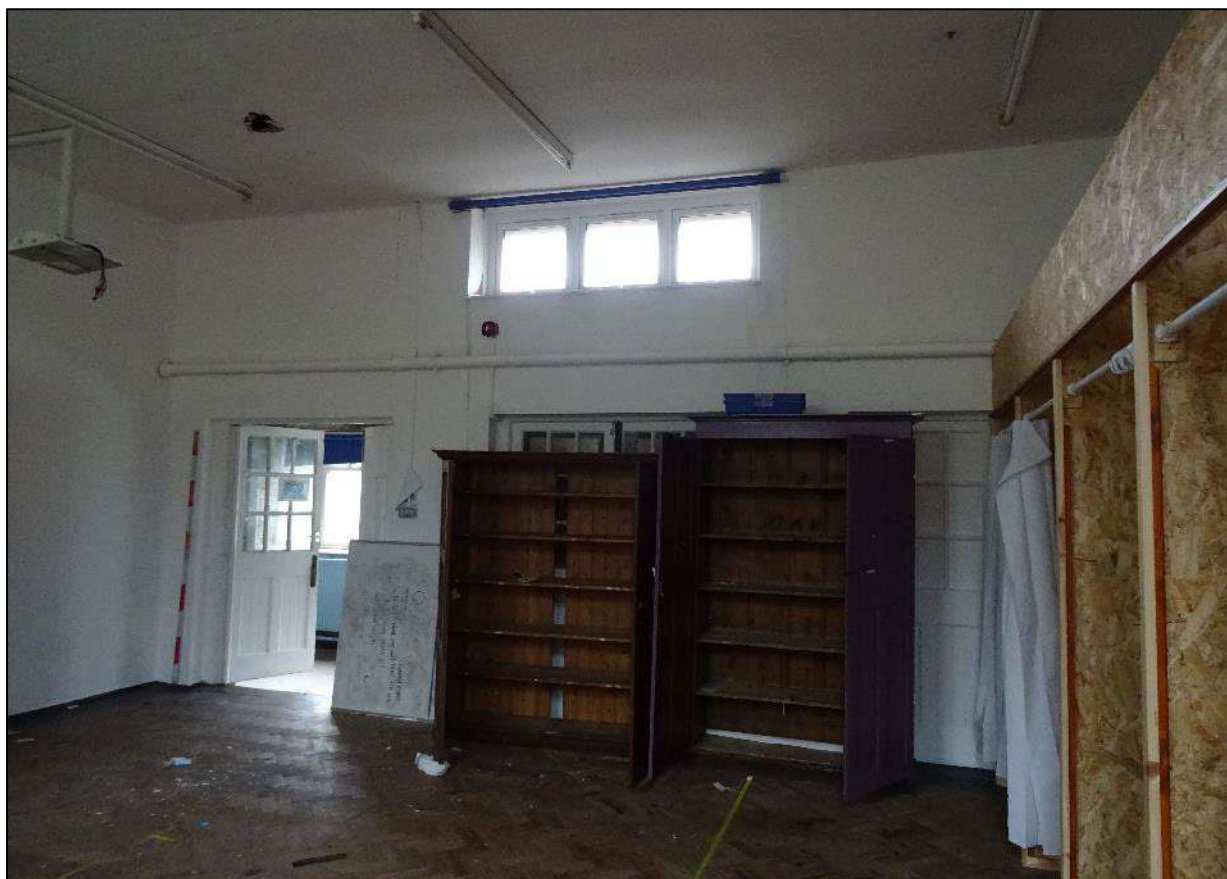
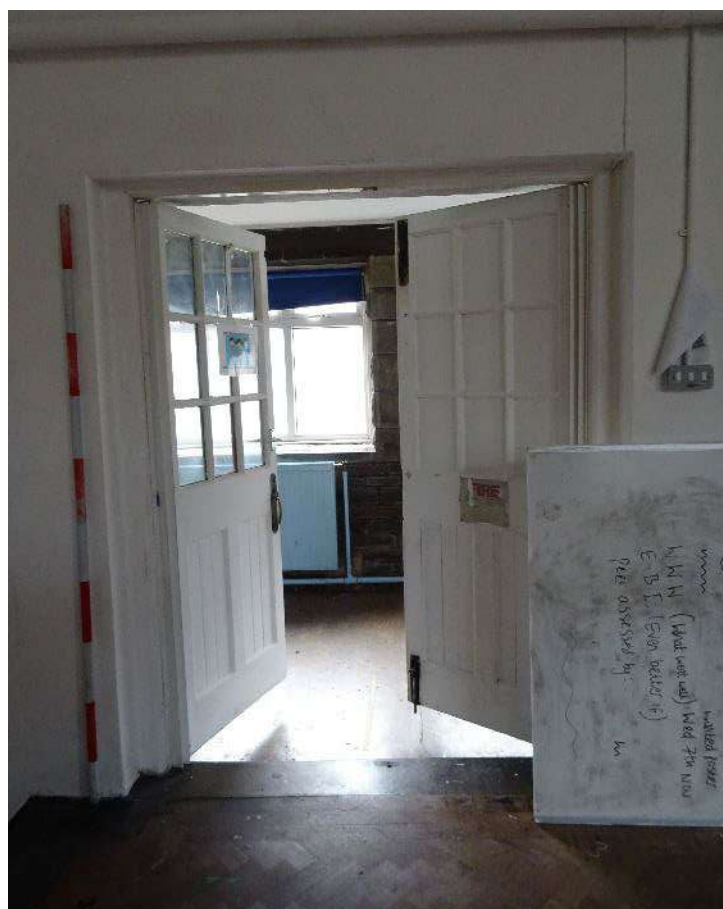
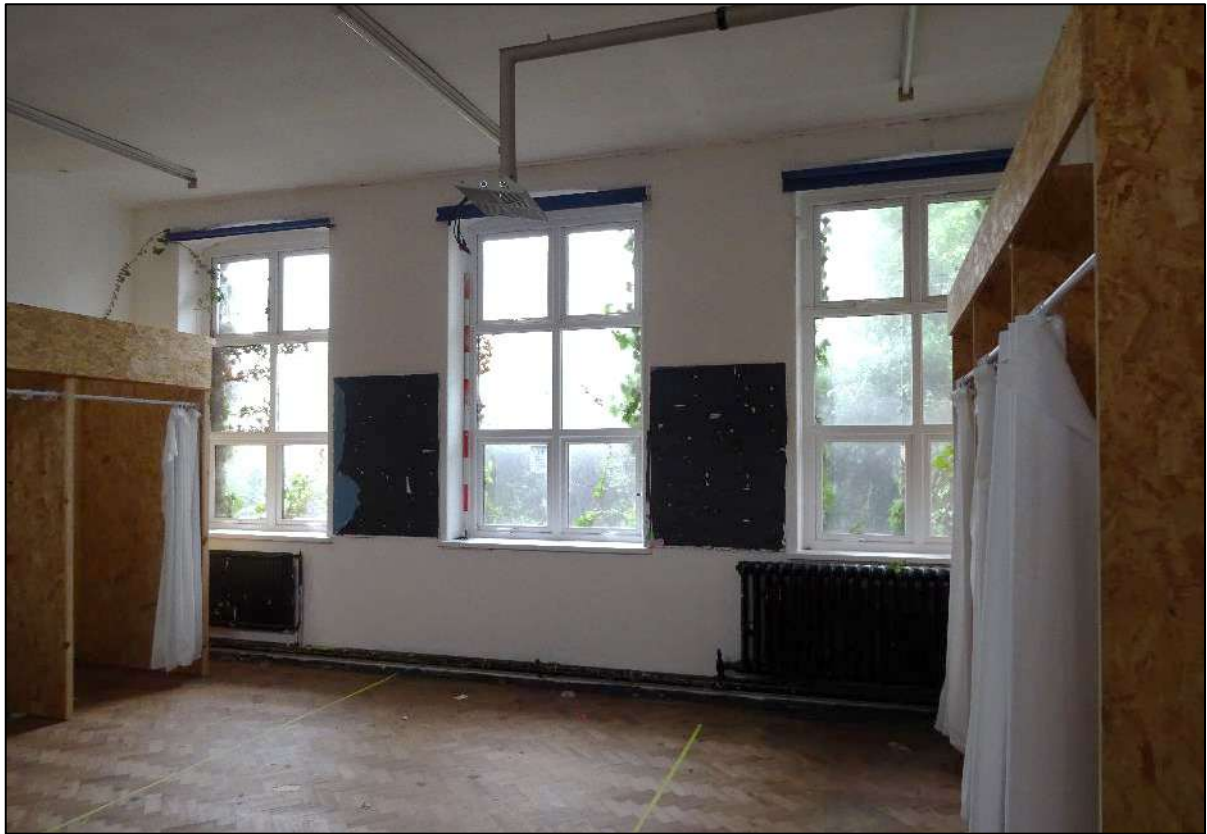
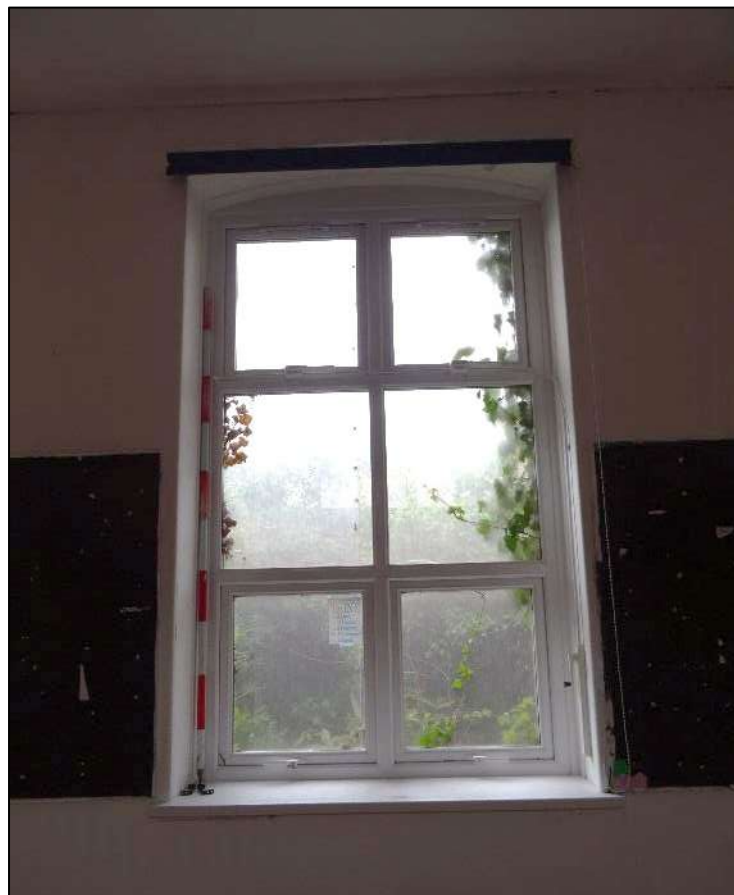
5.25.41. Room 13 is adjacent to Room 12 to the north-west and is essentially the same as Room 12, with some superficial differences (Plates 326 – 330).
