**Level 2 Building Recording:**  
**Former Dyffryn Lower School, Port Talbot**

March 2024

Report No. 2278

Prepared for KEW Planning  
By  
Susan Stratton PhD

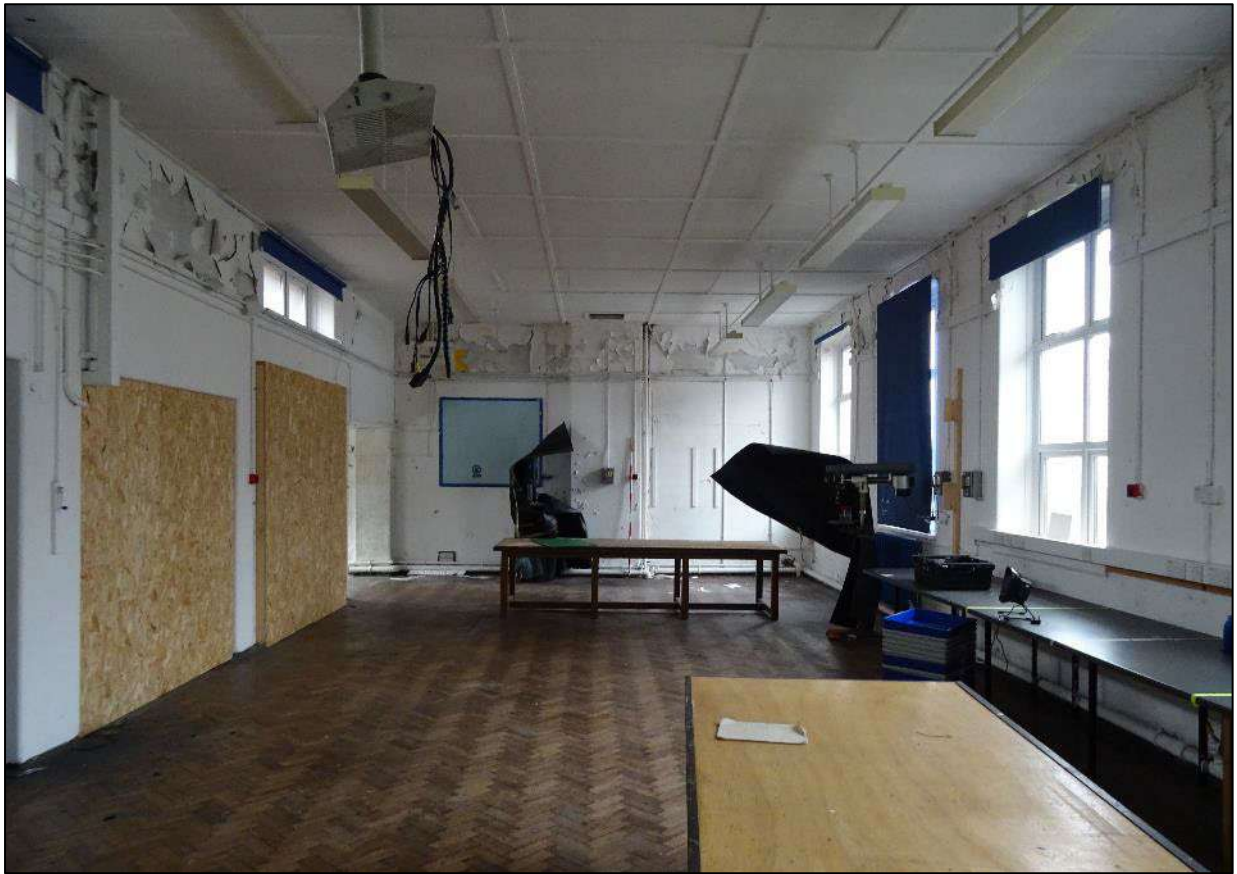
5.25.42. Room 14 is a large, L-shaped room at the north end of the single storey section of the main range. It has a herringbone parquet floor, painted plaster walls and a wooden panelled ceiling (Plates 331 and 332). To the north-west end, the room steps out to the south-west, into the flat roofed section of the range. This area has a polished concrete floor and a lower ceiling (Plate 333).

5.25.46. The line of the inner south-west wall is continued by two square columns with flat arch openings (Plates 331 and 332). The southern two have recently been boarded with chipboard.

*Plate 331. Room 14, Building 4, looking north-west. Scale 2m.*

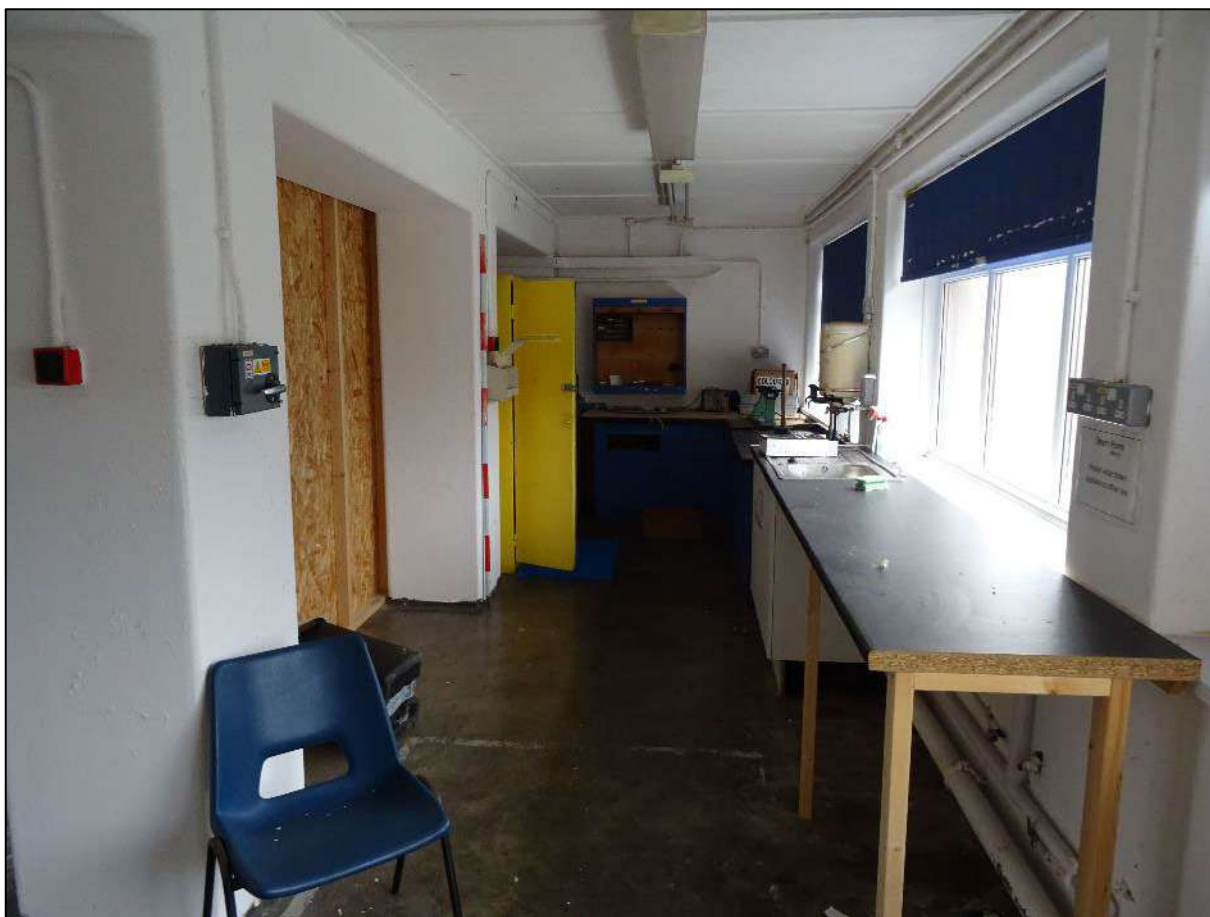
*Plate 333. South-west side of Room 14, looking south-east. Scale 2m.*

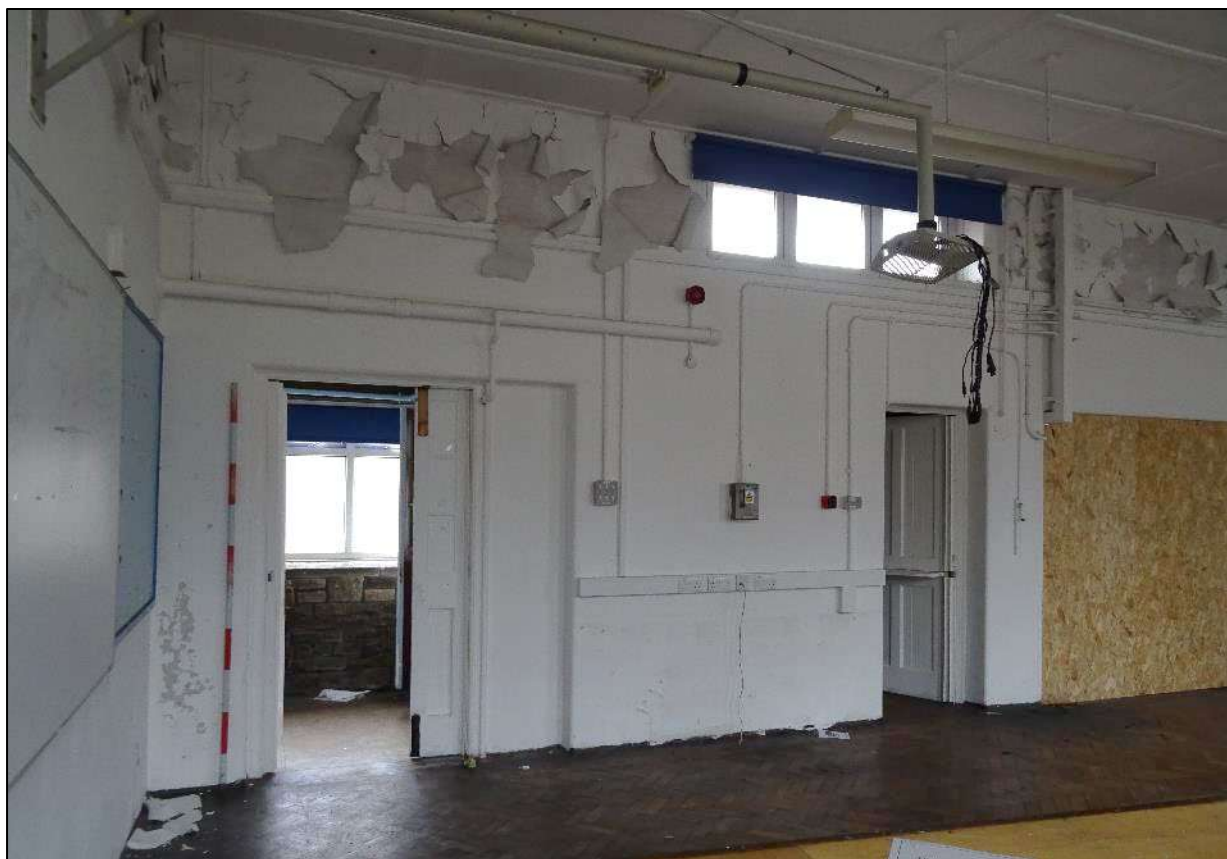
5.25.43. The door from corridor Room 11 is to the left of the south-west wall (Plate 334). The door is as described above (Paragraph 5.25.34), but to this side can be seen to be in a double width flat arch with rounded edges.

*Plate 334. Room 14, Building 4, looking south-west. Scale 2m.*

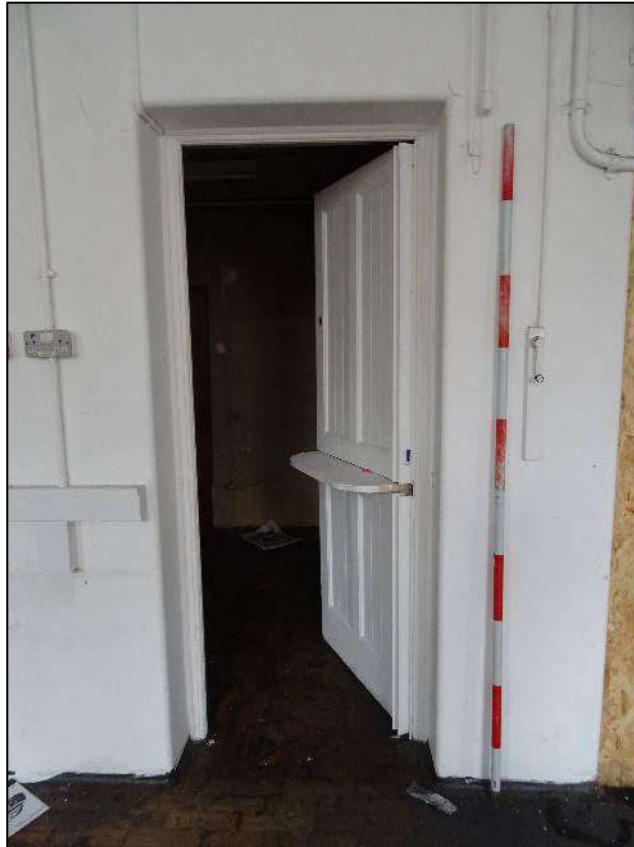
5.25.44. There is also a door to a small store, Room 15, to the right. It is wooden four fielded panel door with a small shelf added to the centre (Plate 335). The frame is moulded wood, painted white. It is recessed in a flat arch headed surround with painted plaster reveals and rounded edges.

*Plate 335. Door to Room 15 from Room 14, looking south-west. Scale 2m.*

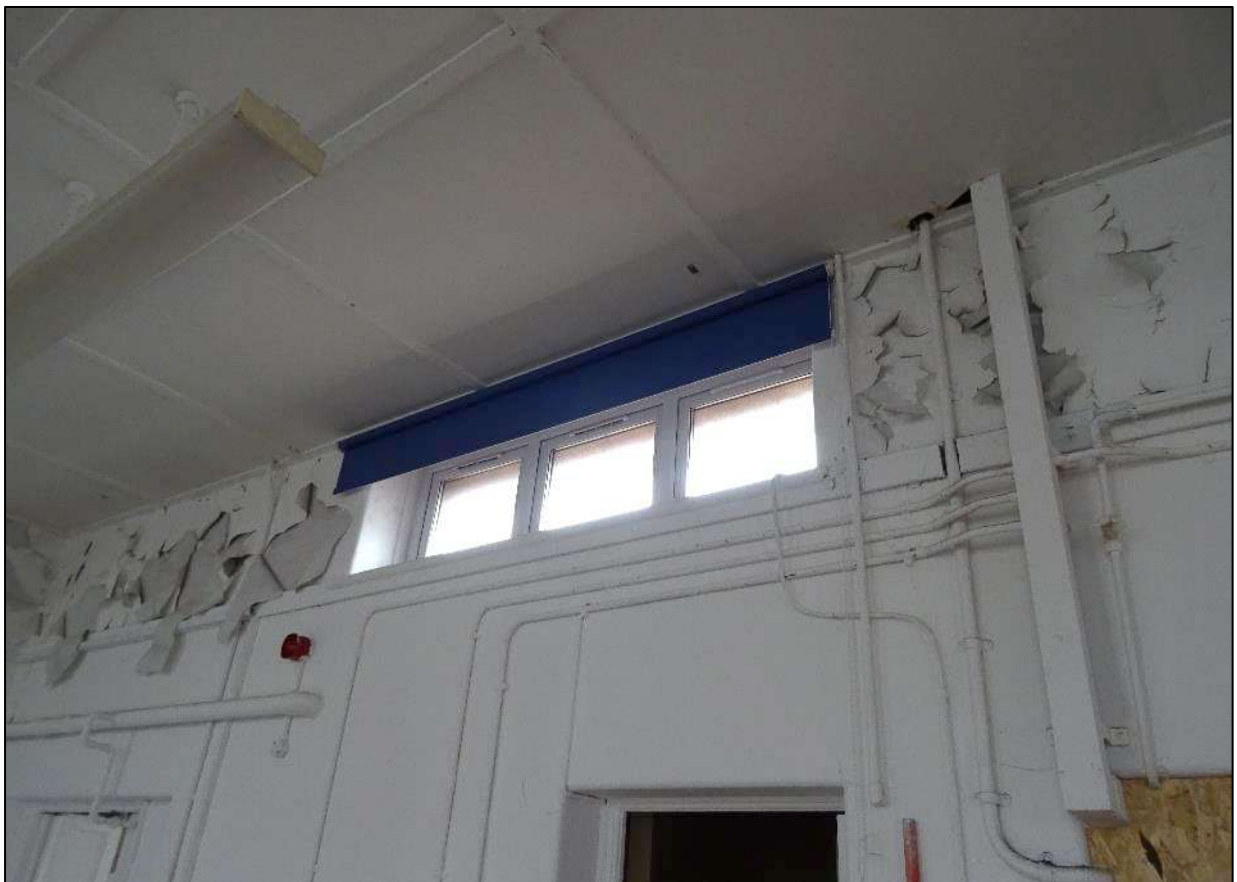
surround, and a moulded wooden sill (Plate 336).

5.25.47. The south-west wall of the stepped-out section has three windows (Plate 336). They are uPVC units with sills in a flat arch headed recess with painted plaster reveals and rounded edges.

*Plate 336. Left-hand window to top of south-west wall, Room 14, looking south.*

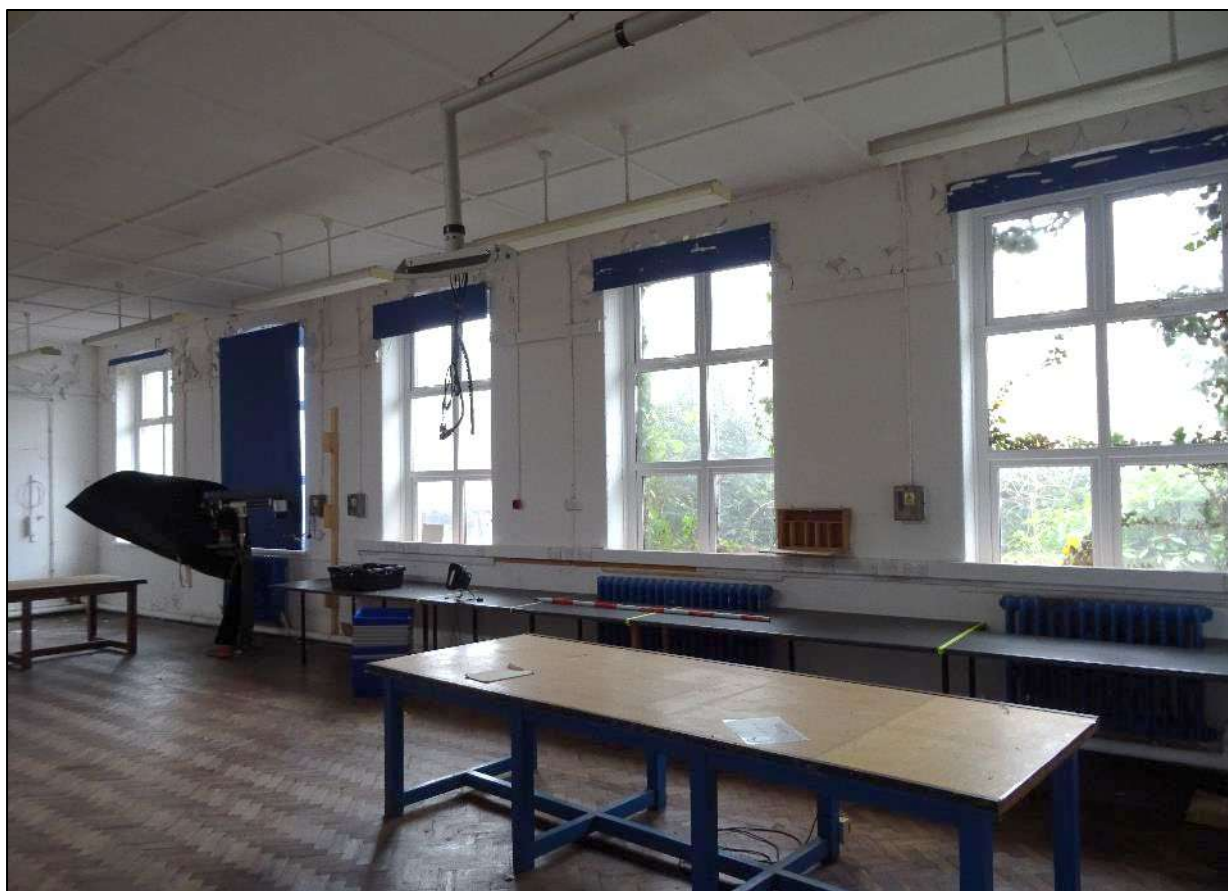
5.25.48. There are six large windows to the north-east wall, as those in Rooms 12 and 13 (Paragraph 5.25.40) (Plate 338).

*Plate 338. Room 14, Building 4, looking north. Scale 2m.*

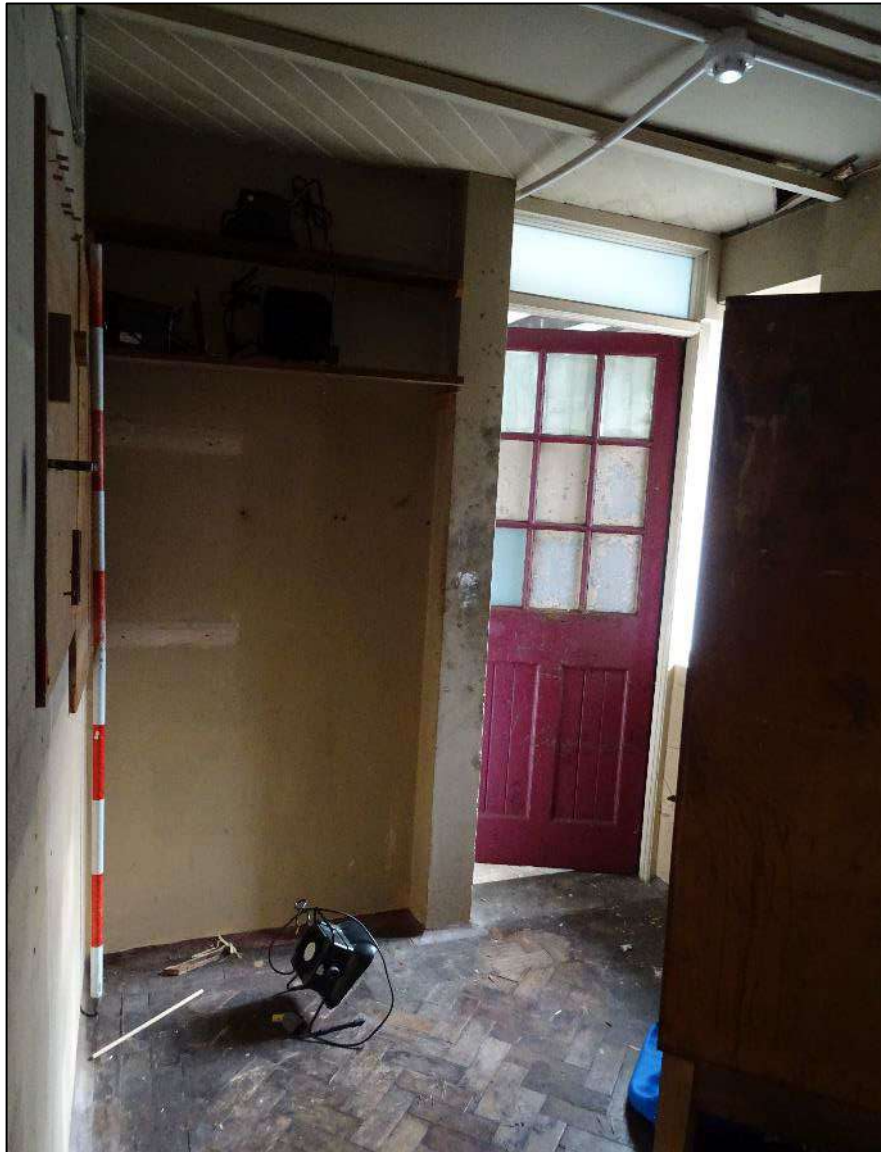
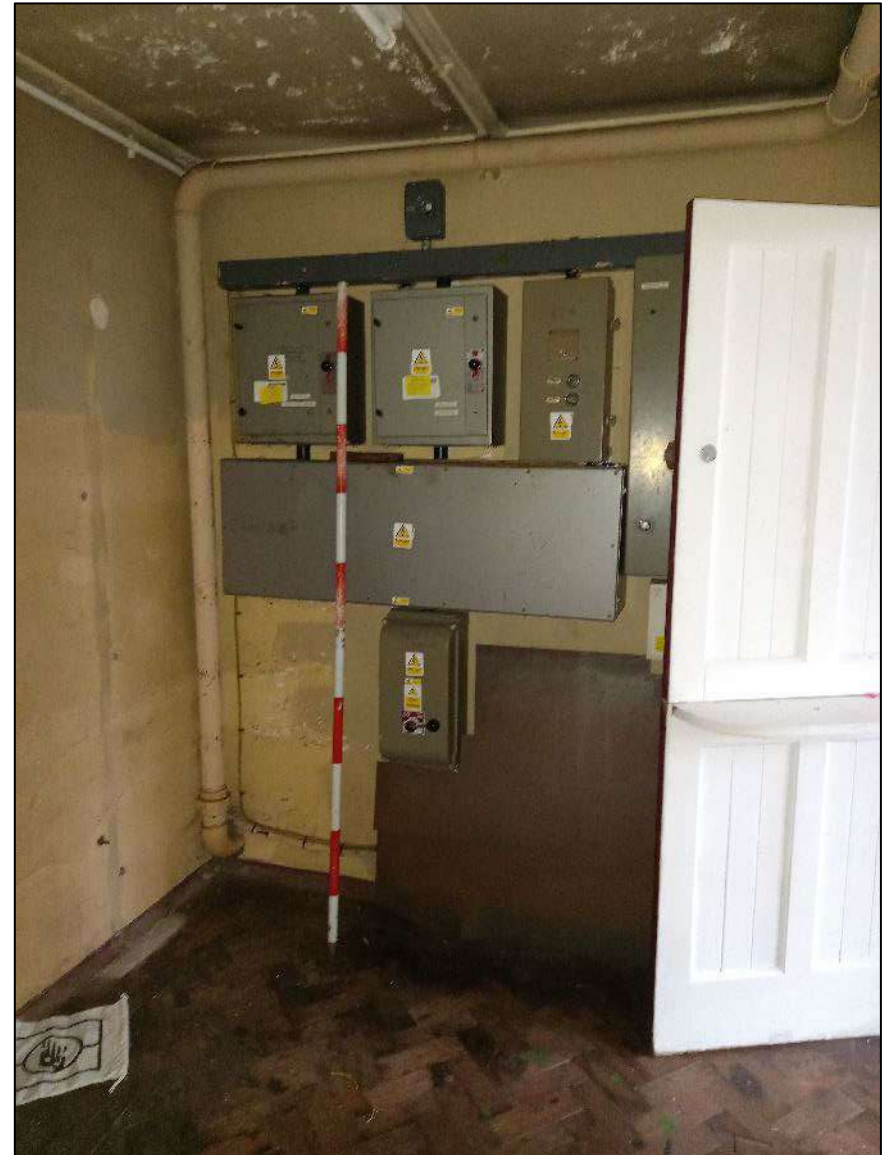
5.25.49. Room 15 is a small storeroom to the south-west of the single storey section, within the flat roofed element. It has a herringbone parquet floor, painted plaster walls and wooden panelled ceiling (Plates 339 and 340).

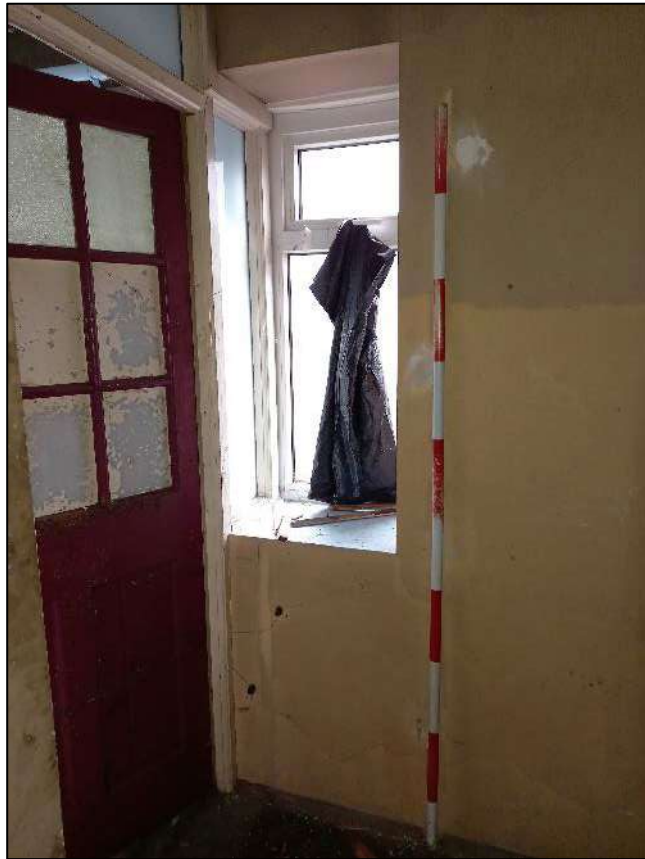
5.25.51. There is a window to the left side of the south-west wall (Plate 341). Originally part of one of the large windows to Room 11, it is in a flat arch headed recess with painted plaster reveals and sill.

*Plate 341. Window to south-west wall of Room 15, looking south. Scale 2m.*

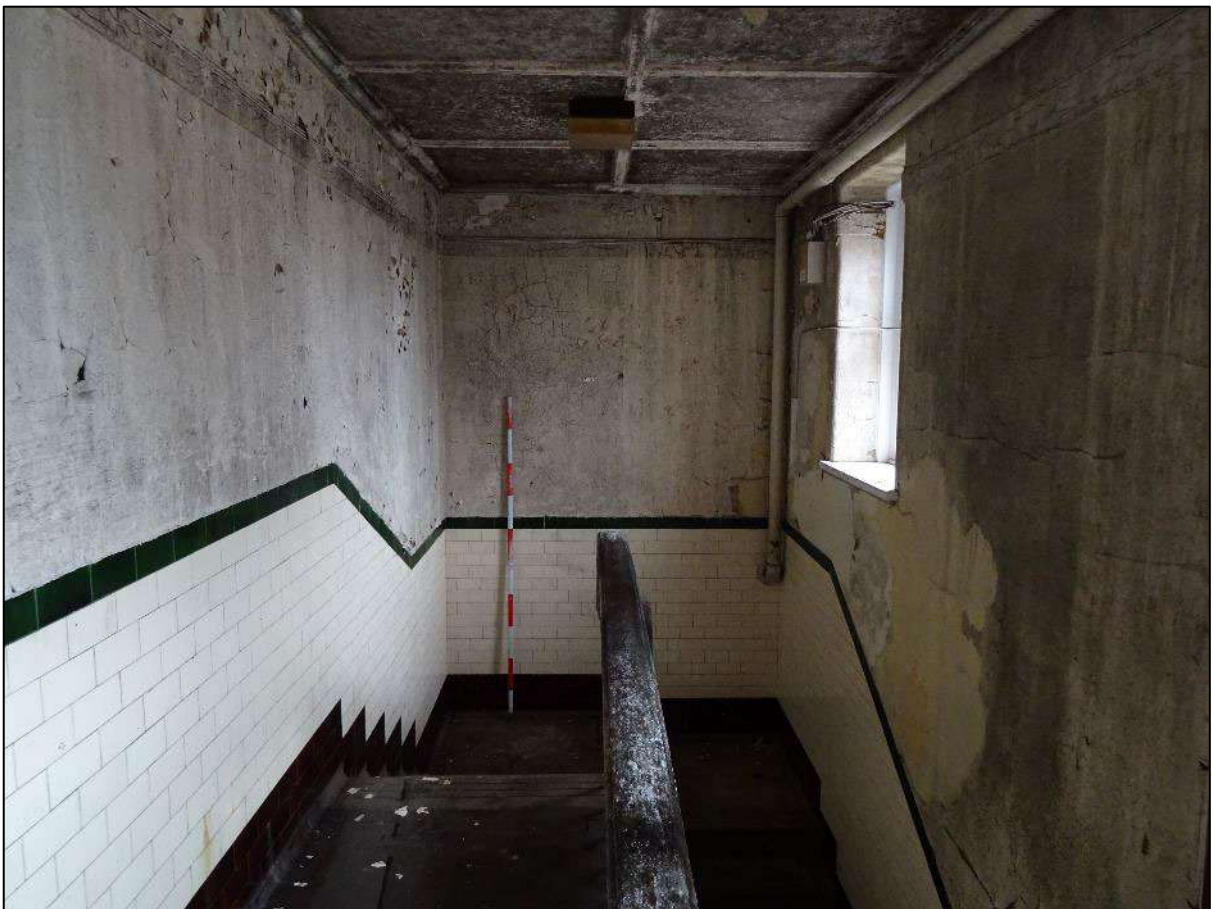
5.26.1. The first-floor landing is reached by the stairwell from Room 1, in the north corner of the building (Plate 342). It has a herringbone parquet floor. The tiled section to the lower walls is a continuation of that to Room 1, with a white central section, brown band to the bottom and green to the top (Plate 343). The ceiling is wooden panelled (Plate 344).

*Plate 342. Stairs from Room 1, Room 16, looking south-east. Scale 2m.*

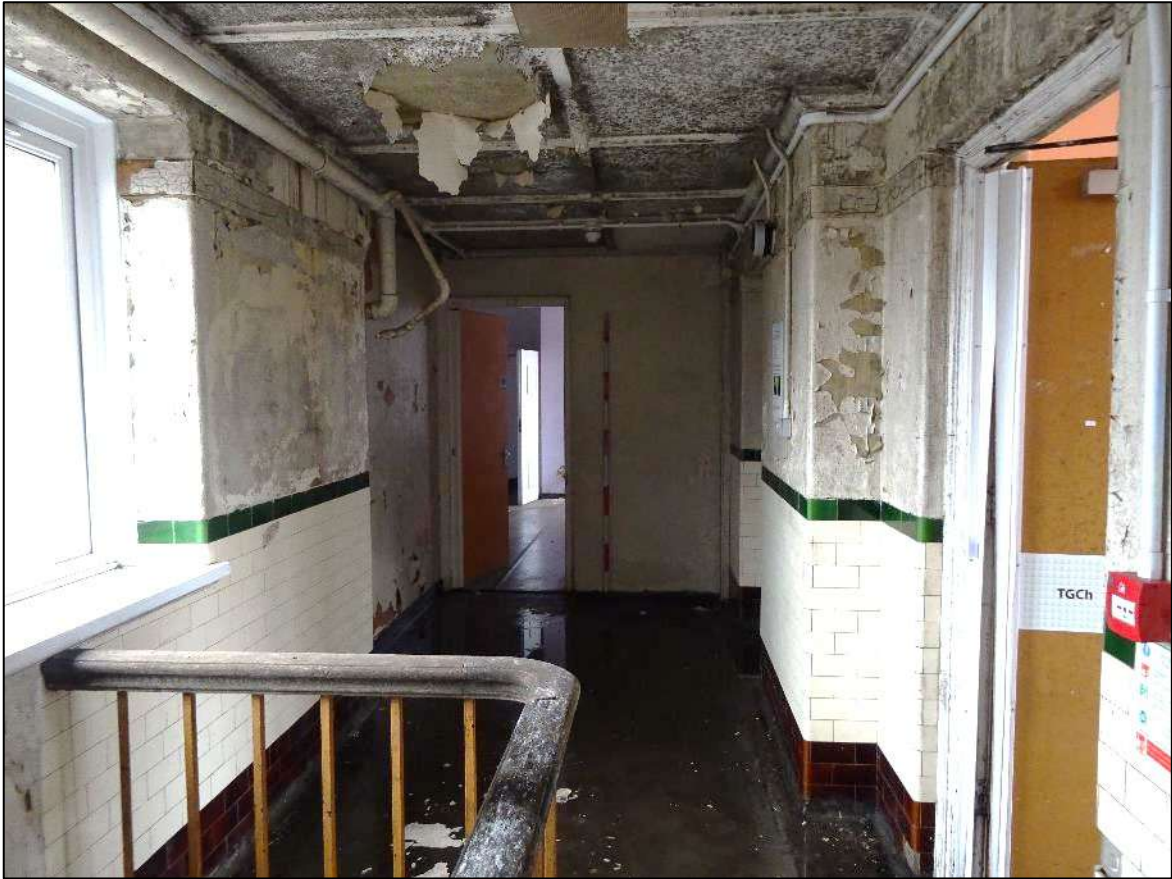
*Plate 343. Landing, Room 16, looking north-west. Scale 2m.*

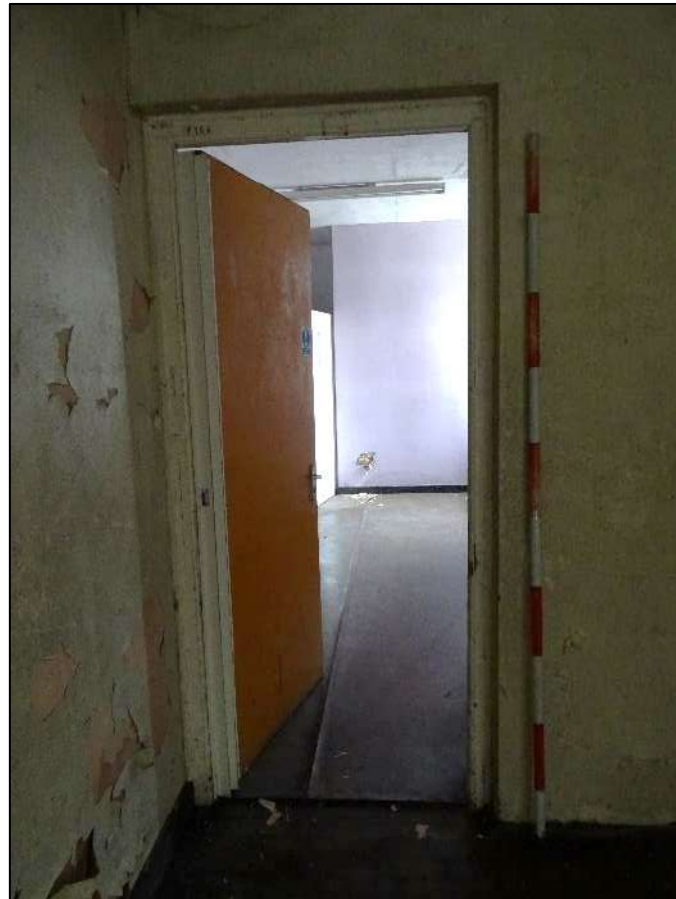
*Plate 344. Doorway from Room 16 to Room 17, looking north-west. Scale 2m.*

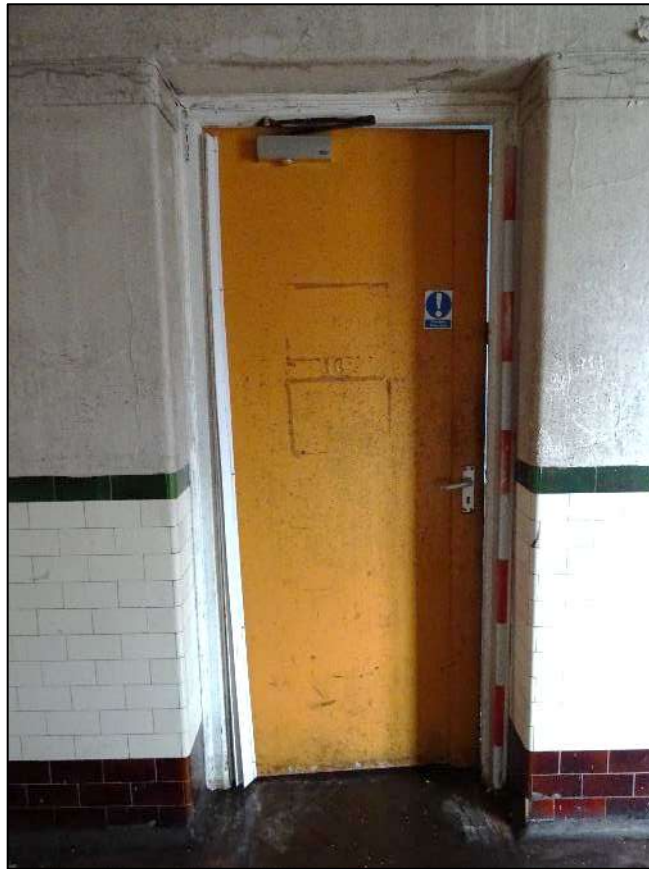
- 5.26.3. There are two doors on the north-east wall, one to Room 19 and one to Room 20. They are both solid wood doors, painted orange, in a white painted moulded wood frame (Plate 345). They are recessed, with the tiling and painted plaster to the reveals as the wall, and rounded edged.
- 5.26.4. To the south-west wall are two windows (Plate 346). The window to the left is half the width of the right, but they are both in flat arch headed recessed with painted plaster reveals and uPVC sills over the original wooden sills (Plates 347 and 348).

*Plate 345. Door to Room 19 from Room 16, looking north-east. Scale 2m.*

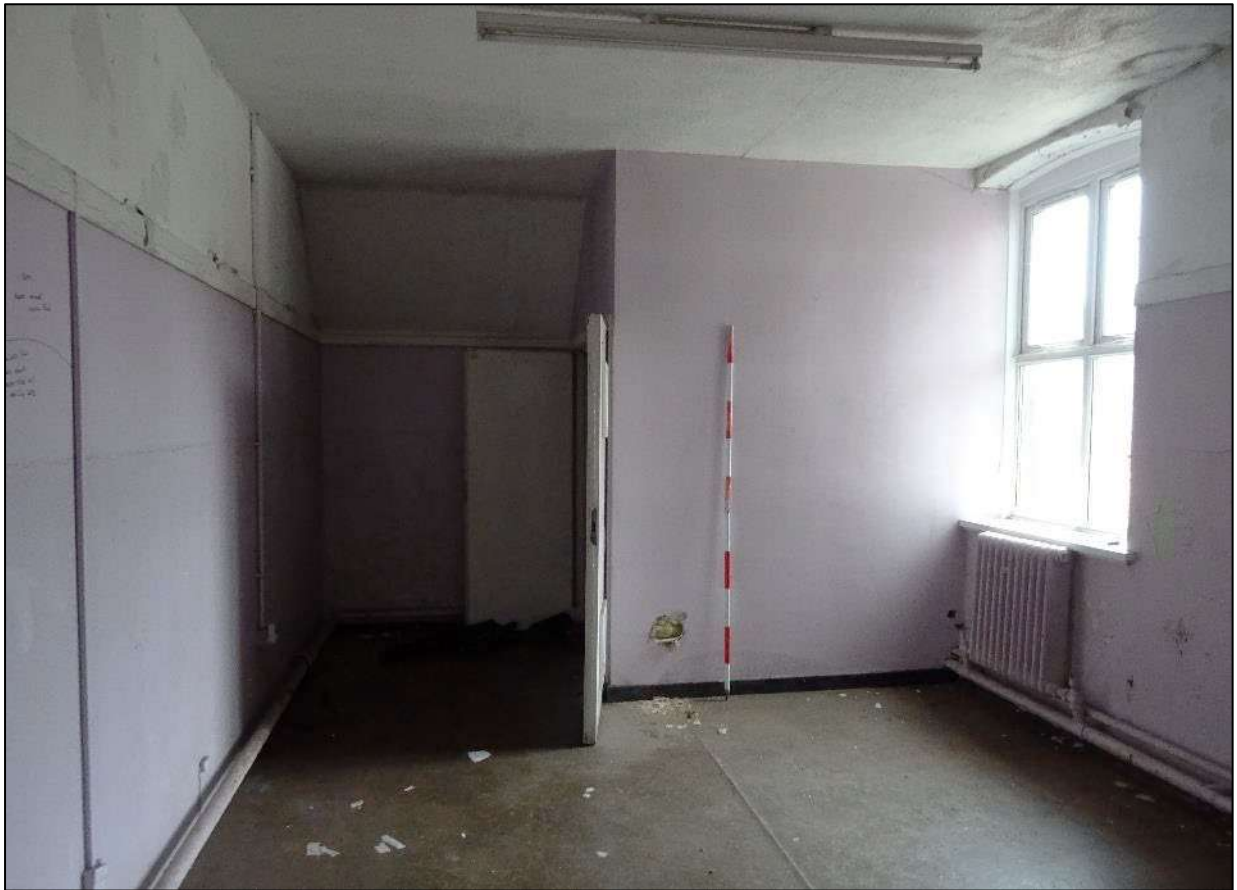
- 5.26.5. Room 17 is a small room within the north-east end of south-west wing. It has linoleum flooring and painted plaster walls and ceiling. There is a tank room in the north corner with stud walls (Plate 349).

- 5.26.8. There is a segmental arch headed window to the north-east wall, with painted plaster reveals and uPVC sills (Plate 349). There is a small cast iron column radiator below.

*Plate 349. Room 17, Building 4, looking north-west. Scale 2m.*

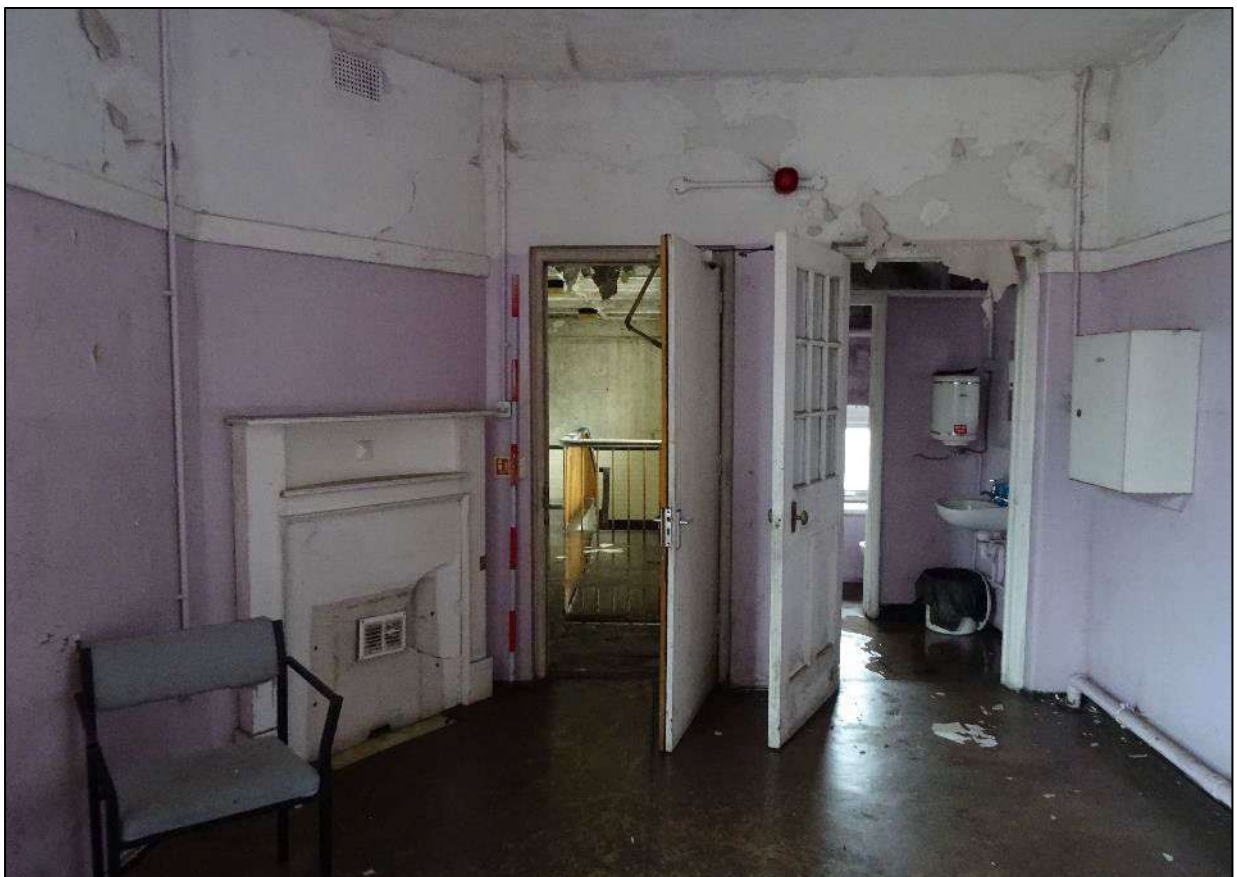
- 5.26.6. The door from Room 16 is to the left of the south-east wall (Plate 350). To the right is a door to Room 18. It is a white painted wooden door with two fielded panels to the bottom and a nine-light glazed panel to the upper (Plate 351). It has a white painted moulded wooden frame in a rounded edge surround.

*Plate 350. Room 17, Building 4, looking south-east. Scale 2m.*

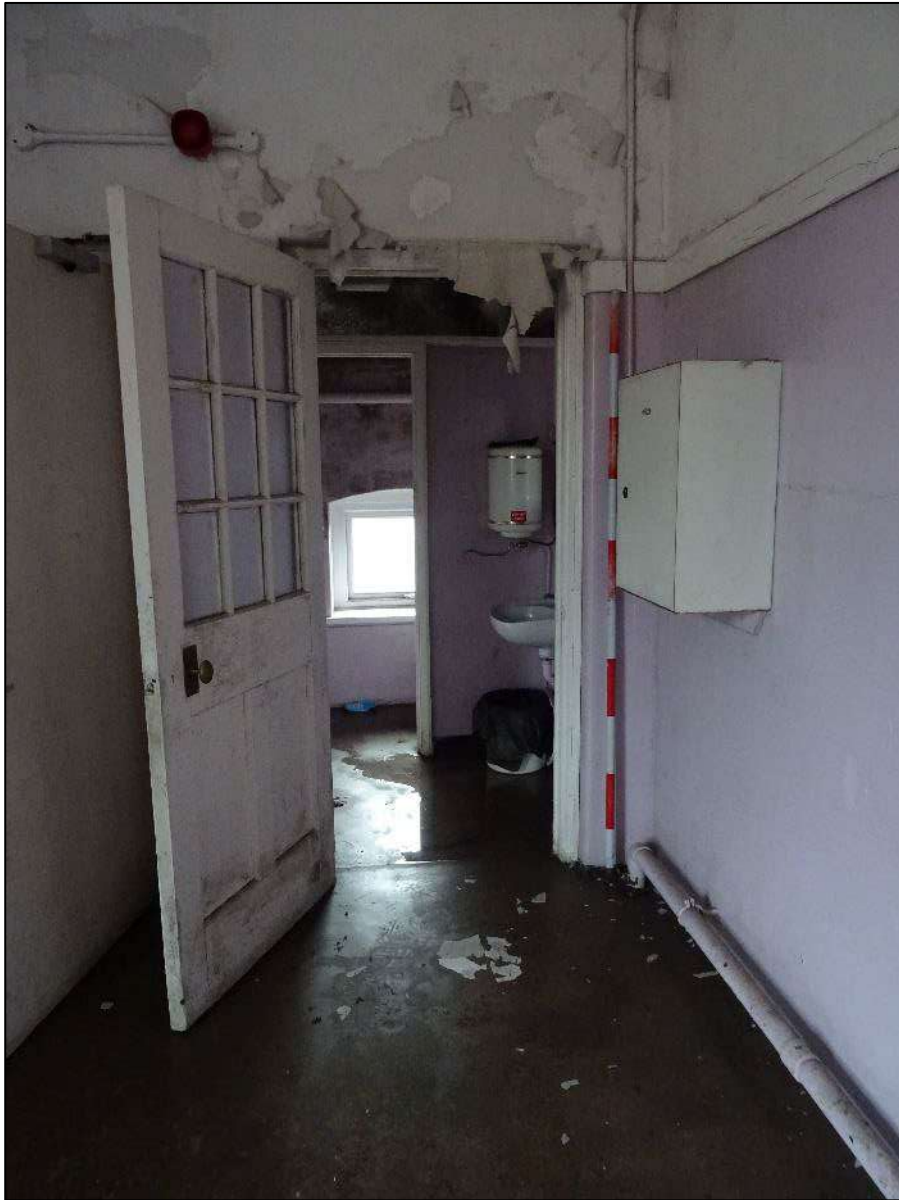
*Plate 351. Door to Room 18 from Room 17, looking south-east. Scale 2m.*

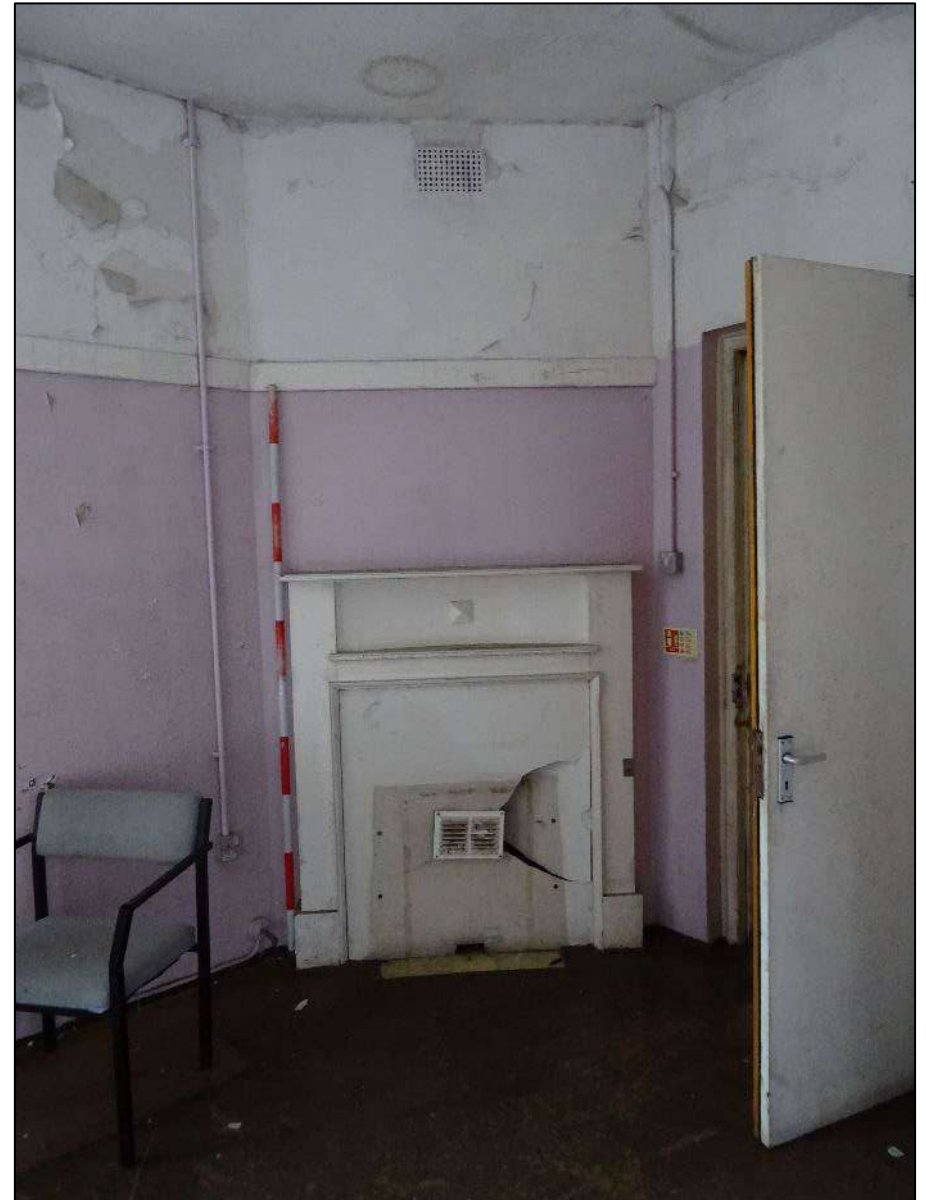
*Plate 352. Fireplace in east corner of Room 17, looking east. Scale 2m.*

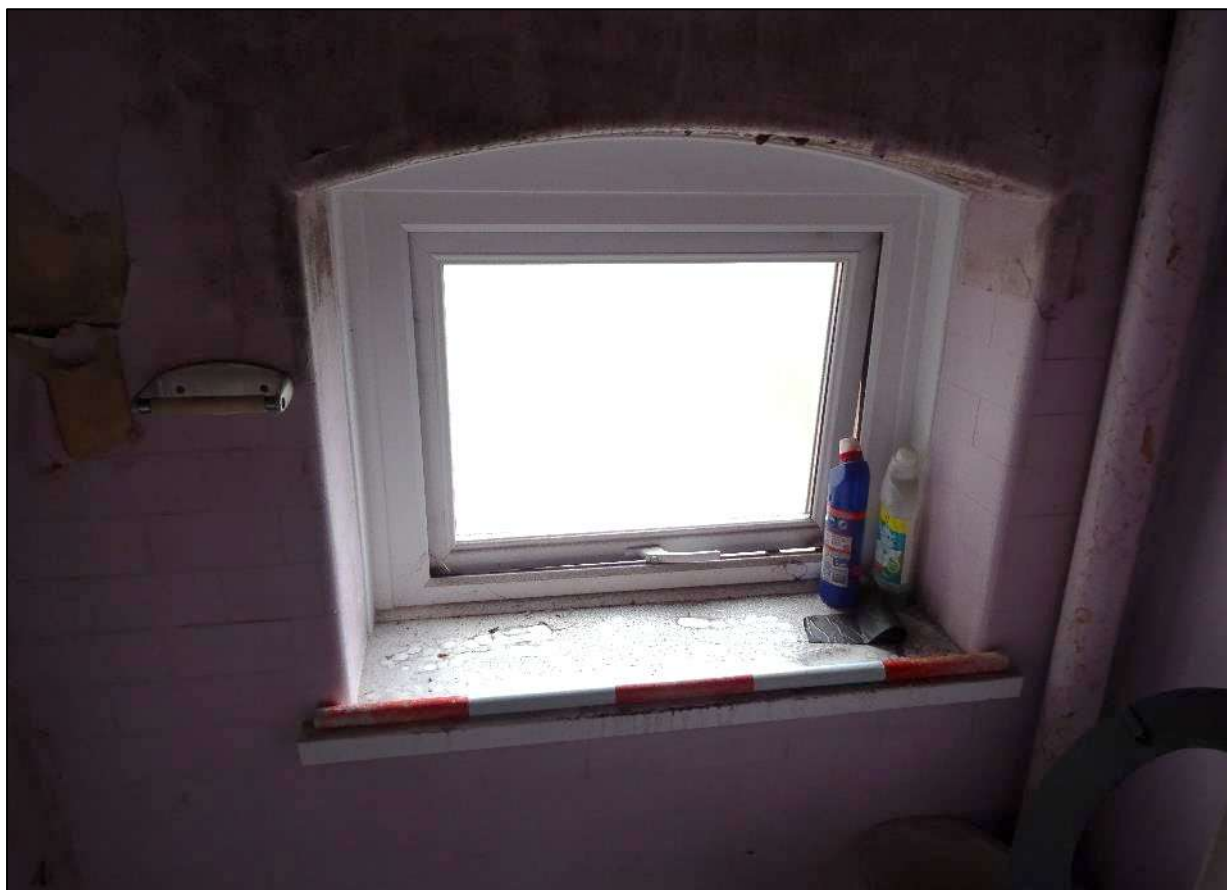
*Plate 356. Window to centre of south-east wall of Room 18, looking south-east. Scale 0.5m.*

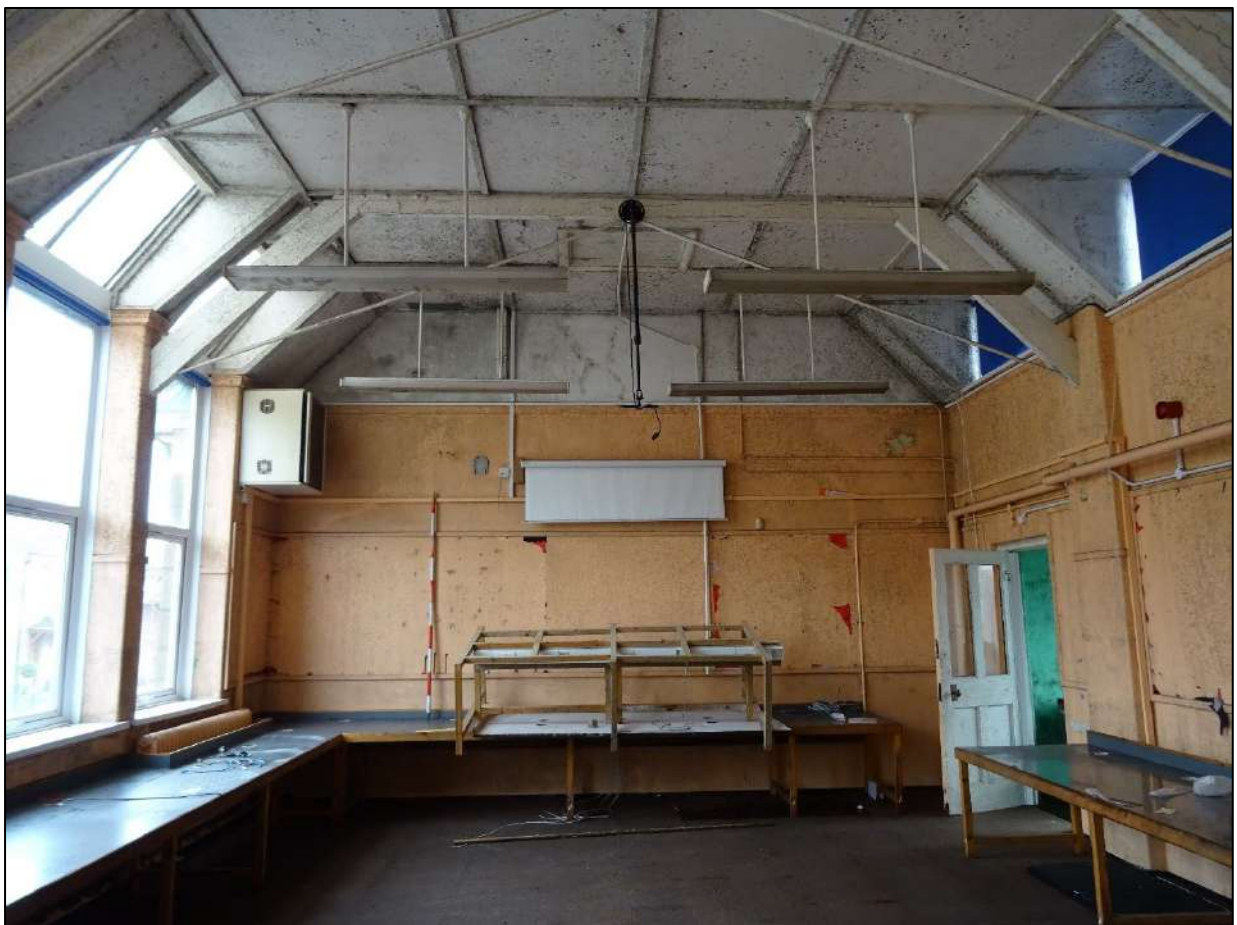
5.26.18. Along the top of the south-west wall are four dormer windows (Plate 364). They have wooden panels to the reveals.

*Plate 364. South-west wall, looking south. Scale 2m.*

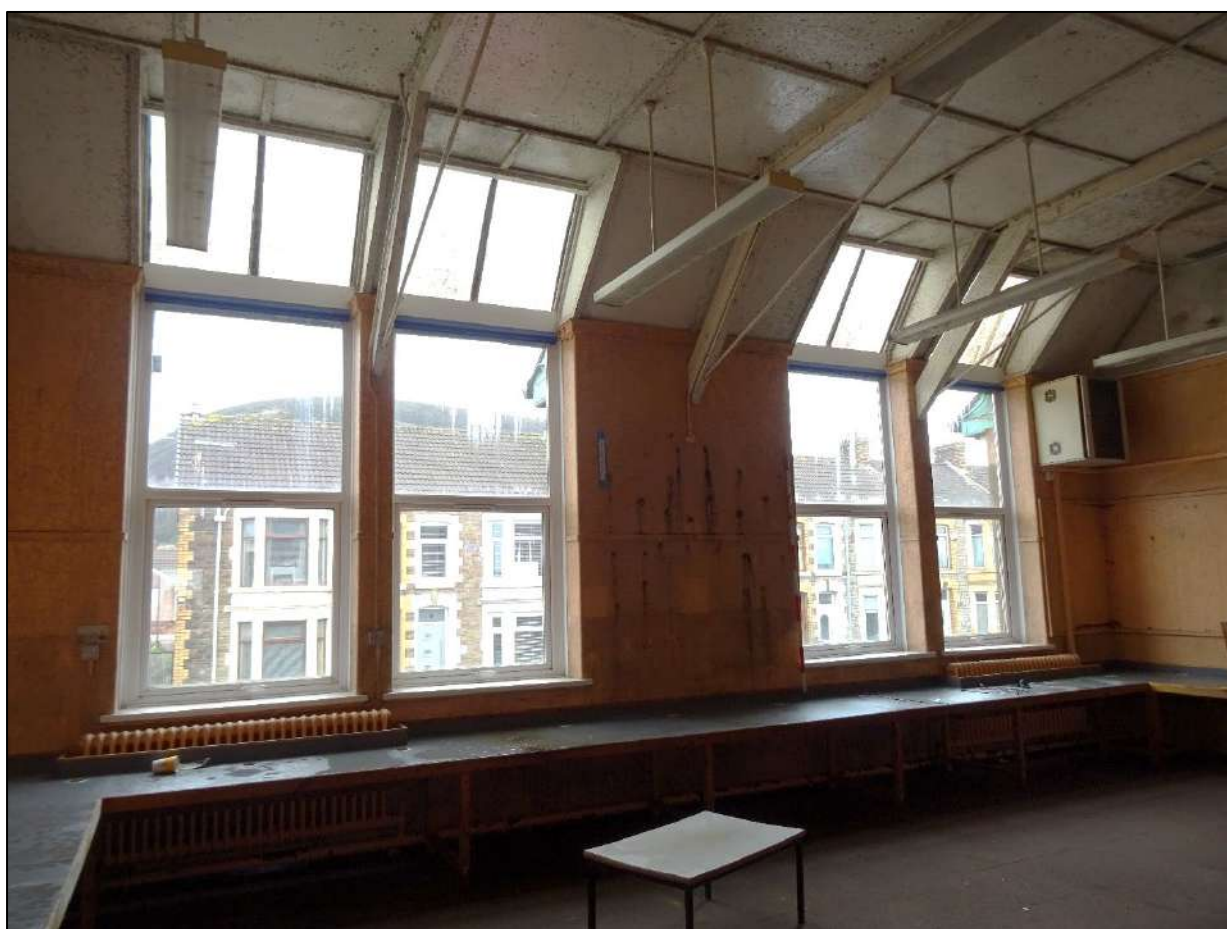
5.26.19. There are two large through-the-cornice mullion windows to the north-east wall (Plate 367). They have painted plaster reveals and uPVC sills. Each has a cast-iron column radiator below.

*Plate 367. Room 20, Building 4, looking east.*

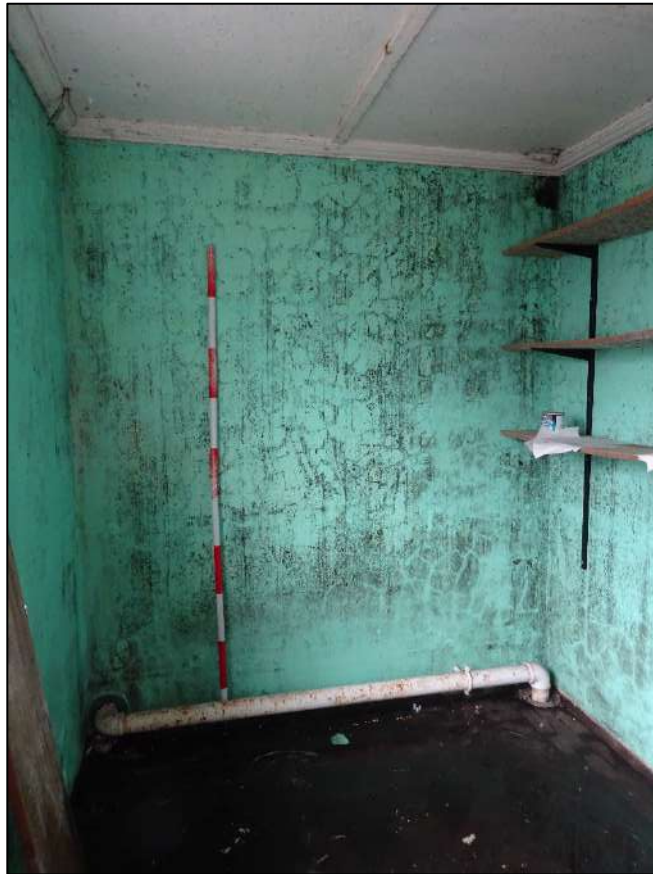
5.26.20. Room 21 is a small office room to the south-west of Room 20. It has herringbone parquet flooring and painted plaster walls with a moulded cornice (Plate 368). The ceiling is wooden panelled (Plate 369).

*Plate 368. Room 21, Building 4, looking north-west. Scale 2m.*

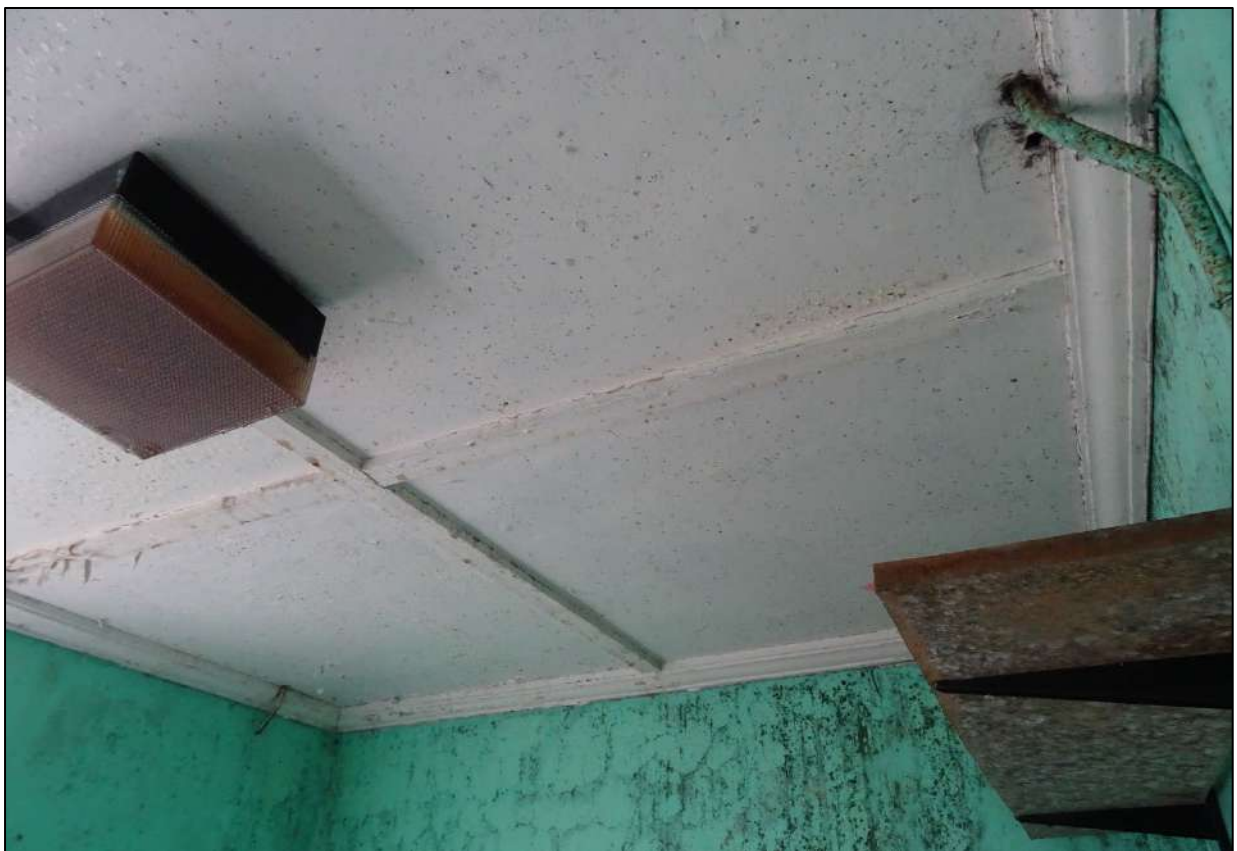
*Plate 369. Ceiling to Room 21, Building 4, looking north-west.*
