**Level 2 Building Recording:**  
**Former Dyffryn Lower School, Port Talbot**

March 2024

Report No. 2278

Prepared for KEW Planning  
By  
Susan Stratton PhD

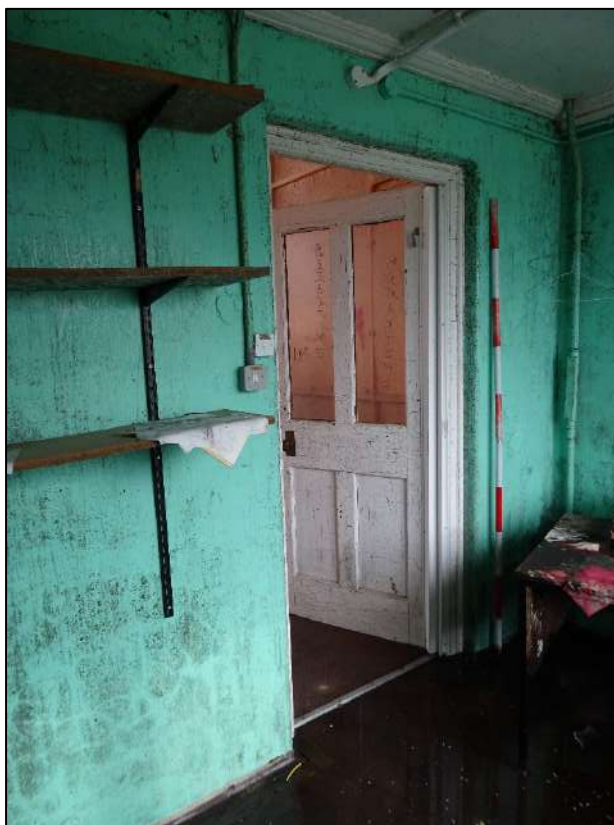
5.26.21. The door to Room 20 is to the right of the north-east wall and is as described in Paragraph 5.26.17 (Plate 370).

*Plate 370. Door to Room 20 from Room 21, looking east. Scale 2m.*

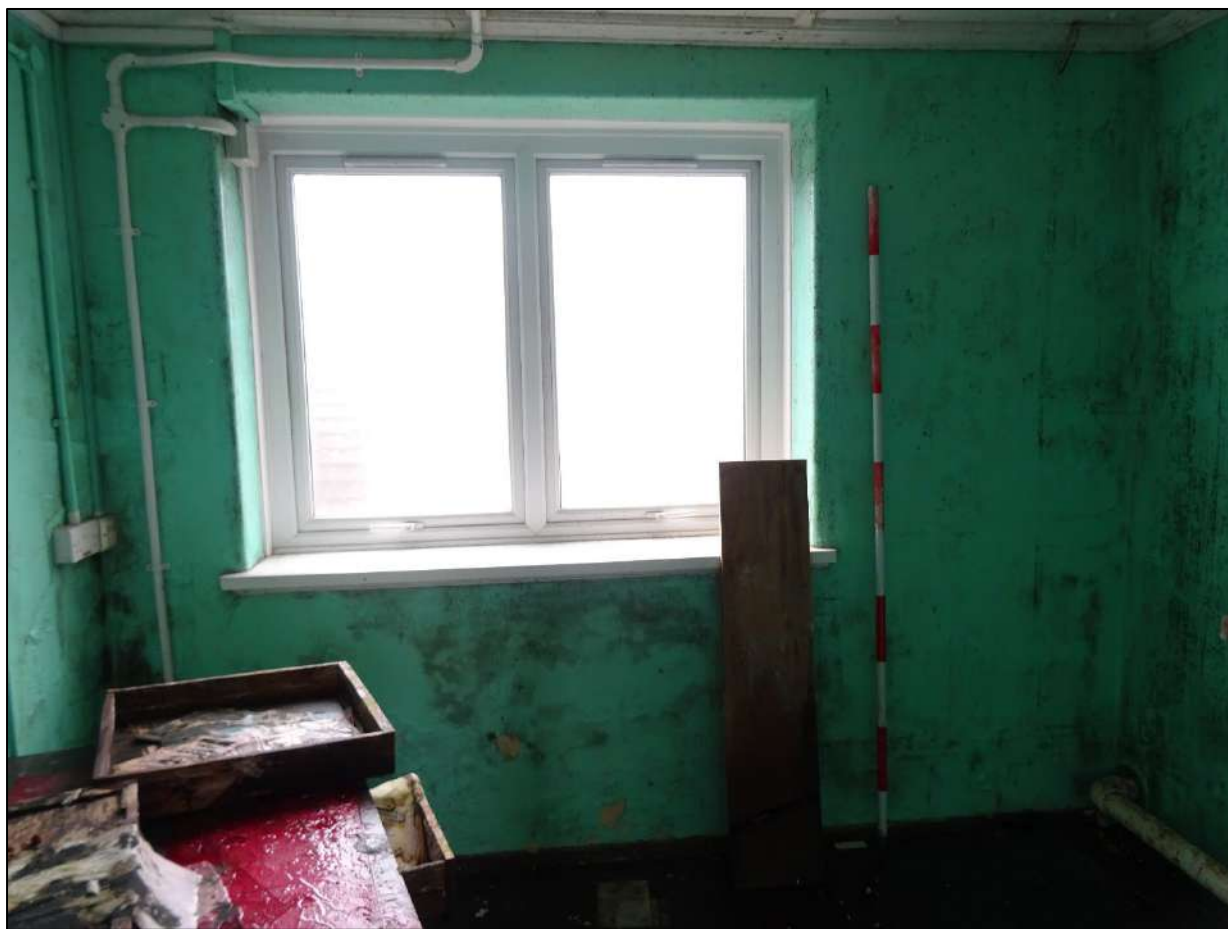
5.26.22. There is a window to the south-west wall (Plate 371). It has a flat arch headed recess with painted plaster reveals and a uPVC sill.

*Plate 371. Room 21, Building 4, looking south-west. Scale 2m.*

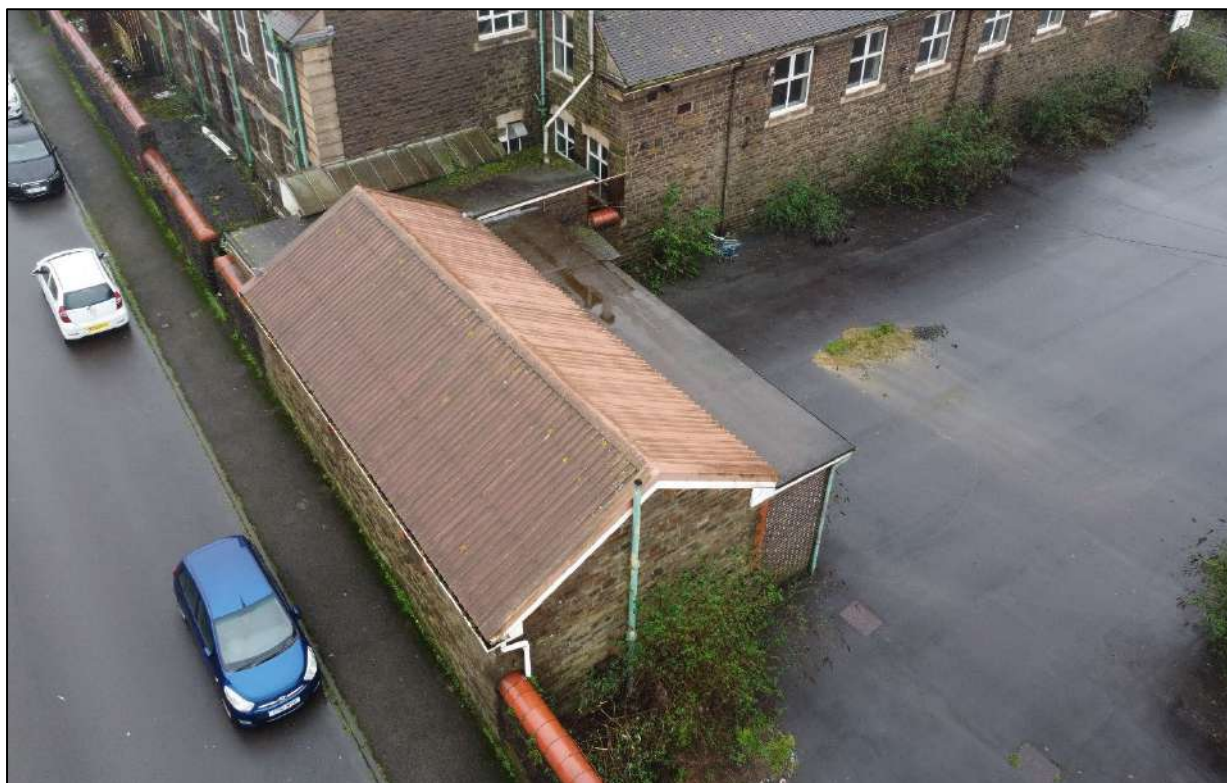
- 5.29.1. To the left of the north-west facing elevation is the gable end. It is of squared rubblestone, brought-to-course (Plate 374). To the right side it has toothed brick quoins (Plate 372). It has plastic bargeboards.
- 5.29.2. To the right is the side of the flat roofed section, built in brown brick.

*Plate 372. Drone shot with Building 5 to centre and Building 4 to rear, looking south. Photo courtesy of Roberts Limbrick.*

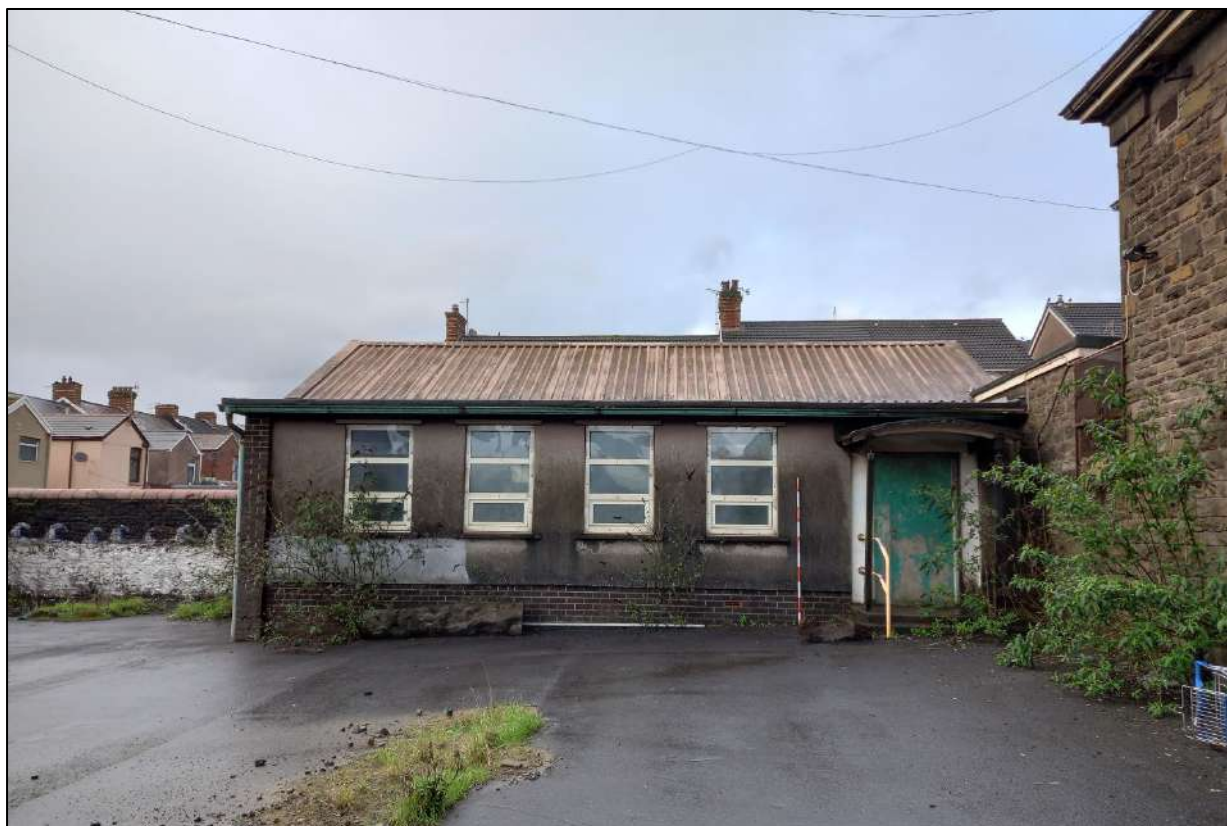
- 5.28.1. The front elevation is of the flat roofed element. It is cement rendered, with brown bricks to the base and quoin to the left side (Plate 373).
- 5.28.2. There is a door with segmental arch canopy supported with metal pillars to the right side of the elevation. The door is a metal security door. There is a plain white painted wooden surround with modern metal handrail to the left.
- 5.28.3. There are four windows to the elevation, all uPVC units covered by clear Perspex. They have narrow concrete sills and lintels.
- 5.28.4. The guttering is moulded stone, painted green.

*Plate 373. Front elevation of Building 5, looking north-east. Scale 2m.*

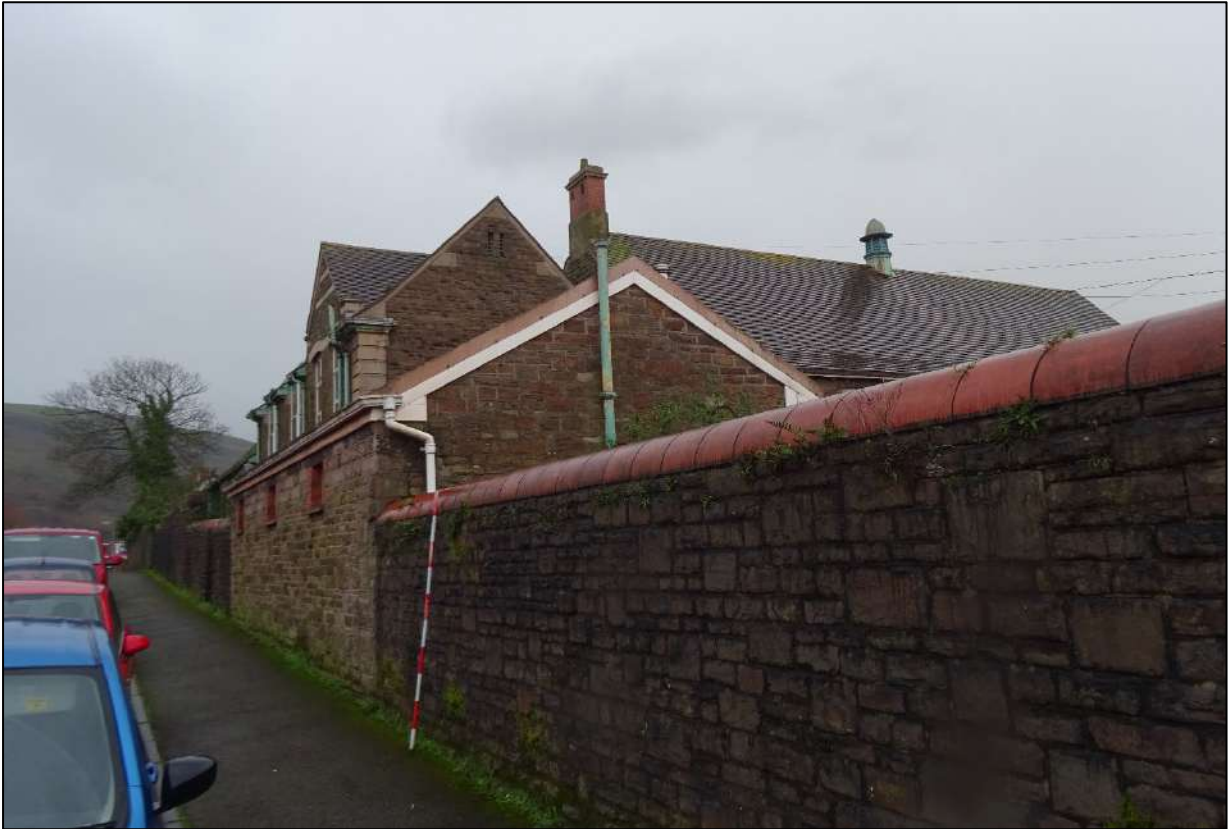
- 5.30.1. The north-east facing elevation sits on the site boundary, and it is keyed-in to the perimeter wall at either end (Plate 374). The elevation is of squared rubblestone, brought-to-course, but with three courses of rock-faced ashlar

*Plate 374. Building 5, looking south from York Place. Scale 2m.*

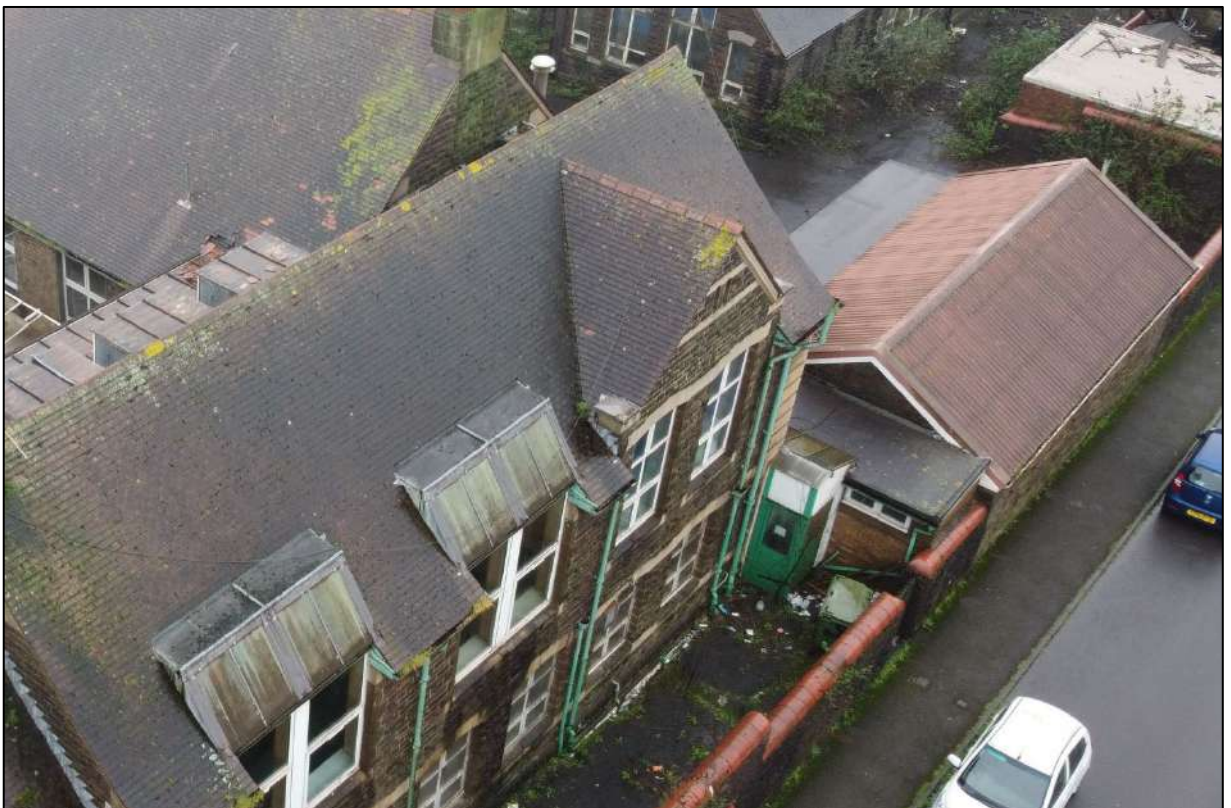
5.31.1. The south-east facing elevation is a gable end with projecting flat roof section (Plate 375). The gable is of squared rubblestone, and it has plastic bargeboards.

*Plate 375. Drone shot with south-east elevation of Building 5 to right, looking west. Photo courtesy of Roberts Limbrick.*

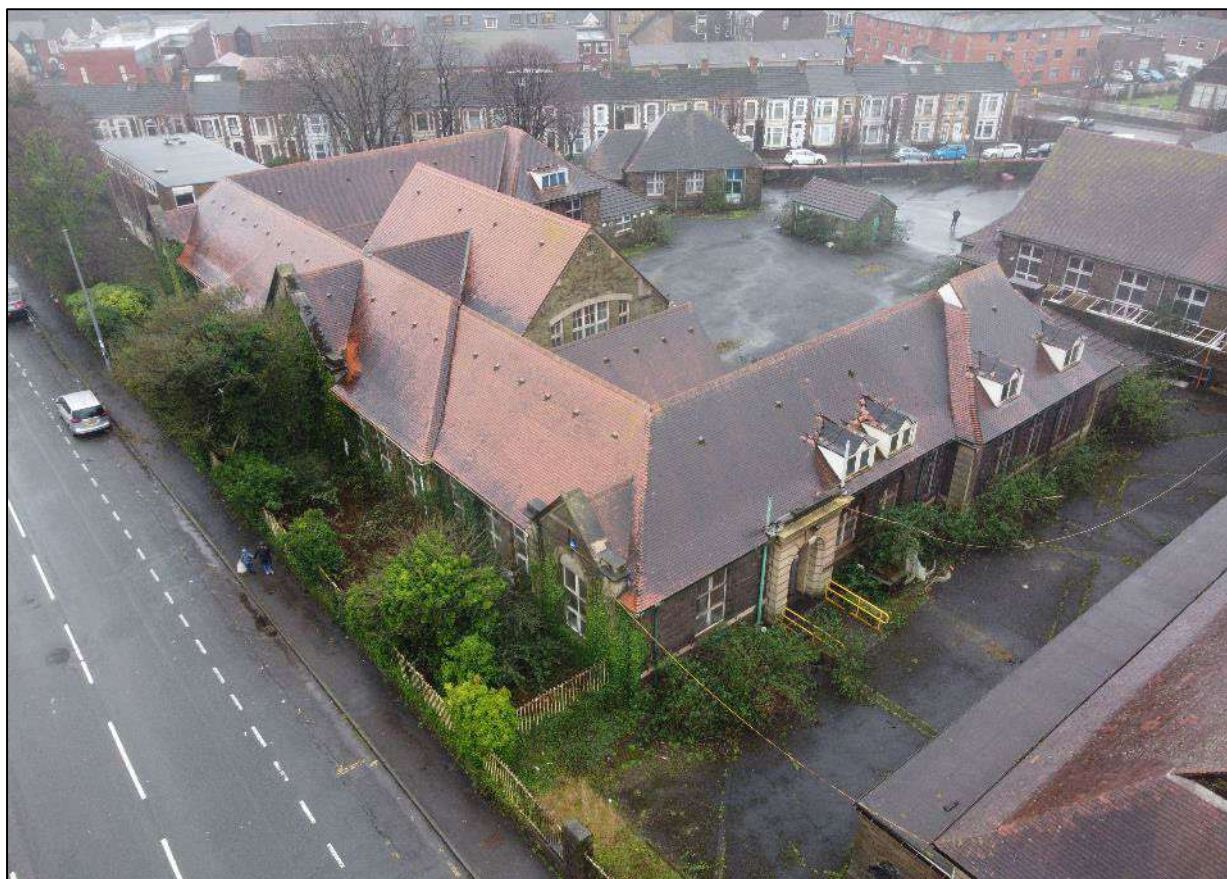
5.33.1. Building 6 is one of the original building school buildings. It is U-shaped, with a long front range to the south-east along Talcennau Road and two wings at either end extending to the north-west (Plate 376). Behind the front range is an attached short gable ended element on the same north-west to south-east orientation, flanked by a cross-gable to either side (Plates 378 and 379). Each wing ends with a pavilion roofed section. Abutting these on both wings is a lower hipped roofed element. There is a late 20th century, two storey, flat roofed extension to the south-west (Plate 379).

*Plate 376. Drone shot of Building 6, looking west, Talcennau Road to bottom left. Photo courtesy of Roberts Limbrick.*

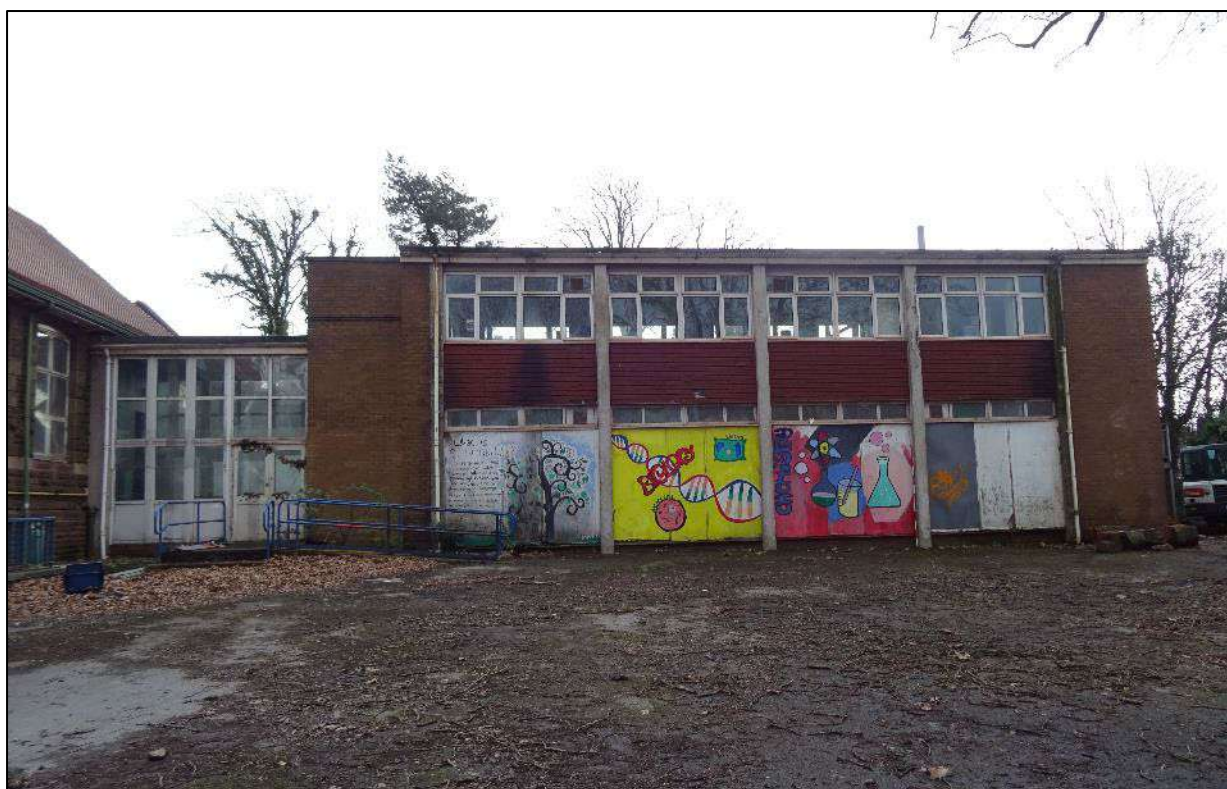
*Plate 379. Modern extension to Building 6, looking north-east. Scale 2m.*

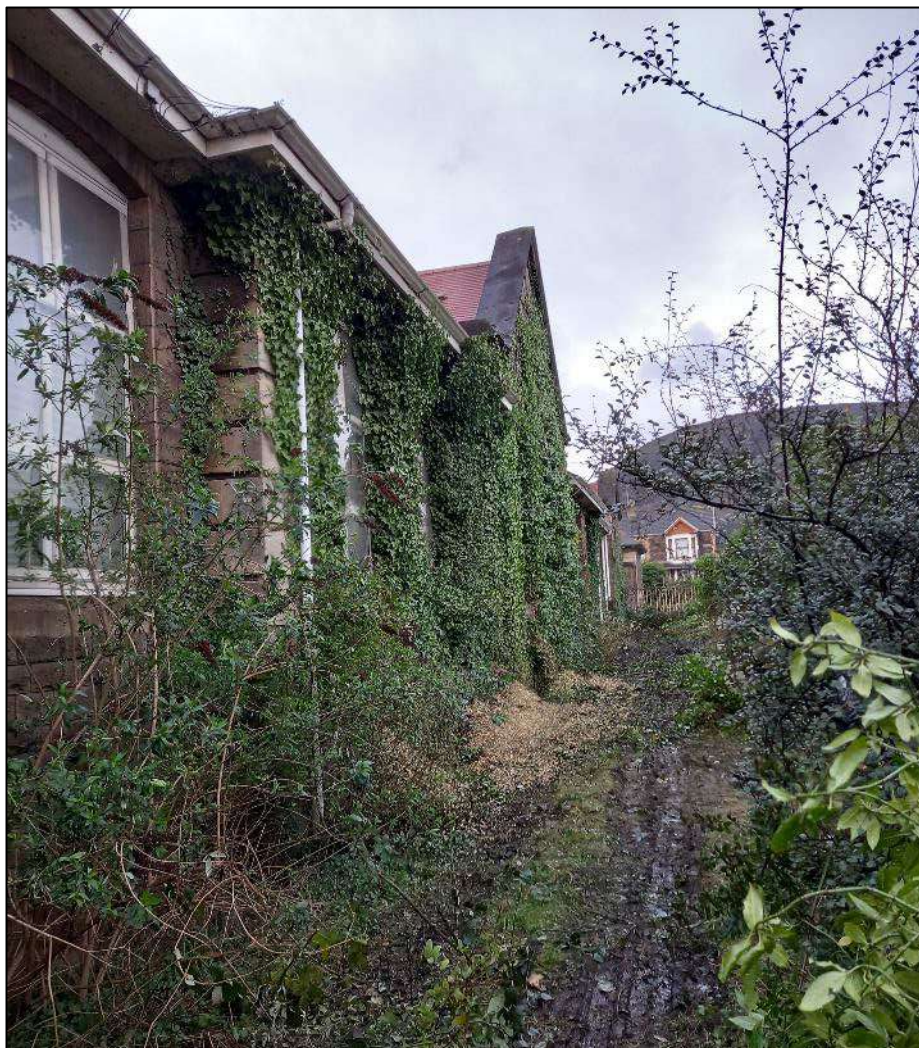
5.34.1. The front elevation was difficult to view due to vegetation on the elevation and trees along the site boundary (Plate 380). The façade is symmetrical, with 17 bays (Plate 381). A band course runs along the whole elevation, forming the level that the windows sit on.

*Plate 380. Oblique shot of front elevation, looking north-west, showing vegetation growth over the elevation.*

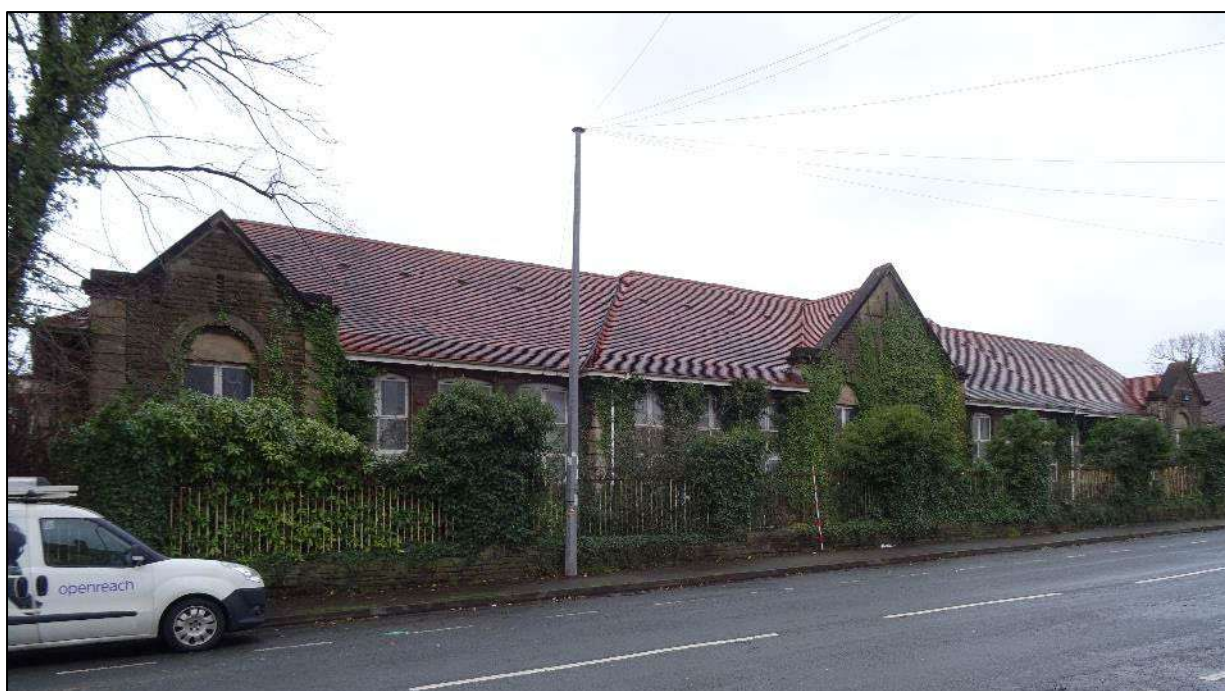
*Plate 381. Front elevation of Building 6, looking west. Scale 2m.*

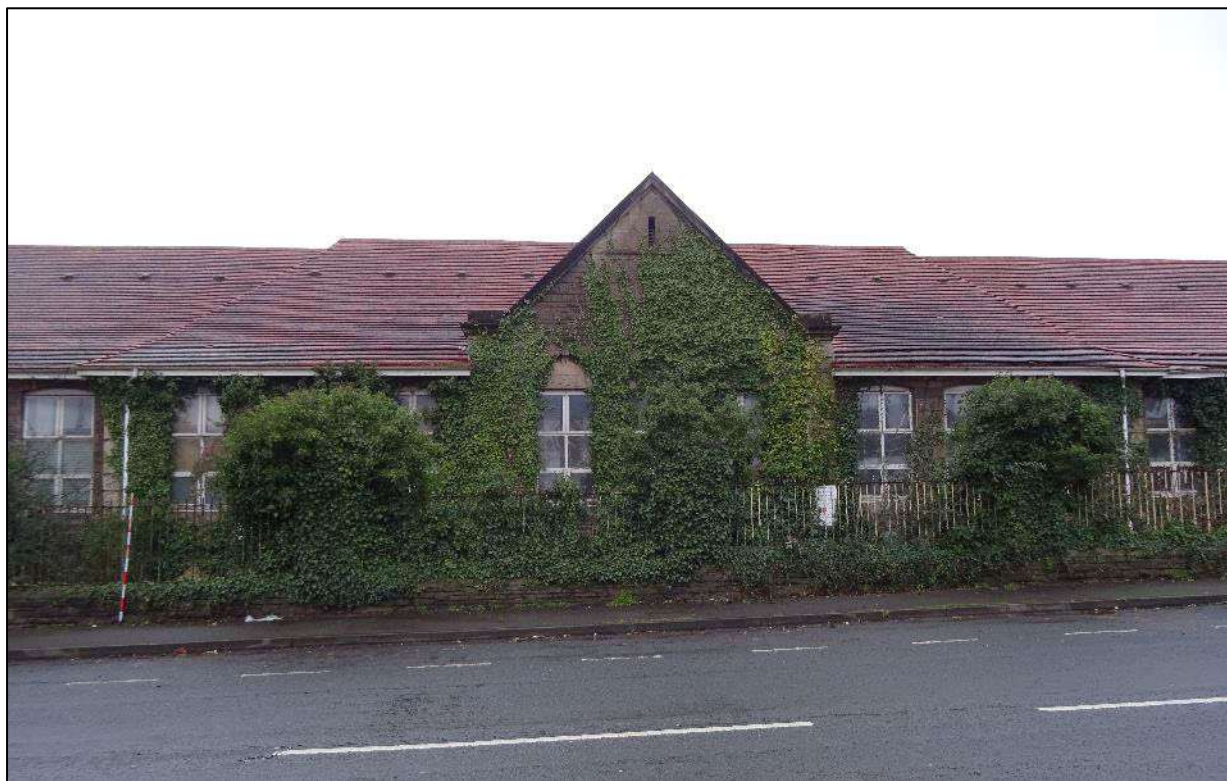
5.34.2. The central three bays are to a slightly projecting cross-gable with rusticated pilasters to the sides and a triangular pediment with moulded cornice (Plate 382). To the centre of the pediment is a limestone plaque, which parts of the engraving "PORT TALBOT SECONDARY SCHOOL" can be made out on (Plate 383). Above this, the apex of the gable is smooth finished limestone with a narrow central vent. The three windows to the cross-gable are rounded arched with keystone. There is smooth finished ashlar limestone recessed in the semi-circular gap below the arch and above the modern uPVC window. The sills are formed of the limestone band course, with a stub in the centre indicating that the windows originally had central stone mullions.

*Plate 382. Central cross-gable and flanking hipped section to front elevation of Building 6, looking north-west. Scale 2m.*

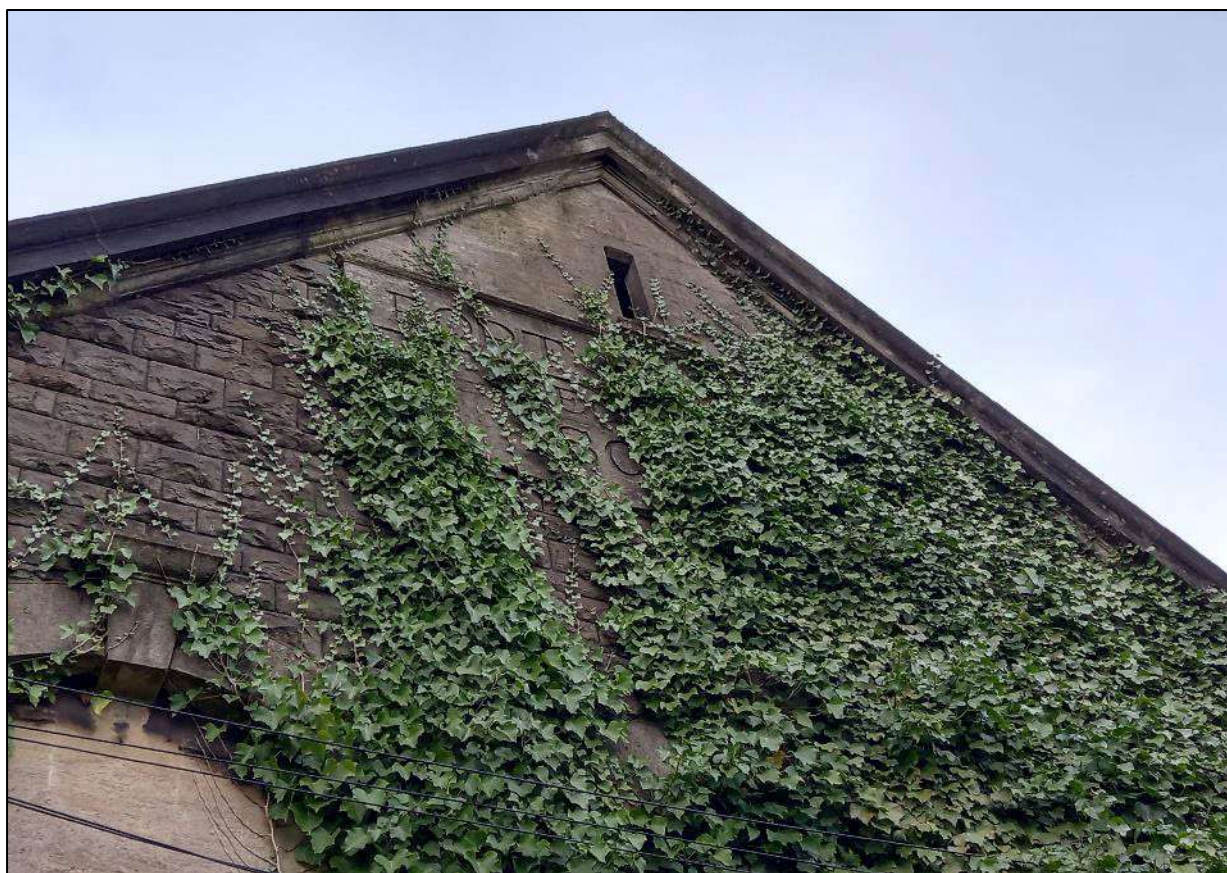
*Plate 383. Detail of central pediment with name plaque, south-east facing elevation, Building 6, looking north.*

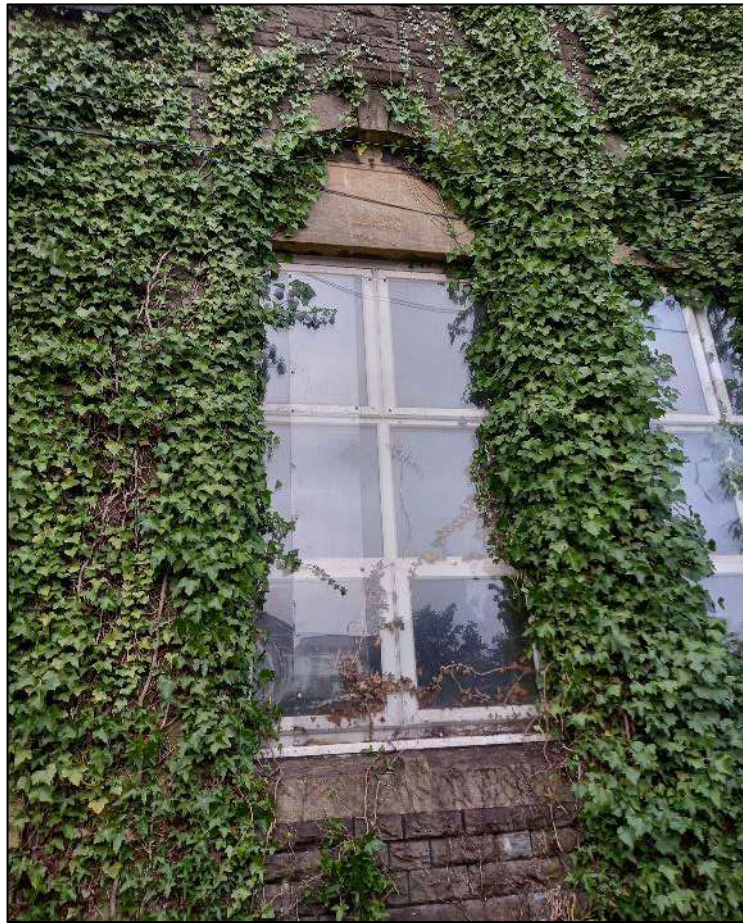
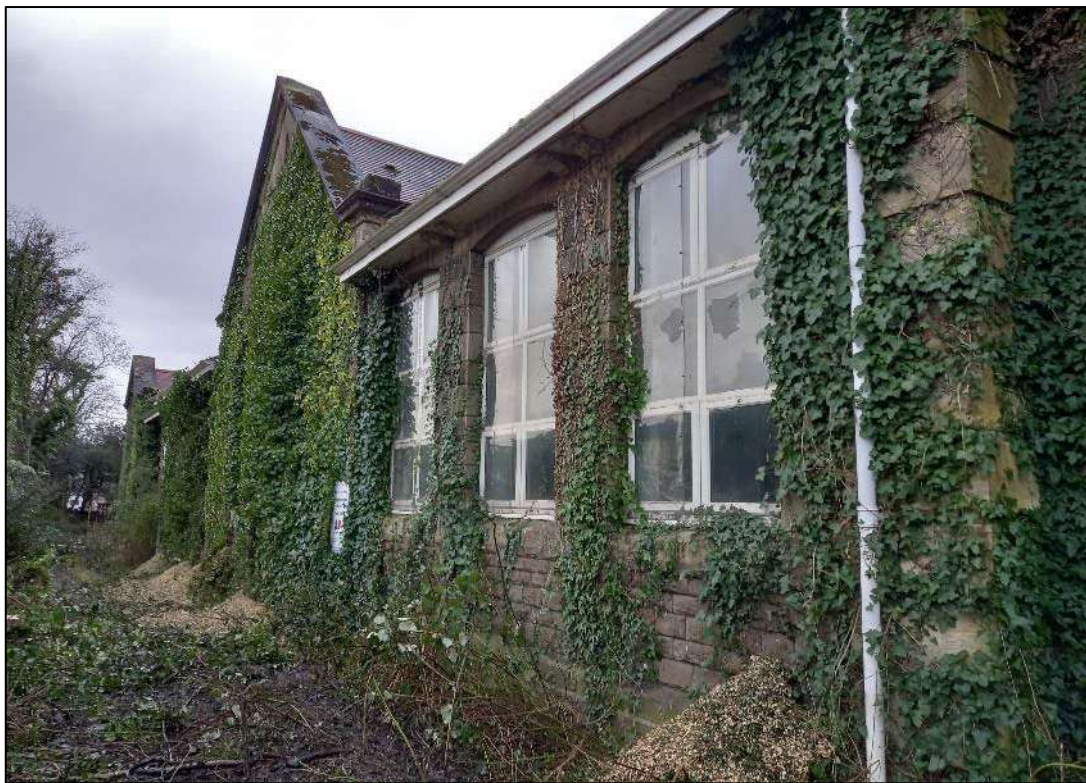
- 5.34.3. The three bays to either side of the central cross-gable are part of a slightly projecting hipped-roof element with rusticated limestone blocks to the corners (Plates 384 and 385). The windows are all segmental arches with limestone lintels and sills set within the band course. They are slightly recessed, with a brush-hammered finish to the reveals and a chiselled margin to the edge.
- 5.34.4. The next three bays to either side have windows of the same style (Plate 386).
- 5.34.5. The two outer bays are slightly projecting cross-gables with triangular pediments and rusticated quoins (Plate 387). The pediments have moulded cornices and a limestone ashlar band course. The window to each is in the same style as those to the central bays (Plate 388).

*Plate 384. Left-hand window to central cross-gable, south-east facing elevation, Building 6, looking north-west.*

*Plate 385. Projecting hipped section and central cross-gable, south-east facing elevation, Building 6, looking west.*

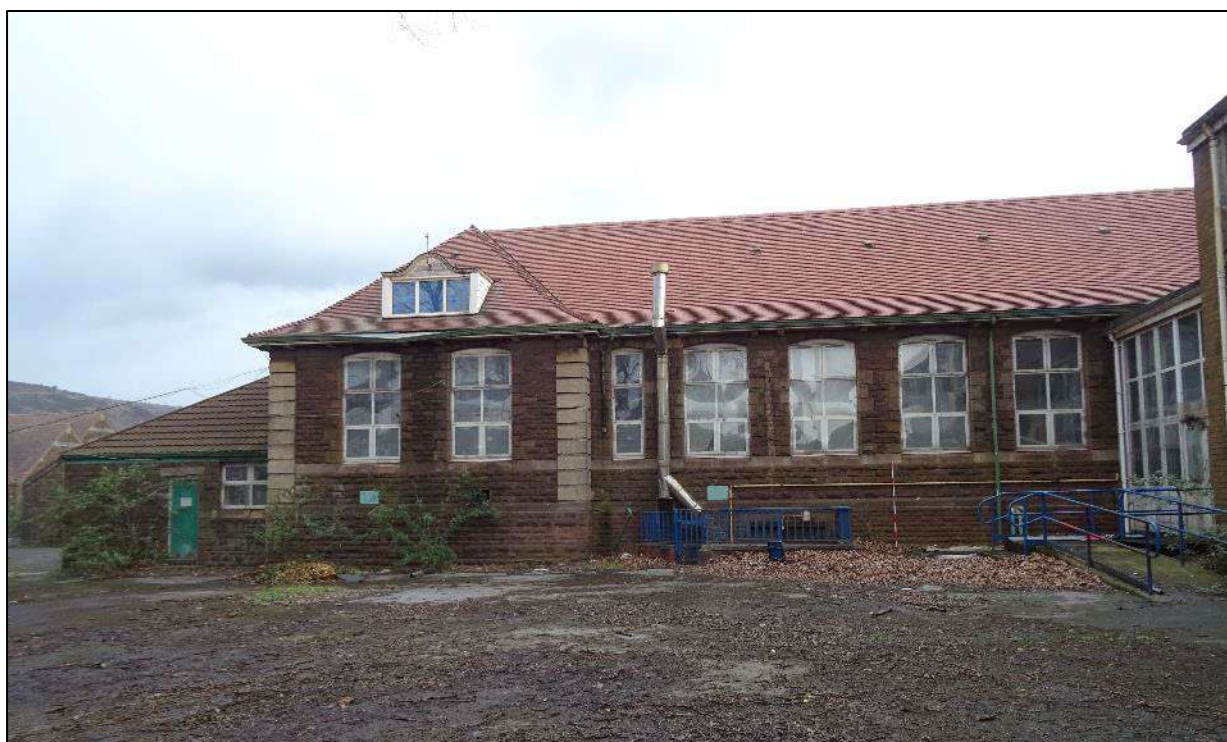
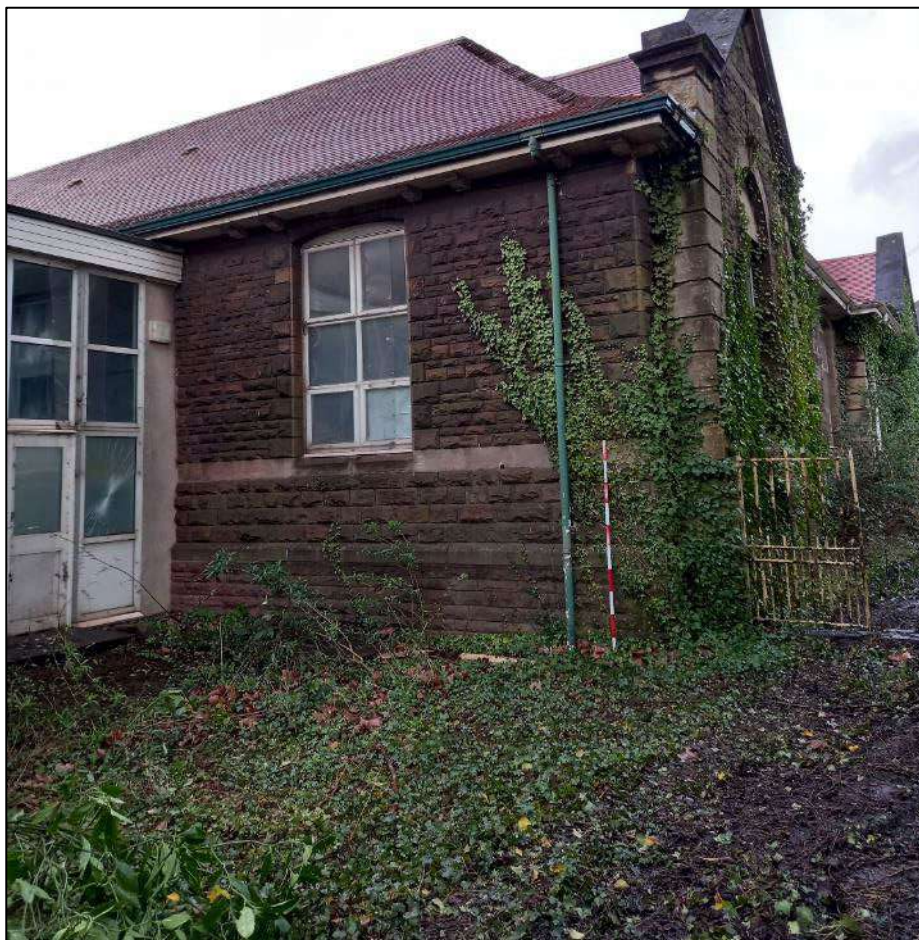
- 5.35.2. The south wing has seven bays along the long wall with a slightly projecting two bay pavilion element with combination roof at the south-west end, and a lower height hipped roof element abutting this (Plates 389 and 390). The modern extension projects from what would originally been the penultimate bay to the right (Plate 391). The original doorway to this bay survives inside the extension.
- 5.35.3. There are six windows the long side of the wing, one of which is to the right of the modern extension (Plate 390). All are in the same style, although the leftmost, adjacent to the projecting pavilion section, is half-width (Plate 391). They have segmental arched limestone lintels, bevelled sills set within the band course, and larger quoin-style rock-faced ashlar with chiselled margins to the sides (Plate 392). They are slightly recessed, with a brush-hammered finish to

*Plate 389. South-west facing elevation of south-west wing, Building 6, looking north-east.  
Scale 2m.*

*Plate 390. Bay to north-east end of south-east facing elevation of south-west wing, Building 6, looking north. Scale 2m.*

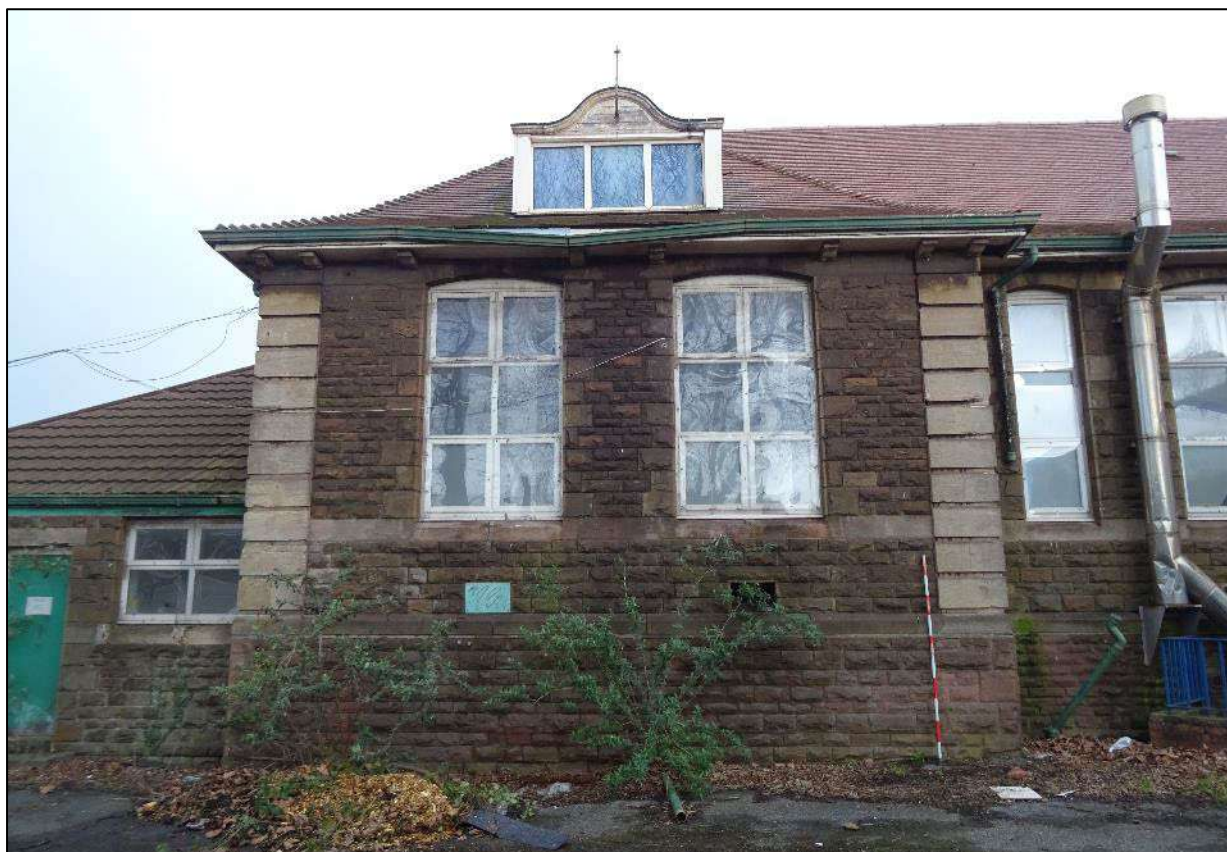
the reveals (Plate 393). All except the half-width have stubs to their sills suggesting they previously had stone mullions.

*Plate 393. Detail of window surrounds and soffits to south-west elevation of south-west wing,  
Building 6, looking north.*

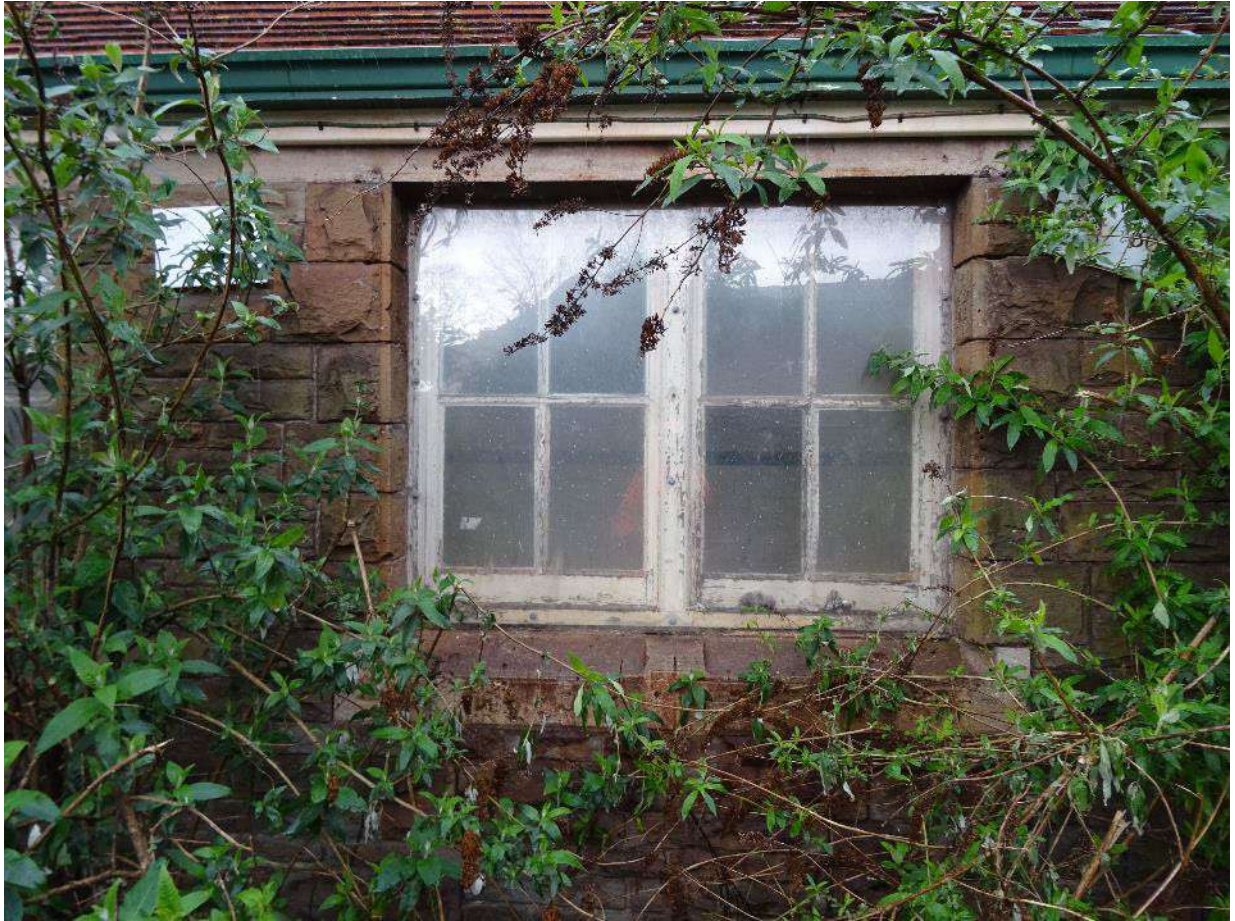
- 5.35.8. There are five windows to the main long side of the wing, all sitting immediately below the eaves. The first three from the left are two-light mullion wooden framed windows with four panes to each light (Plate 404). They have bevelled limestone sills with central stubs of former stone mullions (Plate 404) and rock-faced ashlar quoins with chiselled margins to the sides. The two to the right are narrower but otherwise the same (Plates 405 and 406), although the lefthand of the two have been replaced with a uPVC unit.

*Plate 404. Window to left of south-west elevation of north-east wing, Building 6, looking north-east.*

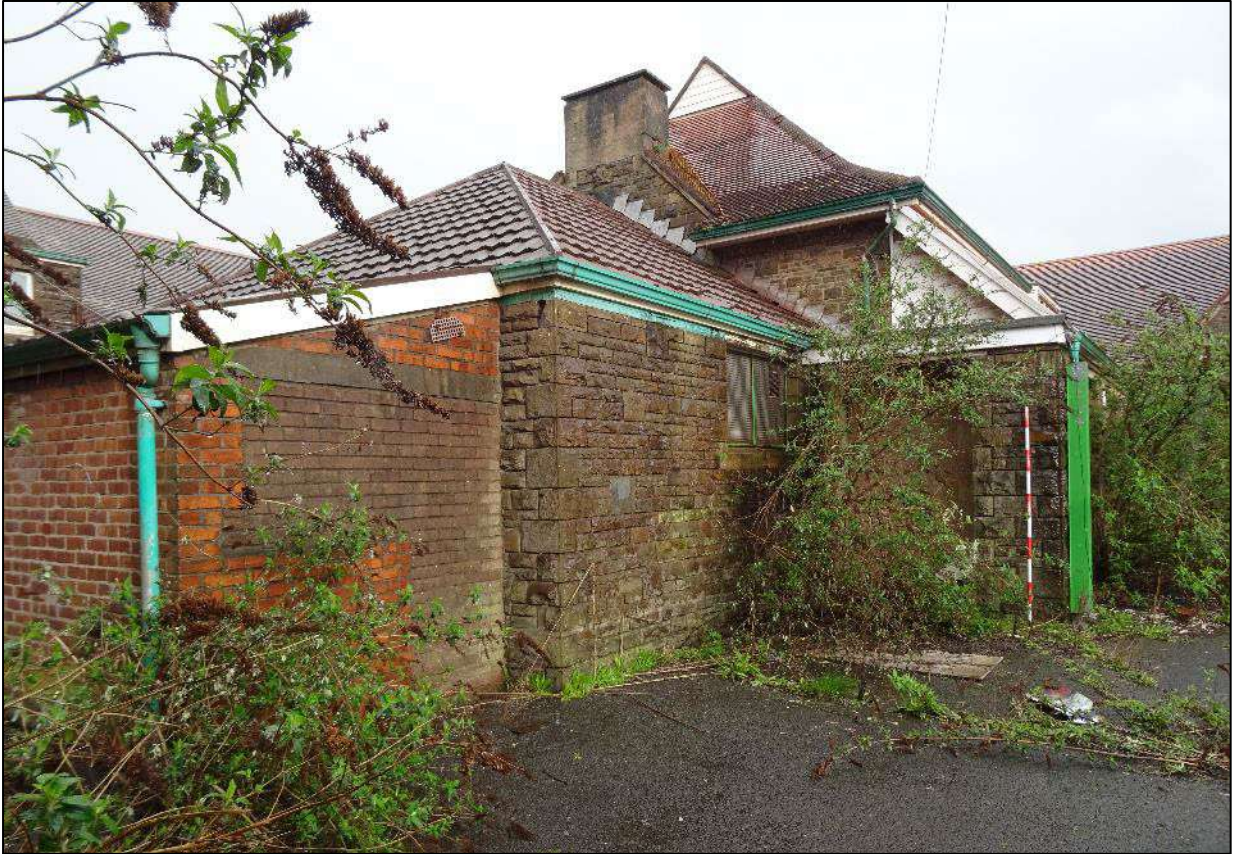
*Plate 410. North-west end of north-west wing, Building 6, looking east. Scale 2m.*

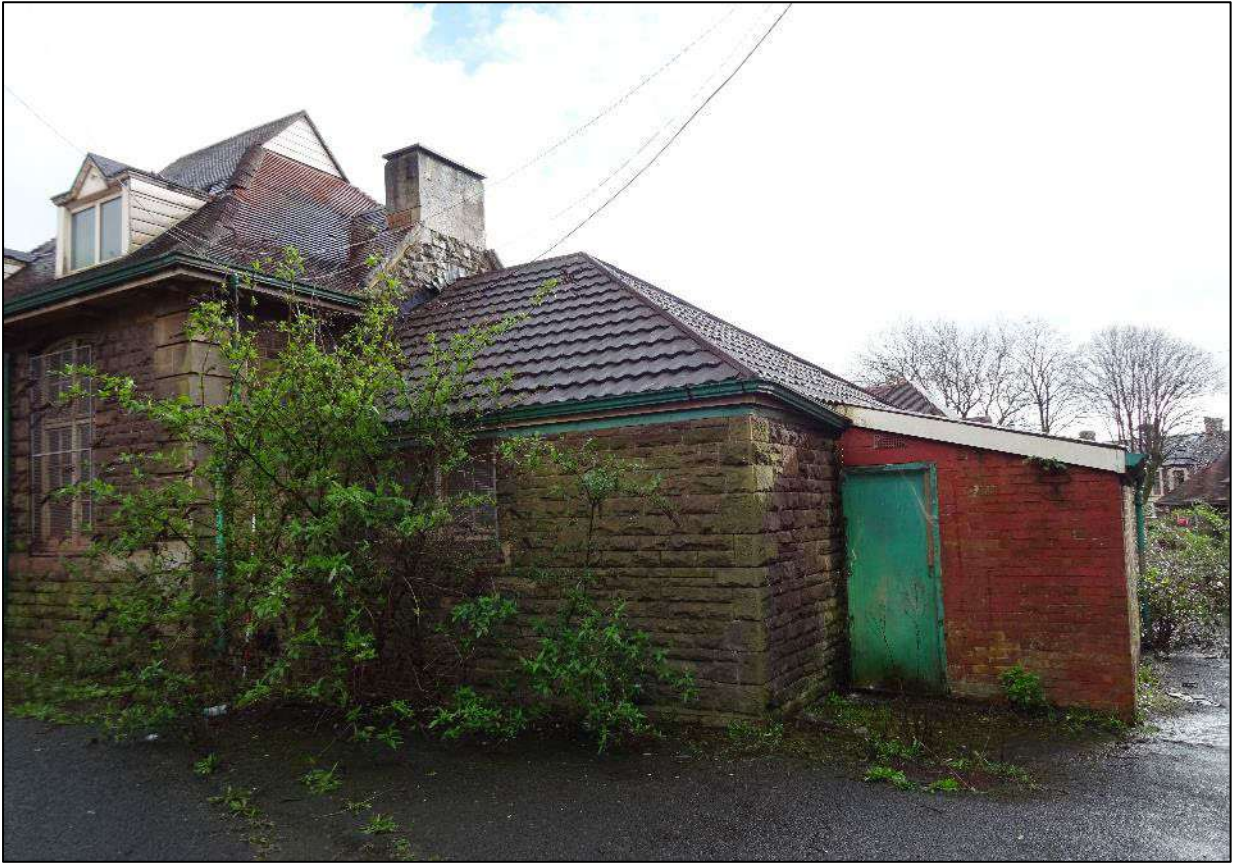
- 5.37.9. There are Dutch gabled dormers to bays six and eight, of the same type as to bays three and four (Plate 437).
- 5.37.10. The low hipped element to the north-west end has a single window to the centre of the elevation, immediately below the eaves (Plate 411). It is a two-light with four panes each, wooden framed window (Plate 438). It has bevelled limestone sills with a stud indicating a former stone mullion, and rock-faced ashlar quoins with chiselled margins to the sides. It is covered by a modern metal grill.

*Plate 411. North-west end of north-west wing, Building 6, looking south. Scale 2m.*

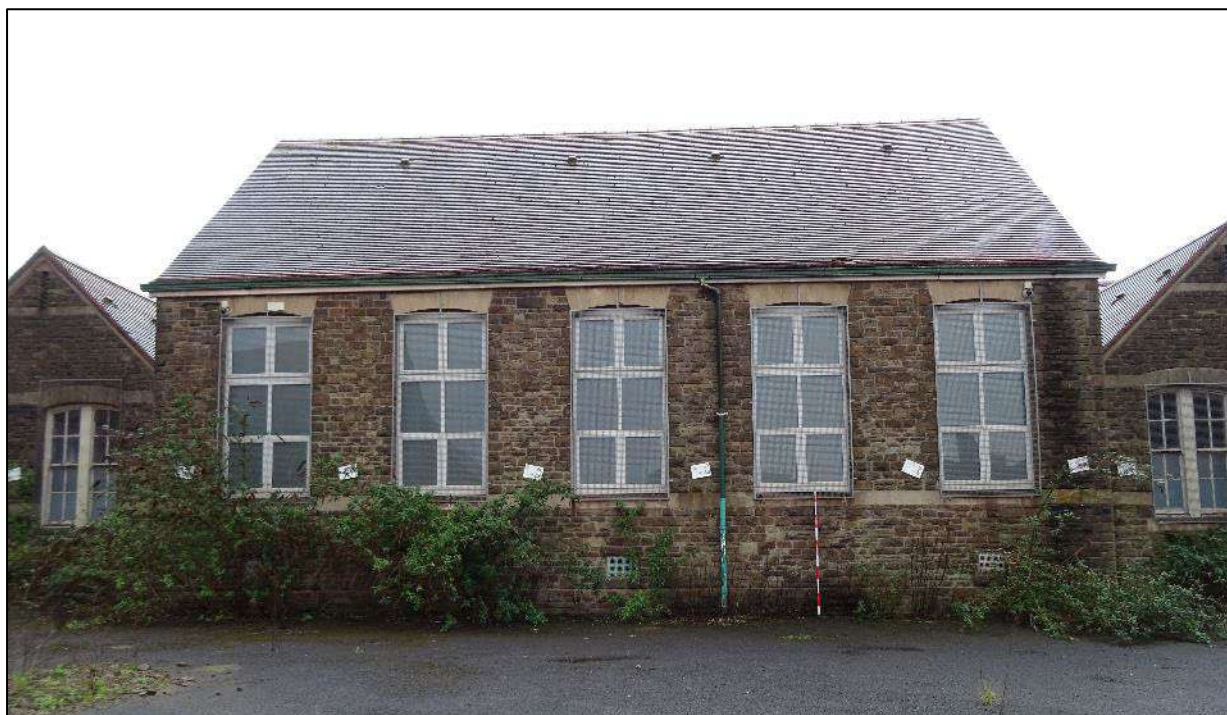
- 5.36.6. The north-west facing elevation of the front range is symmetrical (Plate 415). To the centre is the five bay long side of the gable ended element (Plate 416). The windows are segmental arched with dressed limestone voussoirs (Plate 417). Their sills are bevelled from the limestone band course. There are rock-faced ashlar quoins with chiselled margins to the sides. They are covered with modern metal grills.

*Plate 416. Central gable ended element to rear of front range, Building 6, looking south-east.  
Scale 2m.*
