**Level 2 Building Recording:**  
**Former Dyffryn Lower School, Port Talbot**

March 2024

Report No. 2278

Prepared for KEW Planning  
By  
Susan Stratton PhD

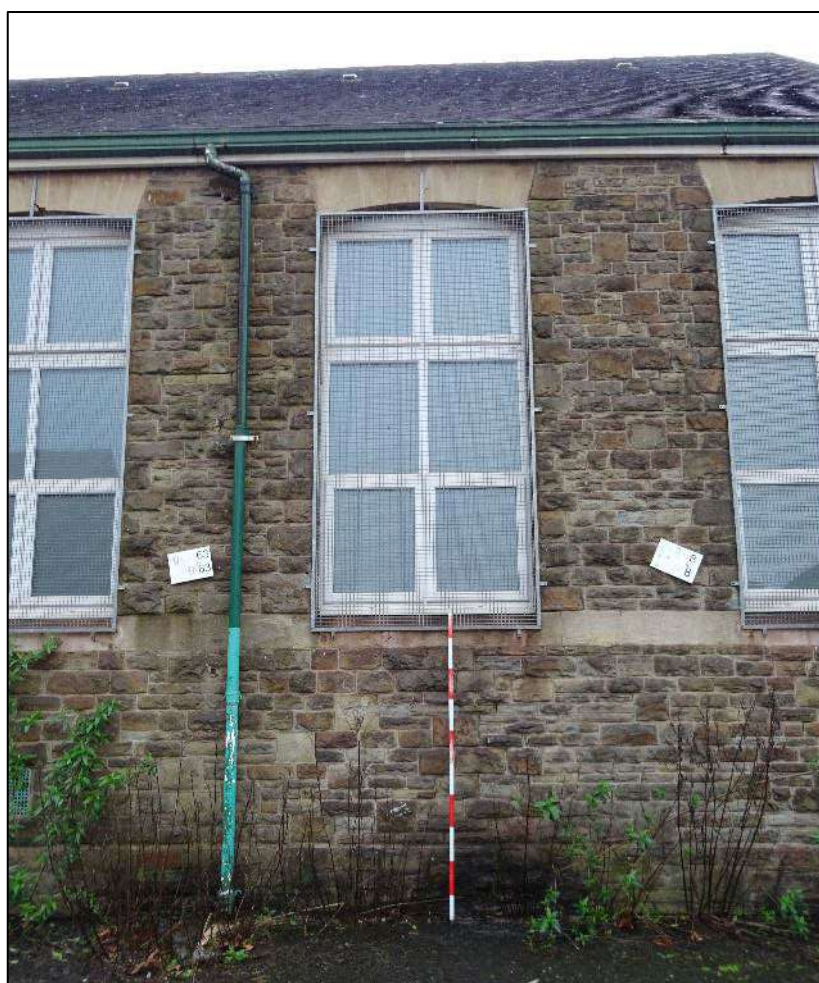
- 5.36.6. The north-west facing elevation of the front range is symmetrical (Plate 415). To the centre is the five bay long side of the gable ended element (Plate 416). The windows are segmental arched with dressed limestone voussoirs (Plate 417). Their sills are bevelled from the limestone band course. There are rock-faced ashlar quoins with chiselled margins to the sides. They are covered with modern metal grills.

*Plate 417. Window to north-west facing elevation of rear of front range, Building 6, looking  
south-east. Scale 2m.*

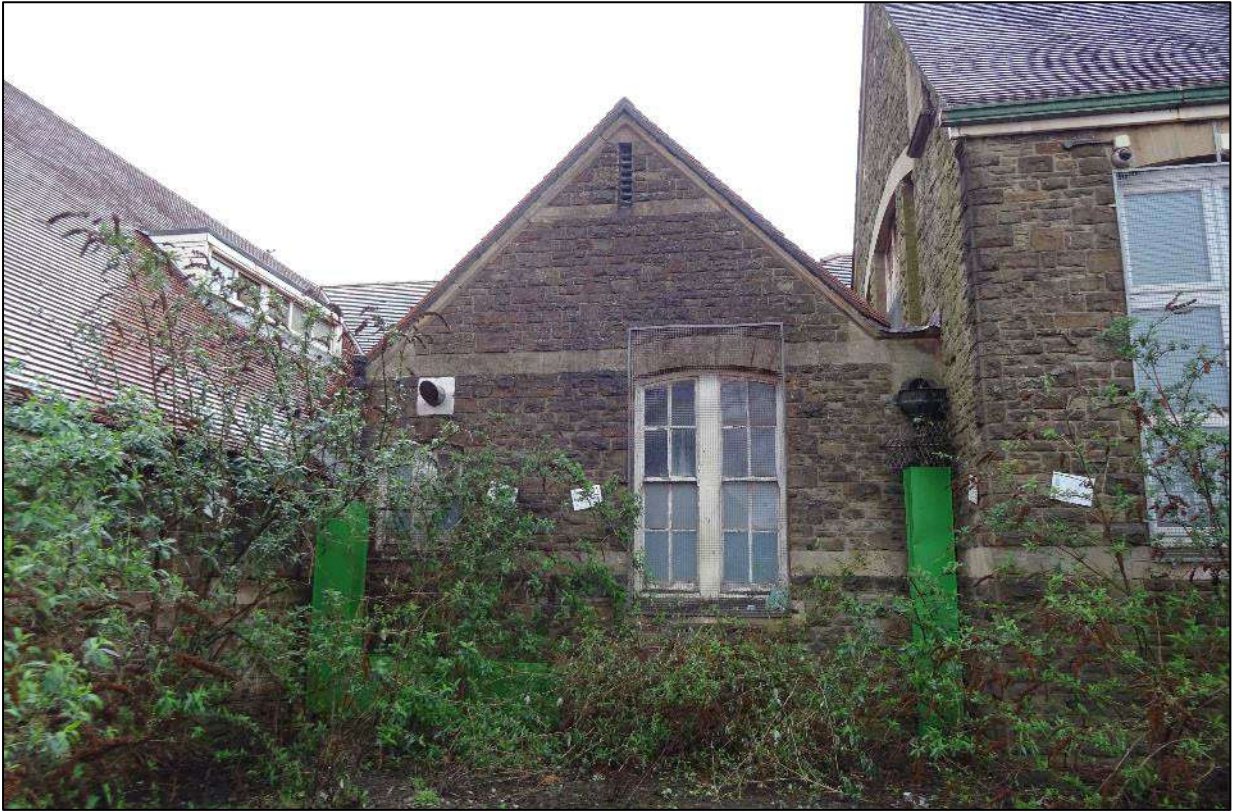
- 5.36.7. Lower cross-gables flank the central element. As well as the main band course around the building they have a dressed limestone band course at eave height and a narrow band course near the apex of the gable (Plates 418 and 419). This forms the sill of a narrow vent to the centre of the apex.

*Plate 418. Left-hand cross-gable to north-west facing elevation of rear of front range, Building 6, looking south-east. Scale 2m.*

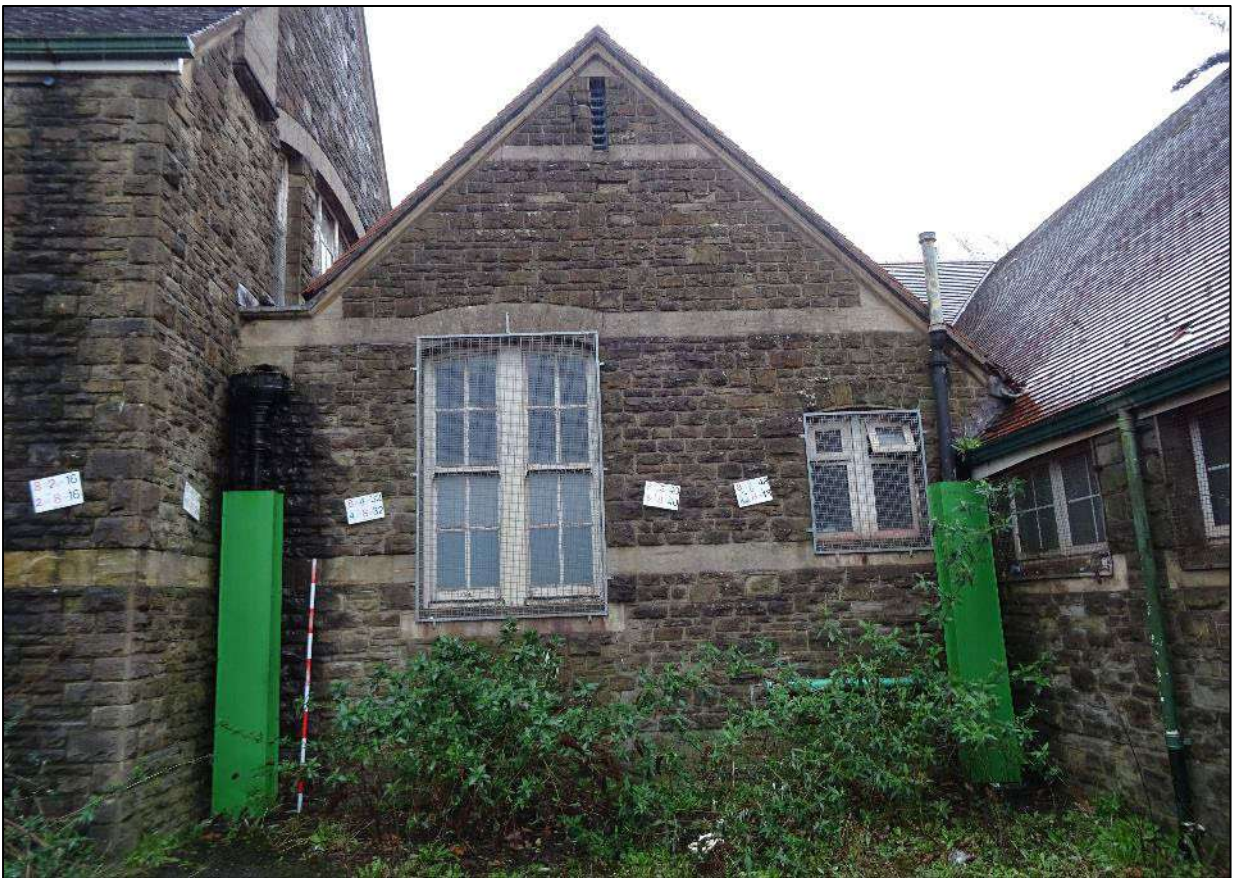
*Plate 419. Right-hand cross-gable to north-west facing elevation of rear of front range, Building 6, looking south-east. Scale 2m.*

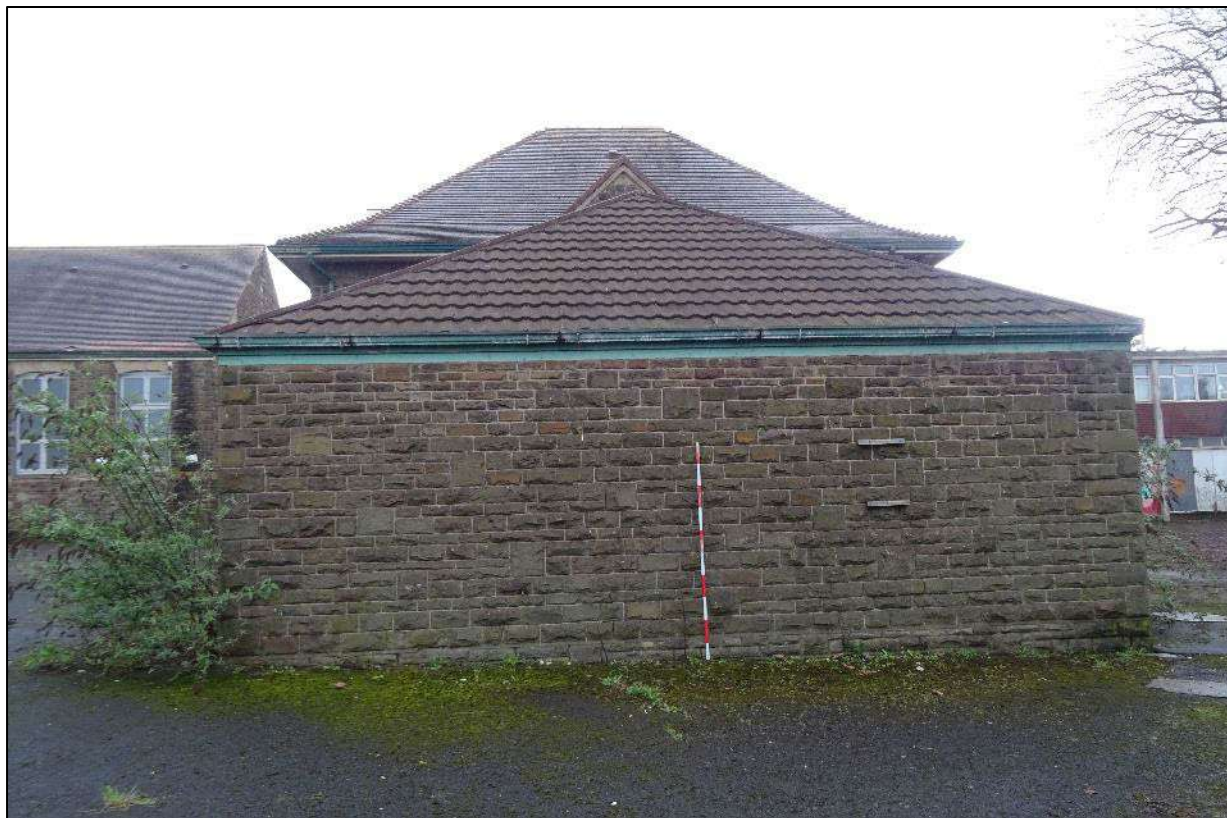
- 5.36.11. The end of the south-west wing has the combination roofed pavilion element, with the lower gabled element abutting it (Plate 423). There is a small cross gable to the centre of the pavilion end with a moulded stone cornice (Plate 424). To either end of the elevation are metal downpipes with a decorative metal hopper just below the height of the lower hipped roofed element's eaves (Plate 425). There are rusticated quoins to the right corner of the elevation but not the left.
- 5.36.12. The lower hipped element has no features to the north-west facing elevation.

*Plate 423. North-west elevation of south-west wing, looking south-east. Scale 2m.*

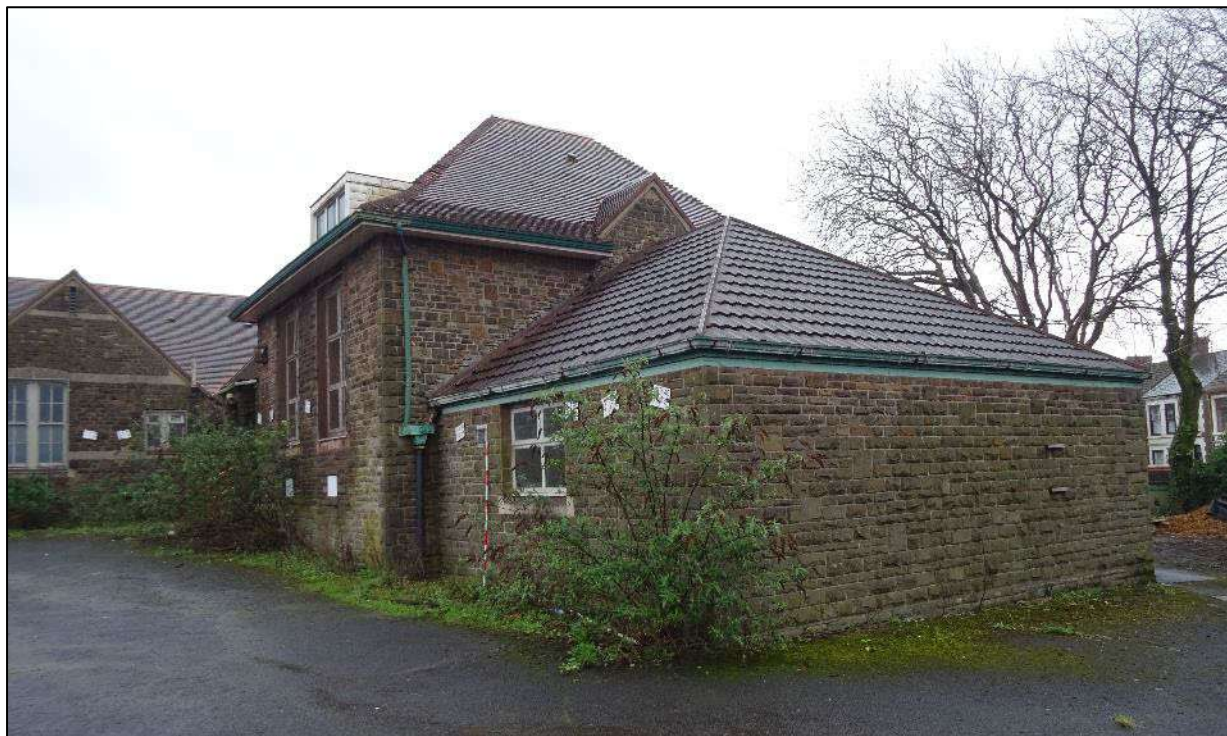
*Plate 424. Oblique view of north-west elevation of south-west wing, looking south. Scale 2m.*

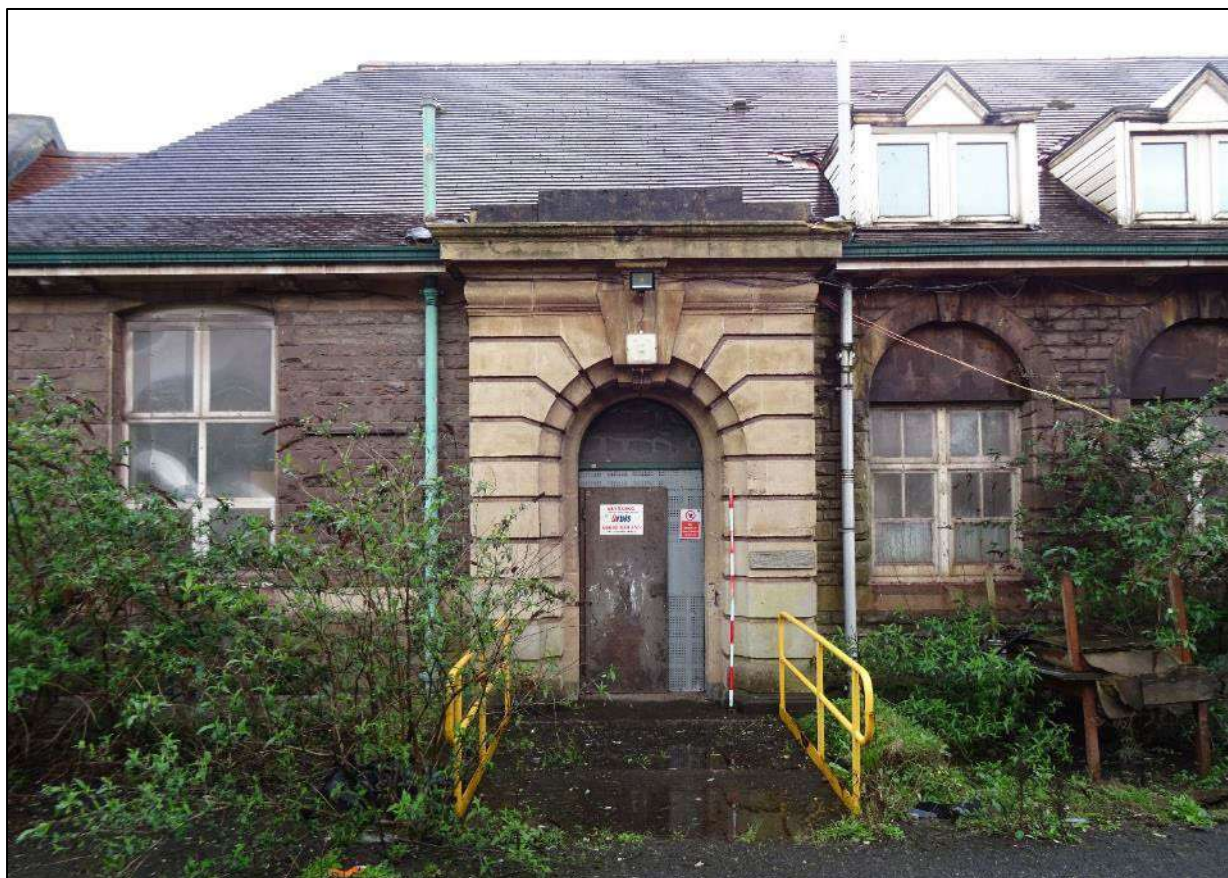
5.37.2. The north-west wing has five bays to the long side of the hipped roofed section, and three bays to the slightly projecting combination roofed pavilion (Plate 426). It also includes the lower hipped roofed element and the brick lean-to.

*Plate 427. Entrance to north-east elevation of north-west wing of Building 6, looking south-west. Scale 2m.*

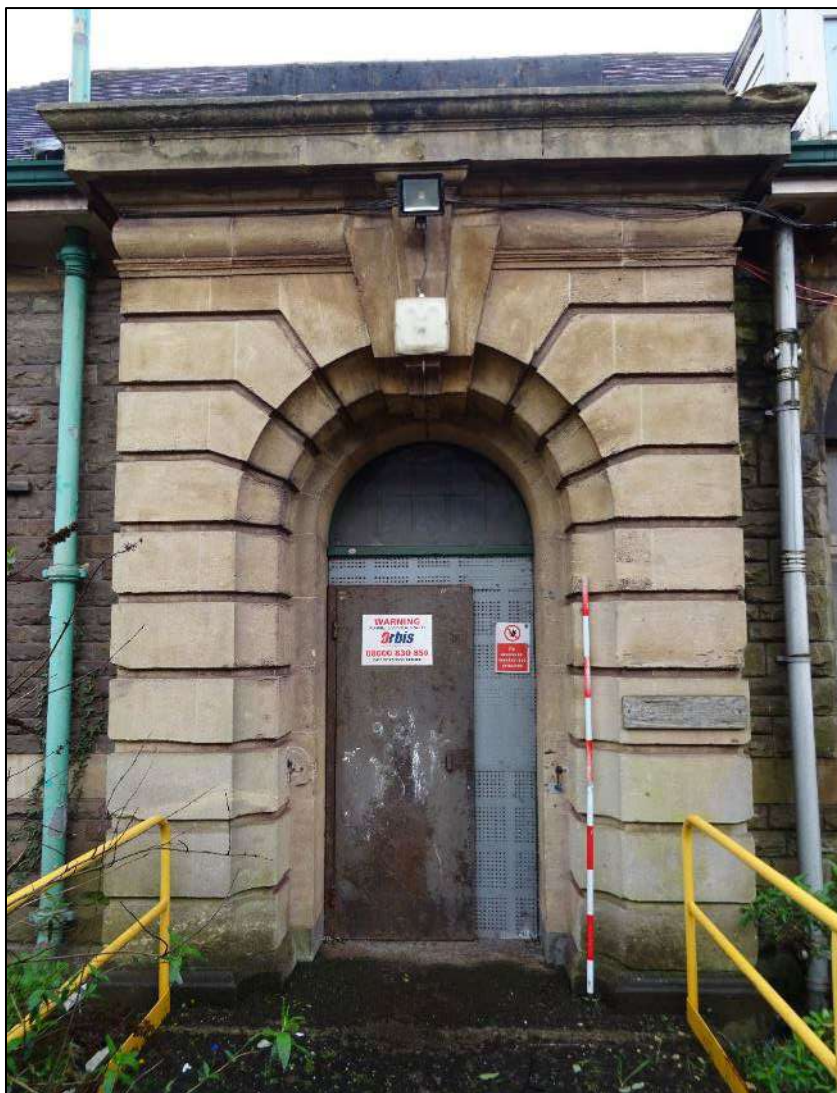
5.37.3. There is an entrance to the second bay from the left (Plate 427). It has a rusticated limestone surround with oversize keystone, pulvinated frieze, and projecting cornice. The doorway is round arched. The door has been replaced by a metal security door and screen. It has modern concrete ramp with metal railings to the front. On the right of the doorway is a wooden sign saying "Penhydd."

5.37.4. To the left of the entrance, the first bay has a segmental arched window (Plate 427). The lintel is within a dressed limestone band course that runs immediately below the eaves and sill is set within the main band course (Plate 428). It is slightly recessed, with a brush-hammered finish to the reveals and a chiselled margin to the edge.

*Plate 428. Entrance to north-east elevation of north-west wing of Building 6, looking south-west. Scale 2m.*

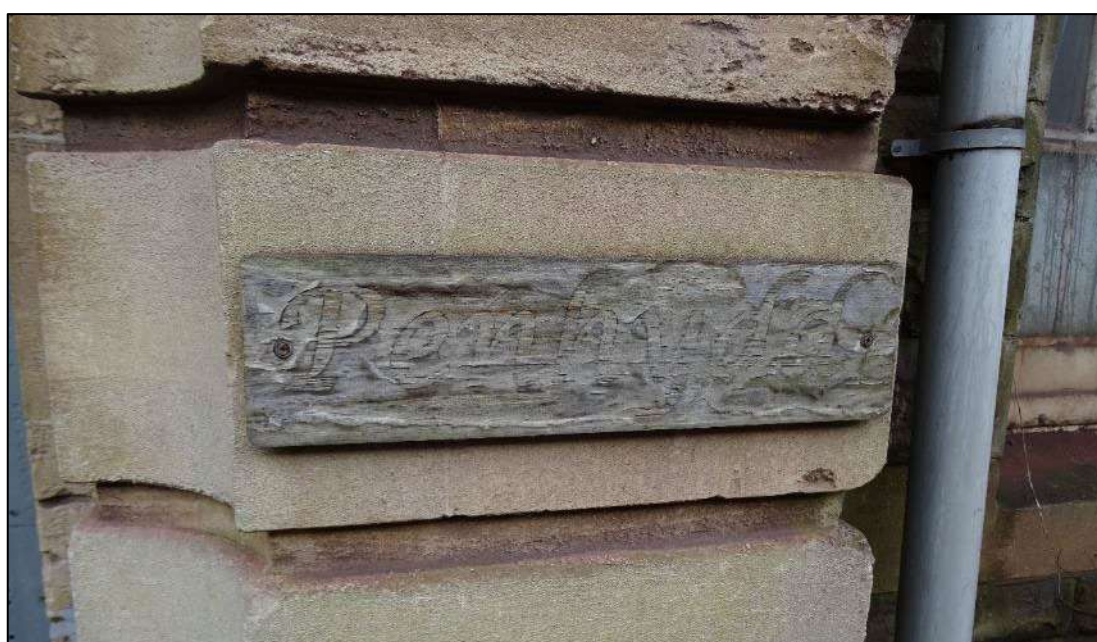
*Plate 429. Wooden sign to right of entrance, north-east elevation, north-west wing, Building 6.*

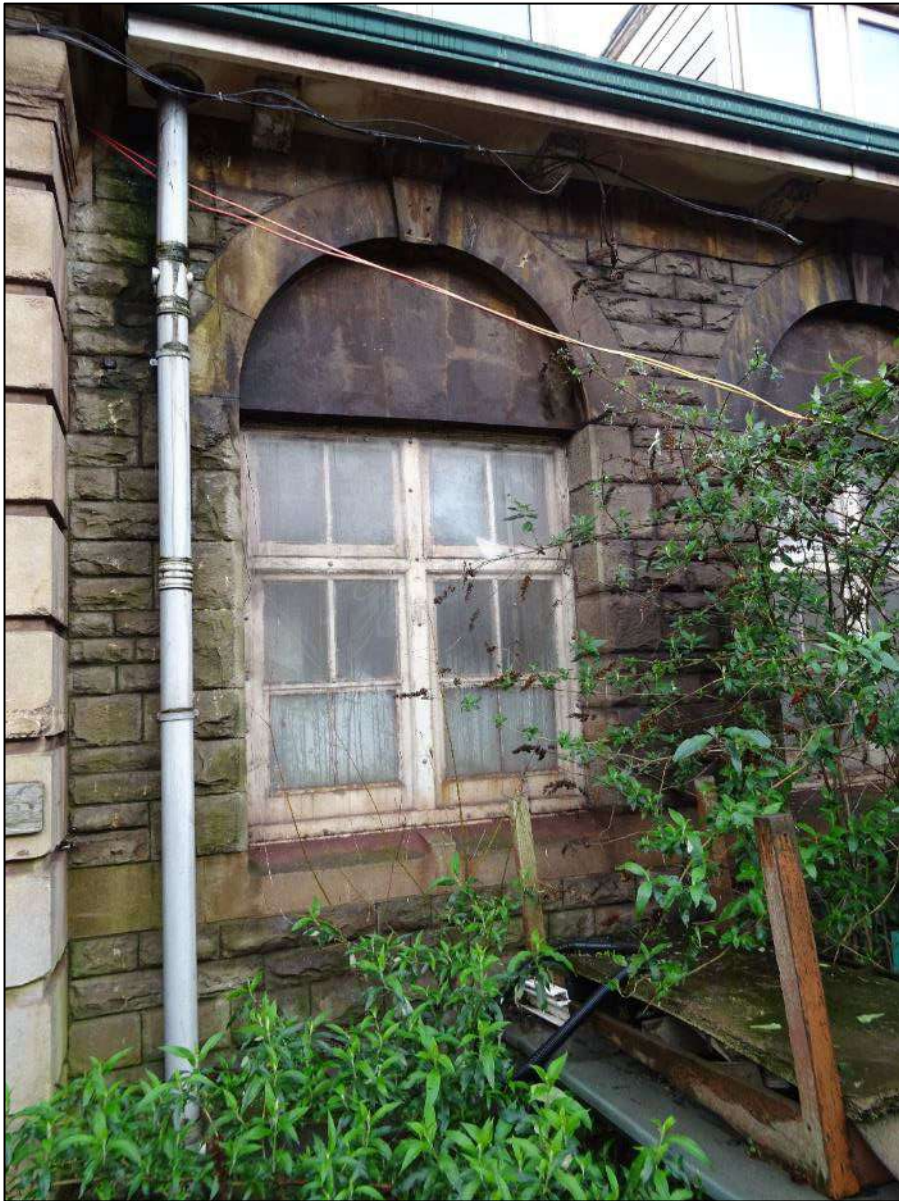
5.37.5. The third and fourth bays, to the right of the entrance, have rounded arch windows (Plate 431). They have dressed limestone rounded arch voussoirs with a keystone (Plate 432). The sills are bevelled and set into the band course, with a stud indicating a former stone mullion. They have rock-faced ashlar quoins with chiselled margins to the sides. The windows are multi-pane wooden framed mullion and transoms. The semi-circular space between the windows and surround is filled with dressed limestone.

cornices (Plate 431).

*Plate 431. Third and fourth bays of north-east elevation of north-west wing, Building 6, looking south-west. Scale 2m.*

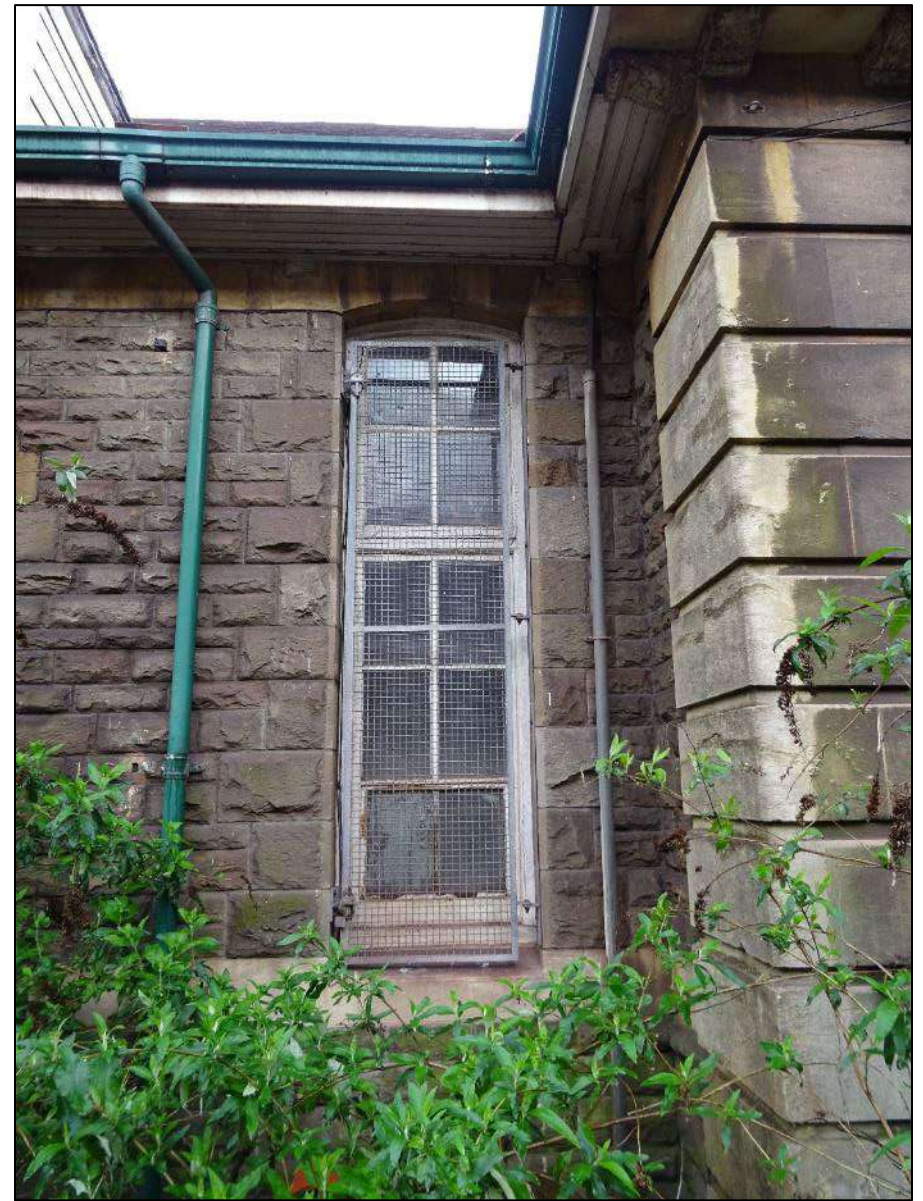
*Plate 432. Window to third bay of north-east elevation of north-west wing, Building 6, looking west.*

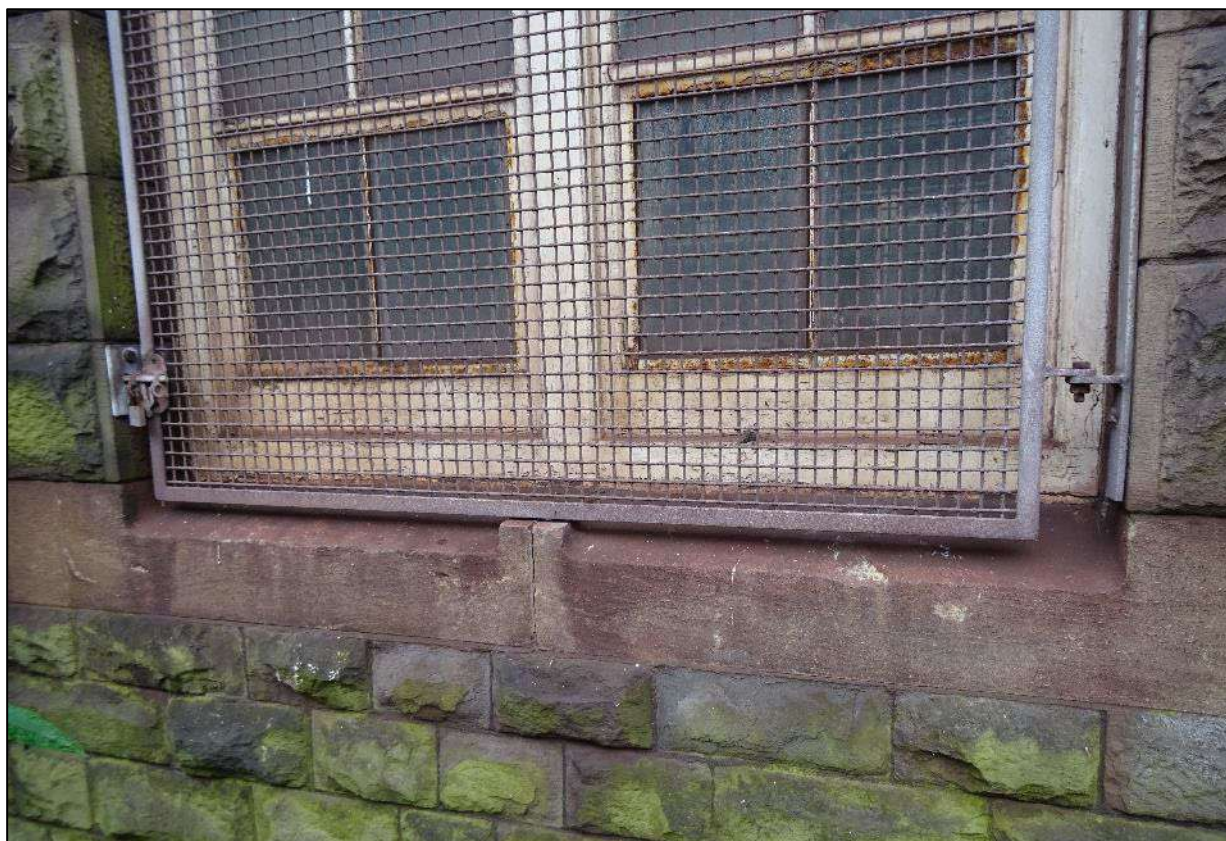
- 5.37.8. Bays six to eight are to the projecting pavilion at the north-west end of the wing (Plate 434). It has rusticated limestone quoins to the corners. The three windows are all four-light, awning opening, multi-pane wooden framed windows (Plate 435). They have segmental dressed limestone lintels, bevelled limestone sills set into the band course, with a stud indicating a former stone mullion (Plate 436), and rock-faced ashlar quoins with chiselled margins to the sides. They are covered by a modern metal grill.

*Plate 435. Window to bay eight north-east elevation of north-west wing, Building 6, looking south-east. Scale increments 0.2m.*

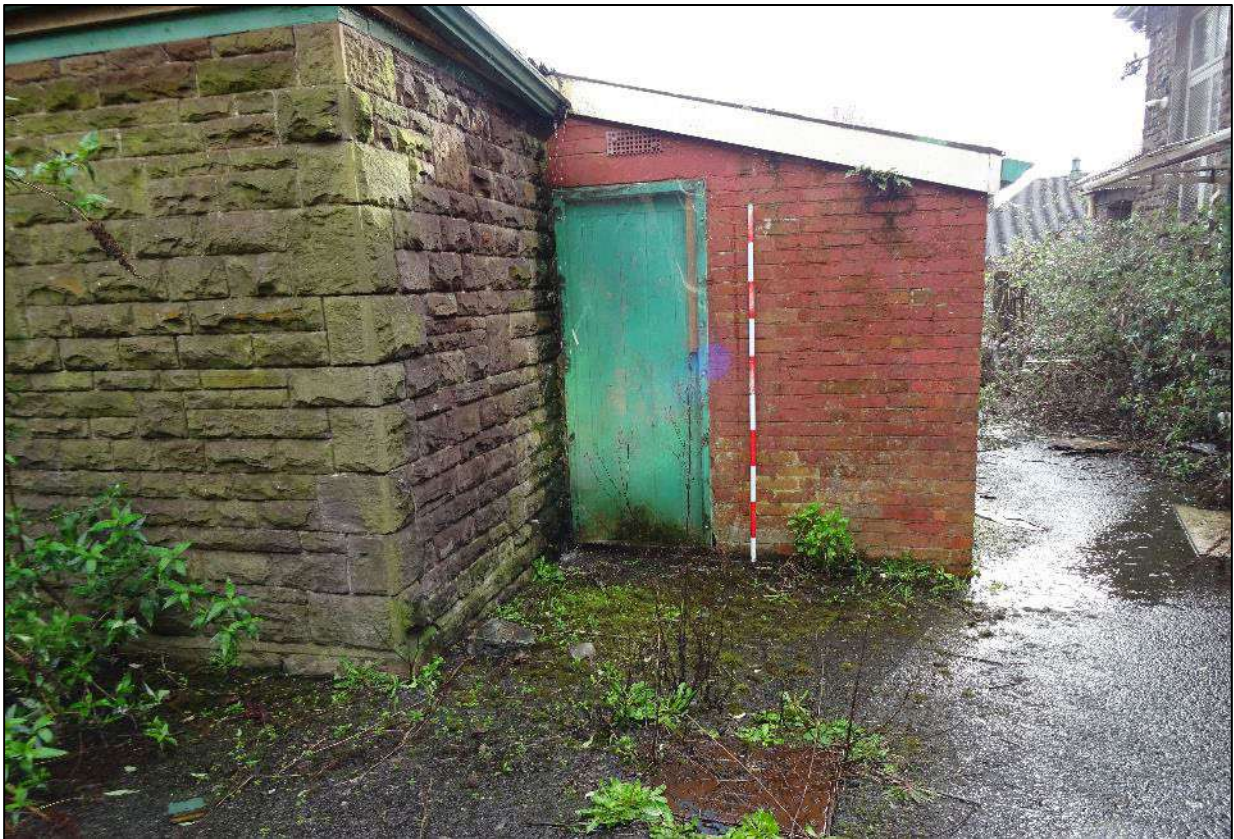
*Plate 439. Brick lean-to addition to north-west end of north-west wing, Building 6, looking south-west. Scale 2m.*

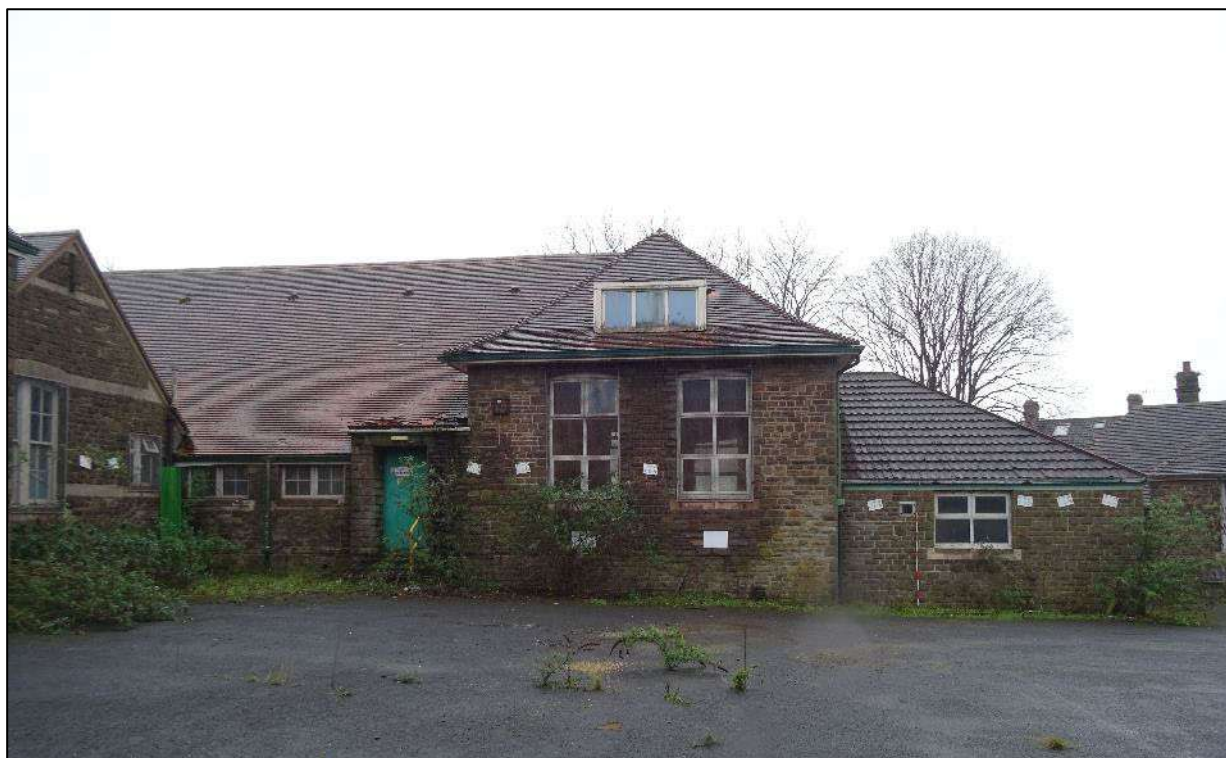
*Plate 440. North-east facing elevation of south-west wing, looking south-west. Scale 2m.*

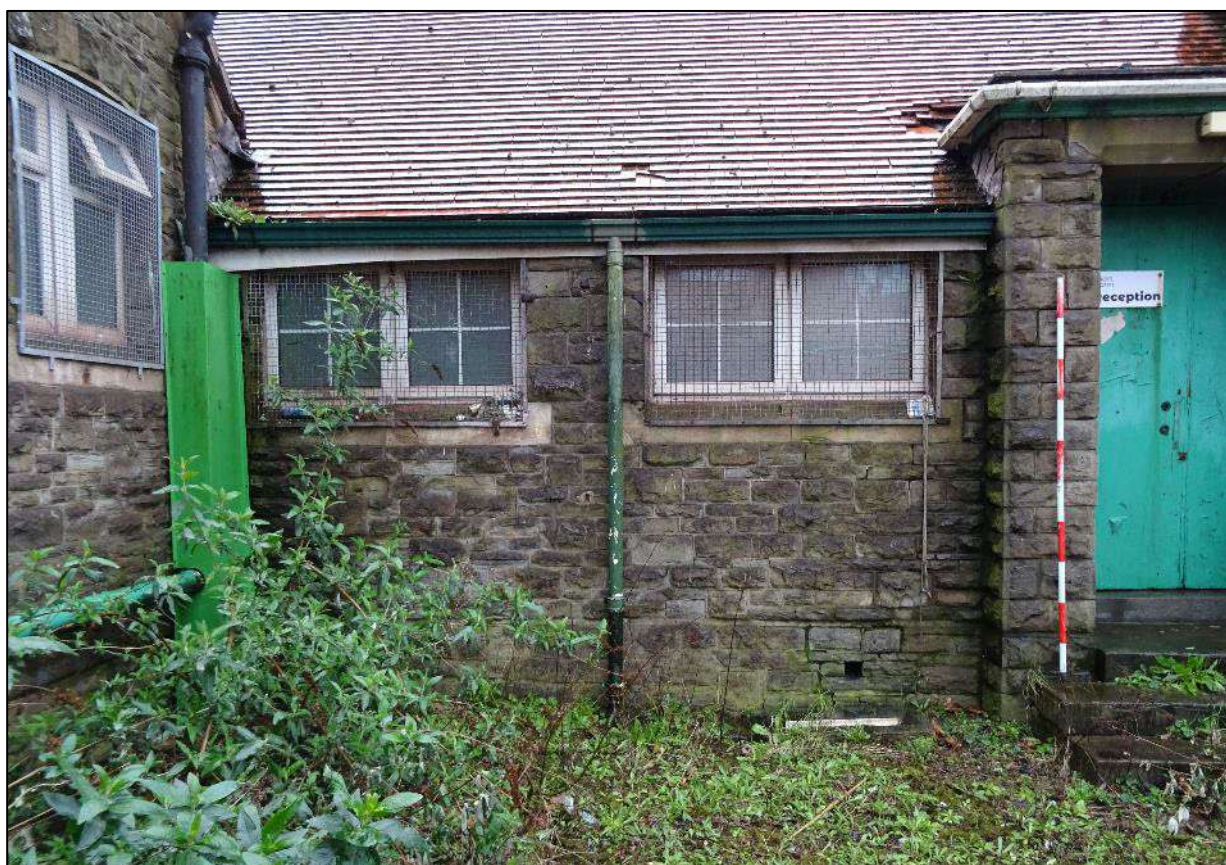
*Plate 441. Bays one and two of north-east facing elevation of south-west wing, looking south-west. Scale 2m.*

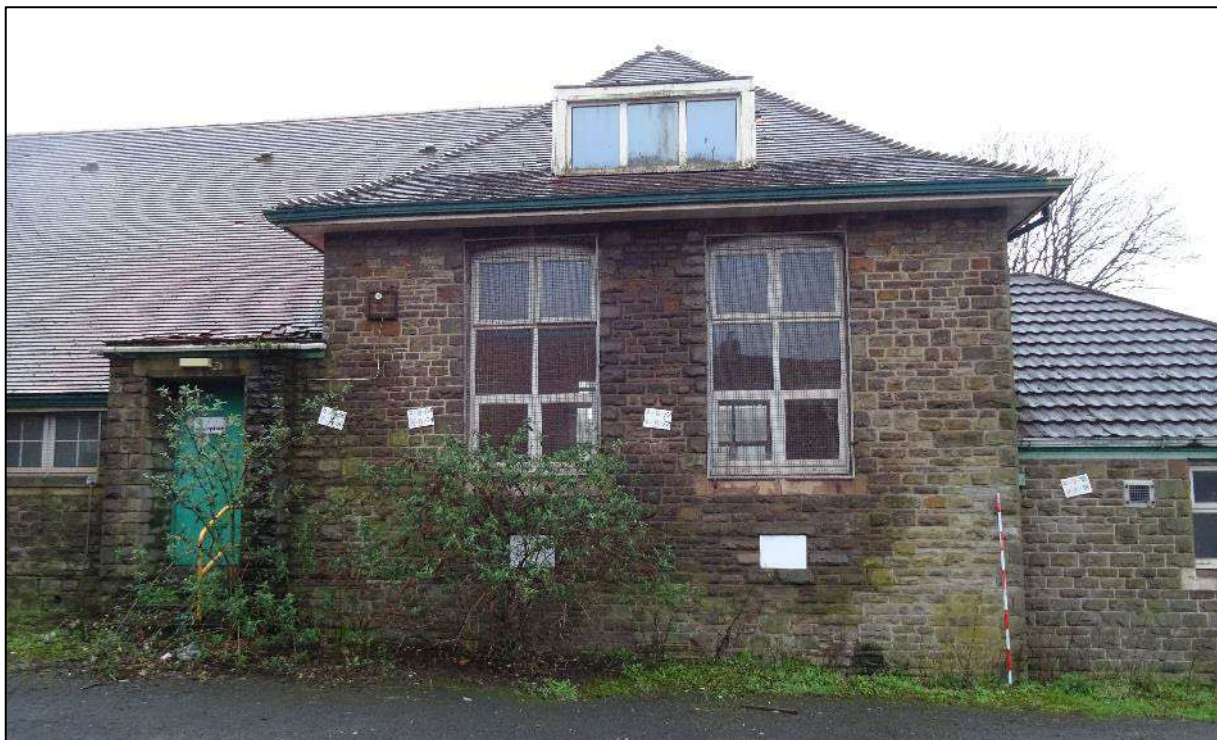
*Plate 444. Pavilion section of south-west wing, north-east facing elevation, Building 6, looking south-west. Scale 2m.*

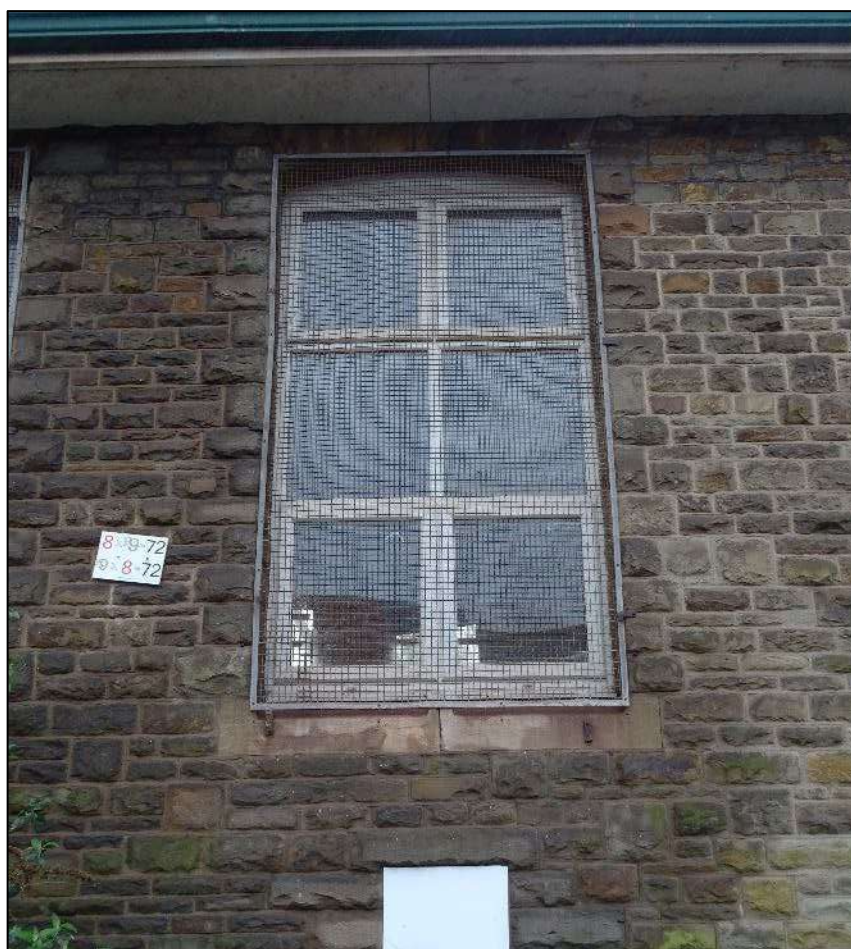
*Plate 445. Window to right of pavilion section of south-west wing, north-east facing elevation, Building 6, looking south-west.*

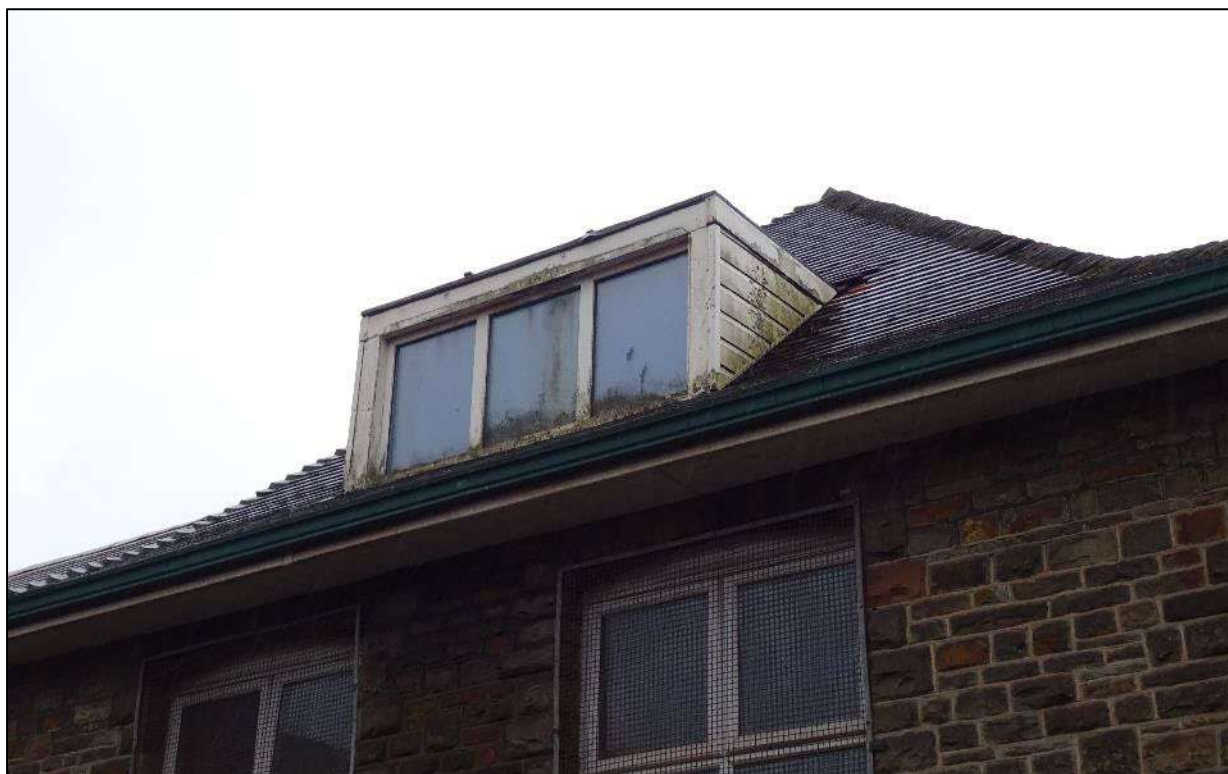
*Plate 446. Dormer to pavilion section of south-west wing, north-east facing elevation, Building 6, looking south.*

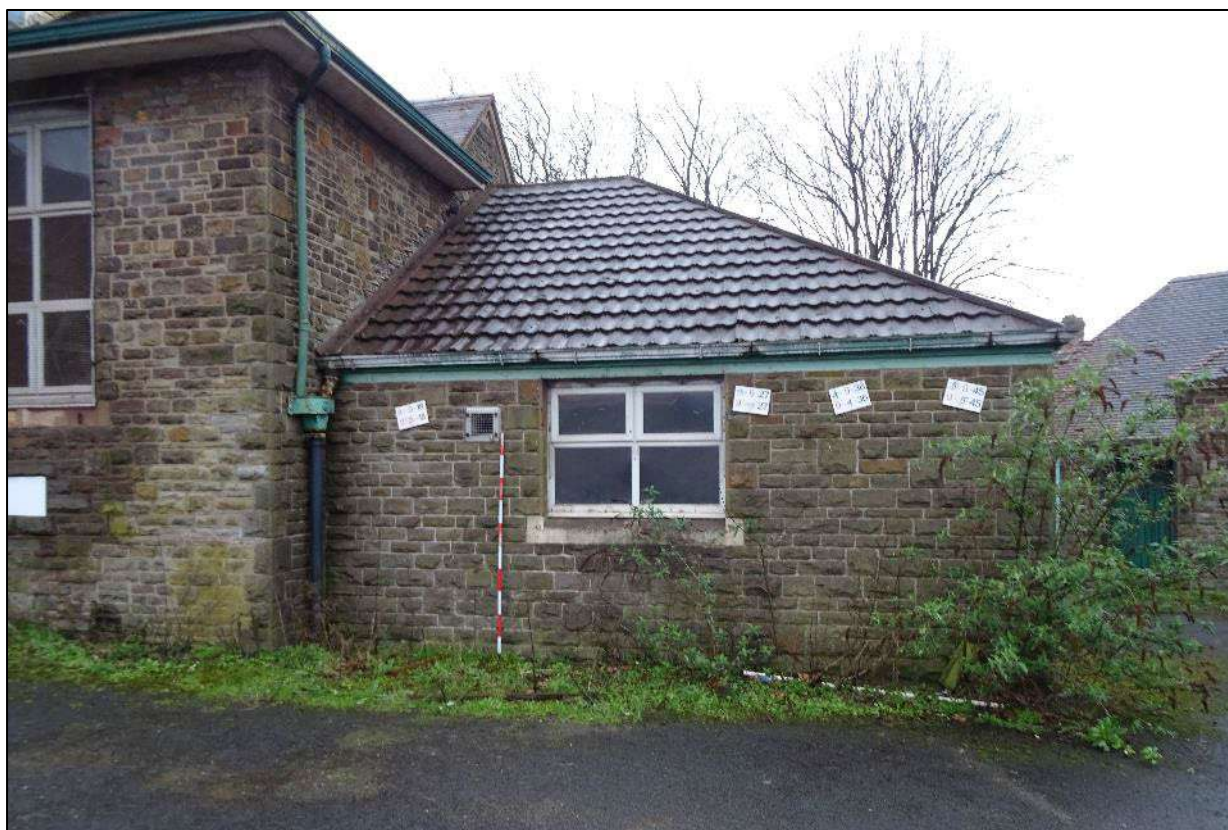
- 5.37.16. The lower hipped roof element to the north-west has a single, off-centre window to the elevation (Plates 447 and 448). It is the same as that to the south-west facing elevation (see Paragraph 5.35.5).

*Plate 447. Lower hipped roof element to north-west of south-west wing, north-east facing elevation, Building 6, looking south-west. Scale 2m.*

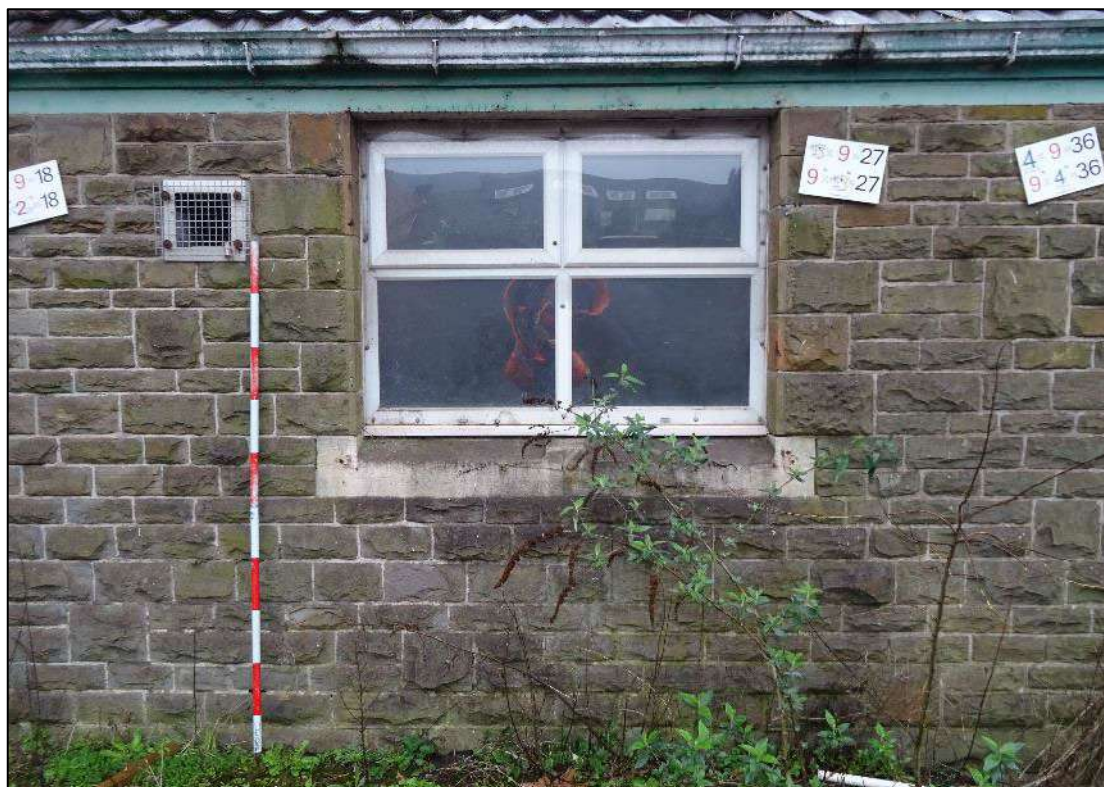
*Plate 448. Window to lower hipped roof element to north-west of south-west wing, north-east facing elevation, looking south-west. Scale 2m.*

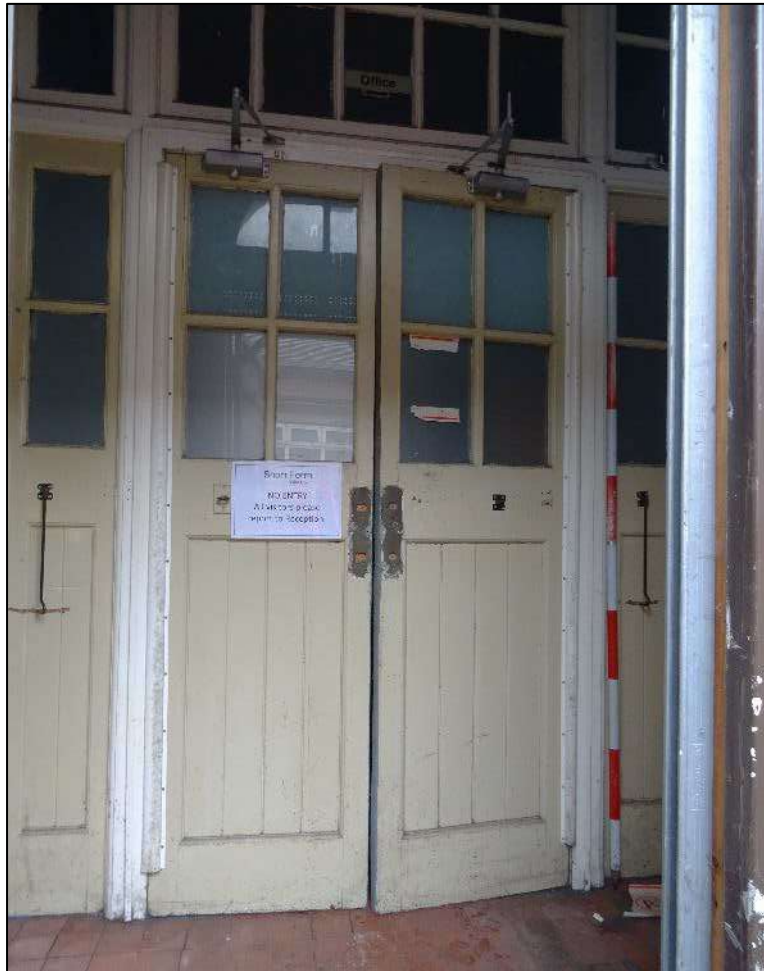
- 5.38.3. Between the vestibule and the main part of the corridor is a wide, segmental arched glazed partition (Plate 452). It has double doors with a fielded panel to the bottom half and four-light panel to the upper. There are matching half width panels to either side, and above is a multi-pane fanlight (Plate 453). The partition is slightly recessed and the opening has rounded edges.

*Plate 452. Door between vestibule a corridor, Room 1, Building 6, looking south-west. Scale 2m.*

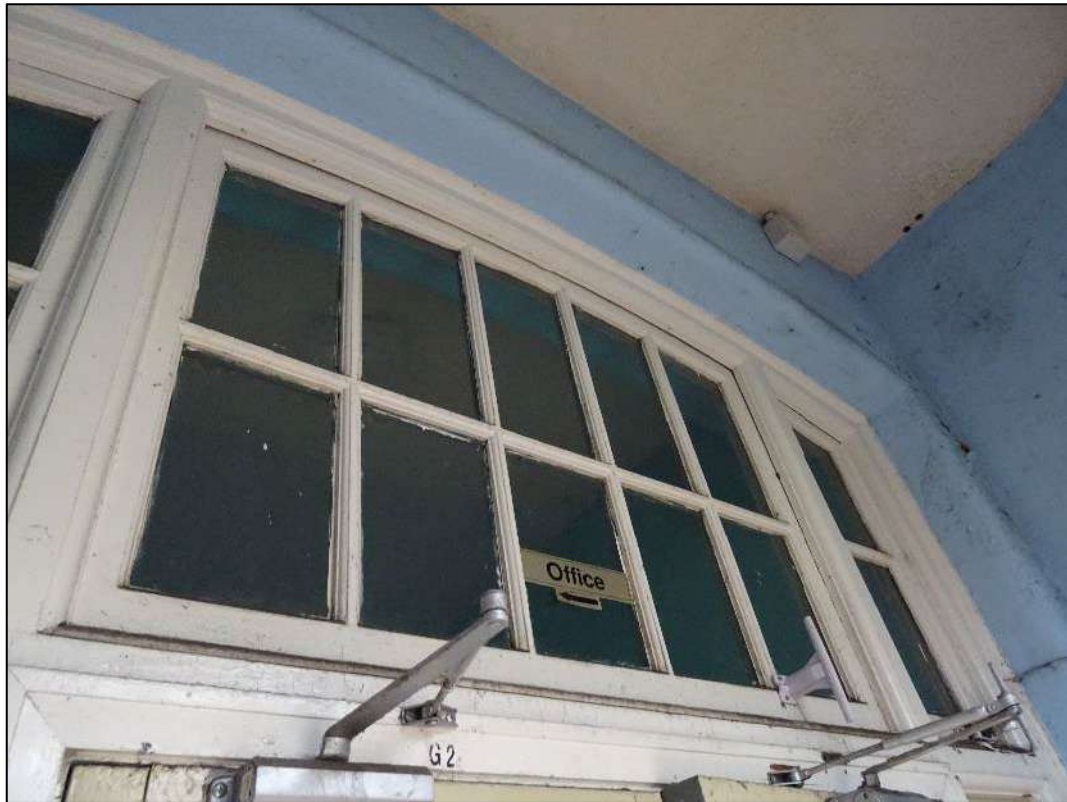
*Plate 453. Fanlight over vestibule door, Room 1, looking west.*

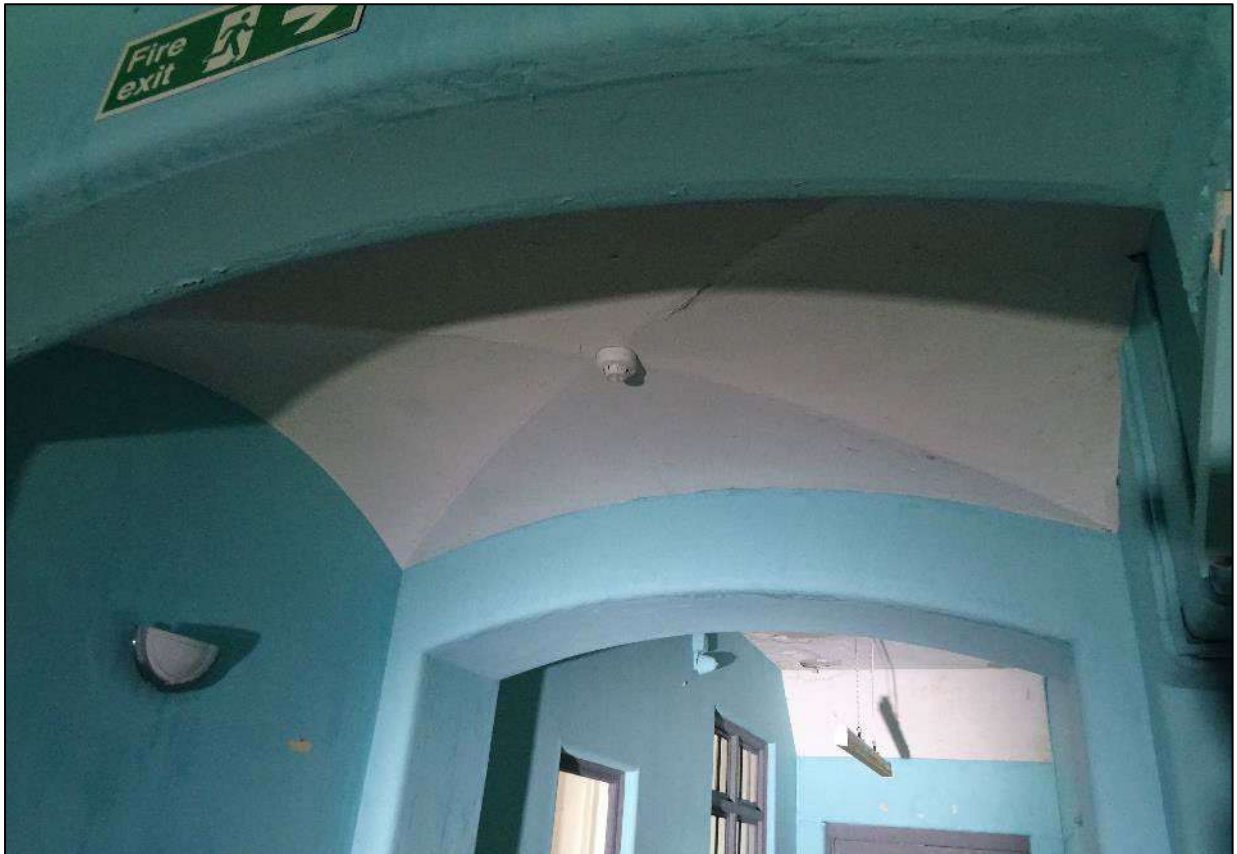
- 5.38.4. The main corridor has the same tiled and painted plaster walls and ceiling as the vestibule (Plate 454). It has herringbone parquet flooring. To the centre of the corridor, where Room 23 extends to the north-west, are two segmental arches with a lower, barrel vaulted ceiling (Plate 455). The ceiling slopes down at the south-west end of the corridor.

*Plate 455. Barrel vaulted ceiling between segmental arches, centre of Room 1, looking south.*
