**Level 2 Building Recording:**  
**Former Dyffryn Lower School, Port Talbot**

March 2024

Report No. 2278

Prepared for KEW Planning  
By  
Susan Stratton PhD

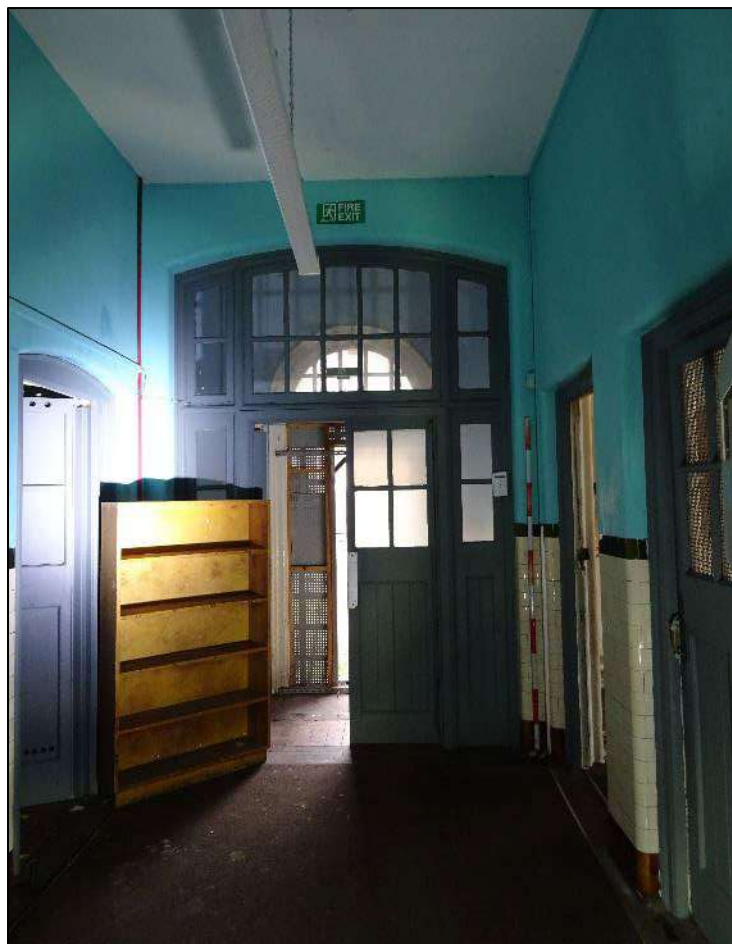
- 5.38.5. The door from the vestibule is to the north-east, as described in Paragraph 5.38.2 (Plate 456).
- 5.38.6. There are three doors off the corridor on the south-east wall, two to Room 2 at the north-east end (Plate 457) and one to Room 3 to the south-west. They are all in the same style, with two fielded panels to the bottom half and a six-light glazed panel to the upper. The edges of the wall to the surround are curved, including the tiles to the lower third. There are two windows to Room 3, one to the right of the doors to Room 2 and one to the south-west end of the corridor (Plate 459). They are four-light mullion and transom wooden windows with three-pane lights to the top and three-over-three to the bottom (Plate 460). The edges of the wall to the surround are curved.

*Plate 456. Doorway to vestibule, Room 1, Building 6, looking north-east. Scale 2m.*

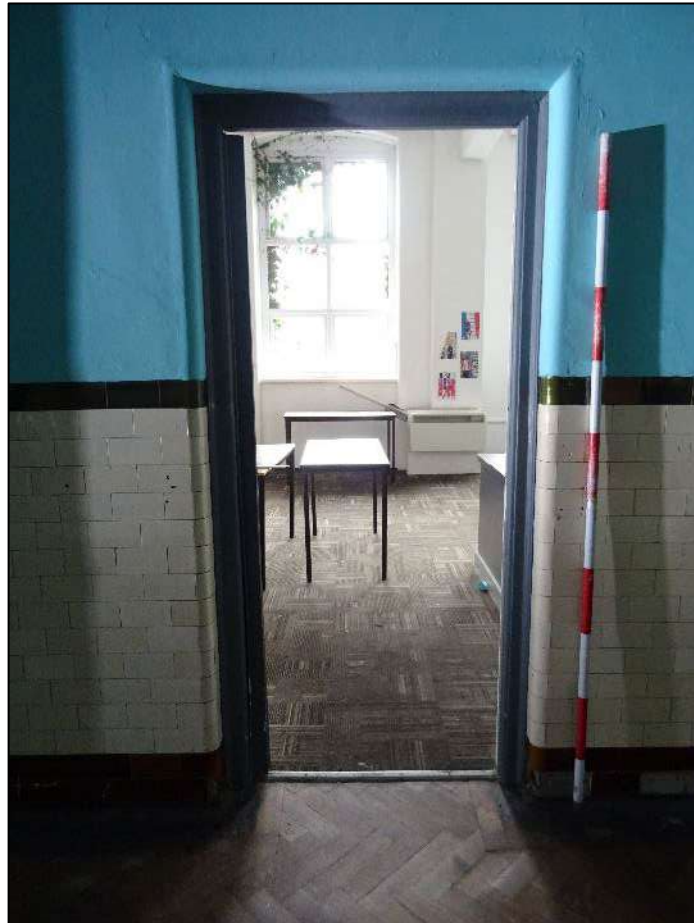
*Plate 458. Door to Room 3 from corridor, Room 1, looking south-east. Scale 2m.*

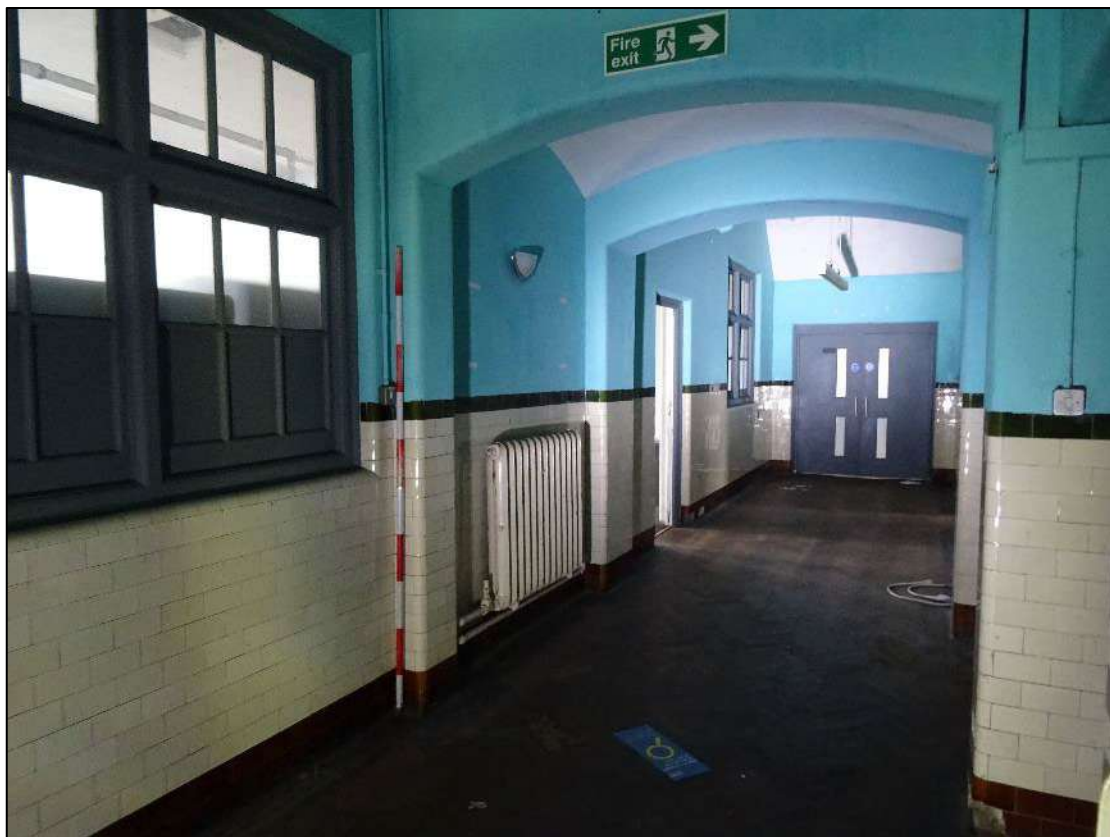
*Plate 459. South-east wall of corridor, Room 1, looking south. Scale 2m.*

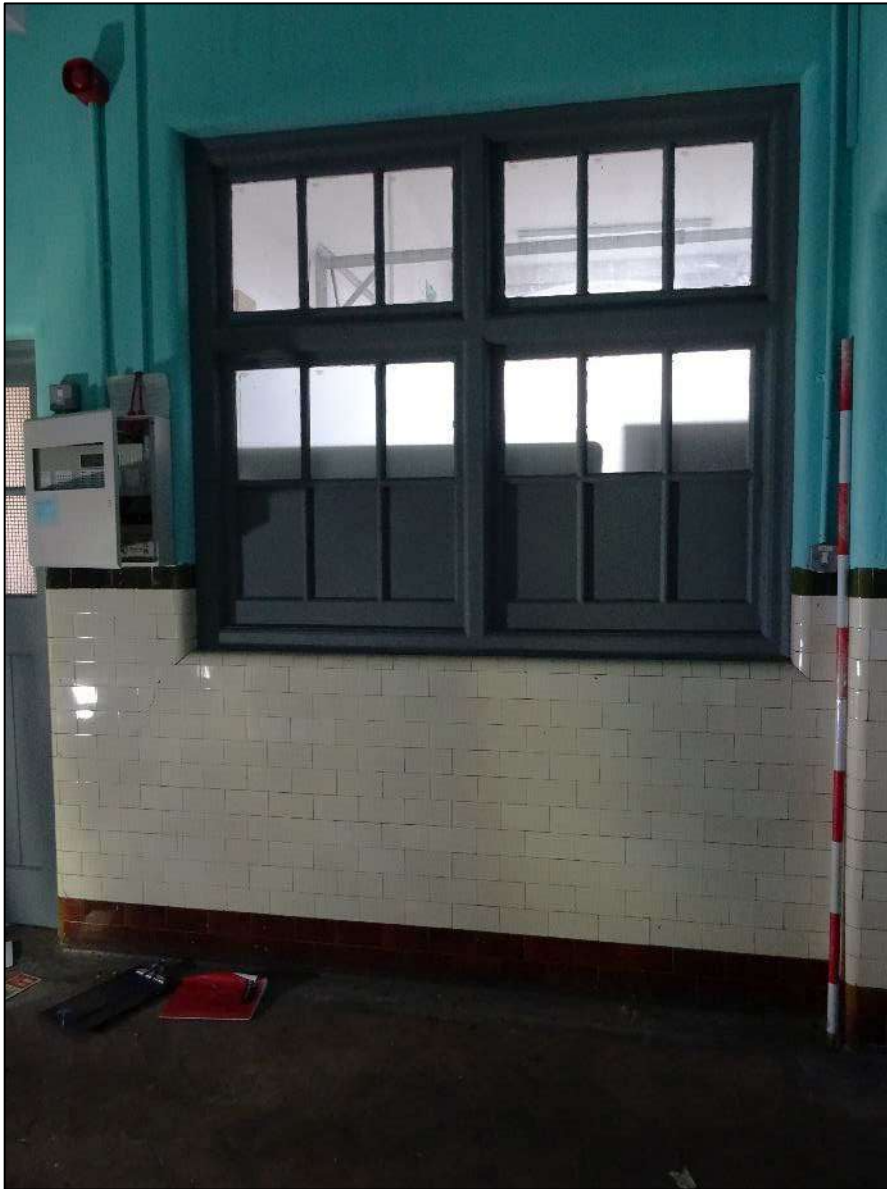
*Plate 460. Window to right of Room 2 doors, Room 1, looking south-east. Scale 2m.*

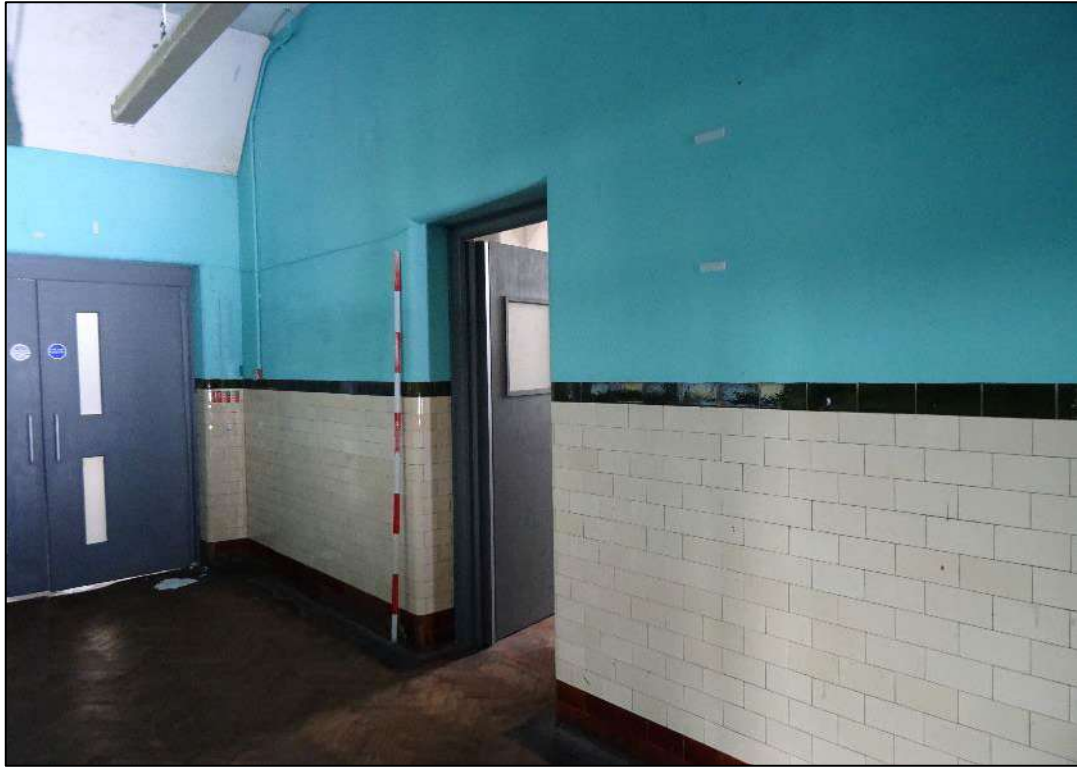
south-west end is a door to Room 4 (Plate 462). It is a modern wooden door with single light to the top half. The door is slightly recessed, with rounded edges and the same tiles and painted plaster to the reveals as the main walls. To the centre of the wall is the door to Room 23 (Plate 463). It is a modern fire door with two vertical lights to the right side, and a solid wood side panel to the right. It has a plain wooden frame recessed in the same style as the door to Room 4. The door to Room 5 is at the north-east end of the corridor. It has two fielded panels to the bottom half and a four-light glazed panel to the upper, now painted over (Plate 464). It has narrow panels to either side. It is in a segmental arched with rounded edges. There is also a segmental arched opening to the stairwell (Room 30), to the right of the door to Room 23 (Plate 465).

*Plate 462. Door to Room 4, Room 1, Building 6, looking west. Scale 2m.*

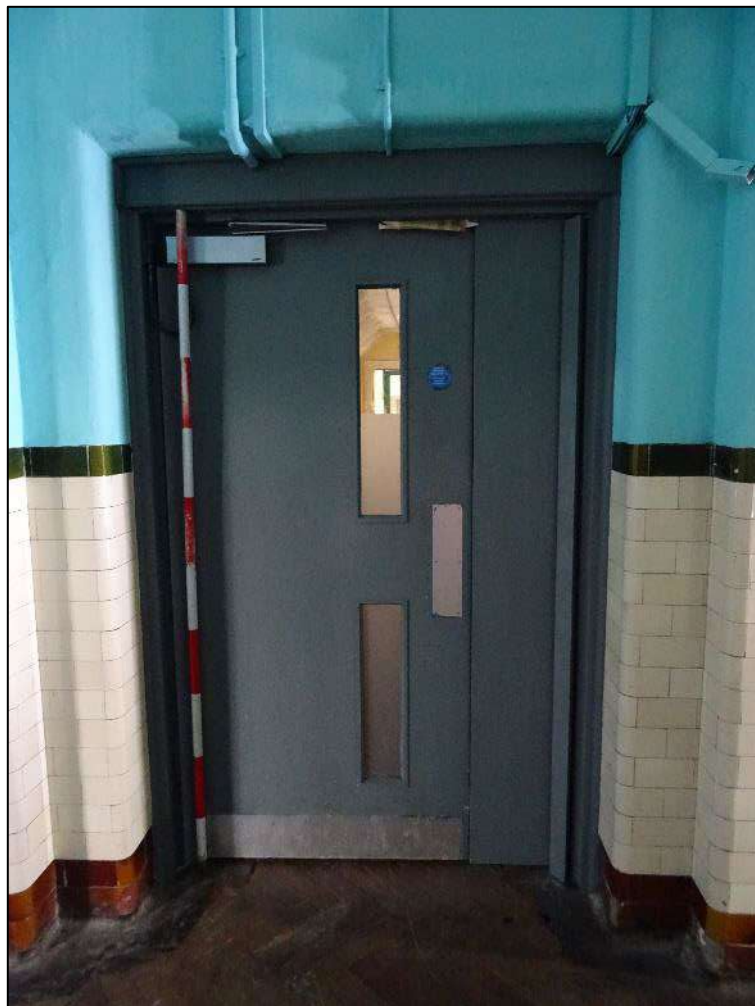
*Plate 463. Door to Room 23, Room 1, looking north-west. Scale 2m.*

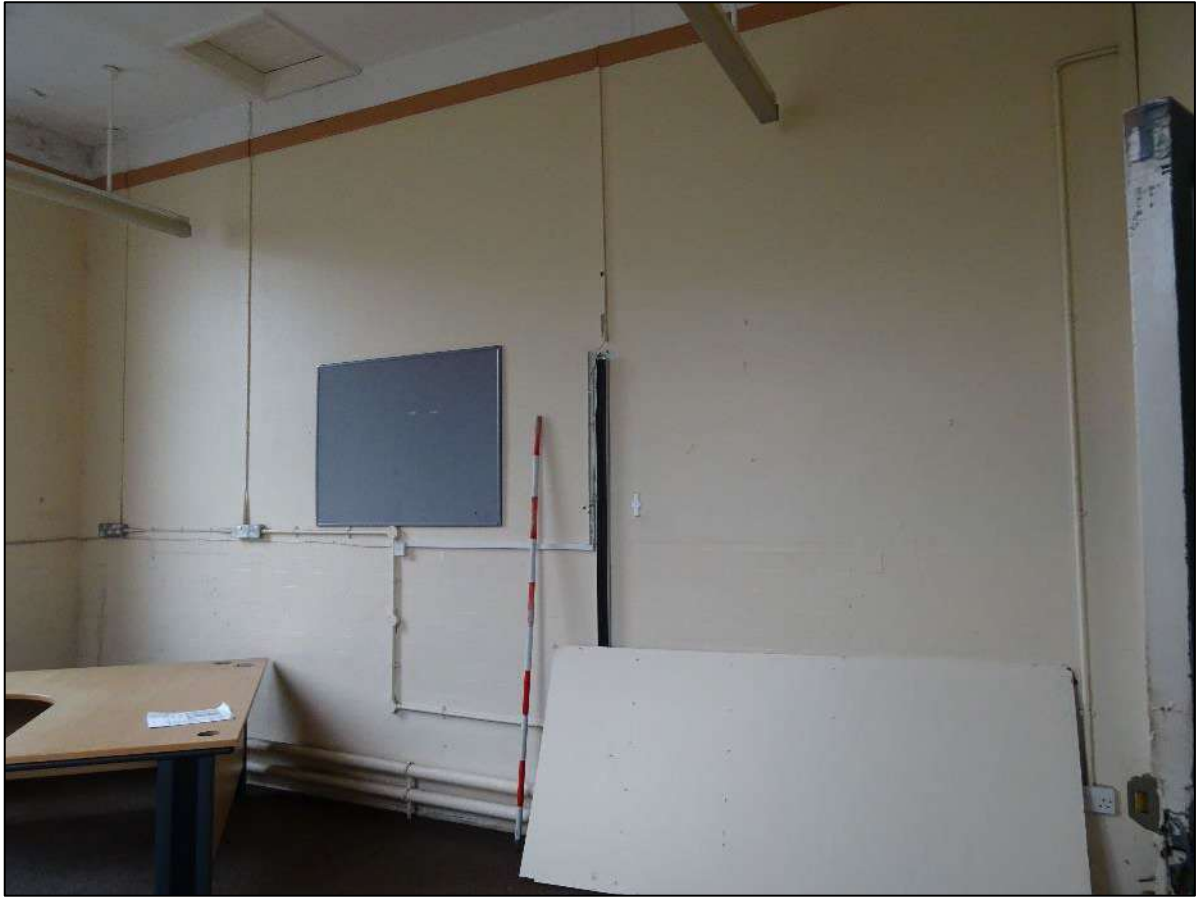
- 5.38.9. Room 2 is an office in the north-east corner of the building, accessed from Room 1 on the north-west wall. It has carpet over a red ceramic tile floor. The walls are painted magnolia, with tiles to the lower third and plaster to the rest (Plate 466). It has an orange painted band near the top of the wall. The ceiling is white painted plaster.
- 5.38.10. The two doors from Room 1 are to the left side of the north-west wall (Plates 467 and 468). They are as described in Paragraph 5.38.6.
- 5.38.11. There is a window to the centre of the north-east wall (Plate 469). It is a uPVC unit in a tall, segmental arched recess. It has a moulded wooden sill under the uPVC addition (Plate 470). There is a window of the same style to the south-east wall (Plate 471).

*Plate 466. Room 2, south-west wall, looking west. Scale 2m.*

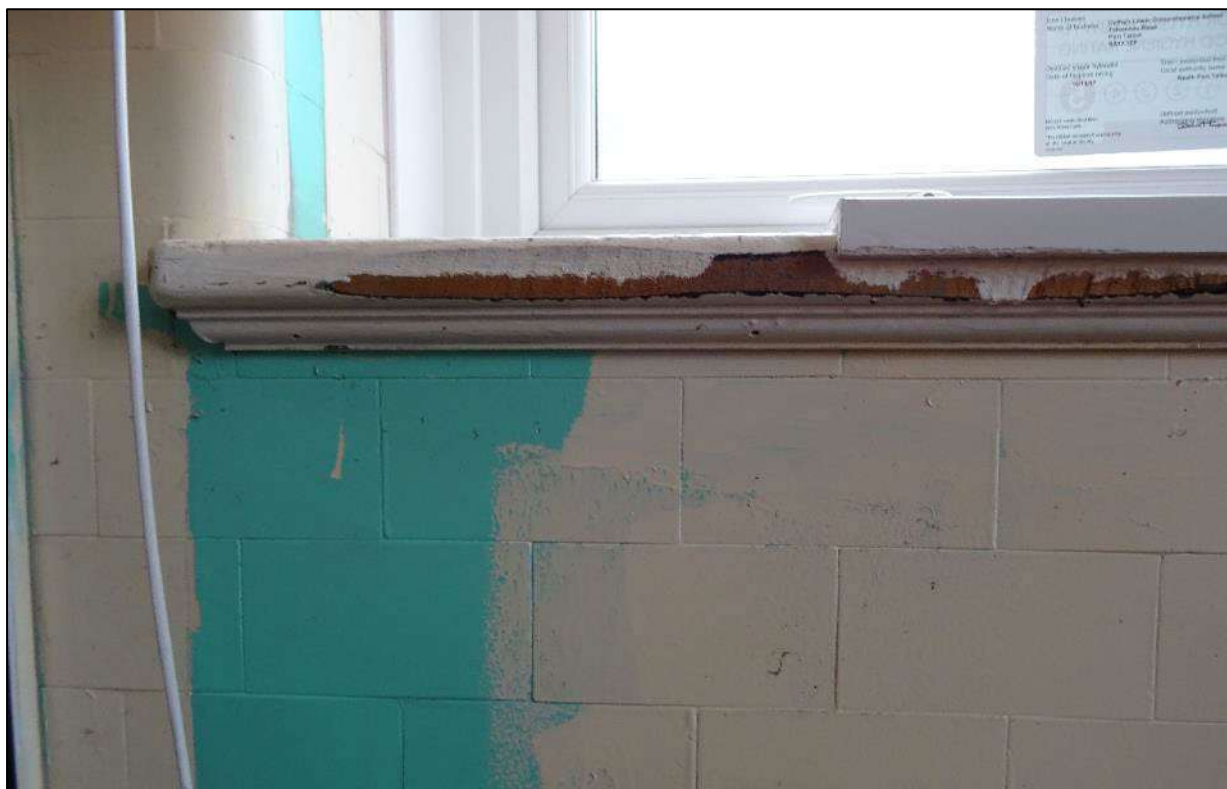
*Plate 470. Detail of windowsill to window on north-east wall of Room 2, looking north.*

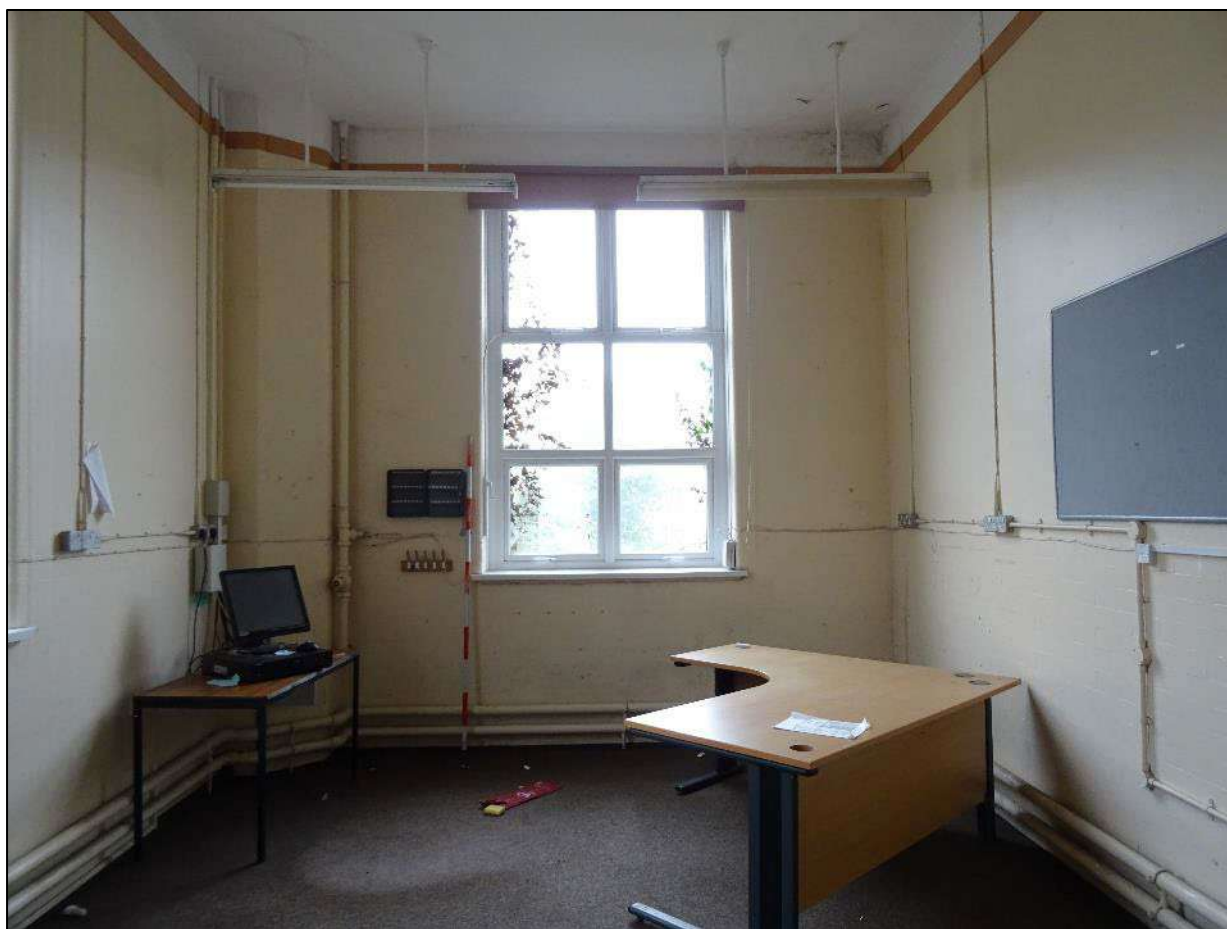
*Plate 471. South-east wall of Room 2, looking south-east. Scale 2m.*

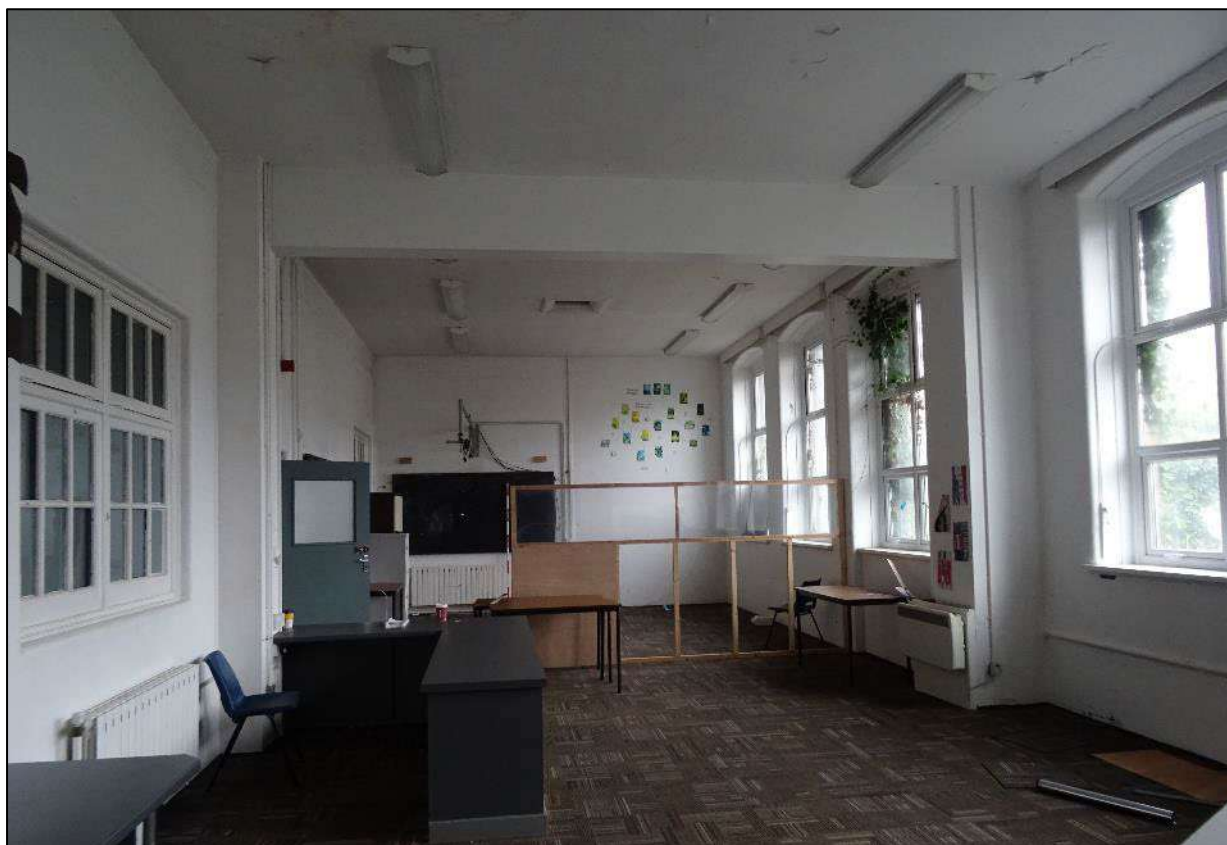
- 5.38.12. Room 3 is a long, rectangular room along the south-east side of Building 6. It has patterned carpet tiles to the floor (Plate 472). The walls and ceiling are white painted plaster, with the lower third of the walls painted tile.

*Plate 472. Room 3, Building 6, looking north-east. Scale 2m.*

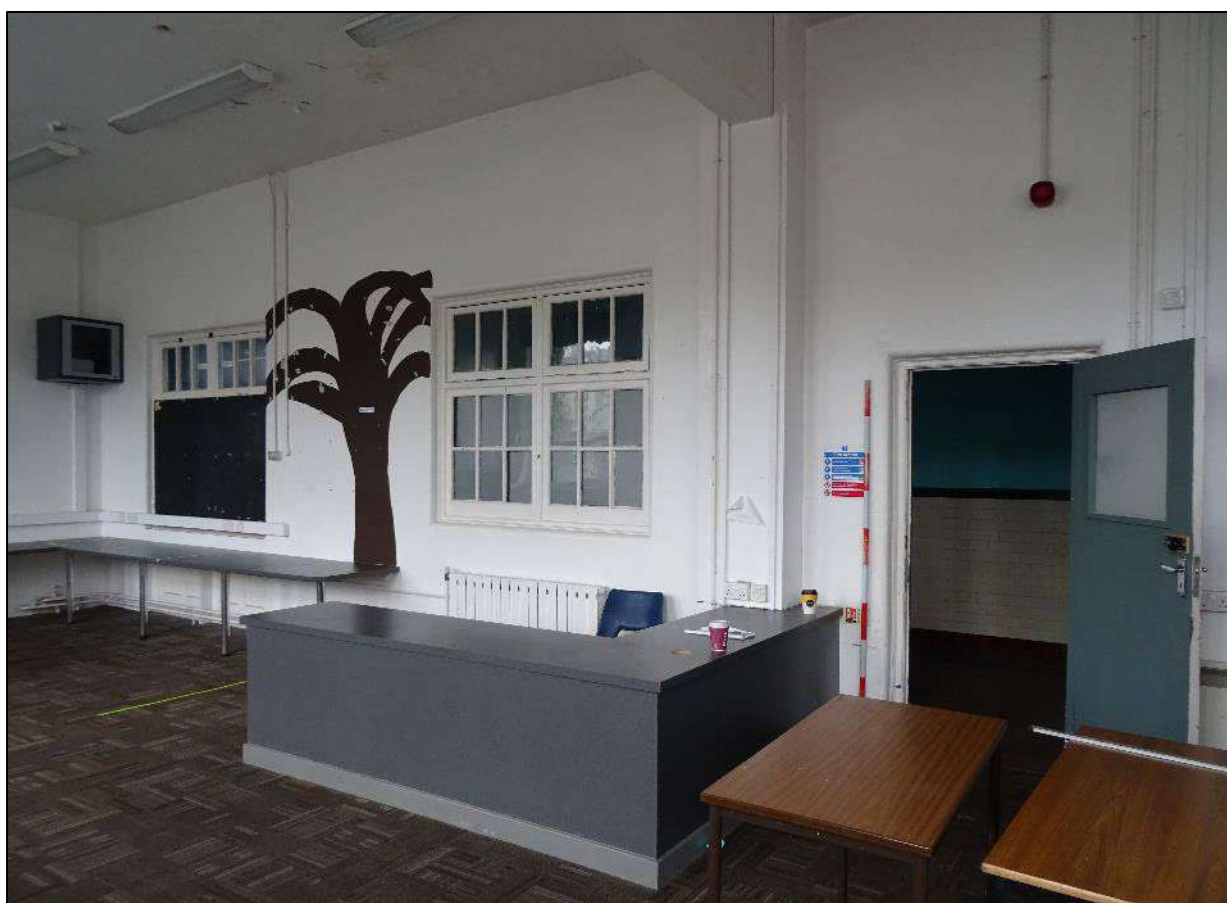
- 5.38.13. The door from Room 1 is to the centre of the north-west wall, as described in Paragraph 5.38.6. There are two windows to the south-west end of the wall (Plate 473) and one to the north-east end (Plate 474).
- 5.38.14. There are six windows to the south-east wall (Plate 476). They are all uPVC units in segmental arched recesses with uPVC sills over the original moulded wood (Plate 477).
- 5.38.15. To the left side of the south-west wall is a slightly projecting chimney breast (Plate 478). The fireplace surround is of the same style as those in Building 1: green glazed ceramic tiles with an elongated keystone and voussoirs, a moulded string band above, a brick-lined fire box, and hearth stone in front (Plate 479).

*Plate 473. South-west end of north-west wall, Room 3, Building 6, looking west. Scale 2m.*

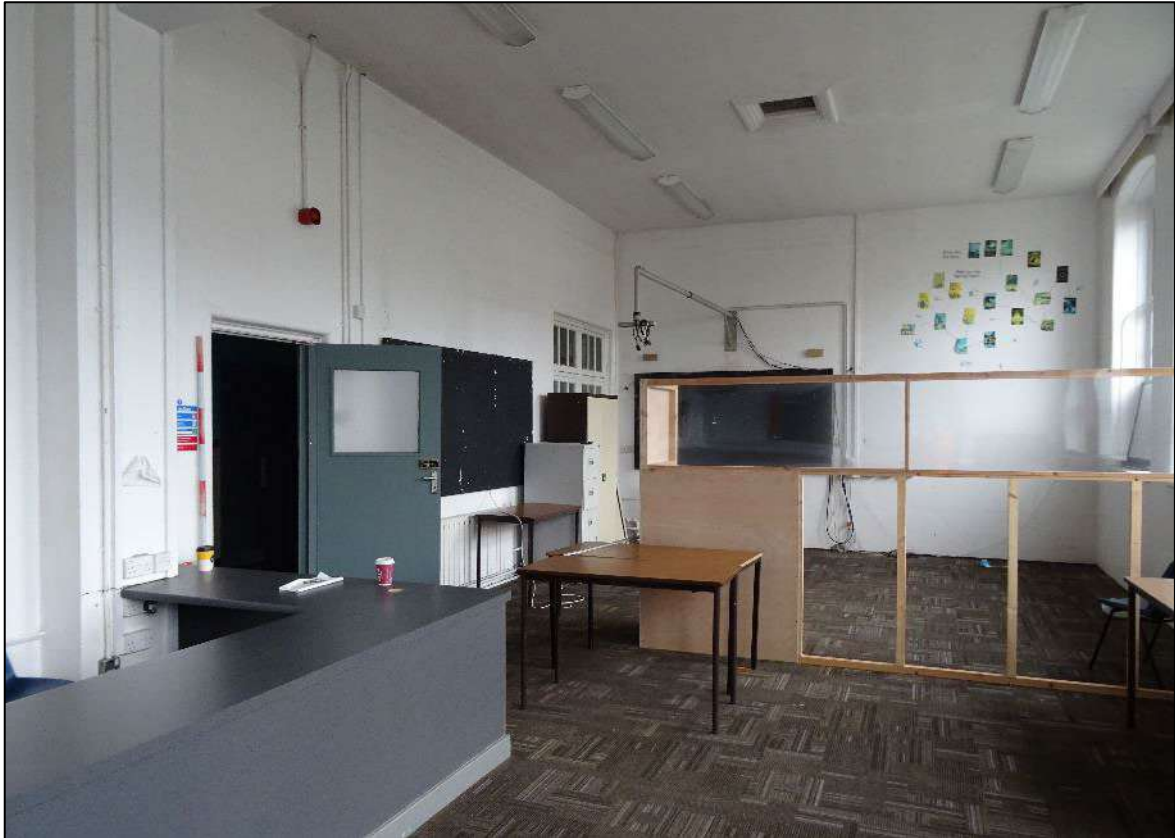
*Plate 474. Room 3, looking north. Scale 2m.*

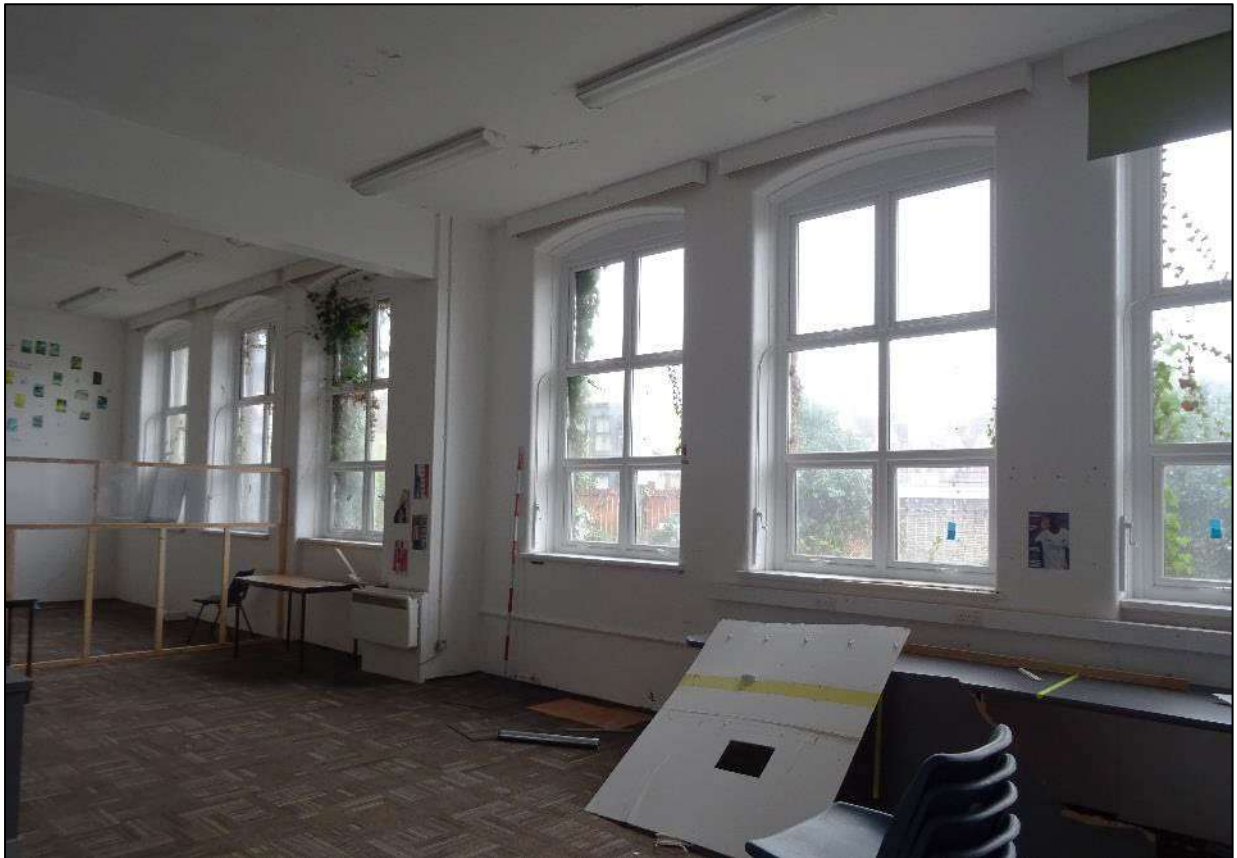
*Plate 476. South-east wall of Room 3, looking east. Scale 2m.*

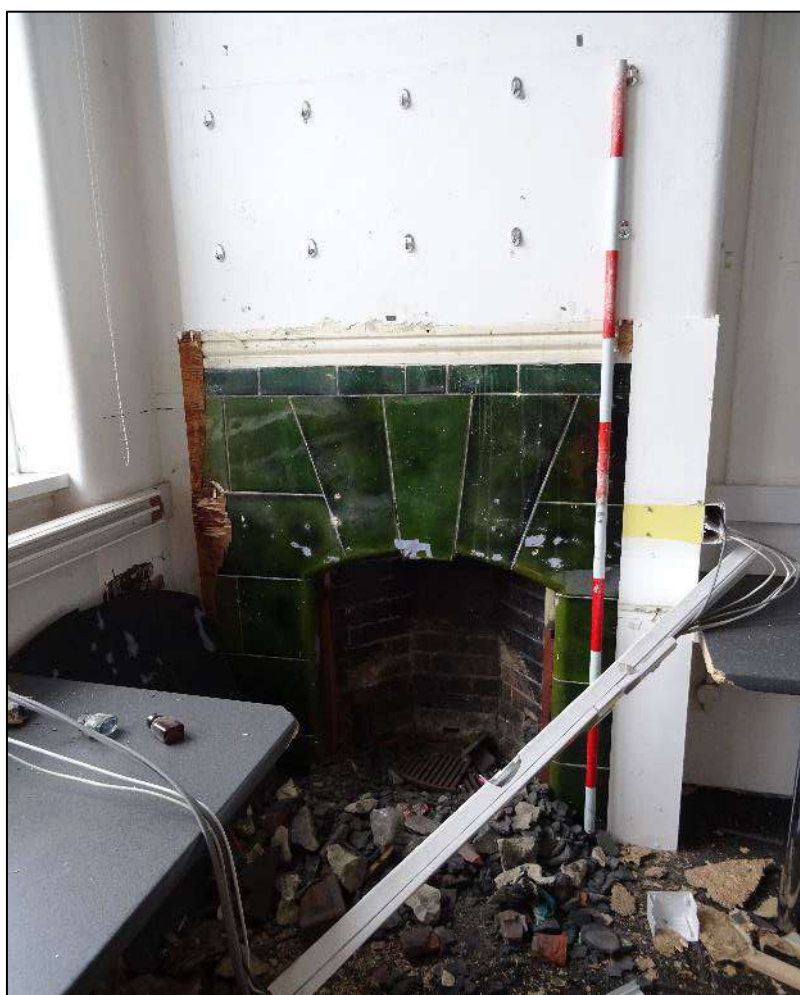
*Plate 479. Fireplace to south-west wall of Room 3, looking south-west. Scale 2m.*

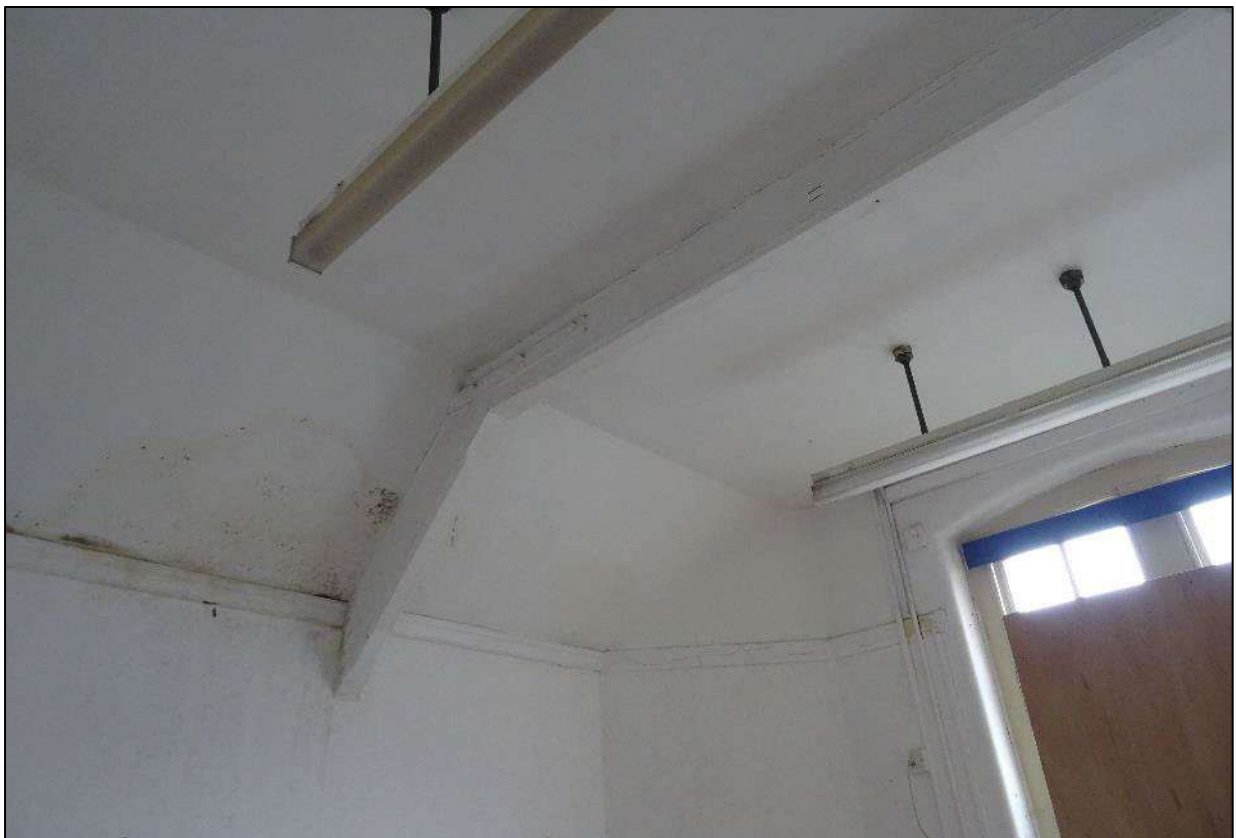
- 5.38.16. Room 4 is a small room to the north-west of the front range, within the cross-gable element. It has an attached storeroom to the north-east. The floor is herringbone parquet and the walls and ceiling are white painted plaster. The north-east wall and storeroom north-west wall are stud partitions. The ceiling slopes down at the south-west side, and there is an exposed raised beam oriented north-east to south-west (Plate 481).

*Plate 481. Ceiling of Room 4, looking west.*

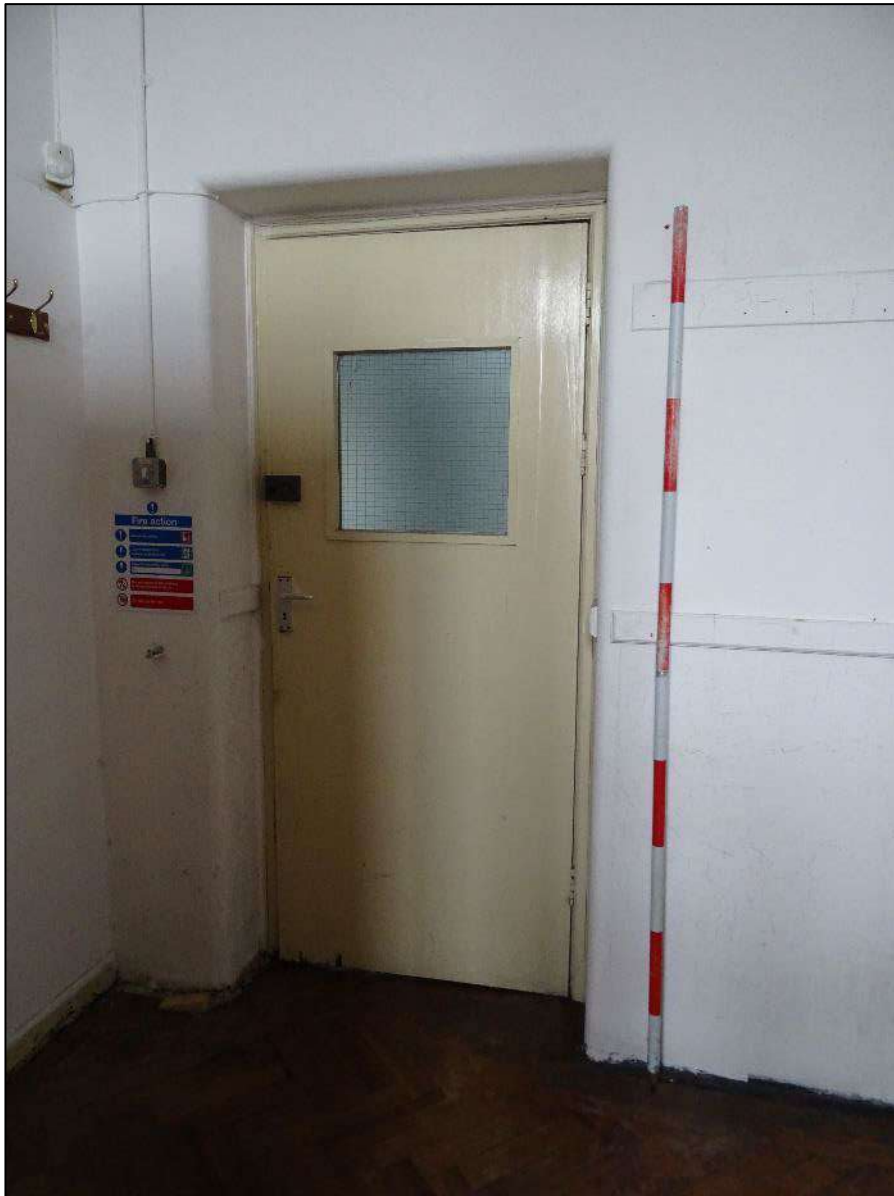
- 5.38.17. The door from Room 1 is on the left side of the south-east wall and is as described in Paragraph 5.38.7 (Plate 482).
- 5.38.18. In the west corner of the room is a corner chimney breast (Plate 483). The fireplace has a glazed brick surround with wooden mantelpiece and a ceramic tile raised hearth.

*Plate 482. Door to Room 1, south-east wall of Room 4, looking south-east. Scale 2m.*

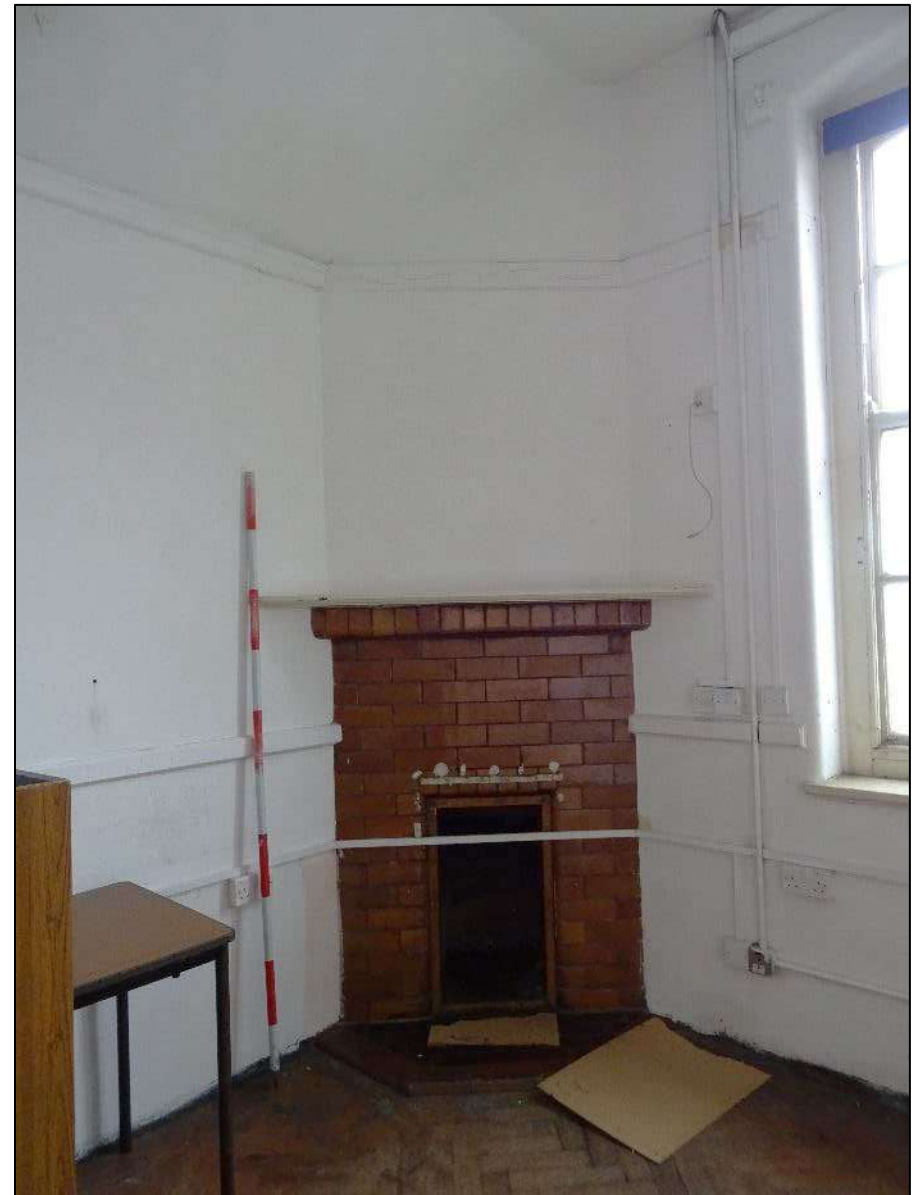
*Plate 483. Fireplace in west corner of Room 4, looking west. Scale 2m.*

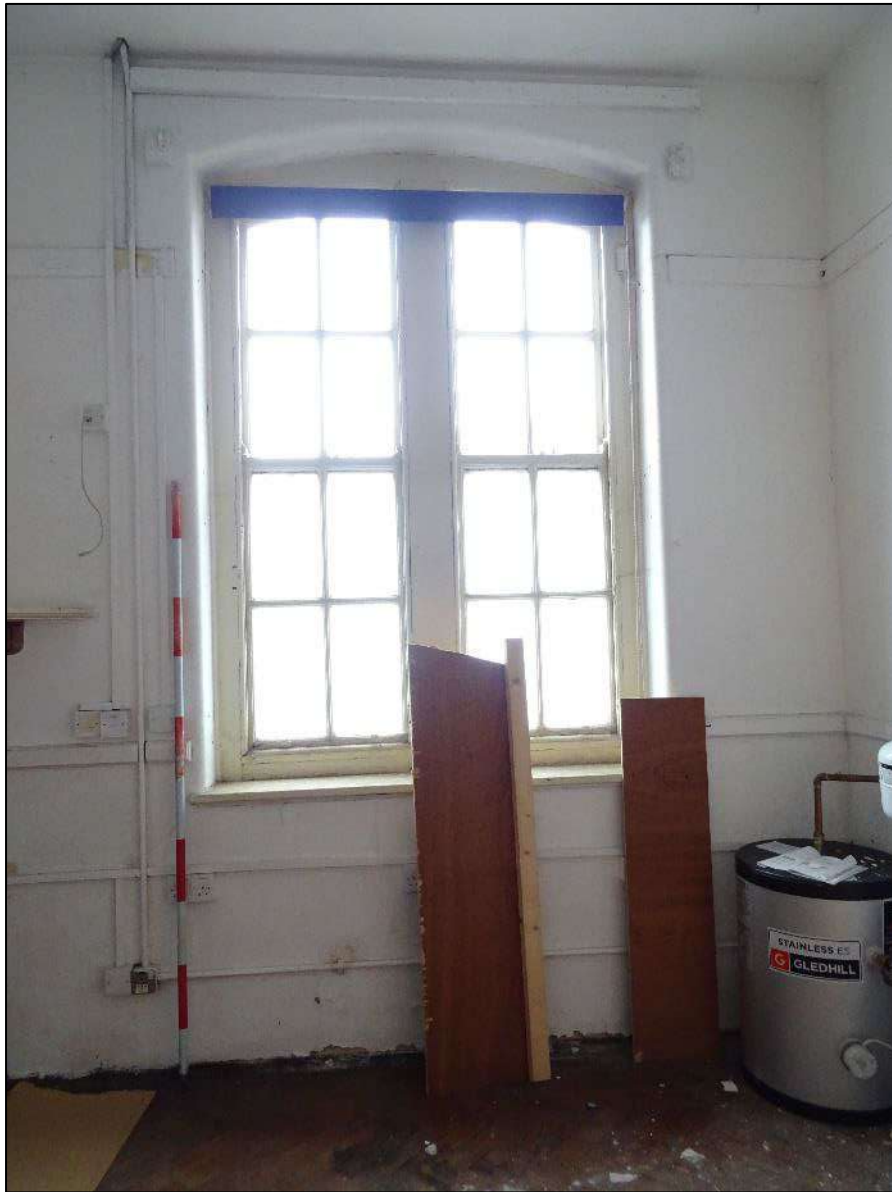
- 5.38.19. To the north-west wall is a wooden framed, mullion four-over-four light sash window (Plates 484 and 485). It is in a segmental arched recess with painted plaster reveals, rounded edges, and a moulded wooden sill.

*Plate 484. Window to north-west wall, Room 4, looking north-west.  
Scale 2m.*

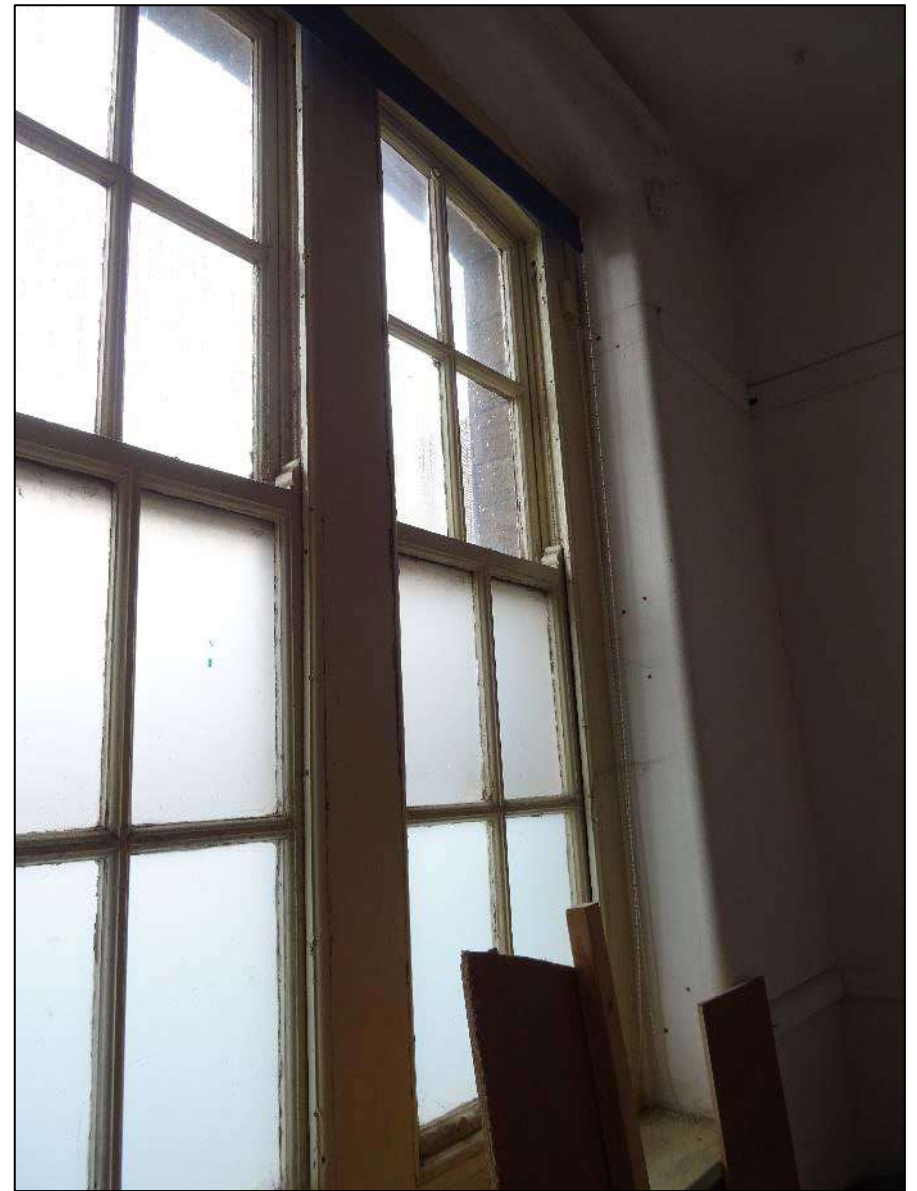
*Plate 485. Detail of sash window to north-west wall, Room 4, looking north.*

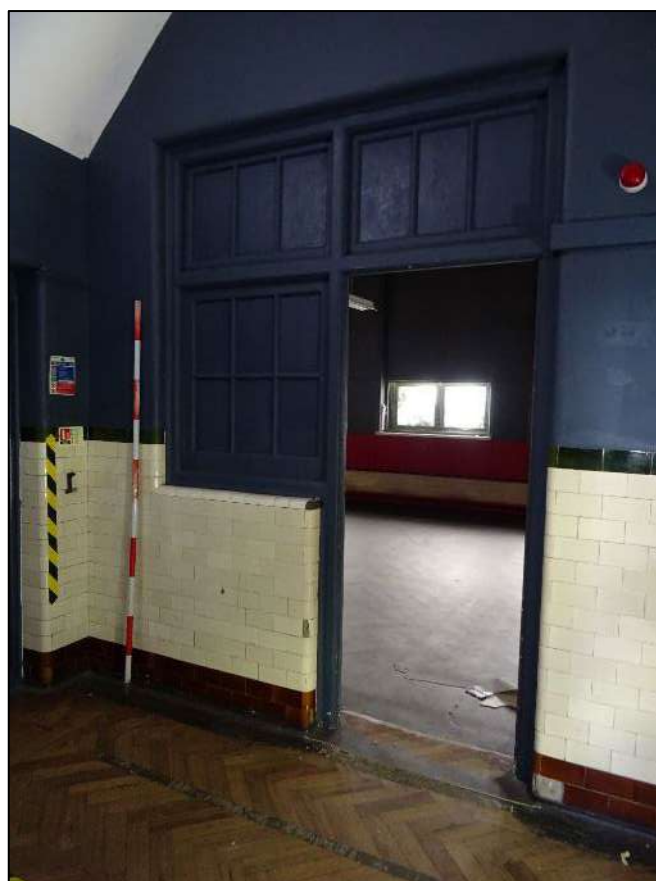
*Plate 507. Door through to Room 9 looking east. Scale 2m.*

5.38.43. Room 9 is a classroom which is accessed through the southern side of Hall Room 6. It has linoleum flooring and the ceiling is white painted plaster. The upper part of walls is blue-grey painted plaster, the middle section of the walls is modern applied square tile painted blue-grey but with occasional blue, red and yellow painted tiles. The lower section is a narrow band of white ceramic tiles with a brown band to the bottom (Plate 515). The north-east wall has a large modern plain board panel extending across the entire central section painted yellow, grey and white. The door to Corridor 8 is as described in Paragraph 5.38.32 (Plate 507). There is also a similar double door to Room 6 (Plate 515).

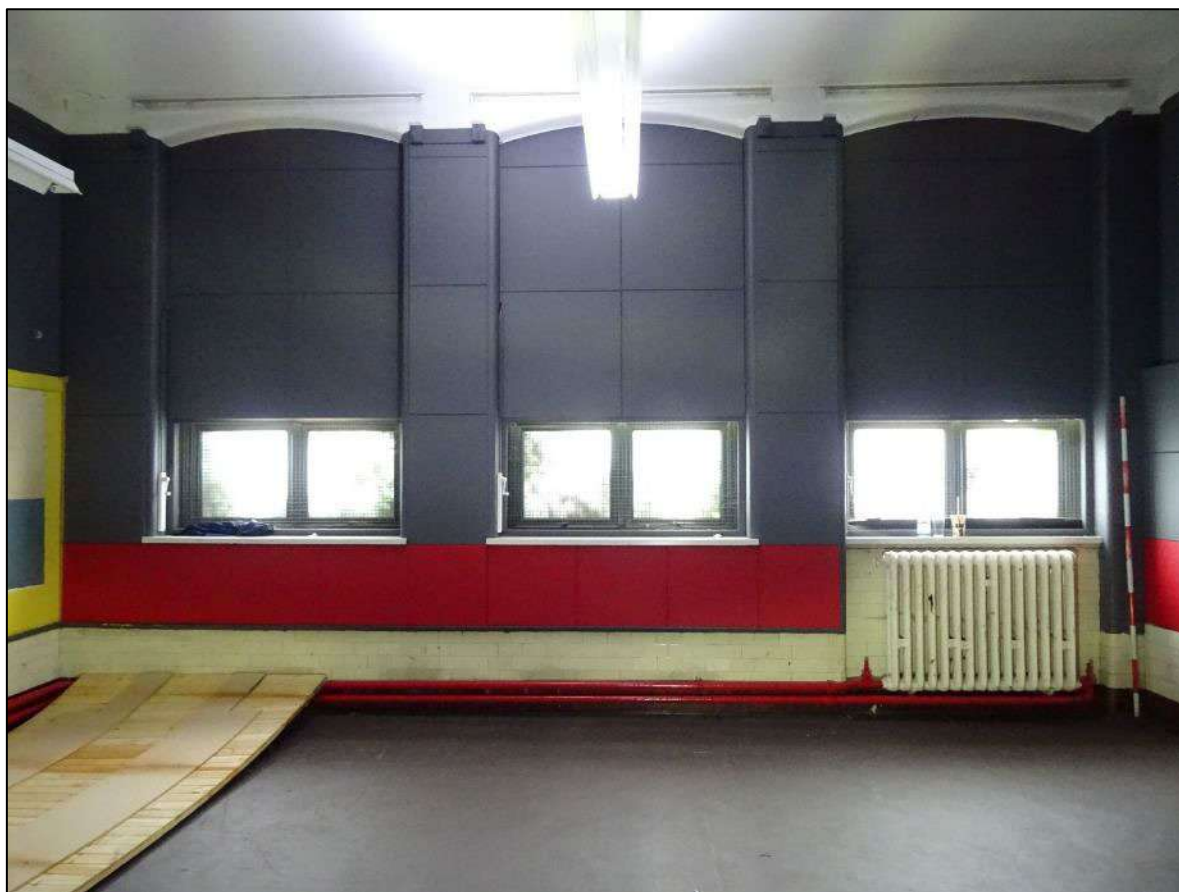
*Plate 516. Partially blocked windows, south-east wall of Room 9, looking south-east. Scale 2m.*

5.38.44. There are three windows to the south-east wall (Plate 516). They are all uPVC units with uPVC sills over the original moulded wood. The upper four lights are blocked with modern plain board painted grey. Below the right-hand window is a single are cast-iron column radiator.

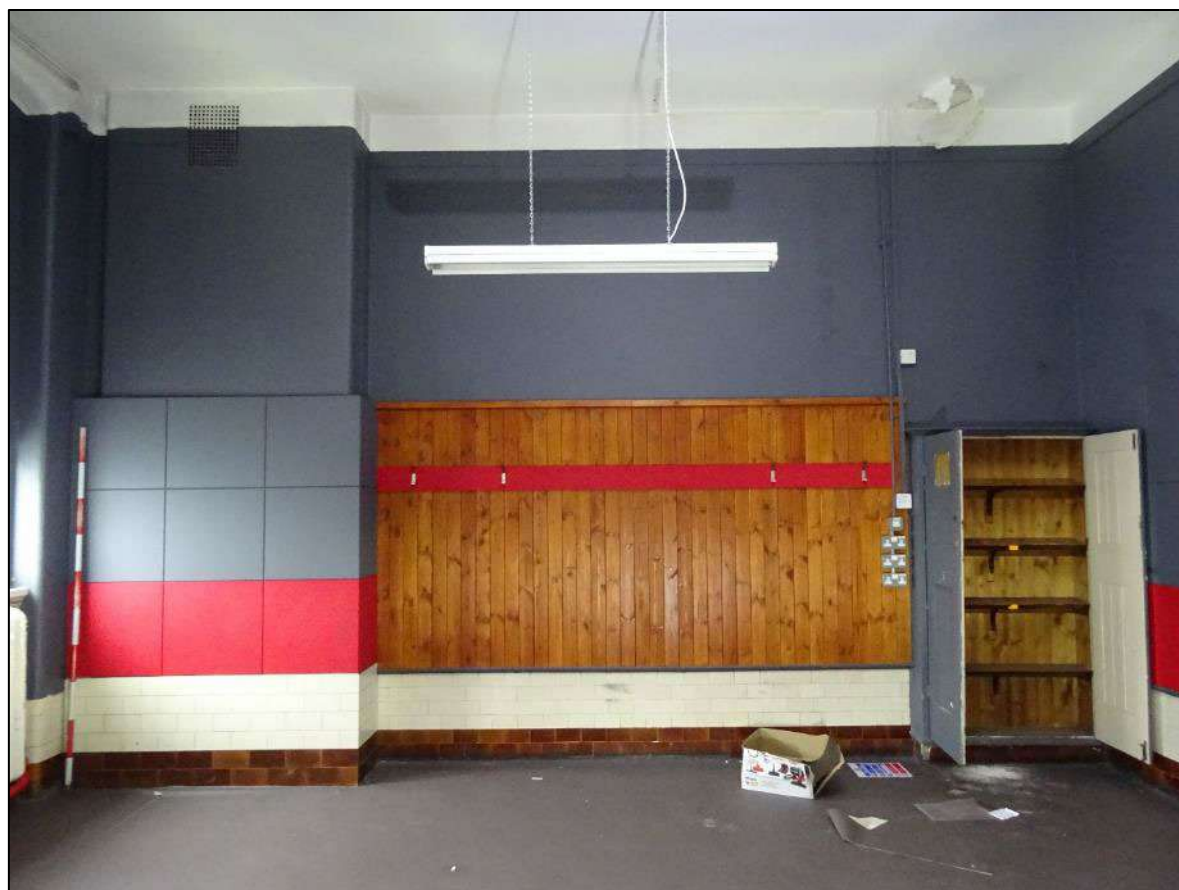
*Plate 517. Blocked fireplace, south-west wall of Room 9, looking south-west. Scale 2m.*

5.38.45. In the southern corner of the room, along the south-west wall, is projecting chimney breast (Plate 517). The fireplace is now blocked but is likely to be similar to that in Room 7 (Plate 504).

5.38.46. In the western corner of the same wall is a fitted painted wooden store cupboard. Between the blocked chimney and the cupboard is a panelled section of wall with coat rail attached (Plate 517).
