**Level 2 Building Recording:**  
**Former Dyffryn Lower School, Port Talbot**

March 2024

Report No. 2278

Prepared for KEW Planning  
By  
Susan Stratton PhD

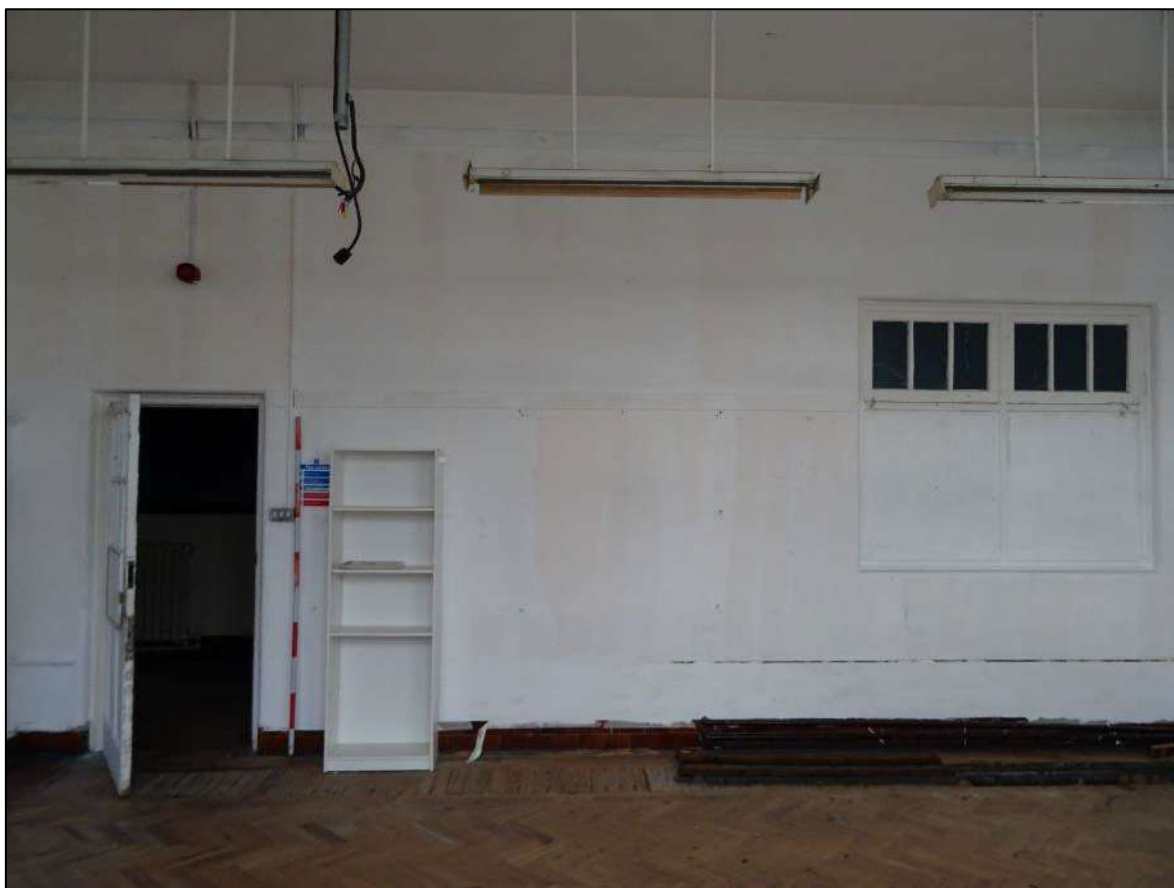
*Plate 518. Room 10 looking north-west. Scale 2m.*

5.38.47. Room 10 is a classroom which is accessed through the southern side of Corridor 8. The floor is herringbone parquet with a border to the north-east of parallel parquet tiles (Plate 518). The ceiling is white painted plaster. The walls are also painted white, the upper third being painted plaster, the central third painted panelling and the lower section painted over ceramic tile (Plate 519). There are three windows to the south-east wall (Plate 520). They are all uPVC

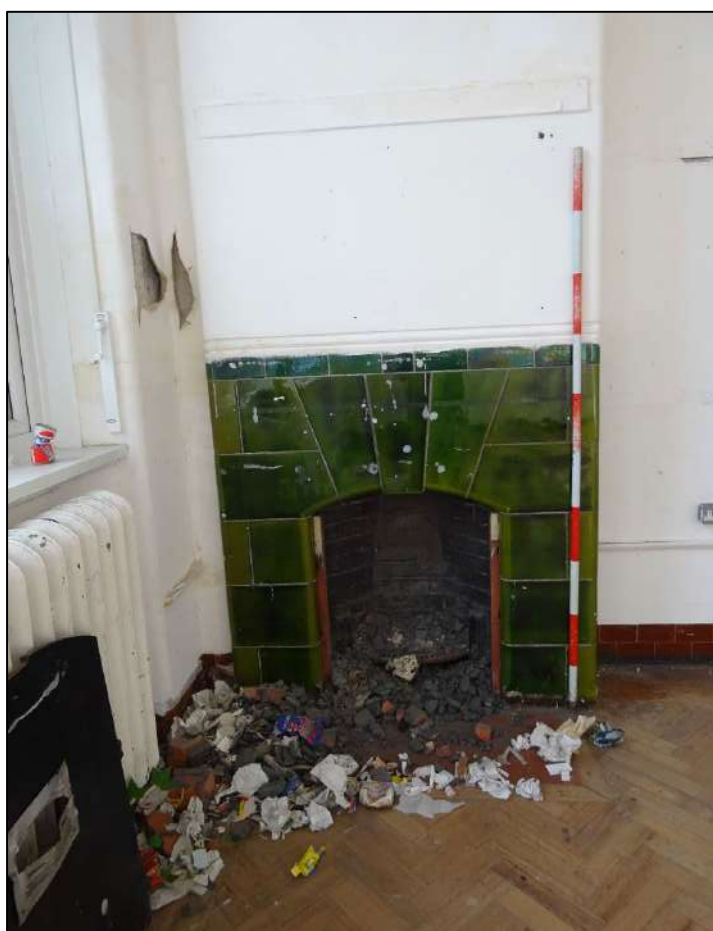
*Plate 521. Room 10 Fireplace looking south. Scale 2m.*

5.38.48. In the southern corner of the room, along the south-west wall is a fireplace with a projecting chimney (Plate 521). The fireplace has a green glazed ceramic tile surround, with elongated keystone and voussoir design, with a moulded string above. There is a brick lining to the fire box and a stone hearth in front.

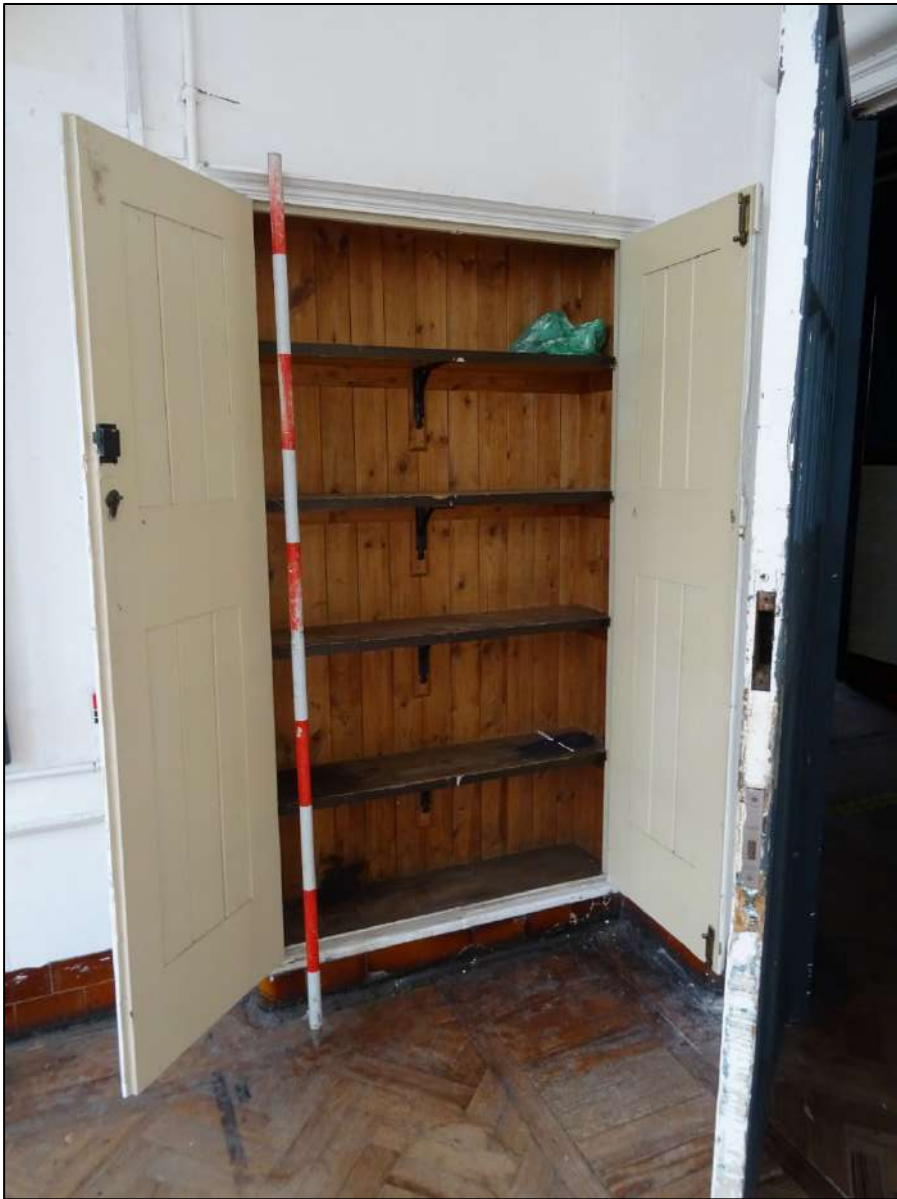
*Plate 522. Room 10 Wooden panelled store cupboard looking south-west. Scale 2m.*

5.38.49. In the western corner of the same wall was a fitted white painted wooden store cupboard (Plate 522).

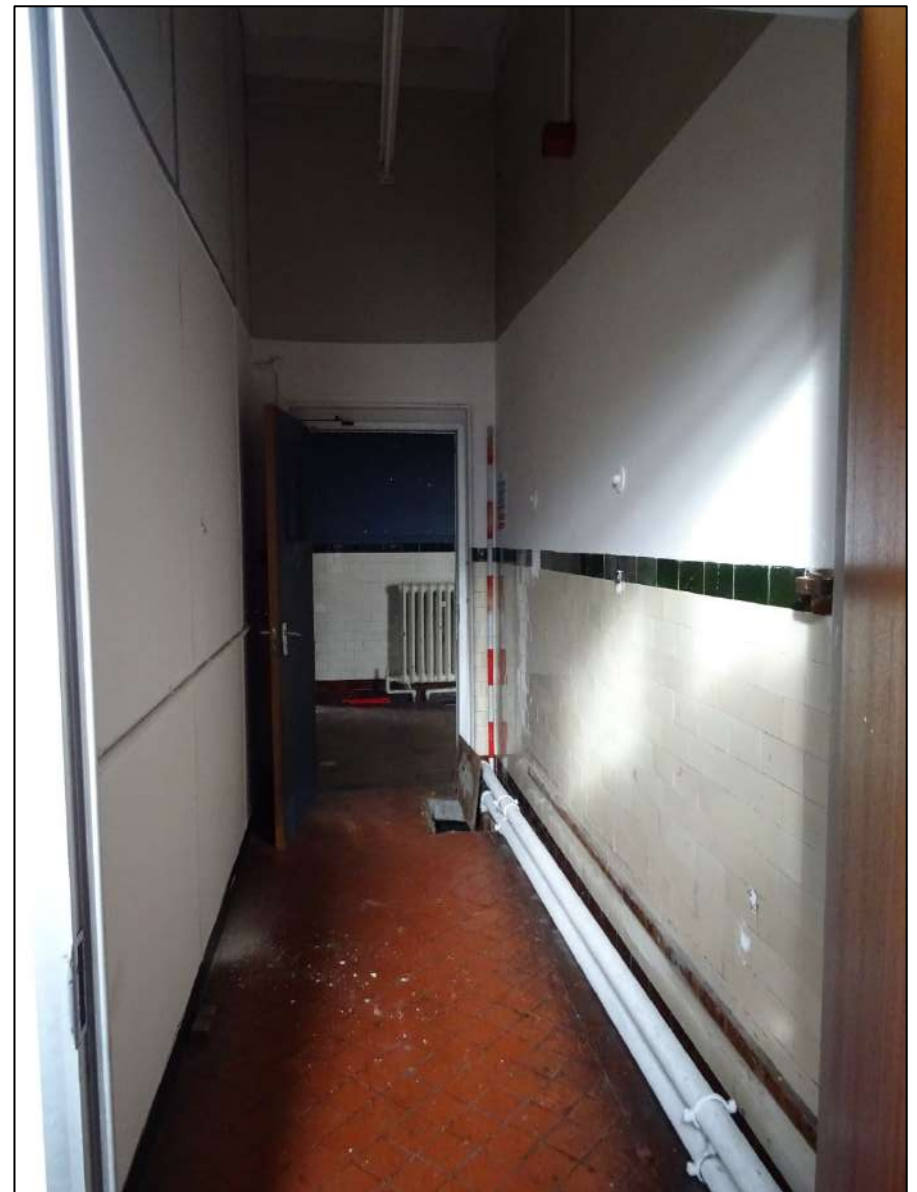
*Plate 523. Room 11 looking north-west. Scale 2m.*

5.38.50. Room 11 is a small connecting corridor linking Hallway 8 with Room 12 (Plate 523). The floor is red ceramic tile. The lower third of the north-east wall is tiled with white ceramic tiles with a band of brown tiles to the bottom and green to the top. The south-west wall is white painted plaster. Above this the walls are plastered, painted light blue, and the ceiling is white painted plaster.

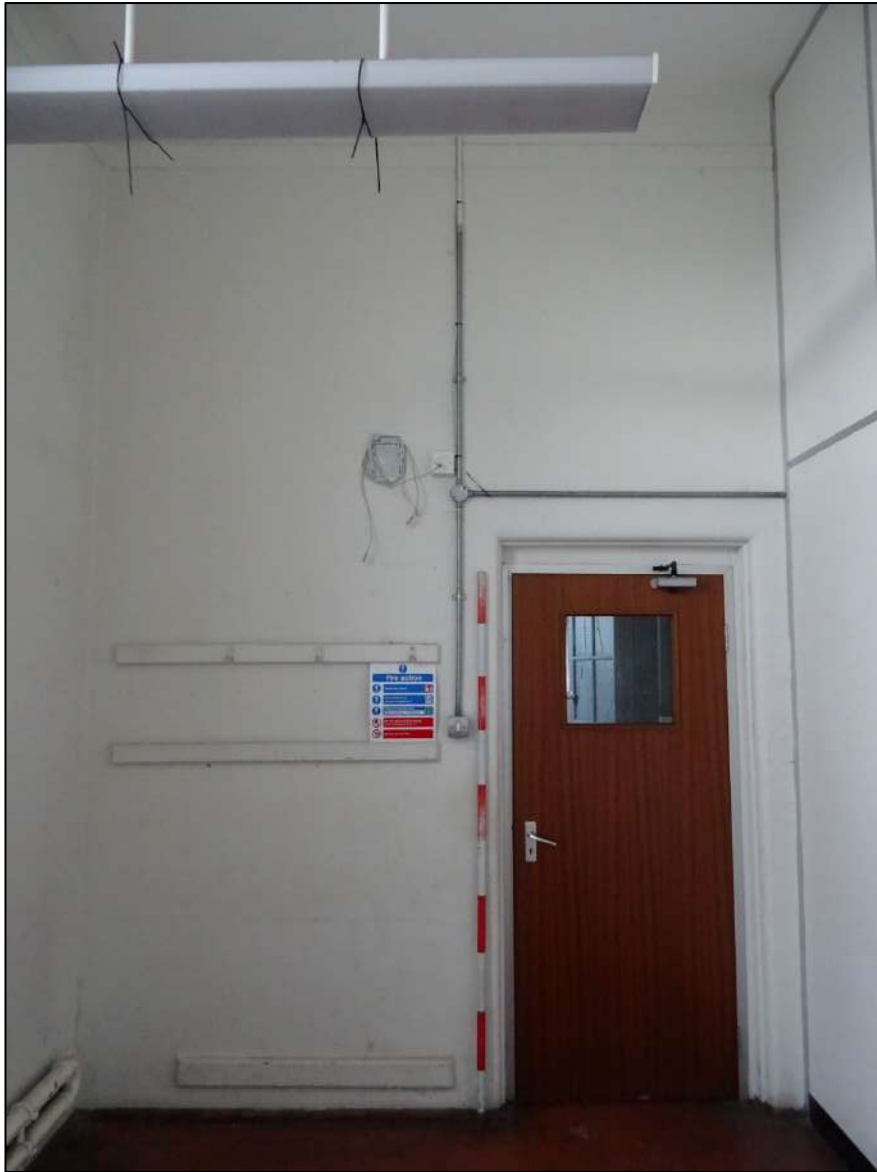
*Plate 526. Room 13 looking north-west. Scale 2m.*

5.38.54. Room 13 is a small office room accessed from hallway Room 8. It appears to represent a modern partition of a former larger room including Rooms 11 and 12 (Plate 526). The floor is red ceramic tile. The north-east and south-east walls are modern partitions. The remaining walls and the ceiling are white painted plaster. The door is as described in Paragraph 5.38.34. Exposed pipework runs along the base of the south-west wall.

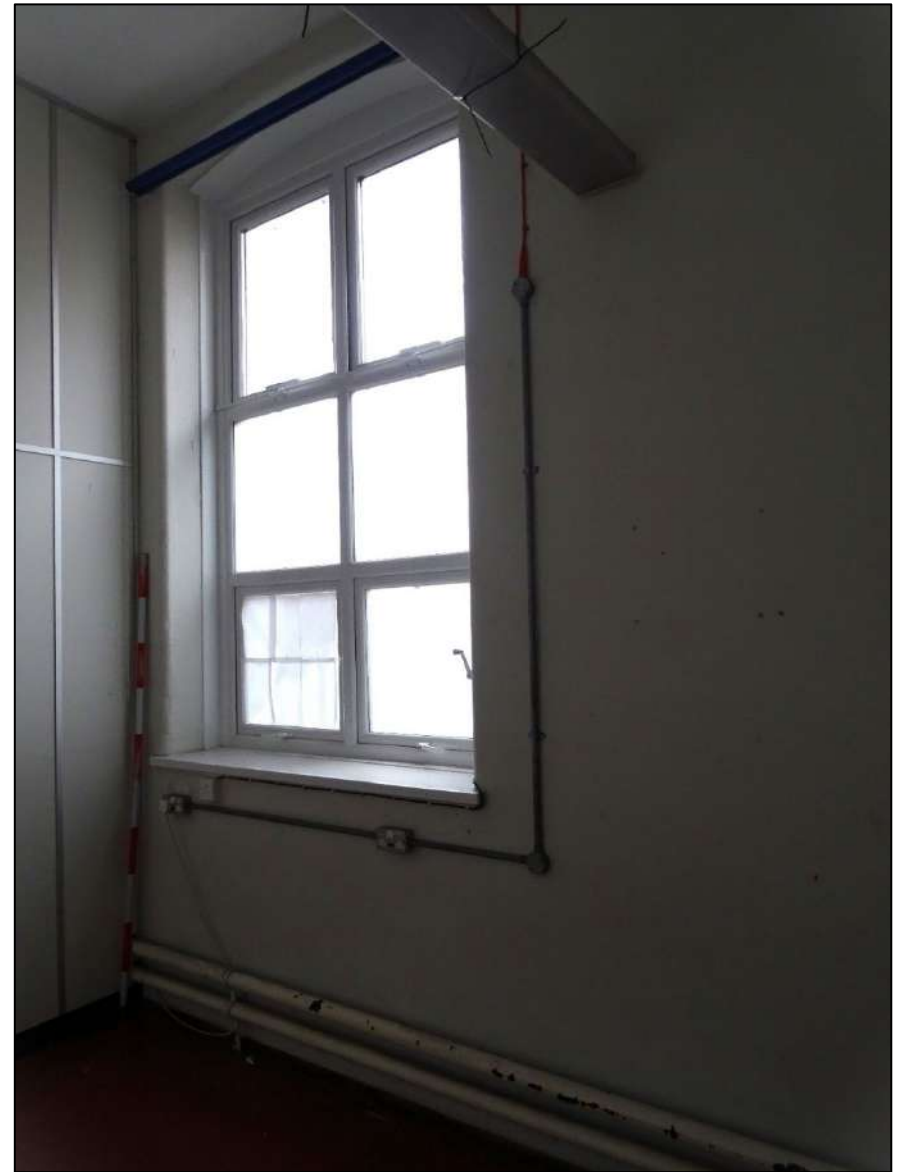
*Plate 527. Room 13 looking south-south-east. Scale 2m.*

5.38.55. There is a window to the centre of the south-west wall (Plate 527). It is a uPVC unit in a tall, segmental arched recess. It has a moulded wooden sill under the uPVC addition.

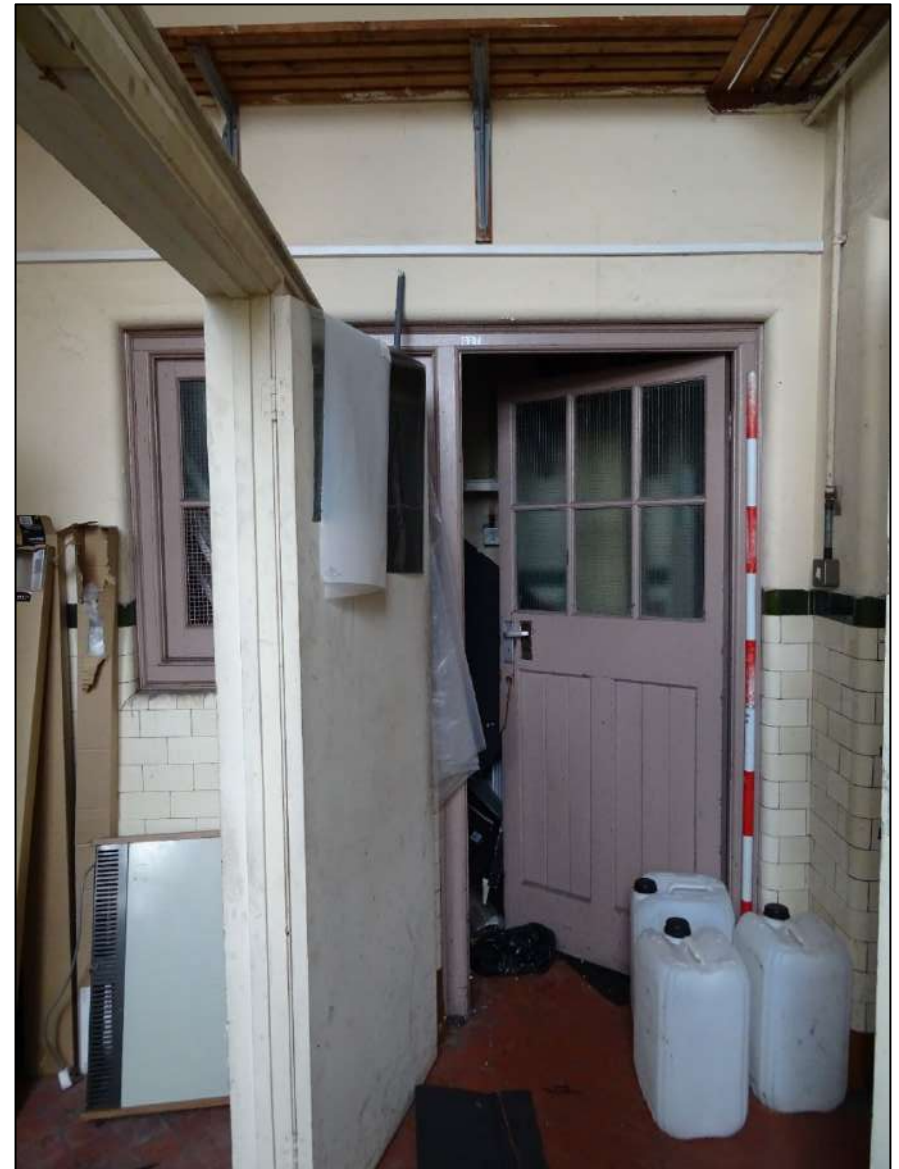
*Plate 529. Room 14 looking north-east. Scale 2m.*

5.38.57. There is a further door and window to the south-east end of the north-east wall leading to a small store cupboard (Plate 529). The window is a four-light mullion and transom wooden window painted pink. The edges of the wall to the surround are curved. The door is two fielded panels to the bottom half and a six-light glazed panel to the upper. The edges of the wall to the surround are curved, including the tiles to the lower third.

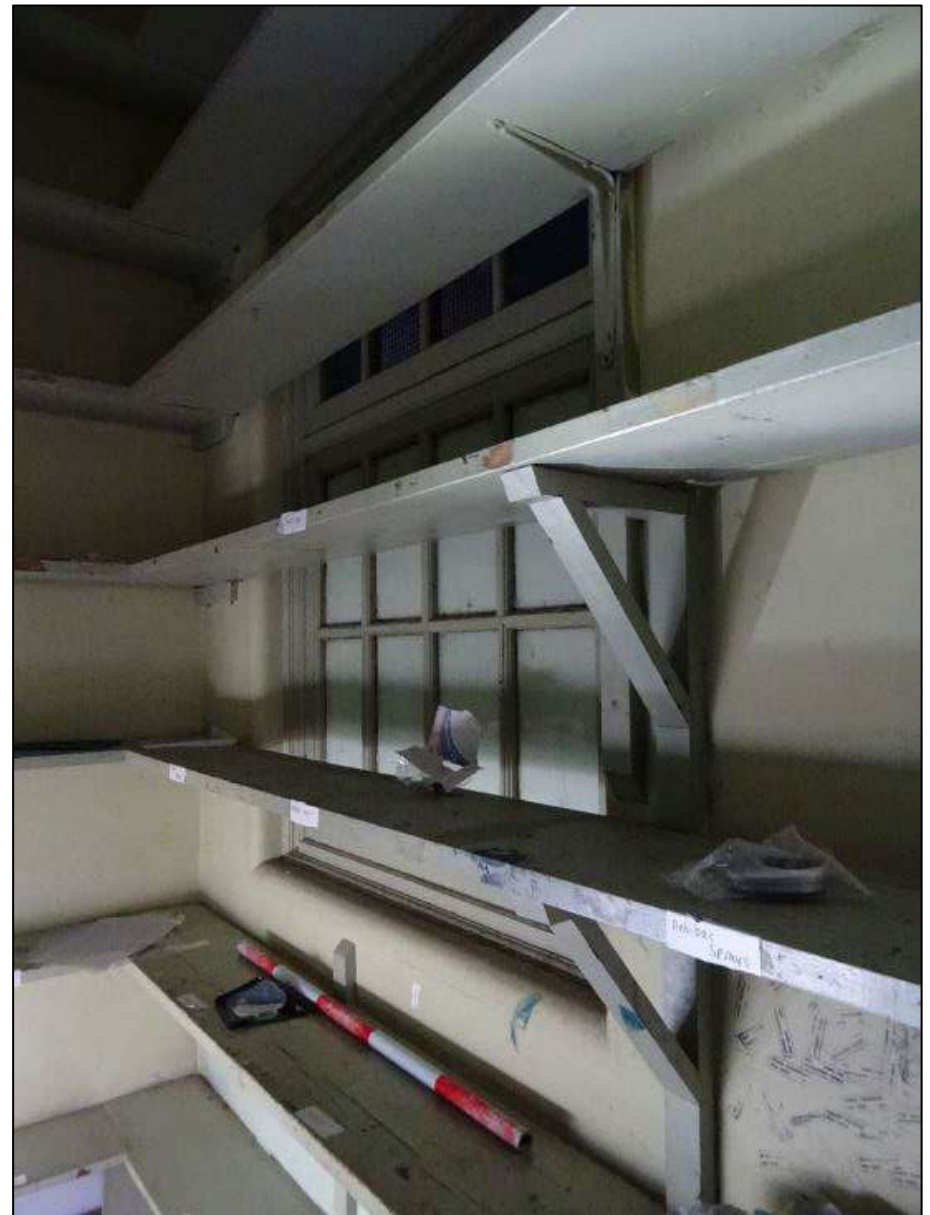
*Plate 531. Room 15 looking north. Scale 2m.*

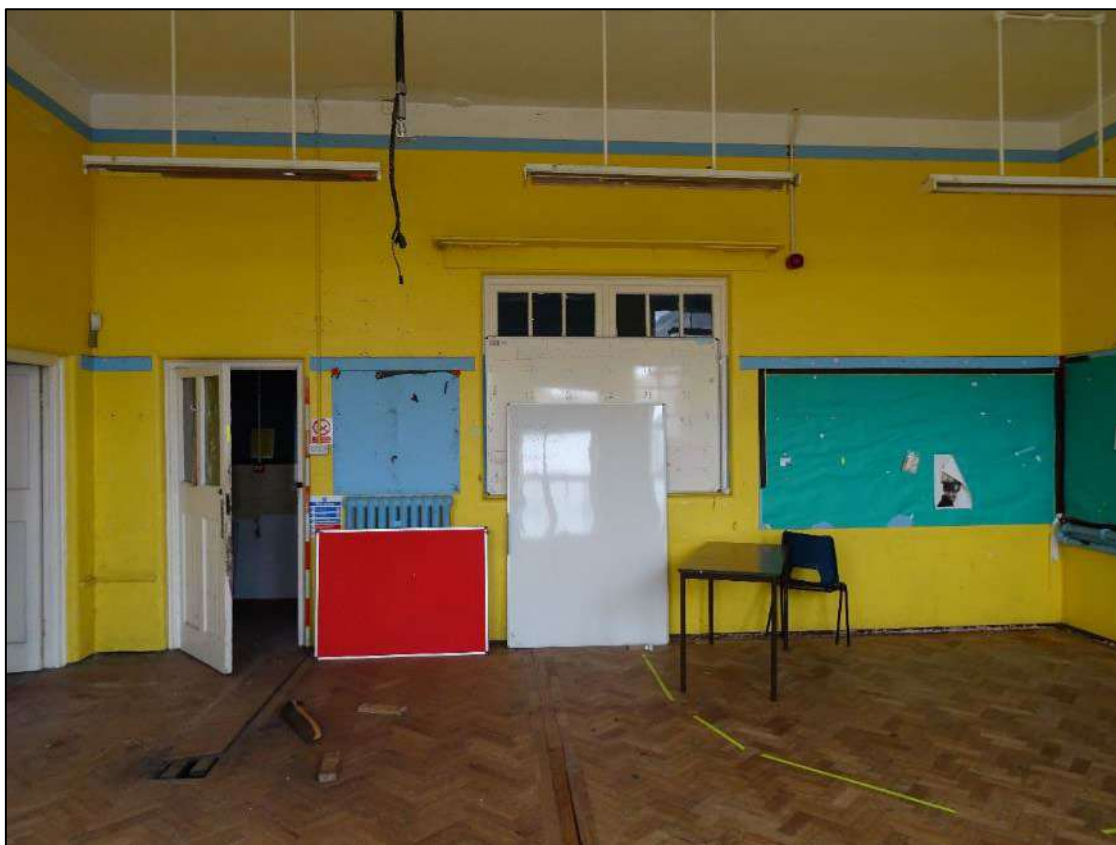
*Plate 532. Plate 157. Room 16 looking north-east. Scale 2m.*

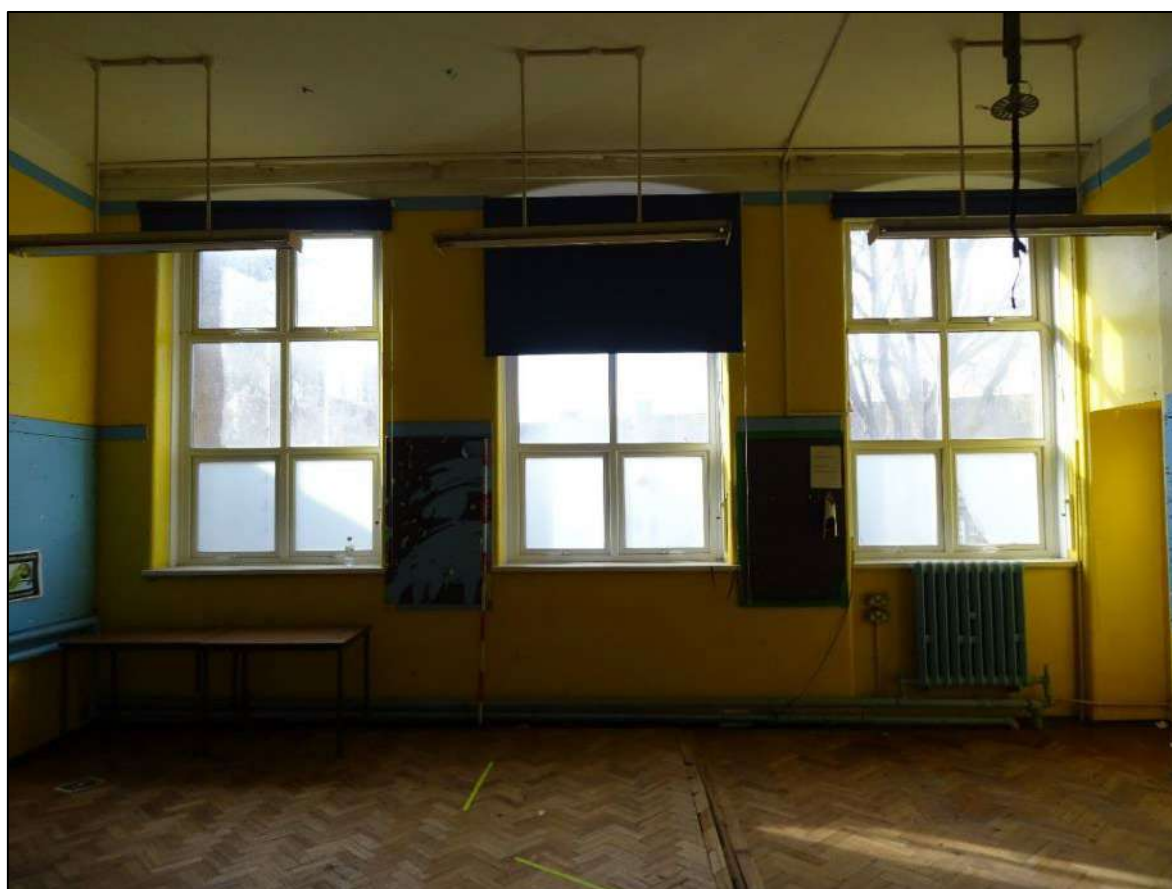
*Plate 533. Room 16 looking south-west. Scale 2m.*

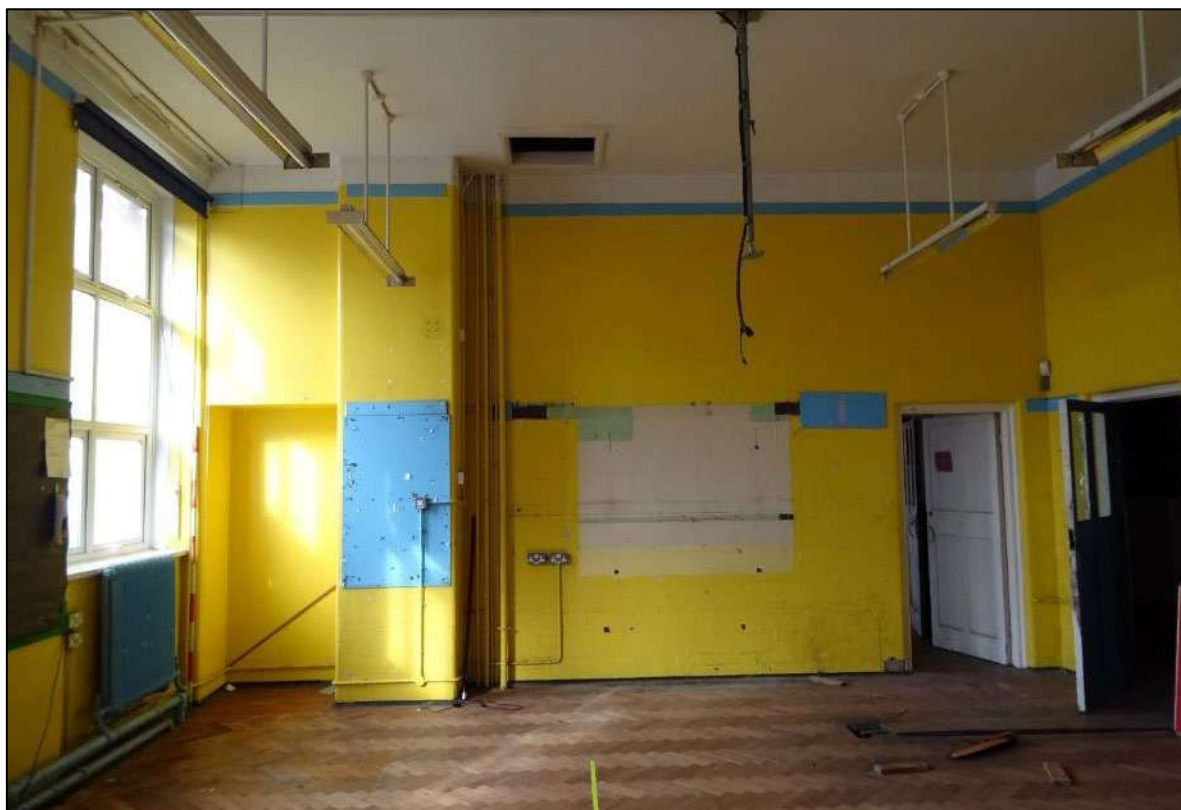
*Plate 534. Plate 159. Room 16 looking north-west. Scale 2m*

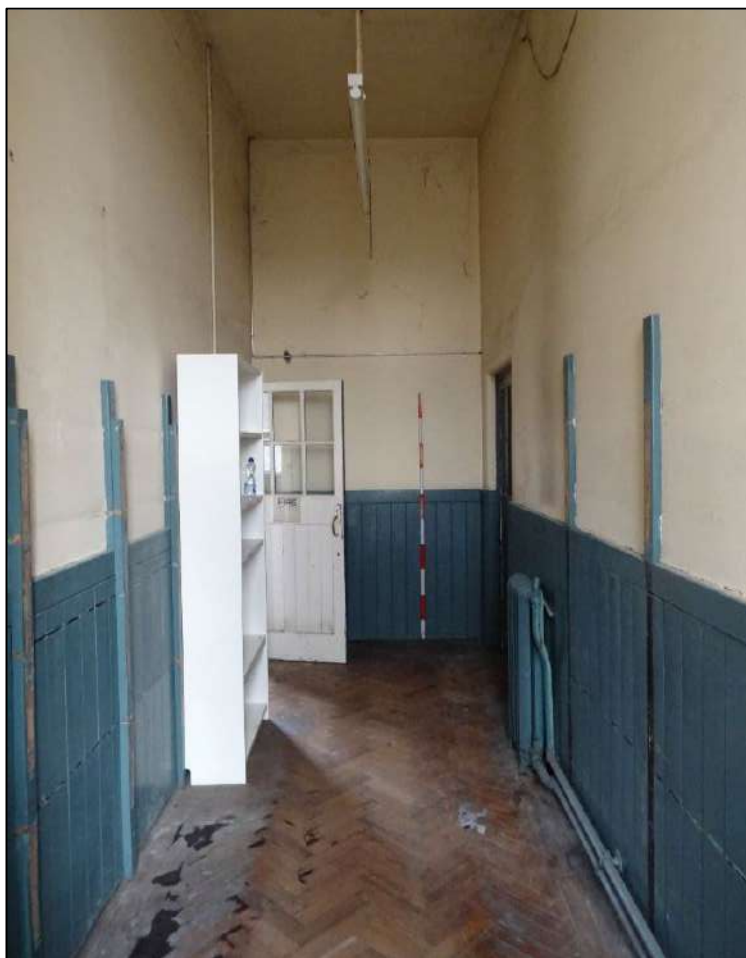
*Plate 536. Room 17 looking north-east. Scale 2m*

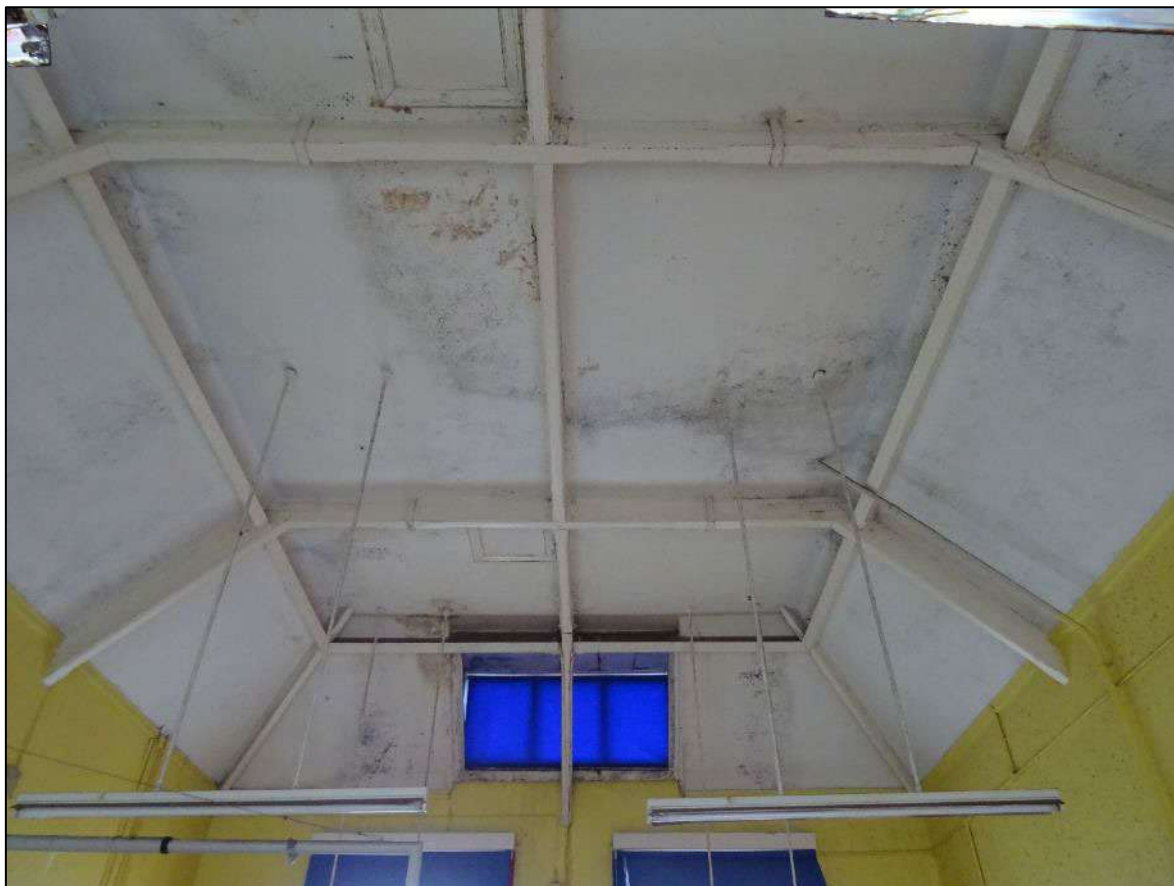
*Plate 538. Room 18, ceiling looking south-west.*

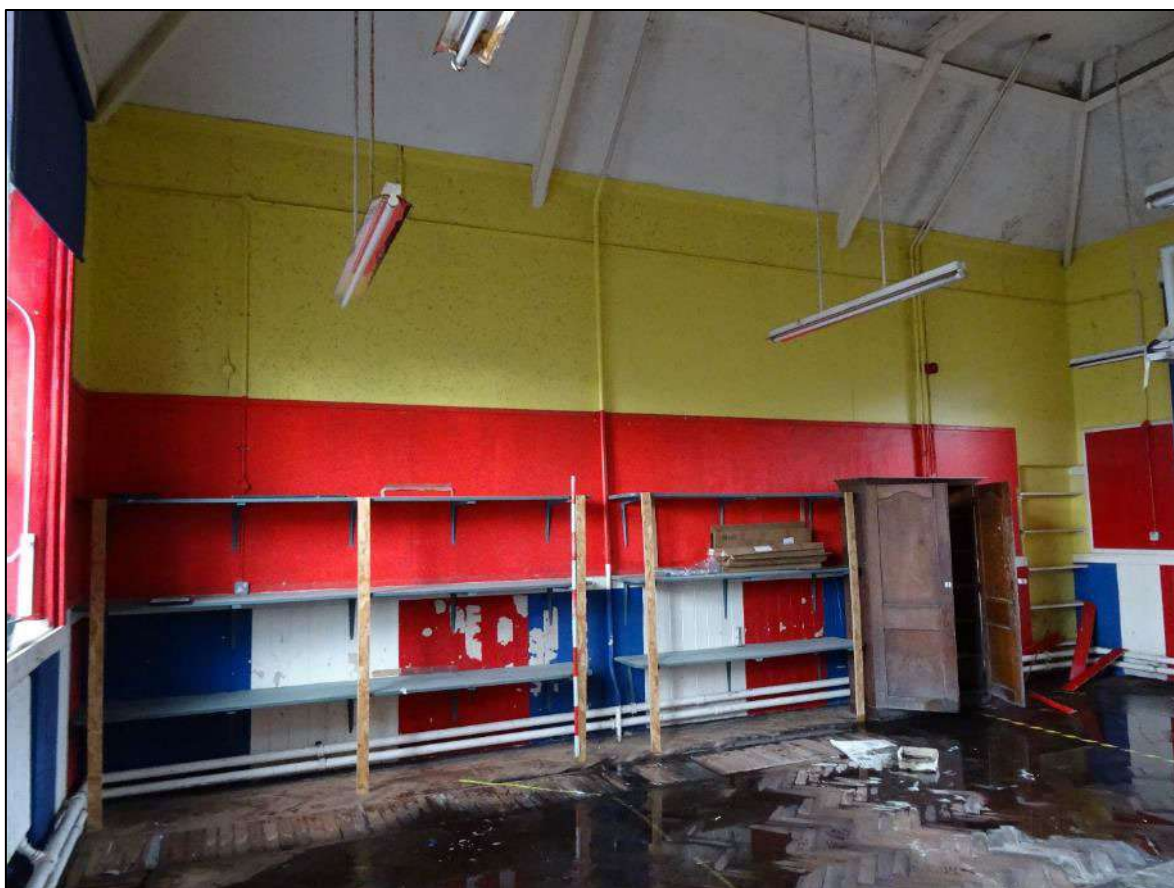
*Plate 539. Room 18 looking north-north-west. Scale 2m*

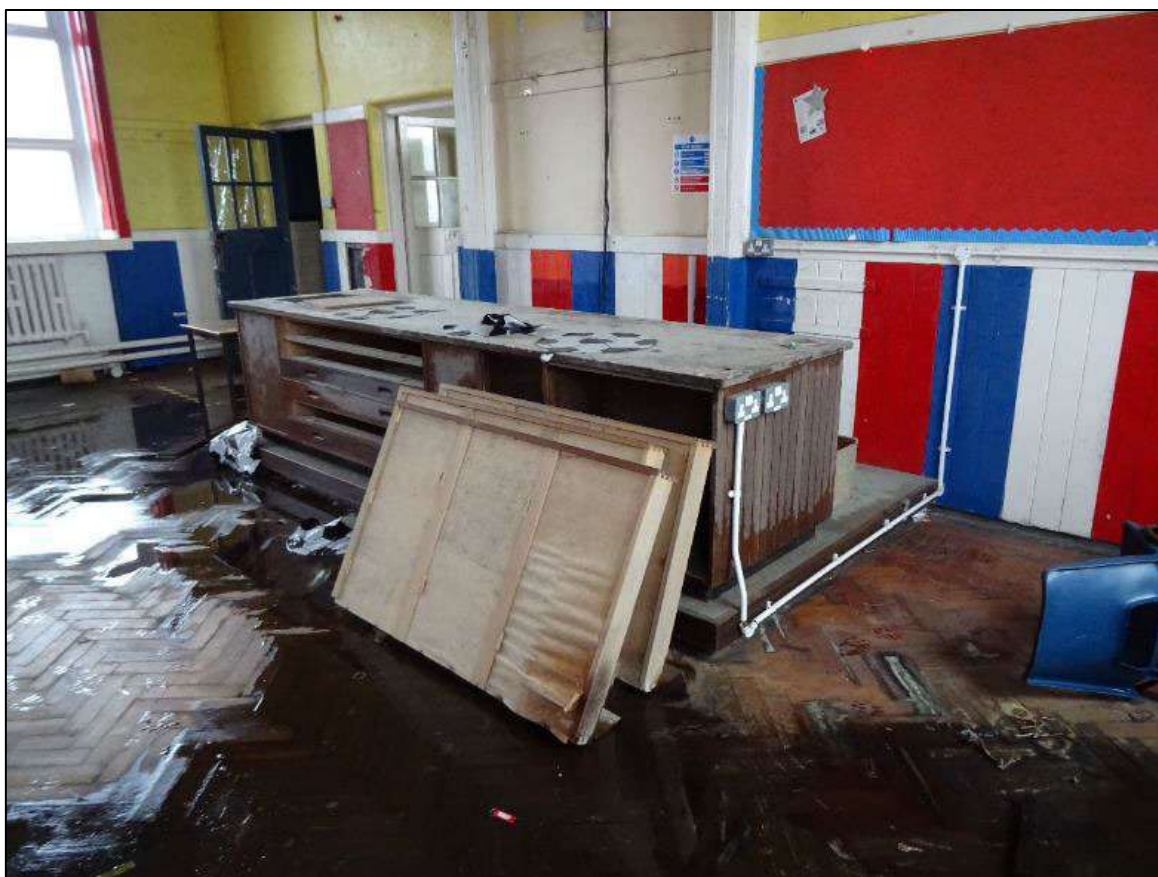
*Plate 541. Room 18 looking east. Scale 2m*

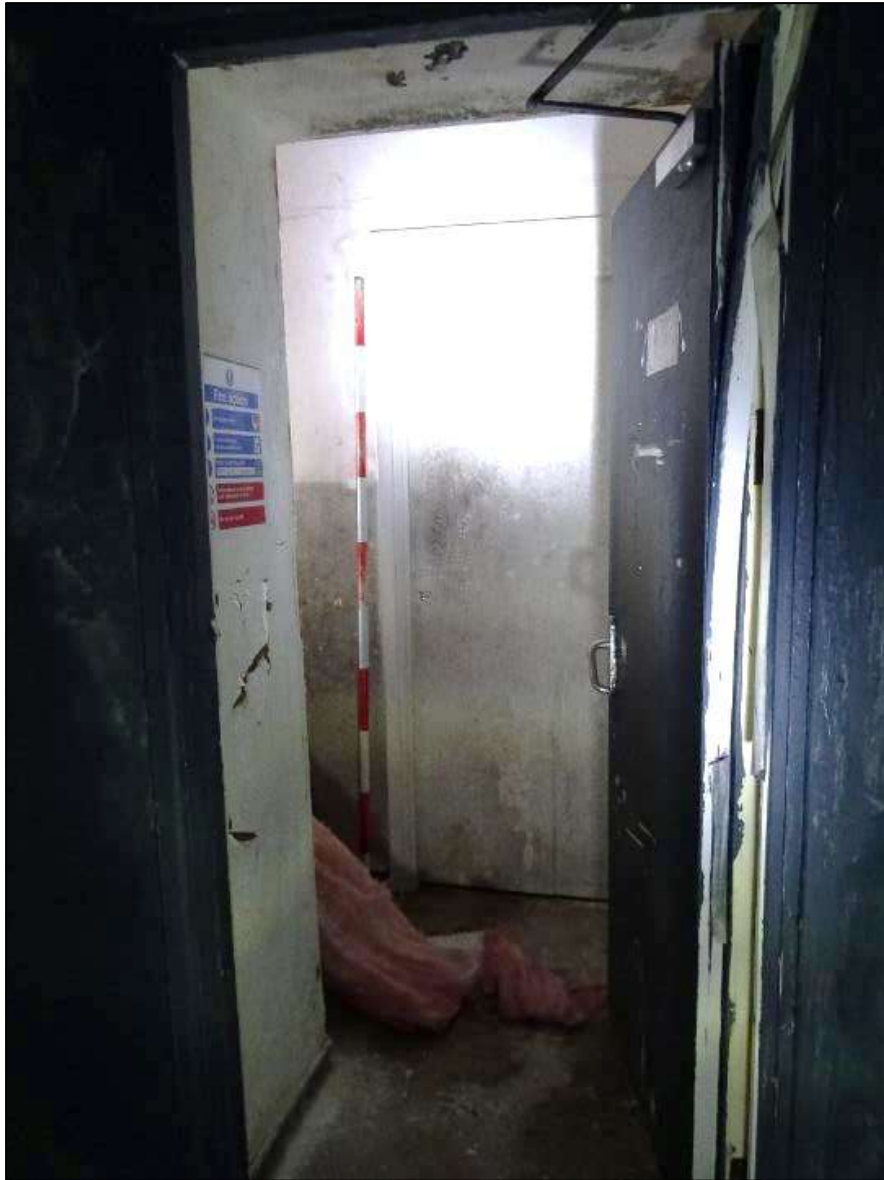
*Plate 542. Room 20, anteroom, looking north-north-east. Scale 2m*

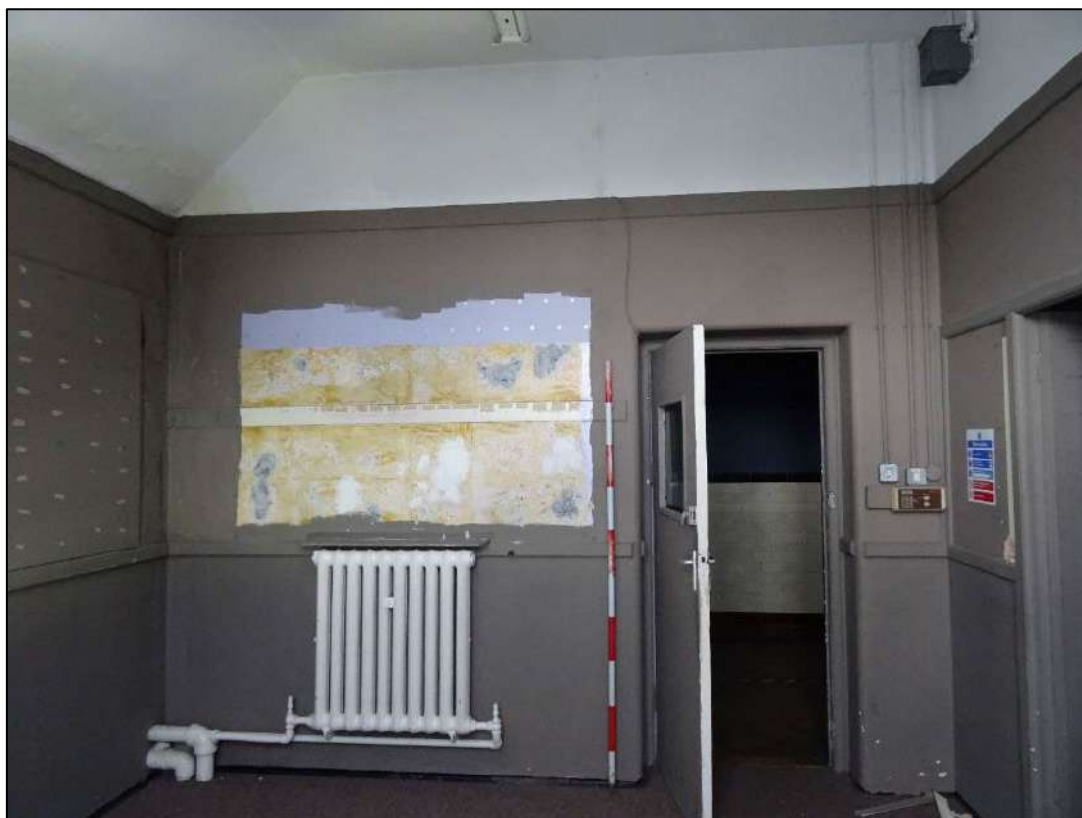
*Plate 544. Room 21, office, looking south-east. Scale 2m.*

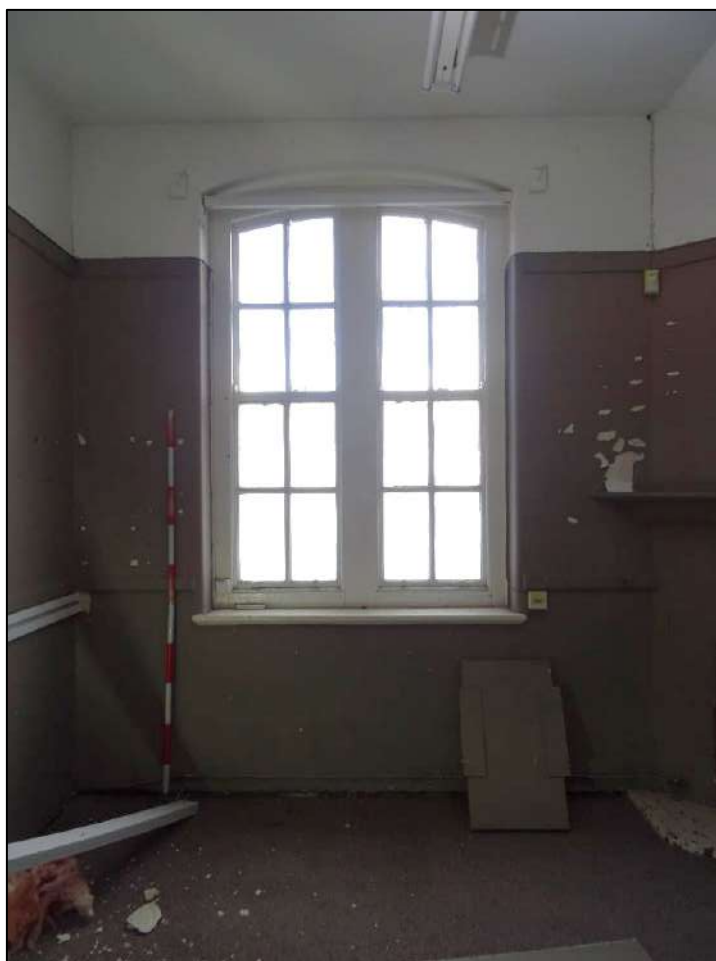
*Plate 545: Room 21, office, looking north-west. Scale 2m..*

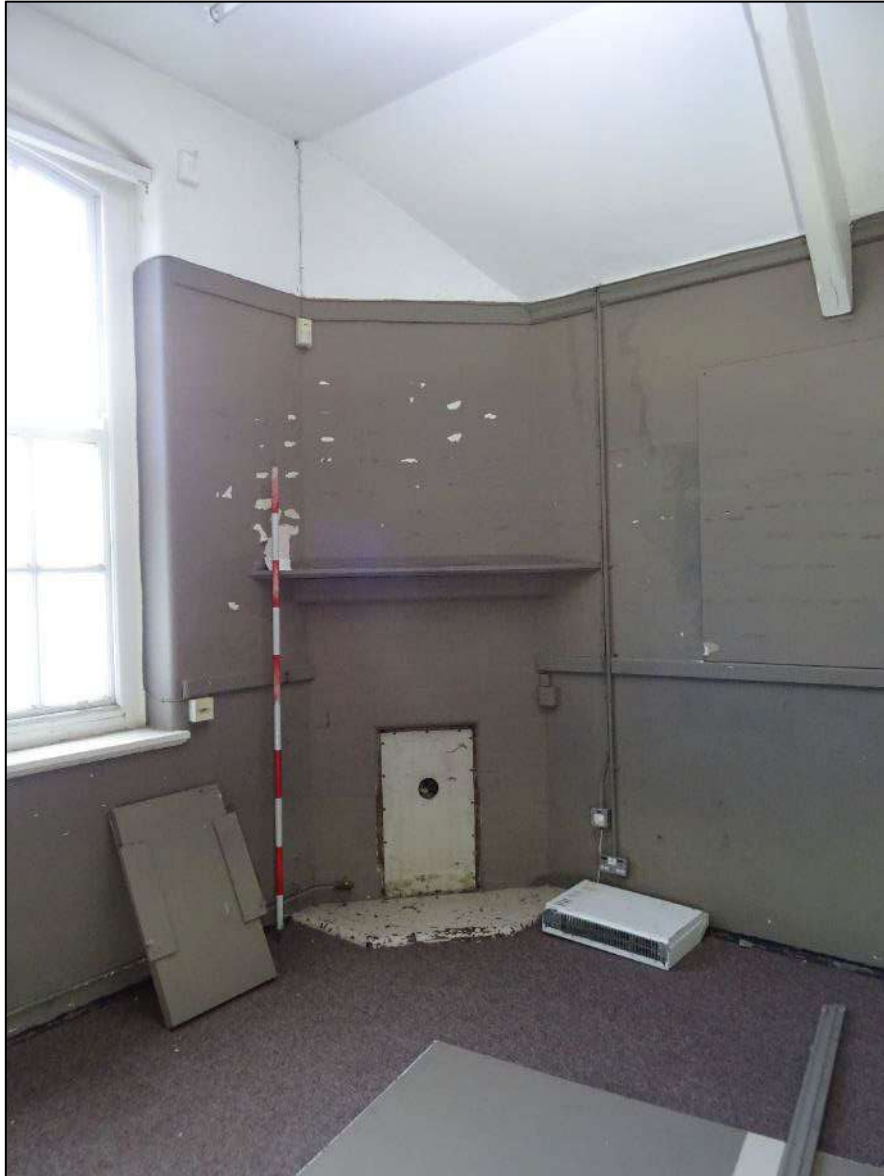
*Plate 546. Room 21, corner fireplace, looking north. Scale 2m.*

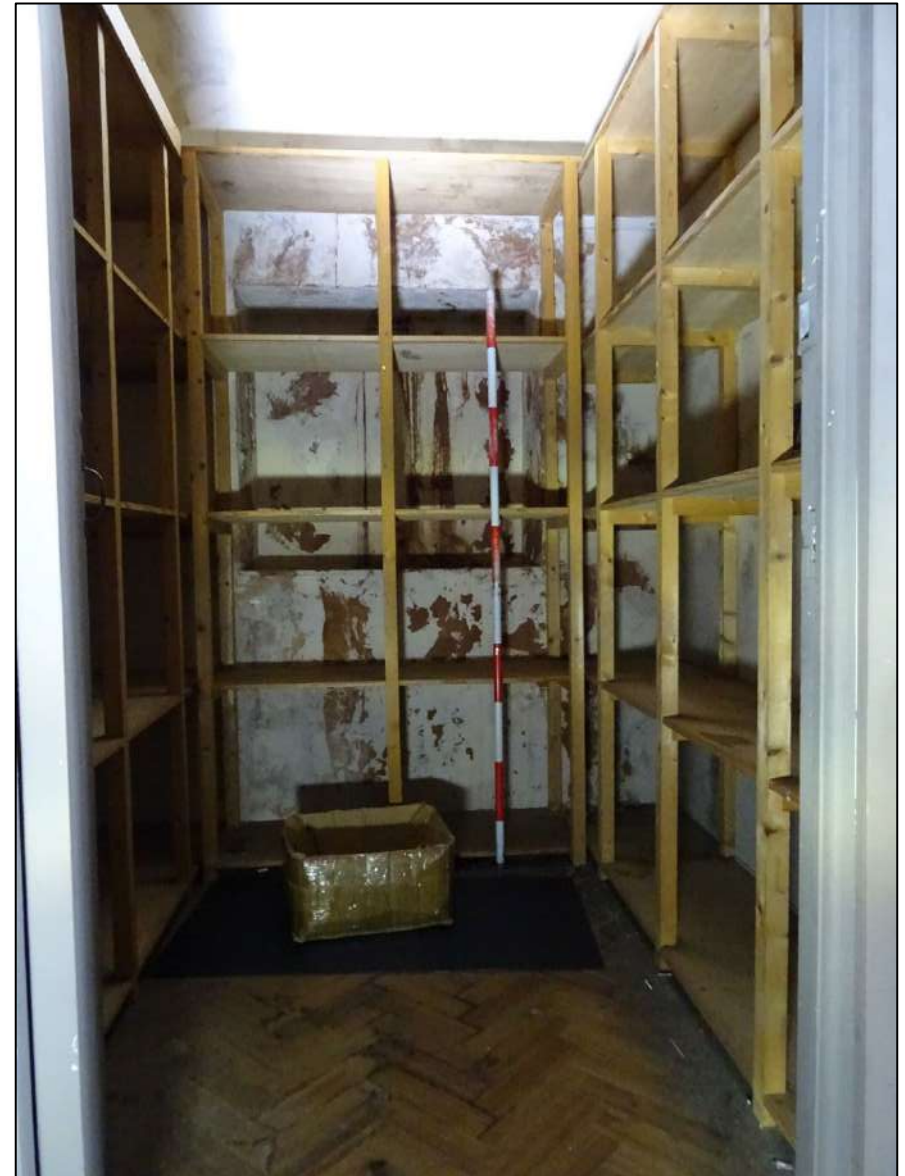
*Plate 547. Room 22, store looking south-west. 2m Scale.*

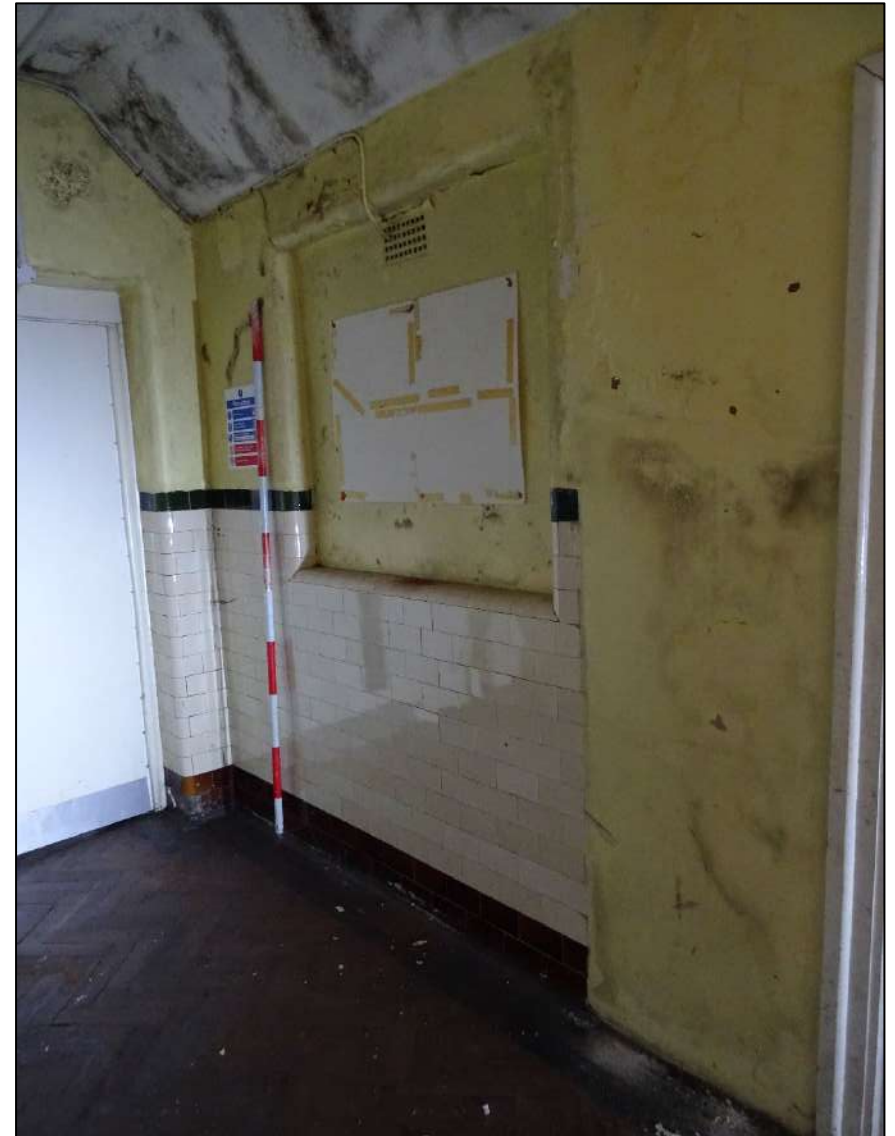
*Plate 549. Blocked window to the south-west wall of Room 23, Building 6, looking east. Scale 2m.*

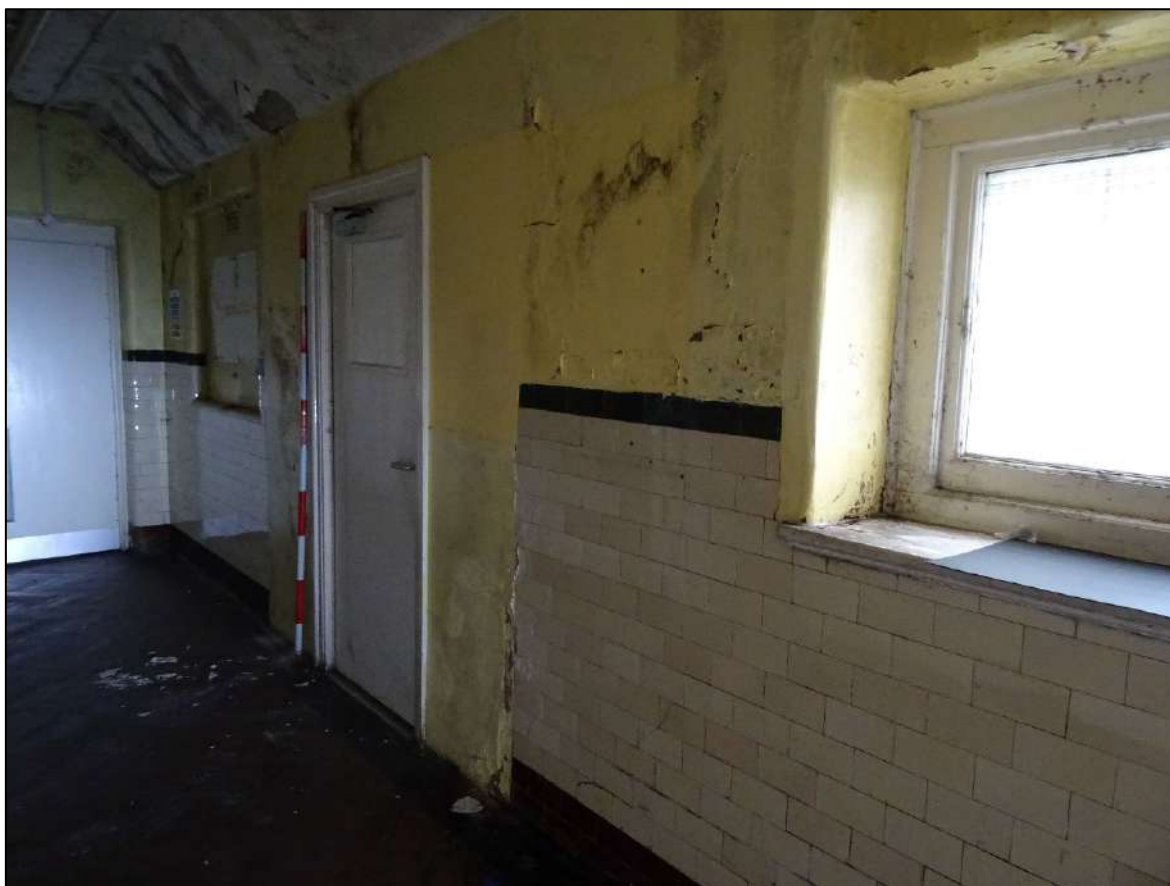
*Plate 550. Doorway to the south-west wall of Room 23, Building 6, looking south. Scale 2m.*
