**Level 2 Building Recording:**  
**Former Dyffryn Lower School, Port Talbot**

March 2024

Report No. 2278

Prepared for KEW Planning  
By  
Susan Stratton PhD

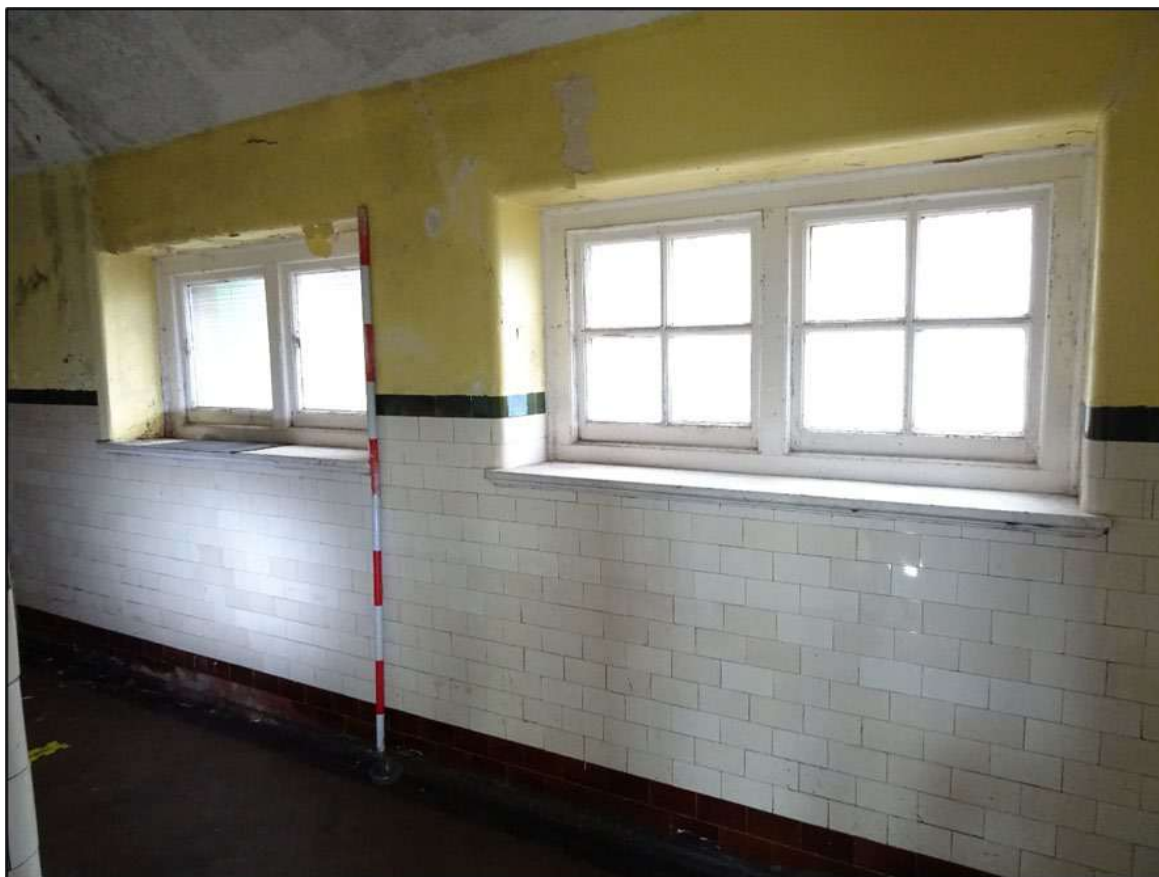
*Plate 551. Windows to the south-west wall of Room 23, Building 6, looking south. Scale 2m.*

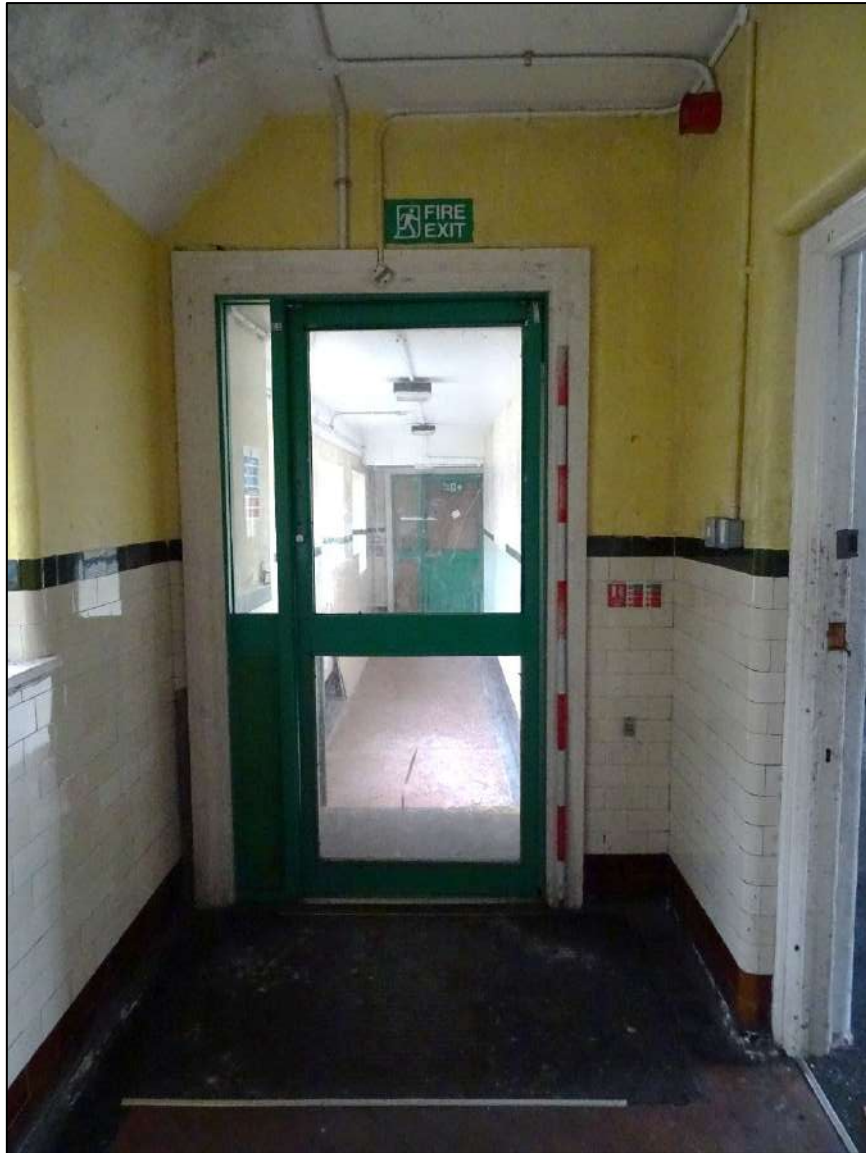
*Plate 552. Doorway to north-west wall of Room 23, Building 6, looking north-west. Scale 2m.*

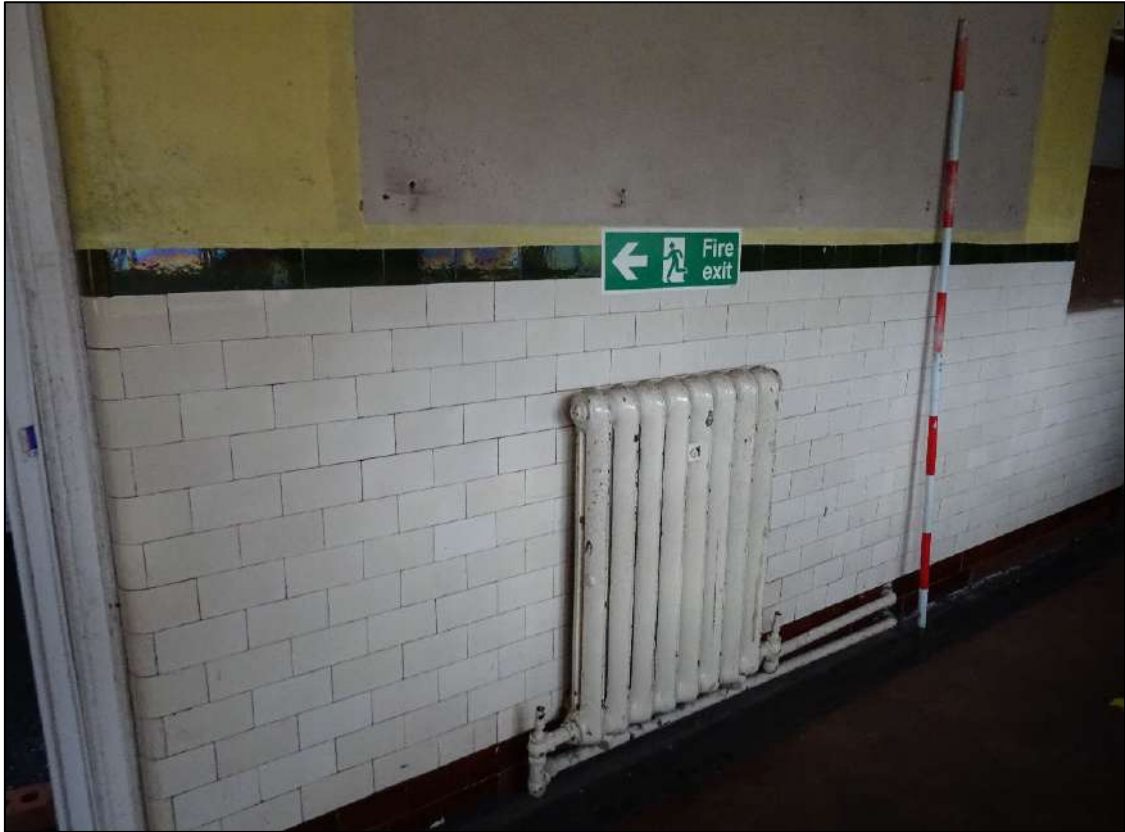
*Plate 554. Cast iron radiator to north-east wall of Room 23, Building 6, looking east. Scale 2m.*

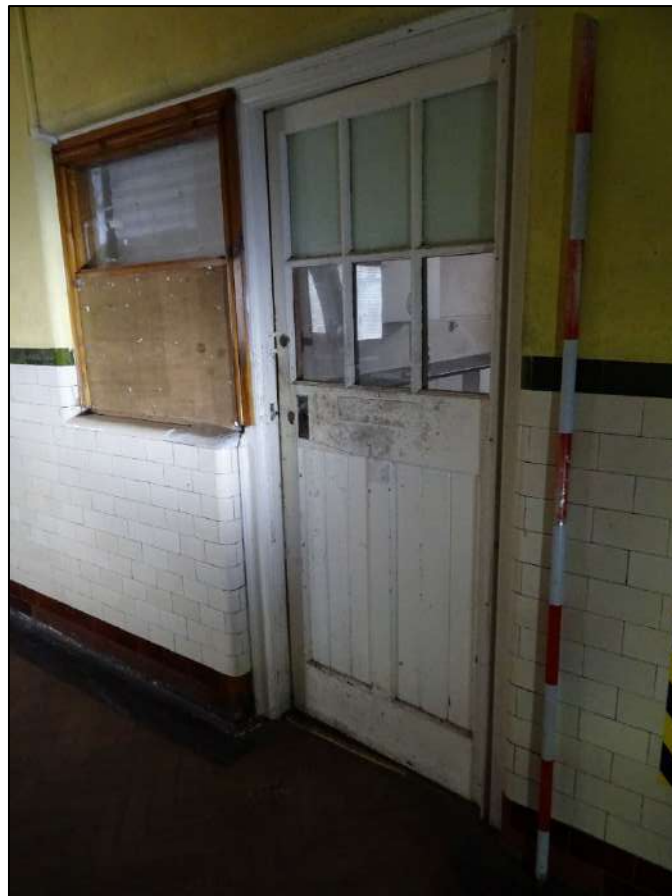
*Plate 555. Partially blocked window and doorway to Room 27, north-east wall of Room 23, Building 6, looking north. Scale 2m.*

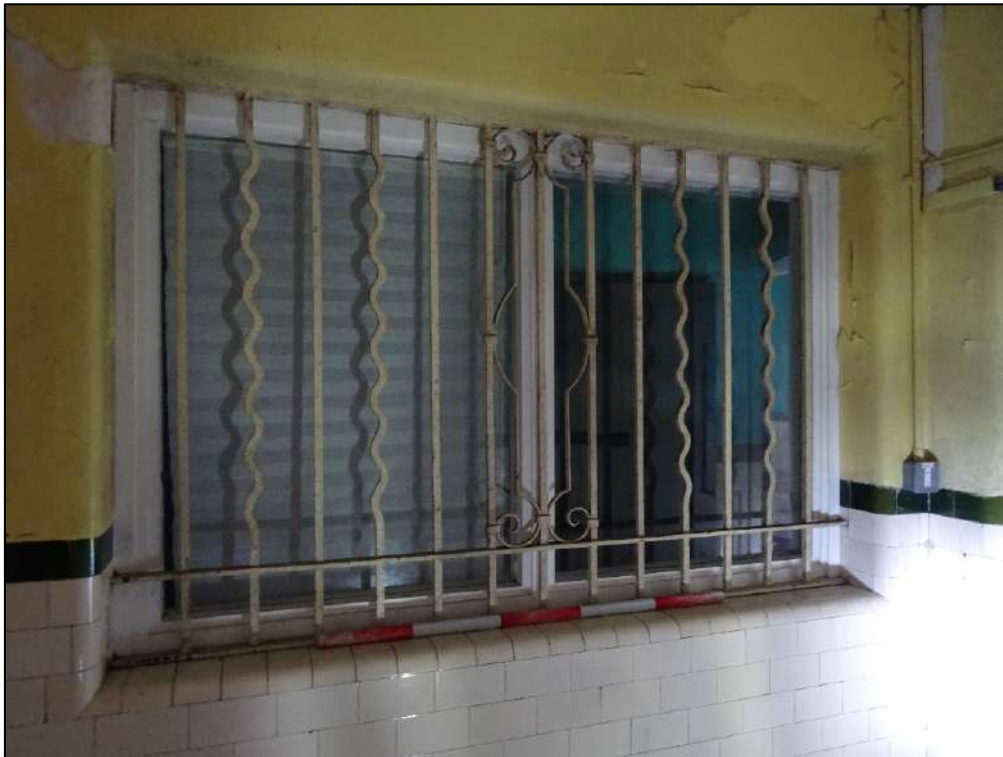
*Plate 556. Window to north-east wall of Room 23, looking north-east through to Room 30.  
Scale 1m.*

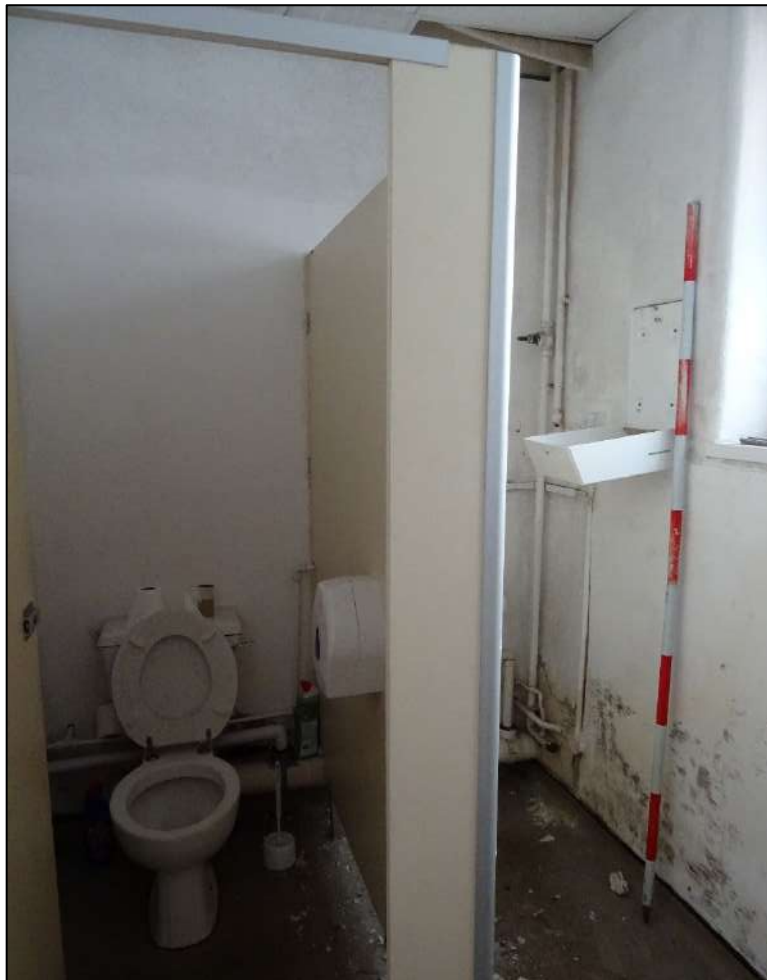
*Plate 557. Room 24, looking south-west. Scale 2m.*

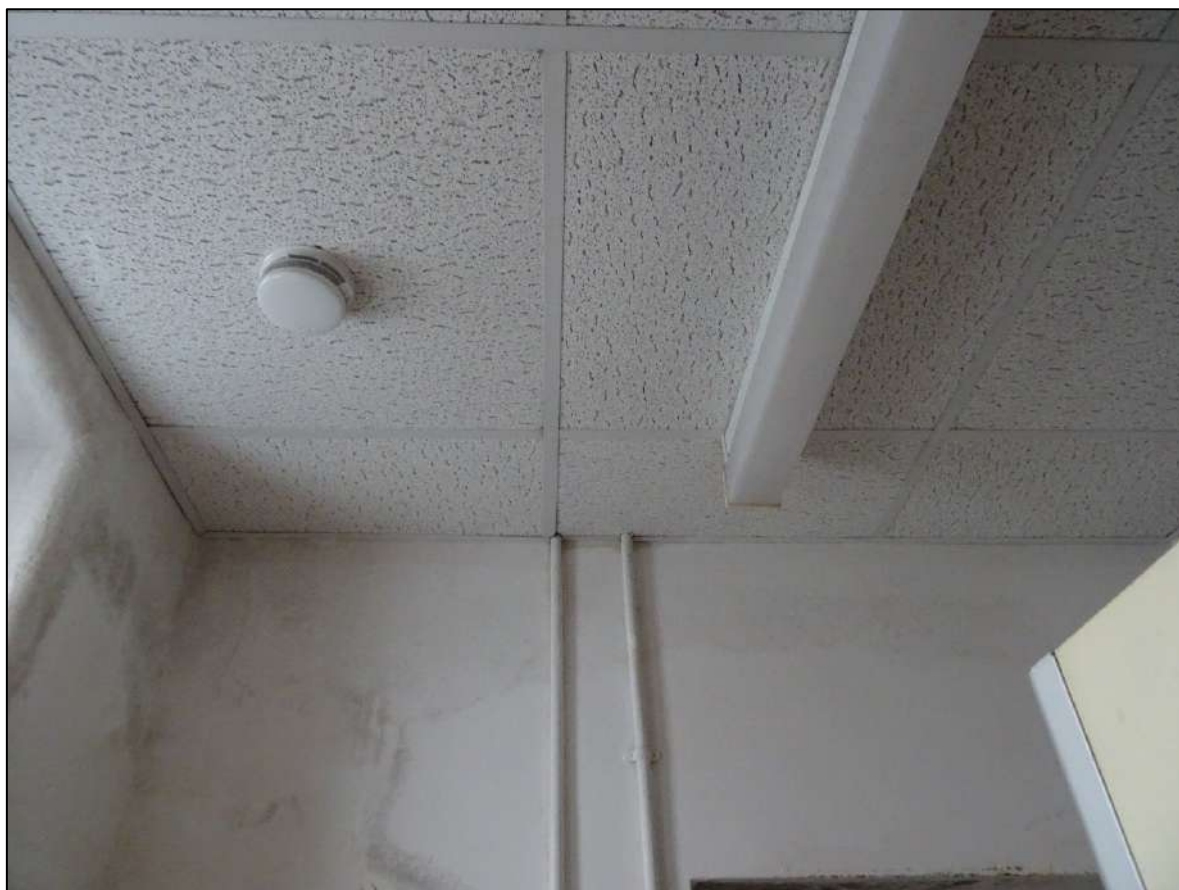
*Plate 558. Suspended ceiling in Room 24, looking north-east.*

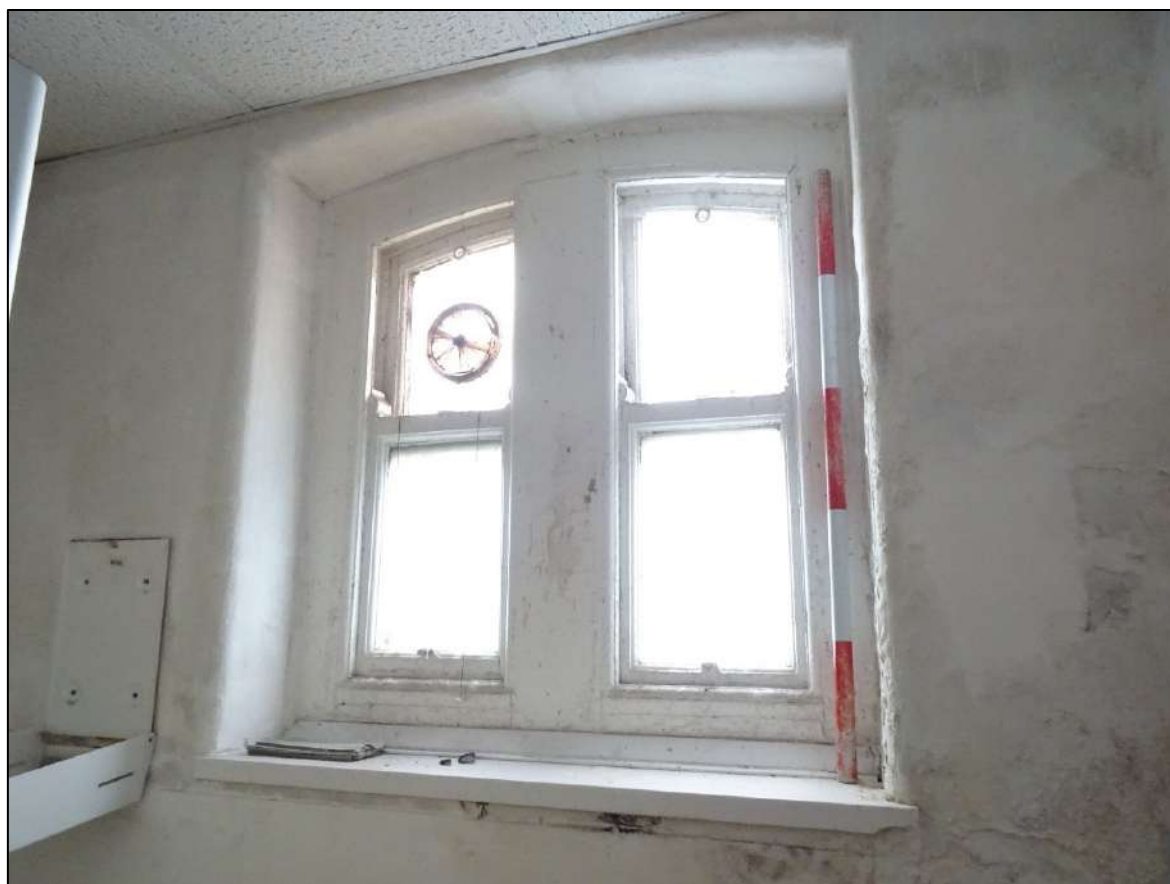
*Plate 559. Window to the north-west wall of Room 24, looking north-west. Scale 1m.*

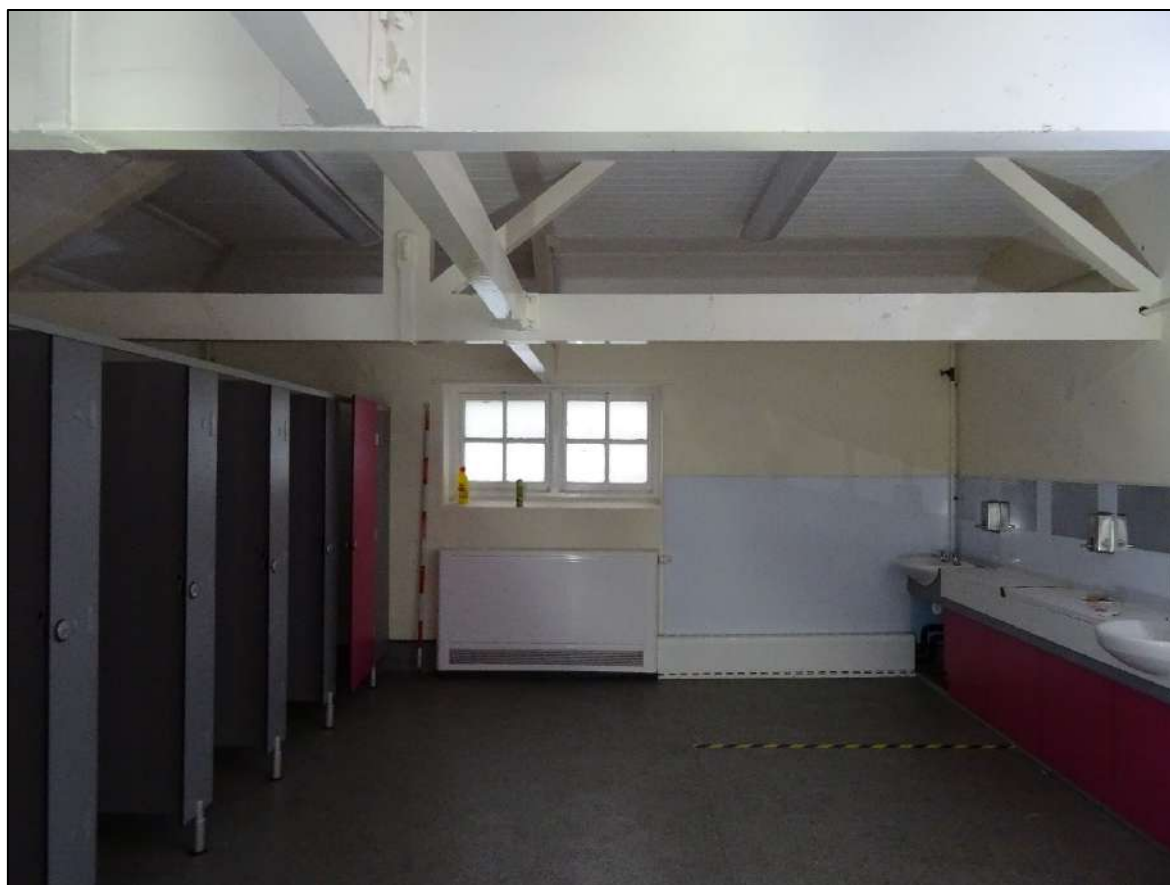
*Plate 561. Room 25, Building 6, looking north-east. Scale 2m.*

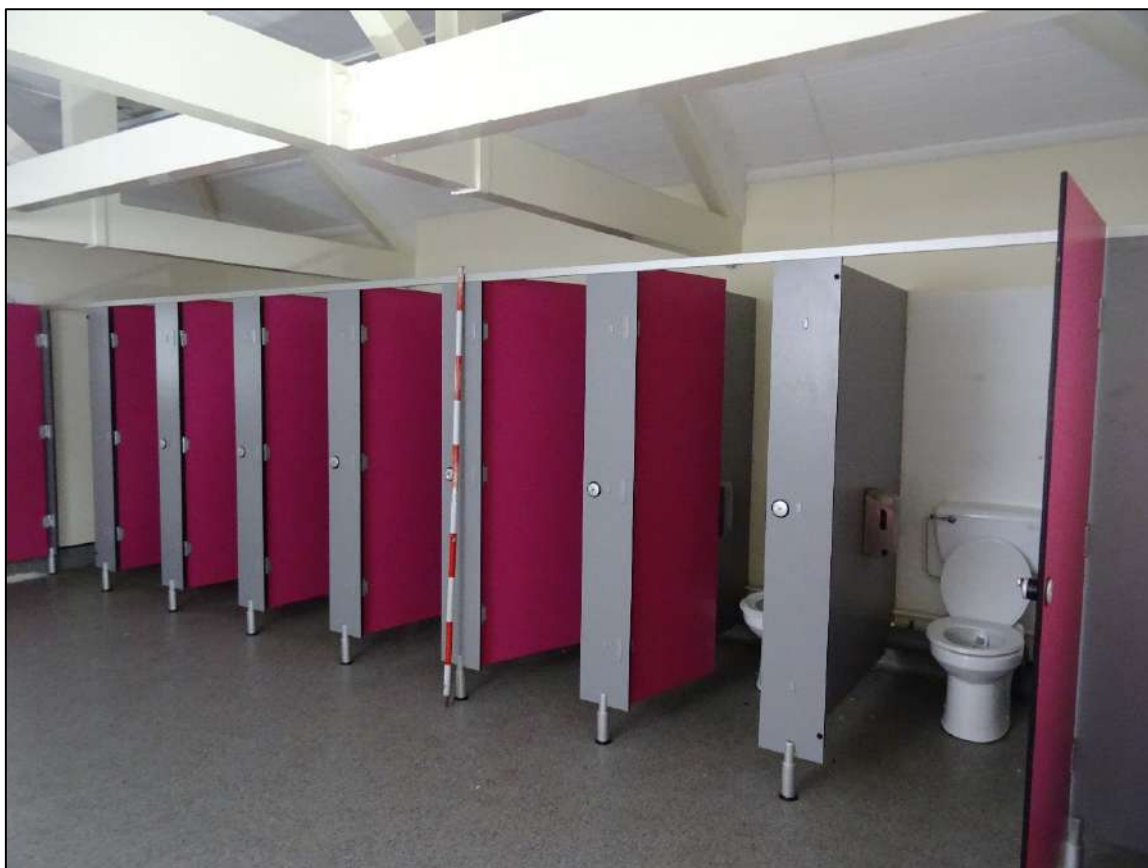
*Plate 562. Toilet cubicles along the north-western wall of Room 23, Building 6, looking west. Scale 2m.*

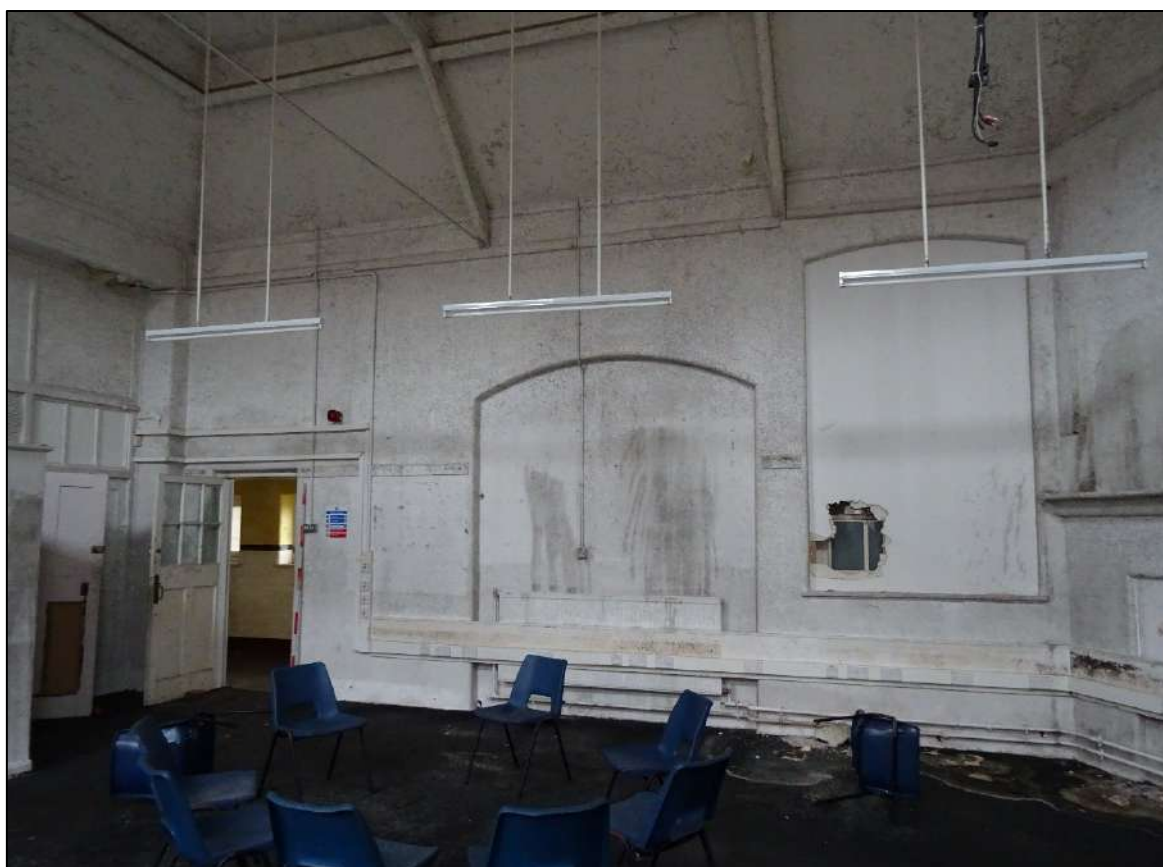
*Plate 563. Room 26, Building 6, looking south-west. Scale 2m.*

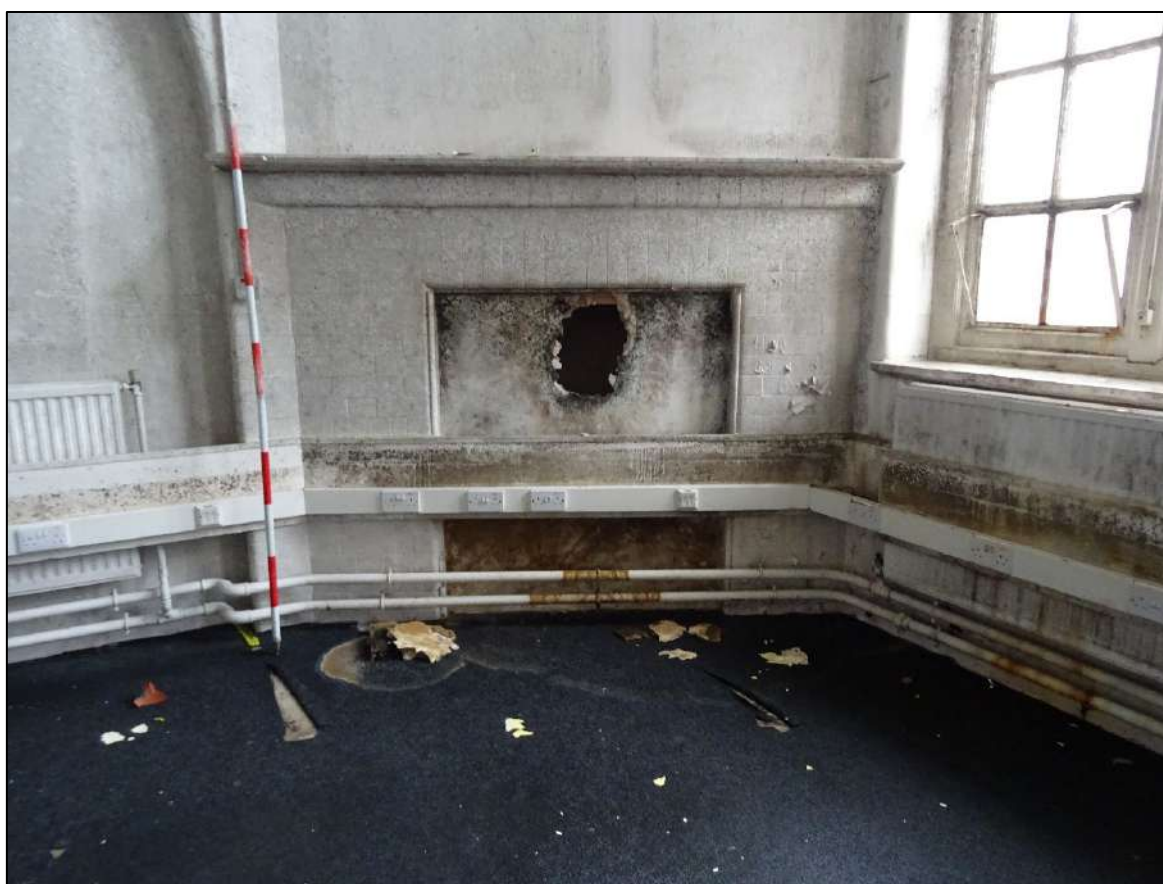
- 5.38.96. There is a large round arch headed recess to the centre of the north-west wall (Plate 564). It is flanked to both sides by angled chimney breasts. Both fireplaces have a ceramic tile surround with soldiers over the fire box and a moulded mantel piece. They have been blocked and painted over with white paint (Plate 565).

*Plate 565. Blocked fireplace in the northern corner of Room 26, Building 6. Scale 2m.*

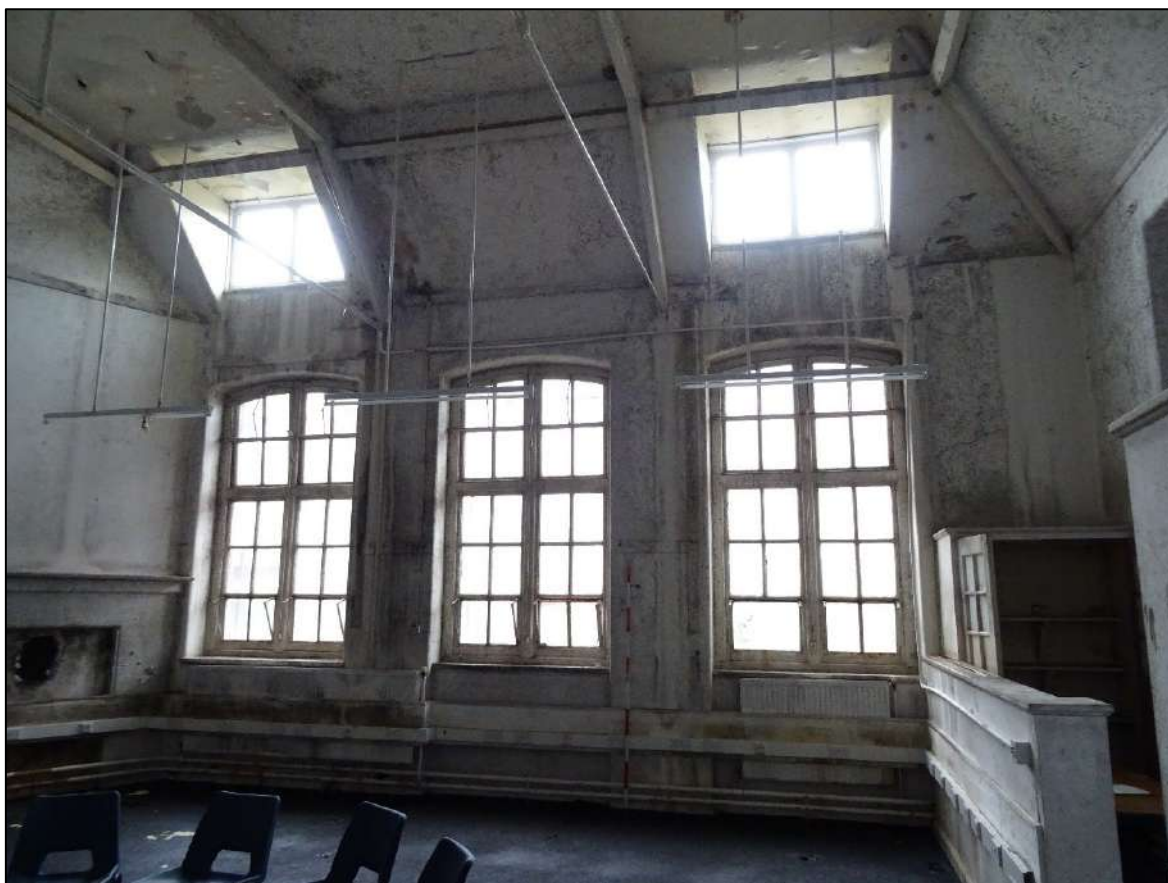
- 5.38.97. The north-eastern wall has three large, wooden framed multi-light mullion and transom windows set in segmental arched recesses with rounded edges and wooden sills (Plate 566). There are two dormer windows above the outer ground floor windows. A small partition wall projects south-west into the room, parallel to the south-east wall.

*Plate 566. Room 26, Building 6, looking north-east. Scale 2m.*

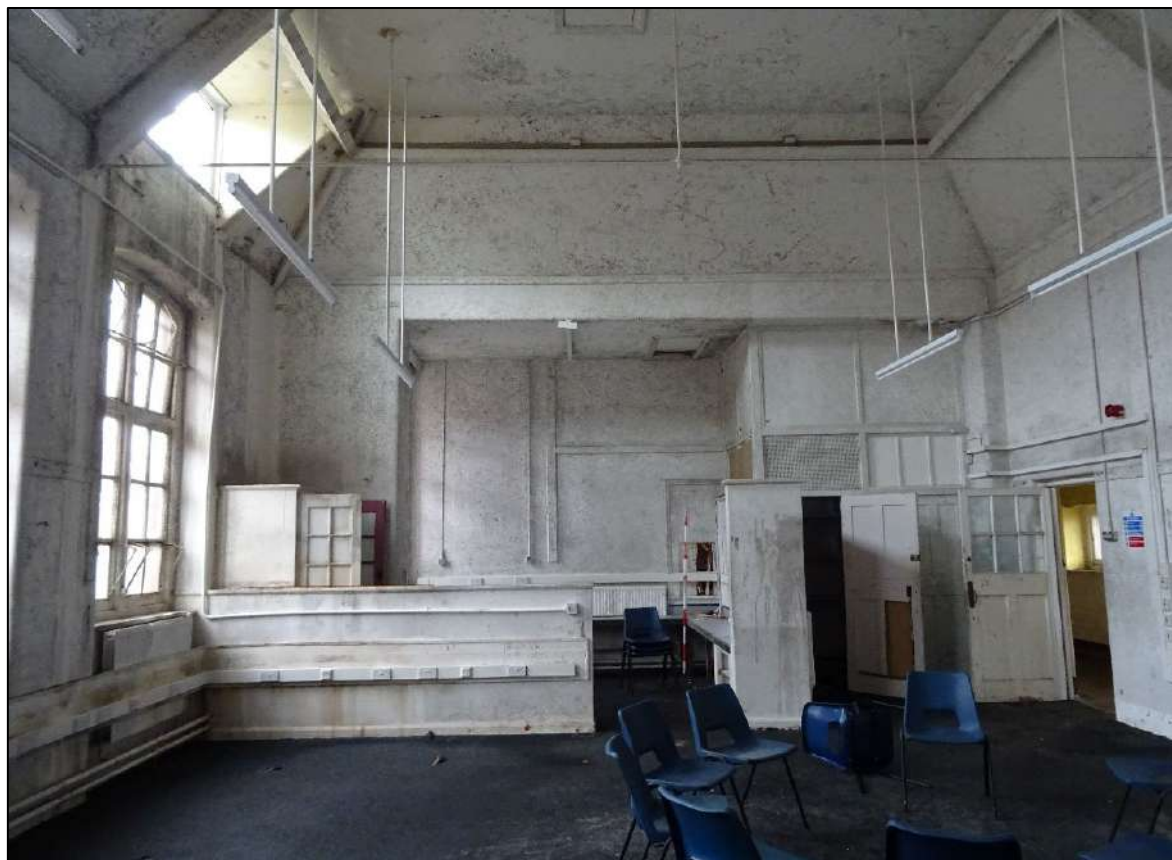
- 5.38.98. The south-east wall has a large, full height flat arched recess (Plate 567). To the right side is a built-in cupboard with wood panel walls. It has a four fielded panel door to the left and a panel in the same style to the left (Plate 568). A three-light fanlight to the right has been painted over, and another over the door has been covered. A short section of partition wall projects from the wall to the left of the cupboard, creating partitioned area to the north corner with the section from the north-east wall.

*Plate 567. The south-east wall of Room 26, Building 6. Scale 2m.*

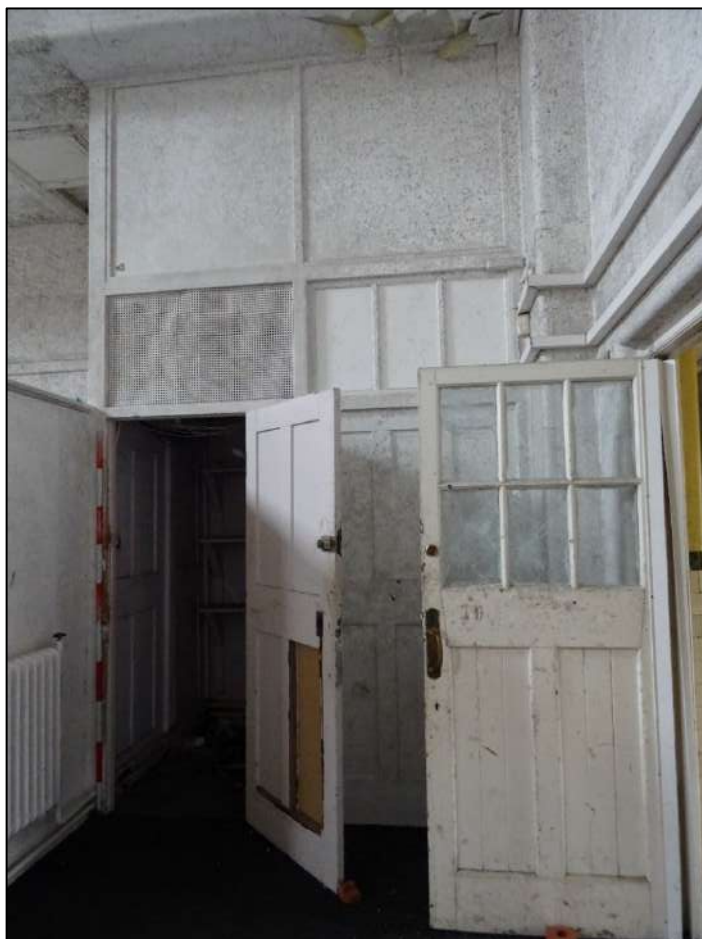
*Plate 568. Built-in cupboard to south-east wall of Room 26, looking south-east. Scale 2m.*

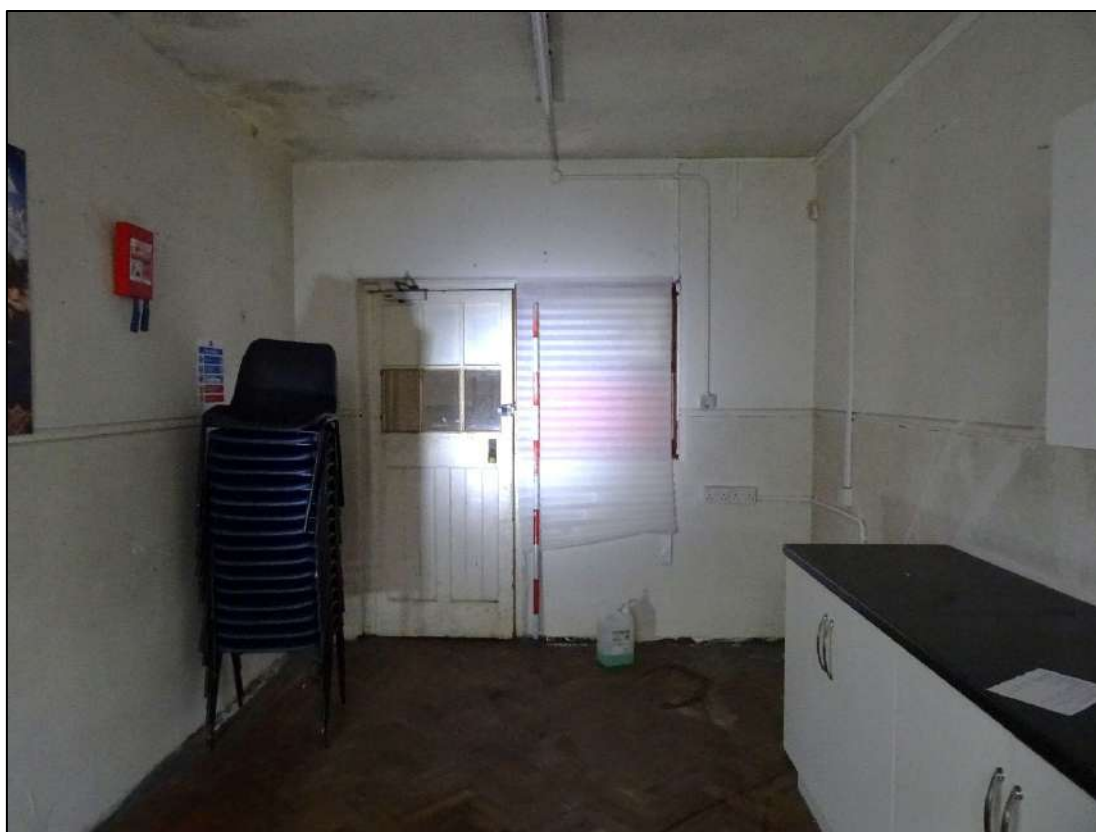
- 5.38.99. Room 27 is a small room accessed from Room 23. The floor is herringbone parquet, the walls and ceiling are a white painted plaster. There is a moulded dado to the walls (Plate 569). There are modern kitchen units along the north-western wall (Plate 570).
- 5.38.100. The door from Room 23 is as described in Paragraph 5.38.86 (Plate 569).
- 5.38.101. On the north-east wall is a wooden framed, four-pane four-light mullion and transom window. It is recessed, with rounded edges and a wooden sill (Plate 570). Beneath the window is a small cast iron column radiator.
- 5.38.102. A doorway to the south-east wall leads through into a toilet. The door is a modern solid wood door in plain wooden frame, painted white, flush with

*Plate 569. Room 27, Building 6, looking south-west. 2m scale.*

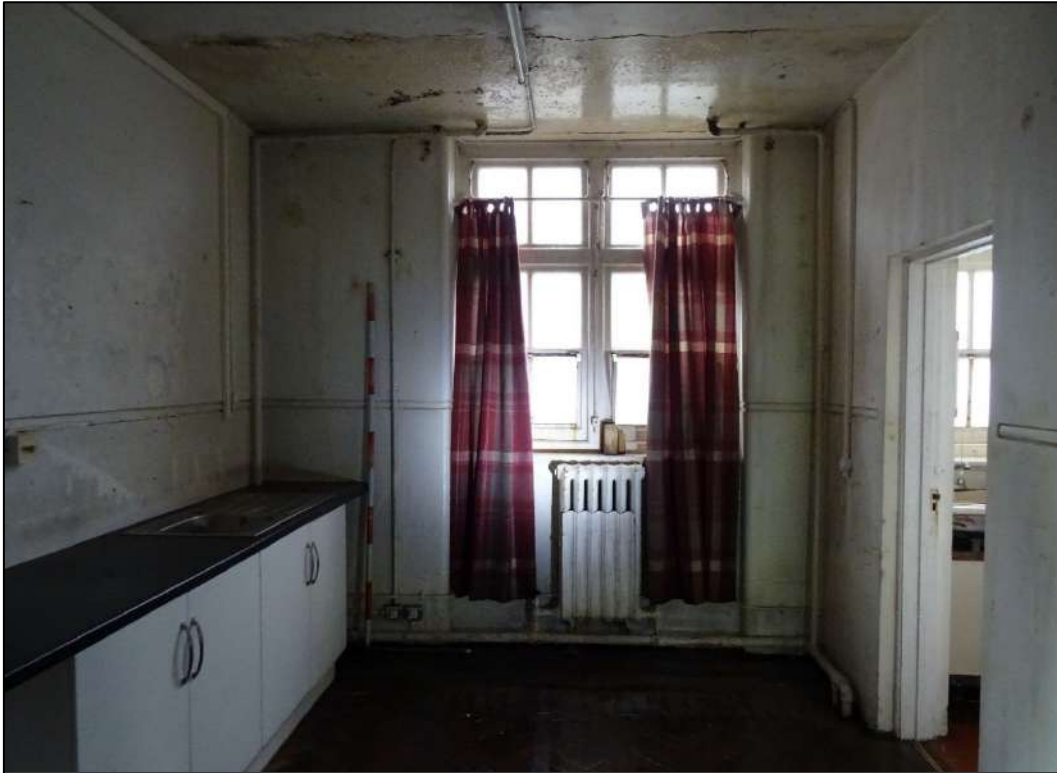
*Plate 570. Room 27, Building 6, looking north-east. Scale 2m.*

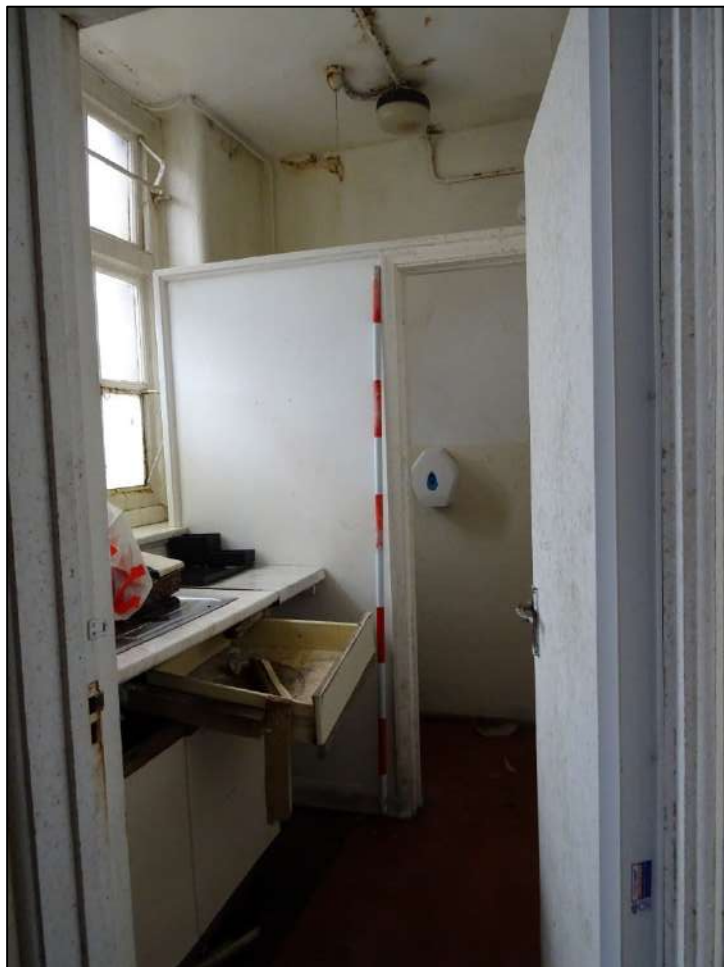
the wall (Plate 571).

- 5.38.103. Within the toilet, the cubicle is a wooden partition built along the south-eastern wall, with a sink and cupboards along the north-eastern wall (Plate 571). A four-pane four-light wooden framed mullion and transom window is recessed into the wall above the sink (Plate 572). It has painted plaster reveals with rounded edges and a wooden sill.

*Plate 571. Doorway to south-east wall of Room 23, leading into a small toilet room, looking south-east. 2m scale.*

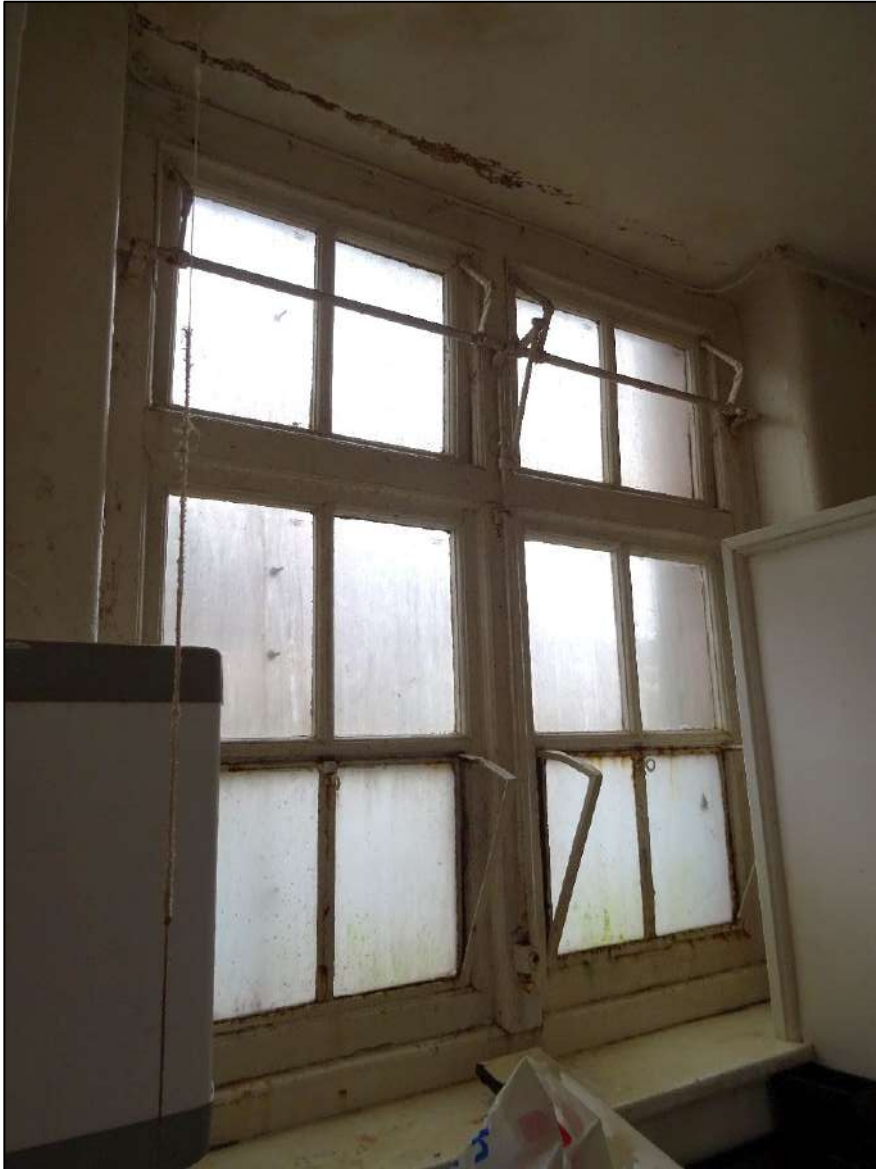
*Plate 572. Window to north-east wall of small toilet room within Room 27, Building 6, looking east.*

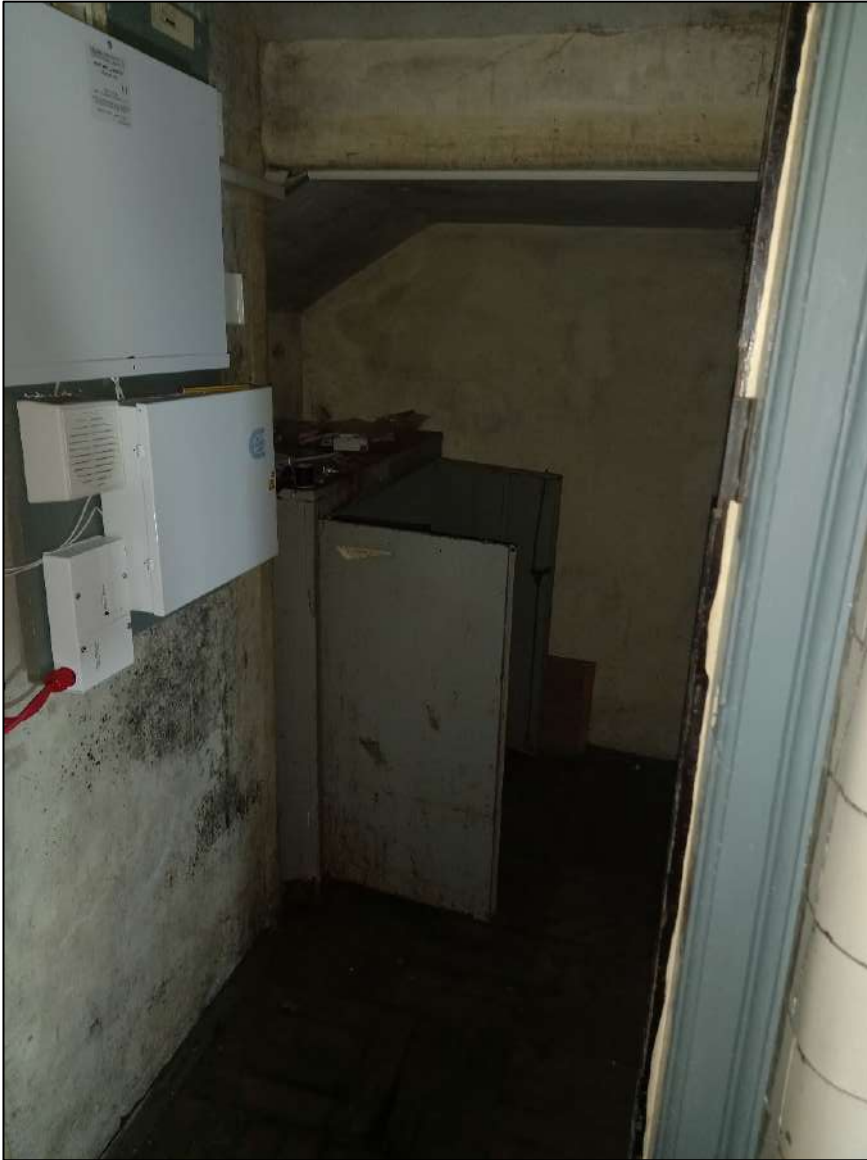
- 5.38.105. Room 29 is accessed from Room 1 and was located at the base of the stairwell, Room 30. The door is a blue painted four fielded panel in a moulded, blue painted frame (Plate 573).
- 5.38.106. The walls are a painted white plaster and floor is herringbone parquet. The ceiling slopes down at the north-eastern end of the room. The room widened at this end, with a recess set into the north-west wall with metal cupboard set into the recess (Plate 574).

*Plate 574. Room 29, Building 6, looking north-east.*

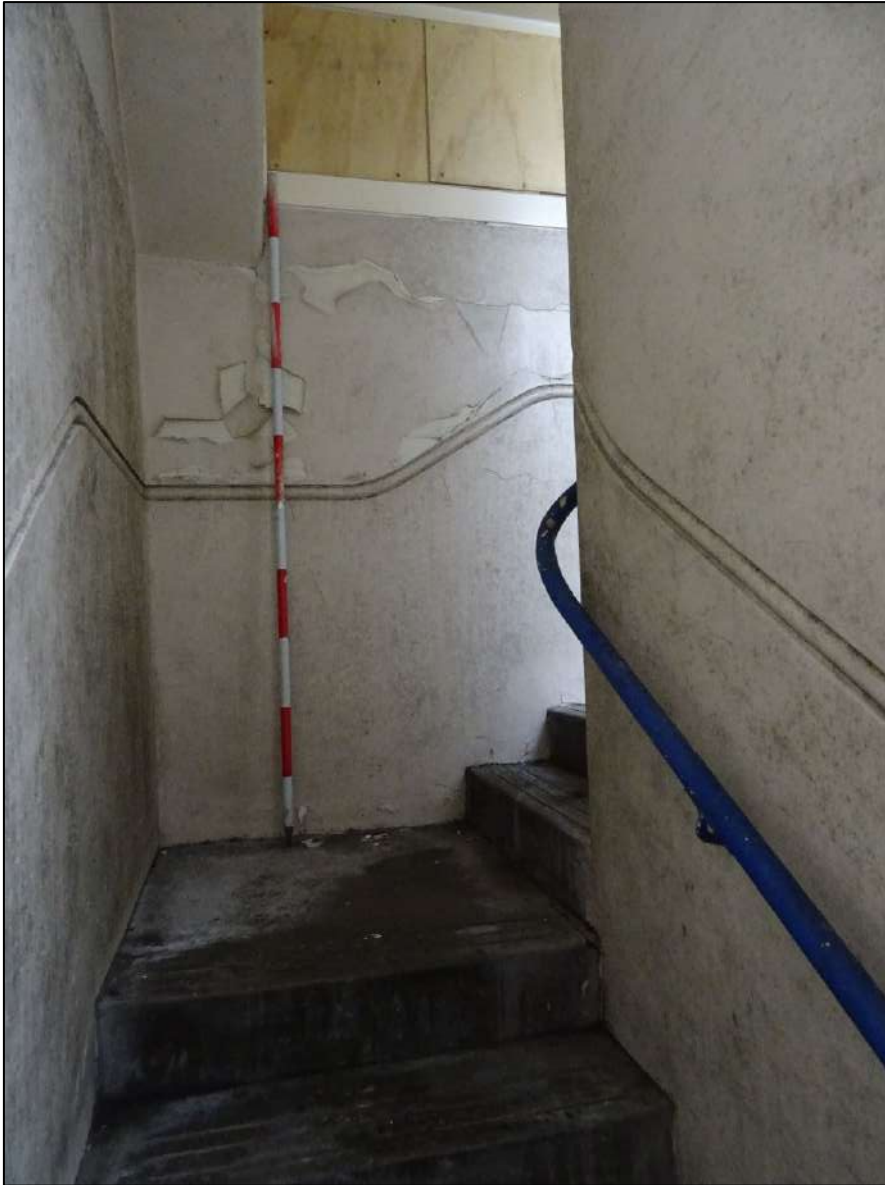
- 5.38.107. The stairwell is accessed from the north-west wall of Room 1 (Plate 575). The stairs are concrete steps. The walls are white painted plaster, with a moulded dado to the outer wall. There is a blue painted metal rail to the inner wall. The south-west wall at the bottom of the stairwell has a tiled lower third continuing from Room 1, with white ceramic tiles with a brown band to the bottom and a green band to the top. Above this the wall is painted blue.
- 5.38.108. The staircase has four short flights of quarter landing stairs (Plate 576). They open onto a short landing, with a metal safety rail along the north-

*Plate 576. Quarter-turn in stairwell Room 30, looking south-east.  
Scale 2m.*

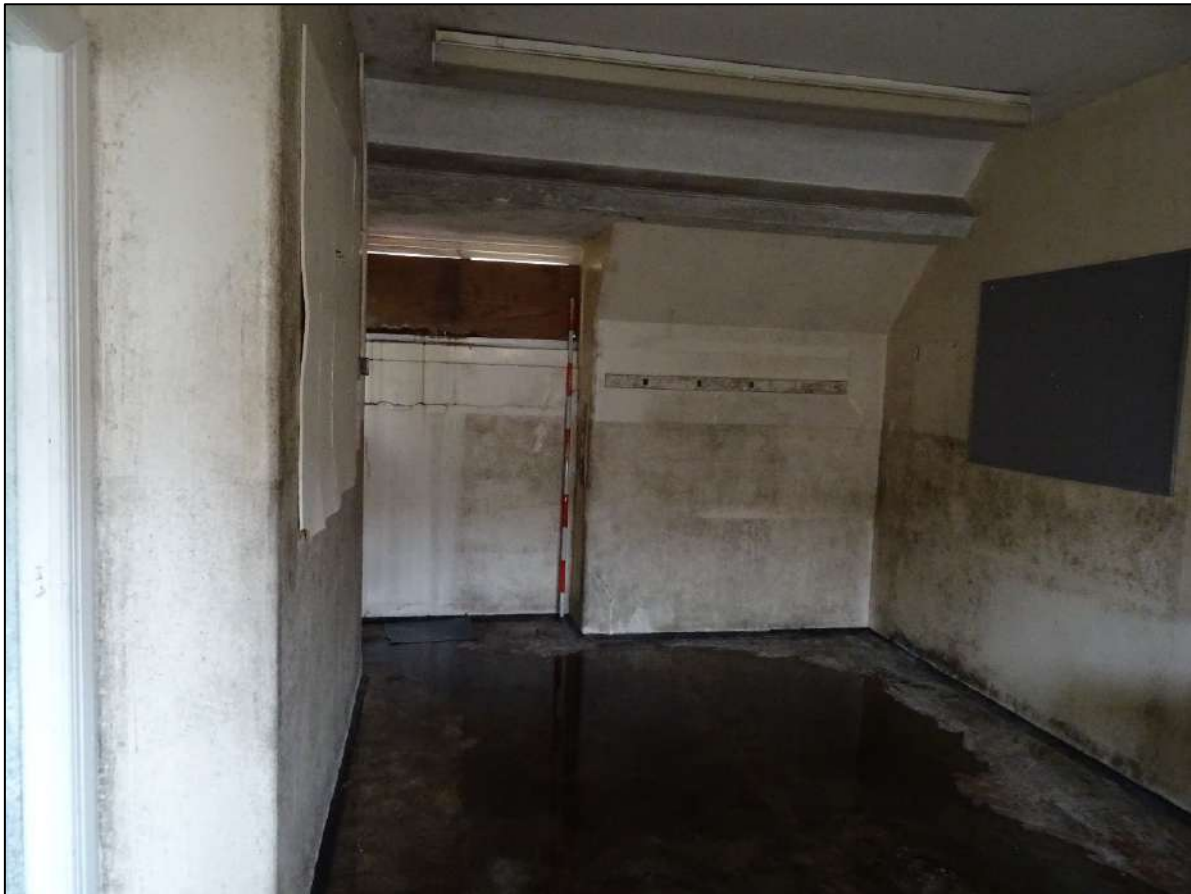
5.38.109. The staff room is accessed by a door within the south-eastern wall from the landing at the top of the stairwell. The walls are a painted white plaster and floor is herringbone parquet (Plate 578). The ceiling is white painted plaster, and along the south-western and north-eastern walls the ceiling slopes down to meet the tops of the walls. A small window is located within the south-west wall. The wall then steps in to meet the north-west wall (Plate 579).

*Plate 578. Room 31, looking south-west. 2m scale.*
