**Level 2 Building Recording:**  
**Former Dyffryn Lower School, Port Talbot**

March 2024

Report No. 2278

Prepared for KEW Planning  
By  
Susan Stratton PhD

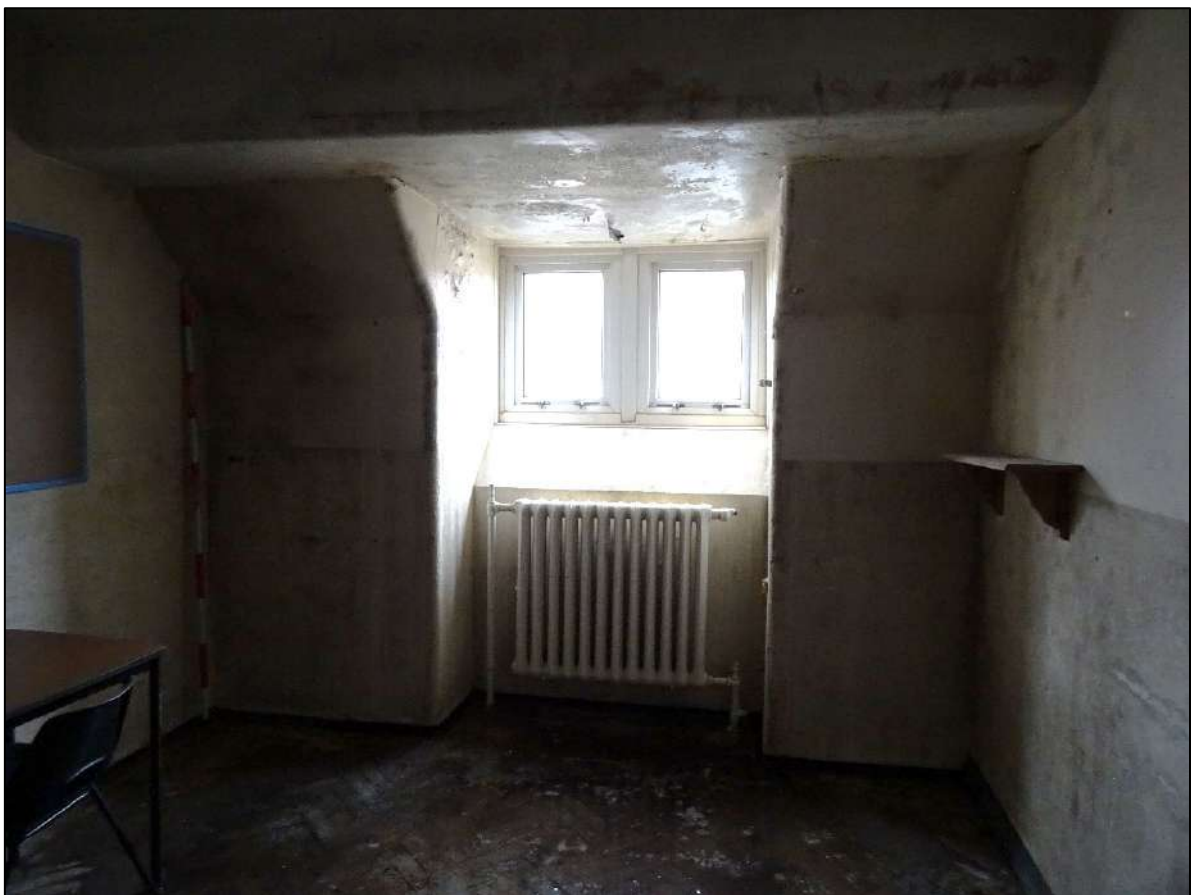
5.38.109. The staff room is accessed by a door within the south-eastern wall from the landing at the top of the stairwell. The walls are a painted white plaster and floor is herringbone parquet (Plate 578). The ceiling is white painted plaster, and along the south-western and north-eastern walls the ceiling slopes down to meet the tops of the walls. A small window is located within the south-west wall. The wall then steps in to meet the north-west wall (Plate 579).

5.38.110. A two-light mullion dormer window is recessed into the north-east wall. It has painted plaster reveals and a canted sill. Beneath the window is a cast iron column radiator (Plate 579).

*Plate 579. Room 31, Building 6, looking north-east. Scale 2m.*

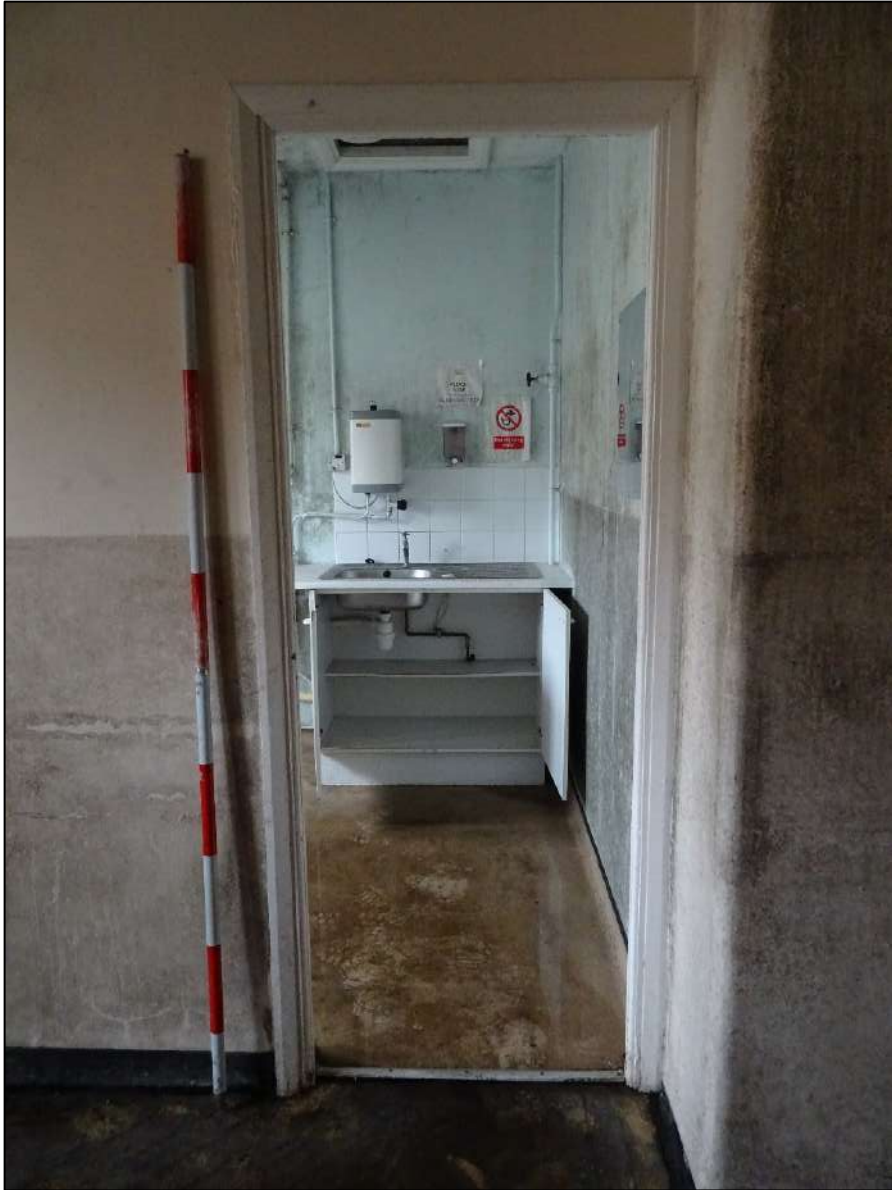
5.38.111. A doorway within the south-east wall leads through to a kitchen, Room 32. The doorway does not contain a door, with the door frame being moulded wood, painted white (Plate 580).

*Plate 580. Doorway leading from Room 31 to Room 32, looking south-east. 2m scale.*

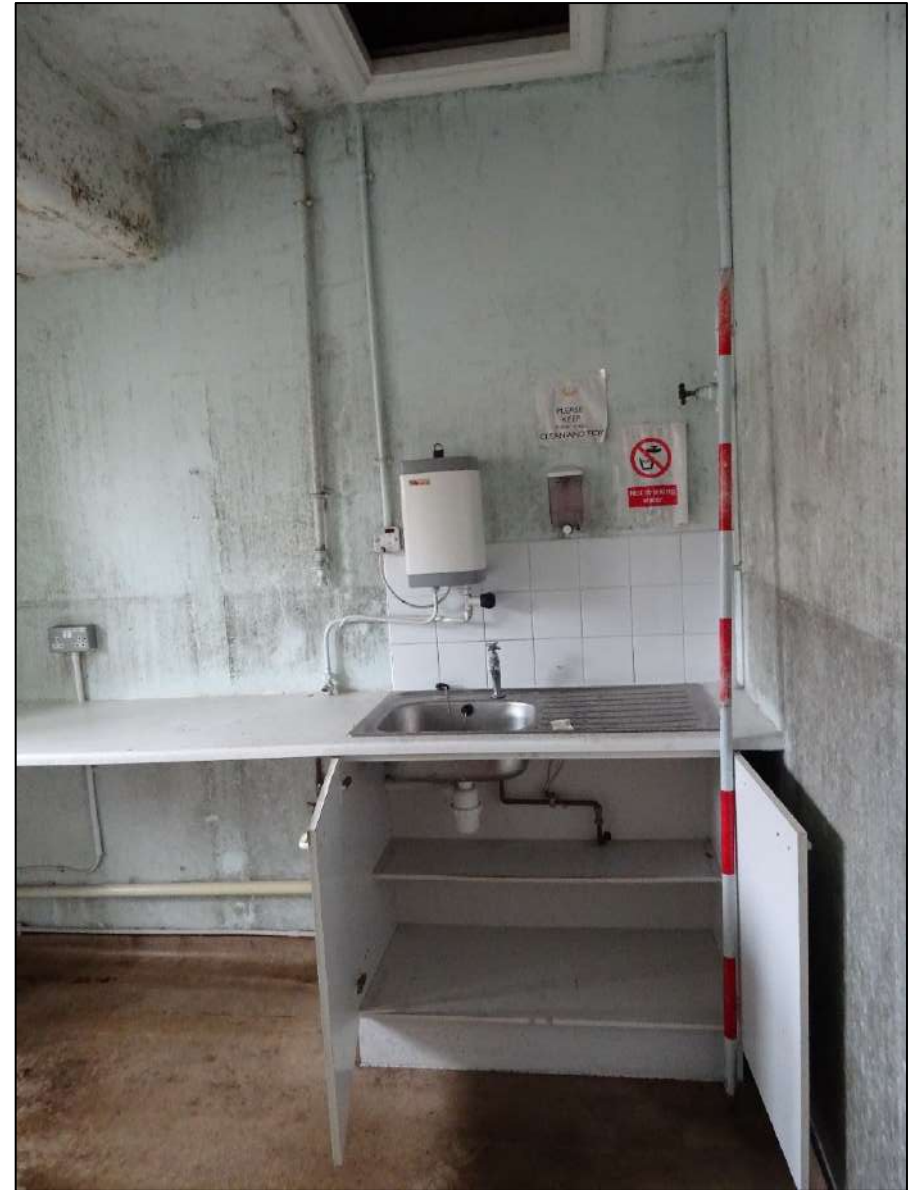
5.38.112. The kitchen is accessed through a doorway from Room 31 on the north-west wall. It has a brown linoleum flooring, light blue painted plaster walls, and a white painted plaster ceiling (Plate 581). The ceiling slopes down to the north-east side.

5.38.113. A sink, cupboard and countertop are located along the south-eastern wall of the room, with a white ceramic tile splashback above the sink (Plate 581).

*Plate 581. Room 32, looking south-east. 2m scale.*

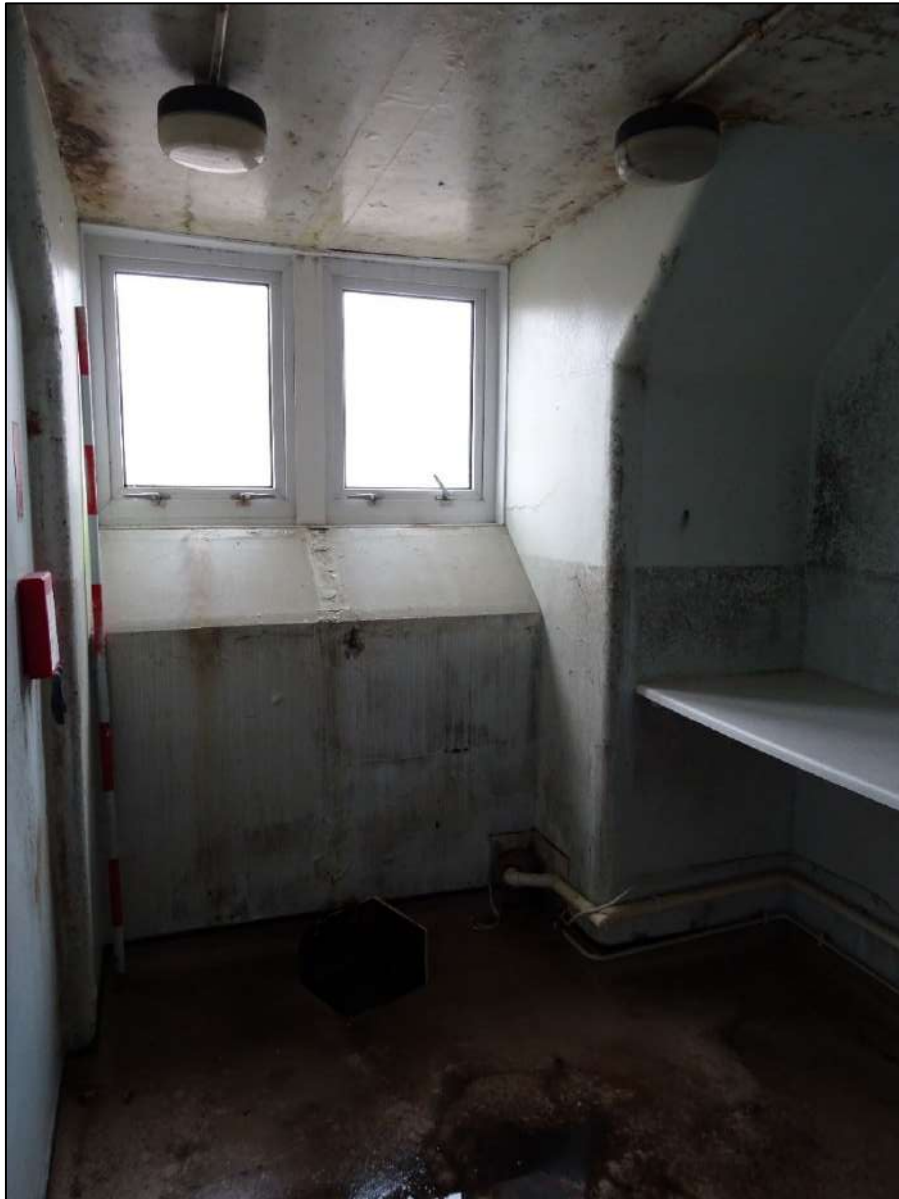
*Plate 582. North-east wall of Room 32, looking east. 2m scale.*

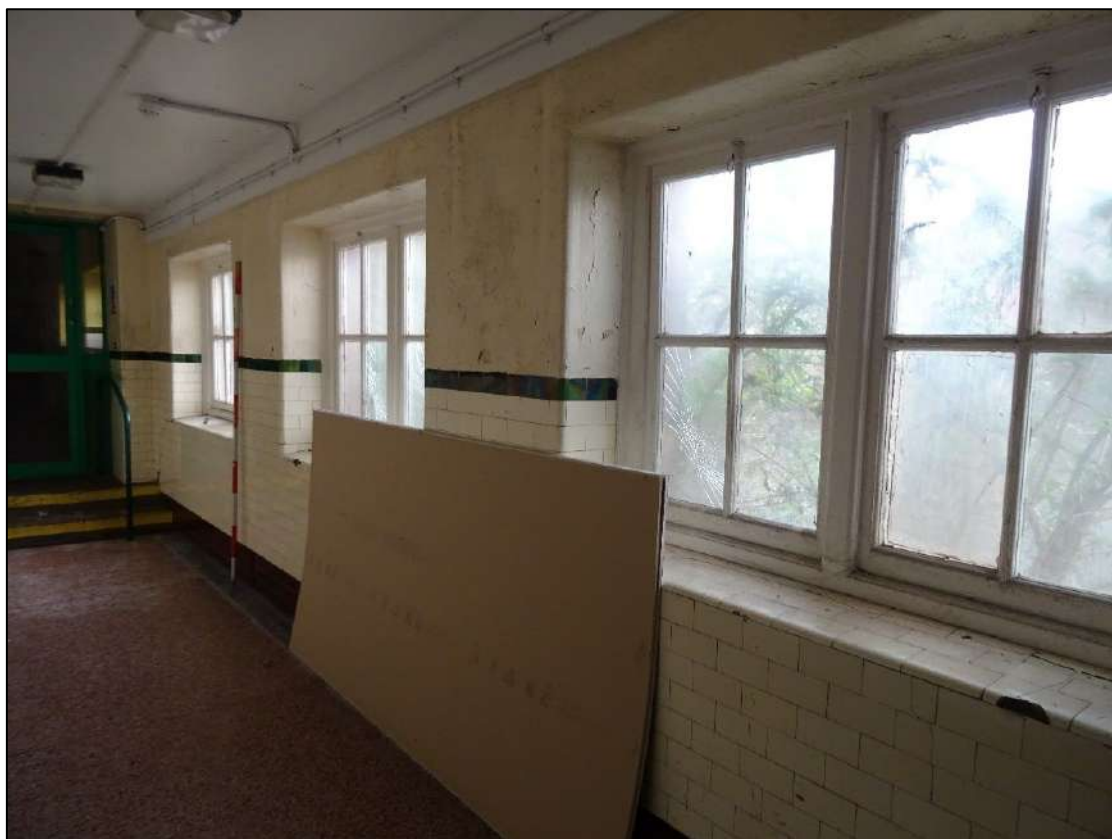
*Plate 584. Room 33, Building 6, showing the three windows to the south-west wall, looking south. 2m scale.*

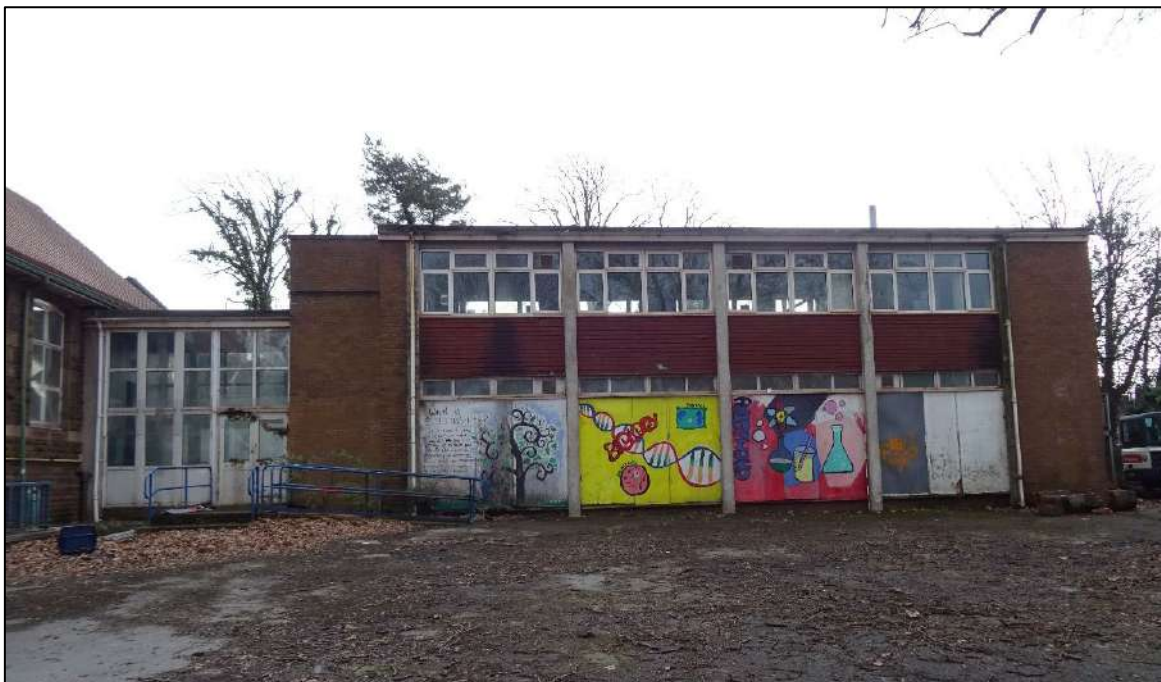
- 5.39.2. The extension is a two-storey flat roofed building orientated north-east to south-west. The connecting section with the original building is one and half storey. The north-east and south-west elevations are the same, although the lower sections have been boarded to the south-west (Plates 586 and 587).

- 5.39.4. The connecting section is fully glazed with metal frames (Plate 586). The glazing is five lights wide and three high.

*Plate 586. North-west facing elevation of modern extension to Building 6, looking south-east.  
Scale 2m.*

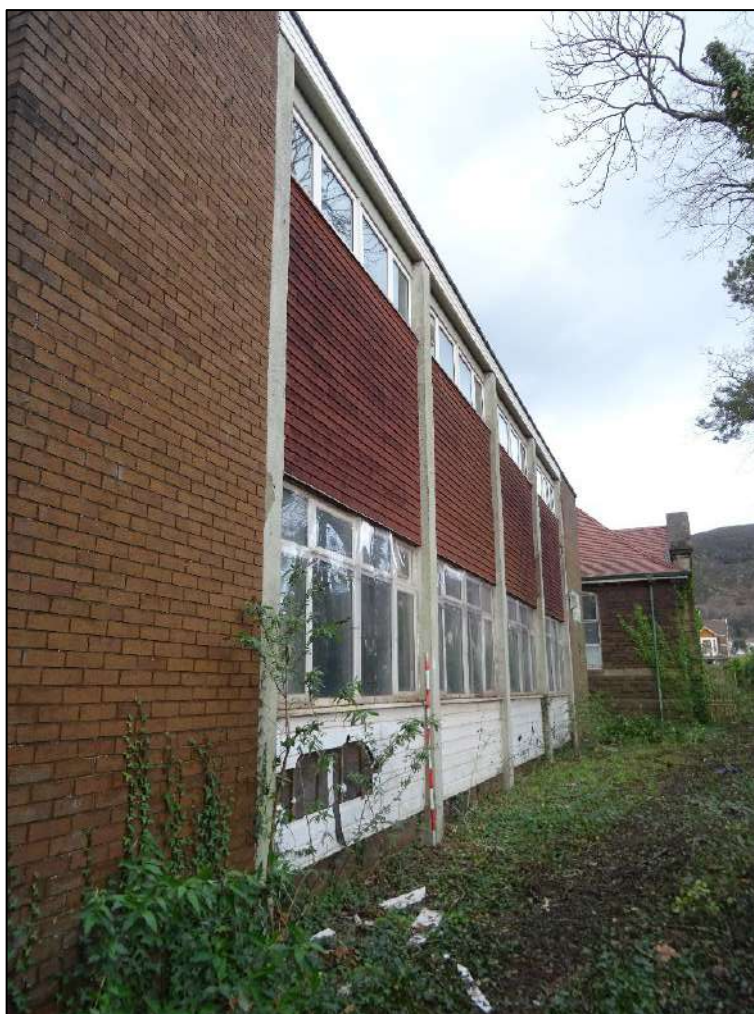
*Plate 587. Oblique view of south-east facing elevation of modern extension to Building 6,  
looking north. Scale 2m.*

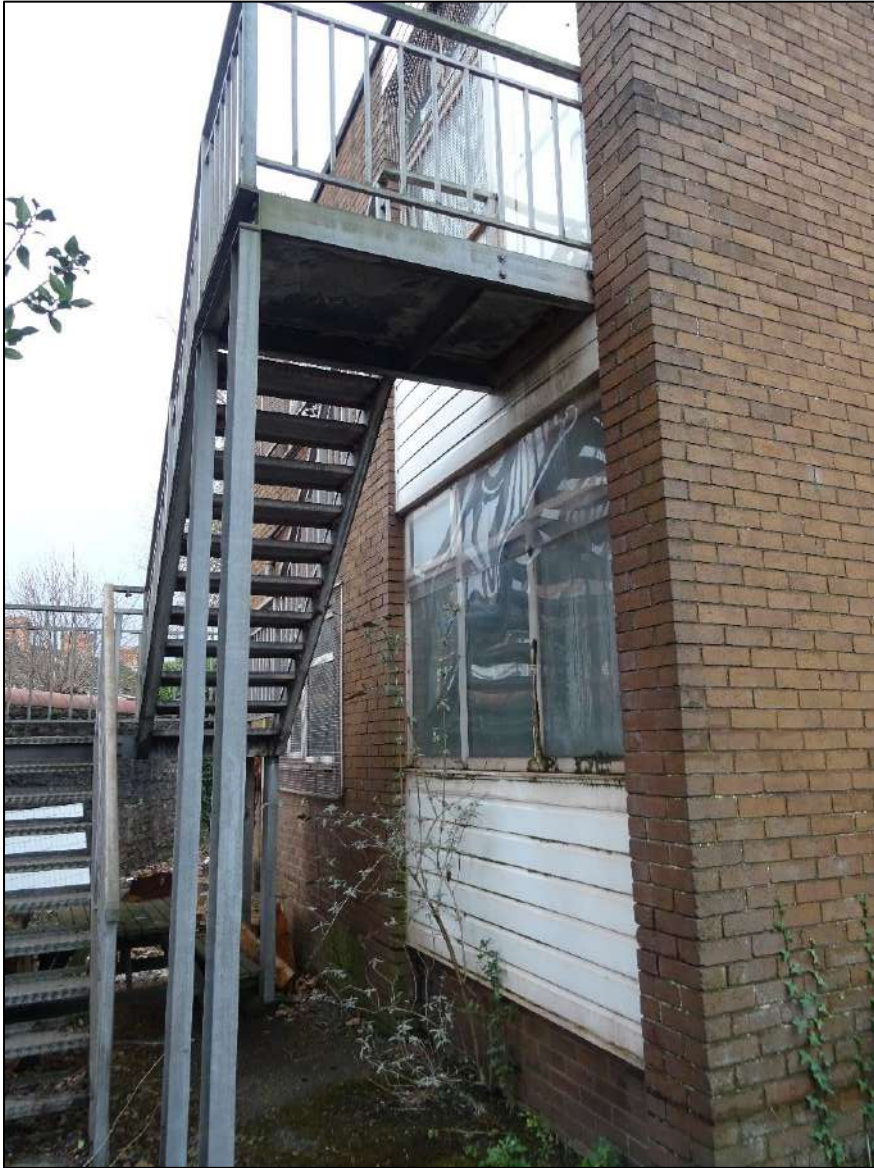
5.39.5. The south-west end of the extension is orange brick in stretcher bond. To the right side are three-over-three light mullion and transom windows with wooden panelling beneath to both storeys (Plate 588). A metal half-turn fire escape is attached to the second storey. To the left side there are two-over-two light mullion and transom windows to both storeys.

*Plate 588. Fire escape staircase on the south-western exterior wall of the modern extension, looking north-west.*

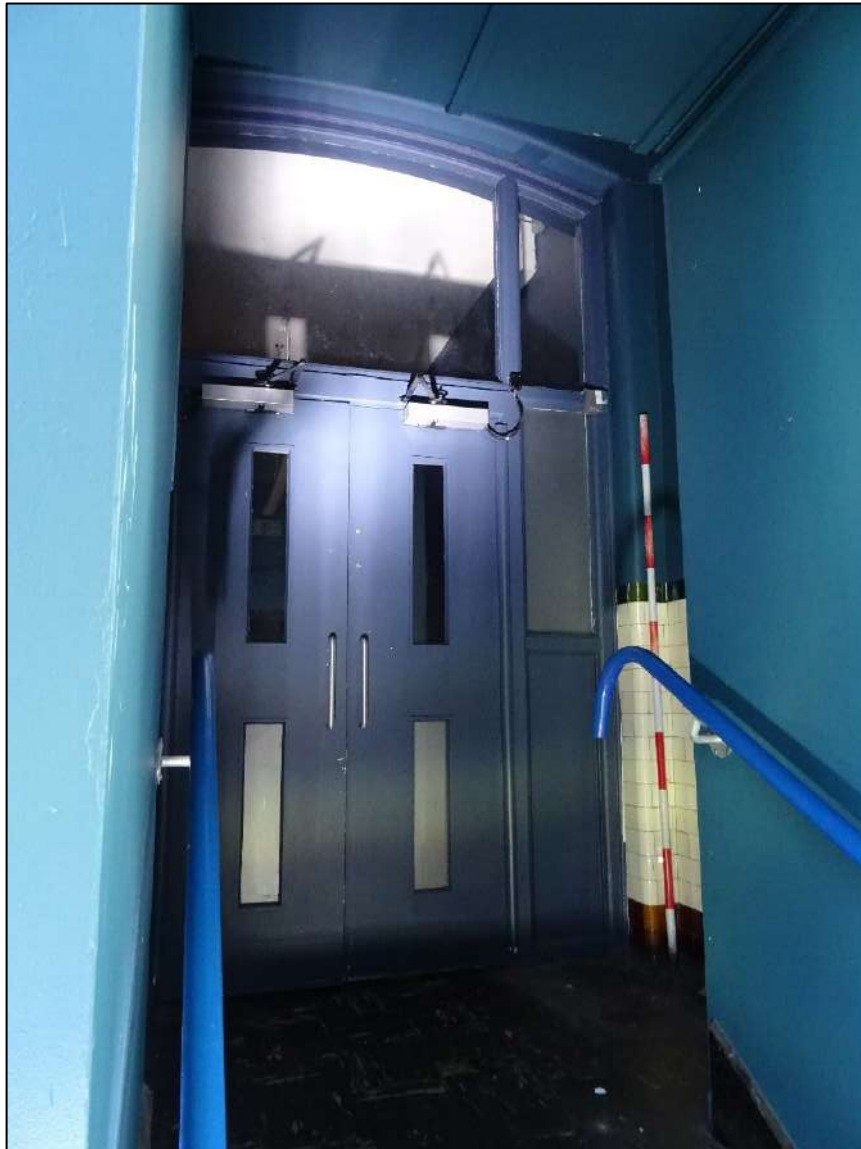
- 5.40.1. Room 34 is the foyer of the modern extension and is accessed through the former main entrance to the south-west wing from Room 8 (Plate 590). The external door has been removed and the existing doorway was originally the inner door to the vestibule. The doors are modern double fire door with central narrow lights, painted dark blue. They are set into a moulded wooden frame within a segmental arch (Plate 590). There are glazed panels to either side and a fanlight above.

*Plate 590. Original vestibule doorway to north-east of Room 34, looking north-east. Scale 2m.*

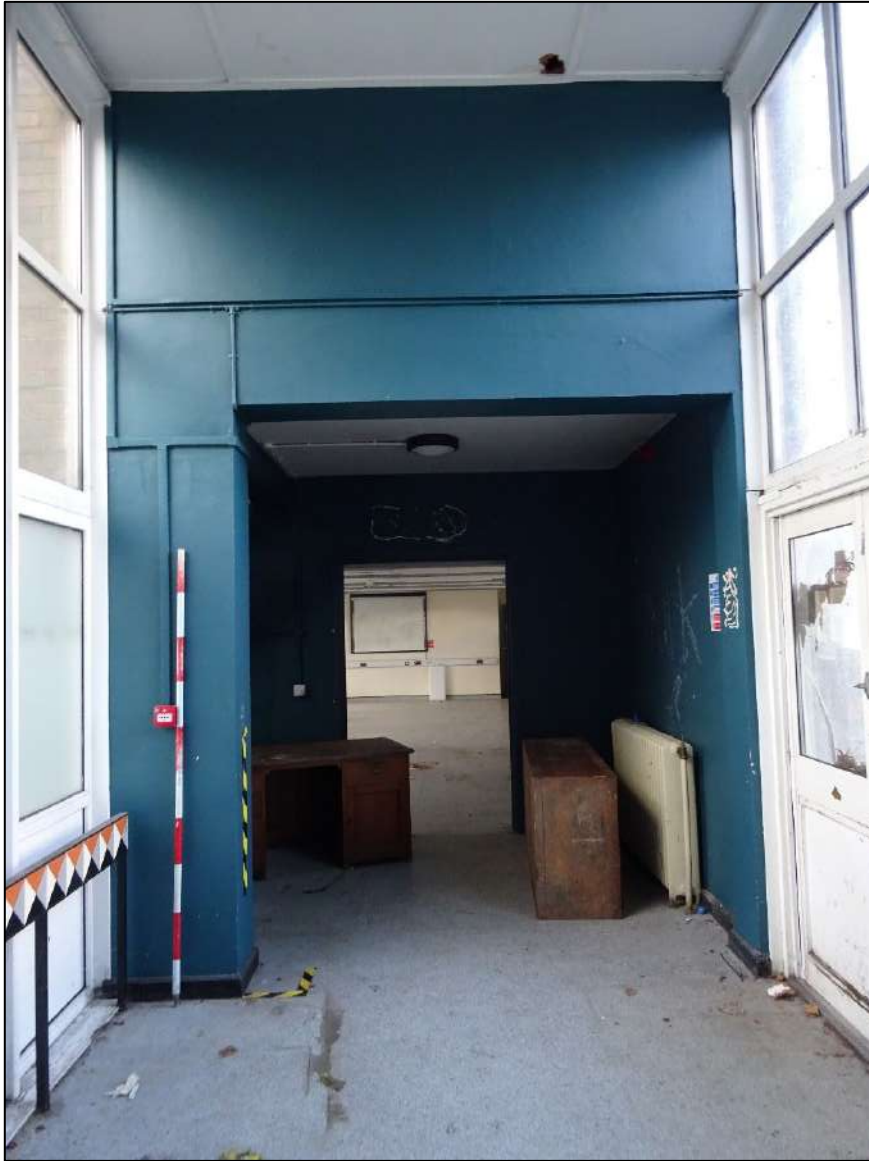
- 5.40.2. The curved walls of the original vestibule survive to the north-west and south-east. They have white ceramic tiles on the lower half of the wall, with a brown band to the bottom and green to the top (Plate 591). The upper section of walls and the ceiling are plaster, painted dark blue. The location of the original exterior door is open, with a set of four steps leading into the main part of the foyer (Plate 592).

- 5.40.4. The main section of the foyer has full height glazed panels with uPVC frames to the north-west and south-east and a panelled ceiling. The south-western end of the foyer has dark blue painted plaster walls, with a lower ceiling of white painted plaster (Plate 592). A doorway leads through into Room 35 to the south-west. To the south-east is a half-turn staircase leading to the first

*Plate 592. Room 34, Building 6 extension, looking south-west.  
Scale 2m.*

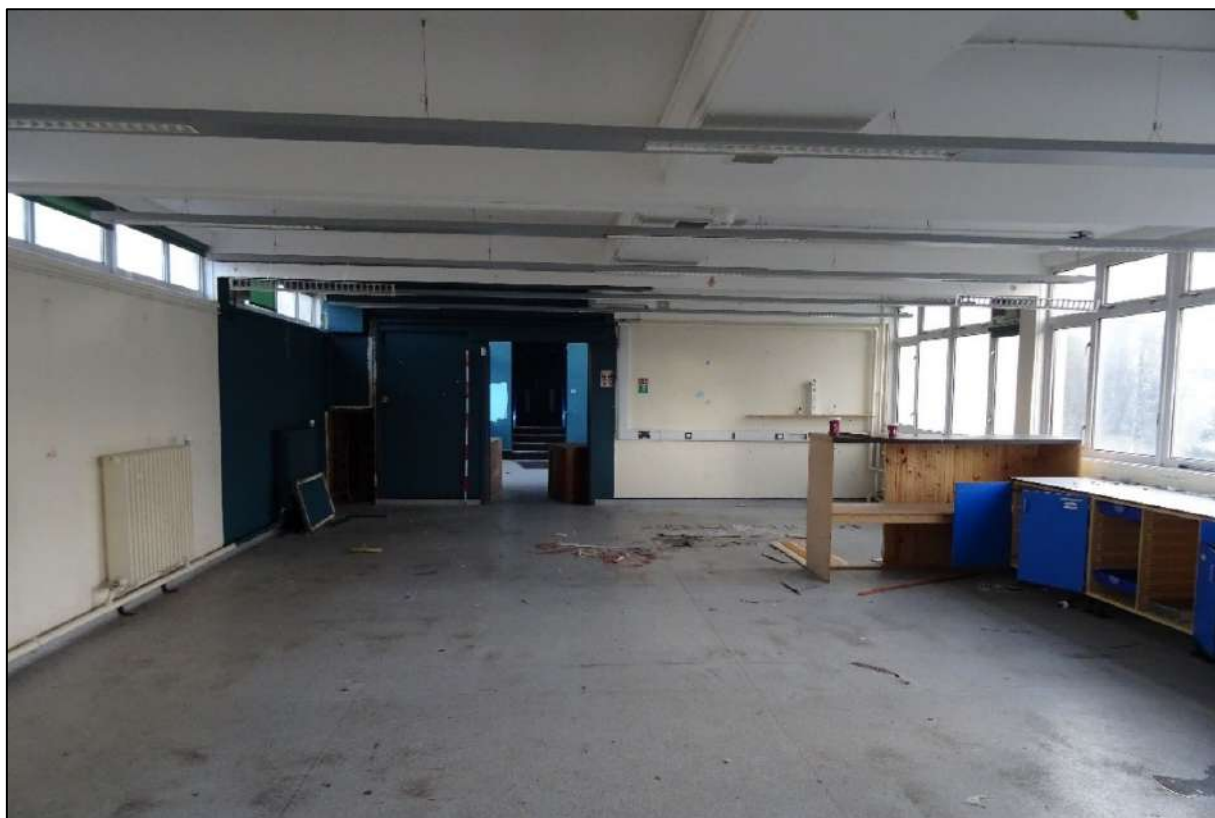
- 5.40.5. Room 35 is accessed through a doorway to the north-eastern wall from Room 34. The walls of the room are painted white plaster, except for an area around the doorway which is the same dark blue painted plaster as Room 34. The floor is a grey linoleum (Plate 594).

- 5.40.6. The upper half of the south-eastern wall was formed of uPVC framed windows, with further small band of windows running along the top section of the north-western wall (Plate 594 and 595).

*Plate 594. Room 35, Building 6 extension, looking north-east. Scale 2m.*

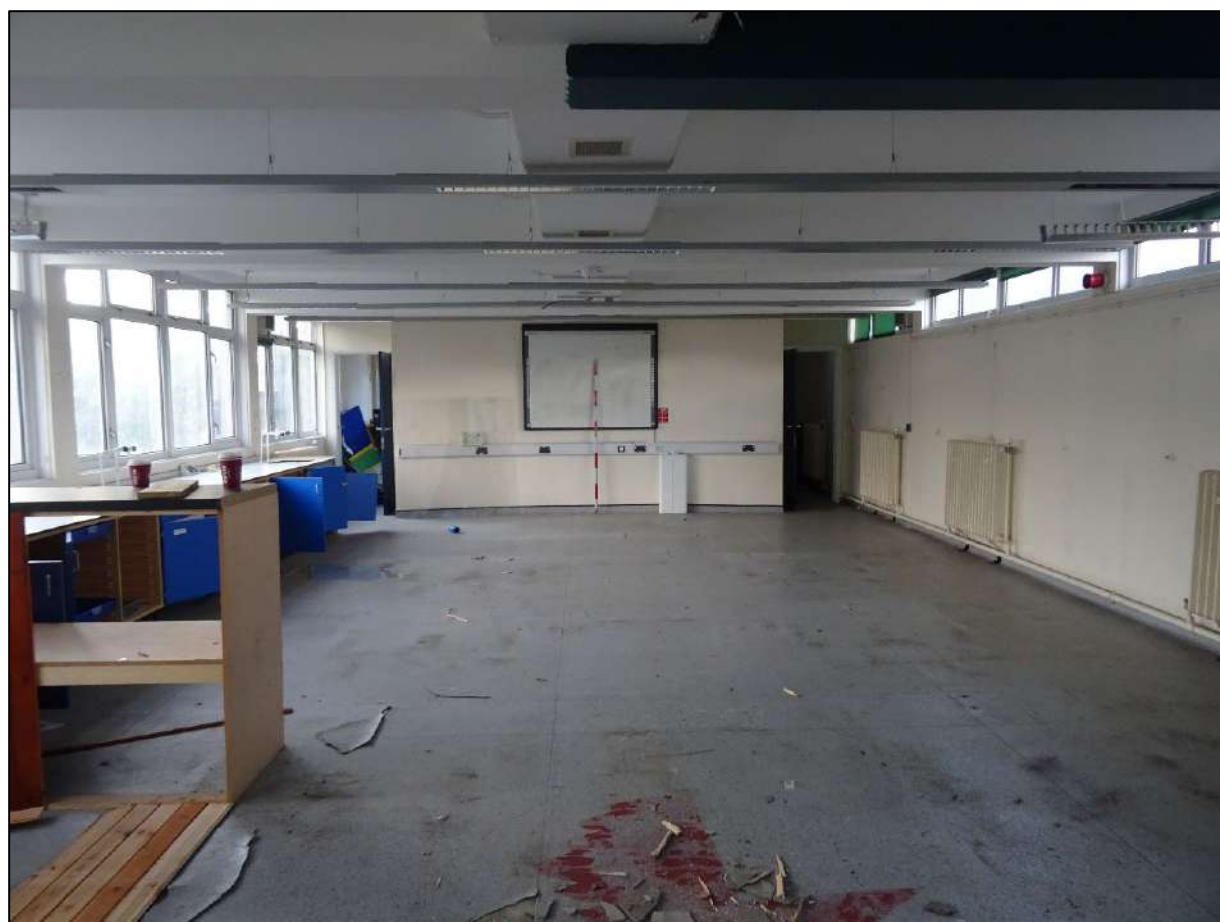
- 5.40.7. Behind the south-western wall of the room, there were two smaller rooms, which were accessed through doorways set into either end of this wall (Plate 595). Both have dark blue painted solid wood doors in white painted wooden frame. There is a small storeroom in the east corner, with walls and ceiling white painted plaster, and a window to the south-west wall (Plate 596). The second room is a prep room, also with white painted plaster walls and ceiling. It has a small uPVC window to the south-west wall (Plate 597).

*Plate 595. Room 35, Building 6 extension, looking south-west. Scale 2m.*

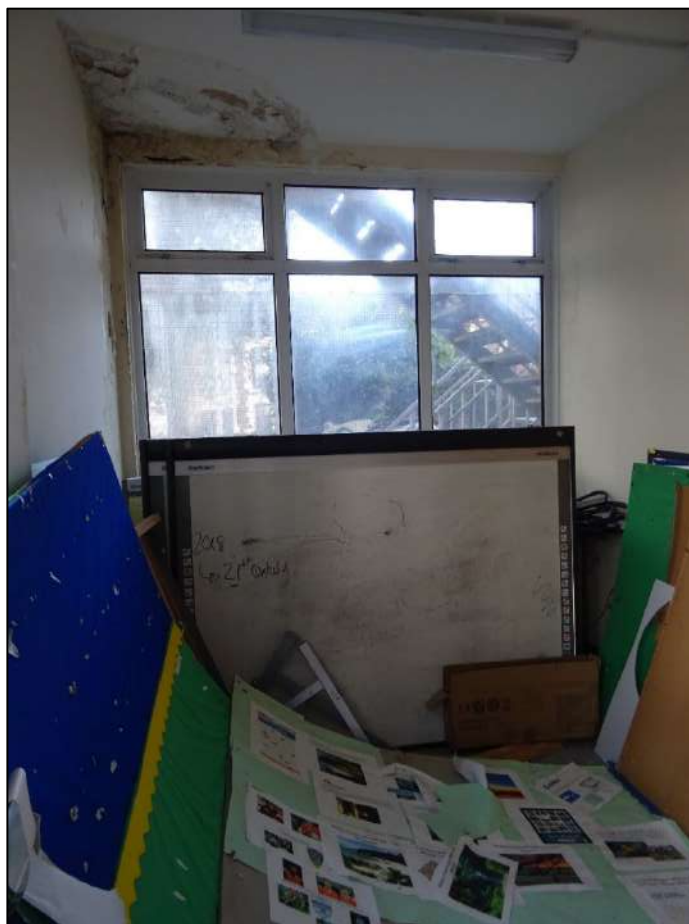
*Plate 596. Storeroom at the south-western end of Room 35, looking south-west.*

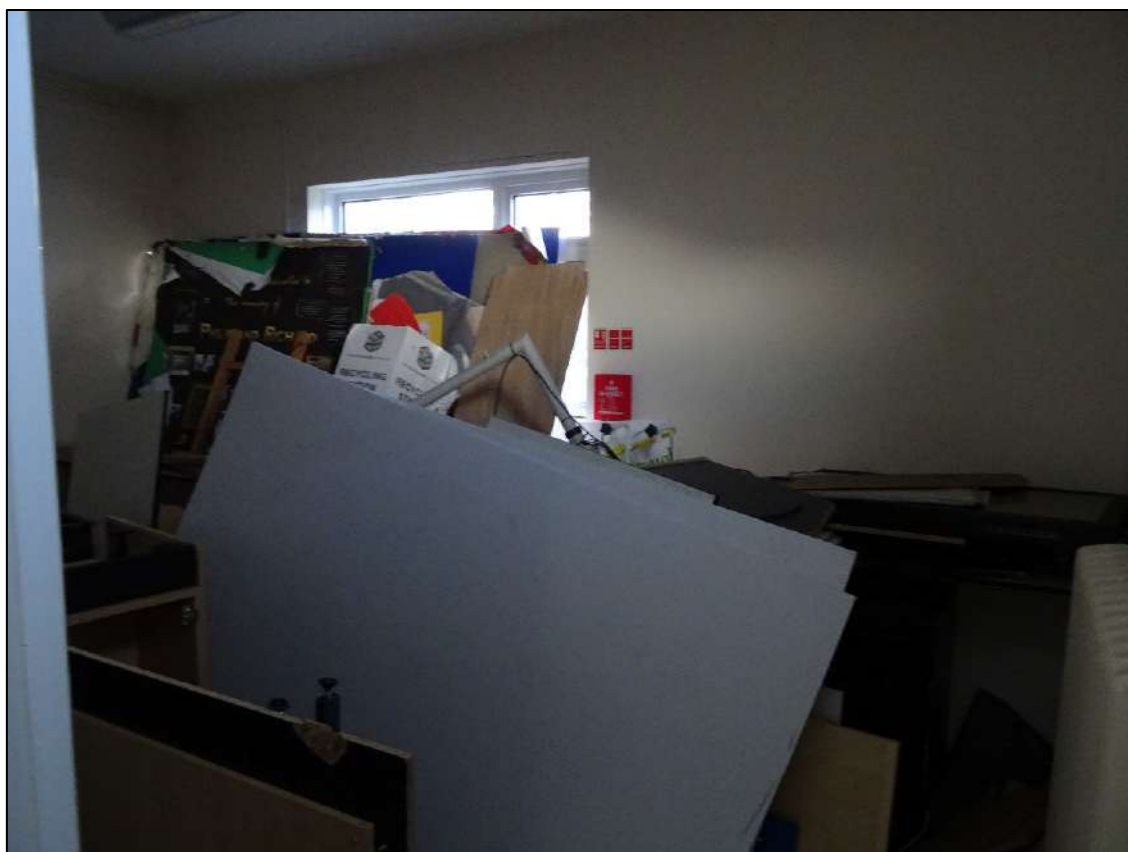
*Plate 597. Prep room at the south-western end of Room 35, looking south-west.*

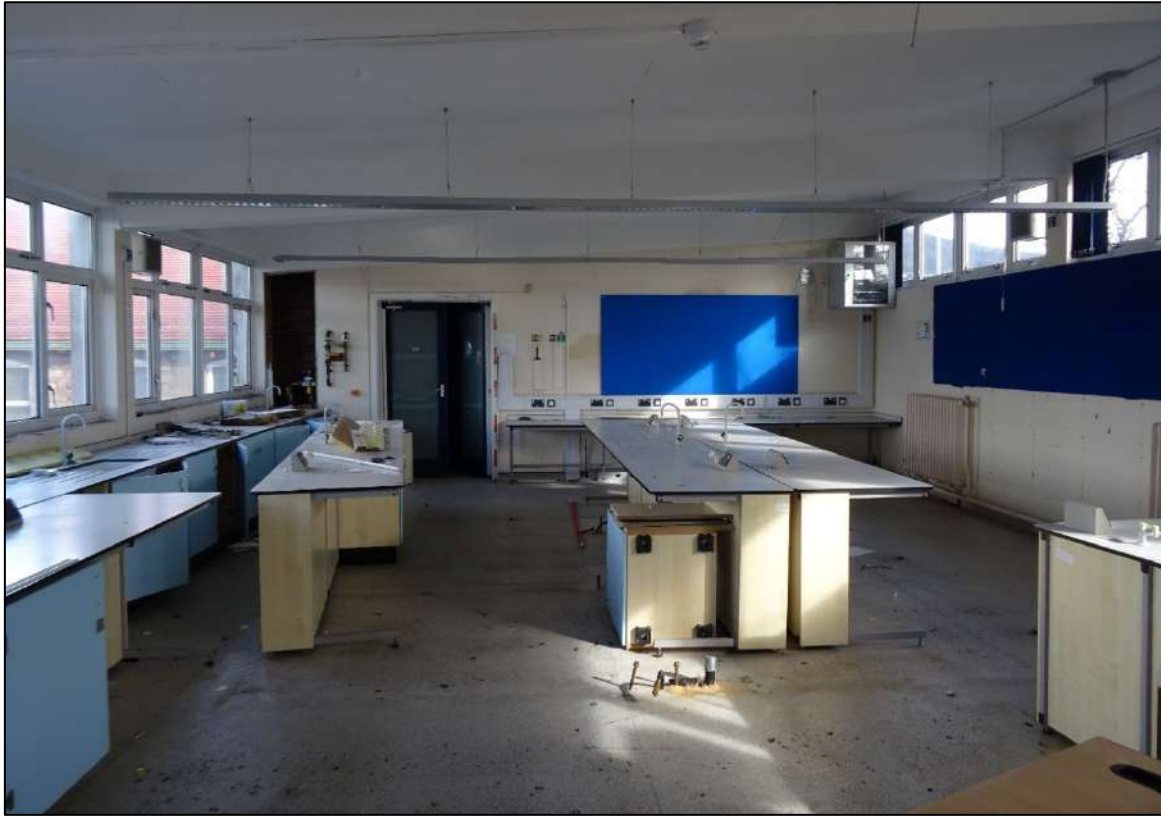
*Plate 598. Room 36, Building 6 extension, looking north-east. Scale 2m.*

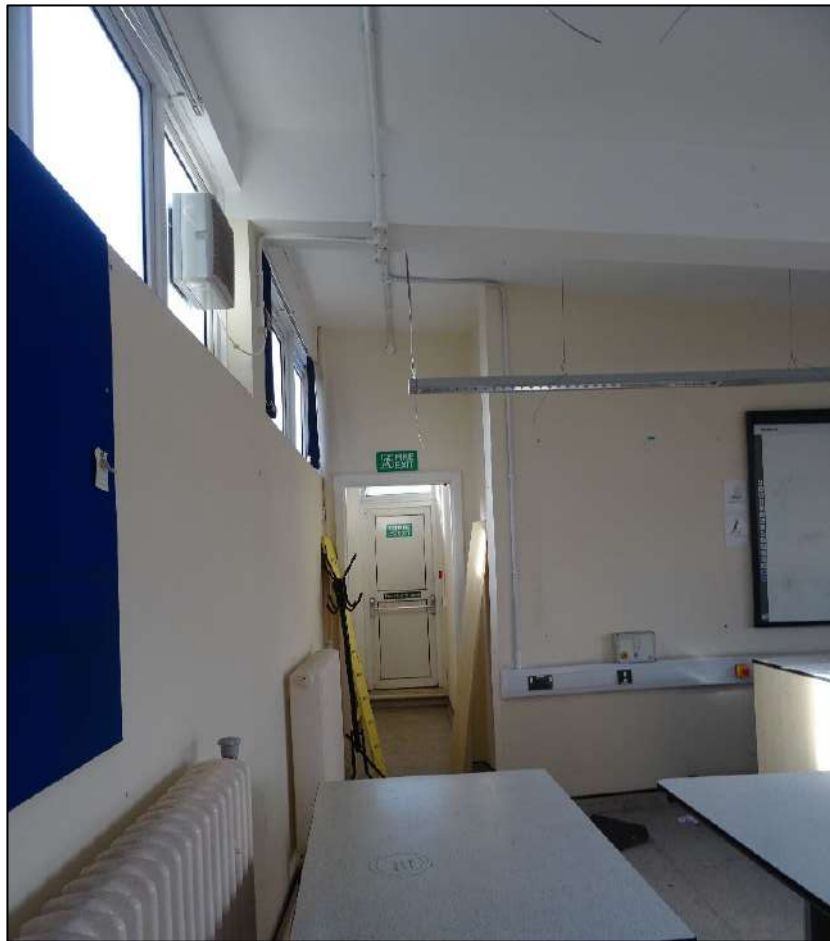
*Plate 599. Corridor in the south corner of Room 36, leading to fire escape, looking south-west.*

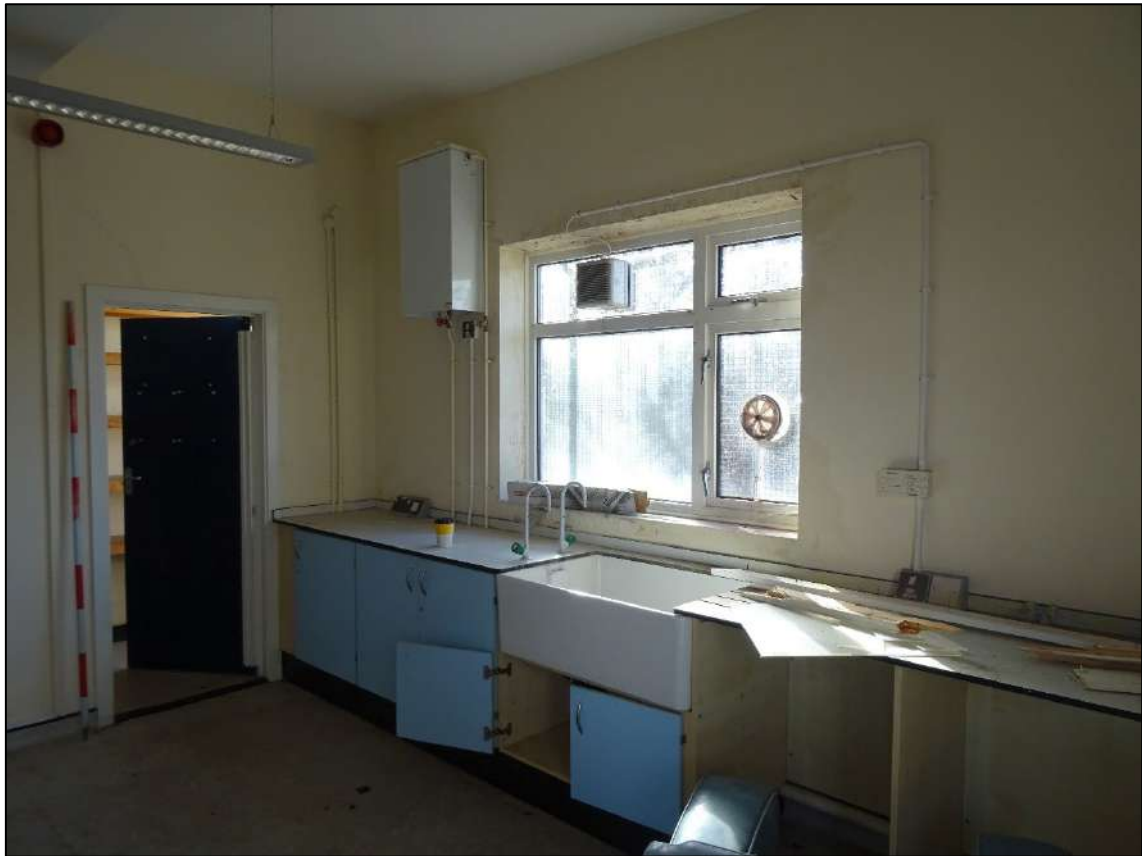
room leads to a small storeroom (Plate 600).

*Plate 600. Prep room at the south-west end of Room 36, looking south. Scale 2m.*
