RHONDDA  
GEOTECHNICAL  
SERVICES

PHASE 2  
CONTAMINATED LAND ASSESSMENT  
REVISION 1  
N.P.T. FULL PLANNING REF. P2021/1086  
EXTENSION TO EXISTING INDUSTRIAL UNIT  
UNIT 21 MARDON PARK  
BAGLAN  
PORT TALBOT  
SA12 7AX  
27/04/2024

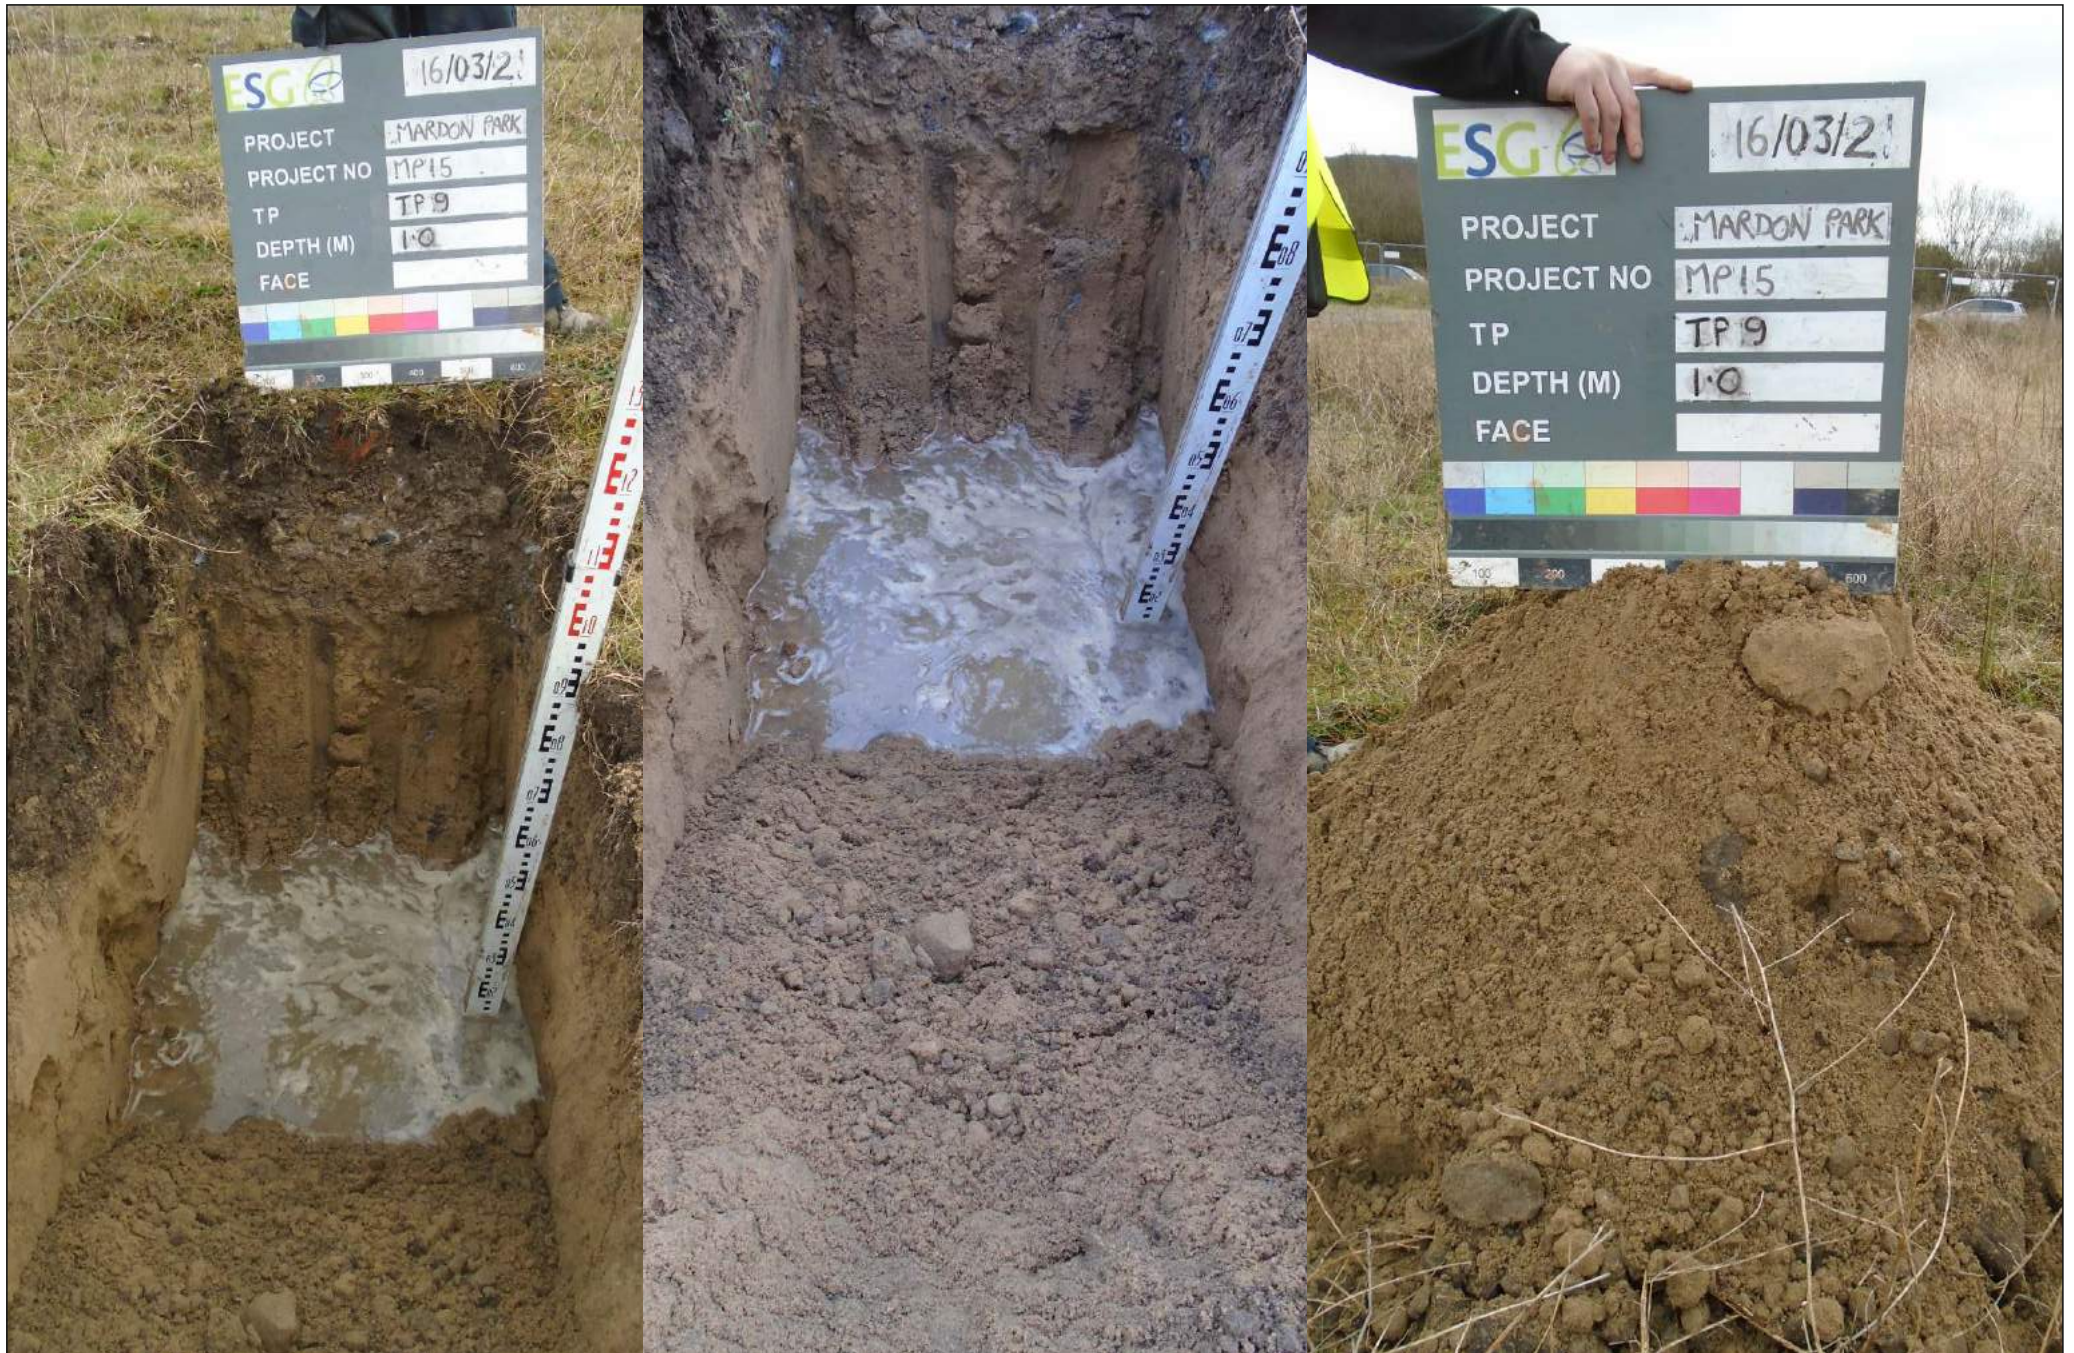
FIGURE 4 TP 9

The full trial pit logs to BS5930:2015 together with photographs of the pits can be found in Appendix A. In summary, all trial pits encountered a thin (0.25m-0.7m) layer of poor Topsoil/Made Ground or fused slag. The thin Made Ground lay directly on top of sand. The sand contained some large fragments of slag at deeper levels indicating some degree of disturbance. It is likely this occurred during the reclamation of Baglan Moors approximately 70 years ago.
