## BS5837 2012 Tree Information – Western Bio-Energy

Western Bio-Energy  
1 Longland Lane  
Port Talbot  
SA13 2NR

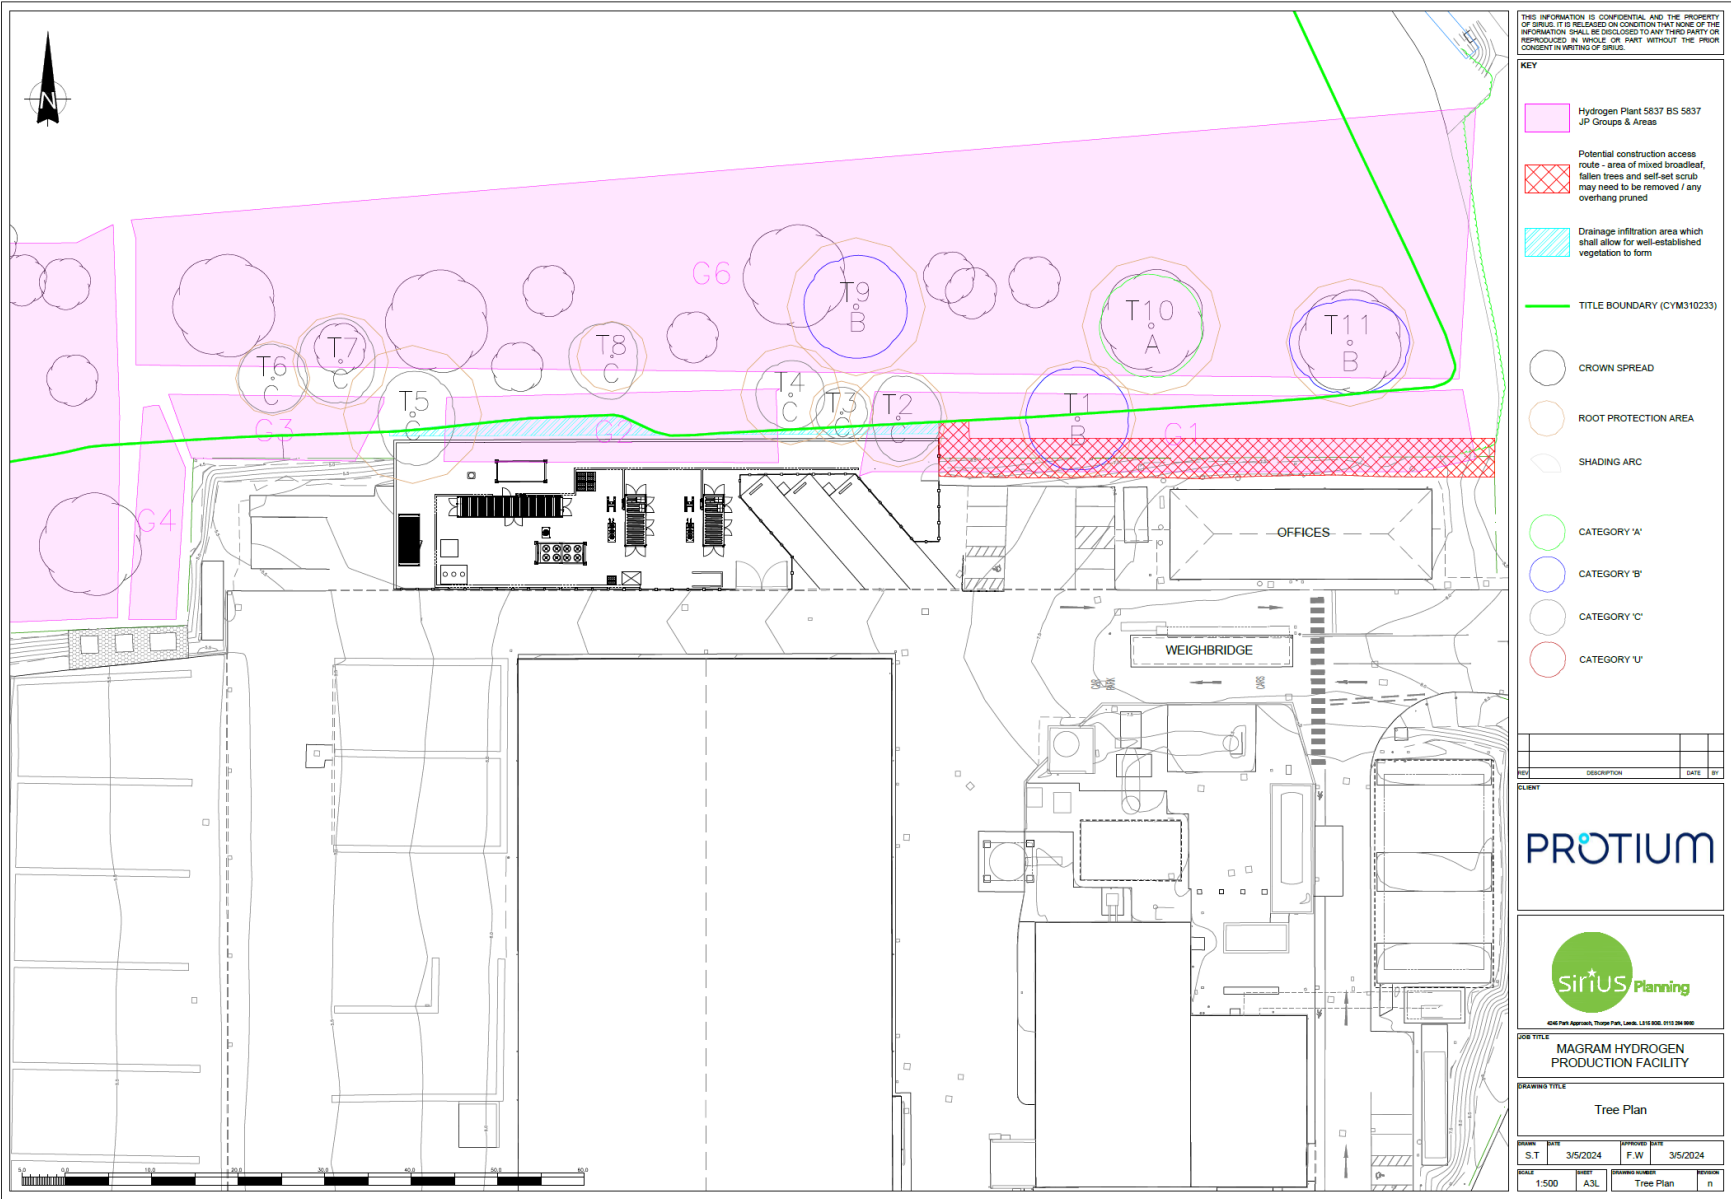
Scale plans can be sent as PDF files if required. The plans are to indicate locations of trees, locations of main objects on site and the location of tree protection fencing. Stem diameters found in tree and tree group data tables should be used to mark out the location of root protection fencing on site.
