# Gnoll Country Park, Neath

**Title** Ground Conditions Assessment Report

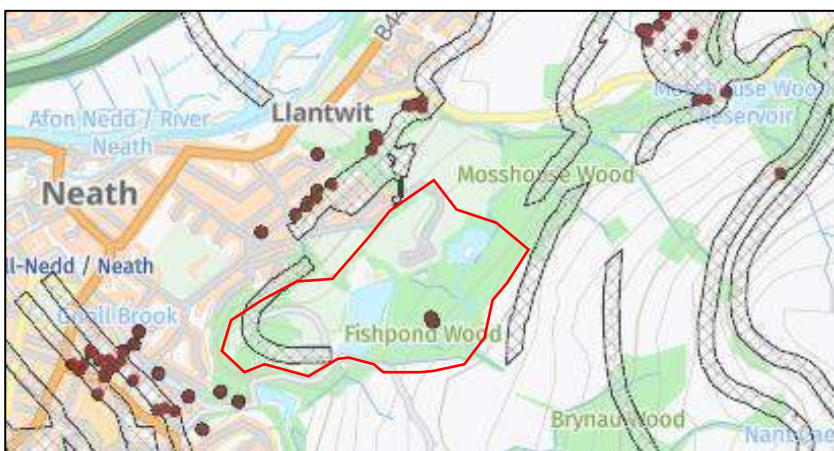
Figure 4: Extract from Coal Authority website, showing Zones of 'Development High Risk' and Mine Shaft Entries

The areas to the north of the reservoir around Areas 2 and 5 appears to be at less of a risk from mining. The probable Brithdir Rider coal seam is shown to crop out in a south-west to north-east orientation some 240m to the north-west, in the area of the former mine entries identified on historical maps. The conjectural outcrop of the Glyngwilym coal seam is shown some 360m to the east. Given the distance from the site and the fact this area of the site is shown to be underlain by *massive* sandstone, the risk of shallow mining activities in these areas is considered low.

The area of the ruins (Area 1) was outside the CMRA but there are no shafts recorded in that area and the house was built in the 1700s so could be argued that it predates any historical mining.

It should be noted that the CMRA does not include the mine entry data sheets for the recorded mine shafts within the wooded area. We therefore recommend that these are obtained as part of any additional works and the CMRA updated accordingly with the findings.

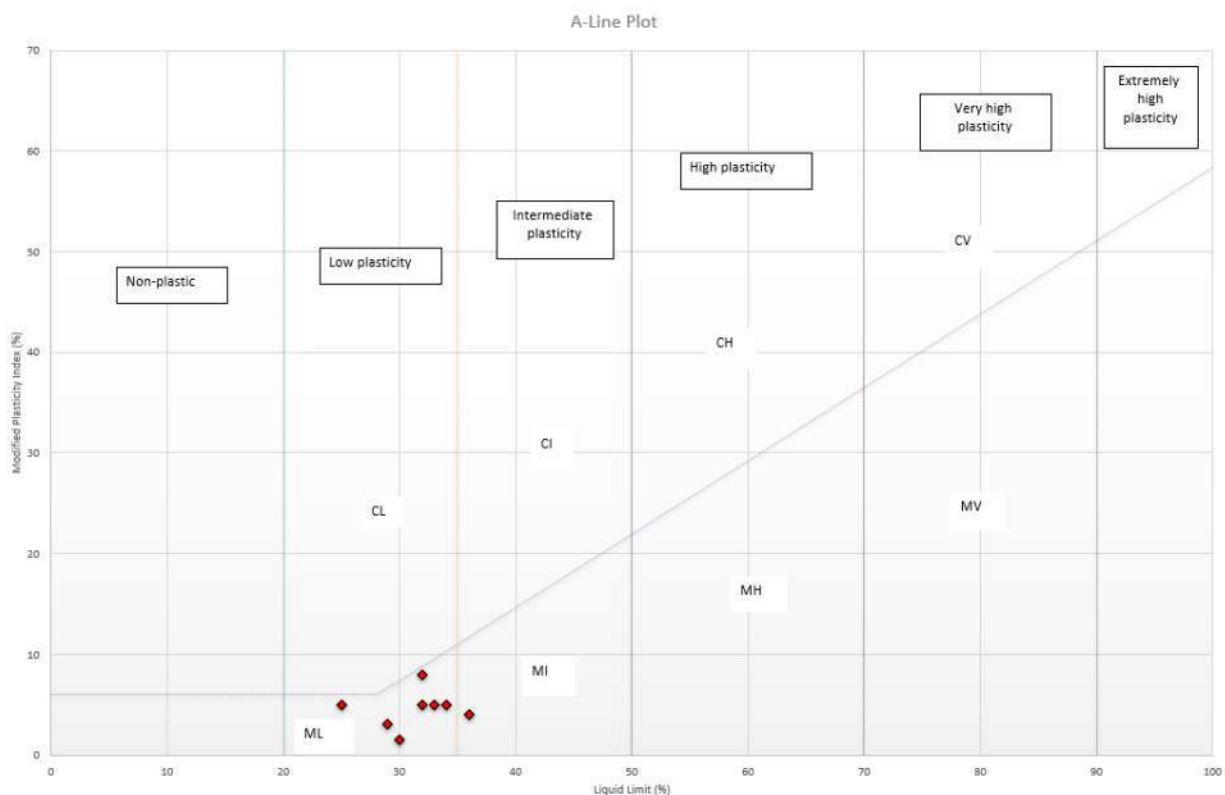
Figure 5: Summary of Plasticity Tests for Pennant Sandstone Formation

The samples of cohesive soil had natural moisture contents between 9% and 22% and a modified plasticity index of between 1% and 8% indicating the soil to be non-shrinkable. The sample comprised between 11% and 62% clay/ silt content.

Taking into account the portion of the sample passing the 425  $\mu\text{m}$  sieve, the reported plasticity index values can be modified in accordance with NHBC standards Chapter 4.2 'Building Near Trees'. Based on this the samples all have a non-shrinkable potential and so no requirement on a minimum foundation depth when building near trees, when foundations are placed within the shallow cohesive residual soils.

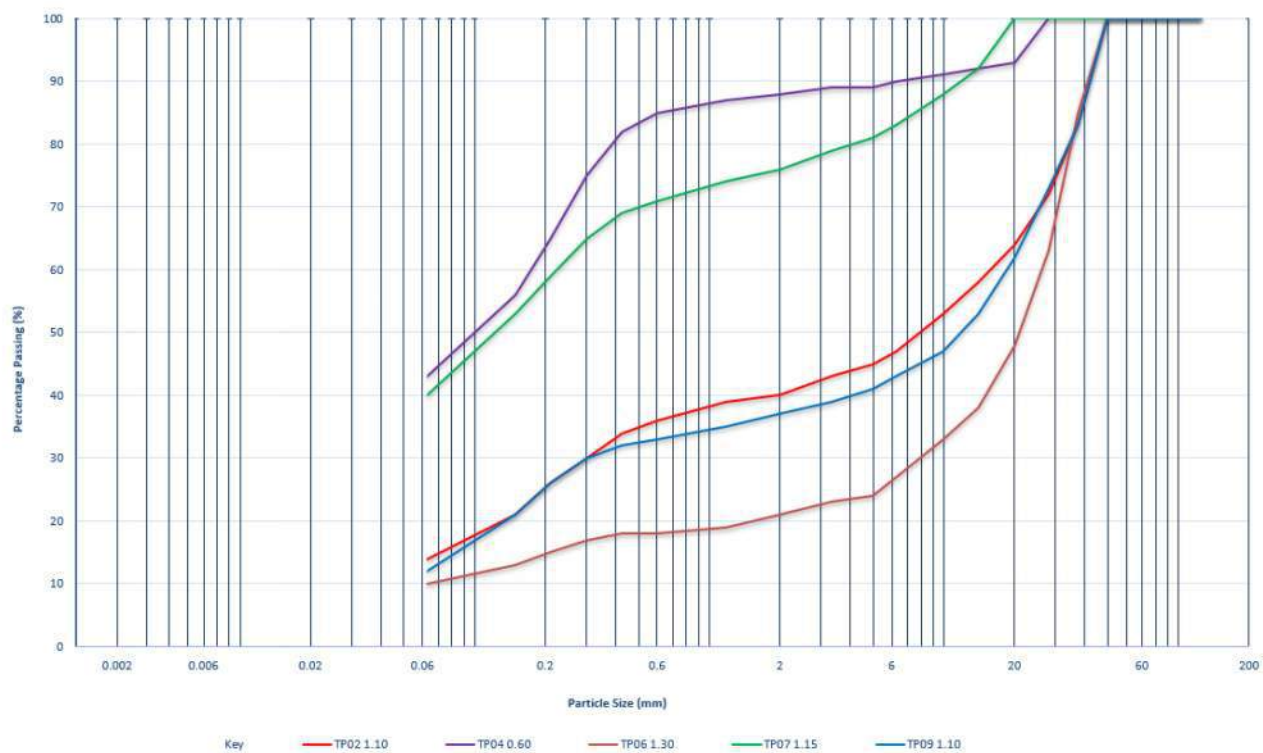
Figure 6: Weathered Pennant Sandstone Formation PSD Curve

Based on the single PSD results, the residual soils could be typically classed as clayey/silty sandy gravel. The PSD curves show two sets of different gradings suggesting the residual soils are slightly varied across whole site, but appears to become more granular with depth as shown both below and the exploratory hole logs contained in **Appendix G**.

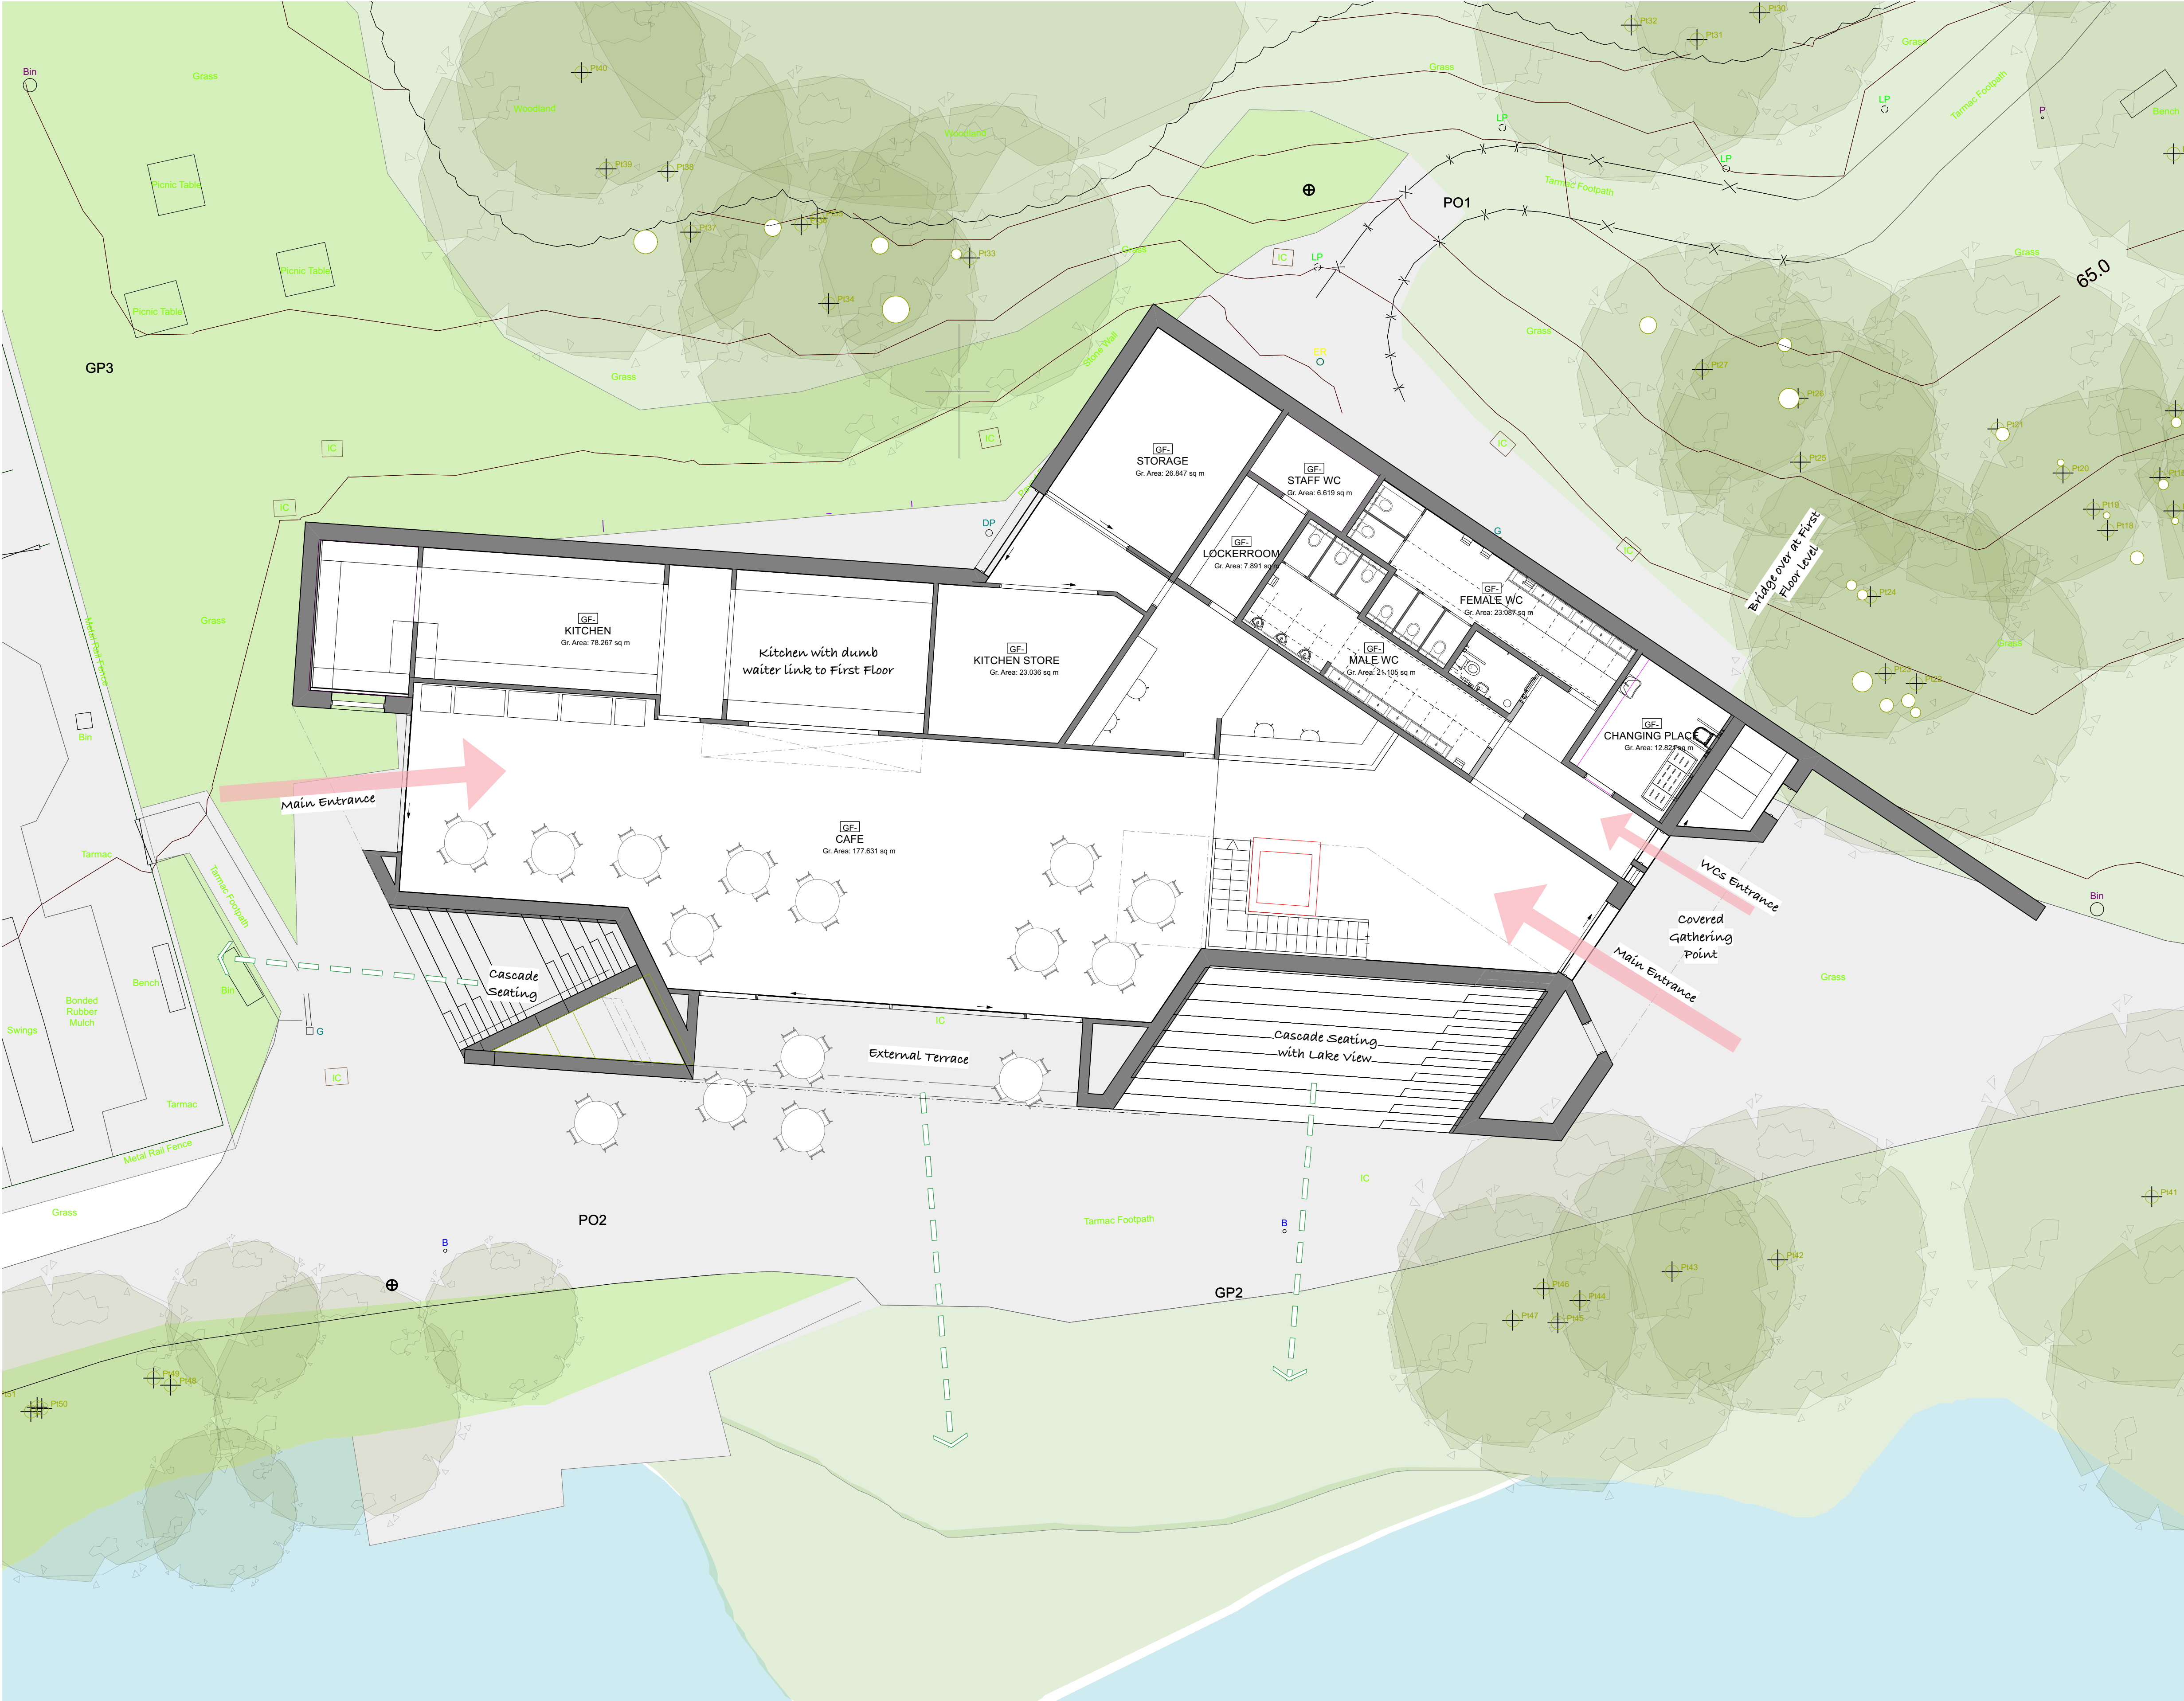
01310.1 GROUND FLOOR PLAN  
SCALE 1:100 @ A1, 1:200 @ A3

The existing visitor centre is proposed to be demolished and replaced with a 2-storey building with a podium and a first-floor timber frame building, with two cascade seating areas on the first floor and an external terrace.

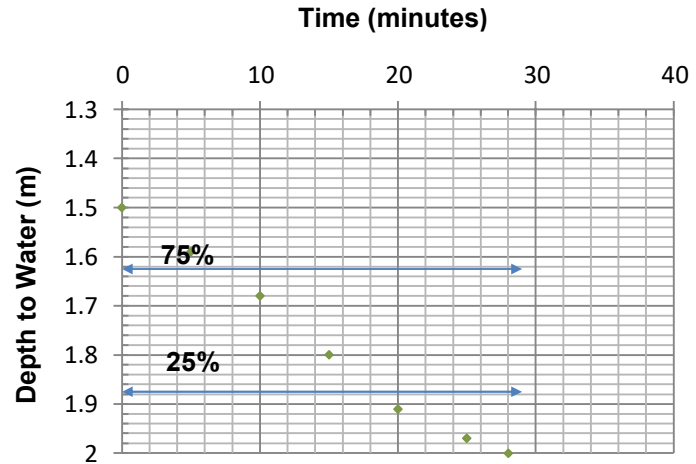
Soil Infiltration Rate,  $f$  2.14E-04 ms<sup>-1</sup>

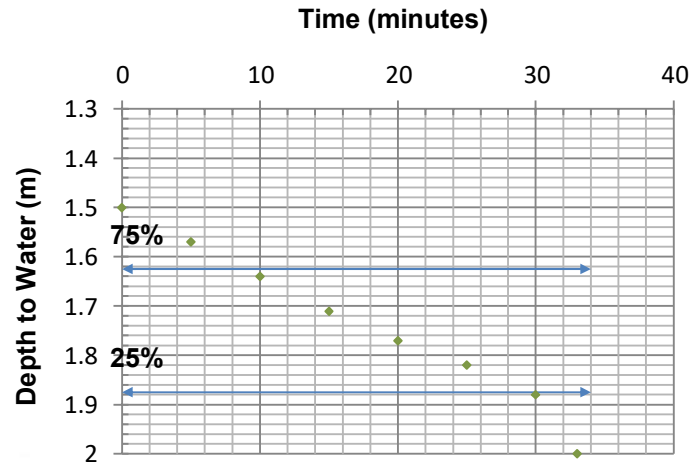
## TEST 2

Length 1.50 m  
Width 0.60 m  
Depth 2.00 m  
Fill Level 1.50 m

Soil Infiltration Rate,  $f$  9.62E-05 ms<sup>-1</sup>

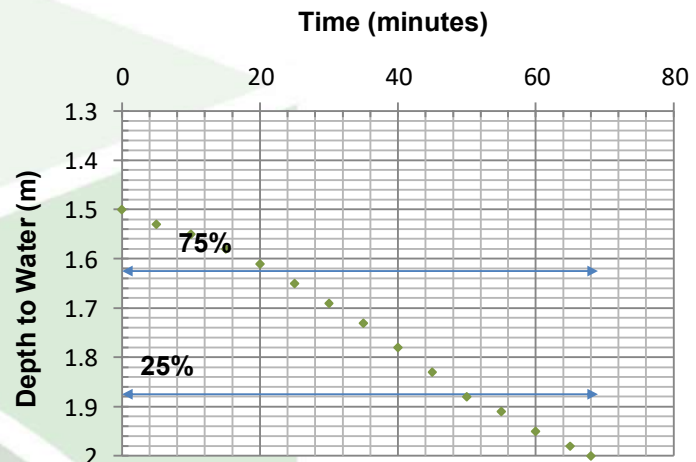
## TEST 3

Length 1.50 m  
Width 0.60 m  
Depth 2.00 m  
Fill Level 1.50 m

Soil Infiltration Rate,  $f$  7.69E-05 ms<sup>-1</sup>

| <b>Drainage</b> | Infiltration drainage will likely be suitable in areas where the base of the soakaways is within the weathered bedrock where infiltration rates of between $1.74 \times 10^{-4}$ m/s and $7.69 \times 10^{-5}$ m/s were recorded. Soakaways were carried out with the base within the residual and failed to infiltrate therefore soakaways within the clays will not be suitable, although they could potentially be extended down to the weathered granular bedrock subject to further testing. |

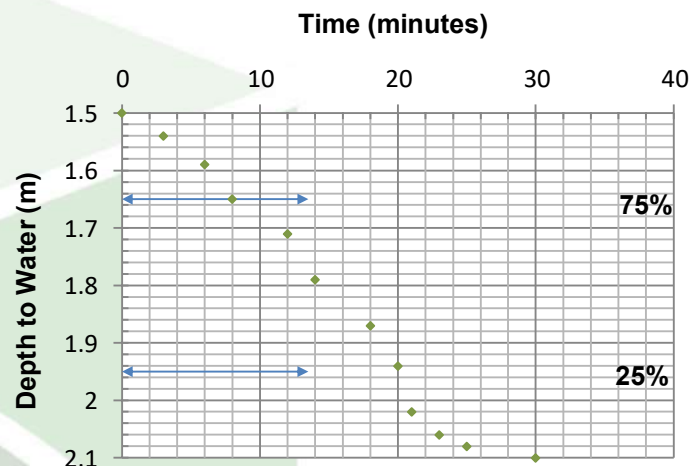
## TEST 3

Length 2.00 m  
Width 0.60 m  
Depth 2.10 m  
Fill Level 0.50 m

Soil Infiltration Rate,  $f$  1.74E-04 ms<sup>-1</sup>

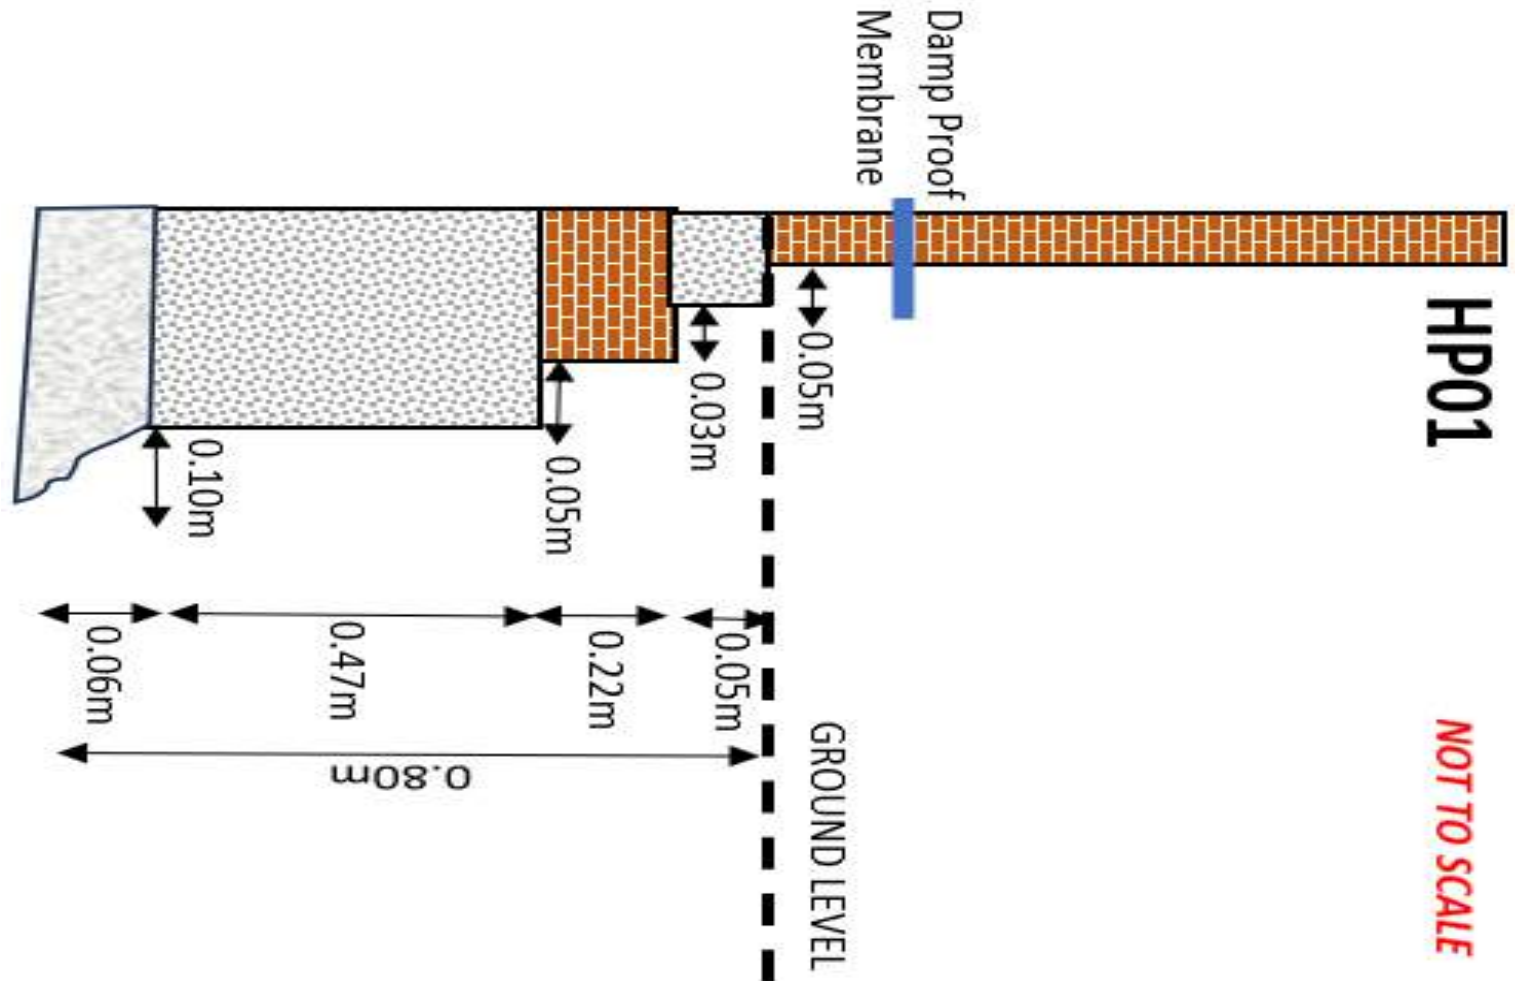
Site Name: Gnoll Park  
 Project Number: 17887  
 Drawing Title: HP01 Foundation Sketch  
 Drawing Number:  
 Scale: Not to scale

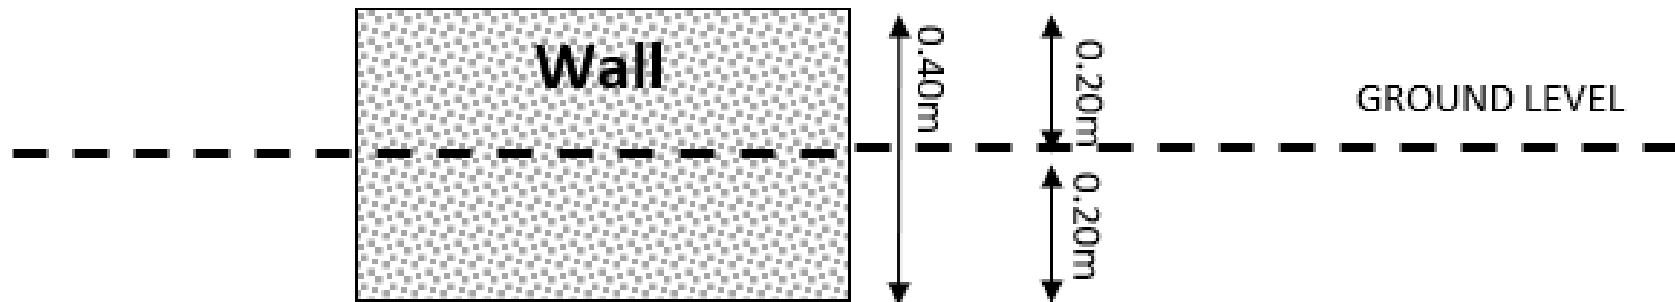
**HP02**

| <p>Site Name: Gnoll Park<br/>Project Number: 17887<br/>Drawing Title: HP02 Foundation Sketch<br/>Drawing Number:<br/>Scale: Not to scale</p> | |

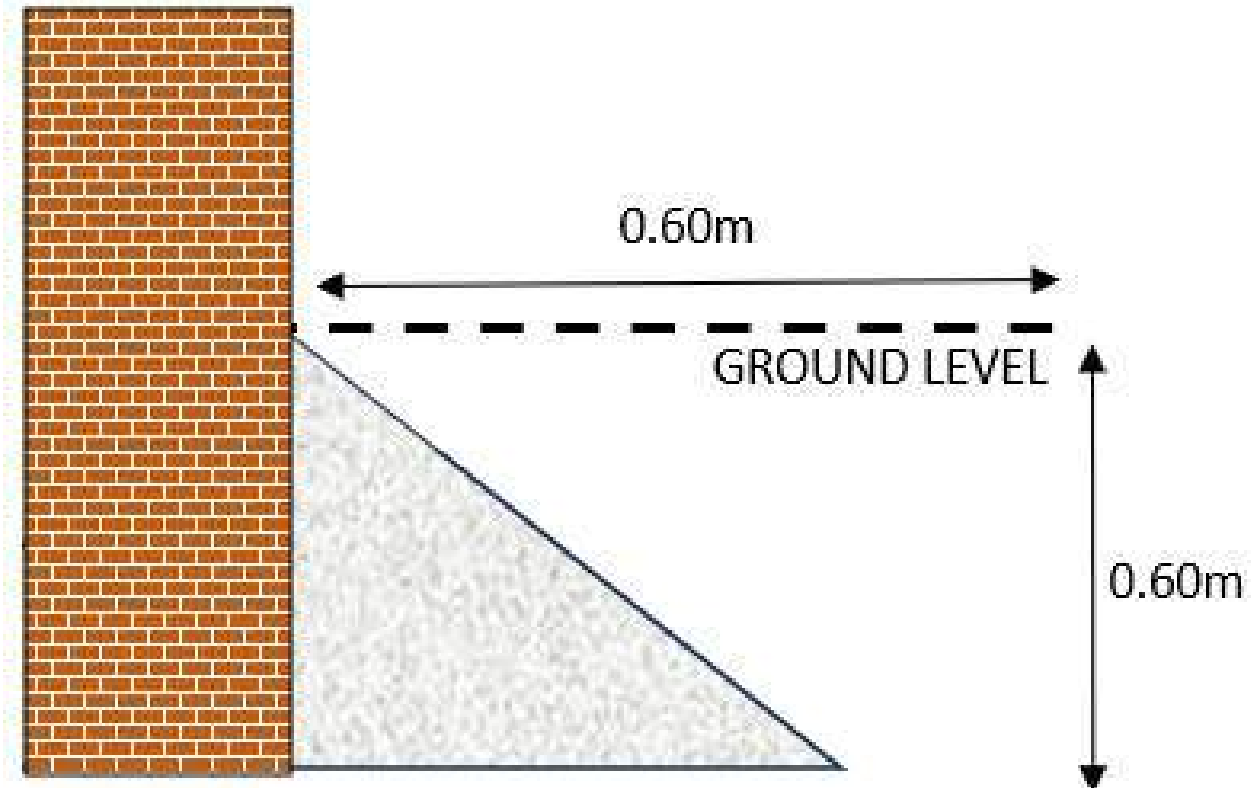
# HP03 *NOT TO SCALE*

| Site Name: Gnoll Park<br>Project Number: 17887<br>Drawing Title: HP03 Foundation Sketch<br>Drawing Number:<br>Scale: Not to scale | |

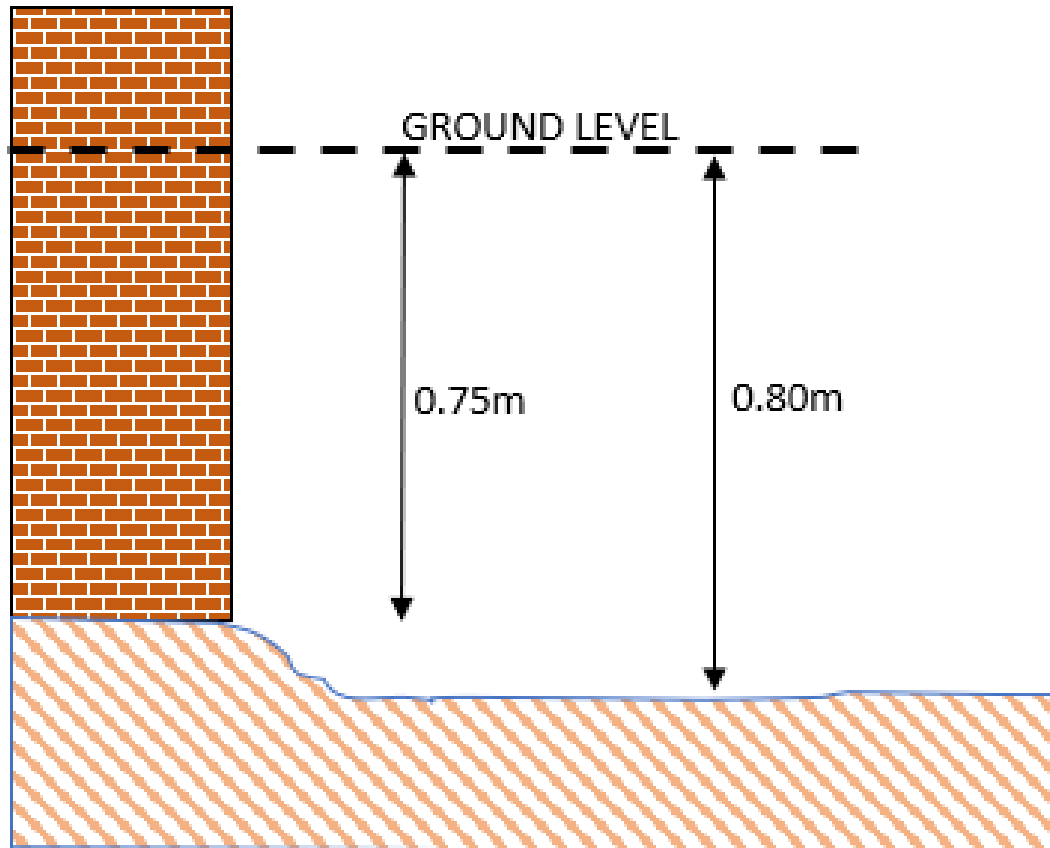
# HP04 *NOT TO SCALE*

Made Ground was encountered in HP04 during foundation exposure of Pond Cottage. The material comprised a 80mm thick crushed concrete gavel at surface, overlying a brown sandy gravelly ashy clay with anthropogenic components of clinker, coal, ash, glass and brick fragments. The depth of the material could not be proven beyond 0.80m below ground level. This fill material likely used a backfill for the foundation excavations during the construction of Pond Cottage.

Site Name: Gnoll Park  
Project Number: 17887  
Drawing Title: HP04 Foundation Sketch  
Drawing Number:  
Scale: Not to scale

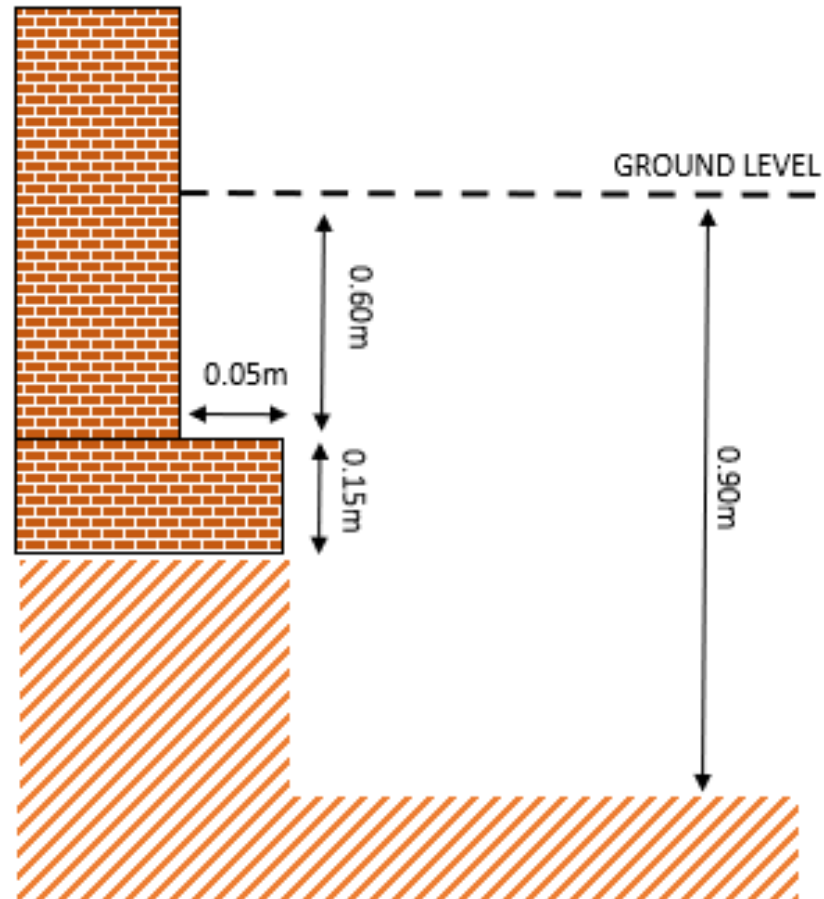
**HP05**

**Site Name: Gnoll Park**  
**Project Number: 17887**  
**Drawing Title: HP05 Foundation Sketch**  
**Drawing Number:**  
**Scale: Not to scale**

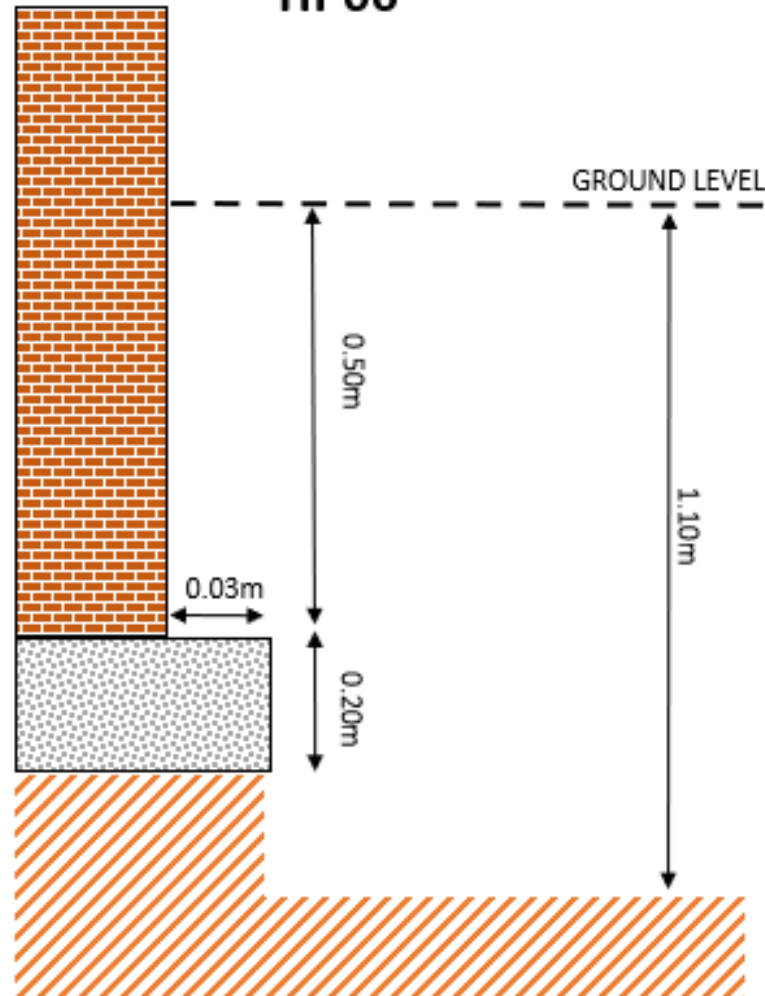
**HP06**

Site Name: Gnoll Park  
Project Number: 17887  
Drawing Title: HP05 Foundation Sketch  
Drawing Number:  
Scale: Not to scale
