**Caewern House, Dwr Y Felin Road, Caewern,  
Neath, Neath Port Talbot, SA10 7RH**

**Bat Survey Report for Linc-Cymru Housing**

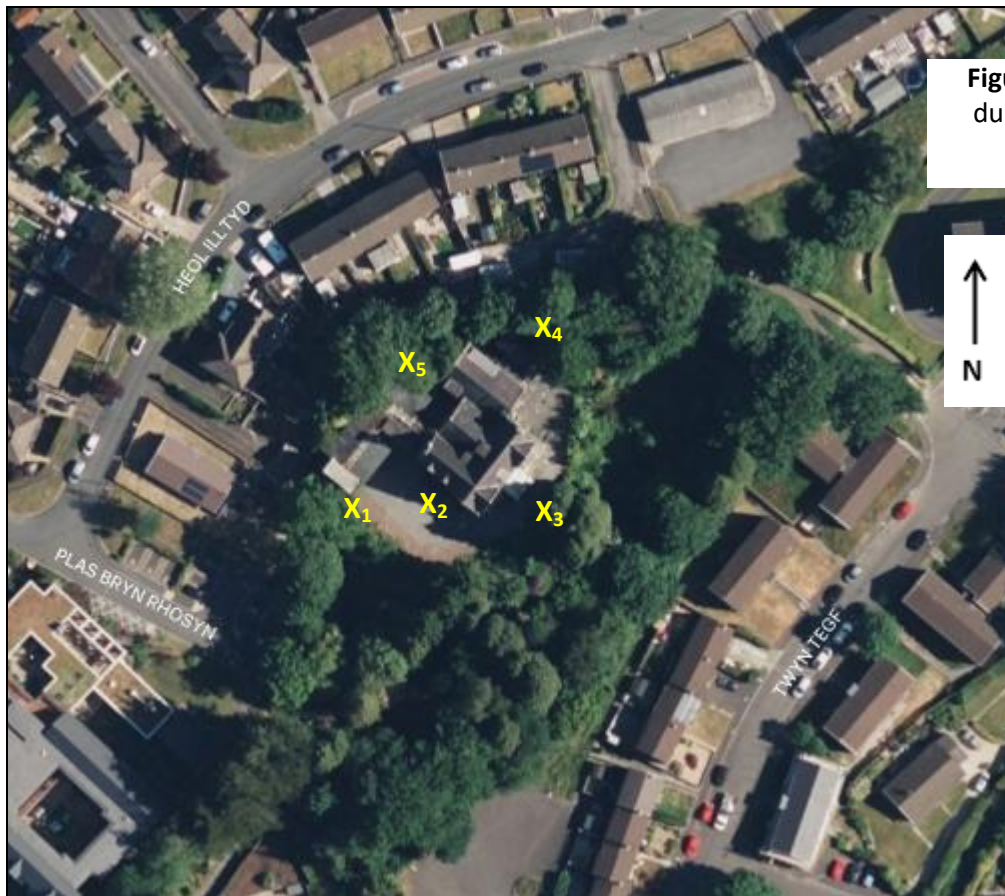
**Figure 4:** Surveyor positions during the activity surveys. (from Apple® Maps)

3.1.6 Figure 4 on the following page shows the position of surveyors during the activity surveys. Each surveyor had a Magenta 5 or an Elekon Batscanner bat detector to assist in identification and detection of bats and their behaviour.

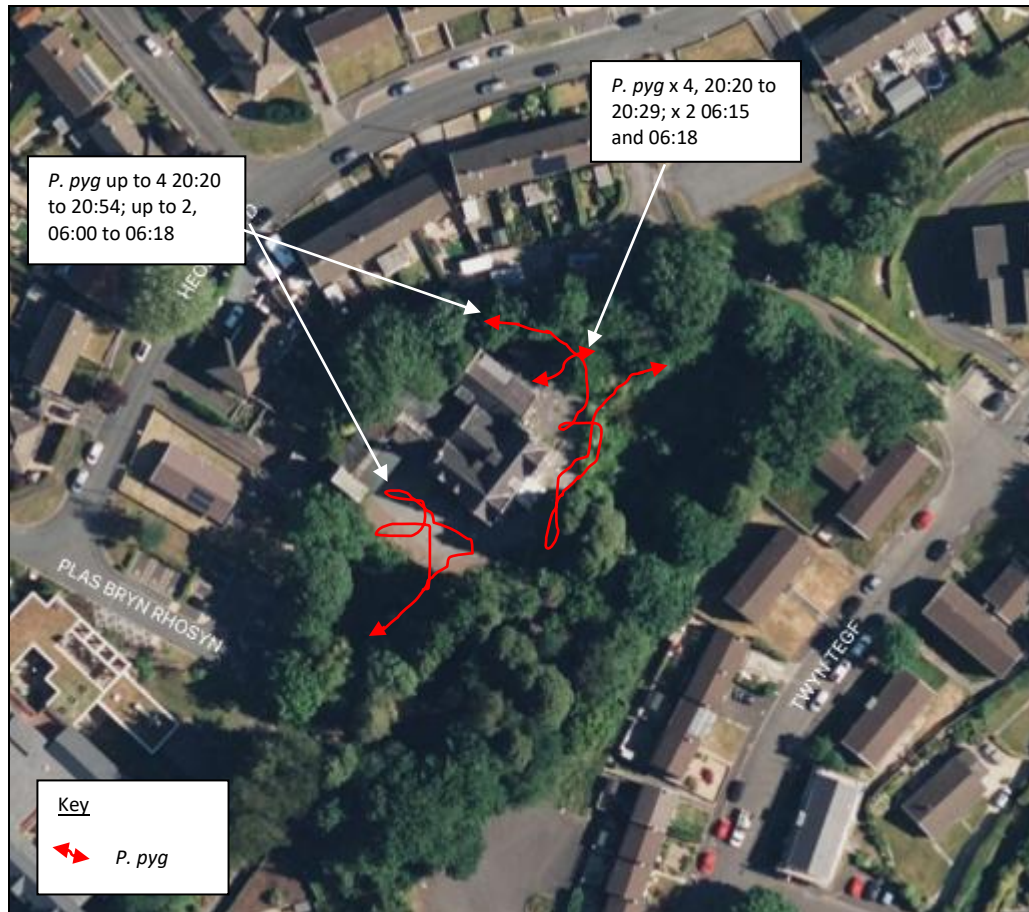
**Figure 5:** Aerial map (from Apple® Maps) showing the flight lines of bats detected on the surveys

3.2.2 Figure 5 shows the flight lines of bats detected and includes the species seen/detected and the times they were detected. Flight activity follows:

25/08/2022: Sunset was at 20:17, the survey started at 20:05 and ended at 22:20  
10/09/2022: Sunrise was at 06:41, the survey started at 04:40 and ended at 06:45

- ***P. pygmaeus***: On the dusk survey four bats were seen to leave a hole in the roof on the single storey section to the north-east with the first emergence at three minutes after sunset and the last at 12 minutes after sunset. Following the first emergence, bats remained on site for around 25 minutes after the last emergence, foraging and commuting to the north, south, and east and sporadic calls were subsequently heard to the north for around 30 minutes. Activity was lower during the dawn survey with only two seen to enter via the same gap at 26 and 23 minutes before sunset with activity on site starting 15 minutes before the first re-entry, although calls were heard to the north during the last hour.

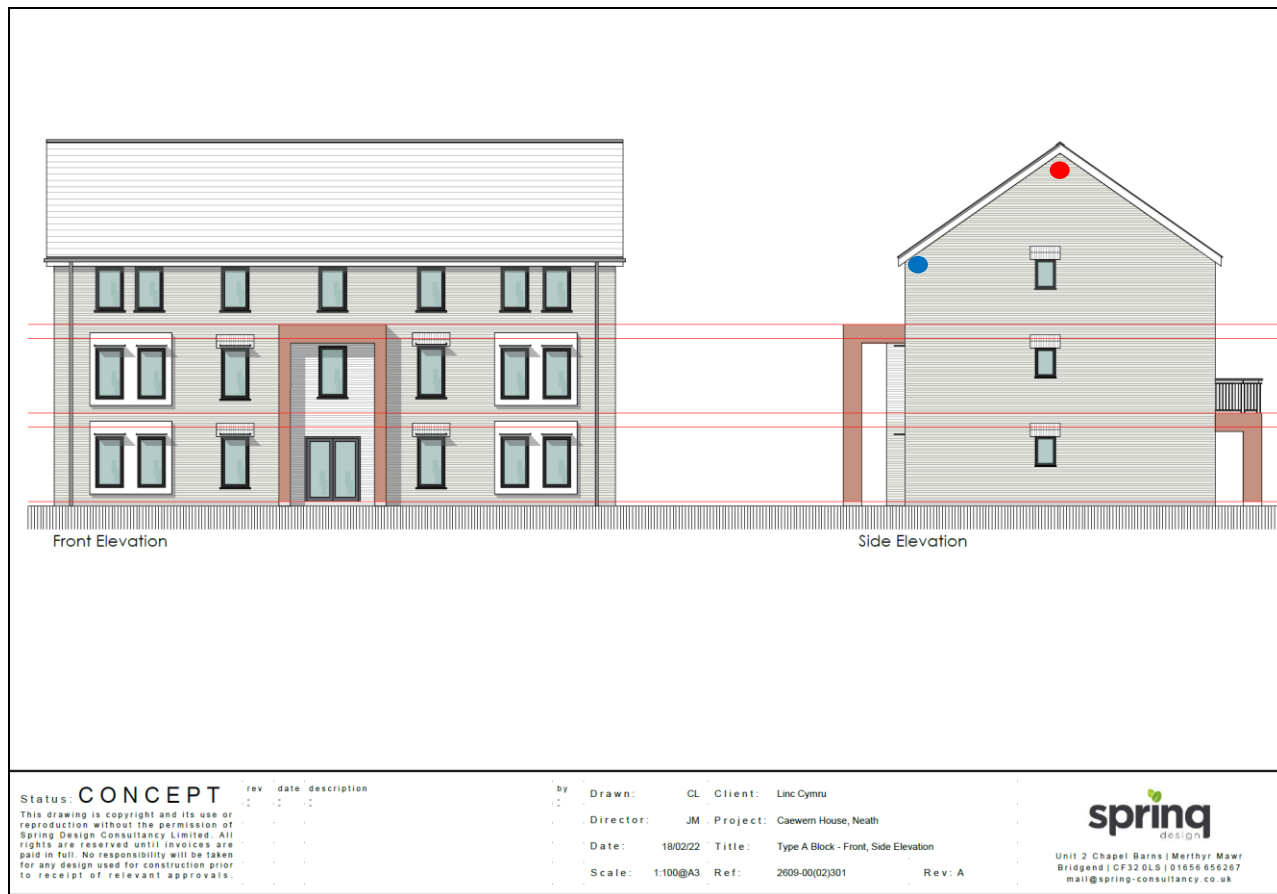
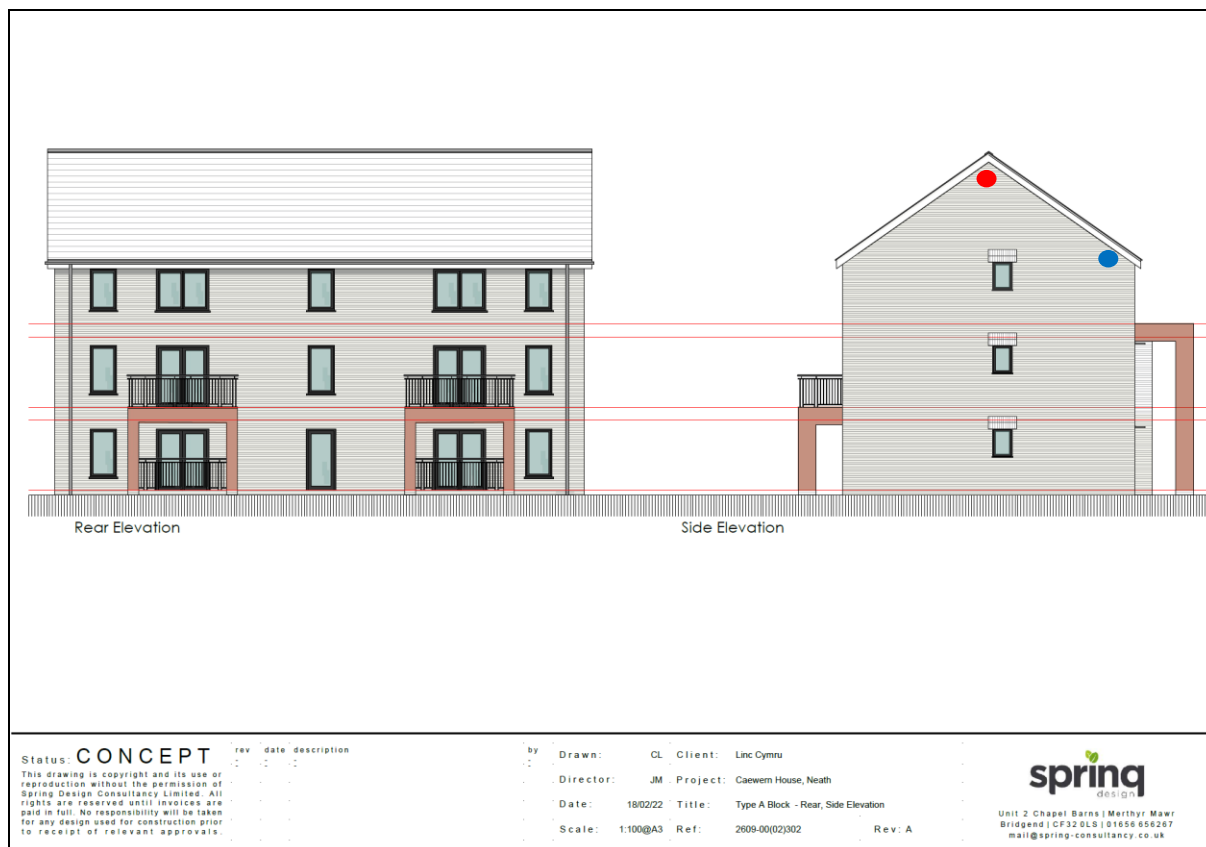
**Above:** Type A Block – proposed front and side elevations. **Below:** Type A Block – proposed rear and side elevations. The proposed locations for the Build-in bat boxes are shown by red dots, and the proposed location for the Sparrow terraces are shown by blue dots.

- ✦ **Recommendation 2 (Mitigation):** Bat access is to be provided on the new buildings through 1 x Vivaro Pro Build-in (or similar) bat box installed in each gable end wall (x 12 in total) of the new buildings.

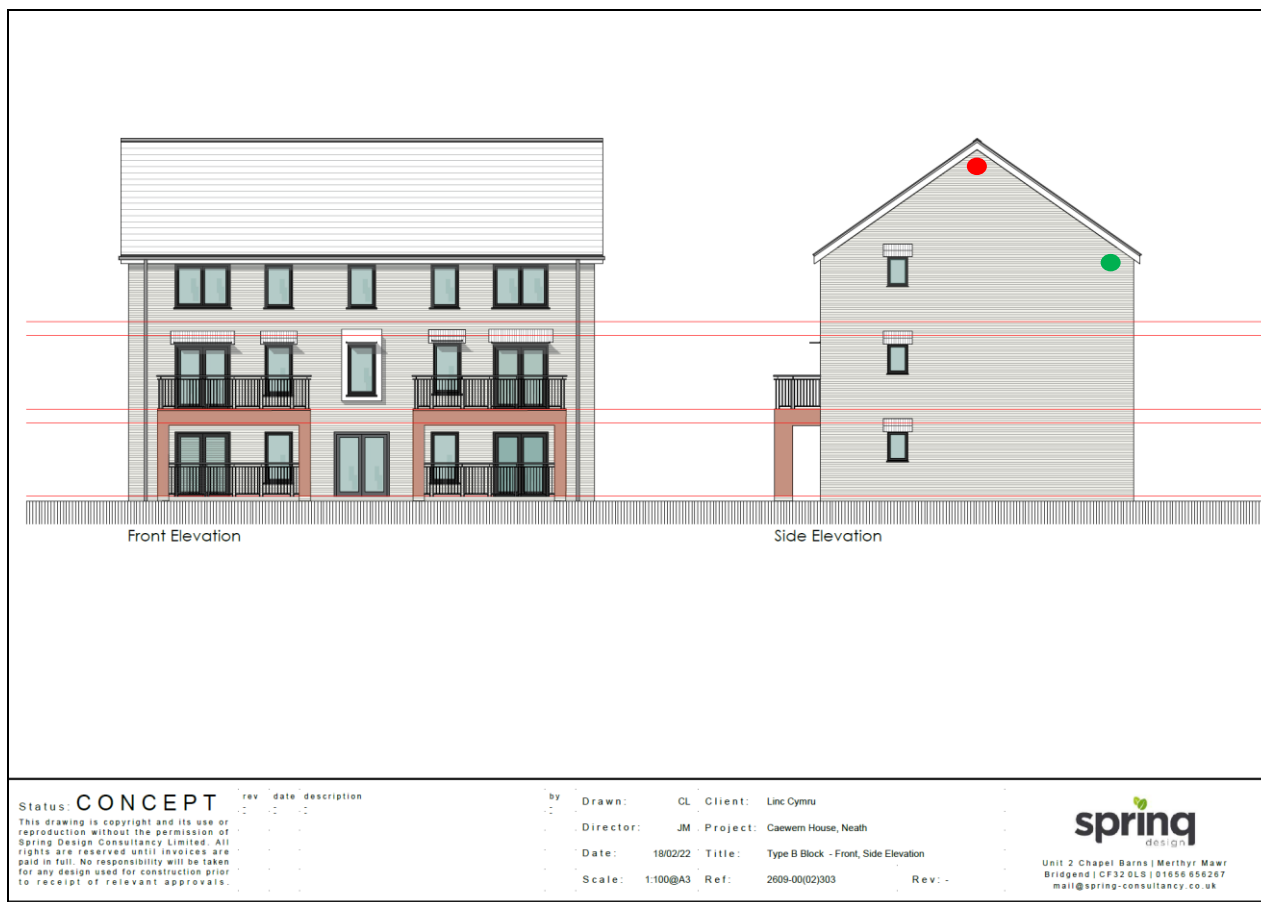
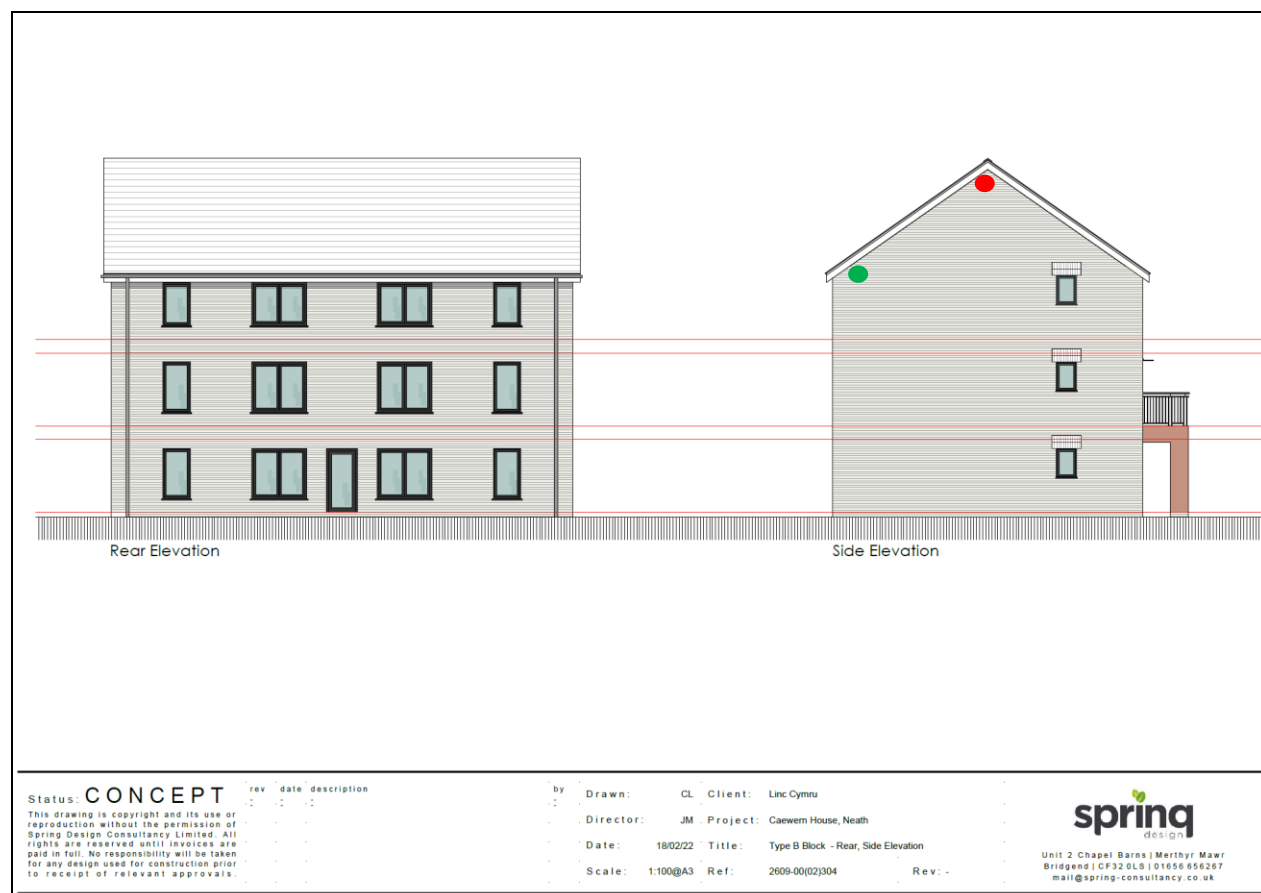
**Above:** Type B Block – proposed front and side elevations. **Below:** Type B Block – proposed rear and side elevations. The proposed locations for the Build-in bat boxes are shown by red dots, and the proposed location for the House martin nest cups are shown by green dots.

- ✦ **Recommendation 4 (Enhancement):** Prior to works commencing, x 2 open-fronted and x 2 small-holed bird boxes to be affixed to mature trees within the curtilage of the property. See [Where To Put A Bird Box | Nestboxes - The RSPB](https://www.rspb.org.uk/where-to-put-a-bird-box-nestboxes-the-rspb)
- ✦ **Recommendation 5 (Enhancement):** x 1 Sparrow terrace to be affixed to each gable end wall of Type A Block buildings (x 2 in total) and x 1 House martin nest cup to be affixed at the apex of each gable end wall of Type B Block buildings.

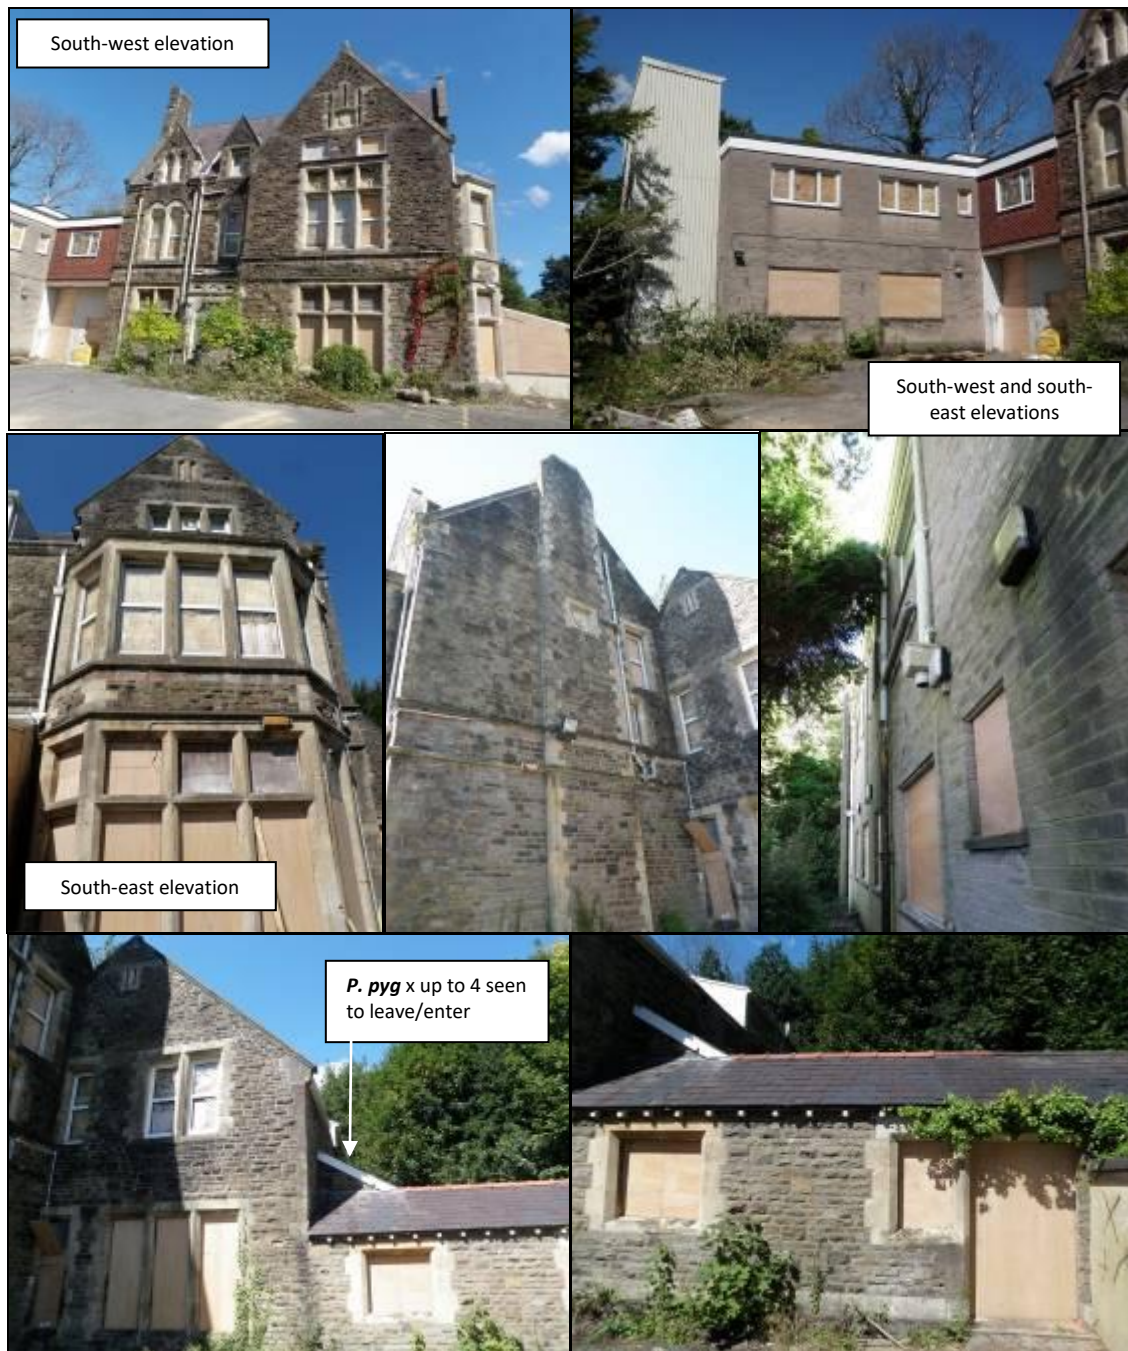
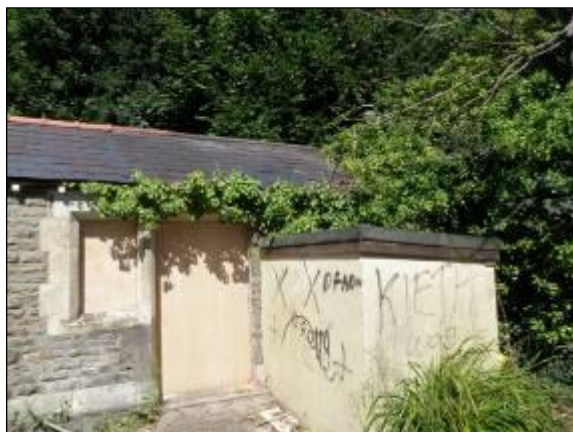
The original part of the property is a large, detached, up to three storey Victorian building constructed of stone walls with pitched slate roofs. The building was found to be in generally good structural condition with no cracks or crevices in the walls, although there are areas of raised flashing, raised ridge tiles and slipped slates. Pitched/monopitch, and flat roof single storey predominantly stone-built sections are attached to the north-east elevation and while the walls are in good condition there is a large hole in the roof in one section (due to vandalism). A shed with stone walls and a corrugated metal roof are also present within the grounds. External inspection identified the buildings as being generally in a good condition.

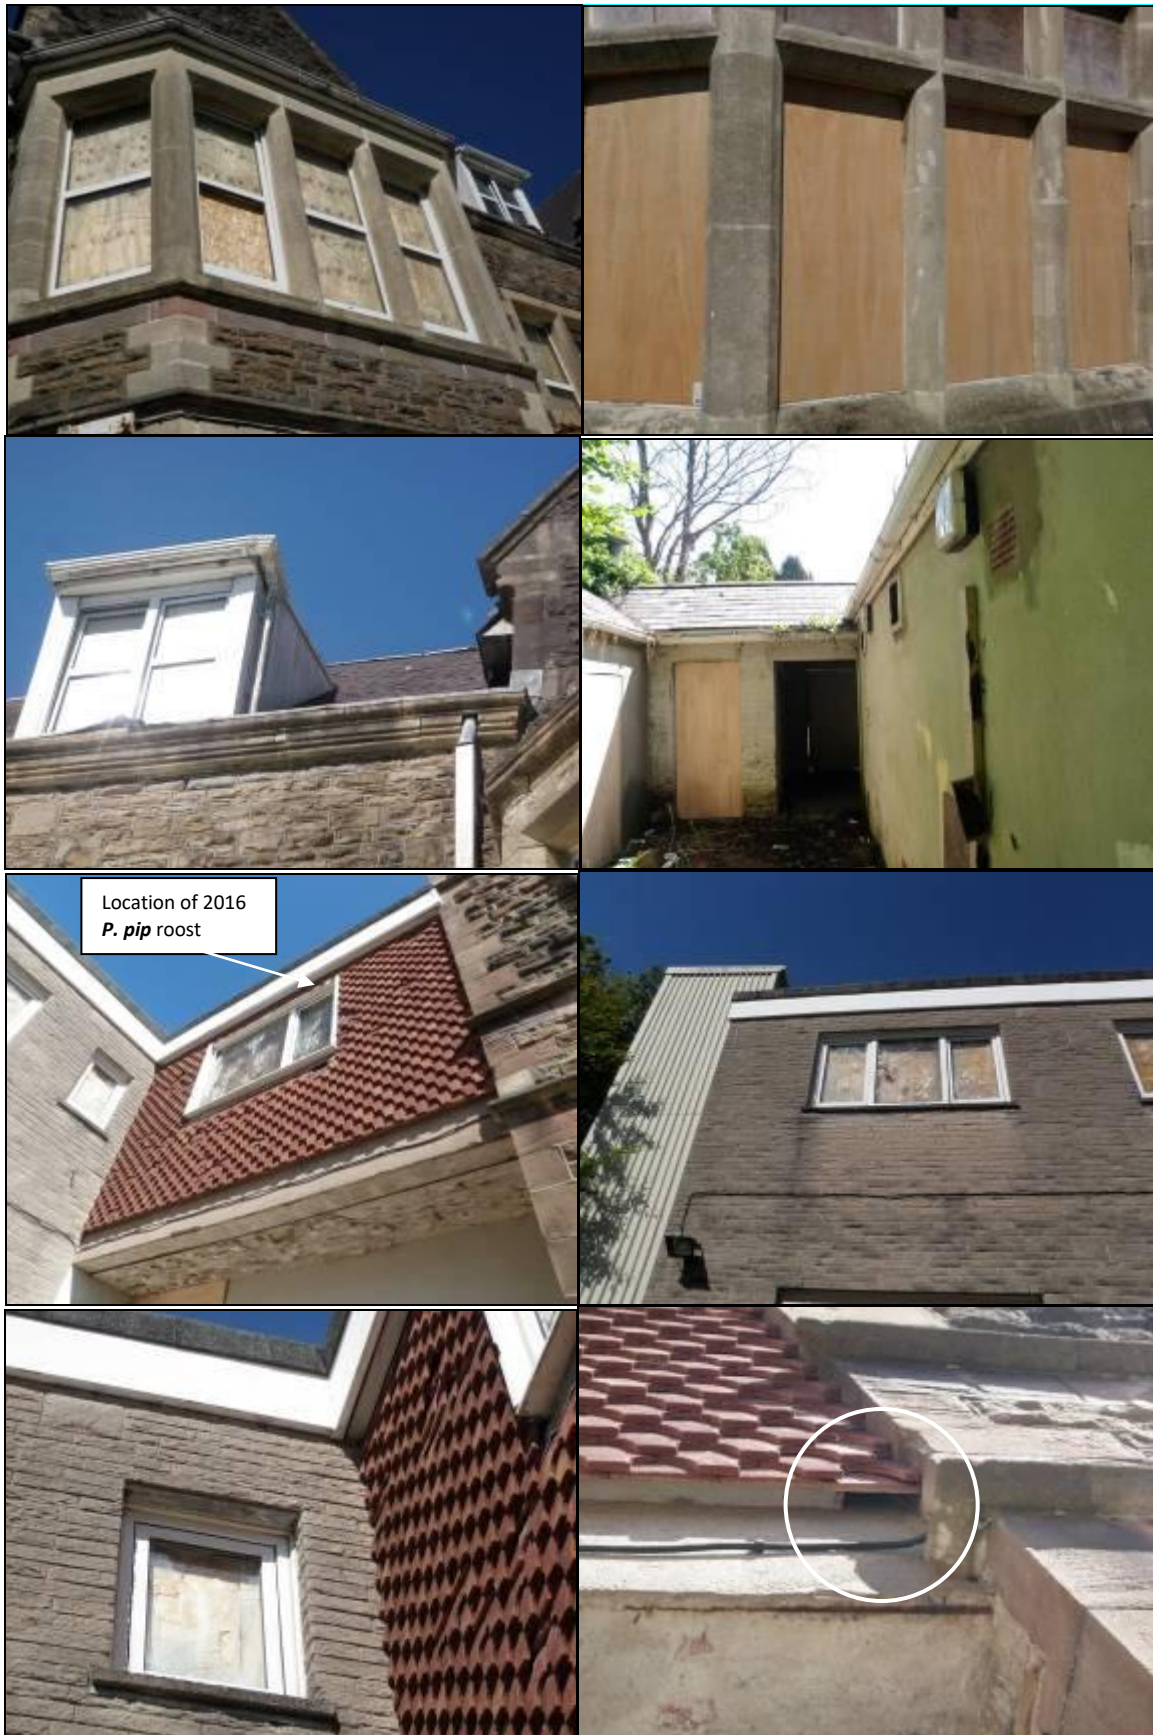
Attached to the northern end of the south-west elevation is a modern two storey extension constructed of rendered and stone faced/clay tile faced brick walls with a flat roof and a two storey metal clad fire escape. The modern flat roof two storey extension of brick construct with an associated metal clad fire escape. Minor gaps were noted between fascia boards and walls but no other potential bat roost features were noted.

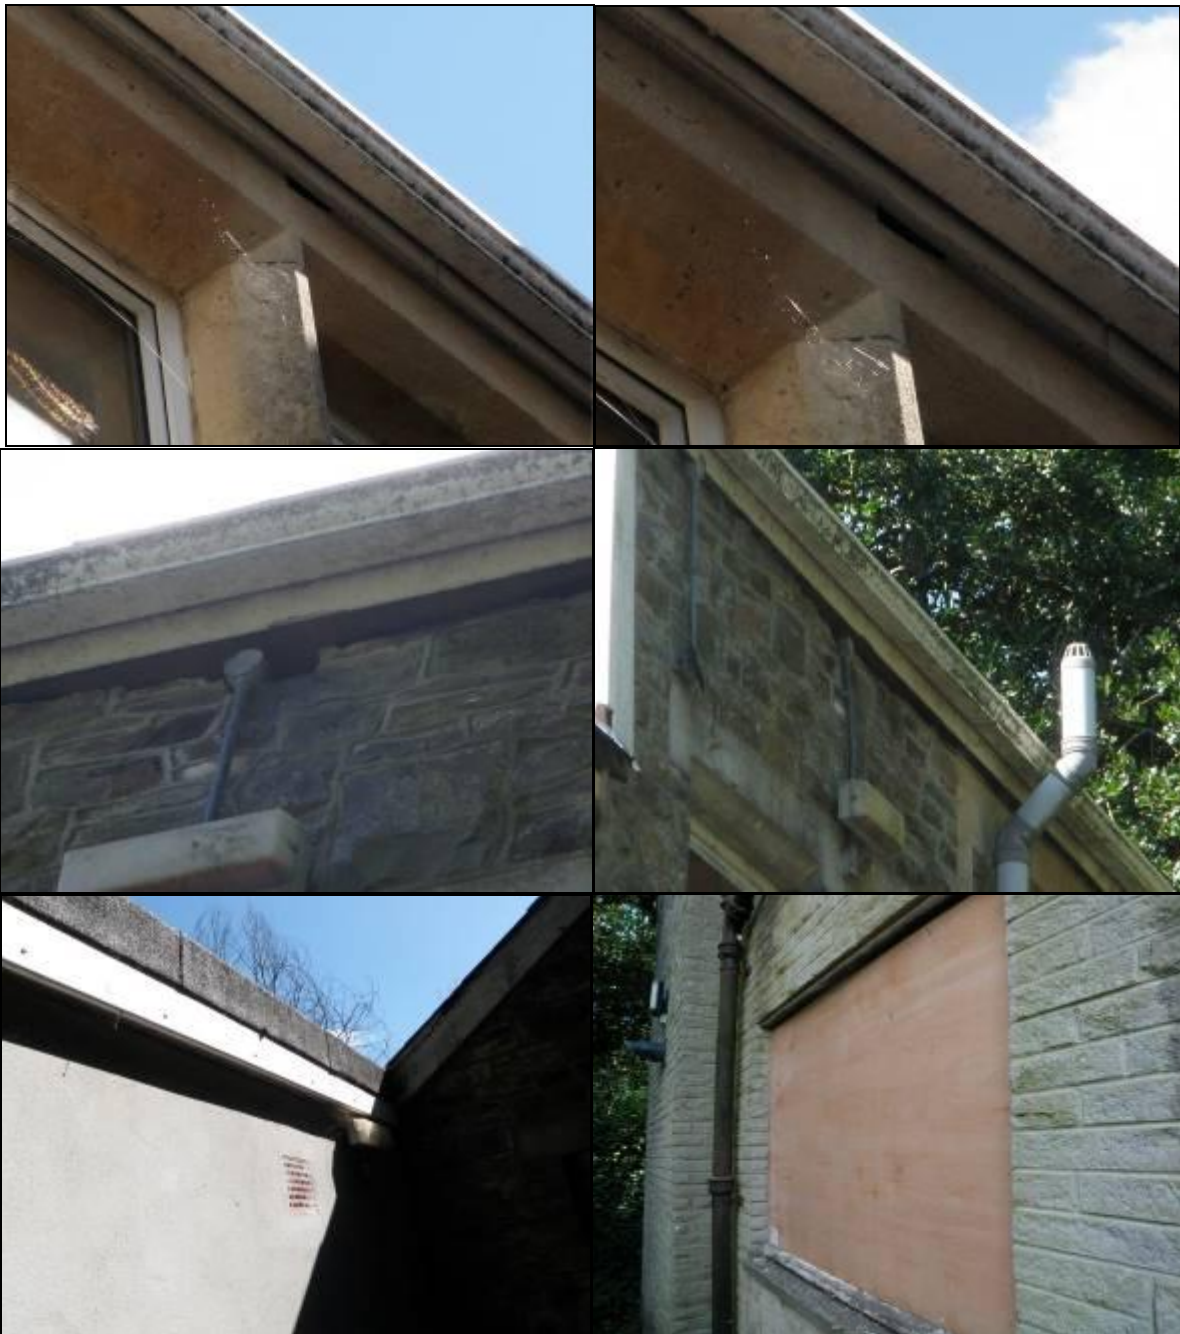
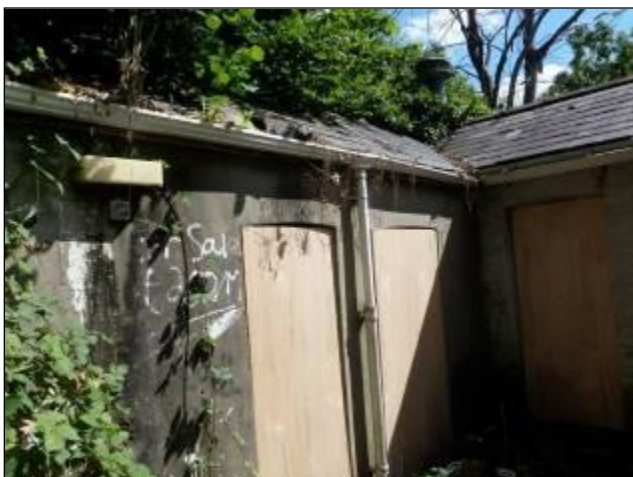
The windows and doors on all areas are either closed or boarded over but ongoing vandalism has meant that there are a small number of windows with broken glazing which could enable access by bat and bird species. Slit windows are also present on the upper level of the original building but all of these are either grilled or bricked up.

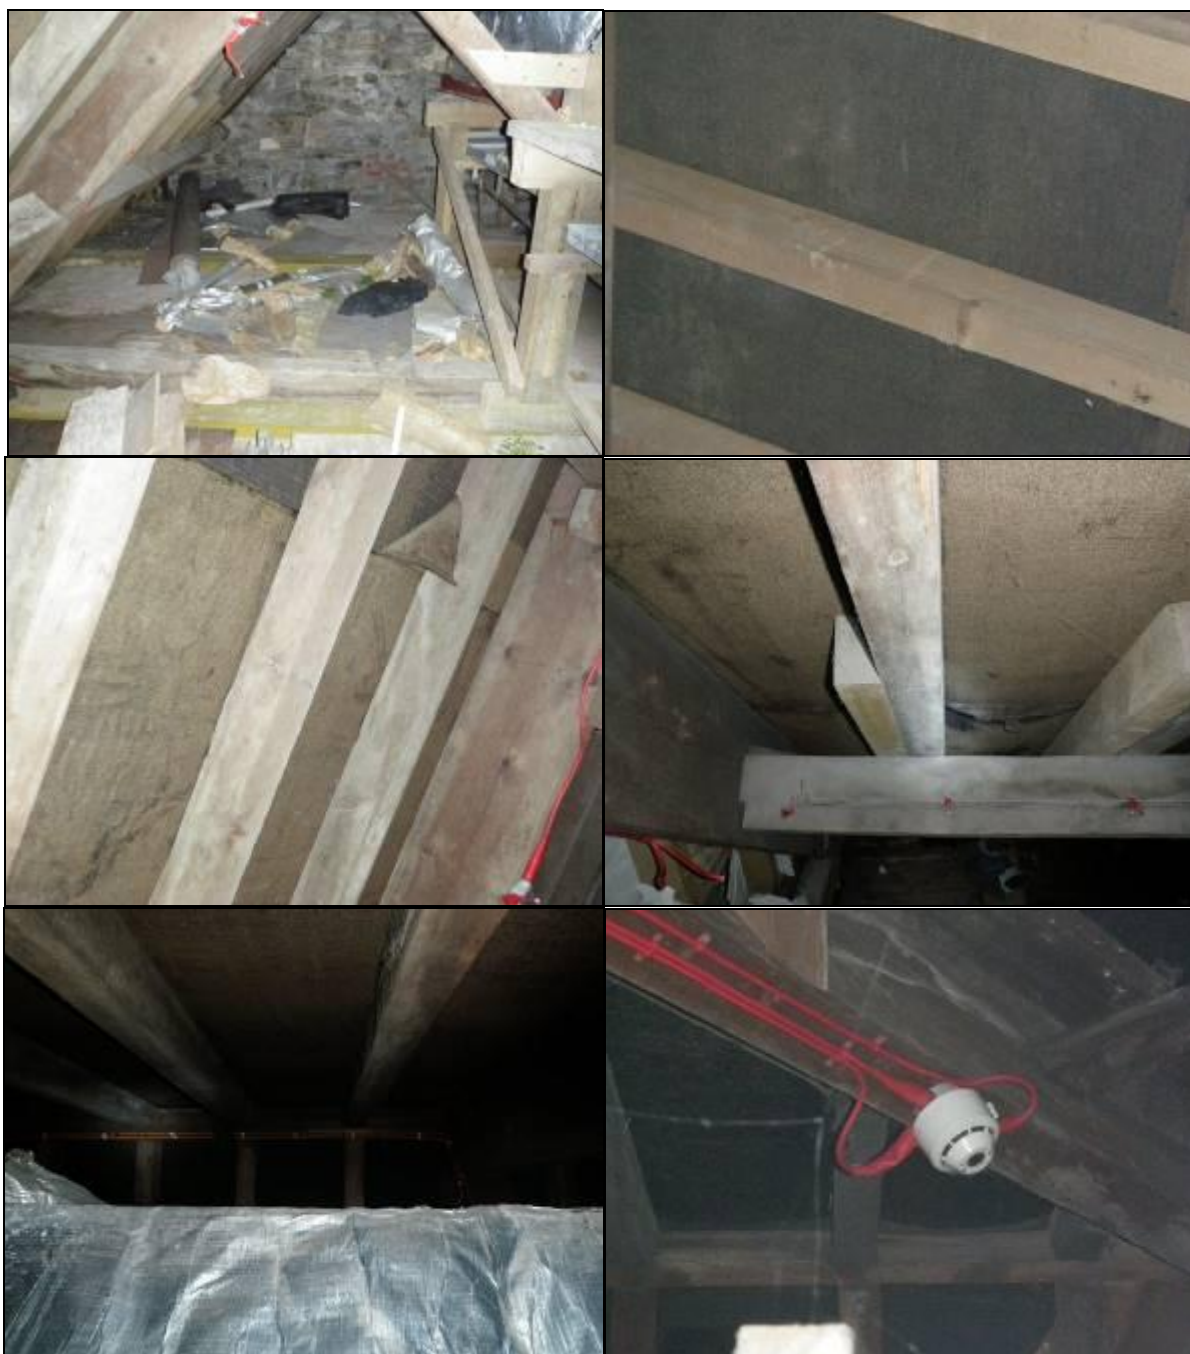
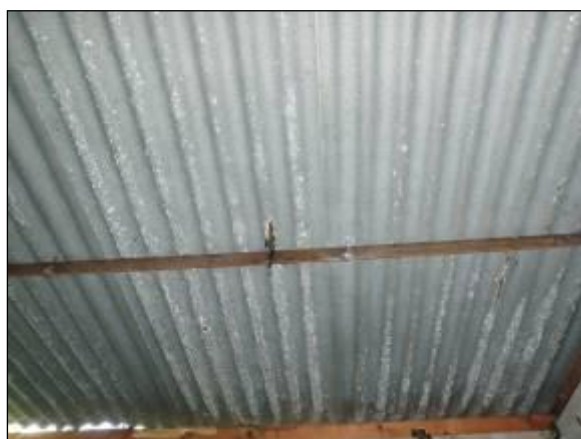
Internally, there are three voids with bitumastic felt lined timber framed roofs that have been insulated throughout. Internally no gaps in roofing material were noted and cobwebs were present throughout the roof voids. The corrugated metal sheet roof was in good condition with only a few wall top areas where shafts of light enter.

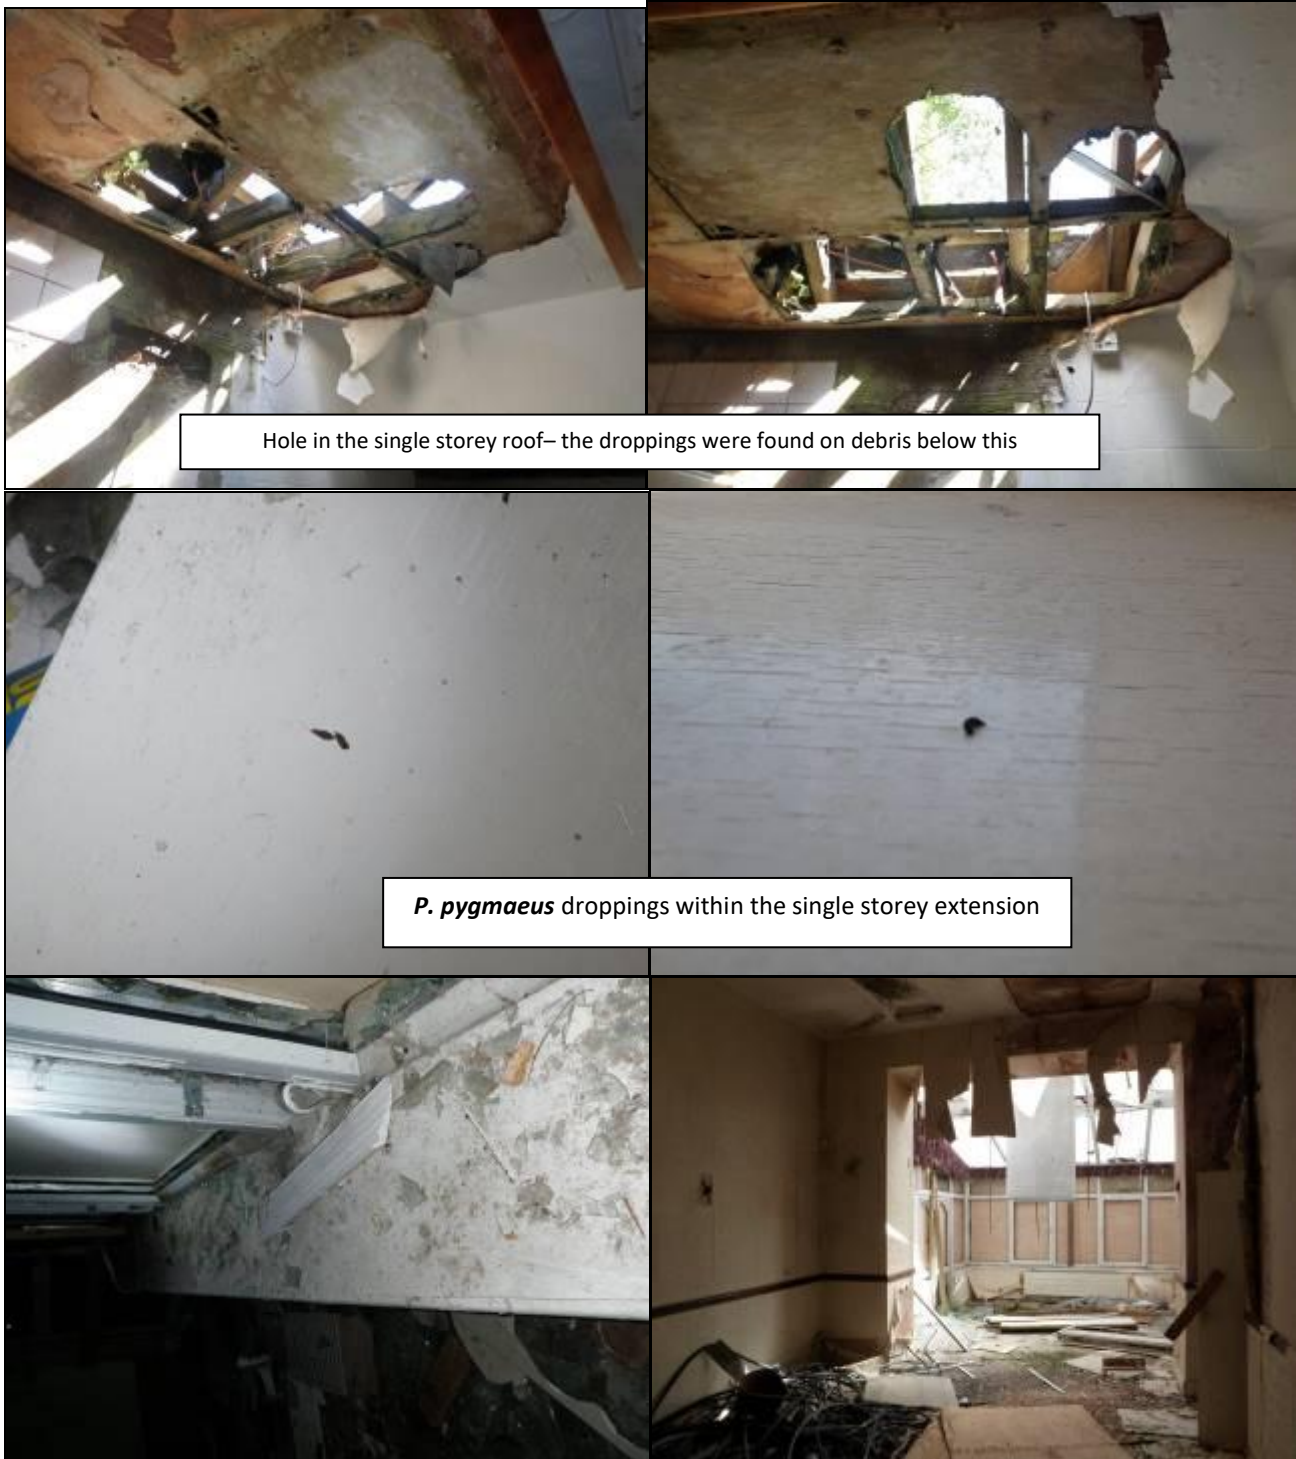
Where the large hole in the roof was found there were droppings on the debris below and DNA analysis confirmed that they were from *P. pygmaeus*.

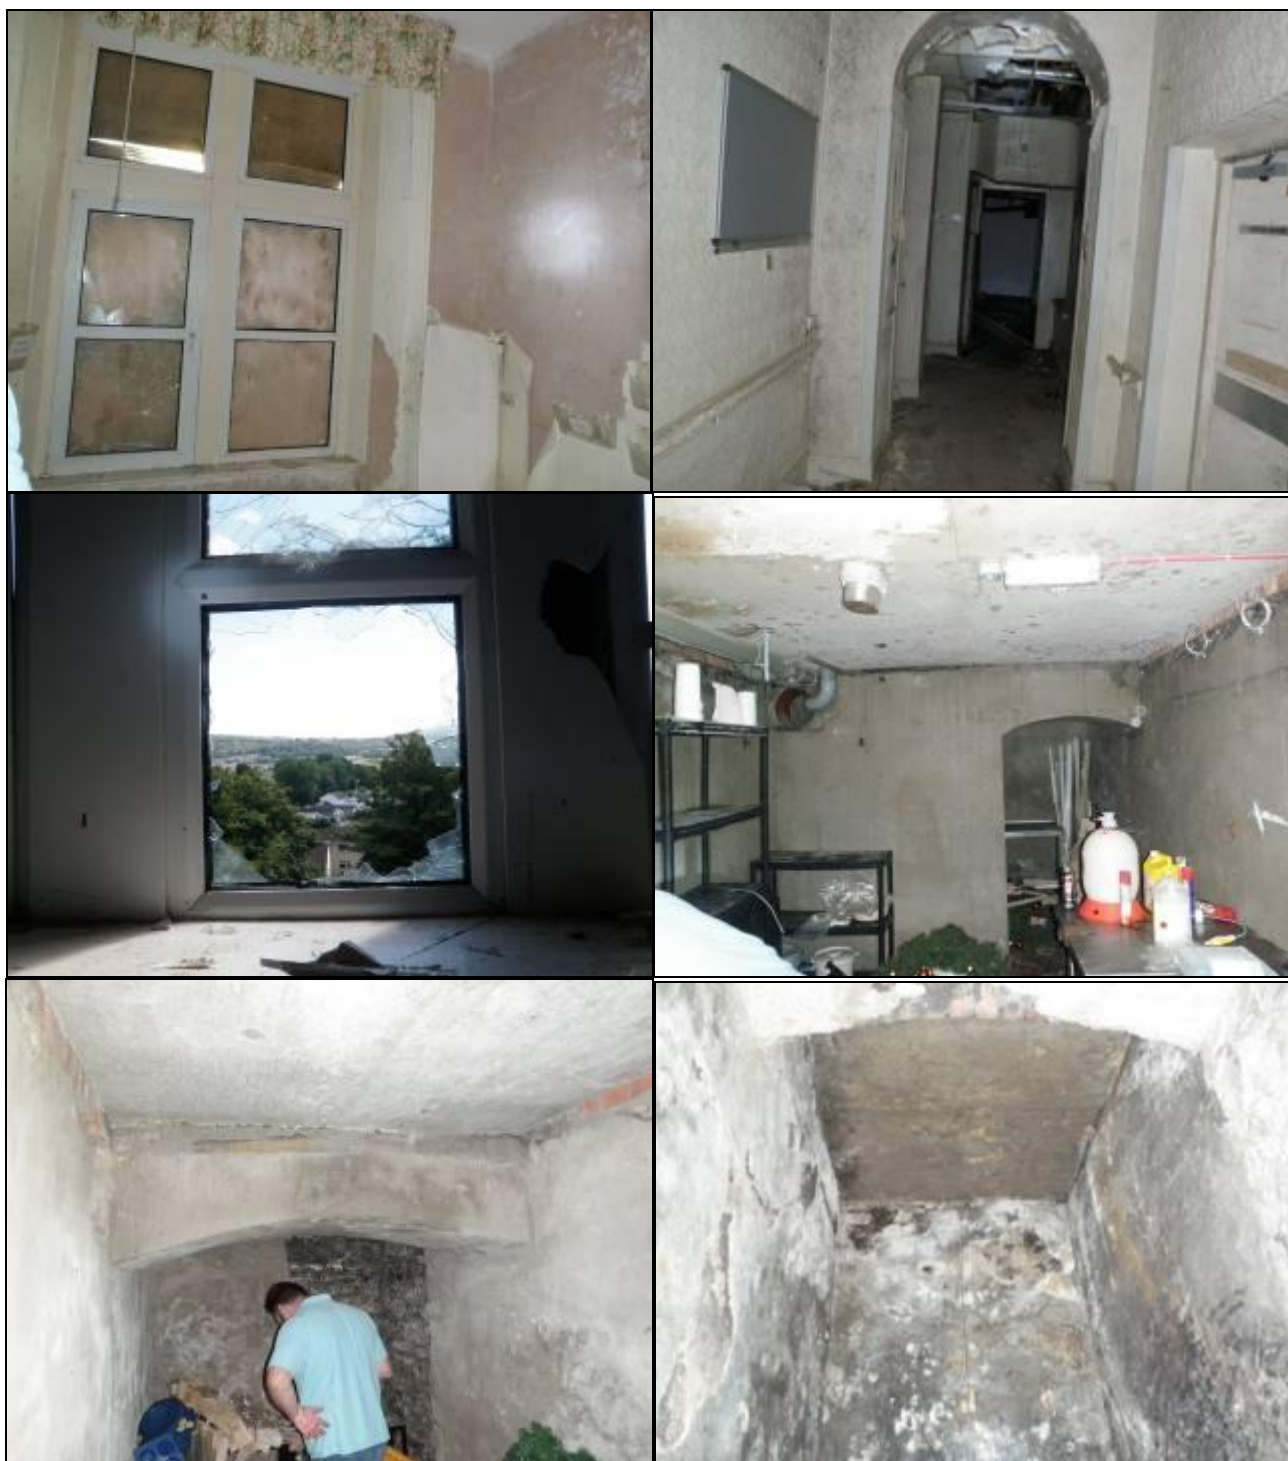
The cellar was also inspected but was found to be accessible only from the interior of the building with no potential bat access points found.
