# **Global Centre of Rail Excellence**

**Phase 1A**

**2022 Bat Survey Report**

October 2022

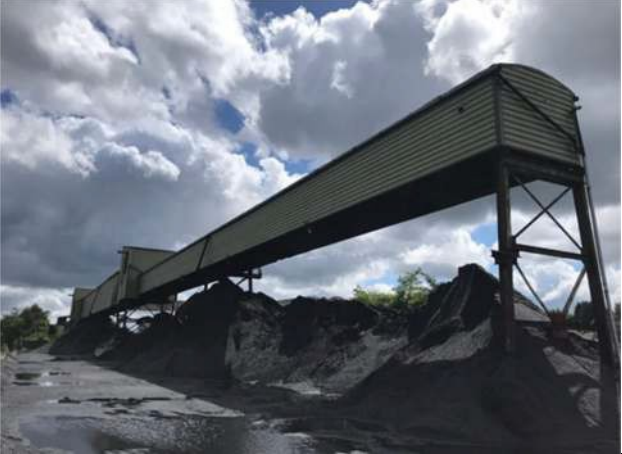
| Building / structure ID and suitability to support roosting bats<br>Refer to Figure 1 for location and Appendix 1 for description) | Photograph |
|---|---|
| Additional 1 Negligible | |

- 5.1.6 Impacts on roosting bats are unlikely to occur during demolition of buildings assessed as having negligible suitability to support roosting bats, and these buildings (with reference to Appendix 2) can be demolished without the need for further checks.

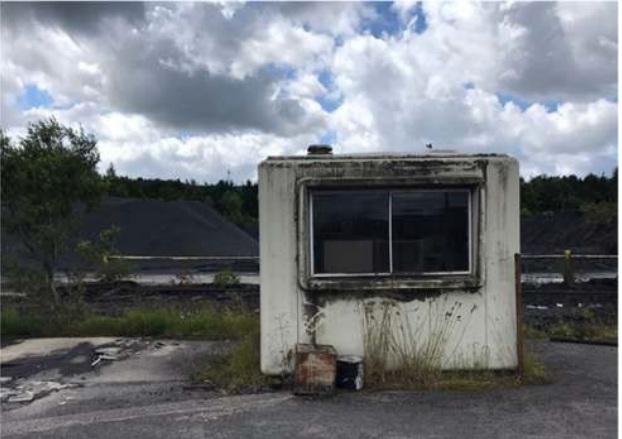
| Building / structure ID and suitability to support roosting bats<br>Refer to Figure 1 for location and Appendix 1 for description) | Photograph |
|---|---|
| Additional 6 Negligible | |

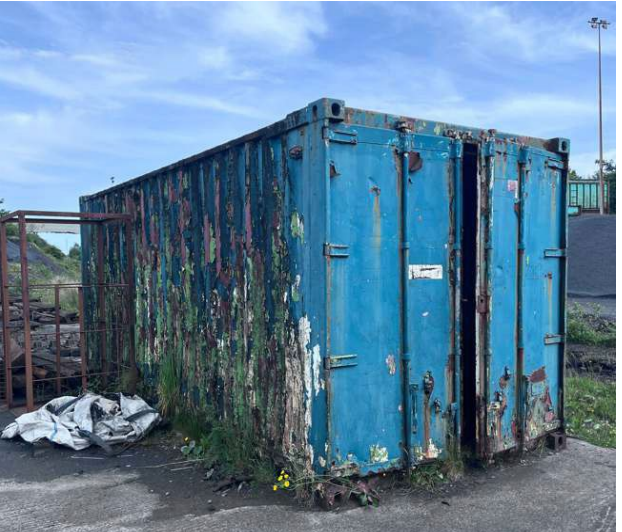
| Location | | Building height | No. of storeys | Walls | | | Roof | | | Comments | | |
|---|---|---|---|---|---|---|---|---|---|---|---|---|
| Additional 7<br>(No longer present)<br>Storage container present. | SN 8440910660 | c. 2 m | 1 | Corrugated metal | N | C | N | Flat | Corrugated material | | Metal storage container. Rusted holes in places but no cavity. | Negligible |

| Building / structure ID and suitability to support roosting bats<br>Refer to Figure 1 for location and Appendix 1 for description) | Photograph |
|---|---|
| Additional 7 Negligible | |

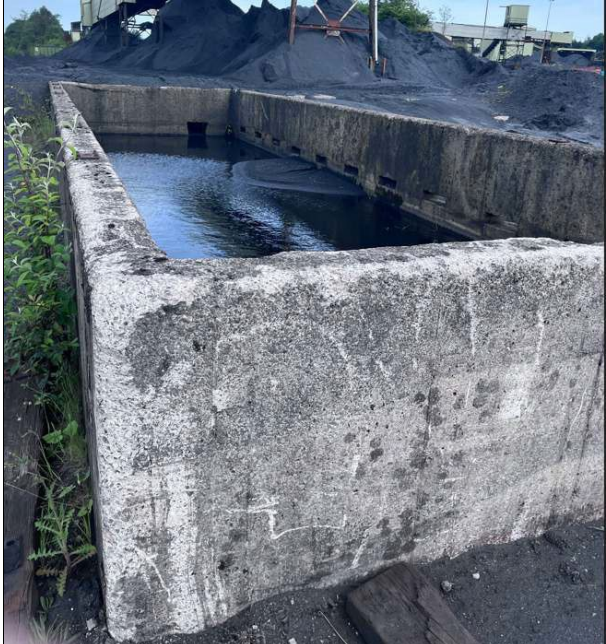
| Additional 8<br>(Only<br>foundations<br>) | SN 84448<br>10663 | | | | | | | | | | Several bricks and<br>mortar missing but<br>no cavities.<br>A 1-2cm gap is<br>present between<br>concrete blocks<br>Foundations holding<br>water | Negligible |

| <b>Building / structure ID and suitability to support roosting bats</b><br><b>Refer to Figure 1 for location and Appendix 1 for description)</b> | <b>Photograph</b> |
|---|---|
| Additional 8 Negligible | |

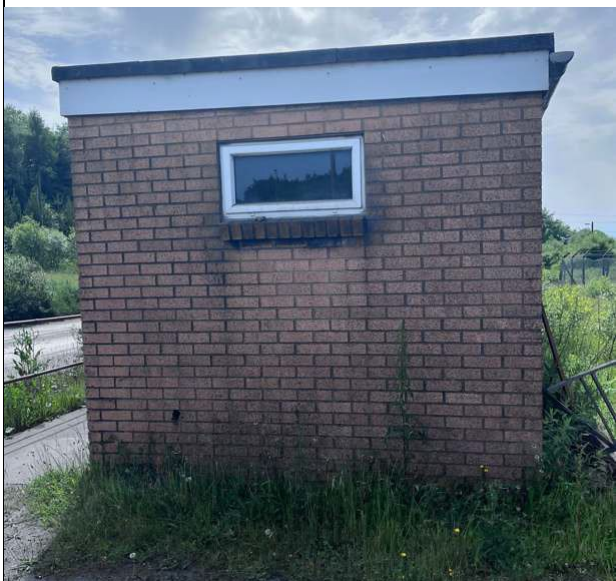
| Building/structure ID | Features |
|---|---|
| B6A | UVPC fascias on the north west and south aspect are lifting, creating gaps between the fascia however, cobwebs are largely present. A 5 cm x 5 cm hole is present at 0.1 m from ground-level and extends into the interior through the cavity wall. |

| <b>Building / structure ID and suitability to support roosting bats</b><br><b>Refer to Figure 1 for location and Appendix 1 for description)</b> | <b>Photograph</b> |
|---|---|
| B6A<br>Low | |

- 5.1.5 It is unlikely that the destruction of the PRFs in buildings assessed as having low suitability for bat roosts (B6A and B8) will have a significant negative impact on the favourable conservation status of the local bat population. However, these structures should be inspected by a suitably experienced ecologist immediately prior to demolition to confirm likely absence of roosting bats.

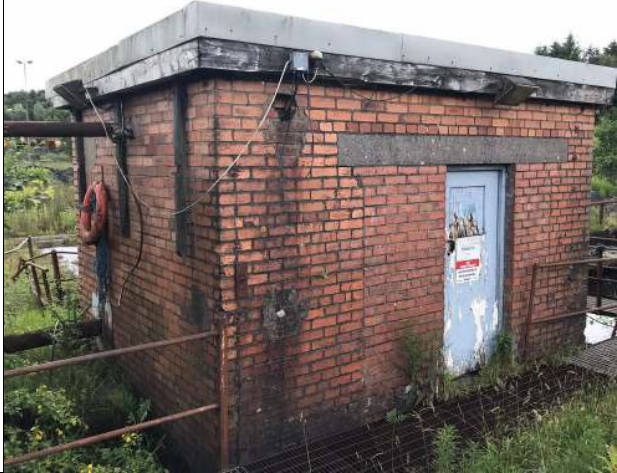
| Building/structure ID | Features |
|---|---|
| B7 | The PRFs recorded on B7 include damaged wooden barge boards on the south and east aspects of the building. Further PRFs in the form of missing mortar and bricks, two large gaps in brickwork leading into the cavity wall and a gap in a wooden soffit are present on the north aspect. |

| <b>Building / structure ID and suitability to support roosting bats</b><br><b>Refer to Figure 1 for location and Appendix 1 for description)</b> | <b>Photograph</b> |
|---|---|
| B7<br>Moderate | |

- 1.1.8 The building B7 has been assessed as having a moderate suitability to support roosting bats and as a precautionary measure, the demolition of this building should be carried out under the licenced method statement that will be required for the buildings containing confirmed roosts in Phase 2A of the Site (as detailed in a separate report for Phase 2A, DM 2022). The buildings B6A and B8, which have low suitability to support roosting bats, should also be checked by a suitably experienced ecologist immediately prior to demolition to confirm likely absence of roosting bats.

- 5.1.4 It is likely that bats will move roost locations regularly and exploit other roost opportunities within the Site. Therefore, the building within Phase 1A of the Site assessed as having moderate suitability to support roosting bats (B7) is likely to contribute to the roosting resource within the Site. As a precautionary measure, the demolition of B7 should be carried out under the licenced method statement that will be required for the buildings containing confirmed roosts in Phase 2A of the Site (DM, 2022).

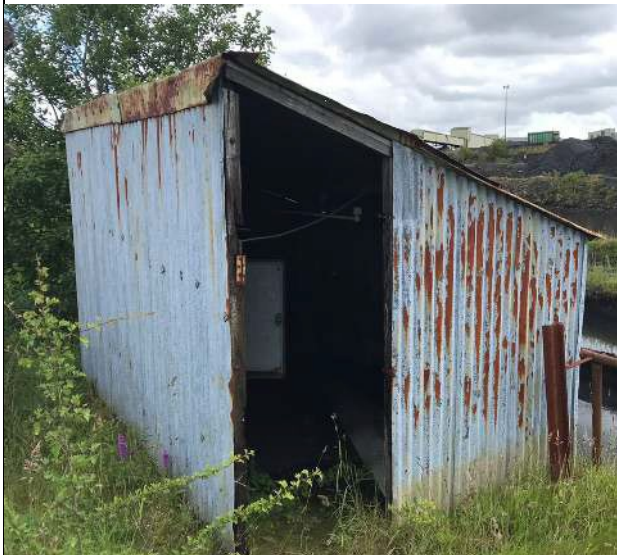
- 3.4.1.1 Access to B8 was restricted due to the presence of fencing. The building inspection was carried out from behind the metal fencing and consequently the interior could not be inspected for feeding remains or signs of bat droppings. This did not present a constraint on the ability to assess the suitability to support roosting bats, as the building is a single skin, corrugated metal building. It is open-sided and exposed on the west aspect and therefore likely to be subject to daylight ingress and driving weather. The building has been categorised as having low suitability for roosting bats.

| Building/structure ID | Features |
|---|---|
| B8 | A corrugated shed with an open side on the west aspect, the building is too open and draughty to support a maternity roost. However, the open side and wooden beam inside may provide a suitable feeding or night- roost perch for bats. |

| <b>Building / structure ID and suitability to support roosting bats</b><br><b>Refer to Figure 1 for location and Appendix 1 for description)</b> | <b>Photograph</b> |
|---|---|
| B8<br>Low | |

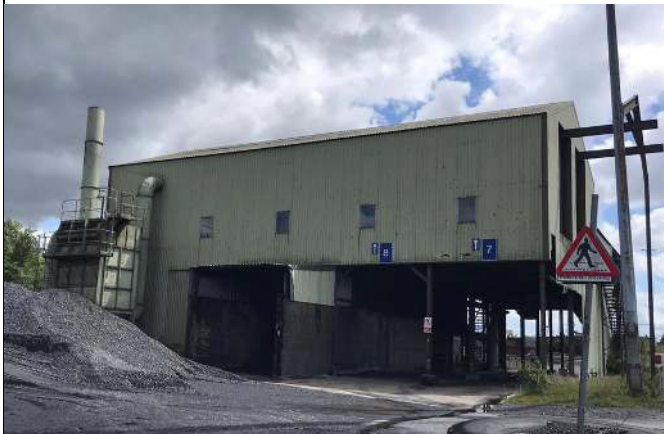
| Location | | Building height | No. of storeys | Walls | | | Roof | | | Comments | | |
|---|---|---|---|---|---|---|---|---|---|---|---|---|
| 29 (Additional 3) | SN 84806 10605 | c. 30 m | 1 | Corrugated metal | Y | S | N | Pitched | Corrugated material | Skylights | Coal processing shed. Access to the interior through missing doors. | Negligible |

| <b>Building / structure ID and suitability to support roosting bats</b><br><b>Refer to Figure 1 for location and Appendix 1 for description)</b> | <b>Photograph</b> |
|---|---|
| B29<br>Negligible | |

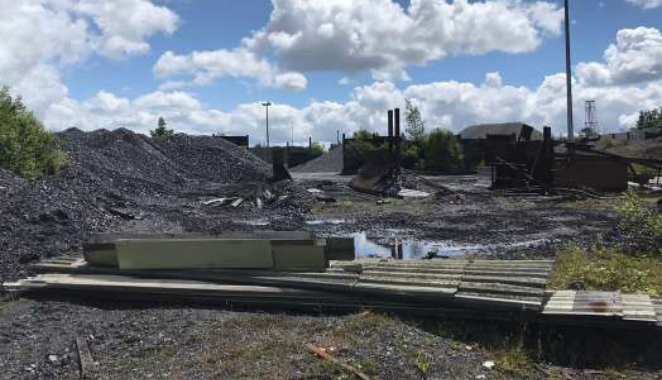
| <b>Building / structure ID and suitability to support roosting bats</b><br><b>Refer to Figure 1 for location and Appendix 1 for description)</b> | <b>Photograph</b> |
|---|---|
| B31 (Additional 3) No longer present<br>None | |
