**Ty Mawr, Pontardawe**  
**Proposed Residential Development**  
**Exploratory Investigation**  
Report Reference: ESP.8293.02.3827.

## Ty Mawr, Pontardawe Proposed Residential Development Exploratory Investigation

Report Reference: **ESP.8293.02.3827**

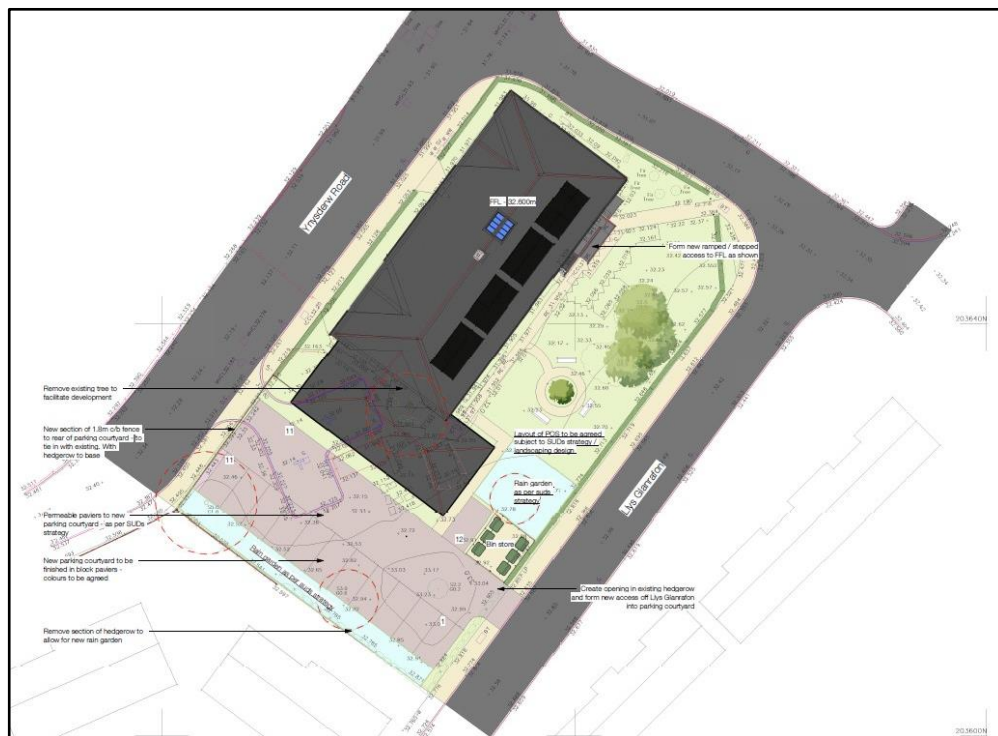
We understand that the proposed development will comprise the refurbishment of the existing detached building and extension to the south elevation. External development will include new access roads, car parking and soft landscaping. It is understood no private gardens are proposed. The development layout is presented as Insert 1 below and also presented on the appended Plates.

Insert 1 – Proposed development layout (provided by the Client)

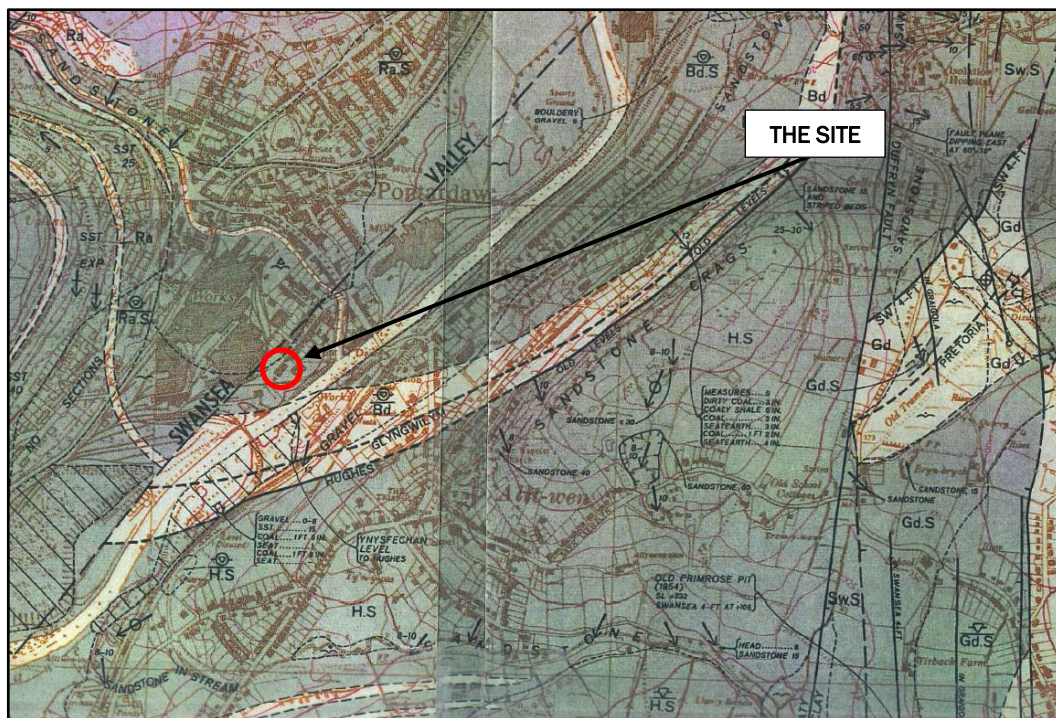
The published 1:10,560 scale geological map for the area of the site (Sheet SN70SW, presented as Insert 3) indicates the site to be underlain by Alluvium overlying bedrock of the Brithdir Beds.

Insert 3 - Extract from BGS Geological Map Sheet SN70SW, original 1:10,560 scale.  
Reproduced with permission (BGS licence number: C15/05 CSL)

The alluvium will likely comprise soft to firm consolidated compressible silty clay with layers of silt, sand, peat and basal gravels. The Brithdir Beds are anticipated to comprise green-grey sandstones with conglomerate lenses at the bases units and thin mudstone/siltstone/coal layers.
