## Technical Note: Ecological Survey notes re vegetation clearance for cable lay

Site: Llandarcy, Neath

Author: Siân Musgrave BSC (Hons) MCIEEM Principal Ecologist AEC Ltd

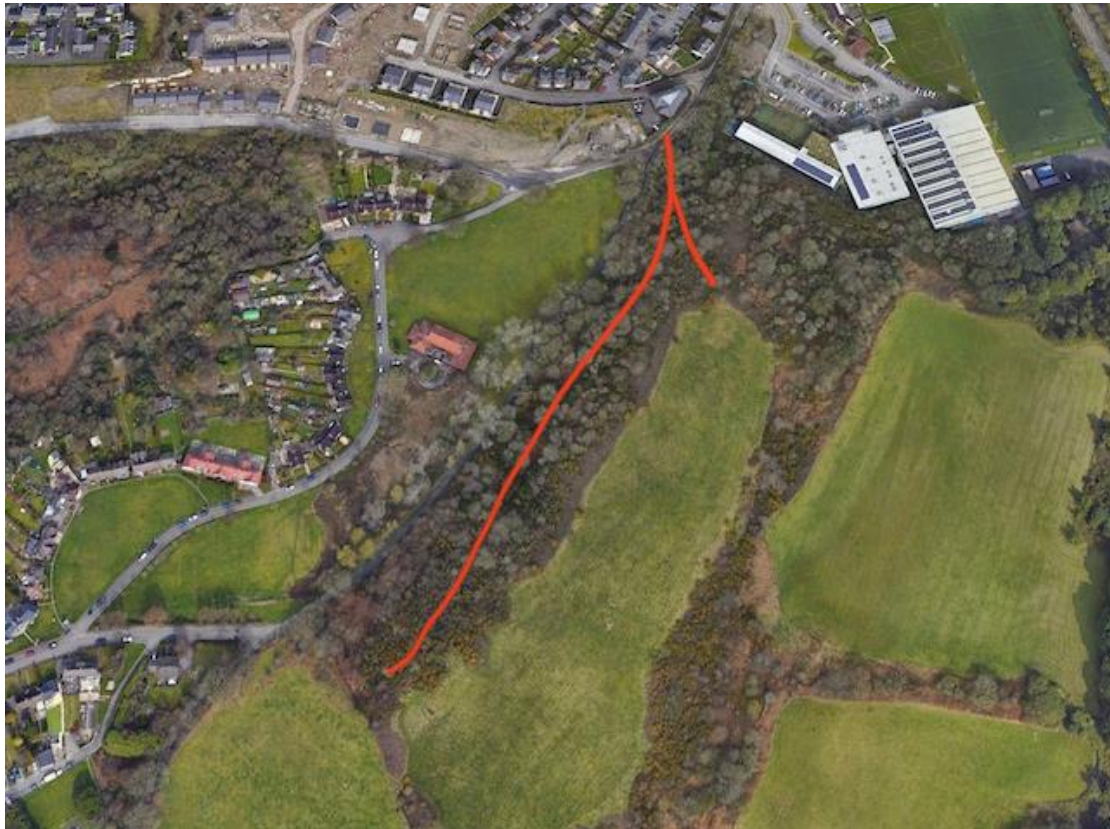
**Figure 3:** Google Earth image of the woodland area that has been partly cleared (red line= approximate area of clearance)

The woodland area lies adjacent to the road and is shown in the Google Earth image in **Figure 3**.

The clearance runs in a swathe approximately 6m – 8m wide (more in places) through the woodland area and towards the field boundary to the west. A small linear area of woodland directly adjacent to the road has been left, and this varies in width as the cleared line moves across the slope.

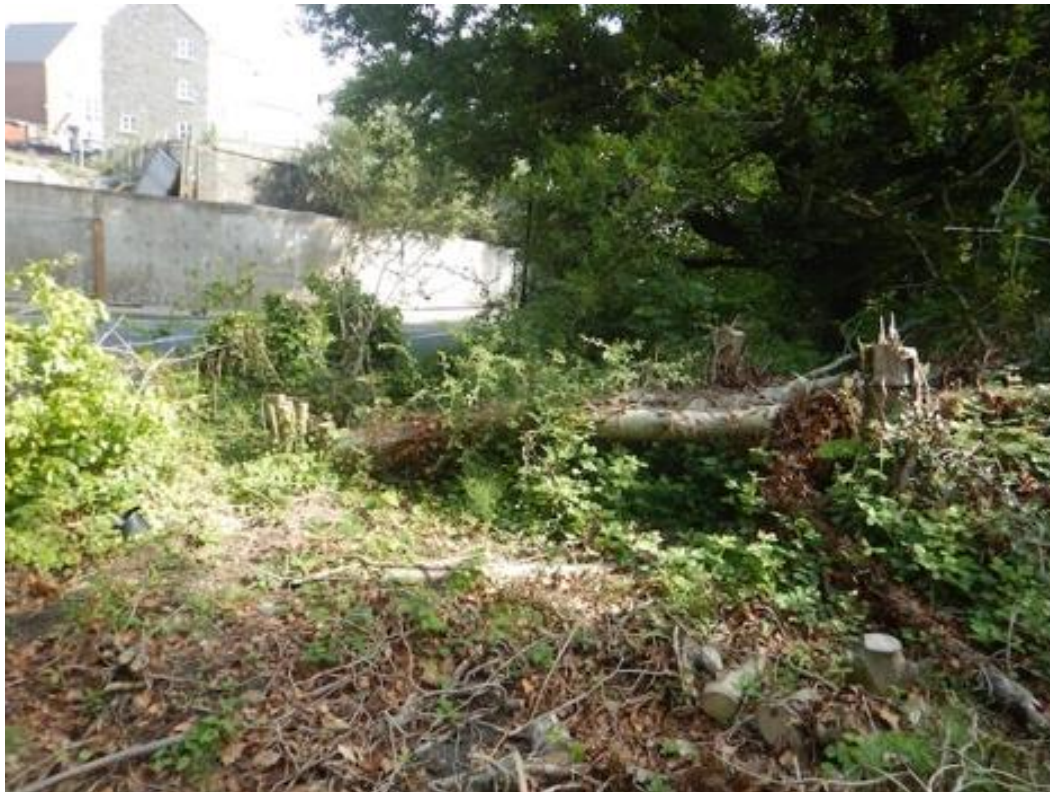
**Figure 4:** Felled roadside trees

Mature Ash *Fraxinus excelsior*, and Oak *Quercus robur* trees have been felled along the roadside and vegetation cleared up to the two existing poles with switches (**Figures 4 & 5**). It is understood that these trees were not within the agreed cleared area and have been felled after the visit by NPTC staff.

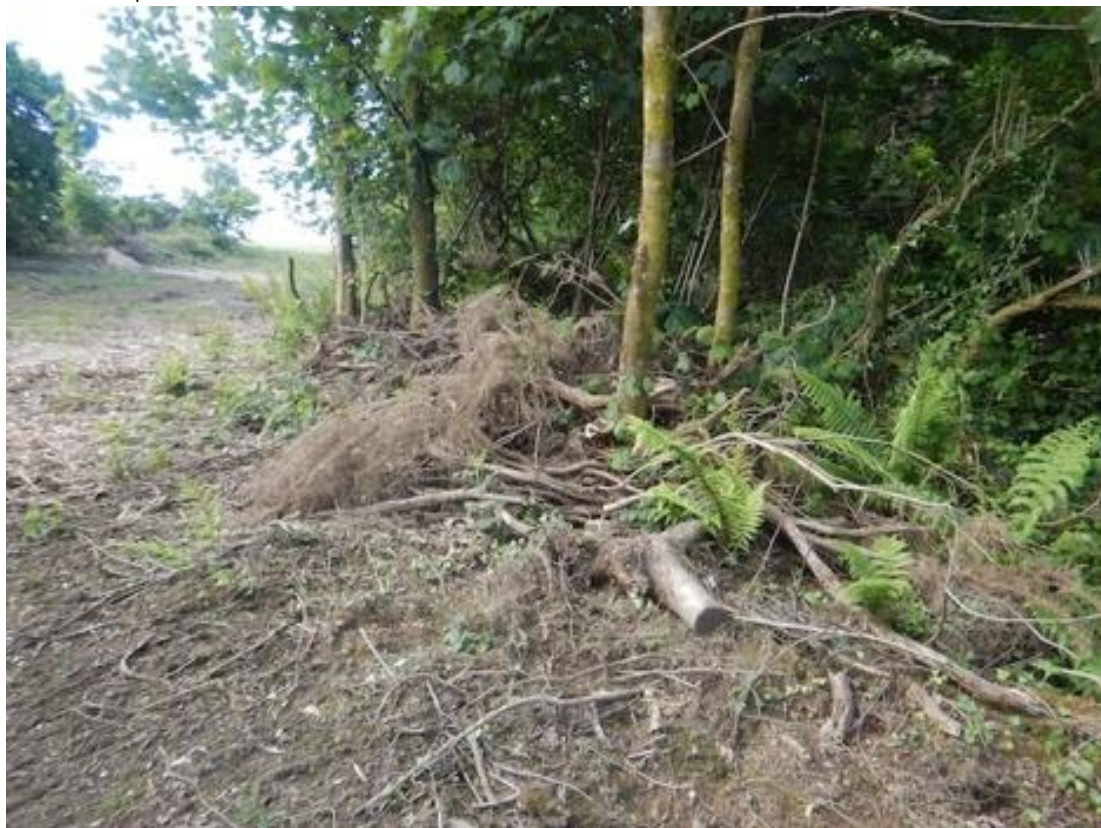
**Figure 6:** Brash piles with Gorse

From the brash that has been left and piled along the edges of the new ride, Gorse *Ulex europaeus*, Bramble *Rubus fruticosus* agg., and saplings have been removed as well as larger trees that have been chipped (Figures 6, 7 & 8). Some trees have had branches removed (Figure 9).

- The ride should be allowed to regenerate naturally following completion of works with access retained for future repairs as required.
- The brash piles and tree stumps are currently piled around the edges of the ride. These are now suitable for use by reptiles and nesting birds as well as hedgehogs and other small mammals. If these piles are within the required working width, then they should be removed after bird nesting season has finished (i.e. September onwards until 1<sup>st</sup> March) and under ecological supervision to ensure no animals that may be using them are harmed.

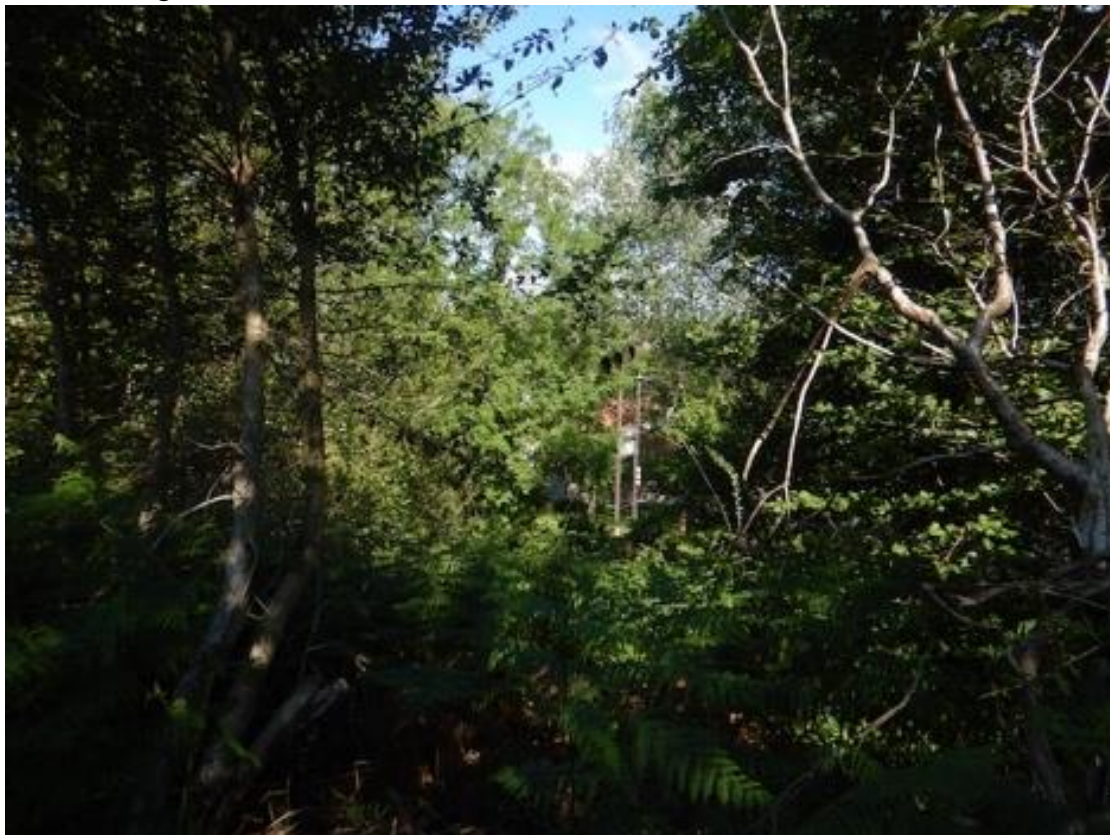
Figure 10: Existing woodland

The surrounding woodland that is left consists in the main of Oak, Sycamore *Acer pseudoplatanus*, Hazel *Corylus avellana*, Ash, Rowan *Sorbus aucuparia*, Hawthorn *Crataegus monogyna*, Willow *Salix* sp., Silver Birch *Betula pendula*, Gorse stands, and Holly *Ilex aquifolium* (Figure 10).

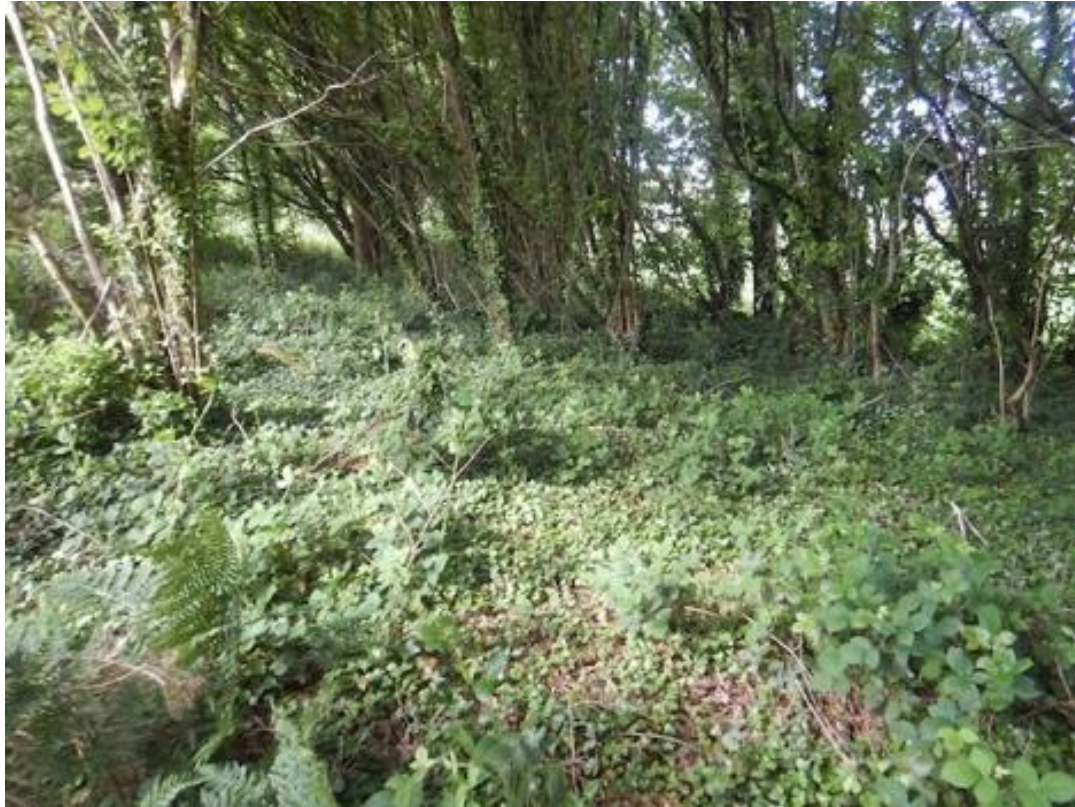
Figure 11: Understorey with Ivy and Bramble

The understorey of the surrounding woodland varies in density and species diversity, from Ivy *Hedera helix* covering the ground with sparse Bramble, to denser stands with Rosebay Willowherb *Chamaenerion angustifolium*, Common Figwort *Scrophularia nodosa*, Lady Fern *Athyrium filix-femina*, Broad Buckler Fern *Dryopteris dilatata* and Male Fern *Dryopteris filix-mas* (Figure 11) amongst other vegetation.

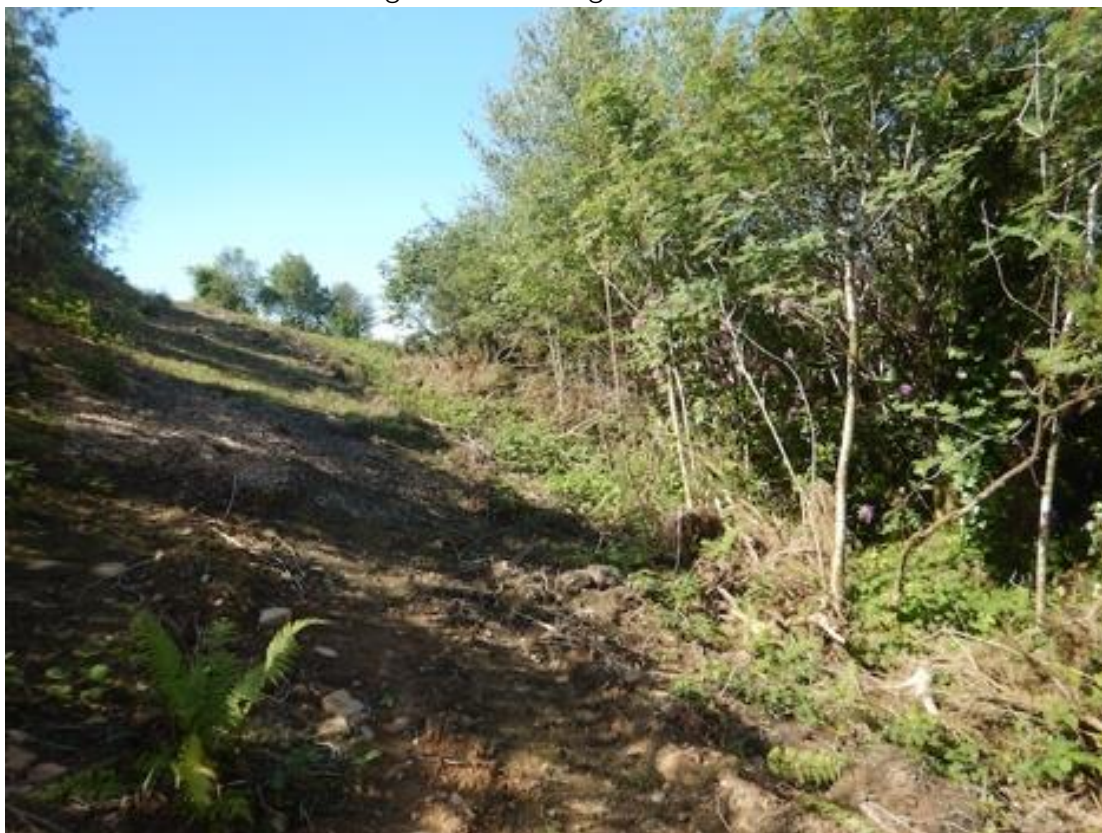
Figure 12: Rhododendron flowering within existing woodland

Rhododendron *Rhododendron ponticum* (with flowers) is also present in some of the woodland understorey (Figure 12).

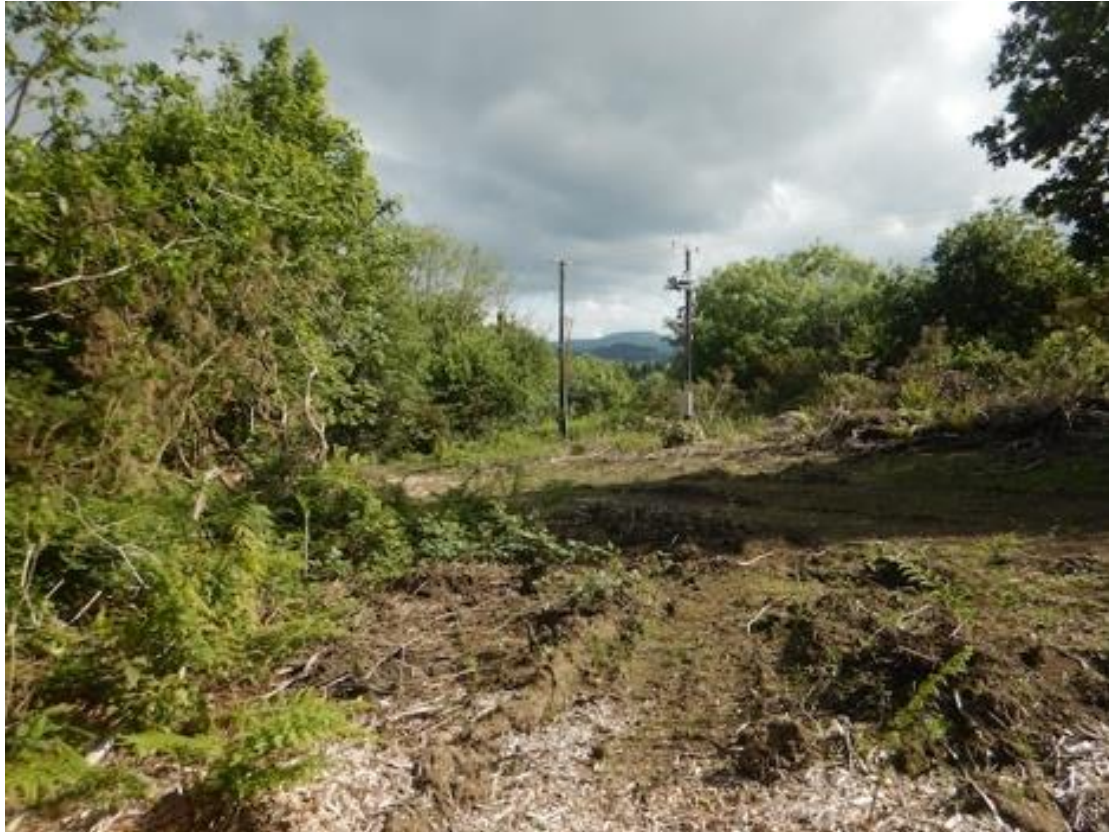
Figure 13: Newly cleared ride

The route that has been cleared is now mainly bare earth with some woodchip from felled trees (Figures 13–15). Some regrowth is present in the form of Bramble, Bracken *Pteridium aquilinum* and ferns. The trees have been chipped, but the root plates and stumps have been pushed to the side of the ride, along with brash such as Gorse (Figure 16).

- Retain the ride as bare ground rendering it unsuitable for nesting birds and reptiles until the cable laying process is complete. This will allow machinery to operate freely within the cleared area with low potential risk of harming these species groups.
