# Gnoll Country Park, Neath

**Title** Ground Conditions Assessment Report

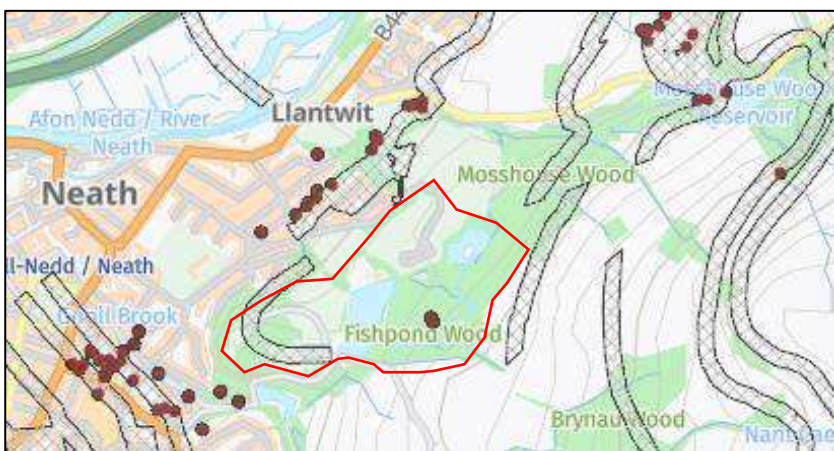
Figure 4: Extract from Coal Authority website, showing Zones of 'Development High Risk' and Mine Shaft Entries

The areas to the north of the reservoir around Areas 2 and 5 appears to be at less of a risk from mining. The probable Brithdir Rider coal seam is shown to crop out in a south-west to north-east orientation some 240m to the north-west, in the area of the former mine entries identified on historical maps. The conjectural outcrop of the Glyngwilym coal seam is shown some 360m to the east. Given the distance from the site and the fact this area of the site is shown to be underlain by *massive sandstone*, the risk of shallow mining activities in these areas is considered low.

It should be noted that the CMRA does not include the mine entry data sheets for the recorded mine shafts within the wooded area. We therefore recommend that these are obtained as part of any additional works and the CMRA updated accordingly with the findings.

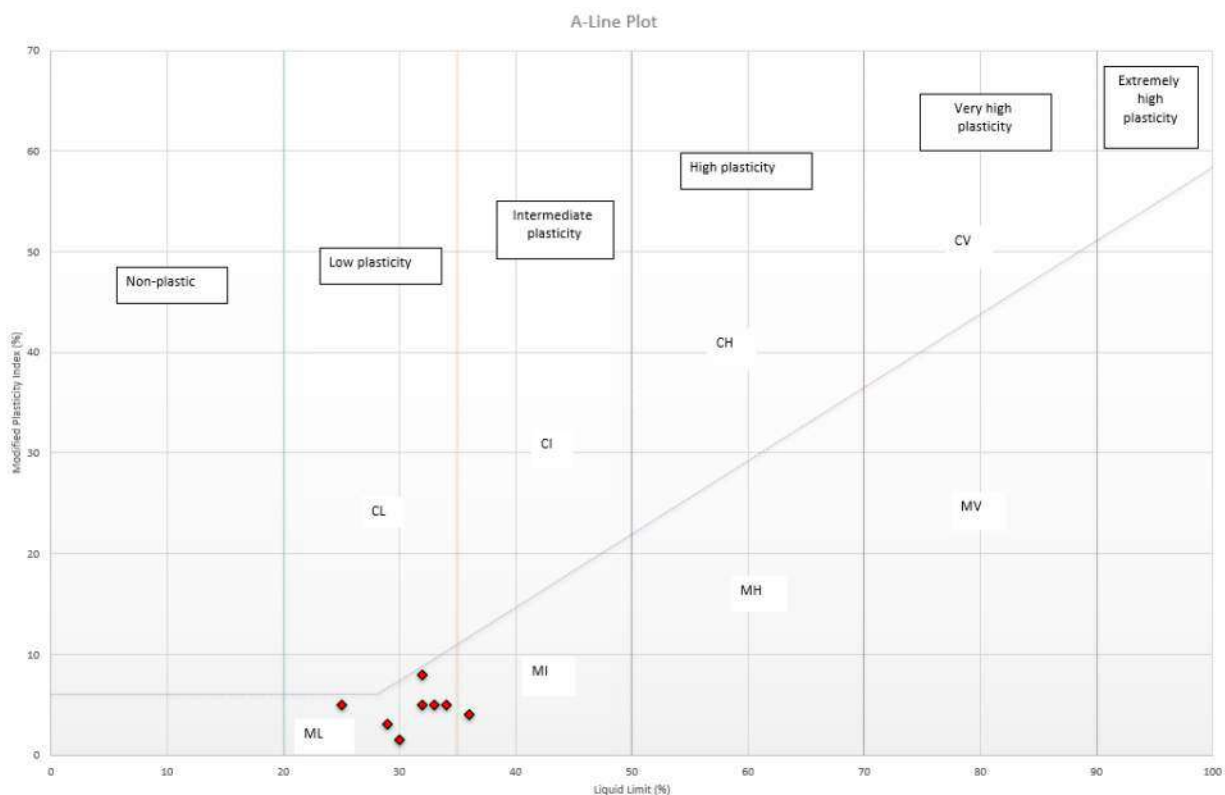
Figure 5: Summary of Plasticity Tests for Pennant Sandstone Formation

The samples of cohesive soil had natural moisture contents between 9% and 22% and a modified plasticity index of between 1% and 8% indicating the soil to be non-shrinkable. The sample comprised between 11% and 62% clay/ silt content.

Taking into account the portion of the sample passing the 425  $\mu\text{m}$  sieve, the reported plasticity index values can be modified in accordance with NHBC standards Chapter 4.2 'Building Near Trees'. Based on this the samples all have a non-shrinkable potential and so no requirement on a minimum foundation depth when building near trees, when foundations are placed within the shallow cohesive residual soils.

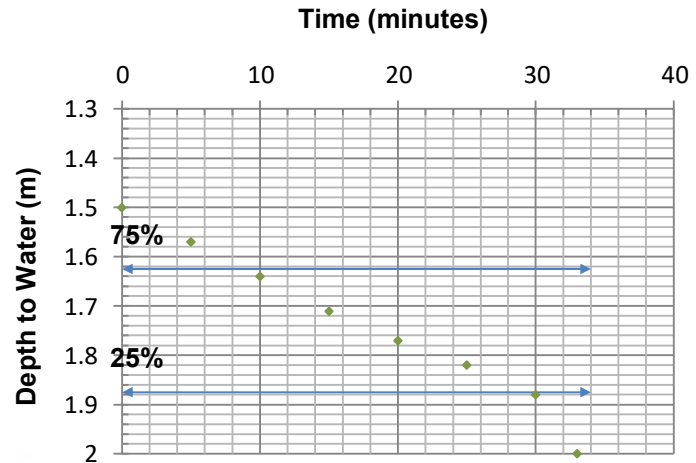
## TEST 3

Length 1.50 m  
Width 0.60 m  
Depth 2.00 m  
Fill Level 1.50 m

$V_{p75-25}$  0.225 m<sup>3</sup>  
 $a_{p50}$  1.95 m<sup>2</sup>  
 $t_{p75-25}$  25 minutes

Soil Infiltration Rate,  $f$  7.69E-05 ms<sup>-1</sup>

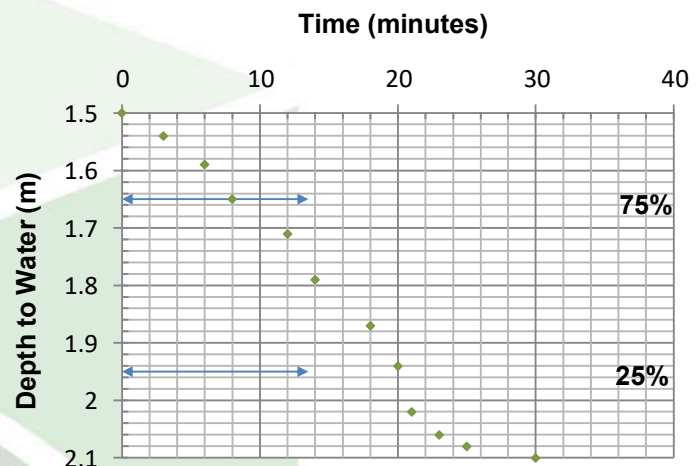
## TEST 3

Length 2.00 m  
Width 0.60 m  
Depth 2.10 m  
Fill Level 0.50 m

$V_{p75-25}$  0.36 m<sup>3</sup>  
 $a_{p50}$  2.76 m<sup>2</sup>  
 $t_{p75-25}$  12.5 minutes

Soil Infiltration Rate,  $f$  1.74E-04 ms<sup>-1</sup>

| <b>Drainage</b> | Infiltration drainage will likely be suitable in areas where the base of the soakaways is within the weathered bedrock where infiltration rates of between $1.74 \times 10^{-4}$ m/s and $7.69 \times 10^{-5}$ m/s were recorded. Soakaways were carried out with the base within the residual and failed to infiltrate therefore soakaways within the clays will not be suitable, although they could potentially be extended down to the weathered granular bedrock subject to further testing. |

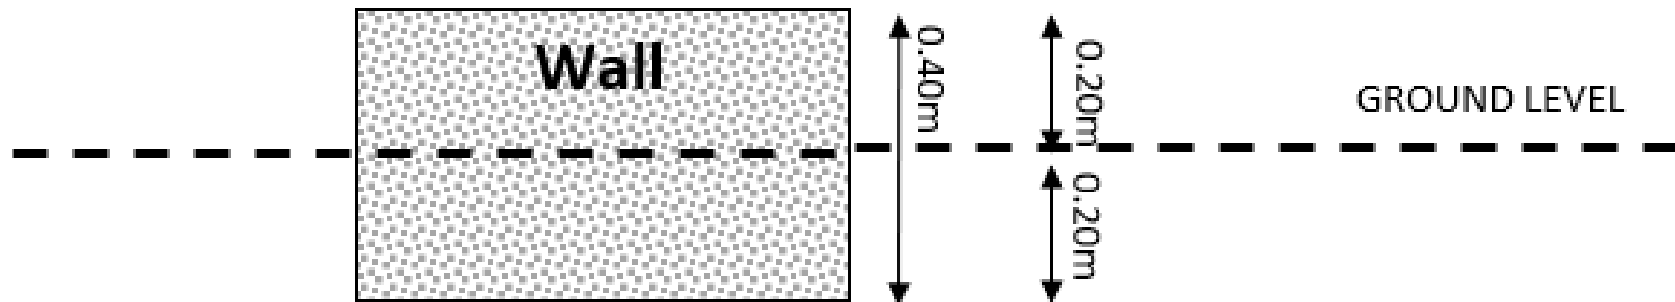
**HP02**

| <p>Site Name: Gnoll Park<br/>Project Number: 17887<br/>Drawing Title: HP02 Foundation Sketch<br/>Drawing Number:<br/>Scale: Not to scale</p> | |

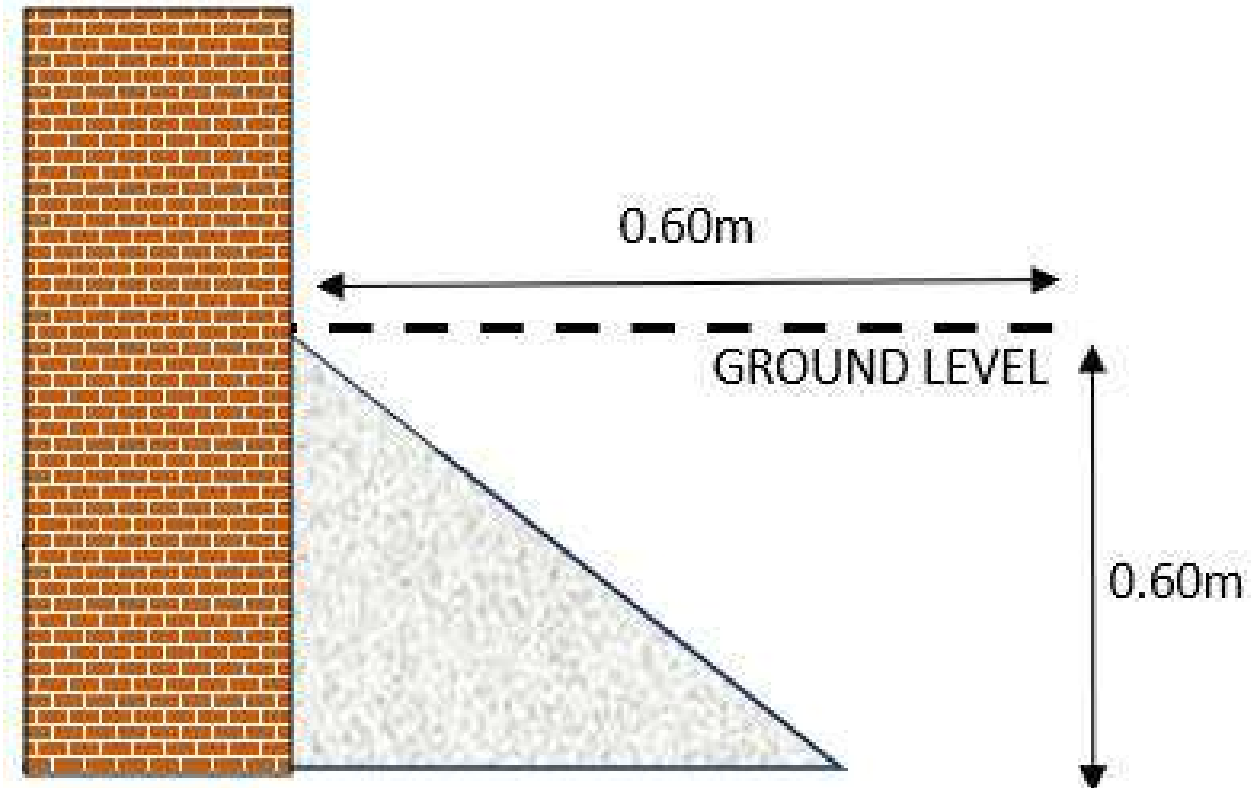
# HP03 *NOT TO SCALE*

Site Name: Gnoll Park  
 Project Number: 17887  
 Drawing Title: HP03 Foundation Sketch  
 Drawing Number:  
 Scale: Not to scale
