# GLOBAL CENTRE OF RAIL EXCELLENCE - WASHERY

Document title: Ground Investigation Report

Document reference: GCRE002-AWJV-EW-XX-RP-GE-00009

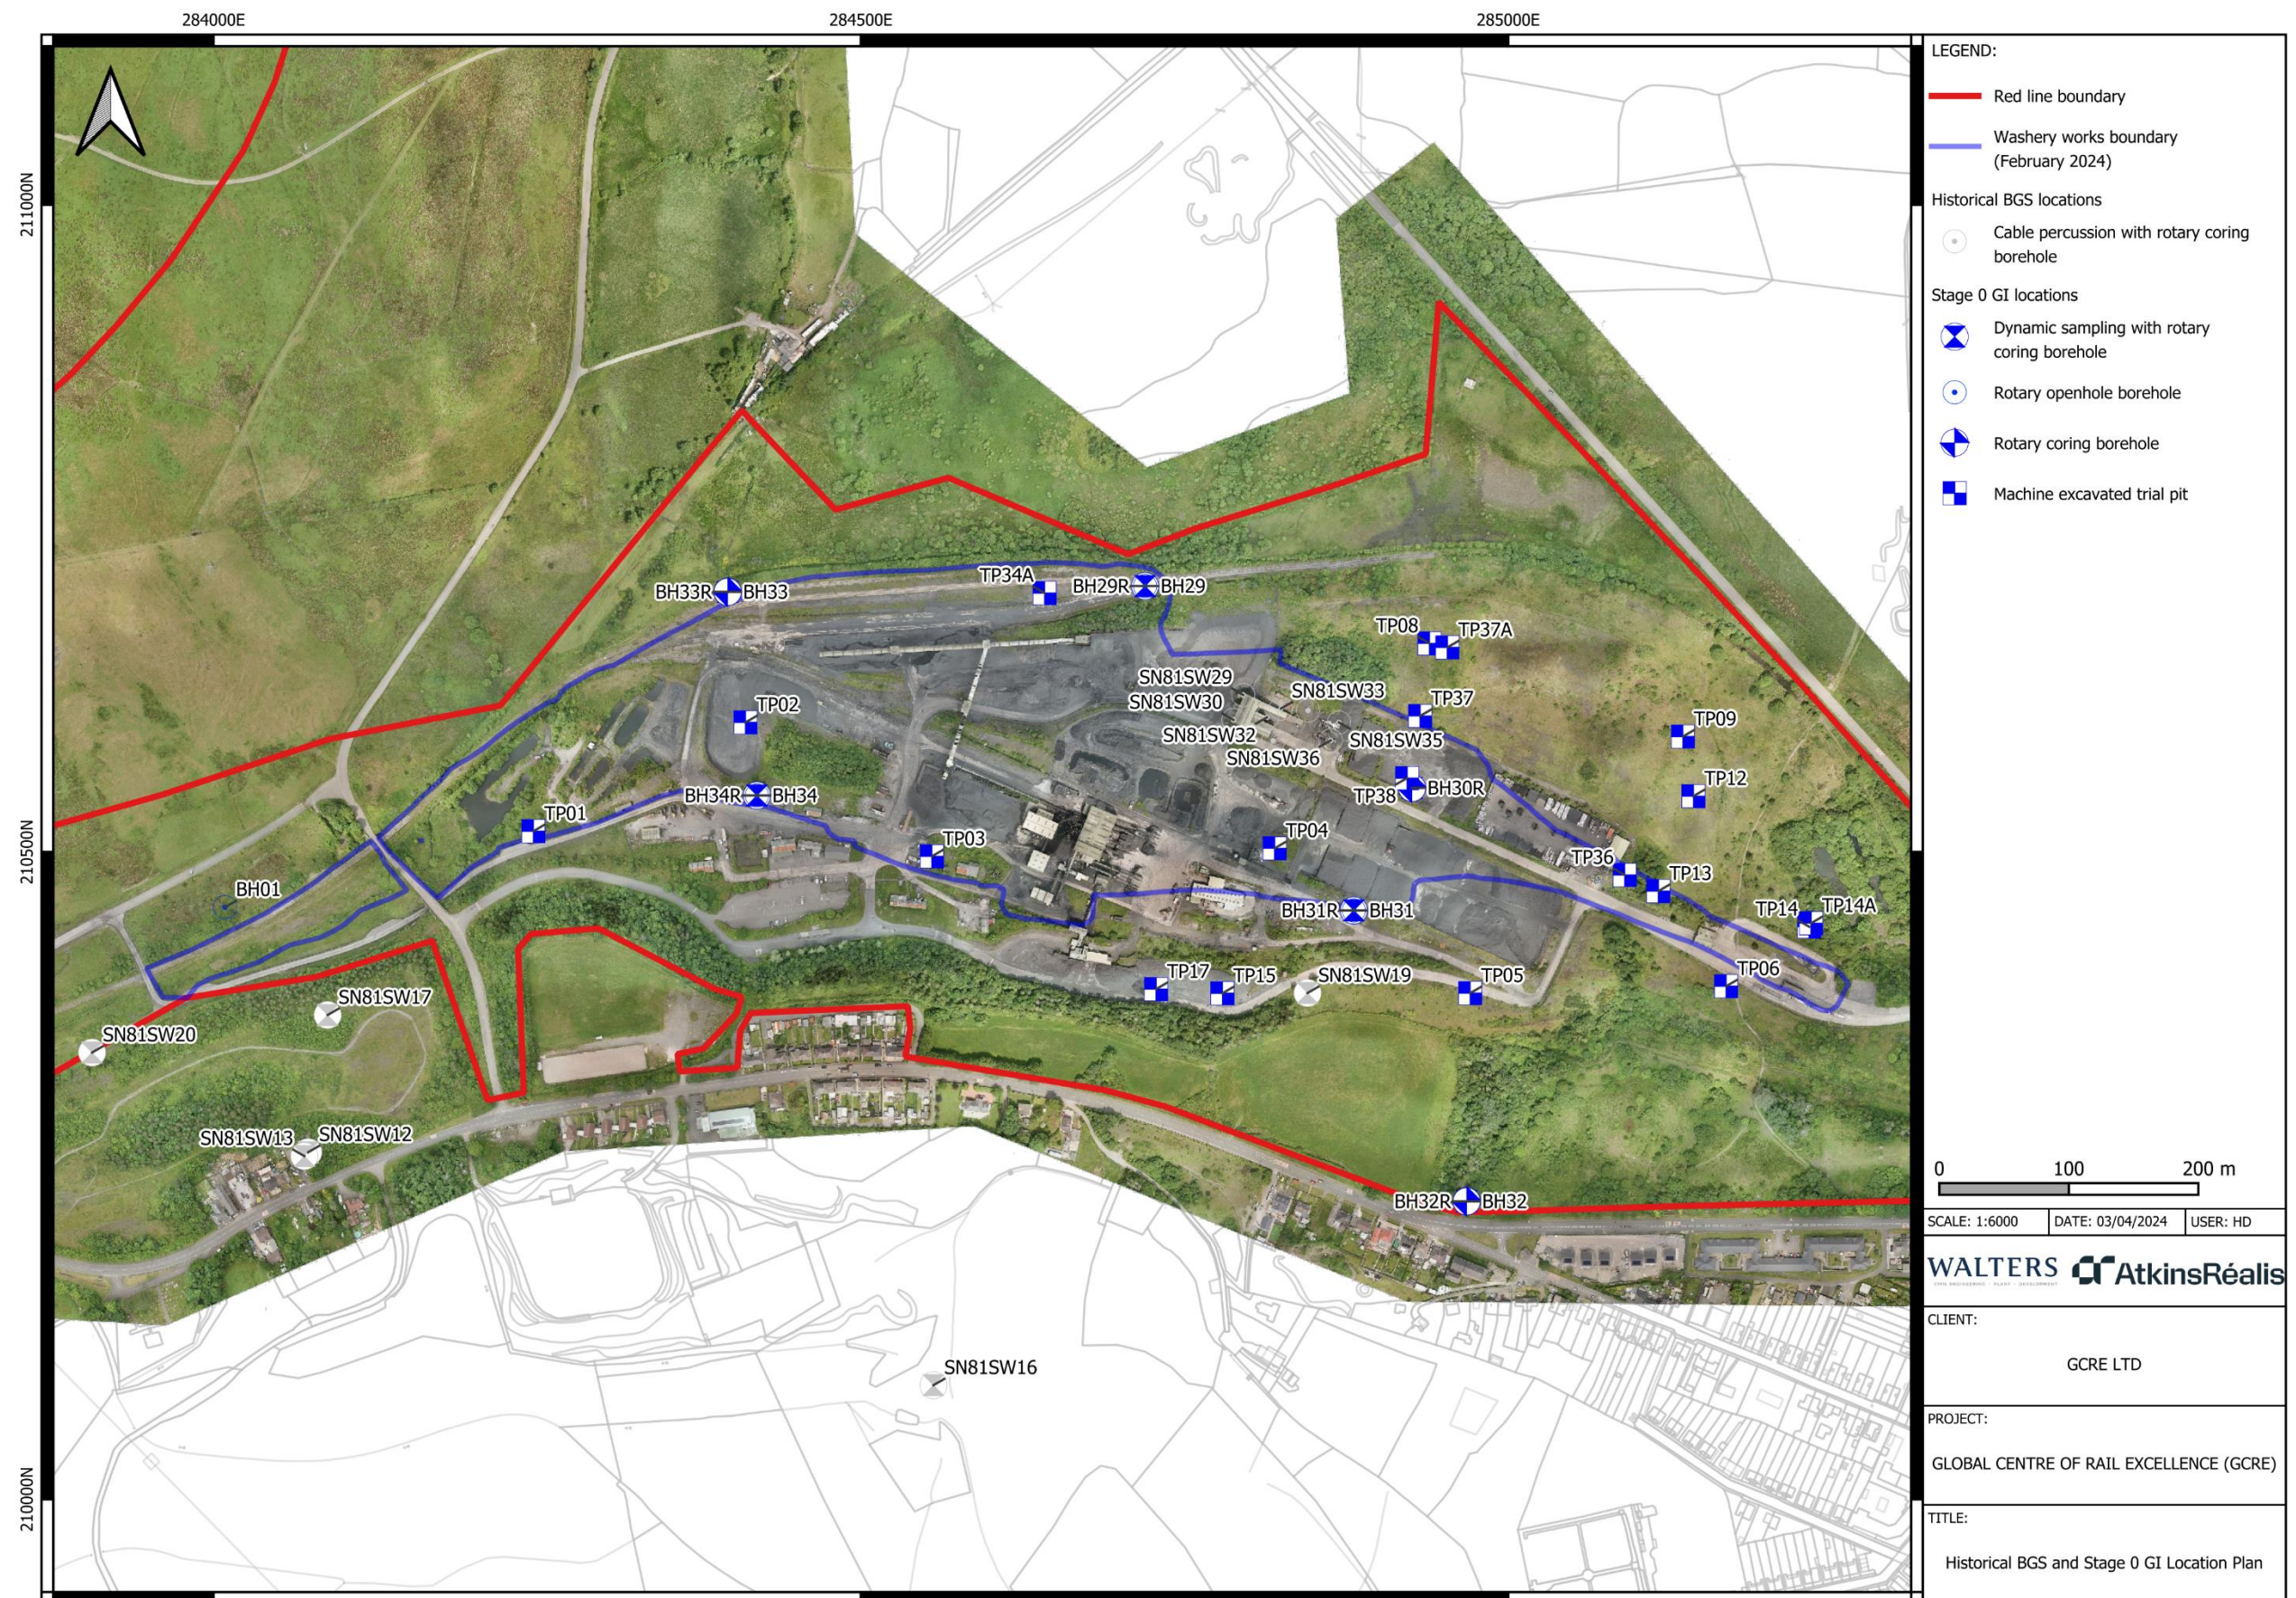
Figure 3-1: Historical BGS and Stage 0 GI Location Plan (Imagery copyright AtkinsRéalis, [16])

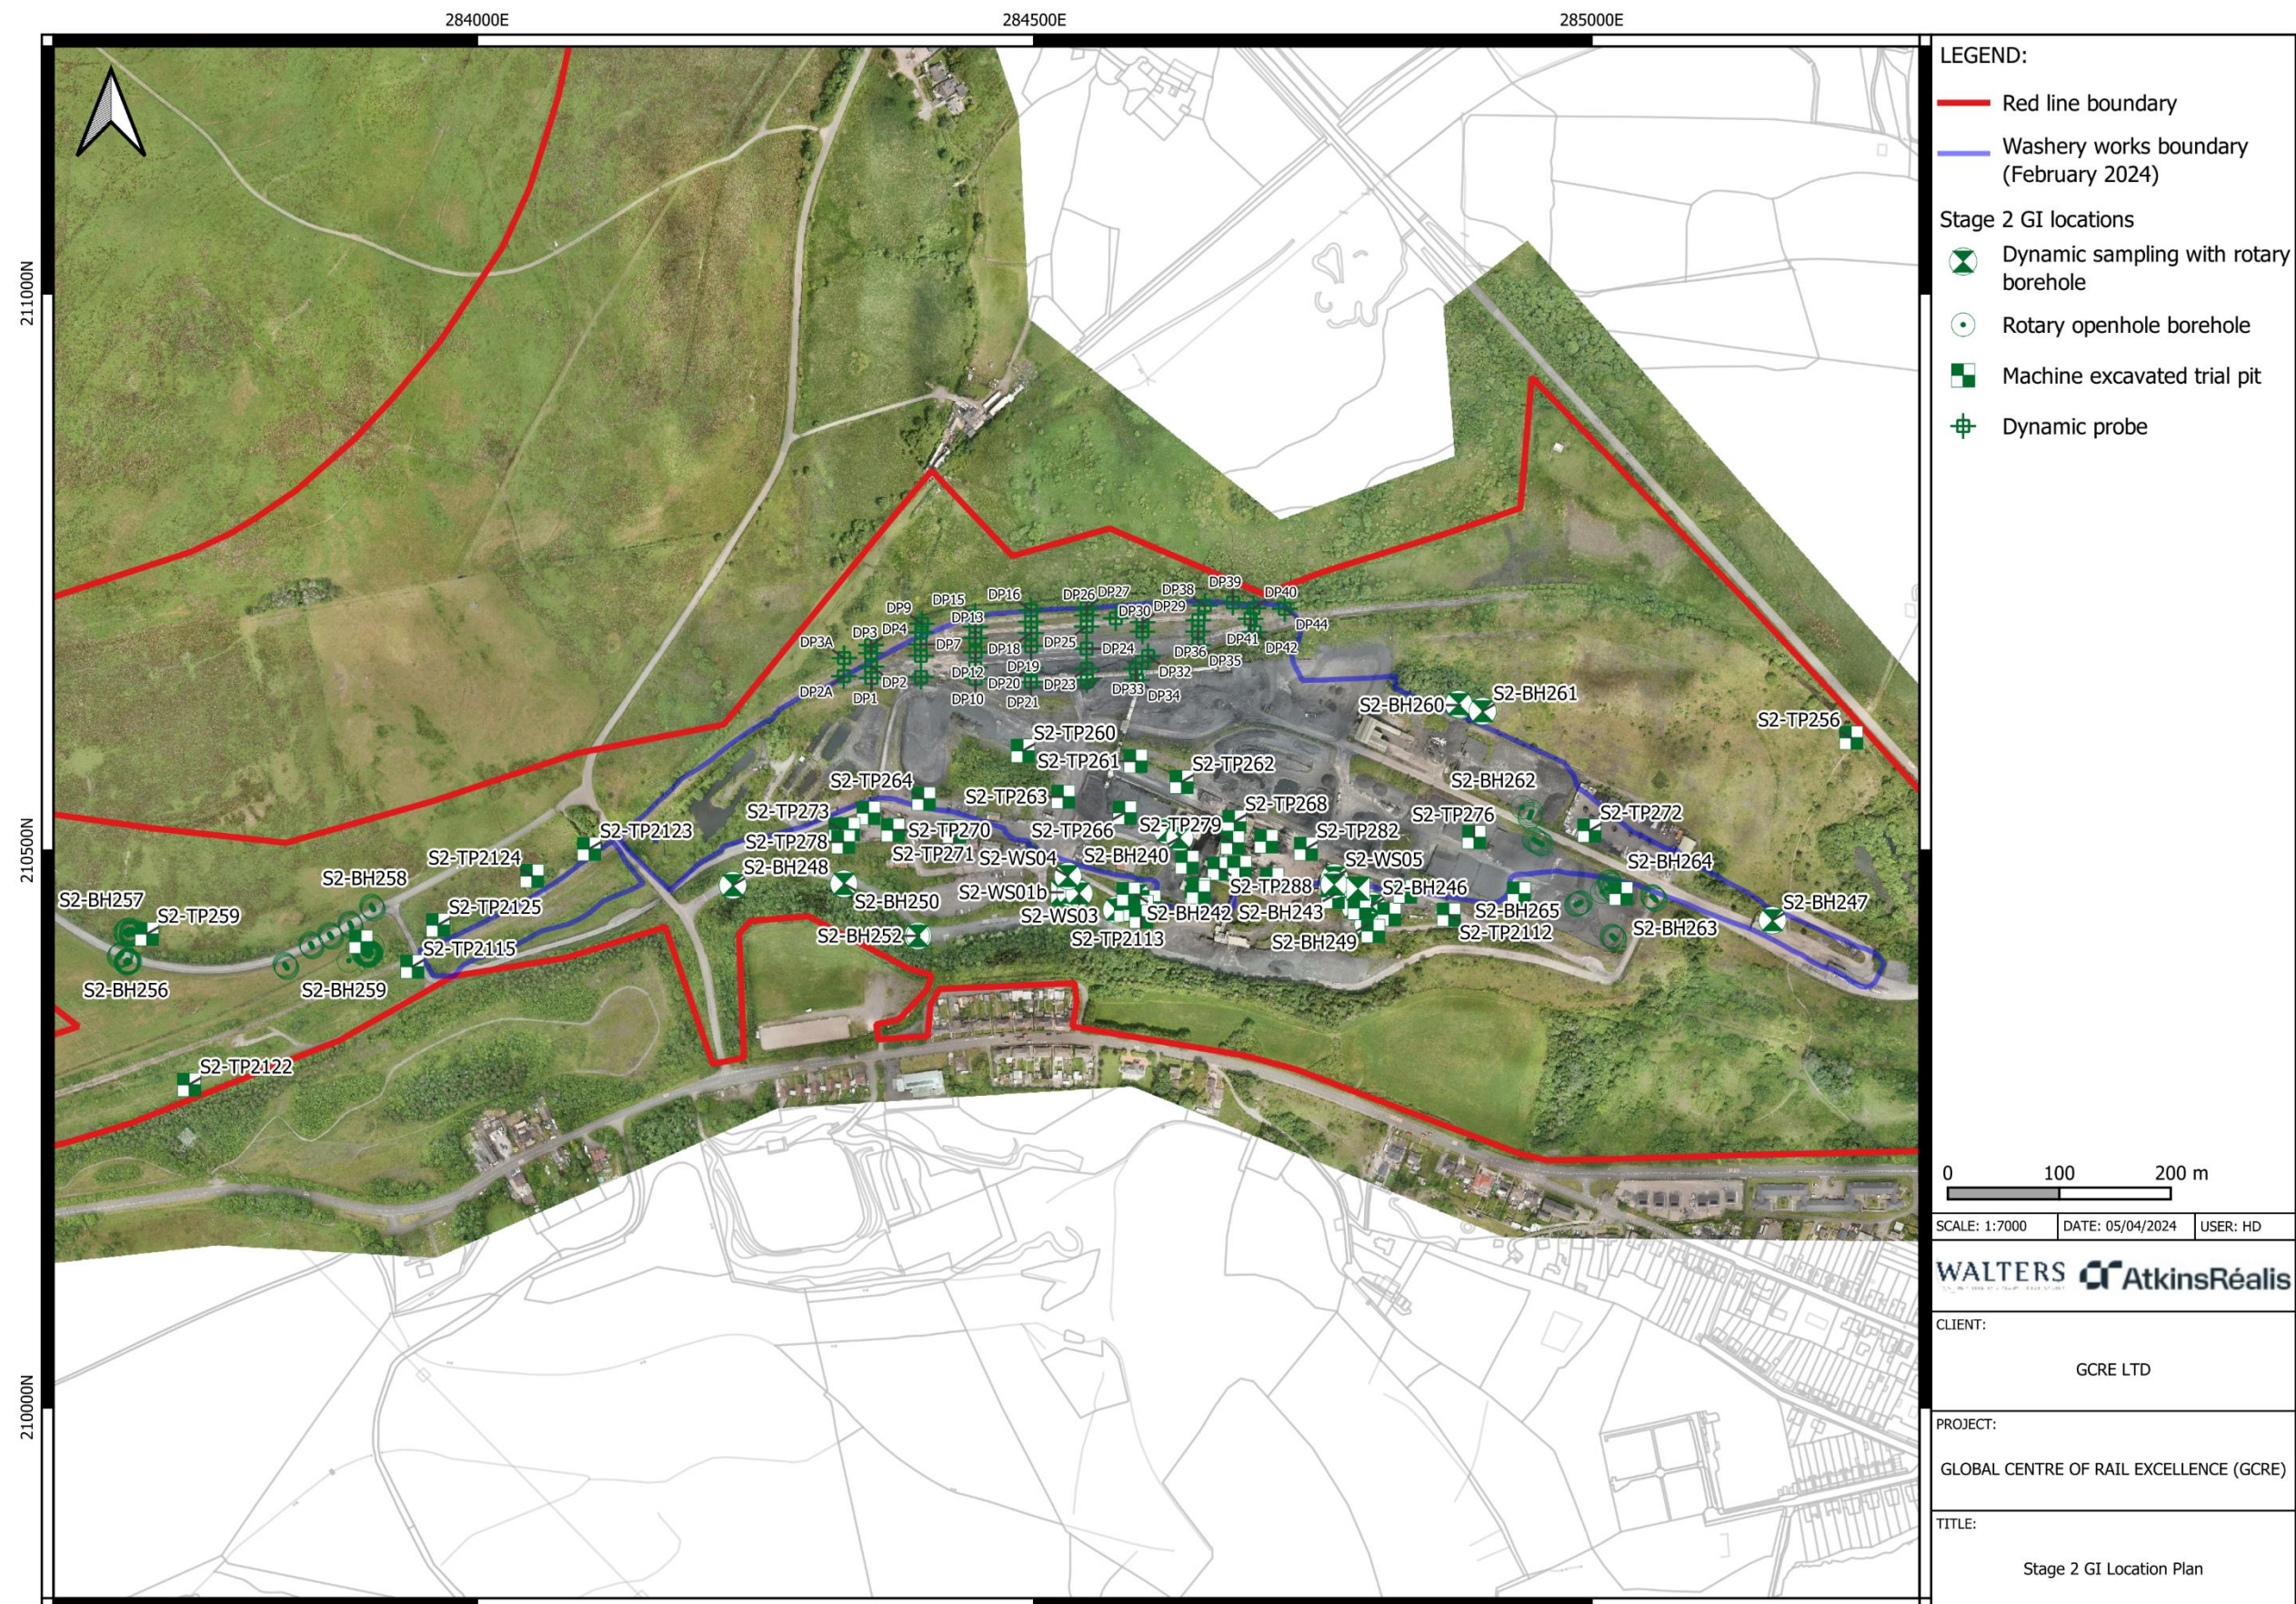
Figure 3-6: Stage 2 GI Location Plan (Imagery copyright AtkinsRéalis)

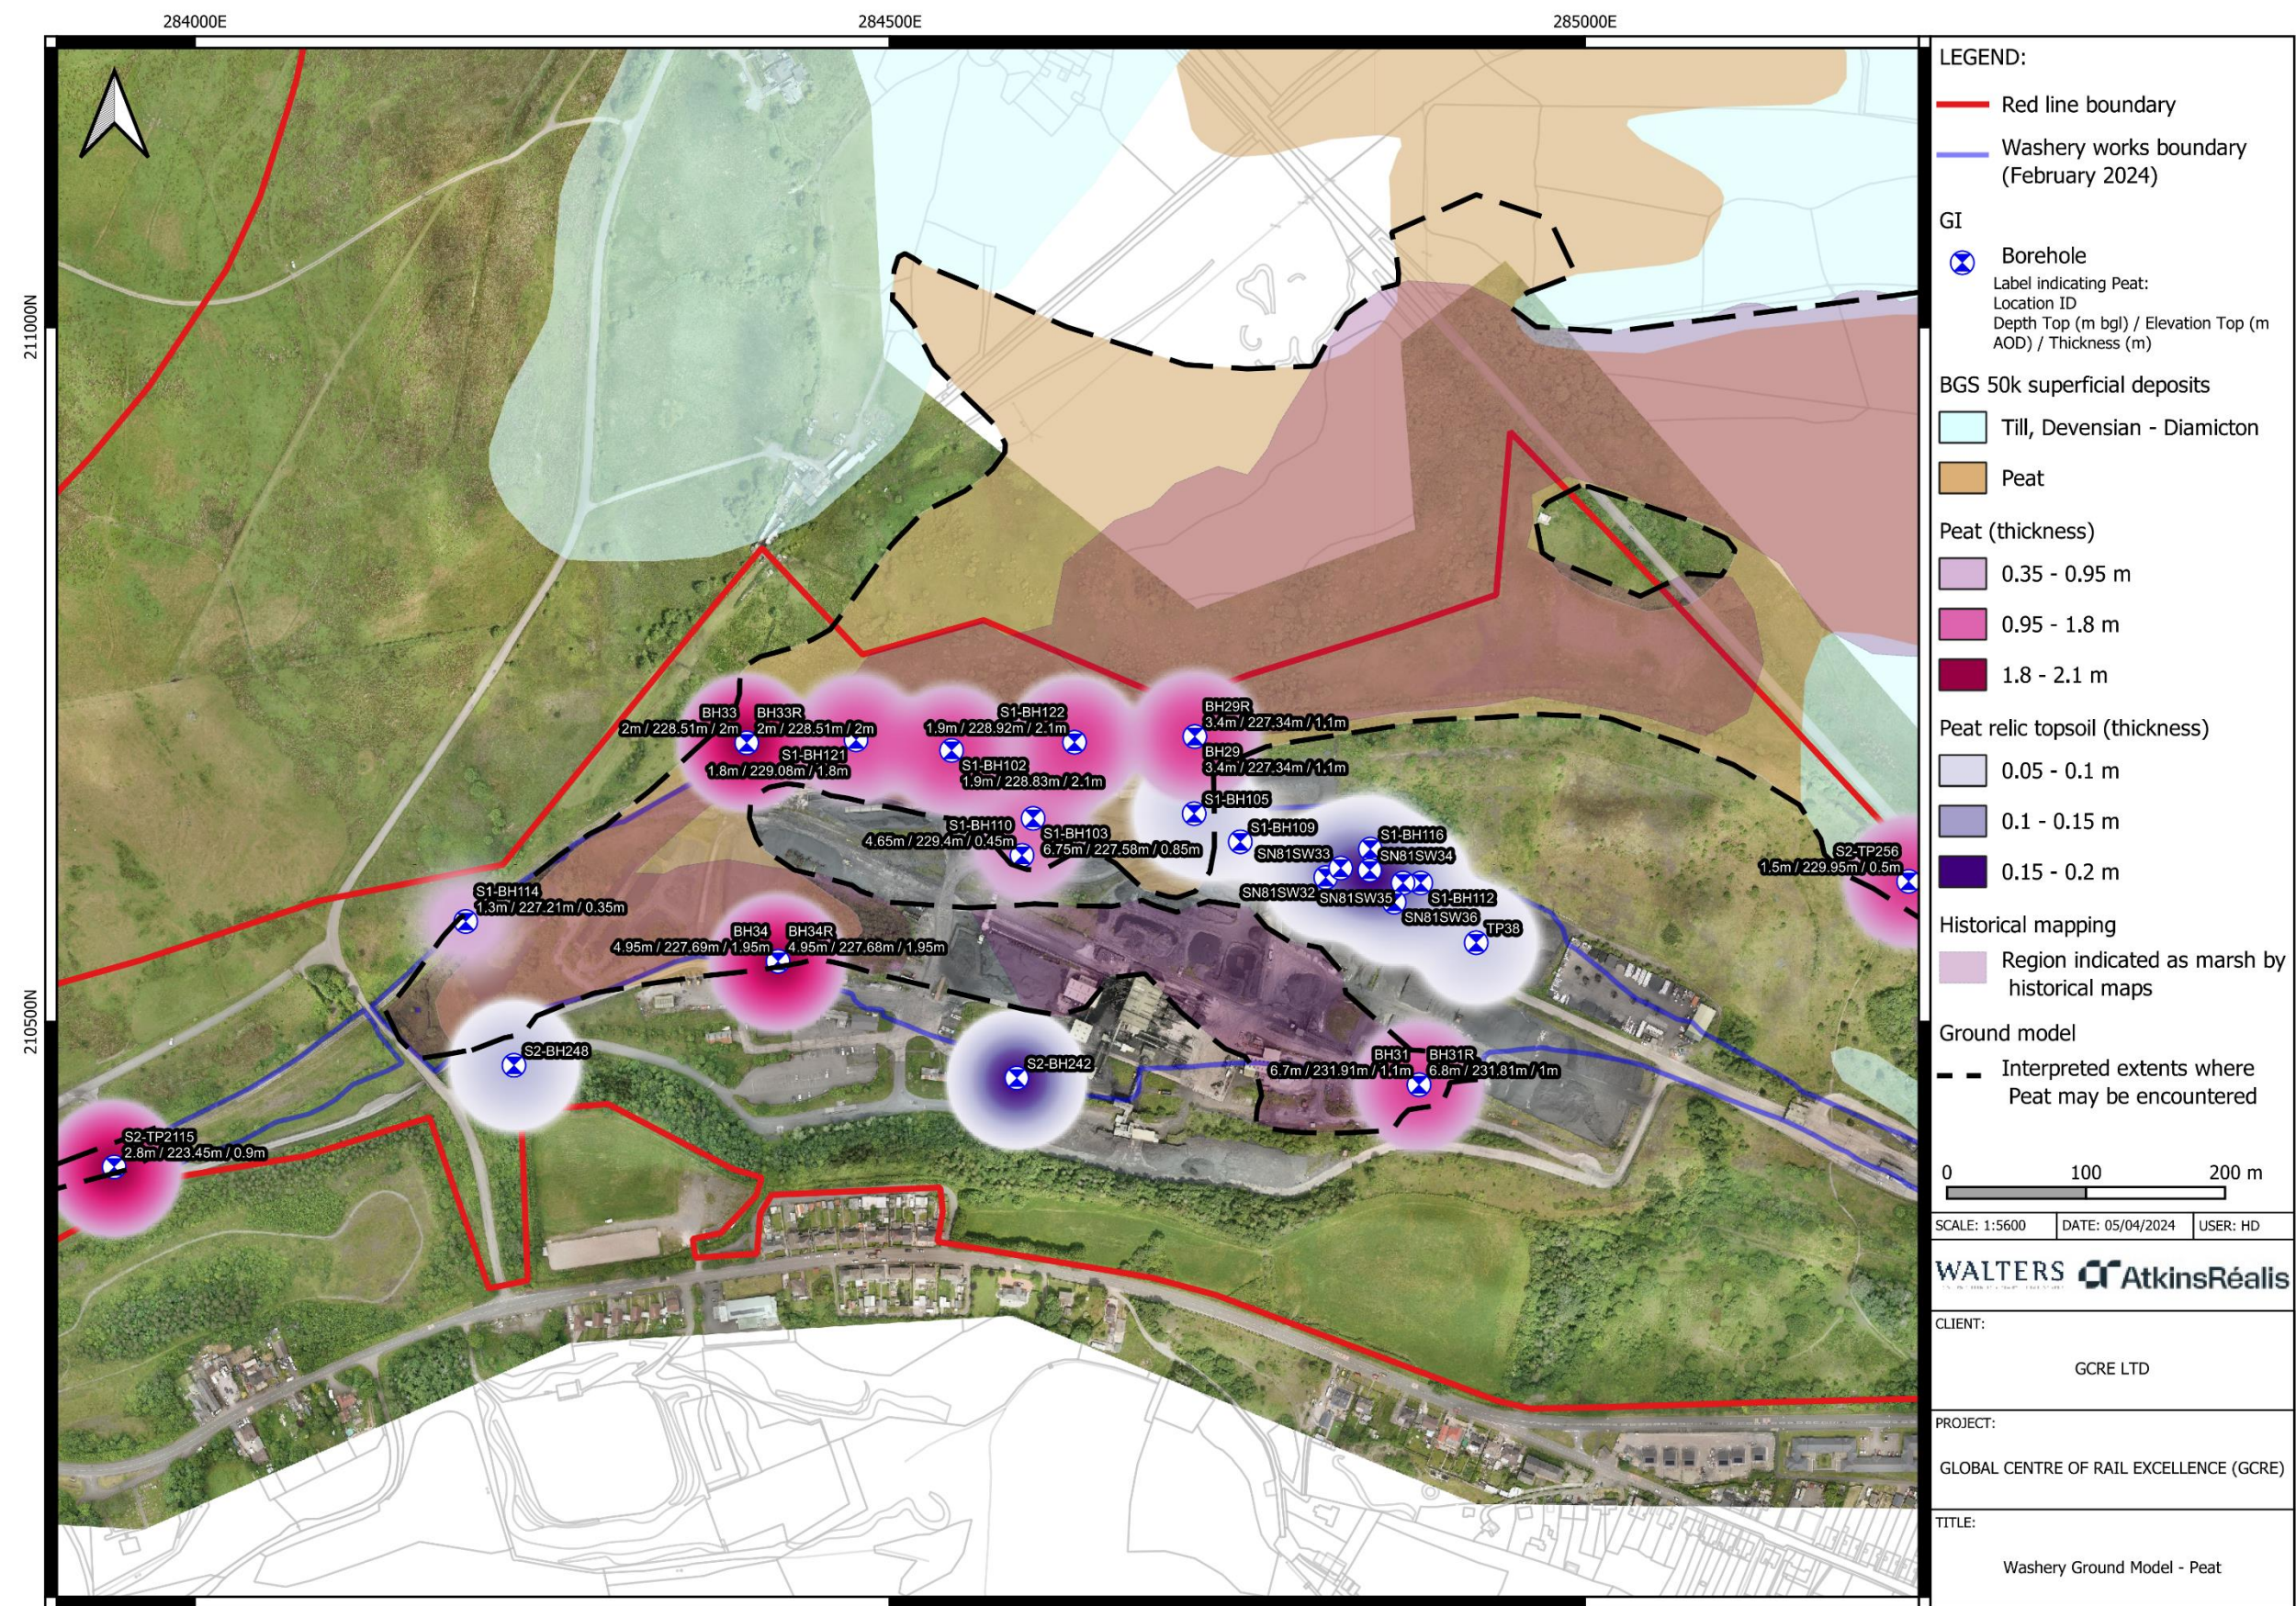
Figure 4-5 below provides an interpreted extent indicating where Peat may be encountered across the Washery.

Figure 4-5: Washery Ground Model – Peat (Imagery copyright AtkinsRéalis, [16])

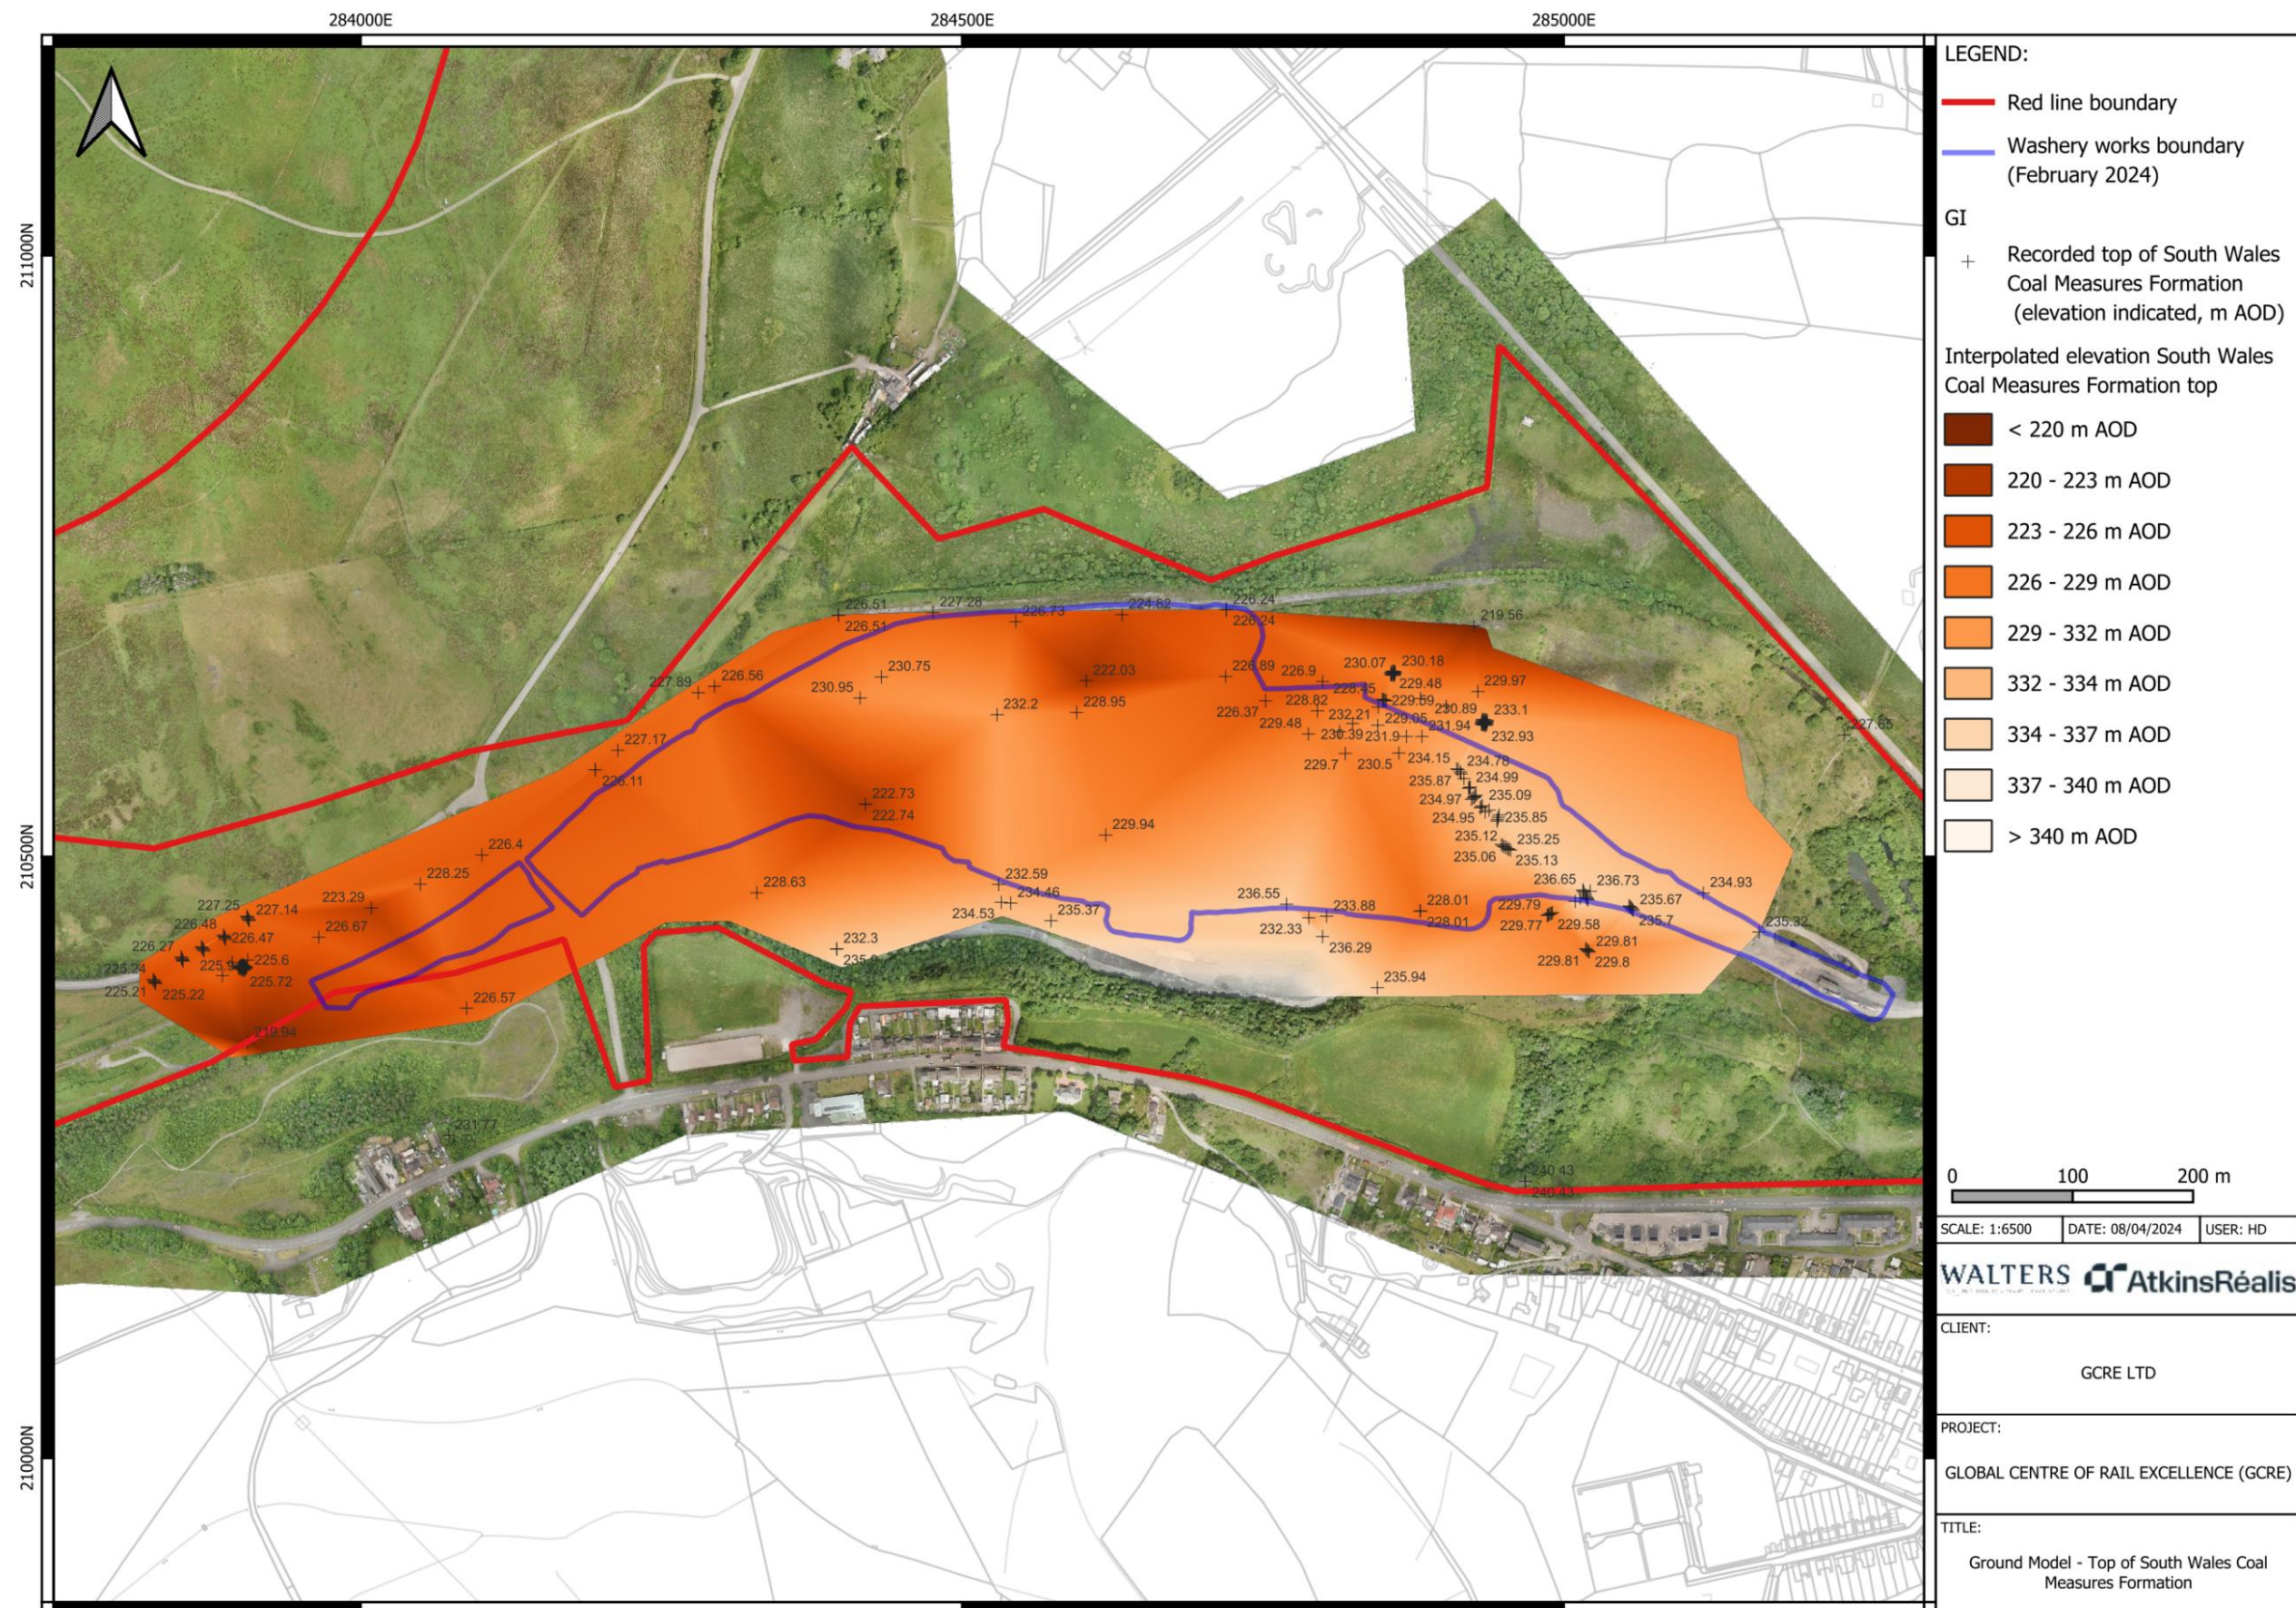
Due to the number and distribution of locations which encountered the bedrock, it was possible to interpolate a surface for the top of the material using the Delaunay triangulation algorithm. The algorithm utilises a nearest neighbour methodology to triangulate between the recorded locations. Areas with a large density of points are anticipated to be more accurate, with areas with large spacing between points likely to be less accurate where any unrecorded localised variations will not be captured. A plan showing the interpolated surface is shown within Figure 4-7.

Figure 4-7: Washery Ground Model – South Wales Coal Measures Formation (Imagery copyright AtkinsRéalis)

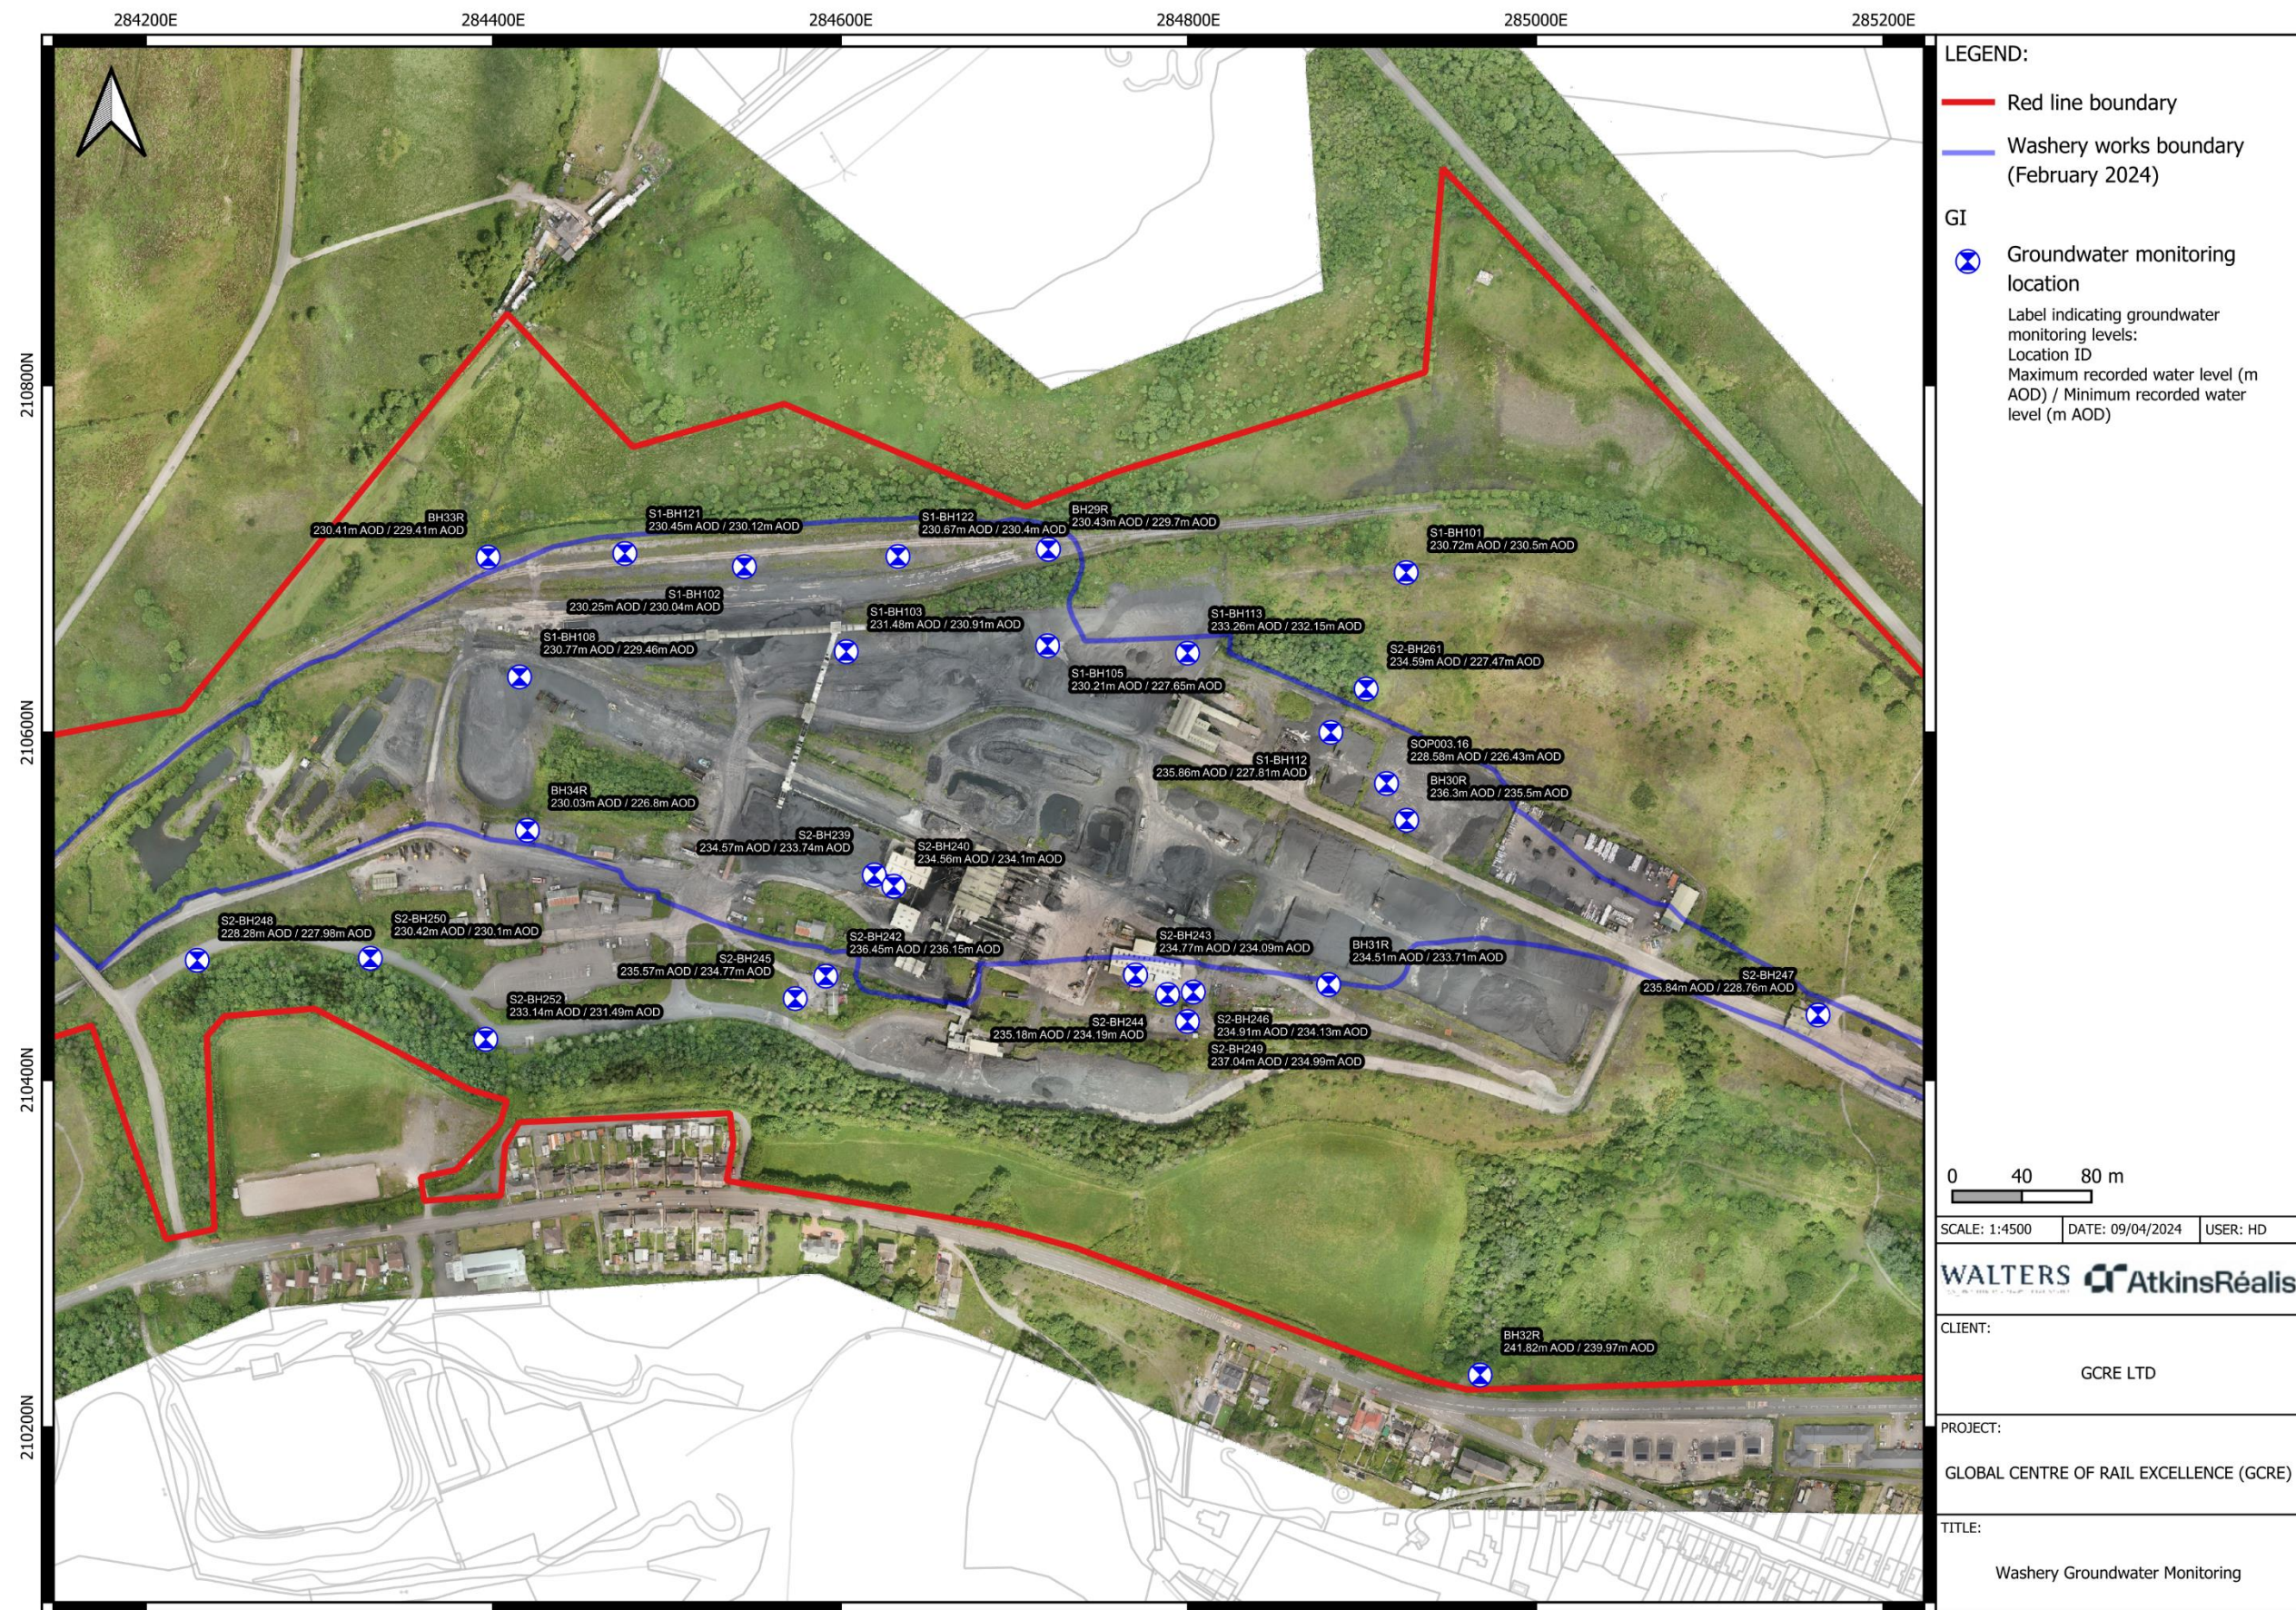
Figure 4-8: Washery Groundwater Monitoring (Imagery copyright AtkinsRéalis)
