**Global Centre of Rail Excellence (GCRE)**

**Stage 1 Ground Investigation**

**Factual Report**

**G22069**

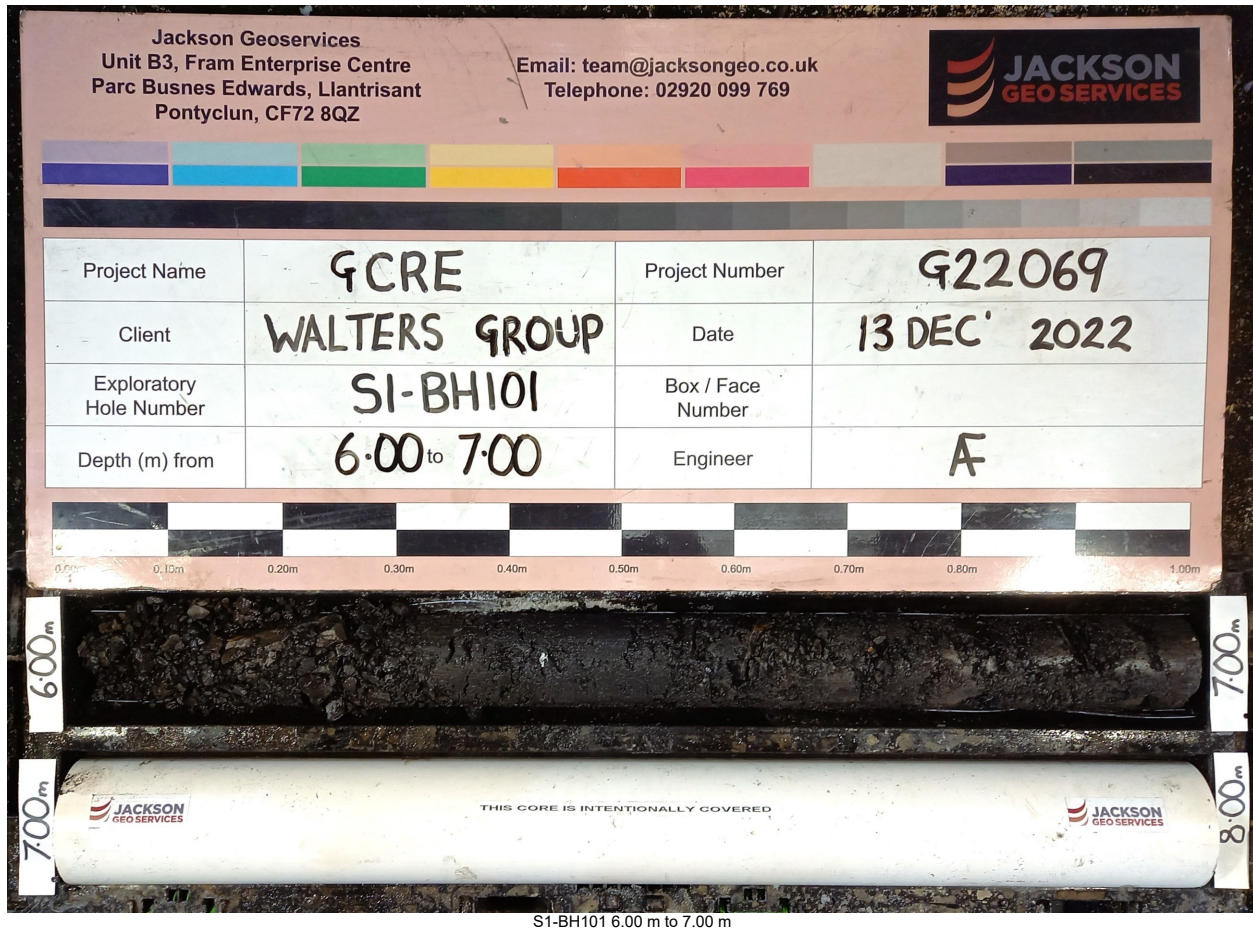
| | | <b>EXPLORATORY HOLE PHOTOGRAPHS</b> | | <b>Remarks</b><br>Hand excavated inspection pit from GL to 1.20m. Dynamic sampling from 1.20m to 17.00m. Rotary open holing from 17.00m to 21.60m. Rotary coring from 21.60m to 24.60m. | | <b>Exploratory Hole</b><br><br><b>S1-BH101</b> |
