| | | <b>EXPLORATORY HOLE PHOTOGRAPHS</b> | | <b>Remarks</b><br>Machine excavated trial pit from GL to 3.50m | | <b>Exploratory Hole</b> |
| <b>Project</b> | Global Centre of Rail Excellence | <b>Easting</b> | 284432.79 | <b>Equipment</b> | 21 Tonne Tracked Excavator | Sheet 2 of 3 |
| <b>Client</b> | Walters UK Limited | <b>Northing</b> | 210649.48 | <b>Method</b> | TP | |
| <b>Project No</b> | G22069 | <b>Level</b> | 231.25 mAOD | <b>Termination Reason</b> | Terminated on bedrock | |

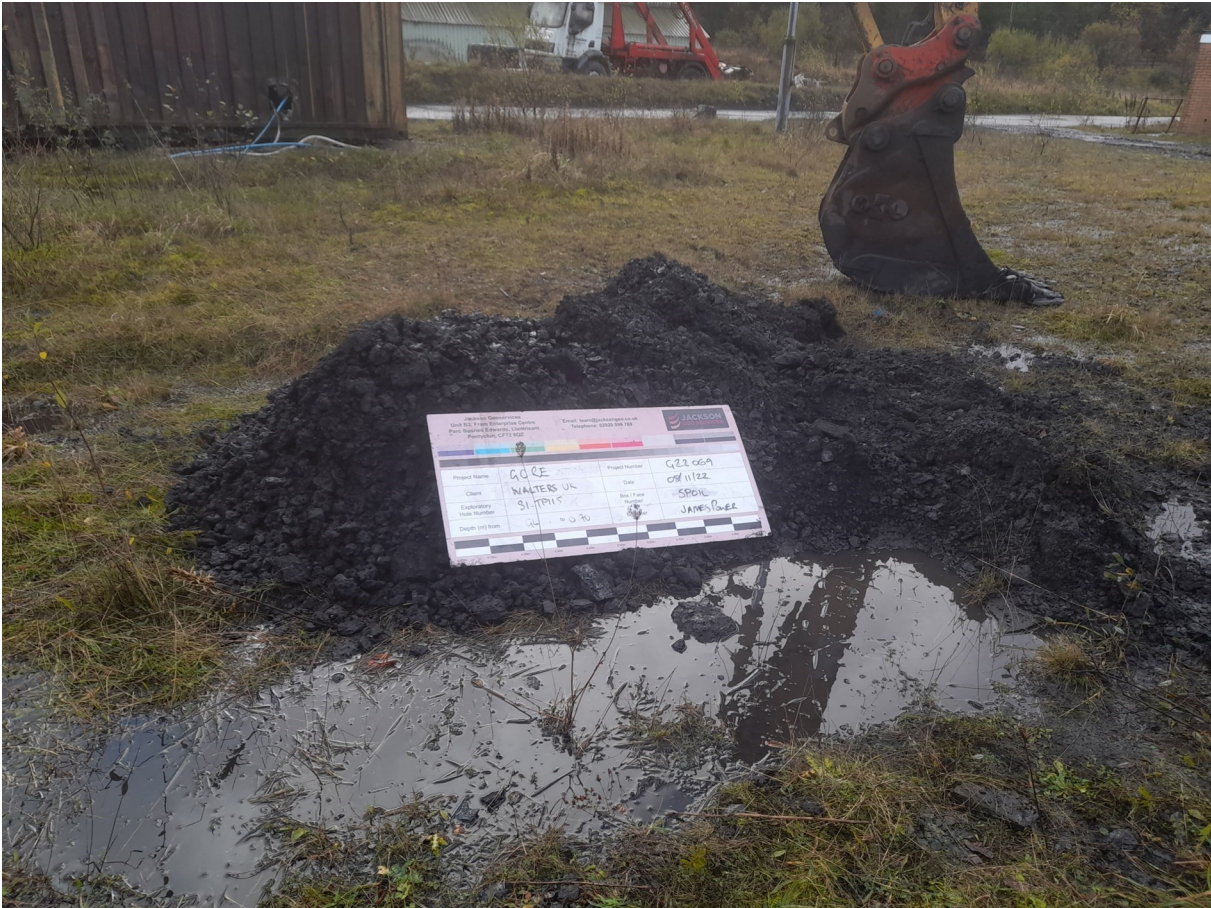
S1-TP115 Spoil

| 1 ES | 0.20 - 0.30 | PID: 1.5ppmv | 0.00 | 229.93 | | Black sandy silty angular to subangular fine to coarse GRAVEL of mudstone, siltstone, sandstone and coal with low cobble content. Sand is fine to coarse locally of ash. Cobbles are angular of mudstone, sandstone and coal. Occasional gravel sized fragments of ceramic. Occasional pieces of cloth (up to 600x500mm). Occasional fragments of wood (up to 130x80mm). (MADE GROUND) Geology Code: MGR 2nd Geology Code: GR | | | | 0.50 | | | |

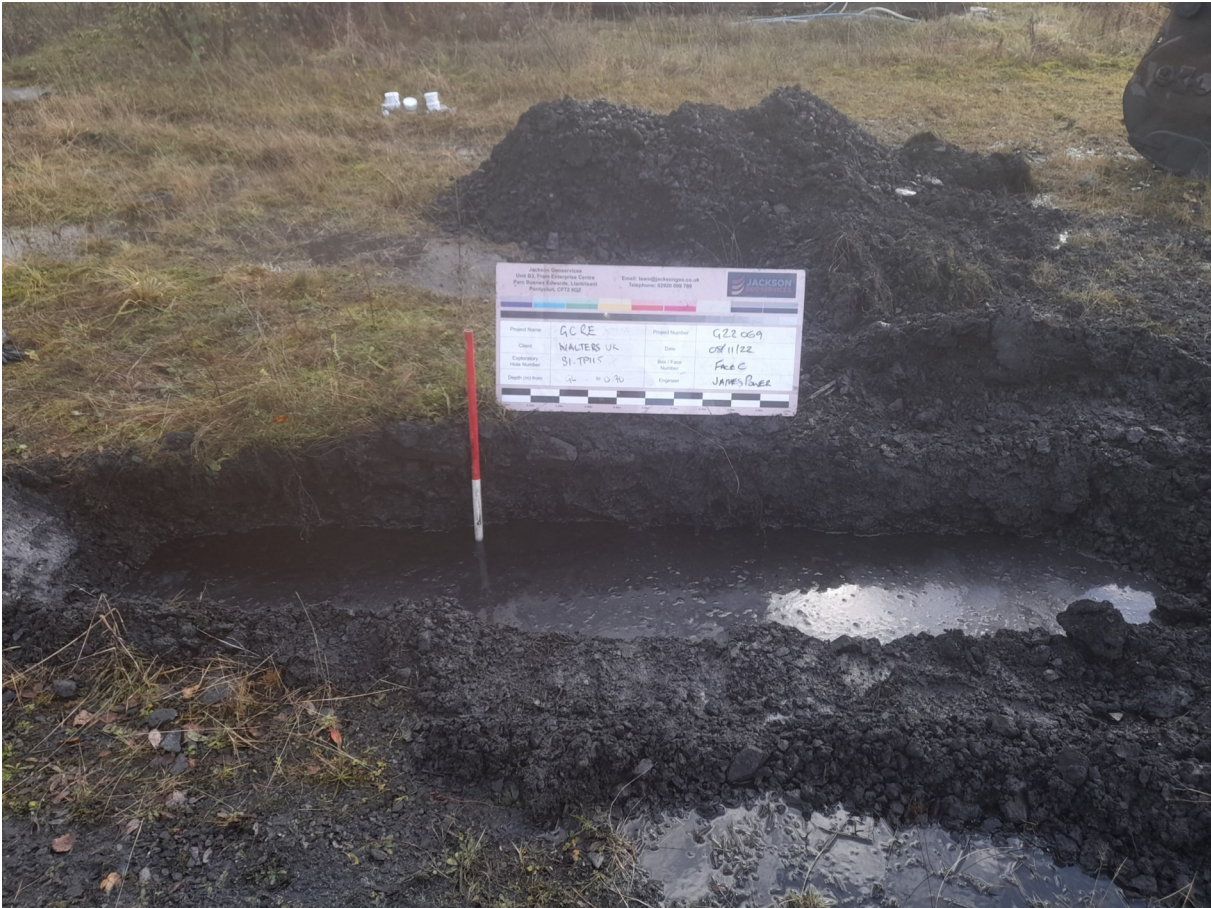
S1-TP115 Face C

| | | 08/11/2022 10:11 | | 0.70 | 0.35 | 20mins | Fast inflow from Face C | | | | | | |
