| Project | Global Centre of Rail Excellence (GCRE)<br>Stage 2 | Easting | 284581.21 | Equipment | JCB 220X 1c | Sheet 1 of 3 |

| <div></div> | | | | TRIAL PIT EXPLORATORY HOLE LOG | | | | Exploratory Hole Progress by Time | | | Exploratory Hole | |

| <div></div> | | | | TRIAL PIT EXPLORATORY HOLE LOG | | | | Exploratory Hole Progress by Time | | | Exploratory Hole | |

| <div></div> | | TRIAL PIT EXPLORATORY HOLE LOG | | | | | | Exploratory Hole Progress by Time | | | Exploratory Hole | | | |

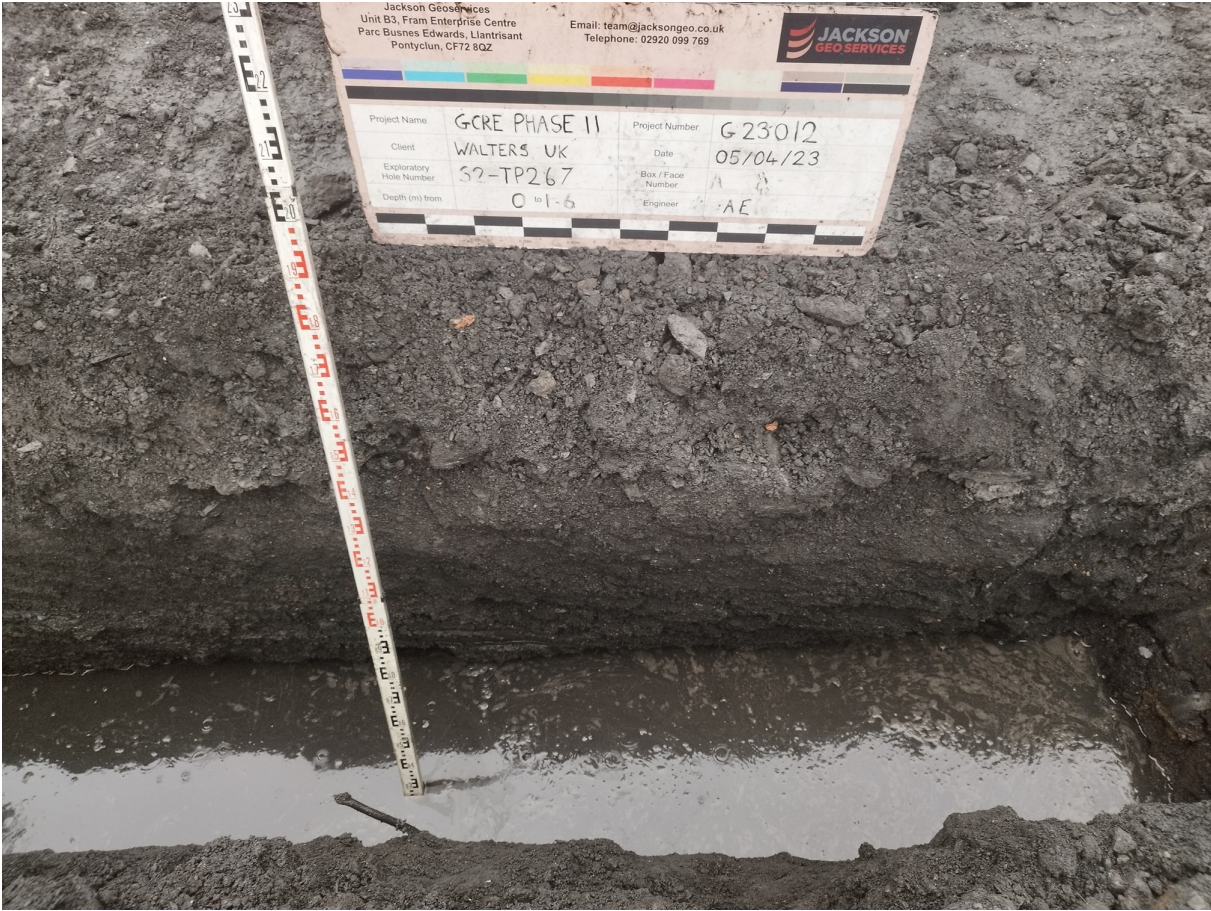
S2-TP267 Face A

| Stability Collapse Face A and C 1.00-1.60m | | | | | | 05/04/2023 16:10 | | 1.50 | 1.20 | 20mins | Fast inflow | |

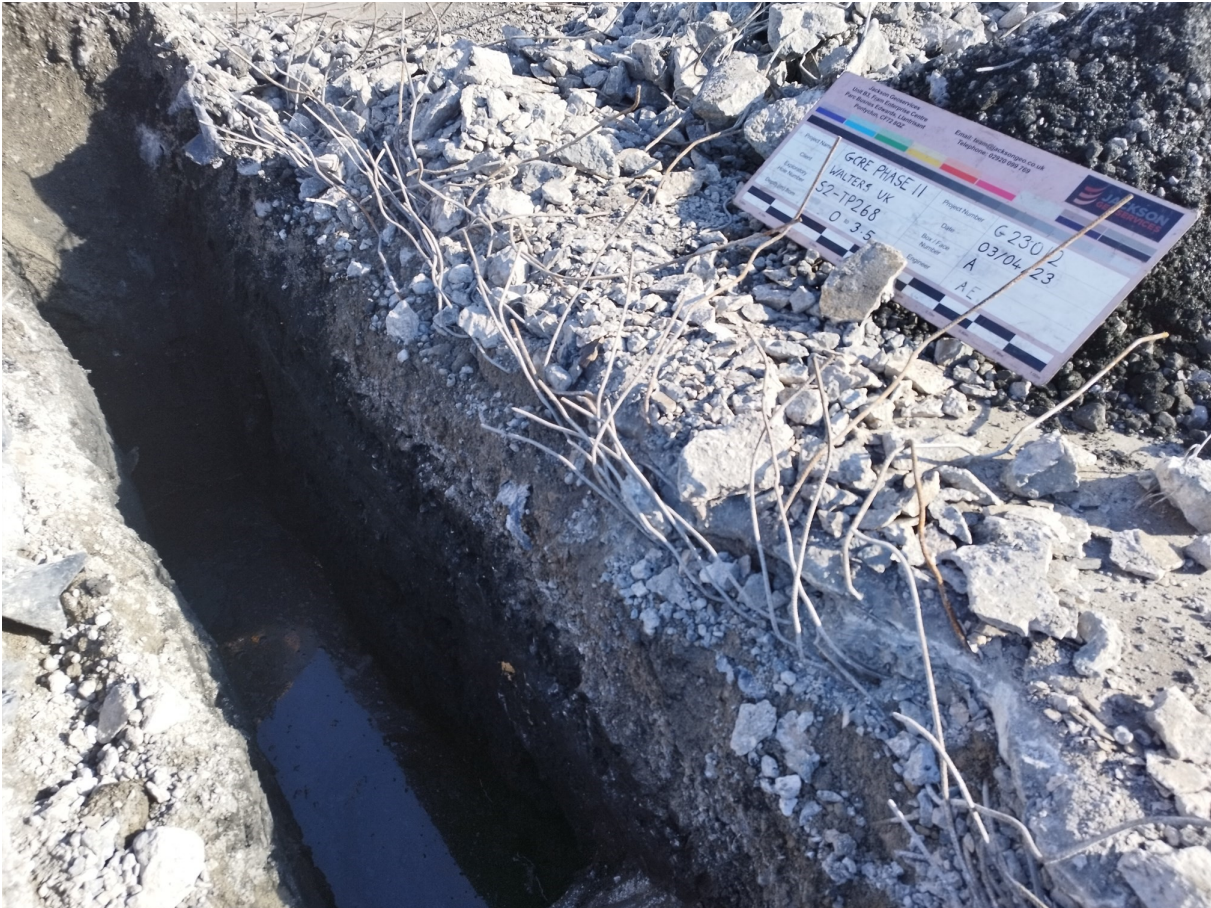
S2-TP268 Face A

| Stability | Collapse. Face A 2.50-3.00m. | | | | | Log presents Face A unless otherwise noted. | 03/04/2023 16:10<br>03/04/2023 16:30 | 1.80<br>3.40 | 1.80<br>2.70 | 20mins<br>20mins | Slow inflow<br>Fast inflow | |

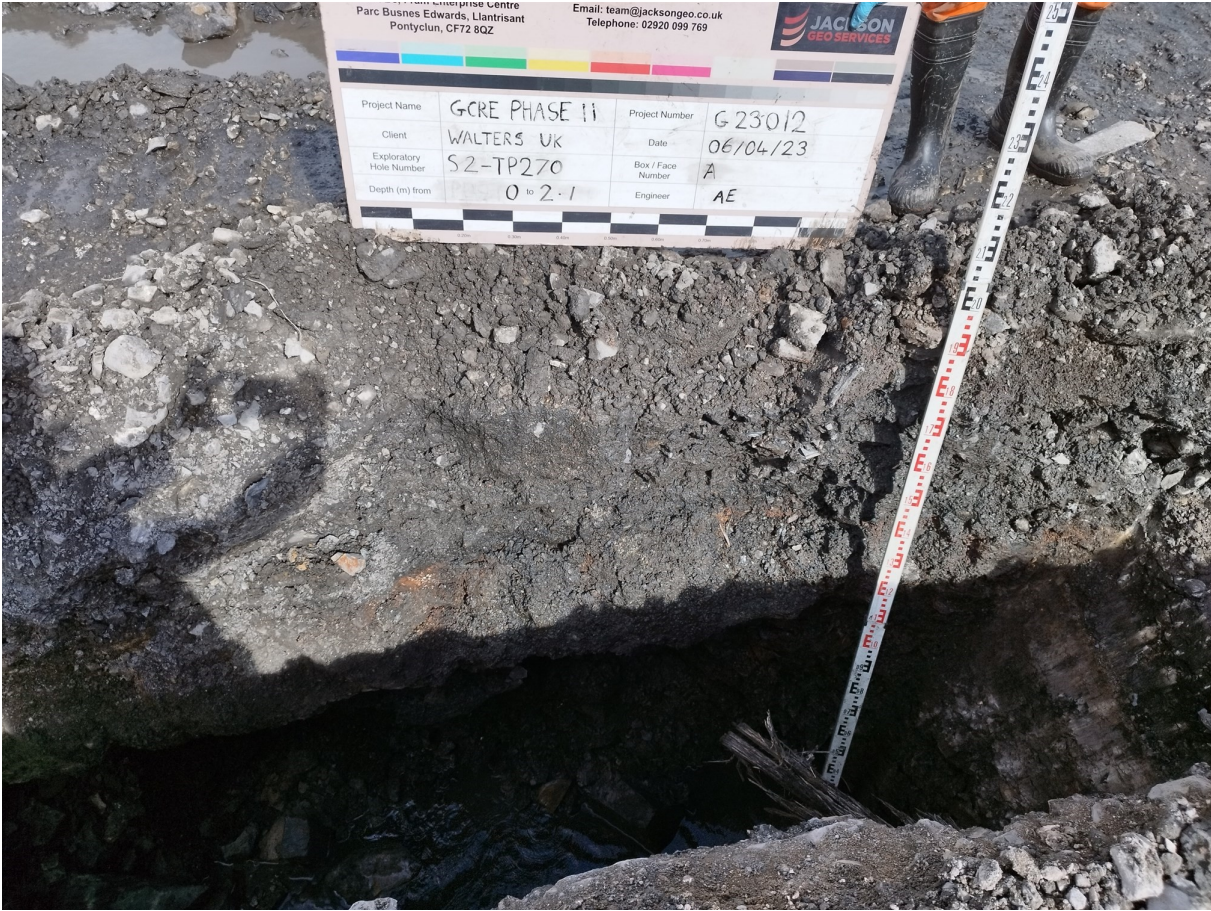
S2-TP270 Face A

| Stability | Collapse Face A and C | | | | | | | 06/04/2023 11:35 | | 2.00 | 1.90 | 20mins | Fast | |
