**Bluefield Land Limited**

**Pontardawe Foundry  
Old Foundry Road, Pontardawe, SA8 4EZ**

**Site Investigation Report**

12360/RAH/19/SI/RevC

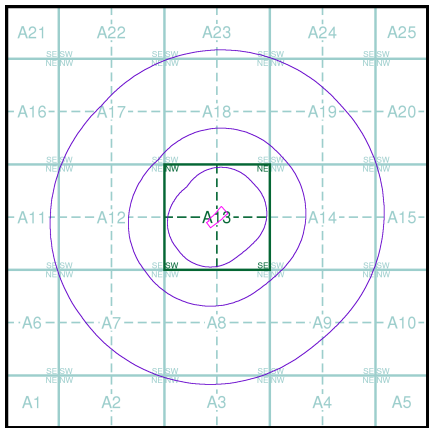
## Industrial Land Use Map - Slice A

- Contemporary Trade Directory Entry
- Fuel Station Entry
- Gas Pipeline
- Points of Interest - Commercial Services
- Points of Interest - Education and Health
- Points of Interest - Manufacturing and Production
- Points of Interest - Public Infrastructure
- Points of Interest - Recreational and Environmental
- Underground Electrical Cables

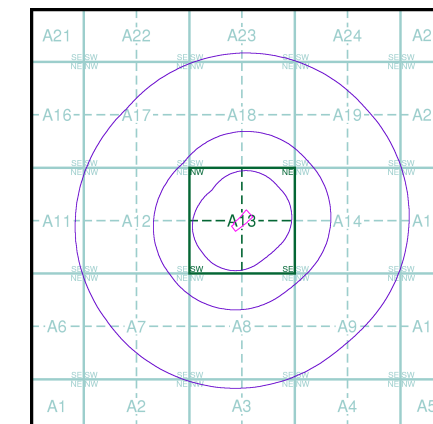
Flood Map - Slice A

- Extreme Flooding from Rivers or Sea without Defences (Zone 2)
- Flooding from Rivers or Sea without Defences (Zone 3)
- Area Benefiting from Flood Defence
- Flood Water Storage Areas
- Flood Defence

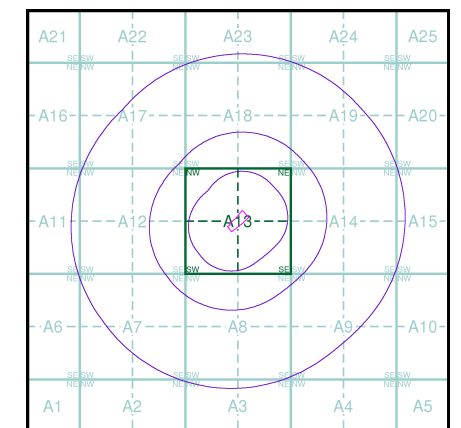
## OS Water Network Map - Slice A

- Standard Contour 105 100 95
- Master Contour 105 100 95
- Spot Height 167.3
- MLW Mean Low Water
- MHW Mean High Water

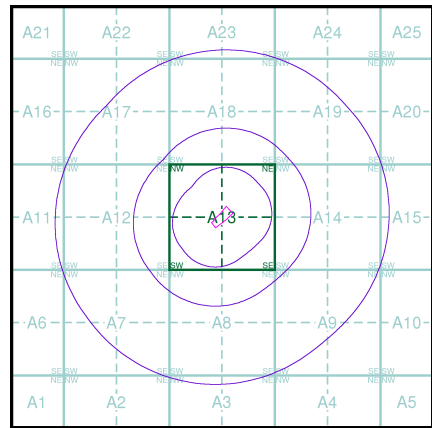
## Estimated Soil Chemistry Lead - Slice A

Lead Concentrations mg/kg

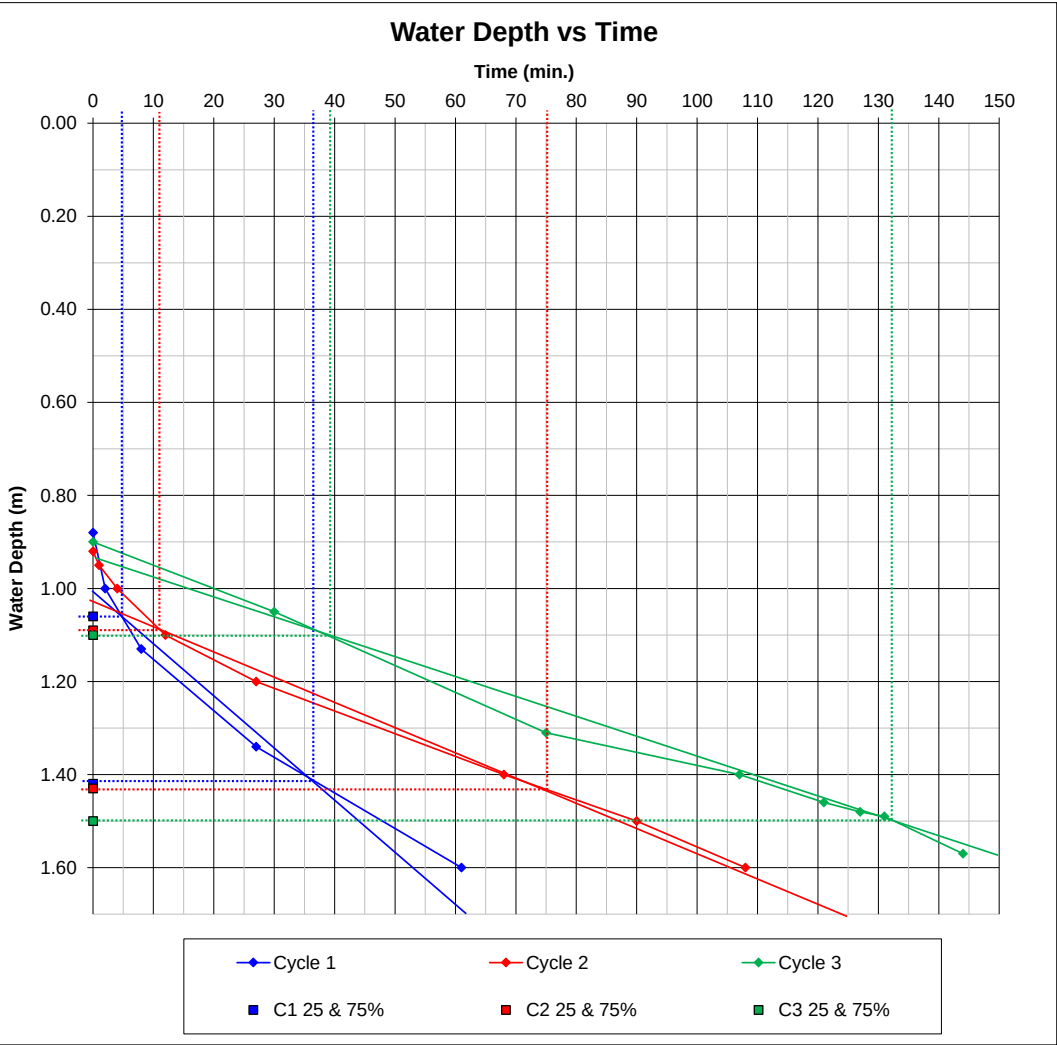
| | Cycle 1 | Cycle 2 | Cycle 3 |
|---|---|---|---|
| Over 75% - 25% effective depth | 8.4E-05 | 4.1E-05 | 3.0E-05 |

Design Soil Infiltration Rate: 3.0E-05 m/s

Large scale infiltration testing was completed in one trial pit only (TP104), three repeat cycles were undertaken on 04/02/2019.
