**PHASE 1 HABITAT SURVEY,**  
**17 PENYGRAIG ROAD, ALLTWEN,**  
**NEATH-PORT TALBOT.**

**LISA ROWE and GARETH GRIFFITHS**

**August 2023**

Preliminary Ecological Appraisal and Preliminary Roost Assessment, 17 Penygraig Road,  
Alltwen  
Hawkeswood Ecology – August 2023

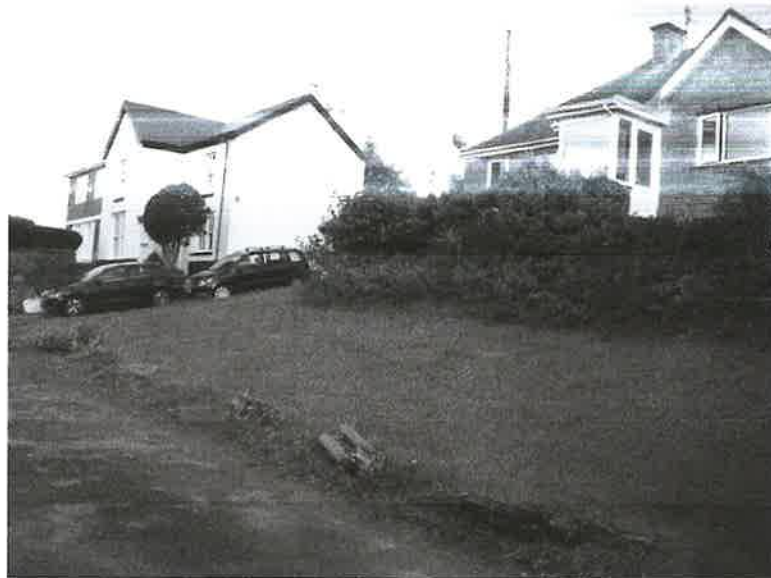
- 5.8 In its current condition, the Site is only likely to support breeding birds in the front garden shrubbery. There was no evidence of birds using the structures on Site for breeding purposes. There is limited potential for common lizard to occur near the drystone walls but given the managed nature of the gardens it is unlikely that they are widespread throughout. There are no other opportunities on the Site for other protected species.

The front lawn and shrubbery

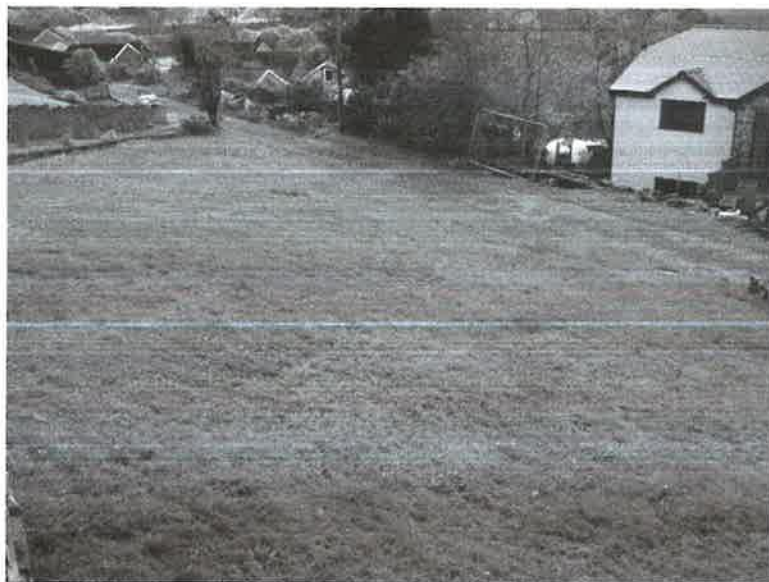
The front lawn to east of the bungalow.

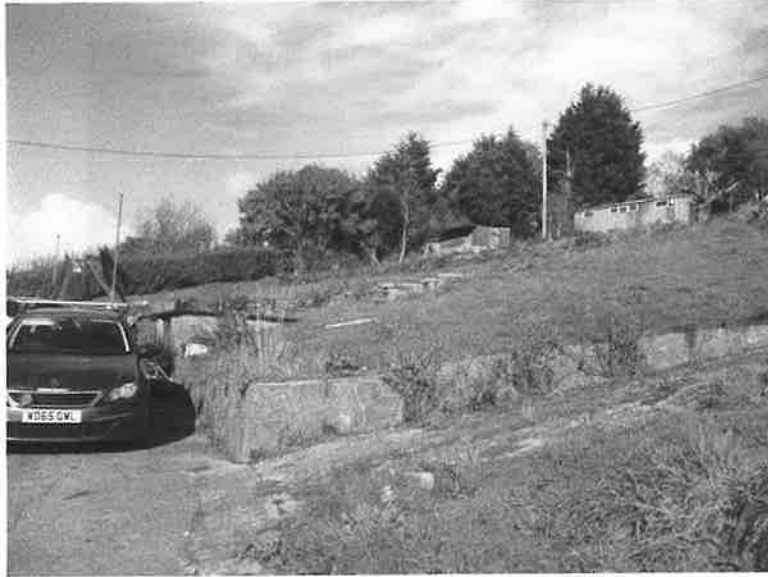
- 5.5 A number of buildings are found at TN's 8, 9, 10 and 11. These are sheds related to the chicken run and keeping stock. No animals are kept now. At TN8 is a block built base with a wooden upper half wall shed which was the main chicken house. The roof is metal profile and polycarbonate 'lights'. Part of the wooden wall is covered with bitumen shed felt which is tight and generally secure. At TN9 is a single skin block shed approximately 1 metre in height with a corrugated zinc sheet roof. The building is sealed and not considered suitable for bats.

- 5.6 AT TN 10 is a timber shed built with plywood walls and a chicken wire frontage. The building is open and has polycarbonate lights in the roof. This building is not considered suitable for bats. The large shed at TN11 is a single skin block built structure which is rendered. The render does have cracks on the south eastern elevation but is generally in fair condition. The roof is metal profile. The building is used for storage and as a workshop and is maintained in good order, it is to be retained.

Views across the rear garden showing the small chicken sheds and the larger workshop

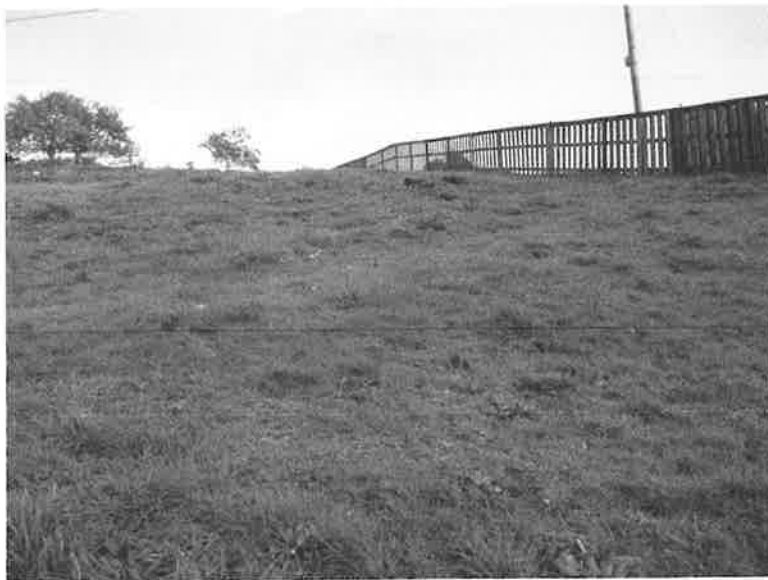
Views to the eastern rear garden boundary

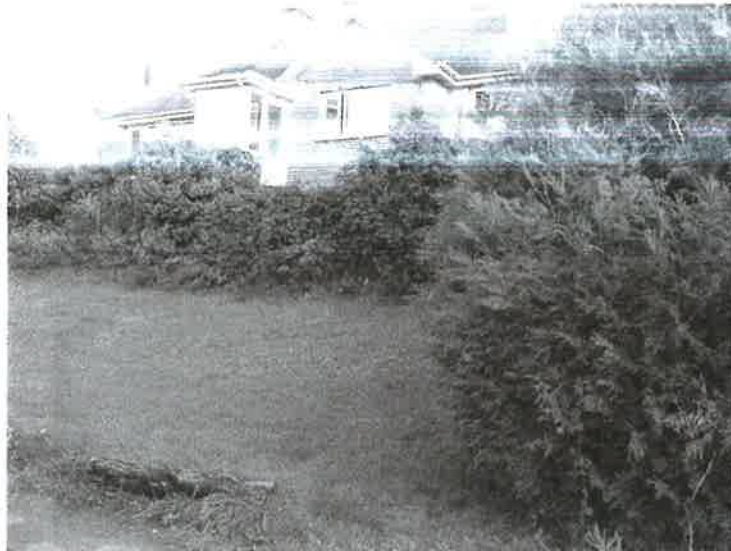
- 5.12 Externally, the bungalow is brick and block built with the front elevation stone faced and the remainder rendered. Generally, the render is in good condition, movement of the eastern part of the bungalow has resulted in cracks in the stone facing and the eastern end of the roof, particularly at the ridge.

The front elevation.

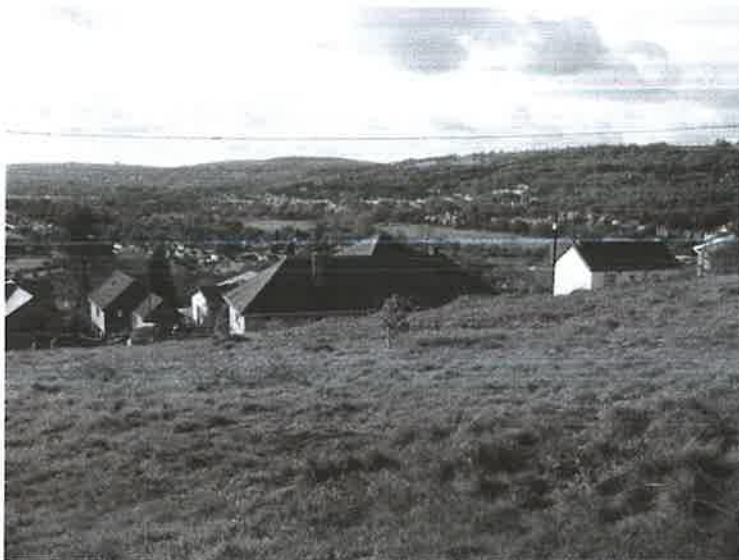
- 5.11 Of the buildings on Site, the bungalow is the only one with significant potential to support the presence of bats. It dates from the 1940's or 50's but has suffered from damage due to apparent slippage of the ground beneath it; it is sited on a relatively steep south facing slope. The nature of the structural problems leading to the requirement to demolish the

structure has resulted in some cracks in the wall and obvious movement in the roof. At the time of the PRA the house was lived in but the owners have now moved to temporary accommodation as they considered the house unfit for habitation.

Looking across the garden to the rear of the property

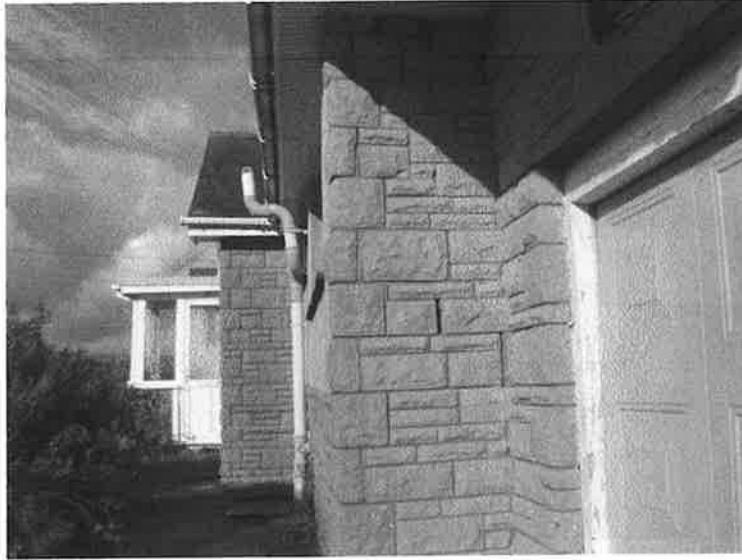
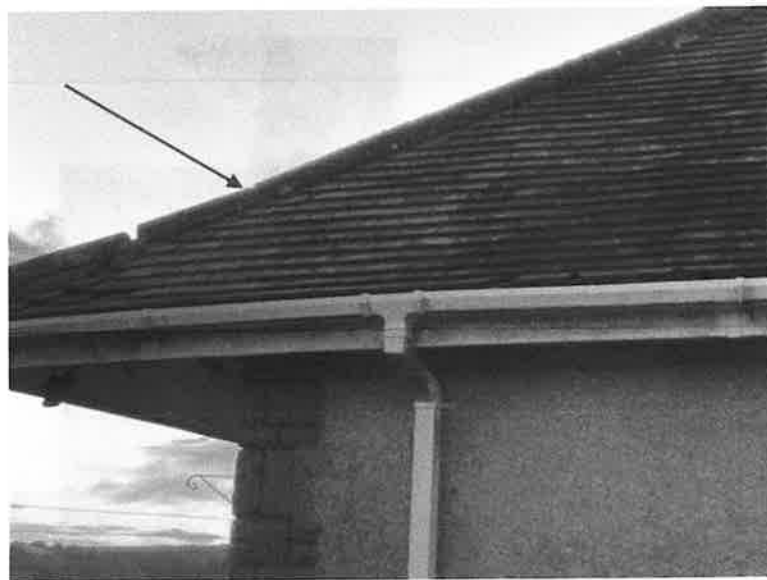
- 5.13 The roof is clay tiled with two stone chimneys. Gaps in the ridge were evident and gaps under the flashing on both chimneys. A dormer window at the front was well sealed although some rot was evident in a fascia board. All roof ancillaries, soffits and bargeboards etc are of UPVC construction.

- 5.21 Activity was less than the May observation and consisted of mainly common pipistrelle with only three soprano pipistrelle passes noted. **The first bat seen was a common pipistrelle emerging from the eastern gable hip ridge at 22.00.**
- 5.22 Common pipistrelle were noted flying up Penygraig Road from the east with no repetition of bats flying in from gardens to the west. Foraging was sporadic throughout the survey. The only other species recorded was a noctule overflying at 22.53. No further activity was associated with the property.

Cracks in the stone facing above, loose ridge tiles, below (Bat emergence location indicated)

- 8.14 Given the building condition, the ridge tiles and eastern hipped area of the roof will be stripped in the presence of the ECW. The tiles and flashing around both chimneys will also be stripped in the presence of the ECW.

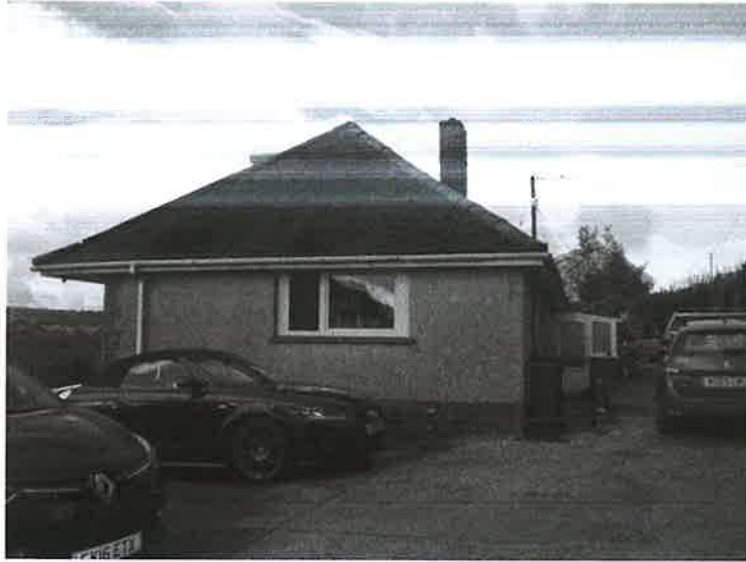
The eastern gable where most of the movement appears to have occurred.

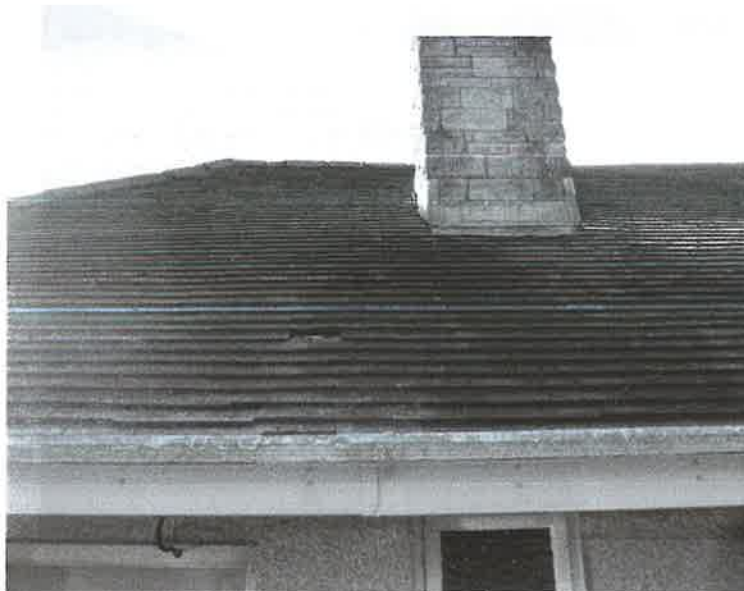
The eastern chimney and hipped roof

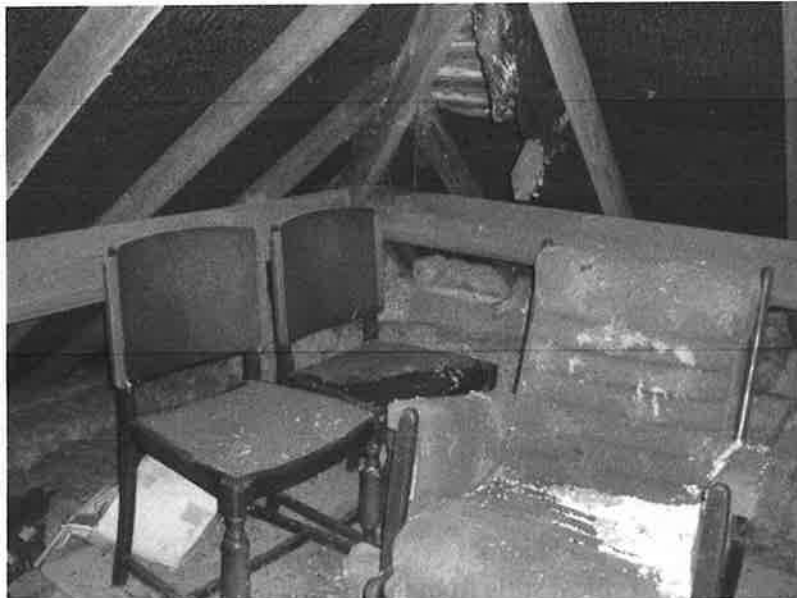
The loft area under the eastern hipped gable

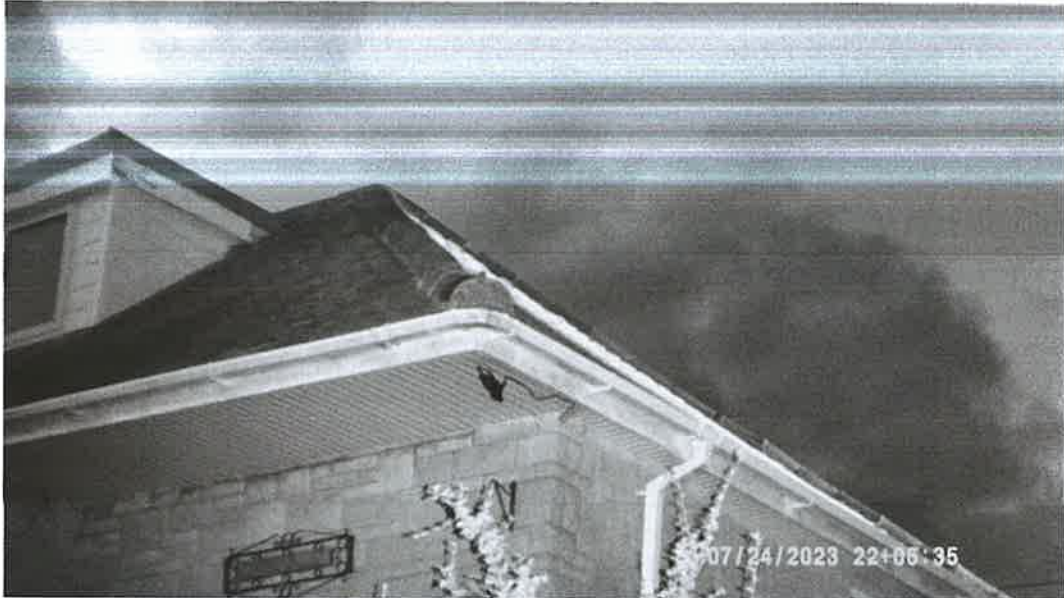
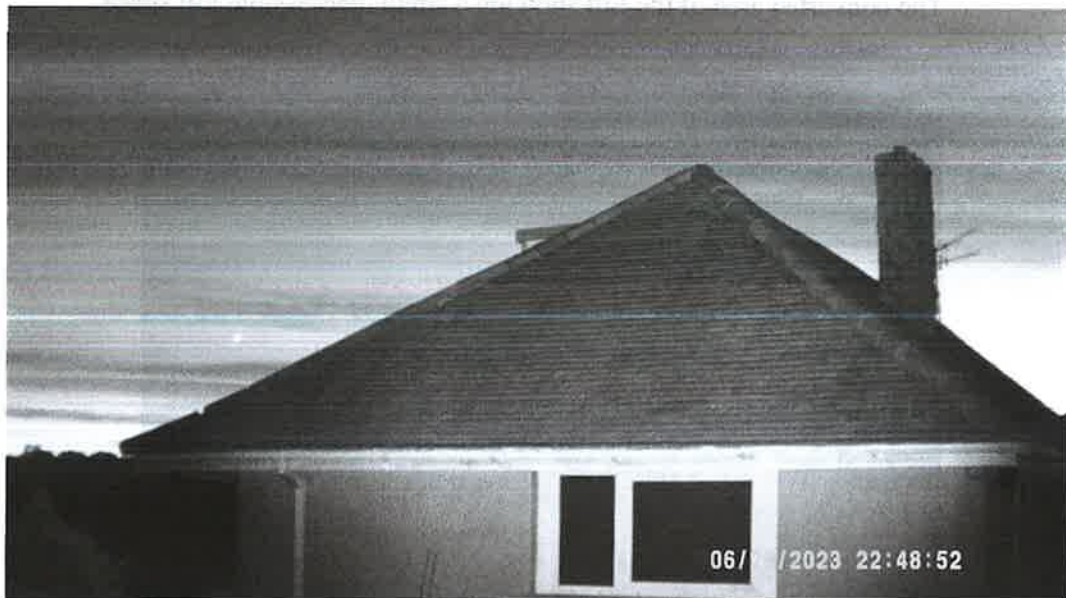
The PRA found the building to be in a relatively sealed condition with the majority of potential bat access points related to the chimneys and the eastern gable end where the hipped roof appears to have moved causing movement of tiles and ridge tiles on the hipped roof and there are cracks in the stone facing. Subsequent observation surveys identified a single common pipistrelle emerging from the hipped ridge during the second observation.

Typical stills from the NVA videos
