## **Method Statement 2<sup>nd</sup> July 2024**

In their response to planning application P2023/0861 dated 10<sup>th</sup> May 2024, Natural Resources Wales ( NRW) requested a Method Statement setting out the actions to be taken to safeguard the water environment should any engineered soakaway / structures be identified during the phased removal of the tip located along the eastern edge of Gwrhyd Quarry.

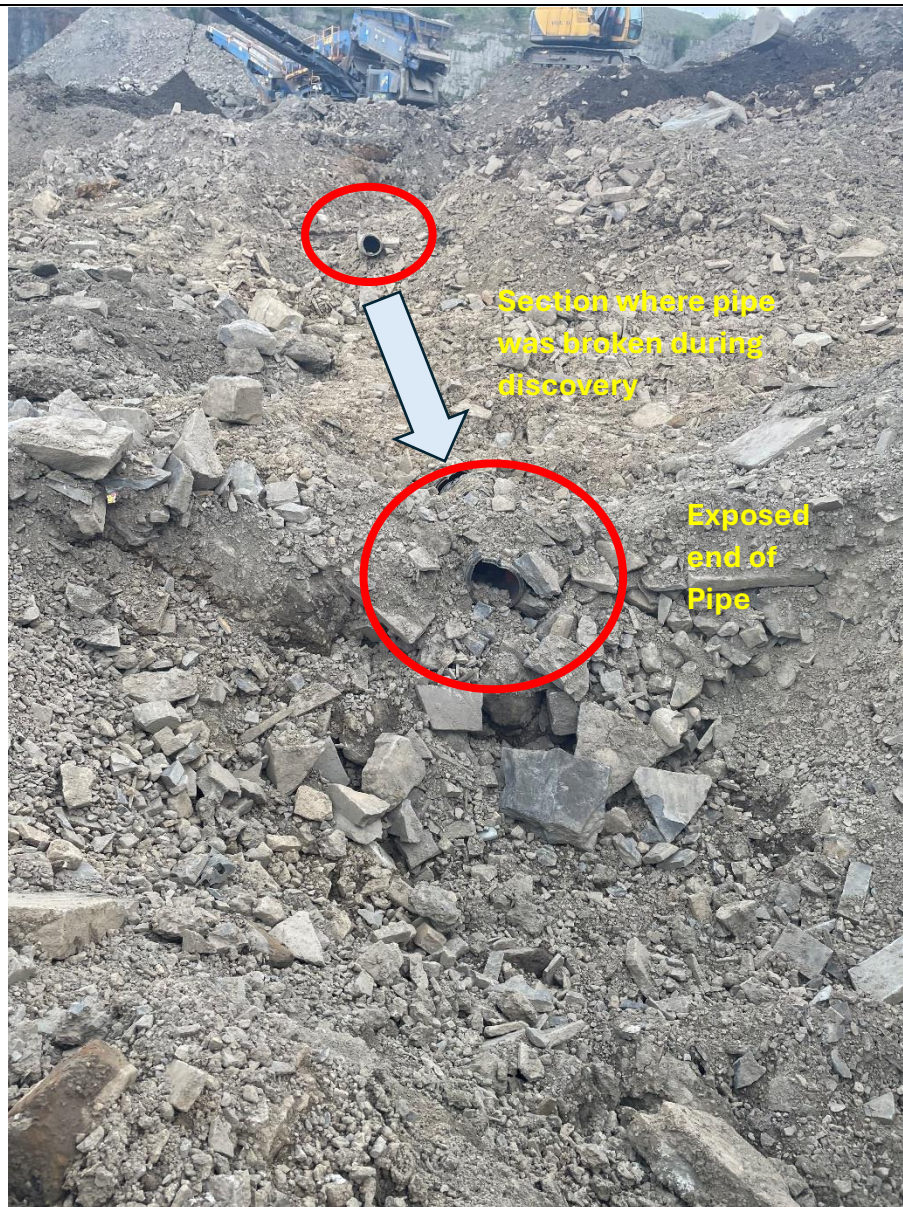
1. Looking north-west, showing end of pipe, located within quarry "Red Line" boundary with no water flow. Gap in pipe is shown where bulldozer excavated it initially. Remaining pipe section is seen with screen and stockpiles above.

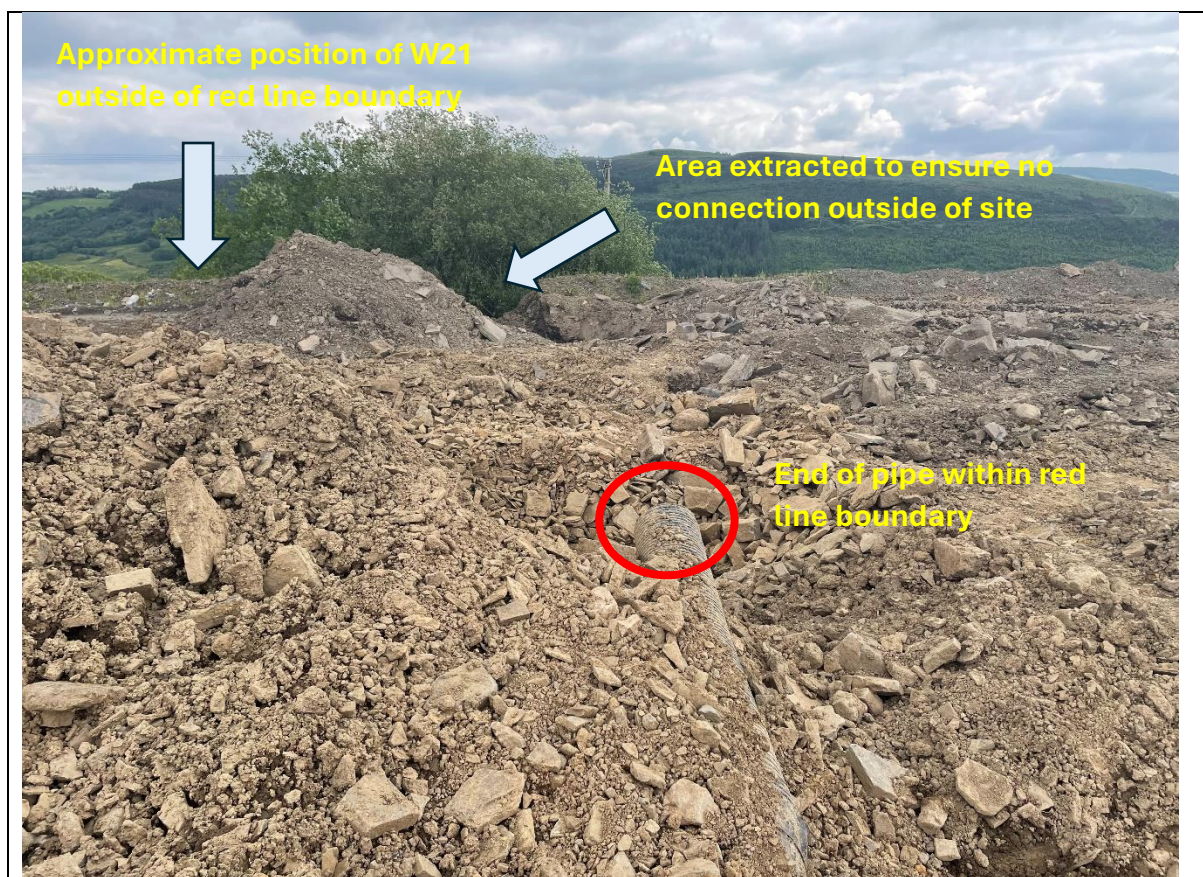
2. Looking south-east, showing end of pipe towards boundary of the approved quarry area. Approximate location of W21 feature outside of the quarry is identified.

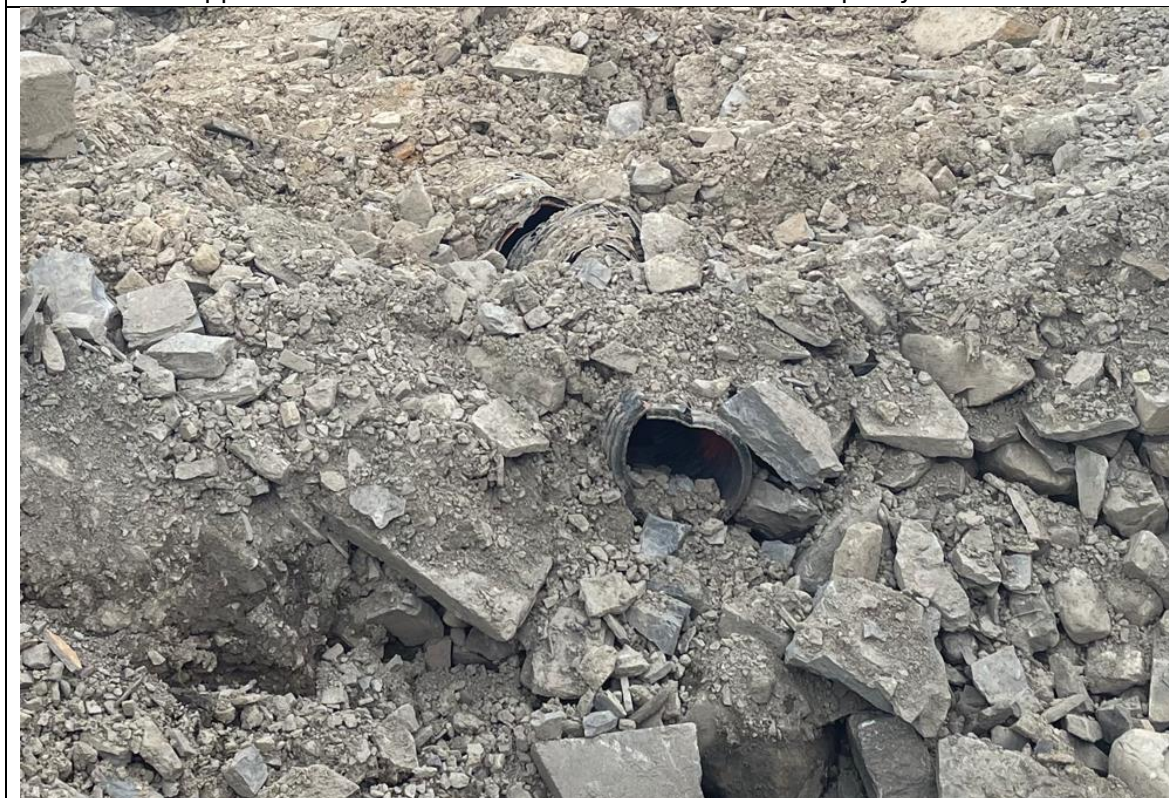
3. Close up view of end of pipe confirming no flow of water.

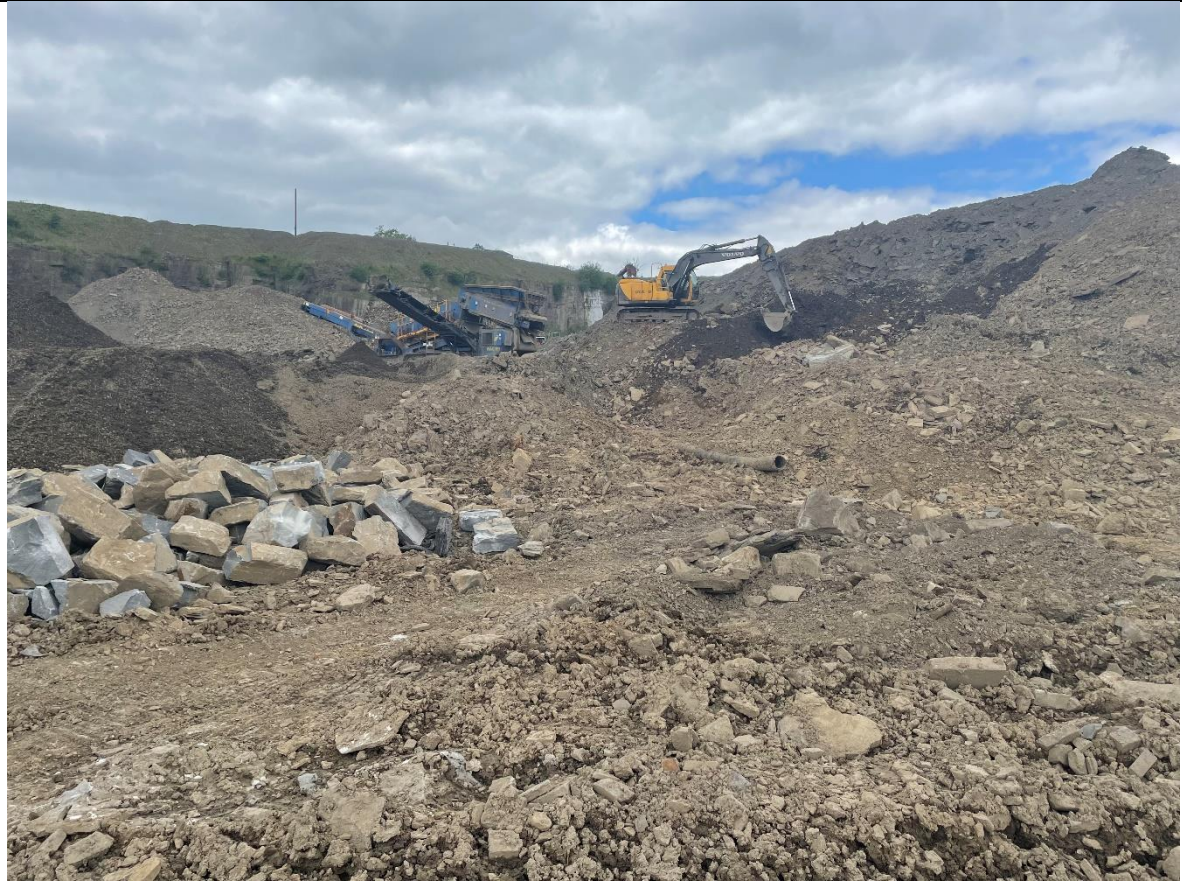
4. View of pipeline traced back to location of screen / screened material stockpile with mineral tip in background in process of being removed in line with Phasing Plan.

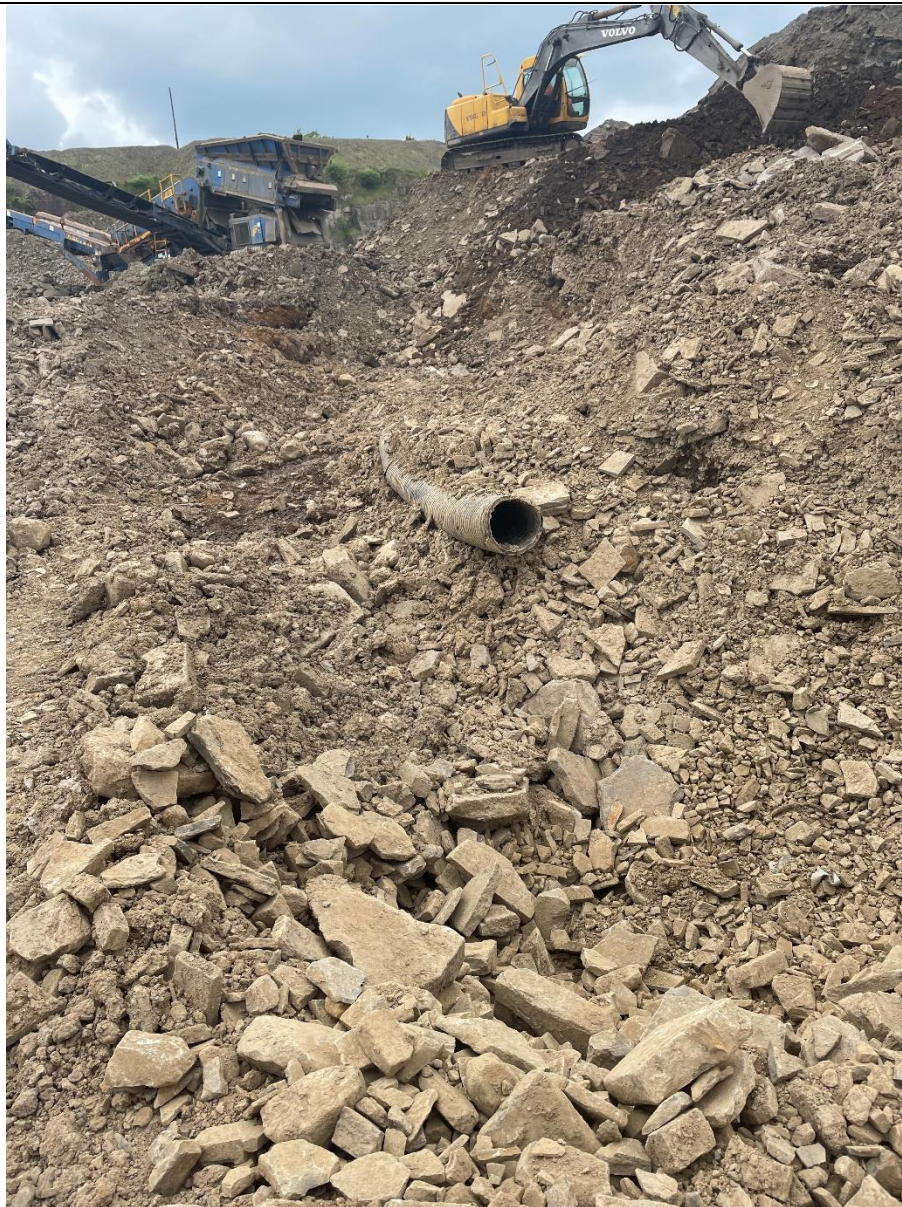
5. Remaining section of pipe. Pipe is visibly clear of any water and is seen to be surrounded by the overlying tip material.

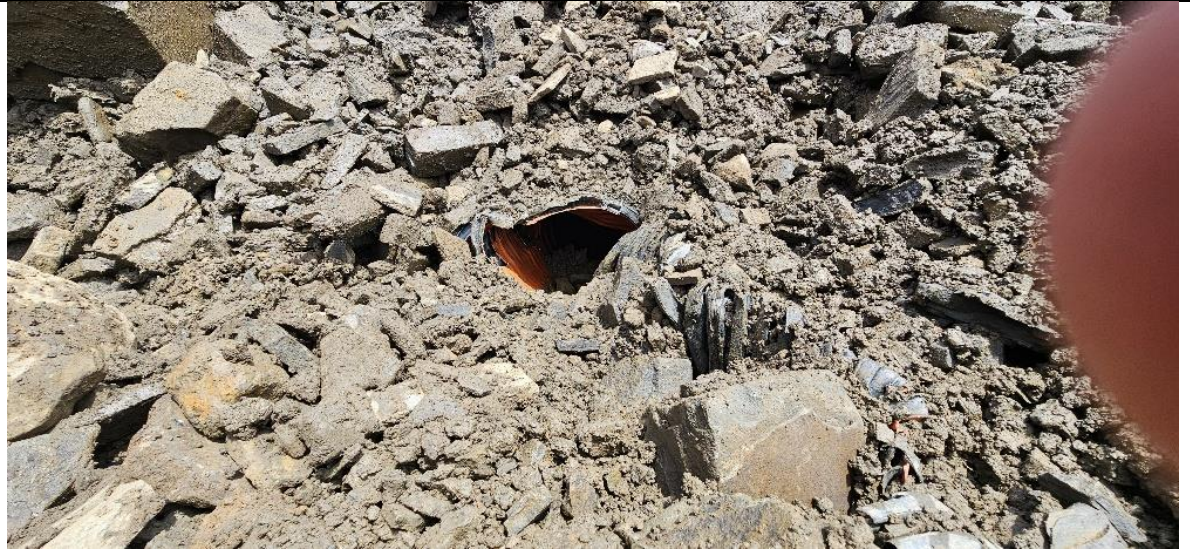
7. Section of pipe on edge of tip. Photo confirms the pipe is free of water.
