CAREDIG HOUSING ASSOCIATION

22 VICTORIA GARDENS, NEATH

**BUILDING INSPECTION (PROTECTED SPECIES) SURVEY**

Document Reference: E24124401 / Doc 01 – June 2024

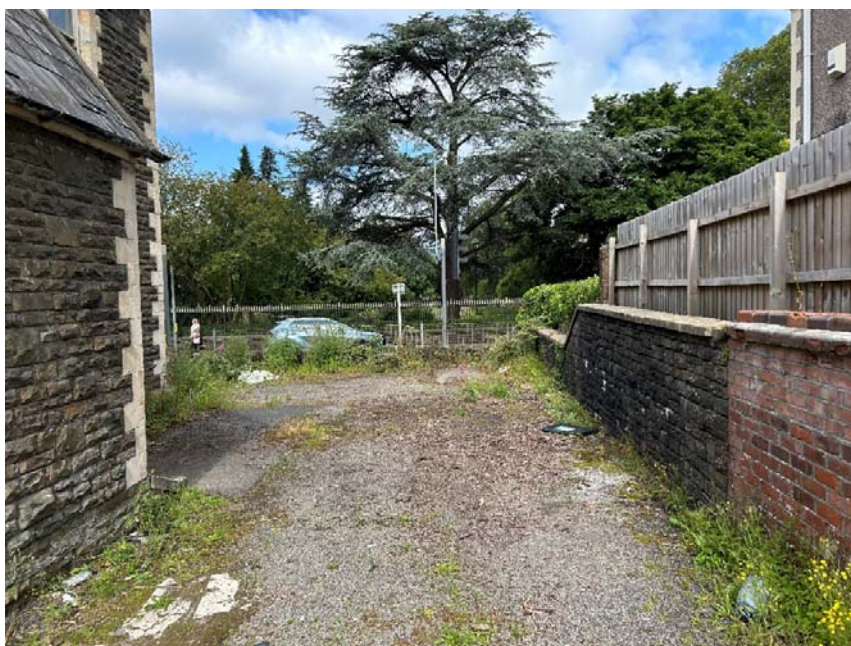
**Plate 2 Bare ground with colonising vegetation. Trees within Victoria Gardens park also shown to the west**

- 3.12 The site access off the rear lane was characterised by bare ground/hardstanding with some colonising vegetation present (see notes, Appendix III). The vegetation was relatively sparse and primarily associated with the less trafficked areas alongside the house and to the boundary wall with No. 24 (Plate 2). Species present were typical of brownfield colonising species and included both native and non-native species such as Butterfly Bush *Buddleja davidii*, Red Valerian *Valeriana rubra*, Cat's ear *Hypochaeris radicata*, Herb Robert *Geranium robertianum*, Yorkshire Fog *Holcus lanatus*, Foxglove *Digitalis purpurea*, Sow Thistle *Sonchus* sp., Wood Avens *Geum urbanum* and Hawksbeard *Crepis* sp.

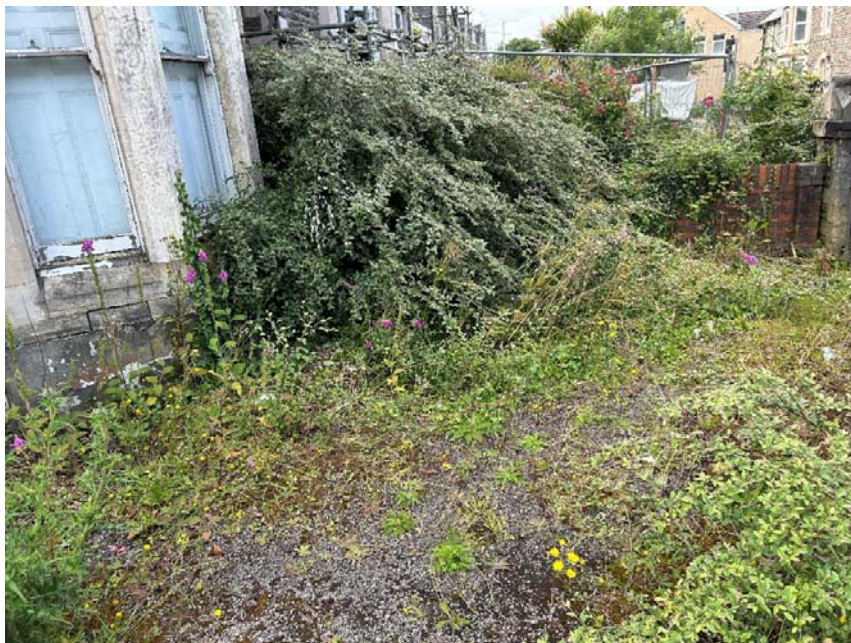
- 3.13 Several shrubs of Cotoneaster are present at the frontage (west) of the site and are likely to have been planted as ornamental cover (Plate 3). Several species of Cotoneaster are listed as non-native invasives

under Schedule 9 of the Wildlife and Countryside Act 1981 (as amended), making it an offence to plant or otherwise encourage such species to grow in the wild.

**Plate 3 Cotoneaster shrubs to site frontage**

- Use of native species or those with a known wildlife benefit to be included for any Soft Landscape planting proposed. Use of a flowering lawn mix is identified on the plan in Appendix IV;
- Removal of Cotoneaster shrubs and replacement with native shrub or hedgerow species as part of landscape planting;

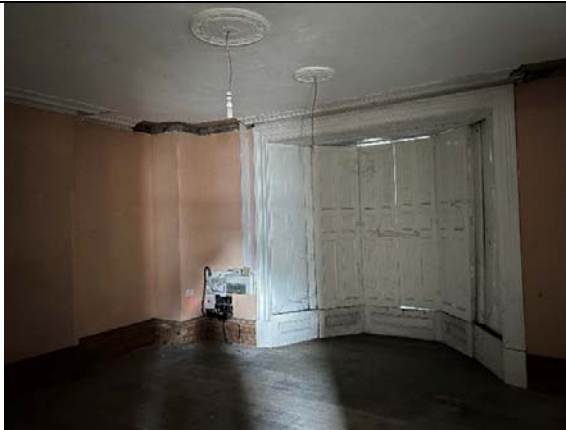
Broken glass in window to Northern elevation would allow access but no evidence to suggest birds or bats present. All other ground floor windows are sound.

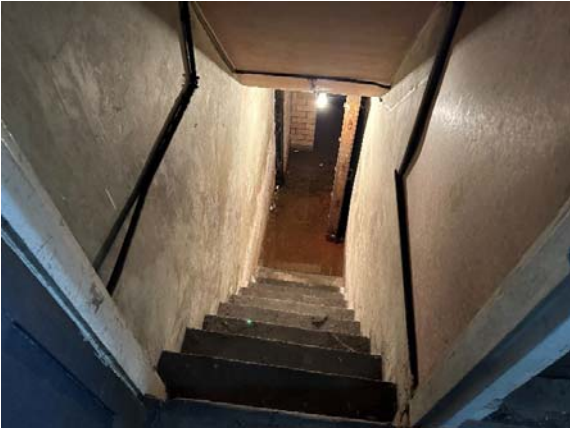
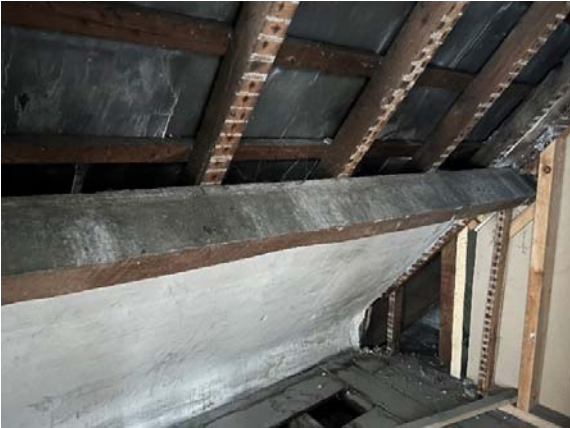
| | <p>Basement is flooded to depth of ca. 150 – 200mm and no direct access. Basement door is open but no evidence on steps leading down and no obvious means of access (from exterior) into the basement.</p> <p>First floor rooms are all well lit with sash windows all intact – no obvious means of access for birds or bats and no evidence noted. Airing cupboard to first floor landing is a dark area (door slightly ajar) but no evidence noted. Some light ingress around door/window board to east end of first floor corridor but no evidence of birds or bats found.</p> <p>Second floor attic rooms have been partially converted in the past with ceilings boarded/plastered. Two small areas on southern and northern elevations where roof slates are visible – no obvious light ingress or means of access into these areas and no evidence of birds or bats found. Windows to second floor all sound.</p> |

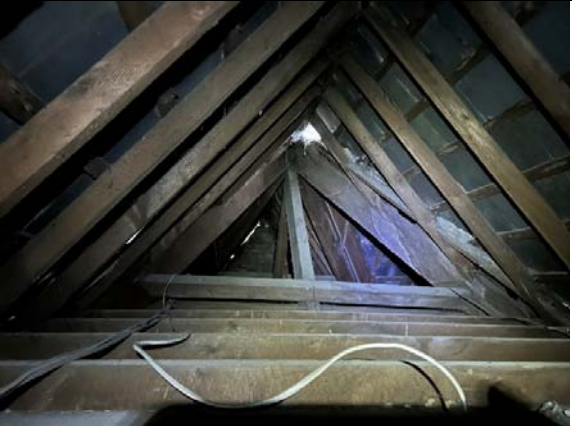
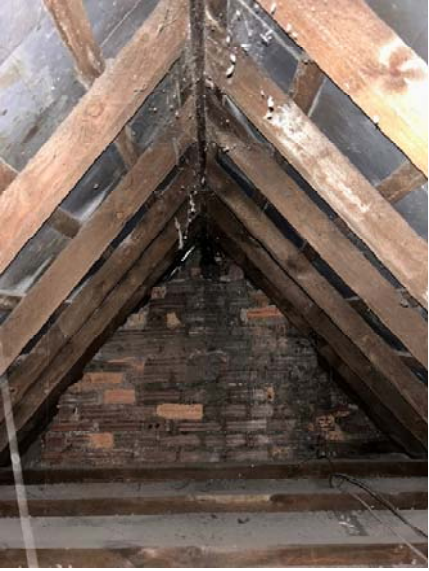
| | <p>Some light ingress at eastern gable end but rubble infill is present which is likely to obstruct/block possible access. Roof timbers heavily cobwebbed.</p> <p>No evidence of birds or bats found within accessible areas of roofspace – western gable end not accessible (light ingress visible here).</p> |

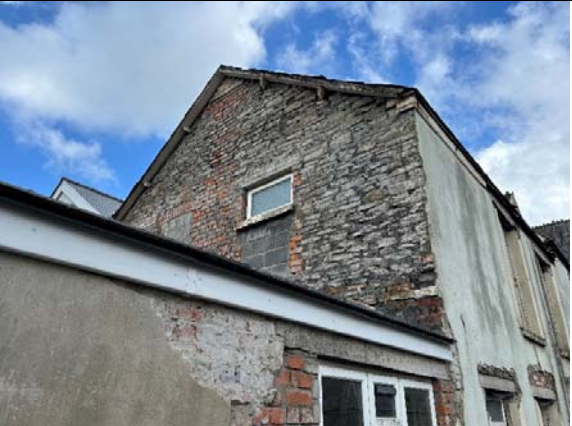
| | <p>Eastern gable with render removed and gaps evident to both sides of apex at wall tops. Old bird nest material visible to northern side. Numerous gaps at wall tops could allow access for birds or bats – no external evidence of bats noted.</p> |

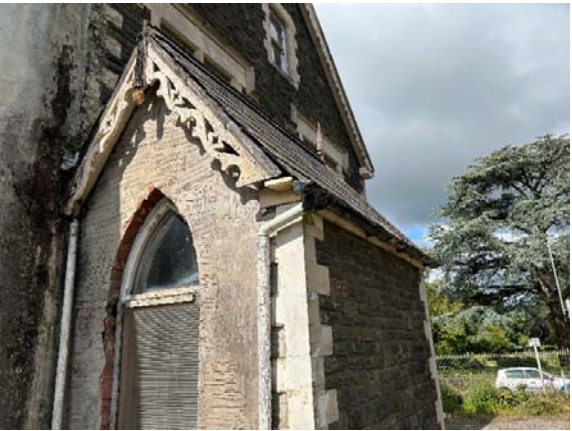
| <b>Porch (North elevation)</b> | <p>Gaps around timber decorative fascia at eastern gable end – access to wall tops and any wall void noted. No external evidence of bats.</p> <p>Active Sparrow nest located to NE corner under raised slate – adult bird seen entering and leaving with foecal sac.</p> <p>Pitched roof is sound with no missing or damaged tiles noted although several raised tiles noted towards ridge line. Ridge tiles and mortar are sound and mortar also intact to end tiles above eaves. Timber fascia to eaves of pitched roof is sound although gap noted between the fascia and the wall which could allow bat access – no visible external evidence of use (e.g. droppings or staining) noted.</p> |

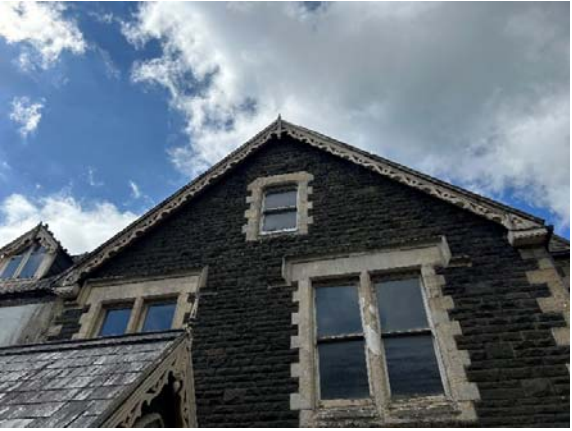
| <p><b>Northern Gable</b></p> | <p>Numerous gaps noted between fascia and stonework allowing access to tops of walls. Bird splashing noted on stonework suggesting previous (or current) - nest material visible to wall tops.</p> |

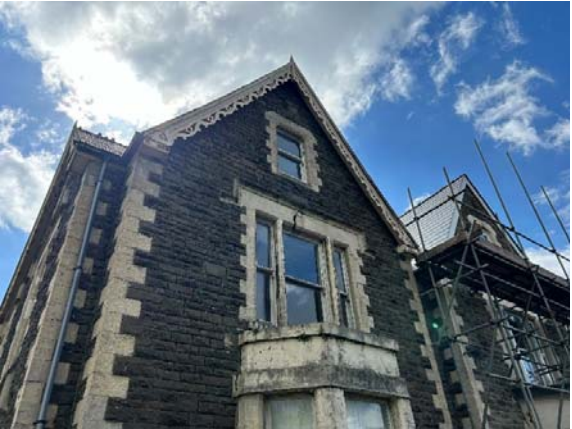
| <p><b>West gable</b></p> | <p>Gaps between fascia and stonework as noted for north gable. Large crack in window lintel also visible but no external evidence of bats.</p> |

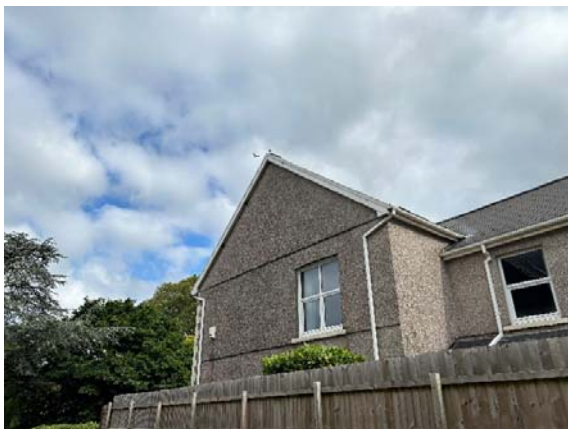
**No. 24 Victoria  
Gardens**

Gable end of property to the north (No. 24) used by nesting House Martin and Sparrow – former seen entering/exiting at apex with House Sparrow using gap in soffit to west side.

- 3.10 Active nests of House Sparrow and House Martin were confirmed on the adjacent property (No.24) with adults seen entering via a gap in the soffit on the western side of the gable and at the apex respectively.
