Youth Offending Team  
Building, Harbourside  
Bat Survey Report  
Date: July 2024

The proposal is to replace the roof covering of the Youth Offending Team Building on Harbourside, Port Talbot.

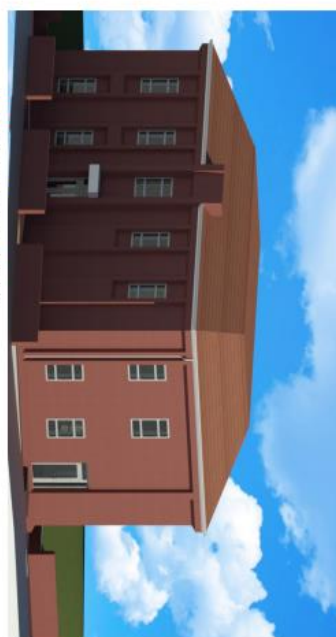
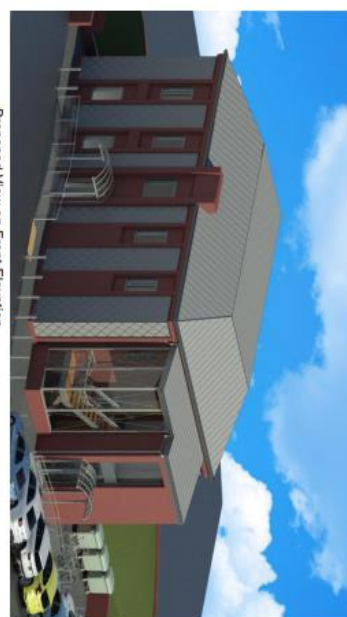
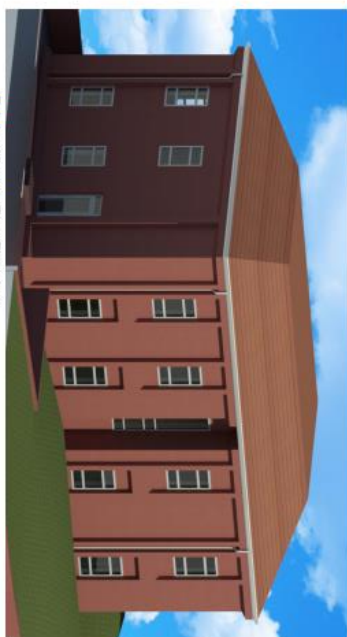
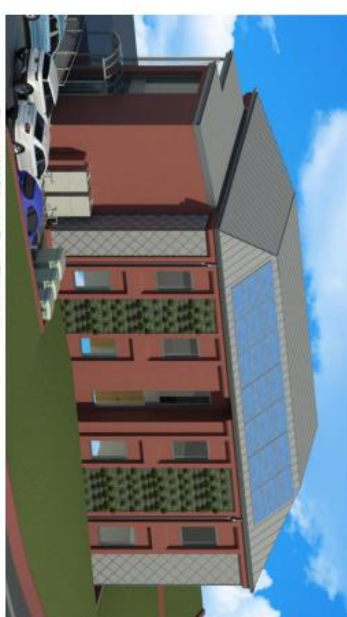
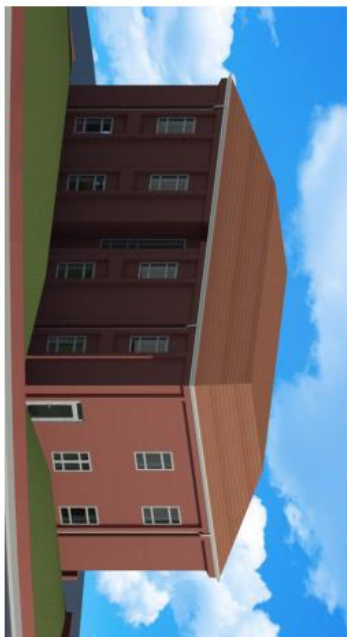
A living green wall is proposed for part of the rear elevation (Figure 2).

Figure 2 – Current design for proposed reroof, extension and biodiversity enhancements (may slightly alter at detailed design phase).

A living green wall (in 2 panels) will be included on the rear elevation of the building. The species used will be wildlife friendly and appropriate to the area (no species will be used that have the potential to become invasive in the brownfield sites surrounding the building). Exact species have not yet been confirmed, this will be finalised during the detailed design phase and agreed with the LPA Ecologist.

3 integrated swift boxes will also be installed on the East elevation of the building, tight to the eaves.

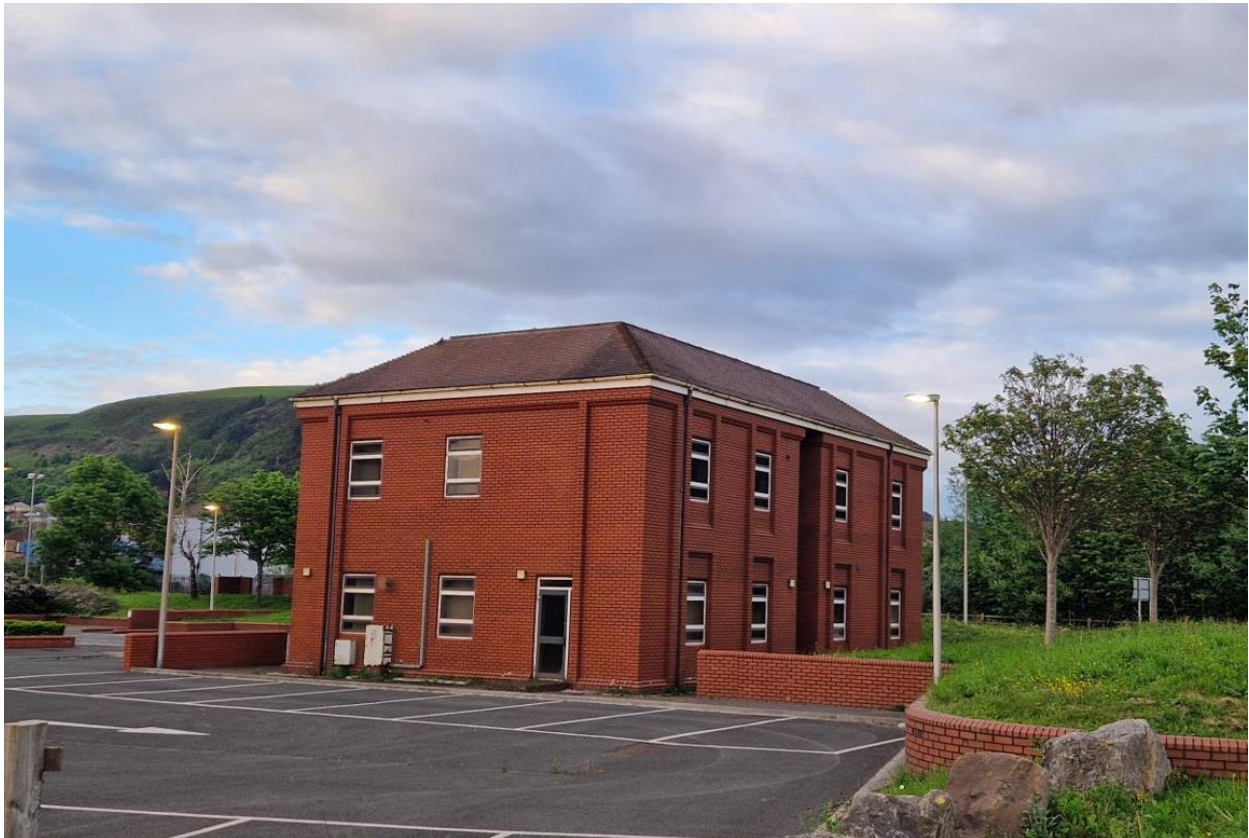
**Figure 3 – East elevation of Youth Offending Team Building showing brick construction and well maintained tile roof.**

The building is of brick construction with a tile roof. The building and roof is overall well maintained with very little potential for crevice dwelling bats. The plastic fascias are also tight against the wall.

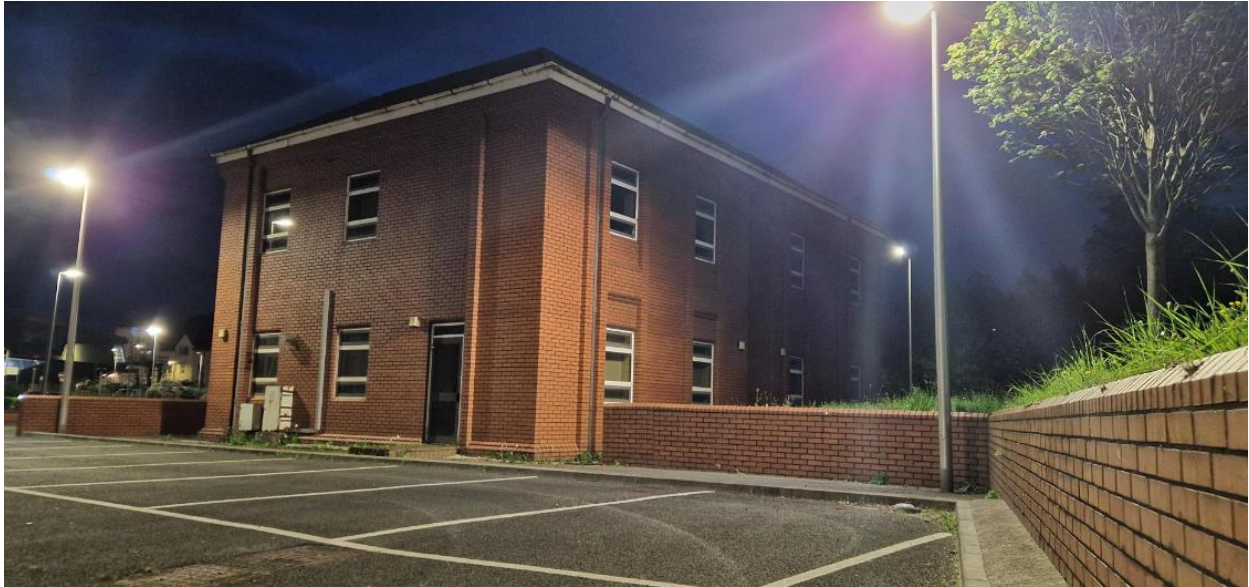
**Figure 4 – East elevation at night showing the high levels of artificial lighting in the area**

During the night, there is a high level of artificial lighting provided by street lights in the car park, and along the adjacent roads, which further reduces the roosting potential of the building.

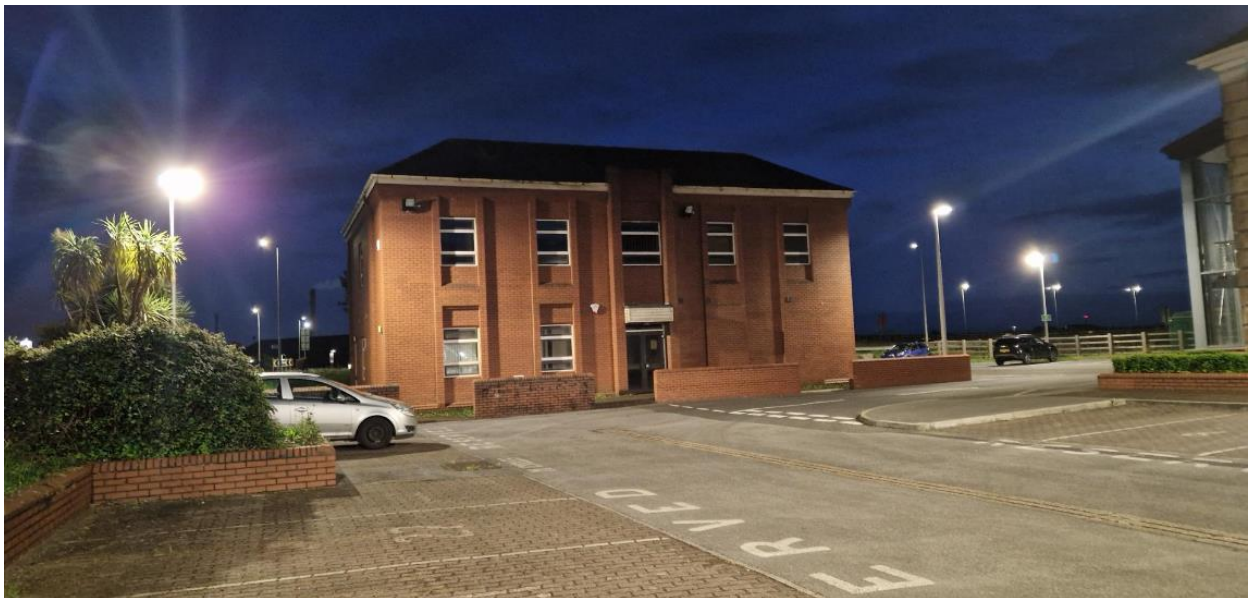
**Figure 5 – North elevation of Youth Offending Team Building, showing high levels of artificial lighting in the surrounding area.**
