| Project | Global Centre of Rail Excellence (GCRE)<br>Stage 2 | Easting | 284894.70 | Equipment | JCB 220X 1c | Sheet 1 of 3 |

EXPLORATORY HOLE PHOTOGRAPHS

Exploratory Hole  
S2-TP276

| <div><div>JACKSON</div><div>GEO SERVICES</div></div> | | | | TRIAL PIT EXPLORATORY HOLE LOG | | | | Exploratory Hole Progress by Time | | | Exploratory Hole | |

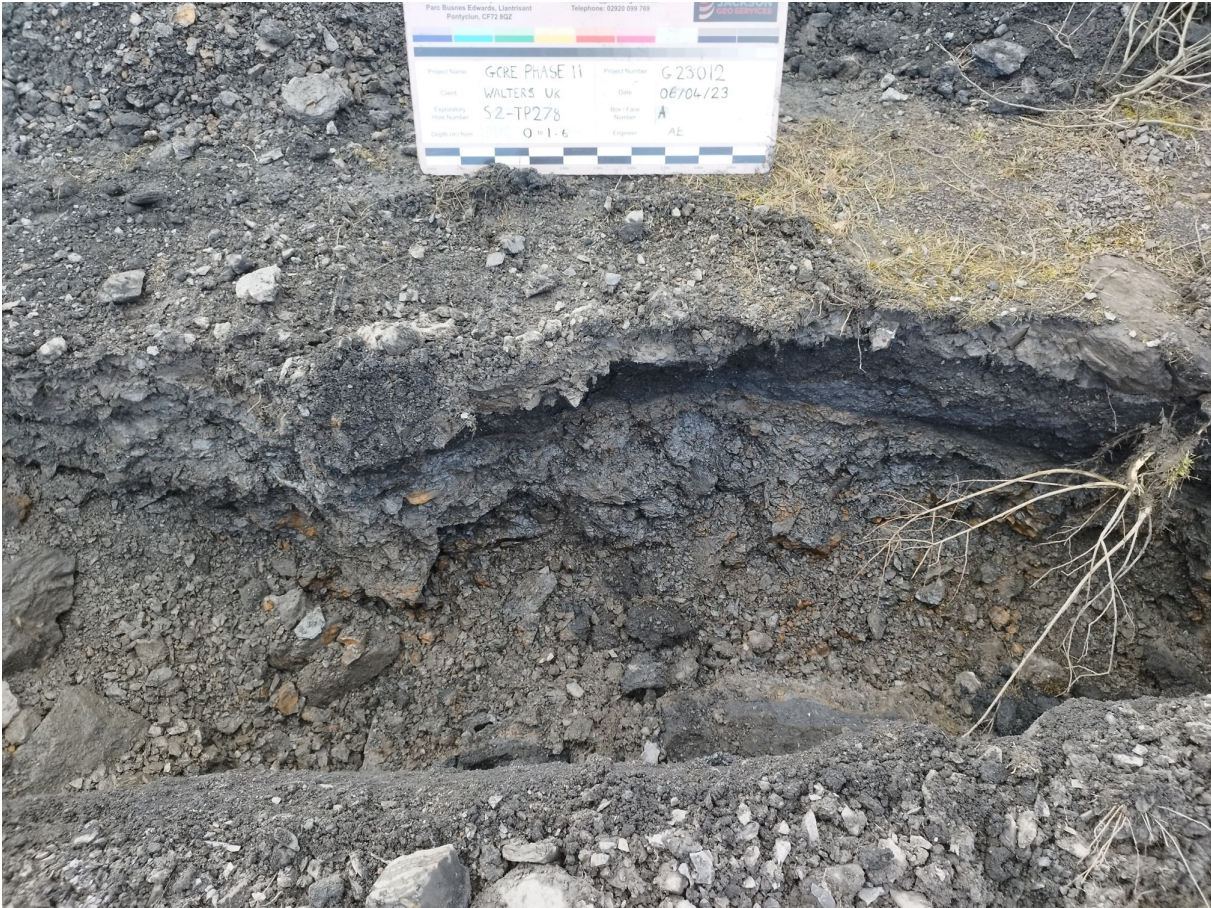
S2-TP278 Face A

| Stability | Collapse Face A and C 0.90-1.6m. | | | | | | 06/04/2023 10:20 | | 1.50 | 1.45 | 10mins | | |

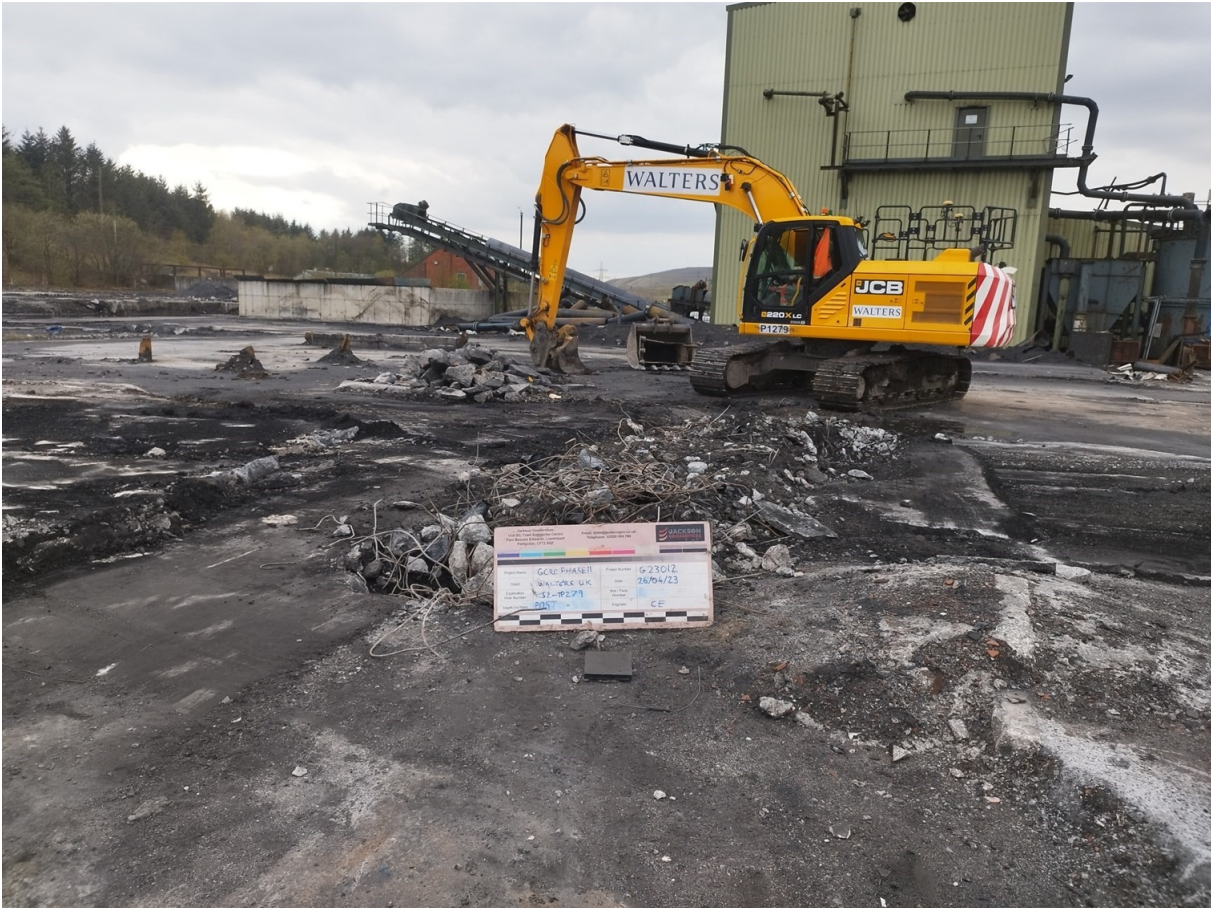
S2-TP279 Post Excavation

| Stability | Collapse 0.70-3.10m<br>Faces A and C | | | | | | 26/04/2023 15:45 | 2.30 | 2.30 | 20mins | No rise. | |
