| | | EXPLORATORY HOLE PHOTOGRAPHS | | | | Exploratory Hole |
| Project | Global Centre of Rail Excellence (GCRE) Stage 2 | Easting | 284666.04 | Equipment | JCB 220X 1c | Sheet 1 of 4 |

| | | TRIAL PIT EXPLORATORY HOLE LOG | | | | | Exploratory Hole Progress by Time | | | Exploratory Hole | | | | | |

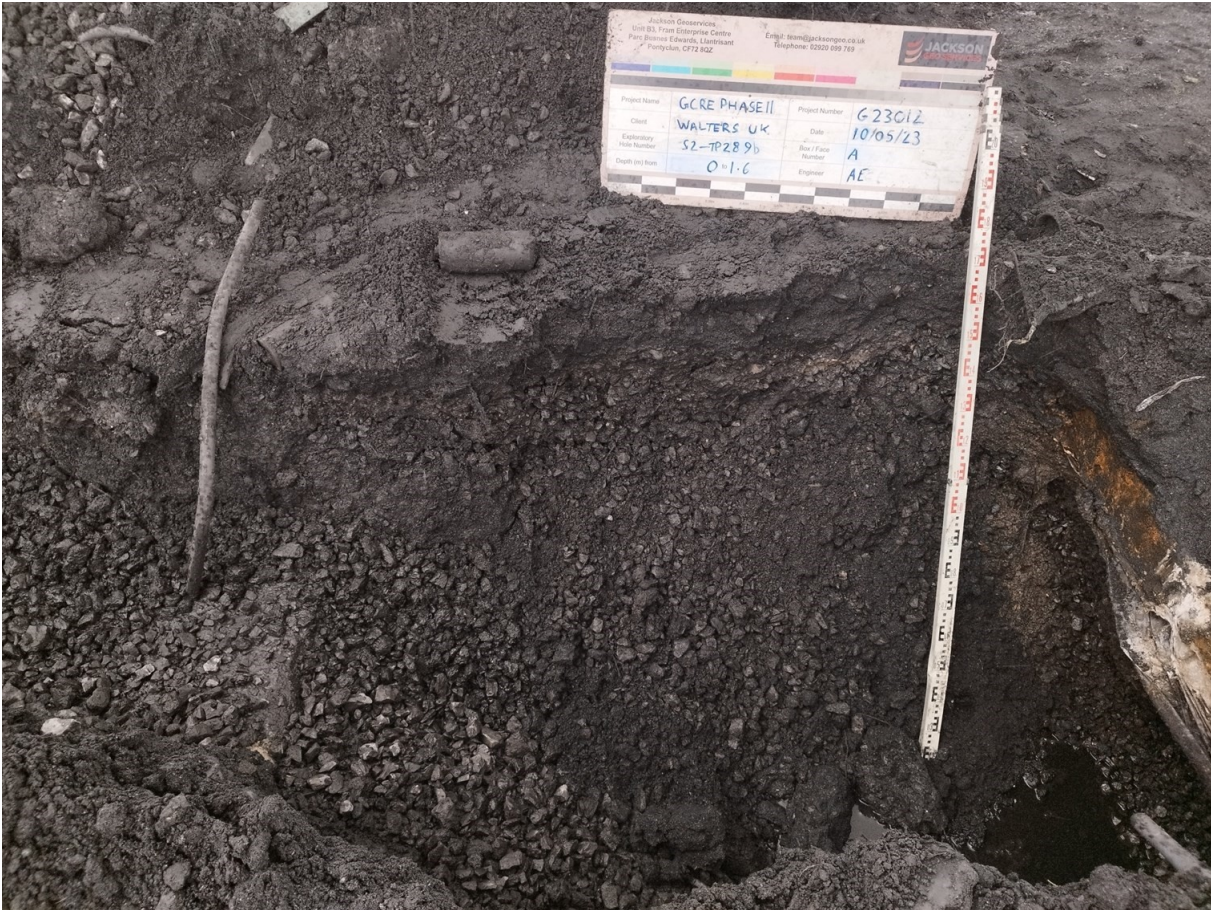
S2-TP289b Face A

| Stability | | Collapse Faces A B and C GL-1.6m. | | | | | | 10/05/2023 12:35 | | 1.50 | 1.37 | 20mins | | | |

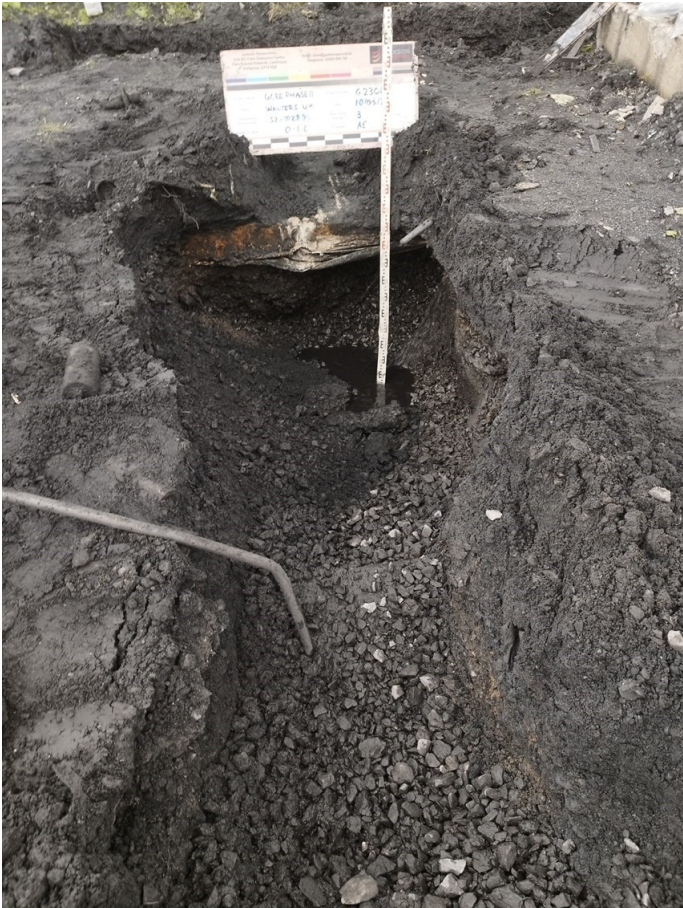
S2-TP289b Face B

| 1 B | 0.10 - 0.30 | PID: 0.0ppmv | | | 0.00 | 236.15 | | Dark grey slightly gravelly fine to coarse SAND with occasional metal scrap (up to 800mm). Gravel is subangular to rounded fine to coarse of siltstone, mudstone, coal and rare sandstone.<br>(MADE GROUND)<br>Geology Code: MGR 2nd Geology Code: SD<br><br><i>0.30m - 0.55m Strong light grey concrete slab in Face B.</i> | | | | | | | |

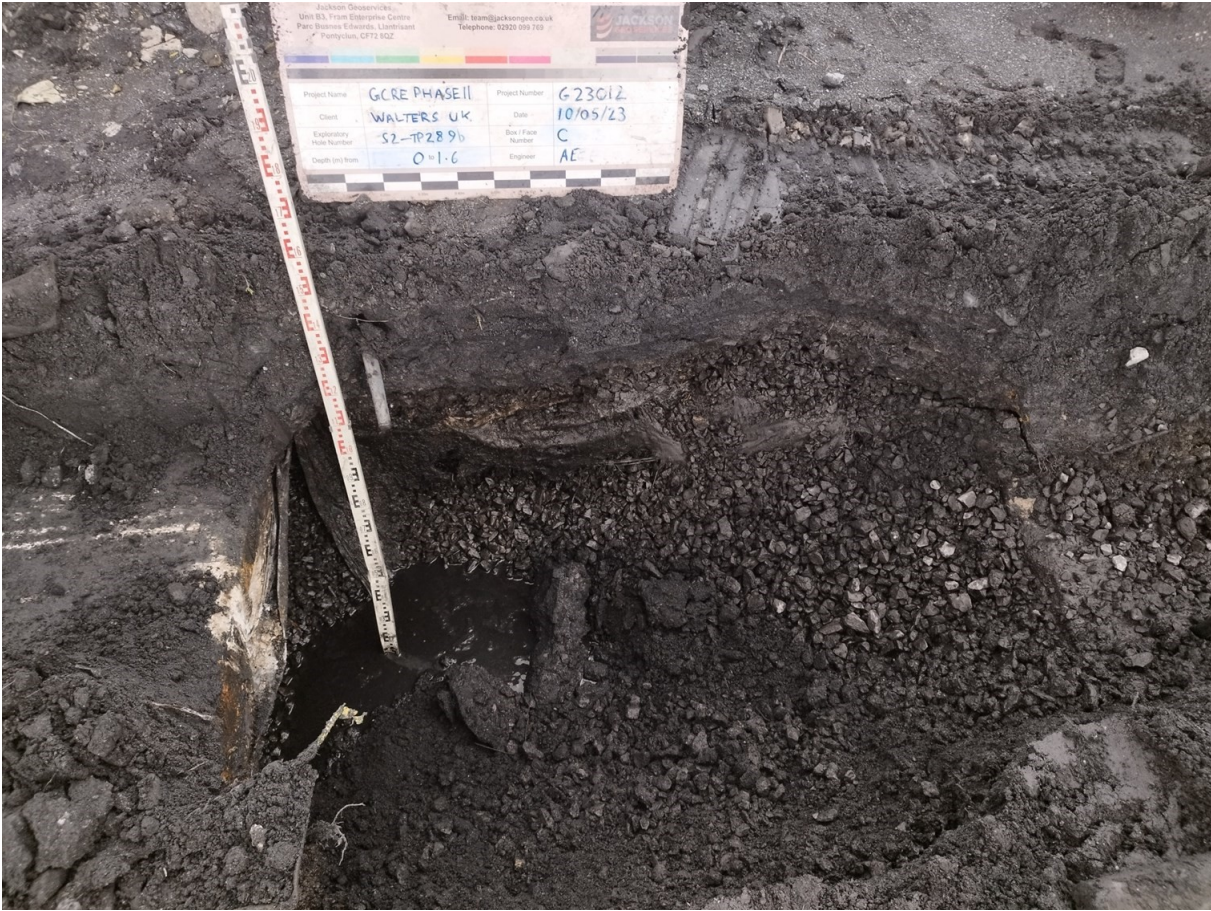
S2-TP289b Face C

| 3 ES | 0.50 - 0.60<br>0.50 | PID: 0.0ppmv | | | (1.25) | 234.90 | | Grey slightly sandy angular to subangular medium to coarse GRAVEL of siltstone. Sand is fine to coarse.<br>(MADE GROUND)<br>Geology Code: MGR 2nd Geology Code: GR<br><br><i>0.70m - 0.75m Light grey concrete slab in Face C.</i><br><i>0.75m - 0.75m Polythene membrane under concrete slab in Face C.</i> | | | | | 0.50 | | |

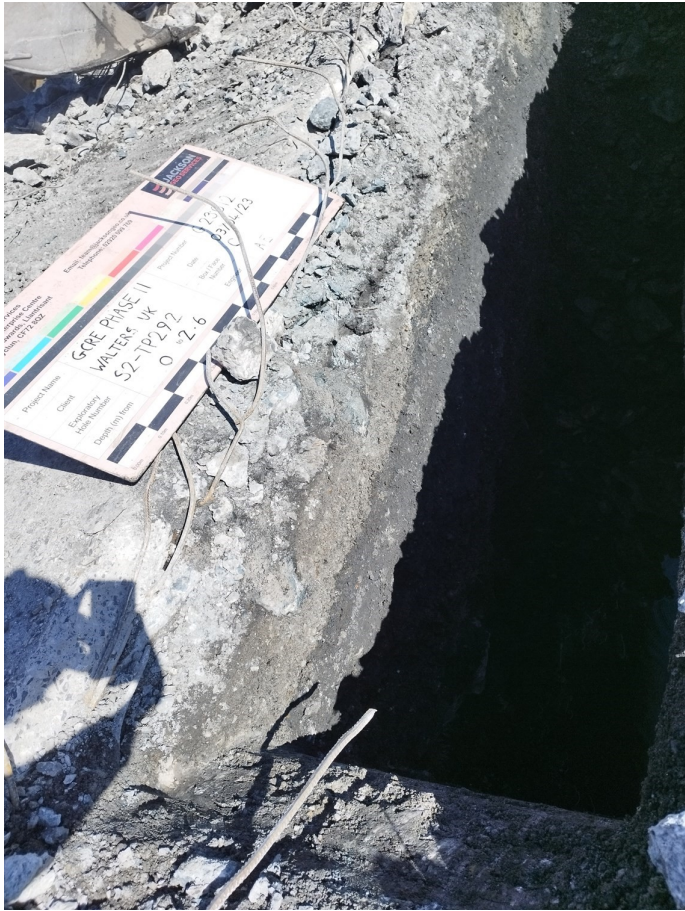
S2-TP292 Face C

| Stability | | Collapse. Face A and C 1.40-2.60m | | | | | | 03/04/2023 10:20 | | 2.40 | | 2.40 | | 20mins | | Fast inflow | |
