**EXPLORATORY HOLE PHOTOGRAPHS**

**S2-TP279**

| Project | Global Centre of Rail Excellence (GCRE)<br>Stage 2 | Easting | 284678.09 | Equipment | JCB 220X 1c | Sheet 2 of 4 |

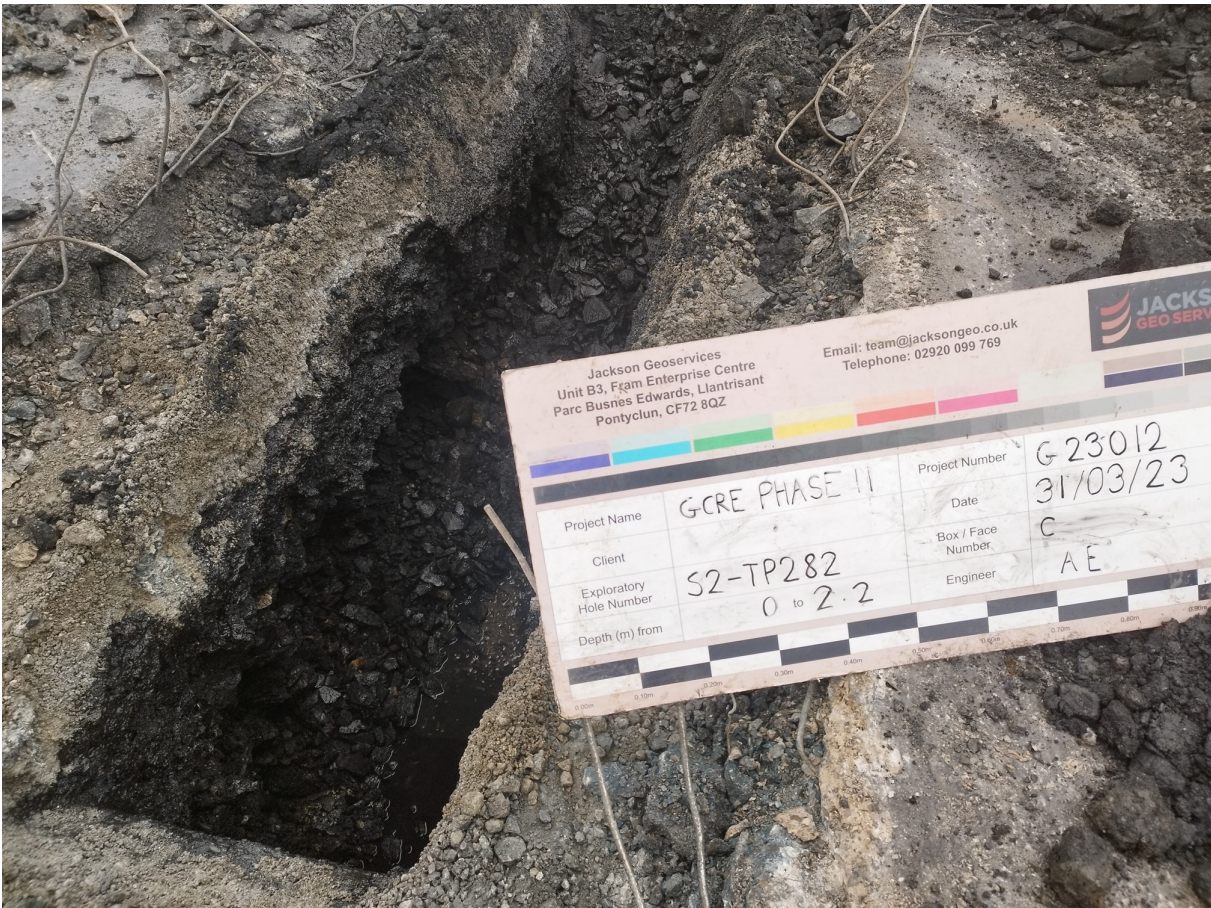
S2-TP282 Face C

| Stability | Collapse. Face A and C 0.50m-2.20m. | | | | | | 31/03/2023 10:05 | 2.10 | 2.10 | 20mins | Fast inflow | | |
