# Geotechnical and Geoenvironmental Report

Site: Land off Tabernacle Terrace, Cwmafan

**REPORT TITLE** : **Geotechnical and Geoenvironmental Report:  
Proposed Residential Development, Land off  
Tabernacle Terrace, Cwmafan, Port Talbot**

**REPORT REFERENCE** : **20/06/2024-14611-ISSUE4**

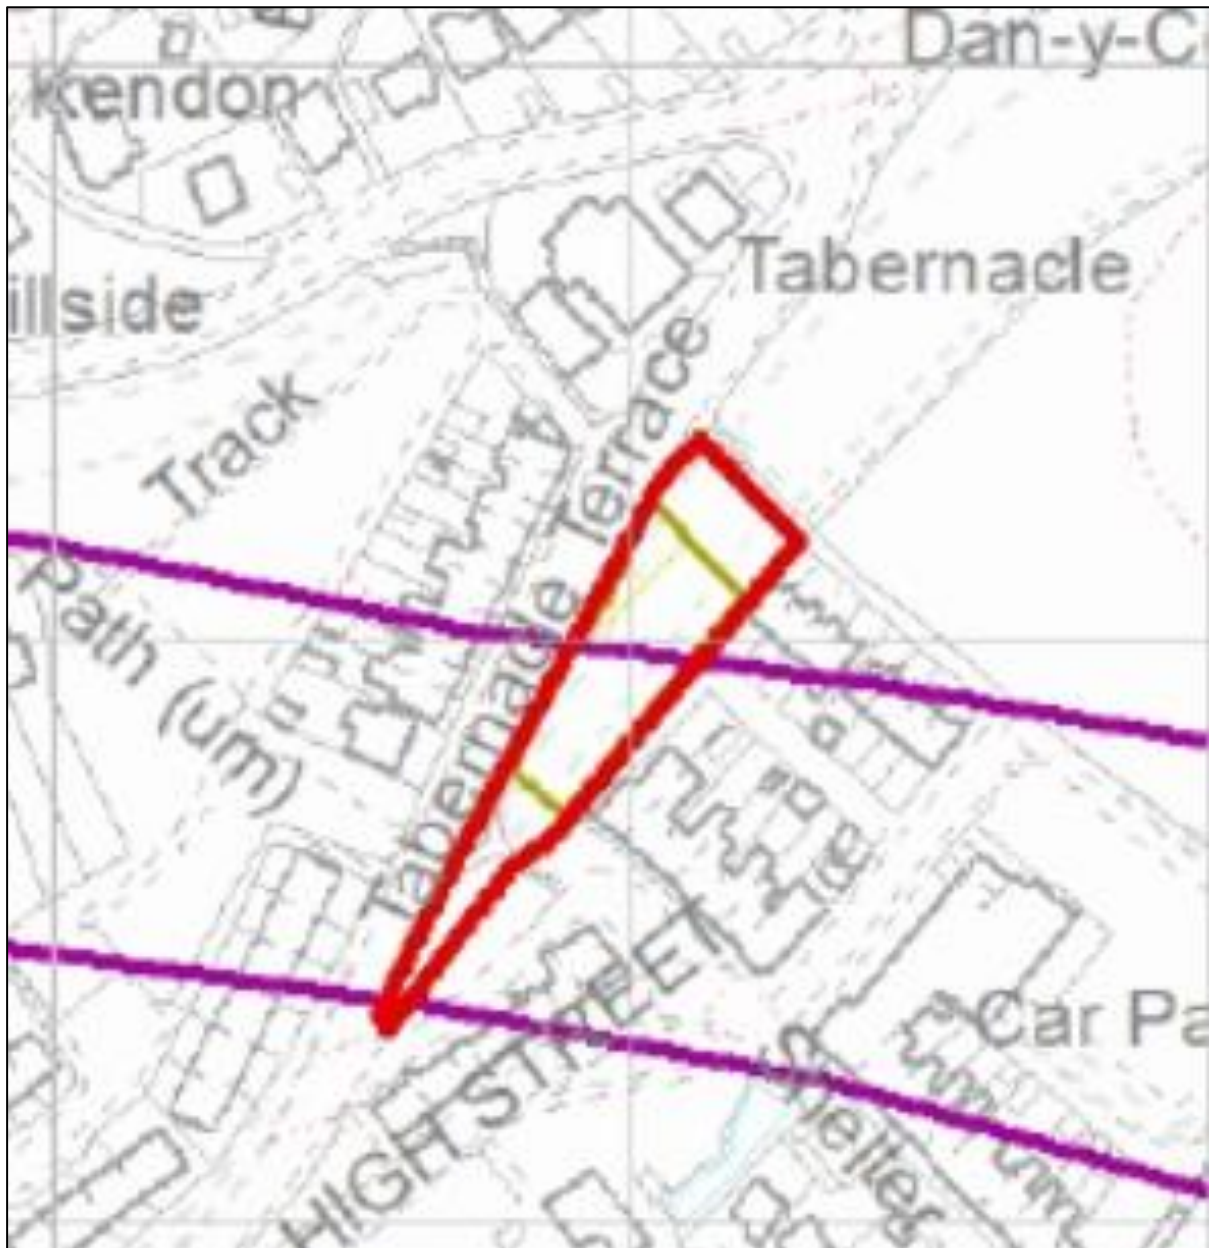
**Figure 3.2 Extract from the map provided by the Coal Authority illustrating the coal seam outcrops in purple on site.**

The Coal Authority Report states that there are two coal seams outcropping on the site, and that the site is in an area where there is coal at or close to the surface which may have been worked at some time in the past. These can be seen in **Figure 3.2** and are projected to outcrop in the southernmost extent and central north of the site, trending east-west. Due to the northwards dip of the local geology, this puts the entirety of the site at risk of potential shallow mine workings.

The seams that are on site are likely the Four-Foot and Five-Foot seams. This is based on information from the 1:10,560 geological map. However, the 1:10,560 geological map of the area conflates these two seams into one which appears to terminate abruptly 360m to the east of the site. It can be confidently assumed that this is a flaw in the mapping as there appears to be no practical reason why these seams would not continue onto site.
