## Drainage Survey Report

**Job Number : 18958**

**Project Name: 7 Ten Acre Wood-SA13 2SU**

**Site Date: 17-06-2024**

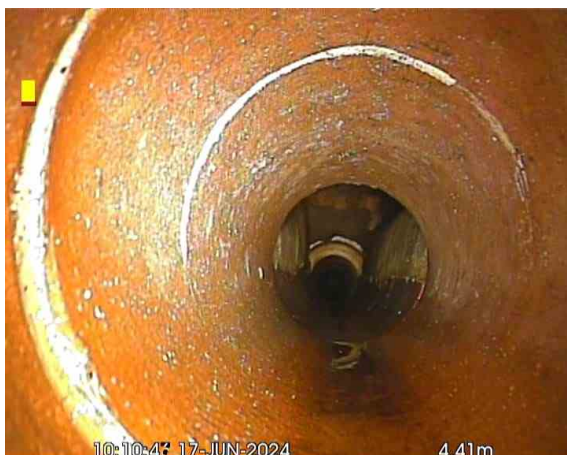
| Scale: | 1:50 | Position [m] | Code | Observation | MPEG | Photo | Grade |
|---|---|---|---|---|---|---|---|
| | | 4.41 | FC | Fracture, circumferential from 9 o'clock to 3 o'clock | 00:00:53 | 1 | 3 / 2 |

1, 00:00:53, 4.41 m  
Fracture, circumferential from 9 o'clock to 3 o'clock

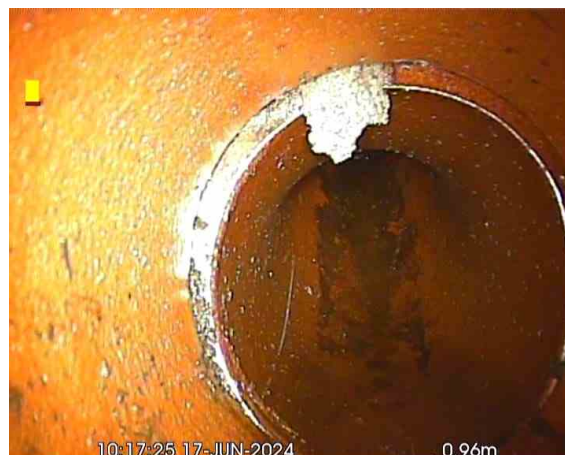
10:17:25 17-JUN-2024 0.96m

2, 00:00:29, 0.96 m  
Attached deposits, encrustation at joint at 11 o'clock, 5%  
cross-sectional area loss

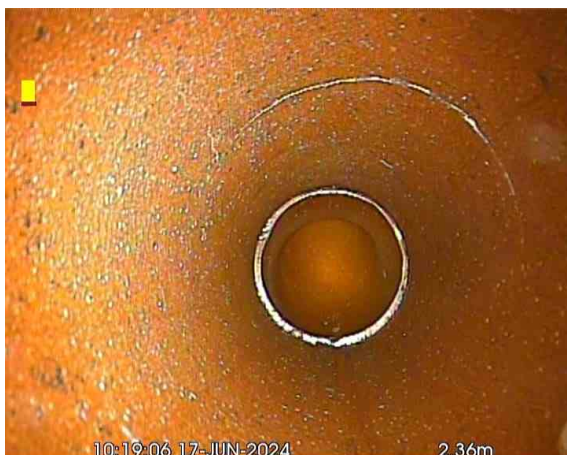
<table><tr><th>Code</th><th>Observation</th><th>MPEG</th><th>Photo</th><th>Grade</th></tr><tr><td>CC</td><td>Crack, circumferential from 10 o'clock to 3 o'clock</td><td>00:00:38</td><td>1</td><td>2 / 2</td></tr></table>

1, 00:00:38, 2.36 m  
Crack, circumferential from 10 o'clock to 3 o'clock

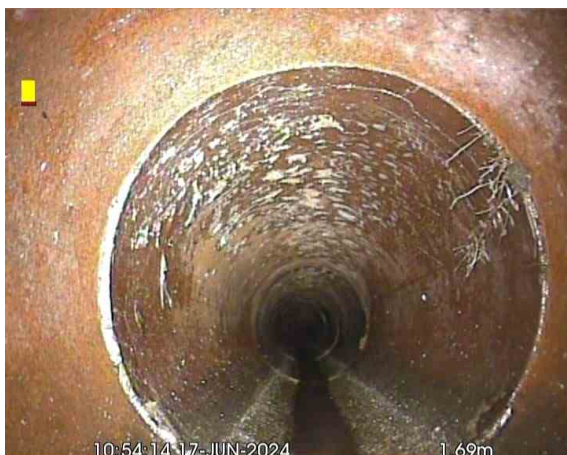
| Scale: | 1:217 | Position [m] | Code | Observation | MPEG | Photo | Grade |
|---|---|---|---|---|---|---|---|
| | | 1.69 | CCJ | Crack, circumferential at joint from 10 o'clock to 2 o'clock | 00:00:26 | 1 | 2 / 2 |

1, 00:00:26, 1.69 m  
Crack, circumferential at joint from 10 o'clock to 2 o'clock

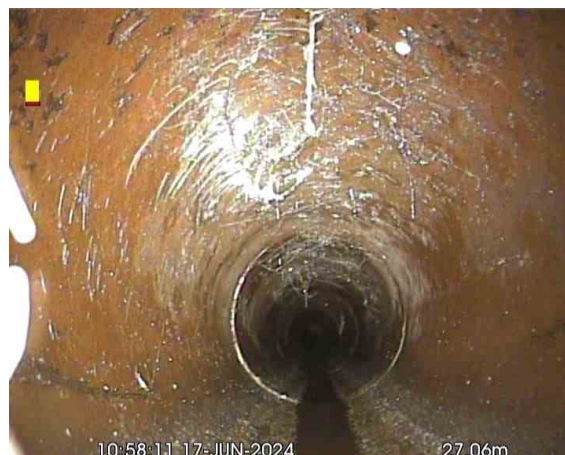
| Scale: | 1:217 | Position [m] | Code | Observation | MPEG | Photo | Grade | | |
|---|---|---|---|---|---|---|---|---|---|
| | | 27.06 | FLJ | Fracture, longitudinal at joint at 11 o'clock | 00:04:24 | 2 | 3 / 2 | | |

2, 00:04:24, 27.06 m  
Fracture, longitudinal at joint at 11 o'clock

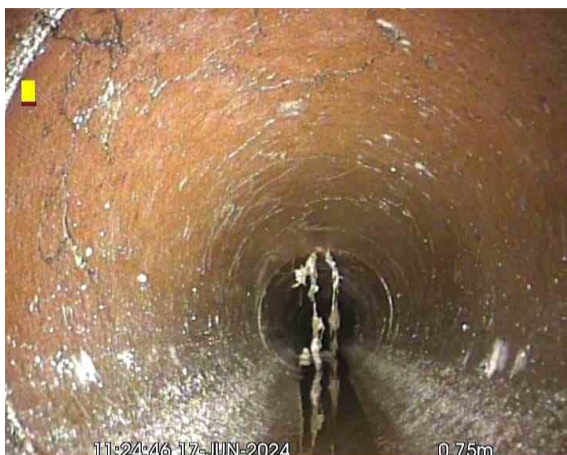
| Scale: 1:148 | Position [m] | Code | Observation | MPEG | Photo | Grade |
|---|---|---|---|---|---|---|
| | 0.75 | CM | Cracks, multiple from 9 o'clock to 2 o'clock | 00:00:19 | 1 | 3 / 2 |

1, 00:00:19, 0.75 m  
Cracks, multiple from 9 o'clock to 2 o'clock

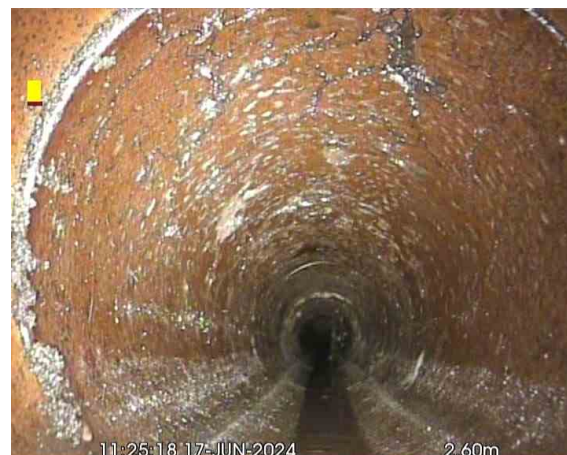
| Scale: 1:148 | Position [m] | Code | Observation | MPEG | Photo | Grade |
|---|---|---|---|---|---|---|
| | 2.60 | CMJ | Cracks, multiple at joint from 9 o'clock to 1 o'clock | 00:00:50 | 2 | 3 / 2 |

2, 00:00:50, 2.60 m  
Cracks, multiple at joint from 9 o'clock to 1 o'clock

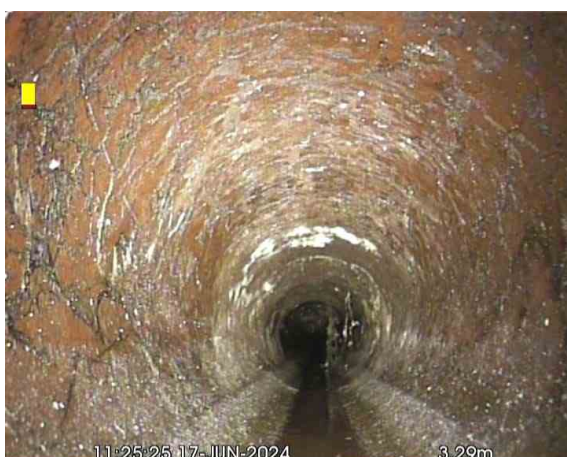
| Scale: 1:148 | Position [m] | Code | Observation | MPEG | Photo | Grade |
|---|---|---|---|---|---|---|
| | 3.29 | CM | Cracks, multiple from 12 o'clock to 12 o'clock | 00:00:58 | 3 | 3 / 2 |

3, 00:00:58, 3.29 m  
Cracks, multiple from 12 o'clock to 12 o'clock

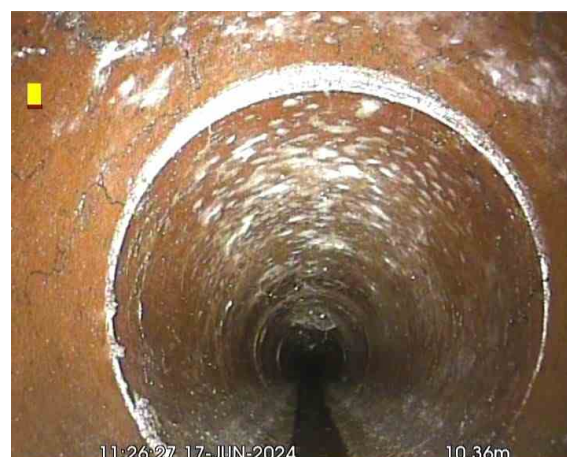
| Scale: 1:148 | Position [m] | Code | Observation | MPEG | Photo | Grade |
|---|---|---|---|---|---|---|
| | 10.36 | CMJ | Cracks, multiple at joint from 9 o'clock to 12 o'clock | 00:02:00 | 4 | 3 / 2 |

4, 00:02:00, 10.36 m  
Cracks, multiple at joint from 9 o'clock to 12 o'clock

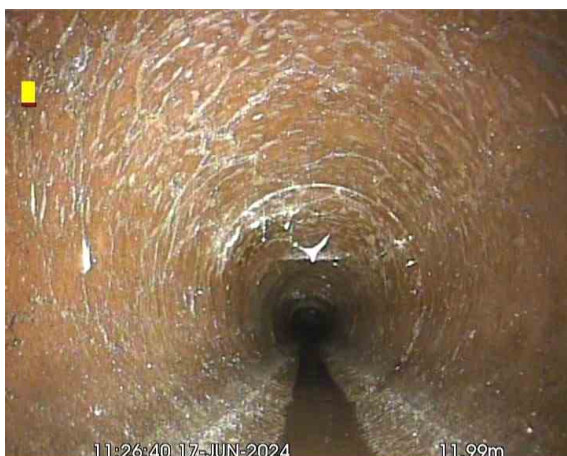
| Scale: 1:148 | Position [m] | Code | Observation | MPEG | Photo | Grade |
|---|---|---|---|---|---|---|
| | 11.99 | CM | Cracks, multiple from 8 o'clock to 3 o'clock | 00:02:13 | 5 | 3 / 2 |

5, 00:02:13, 11.99 m  
Cracks, multiple from 8 o'clock to 3 o'clock

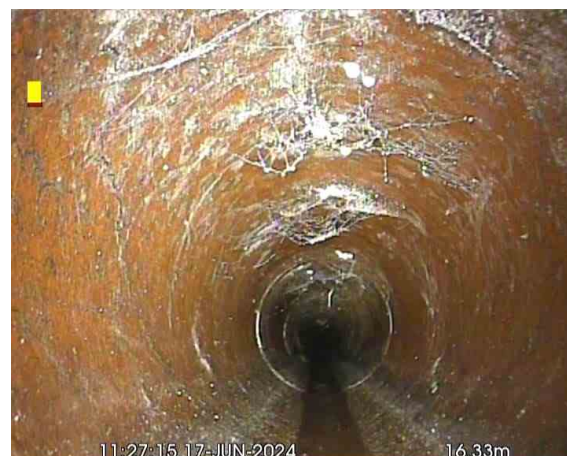
| Scale: 1:148 | Position [m] | Code | Observation | MPEG | Photo | Grade |
|---|---|---|---|---|---|---|
| | 16.33 | FS | Fracture, spiral from 9 o'clock to 11 o'clock | 00:02:48 | 6 | 4 / 2 |

6, 00:02:48, 16.33 m  
Fracture, spiral from 9 o'clock to 11 o'clock
