# Gnoll Country Park, Neath

**Title** Ground Conditions Assessment Report

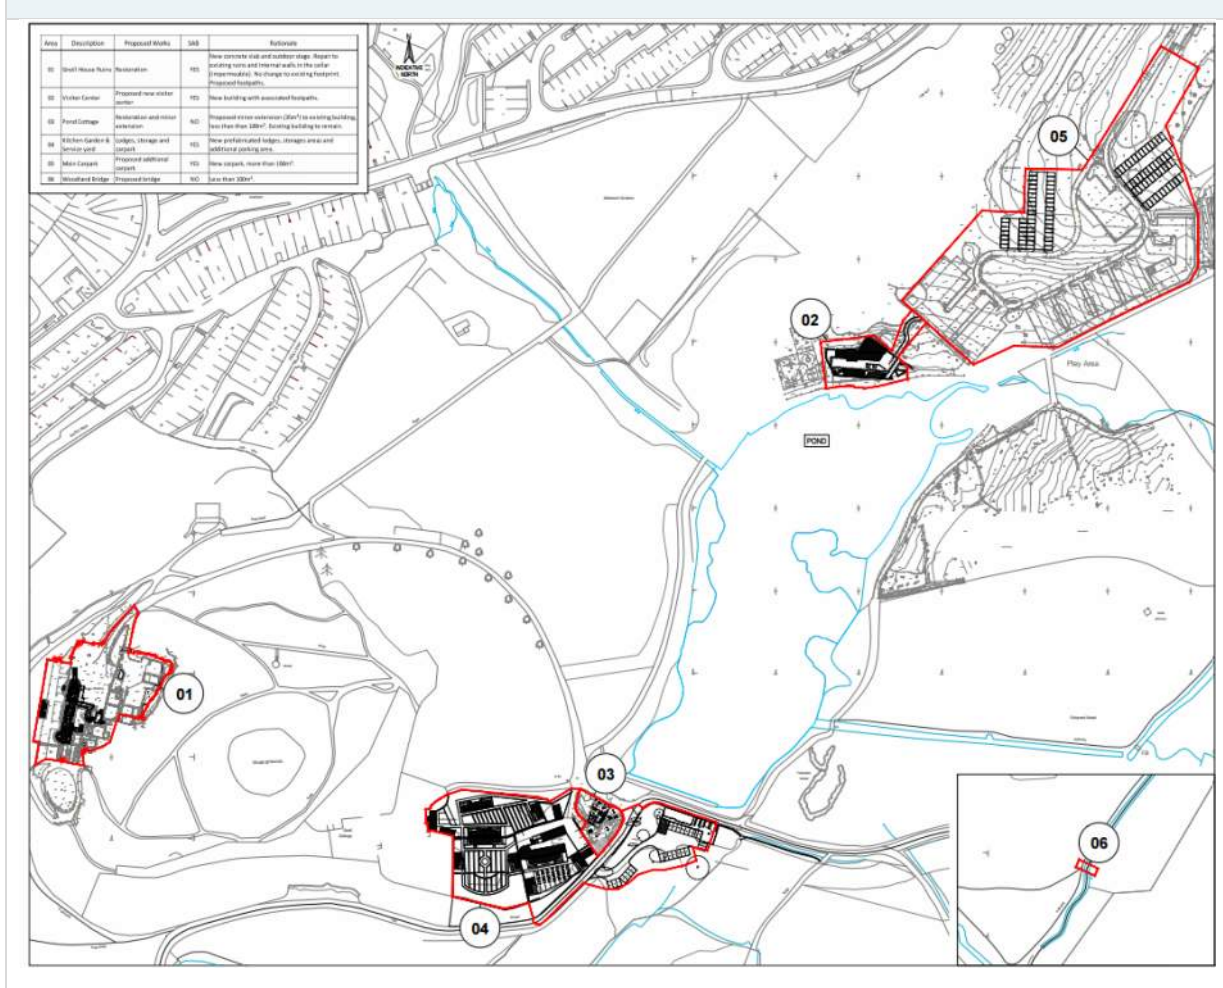
Figure 1: Site Location

The site is located around the Gnoll Country Park situated in the town of Neath, in South Wales, approximately 11km to the northeast of Swansea. The site is situated on the eastern fringes of the town with the main entrance over the northern part of the estate accessed off Fairyland, with a second entrance from the southern end via Rockwood Close off Cimla Road. The different areas of the site referred to in this report are outlined in Figure 1 below.

The proposed site development is split into six specific areas of the wider country park as per Figure 1. A description of each area and what it is referred to is as follows:-

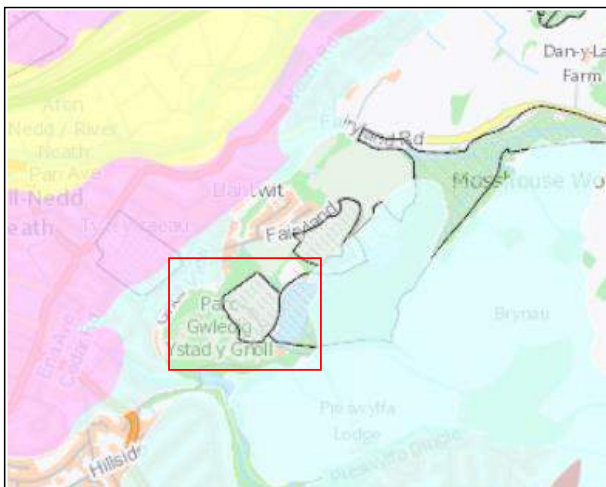
Figure 2: Superficial Geology (BGS)

The online BGS Geology of Britain Viewer and the 1:10,560 Geological Sheet (Sheet SS79NE) show Areas 2 and 5 over the northern part of the site, to be underlain by the Brithdir Sandstone Member, which is overlain by superficial deposits of Glacial Till (Diamicton). Areas 1, 3, 4 & 6 to the south are shown to be directly underlain by the Swansea Sandstone Member. Both Members are described as micaceous sandstones with thin interbeds of mudstone/siltstone and thin coals beds. These formations form part of the Pennant Sandstone parent group.

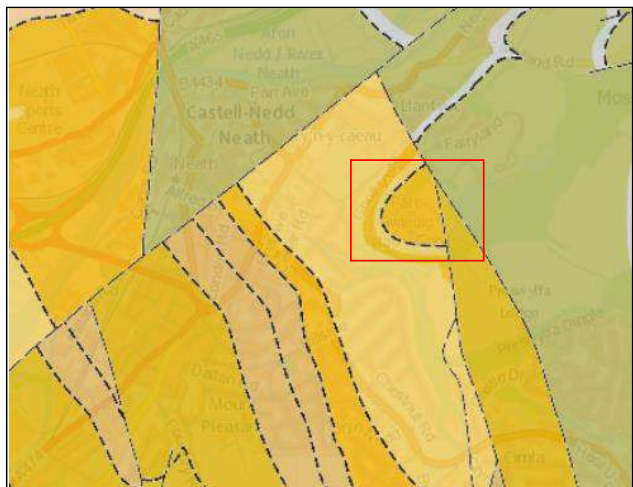
Figure 3: Bedrock Geology and Linear Features

The Brithdir beds (shown as green in figure 3) lies within a triangular fault block defined by the Gnoll Fault to the east and two unnamed faults to the north and south. In the eastern part of this fault block, the strata is indicated to dip to the west at 30 to 40°. The Swansea Beds strata (shown as the light and dark orange) is indicated to dip to the north-east at between 12 and 15°.

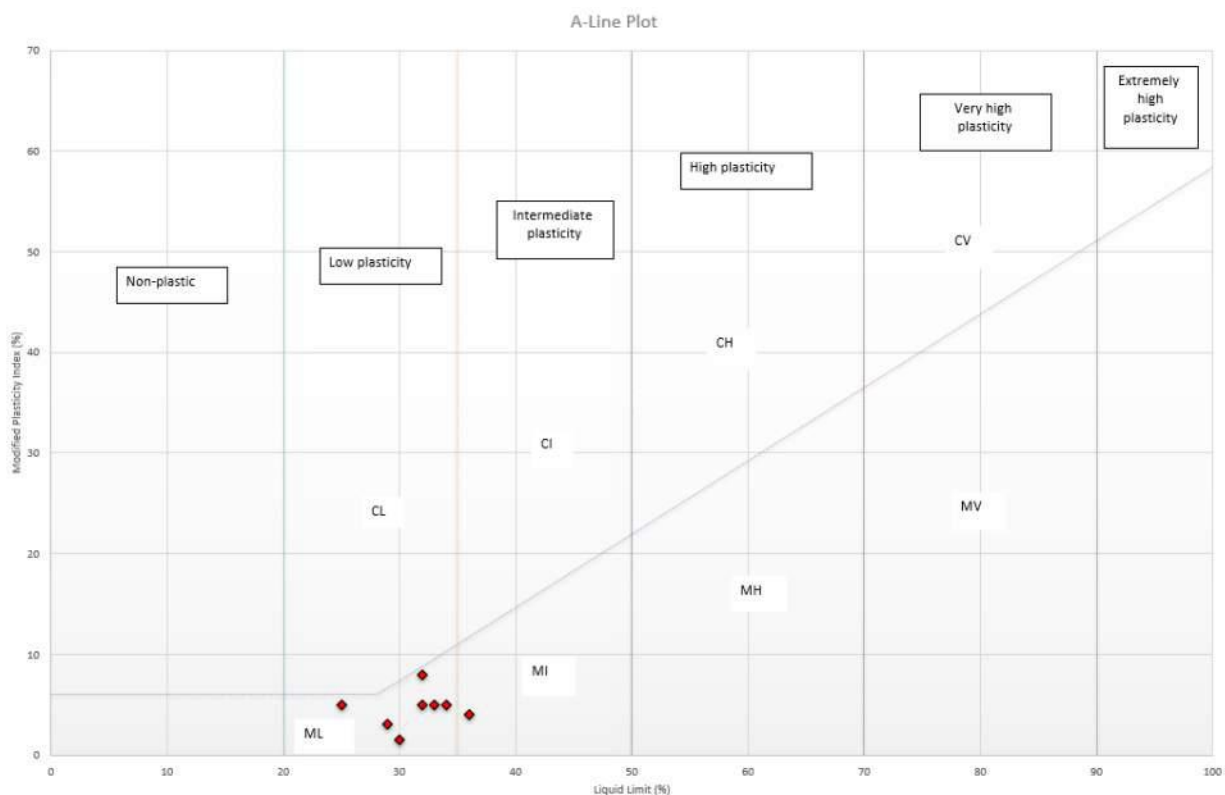
Figure 5: Summary of Plasticity Tests for Pennant Sandstone Formation

The samples of cohesive soil had natural moisture contents between 9% and 22% and a modified plasticity index of between 1% and 8% indicating the soil to be non-shrinkable. The sample comprised between 11% and 62% clay/ silt content.

Taking into account the portion of the sample passing the 425  $\mu\text{m}$  sieve, the reported plasticity index values can be modified in accordance with NHBC standards Chapter 4.2 'Building Near Trees'. Based on this the samples all have a non-shrinkable potential and so no requirement on a minimum foundation depth when building near trees, when foundations are placed within the shallow cohesive residual soils.

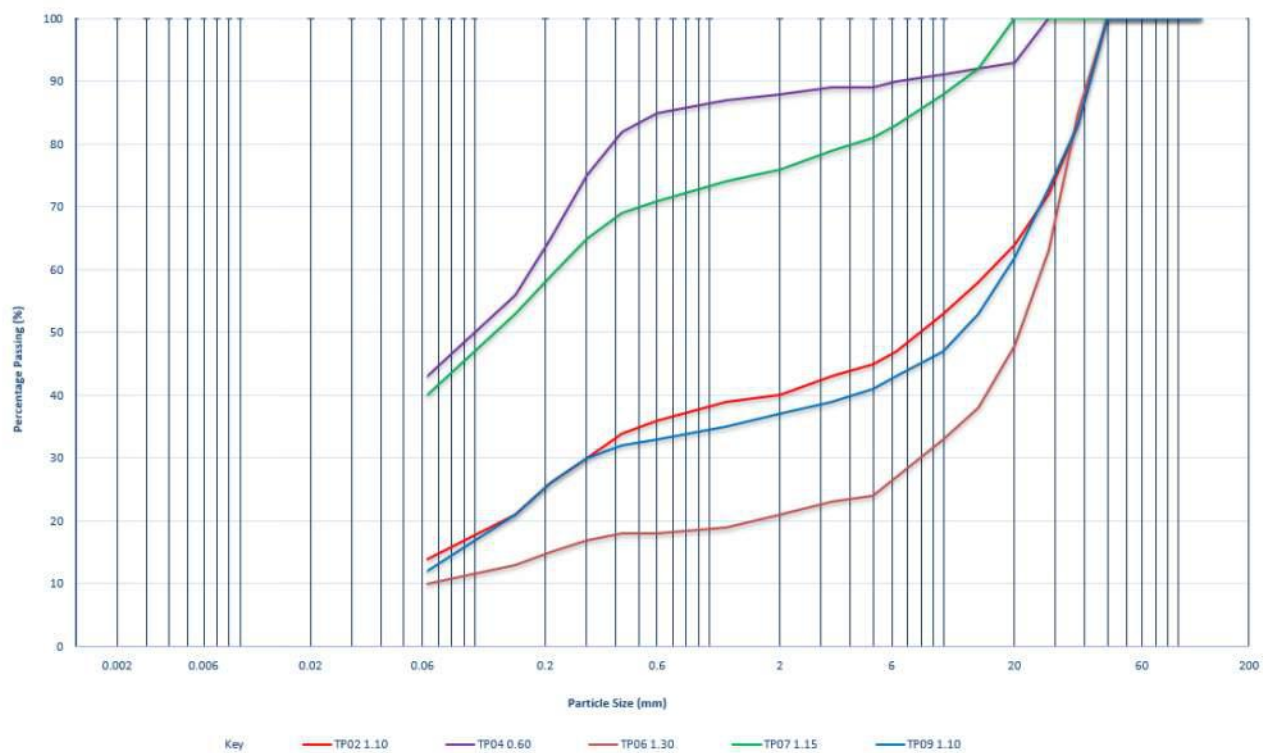
Figure 6: Weathered Pennant Sandstone Formation PSD Curve

Based on the single PSD results, the residual soils could be typically classed as clayey/silty sandy gravel. The PSD curves show two sets of different gradings suggesting the residual soils are slightly varied across whole site, but appears to become more granular with depth as shown both below and the exploratory hole logs contained in **Appendix G**.

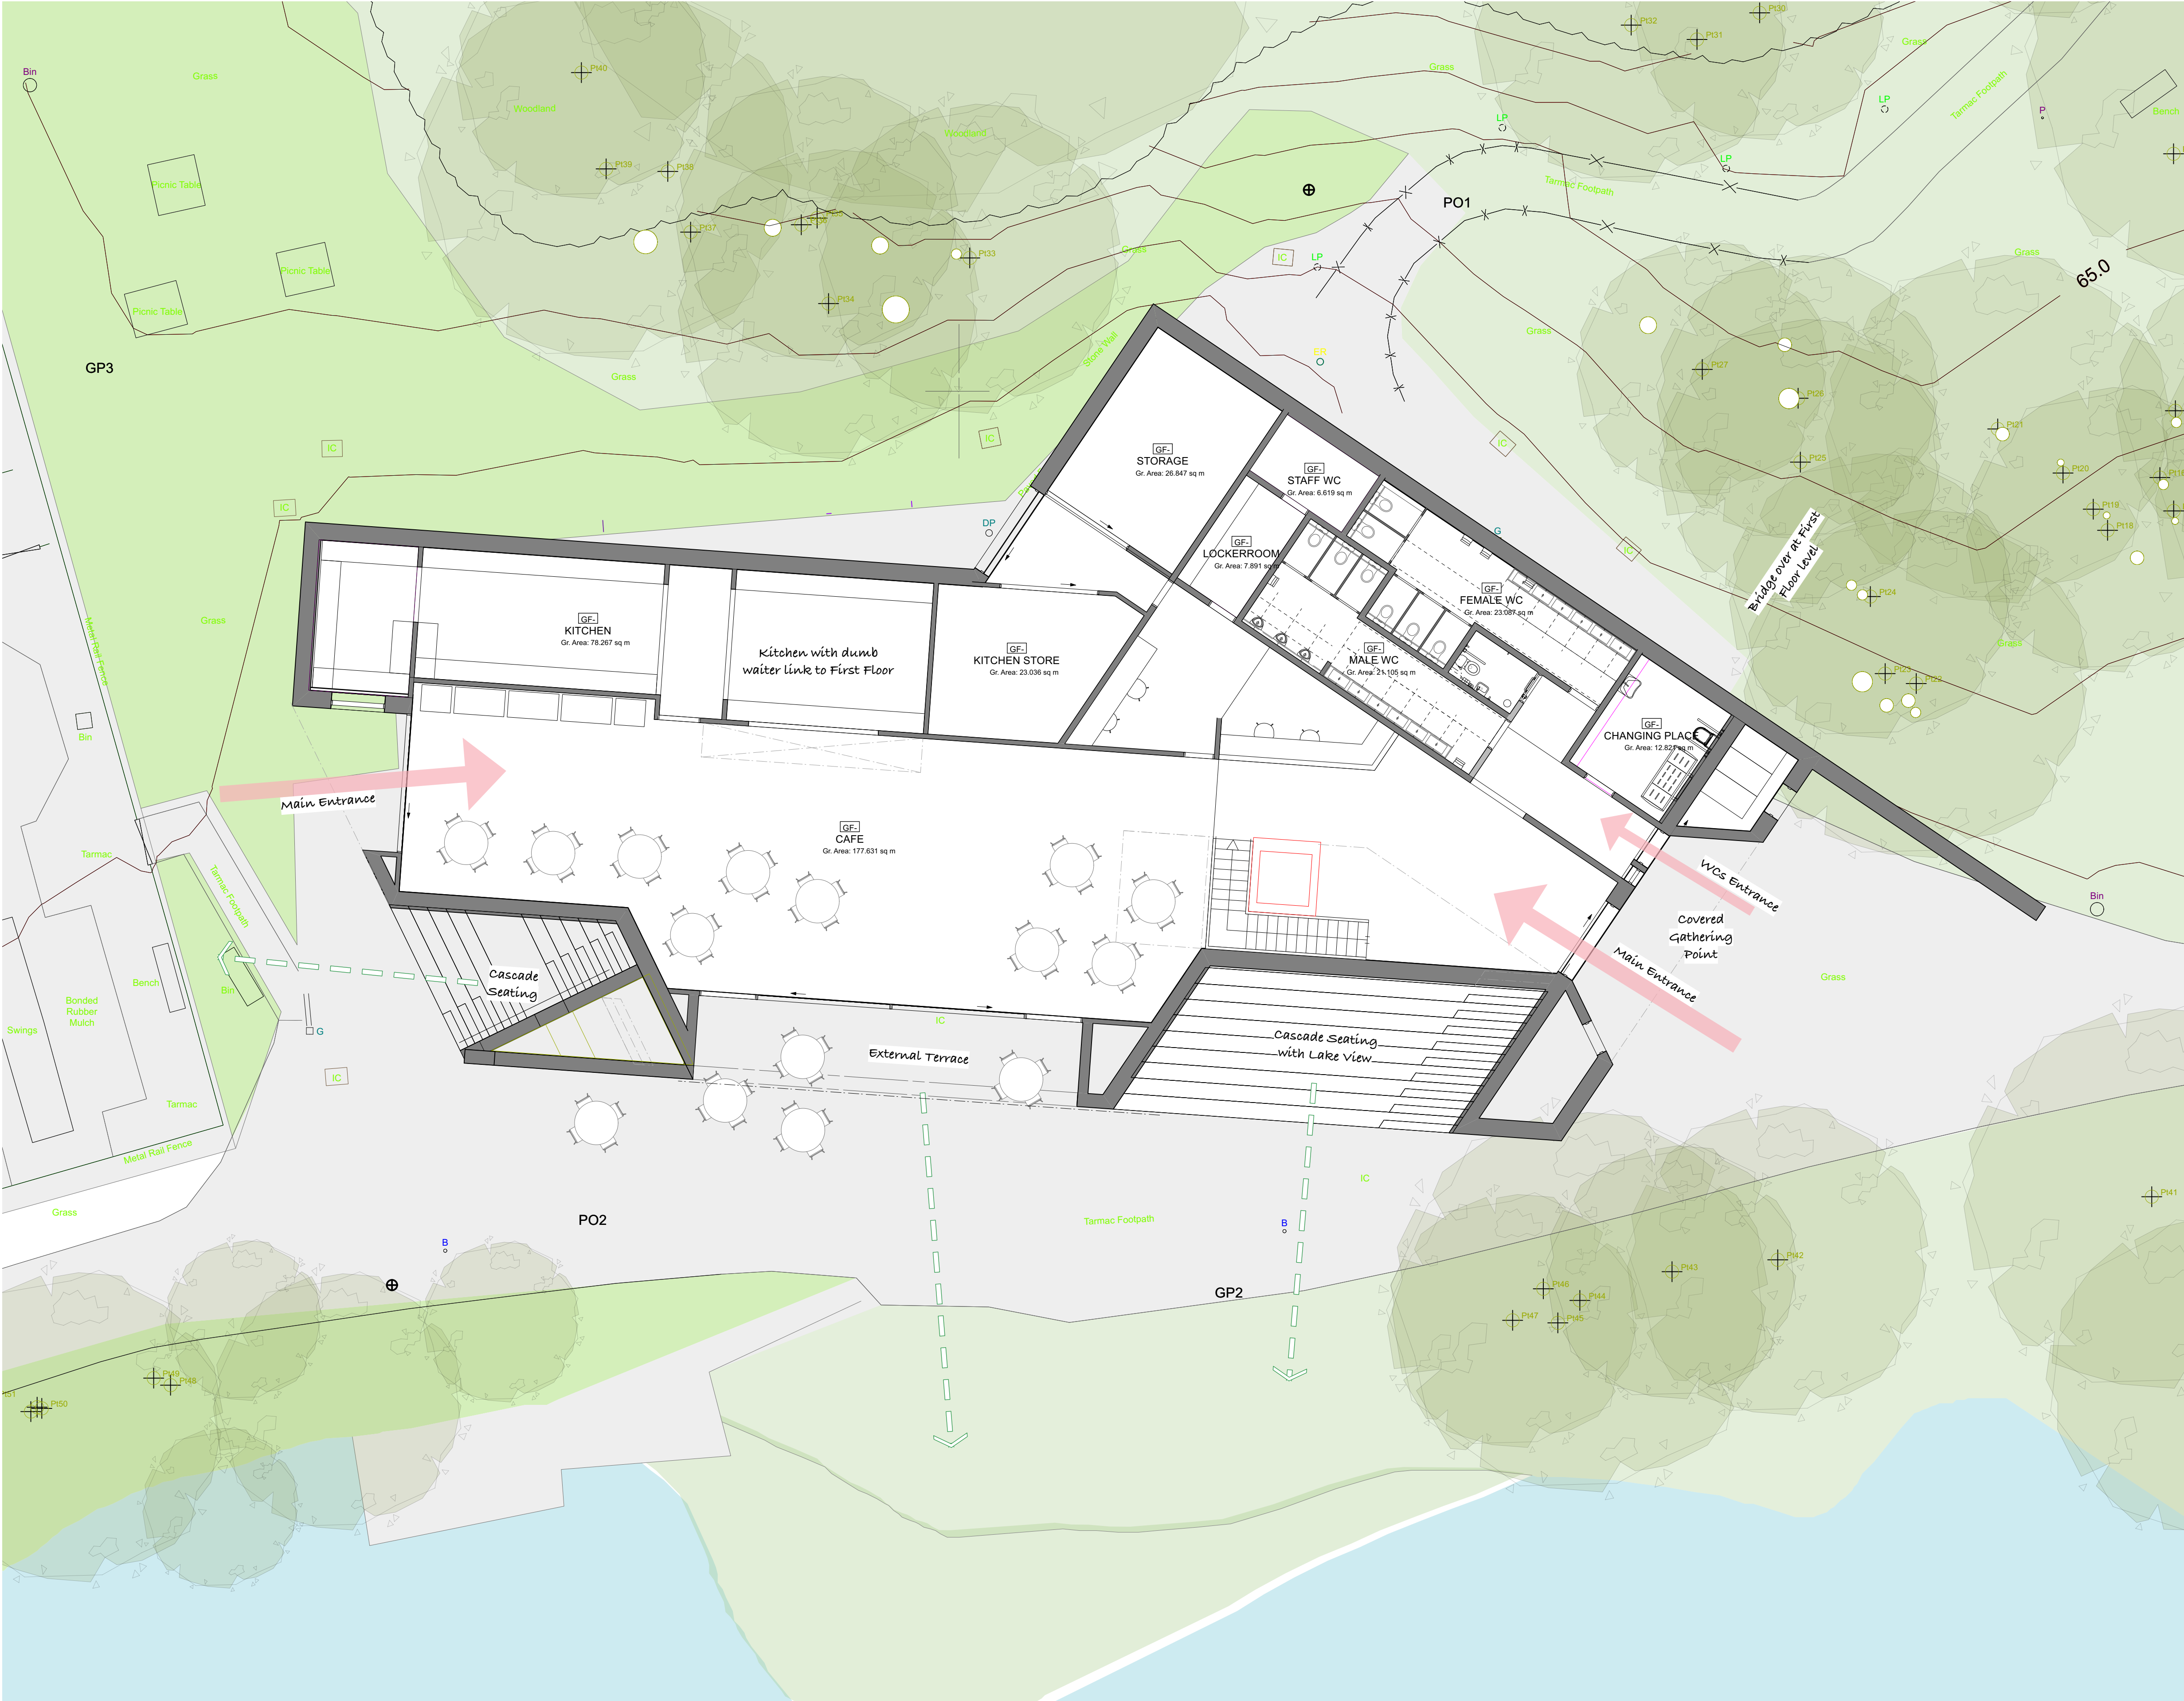
01310.1 GROUND FLOOR PLAN  
SCALE 1:100 @ A1, 1:200 @ A3

The existing visitor centre is proposed to be demolished and replaced with a 2-storey building with a podium and a first-floor timber frame building, with two cascade seating areas on the first floor and an external terrace.

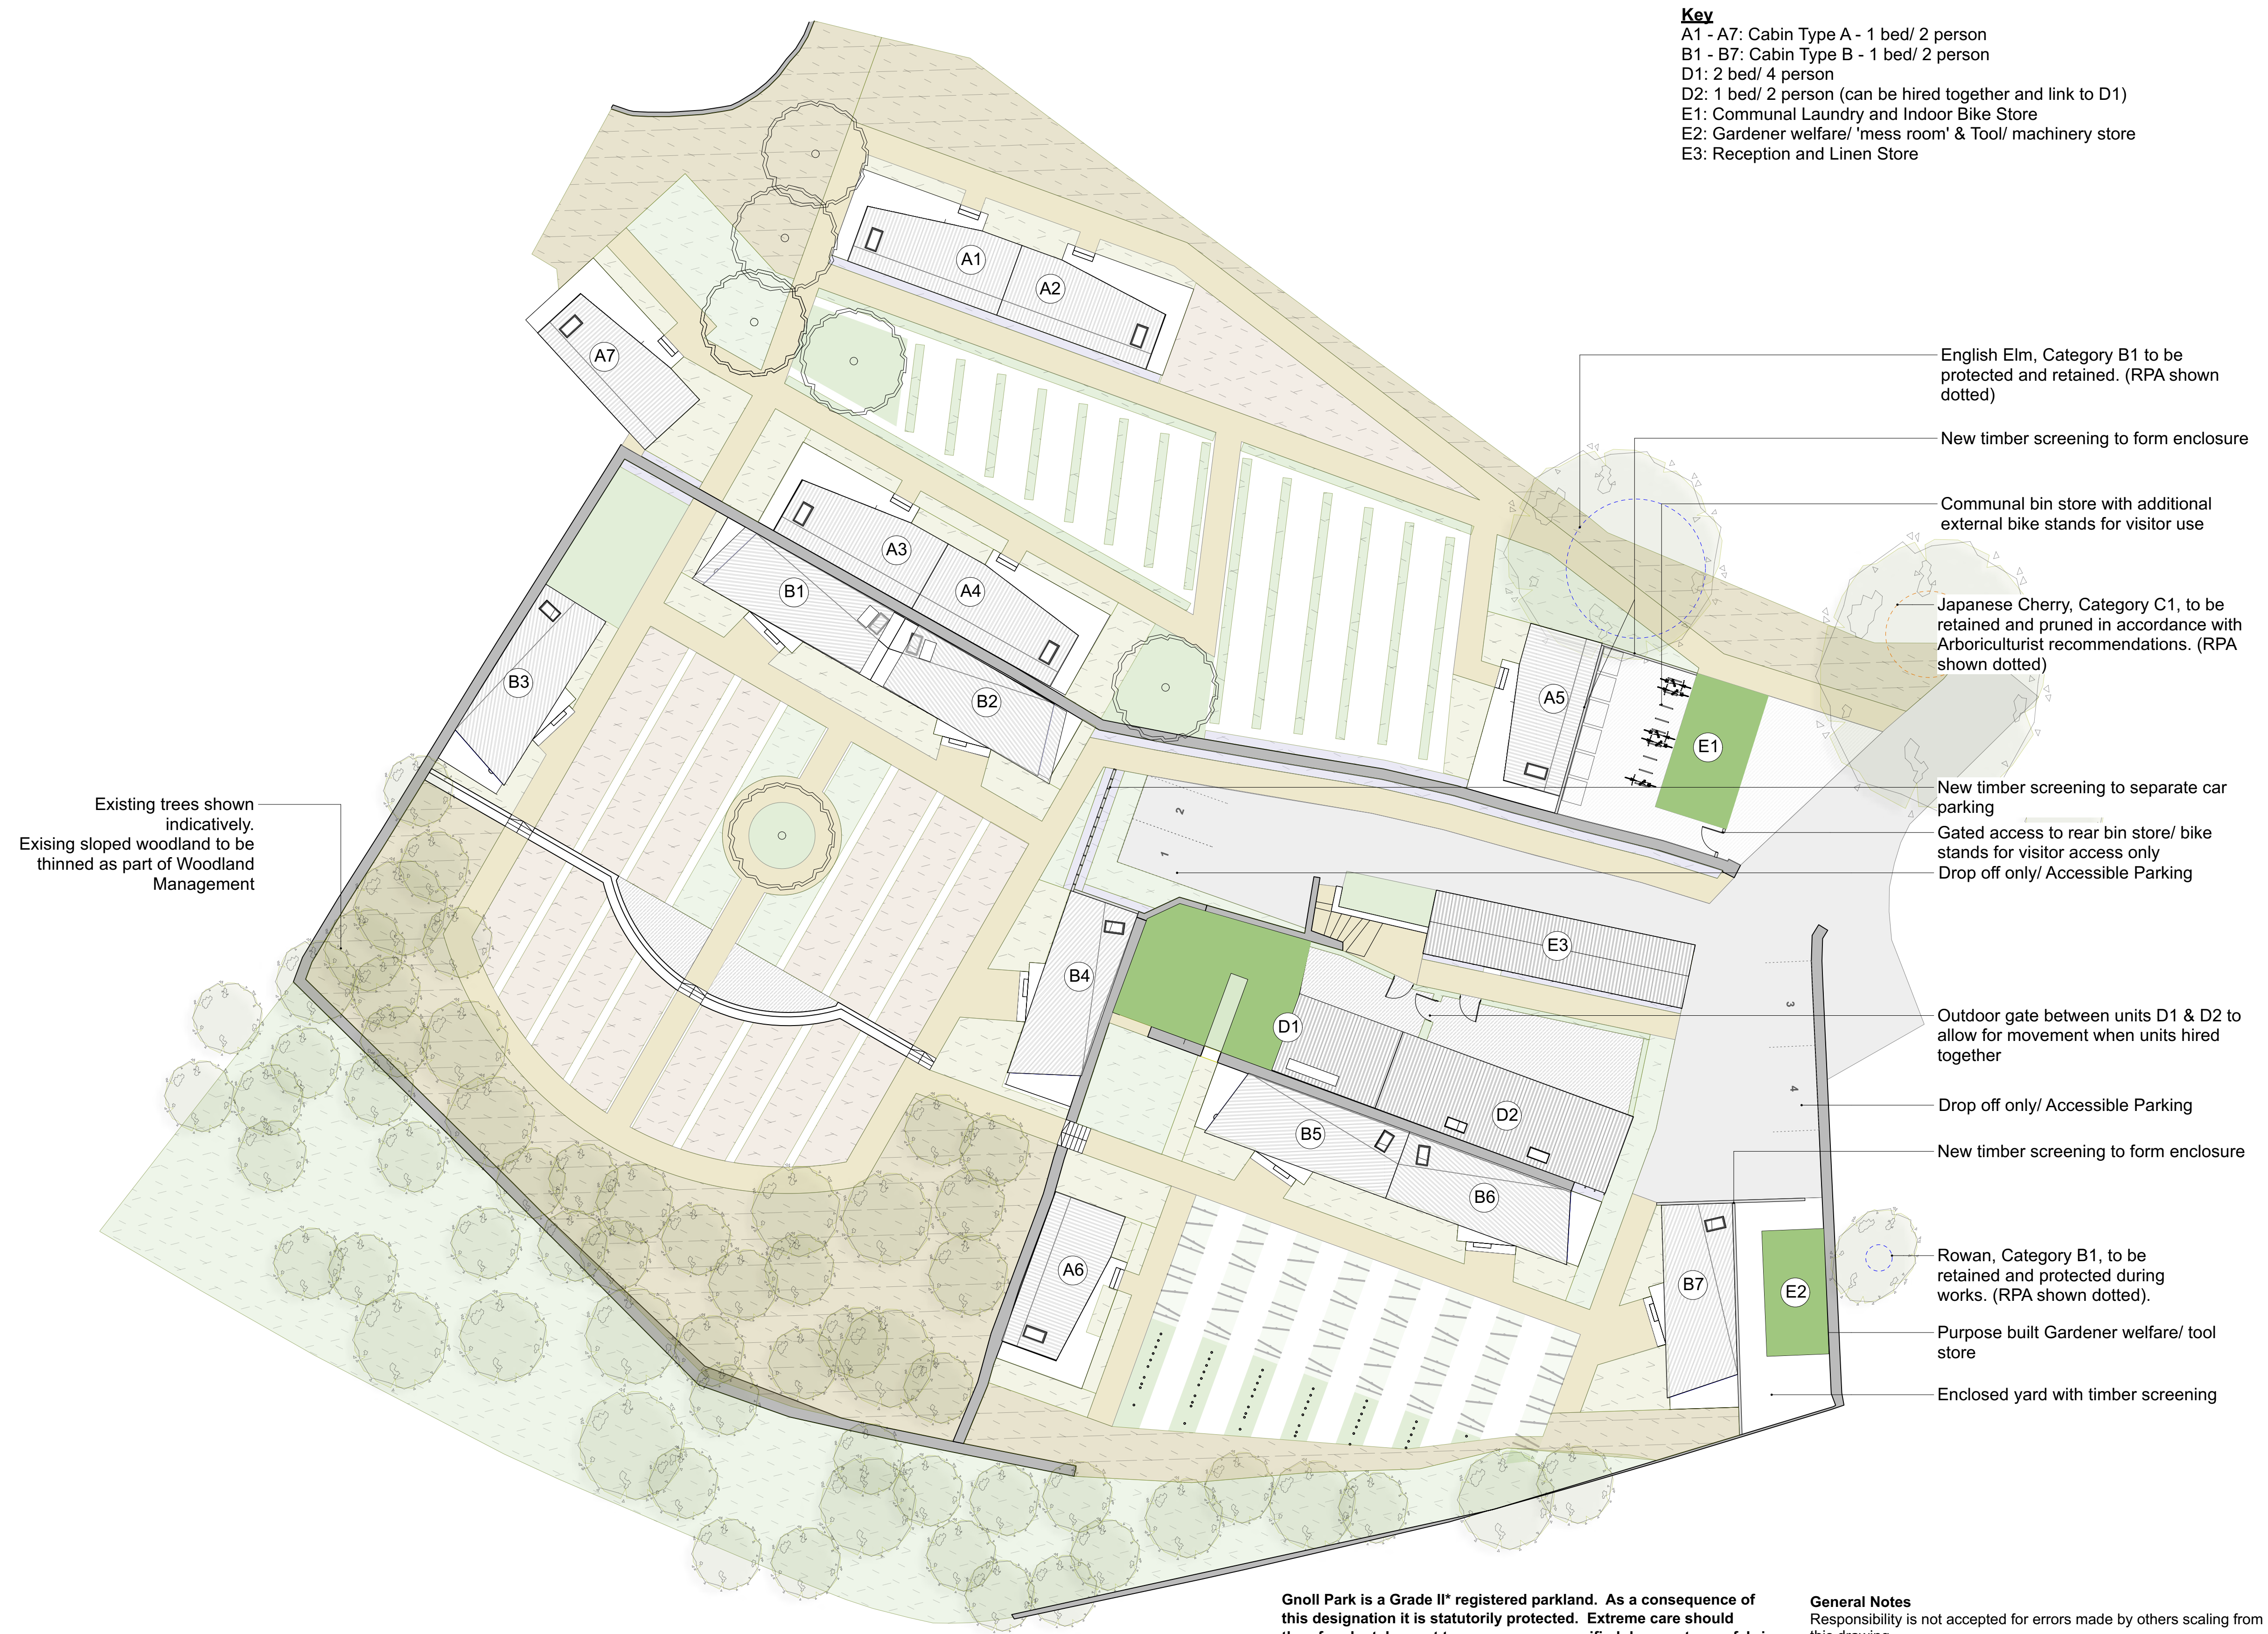
- Key**  
A1 - A7: Cabin Type A - 1 bed/ 2 person  
B1 - B7: Cabin Type B - 1 bed/ 2 person  
D1: 2 bed/ 4 person  
D2: 1 bed/ 2 person (can be hired together and link to D1)  
E1: Communal Laundry and Indoor Bike Store  
E2: Gardener welfare/ 'mess room' & Tool/ machinery store  
E3: Reception and Linen Store

- English Elm, Category B1 to be protected and retained. (RPA shown dotted)
- New timber screening to form enclosure
- Communal bin store with additional external bike stands for visitor use
- Japanese Cherry, Category C1, to be retained and pruned in accordance with Arboriculturist recommendations. (RPA shown dotted)
- New timber screening to separate car parking
- Gated access to rear bin store/ bike stands for visitor access only
- Drop off only/ Accessible Parking
- Outdoor gate between units D1 & D2 to allow for movement when units hired together
- Drop off only/ Accessible Parking
- New timber screening to form enclosure
- Rowan, Category B1, to be retained and protected during works. (RPA shown dotted).
- Purpose built Gardener welfare/ tool store
- Enclosed yard with timber screening

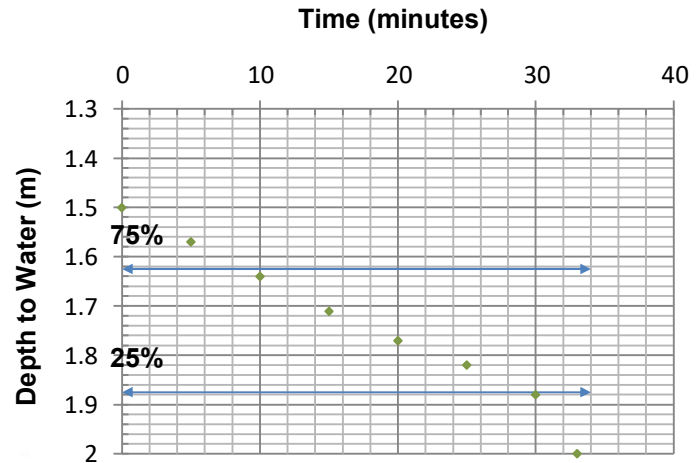
Length 1.50 m  
Width 0.60 m  
Depth 2.00 m  
Fill Level 1.50 m

Soil Infiltration Rate,  $f$  7.69E-05 ms<sup>-1</sup>

| <b>Drainage</b> | Infiltration drainage will likely be suitable in areas where the base of the soakaways is within the weathered bedrock where infiltration rates of between $1.74 \times 10^{-4}$ m/s and $7.69 \times 10^{-5}$ m/s were recorded. Soakaways were carried out with the base within the residual and failed to infiltrate therefore soakaways within the clays will not be suitable, although they could potentially be extended down to the weathered granular bedrock subject to further testing. |

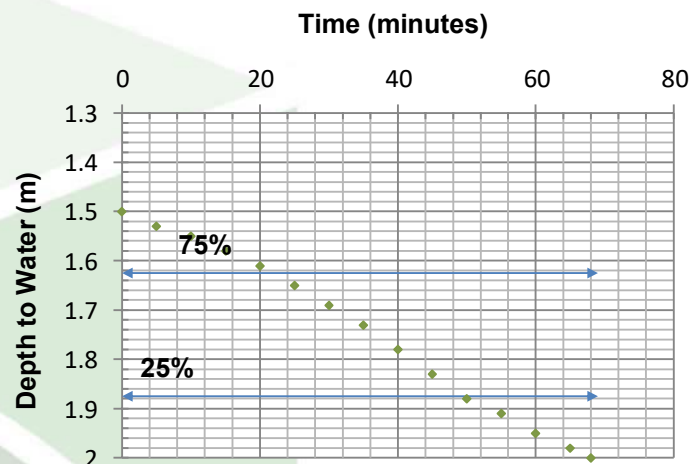
$V_{p75-25}$  0.225 m<sup>3</sup>  
 $a_{p50}$  1.95 m<sup>2</sup>  
 $t_{p75-25}$  25 minutes

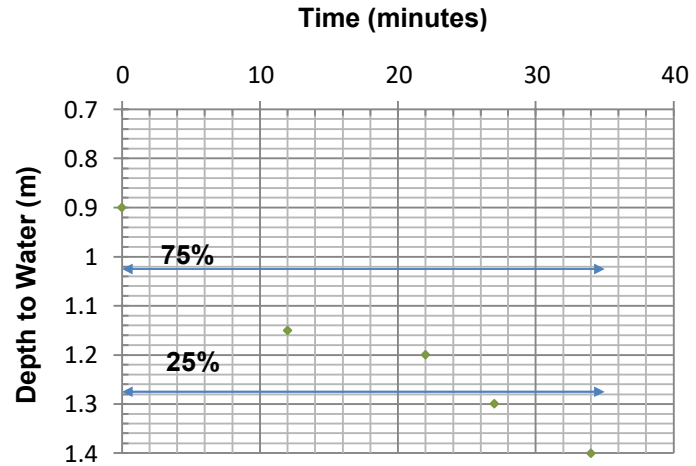
$V_{p75-25}$  0.225 m<sup>3</sup>  
 $a_{p50}$  1.95 m<sup>2</sup>  
 $t_{p75-25}$  0.22 minutes

Soil Infiltration Rate,  $f$  8.74E-03 ms<sup>-1</sup>

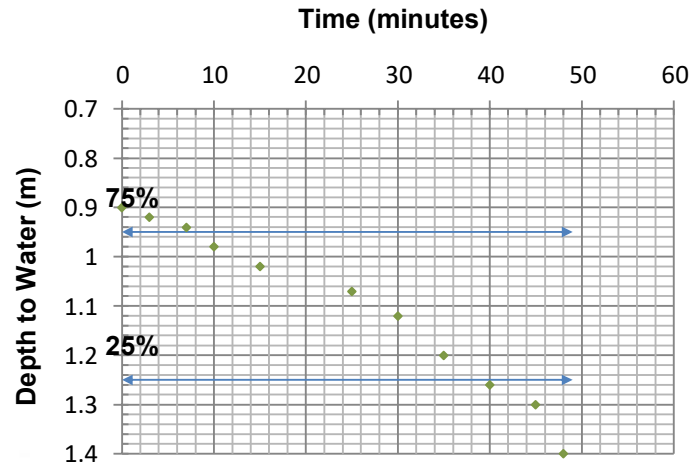
Length 1.50 m  
Width 0.60 m  
Depth 1.40 m  
Fill Level 0.90 m

$V_{p75-25}$  0.27 m<sup>3</sup>  
 $a_{p50}$  2.16 m<sup>2</sup>  
 $t_{p75-25}$  30 minutes

Soil Infiltration Rate,  $f$  6.94E-05 ms<sup>-1</sup>

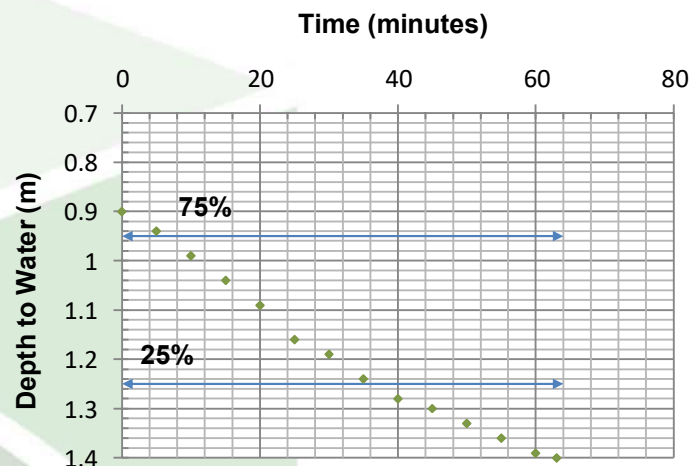
Length 1.50 m  
Width 0.60 m  
Depth 1.40 m  
Fill Level 0.90 m

$V_{p75-25}$  0.27 m<sup>3</sup>  
 $a_{p50}$  2.16 m<sup>2</sup>  
 $t_{p75-25}$  30 minutes

Soil Infiltration Rate,  $f$  6.94E-05 ms<sup>-1</sup>

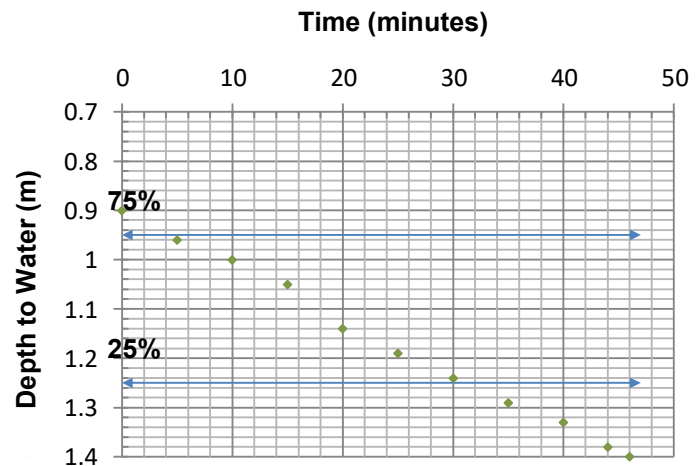
$V_{p75-25}$  0.27 m<sup>3</sup>  
 $a_{p50}$  2.16 m<sup>2</sup>  
 $t_{p75-25}$  27 minutes

Soil Infiltration Rate,  $f$  7.72E-05 ms<sup>-1</sup>

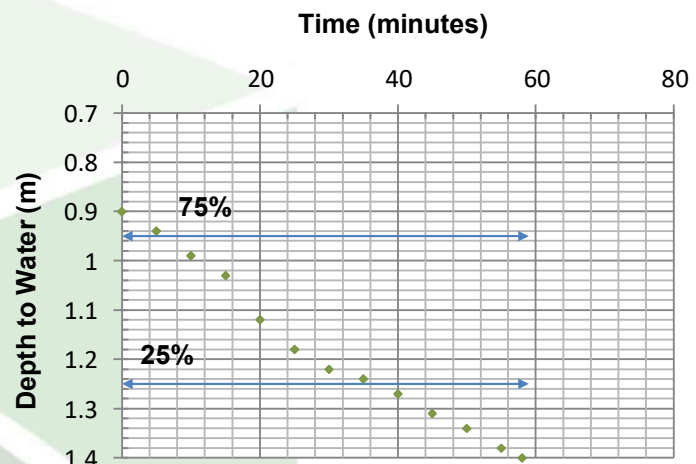
Length 1.50 m  
 Width 0.60 m  
 Depth 1.40 m  
 Fill Level 0.90 m

$V_{p75-25}$  0.27 m<sup>3</sup>  
 $a_{p50}$  2.16 m<sup>2</sup>  
 $t_{p75-25}$  30 minutes

Soil Infiltration Rate,  $f$  6.94E-05 ms<sup>-1</sup>

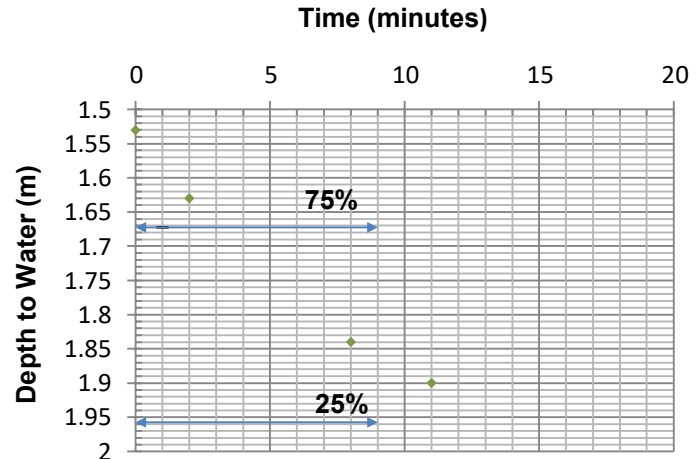
$V_{p75-25}$  0.342 m<sup>3</sup>  
 $a_{p50}$  2.682 m<sup>2</sup>  
 $t_{p75-25}$  8 minutes

Soil Infiltration Rate,  $f$  2.66E-04 ms<sup>-1</sup>

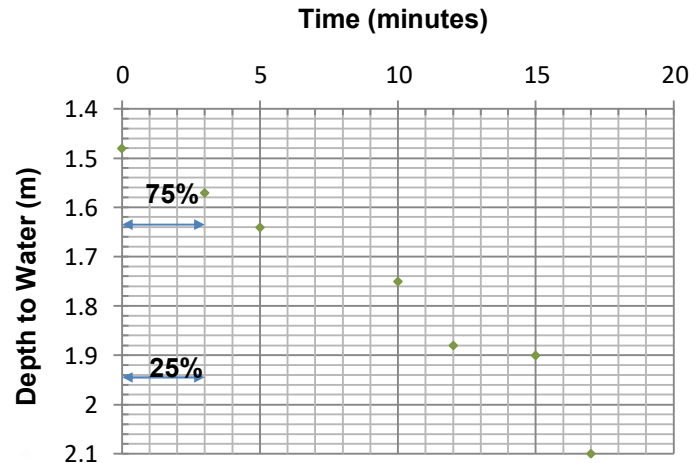
Length 2.00 m  
 Width 0.60 m  
 Depth 2.10 m  
 Fill Level 1.48 m

$V_{p75-25}$  0.372 m<sup>3</sup>  
 $a_{p50}$  2.812 m<sup>2</sup>  
 $t_{p75-25}$  2 minutes

Soil Infiltration Rate,  $f$  1.10E-03 ms<sup>-1</sup>

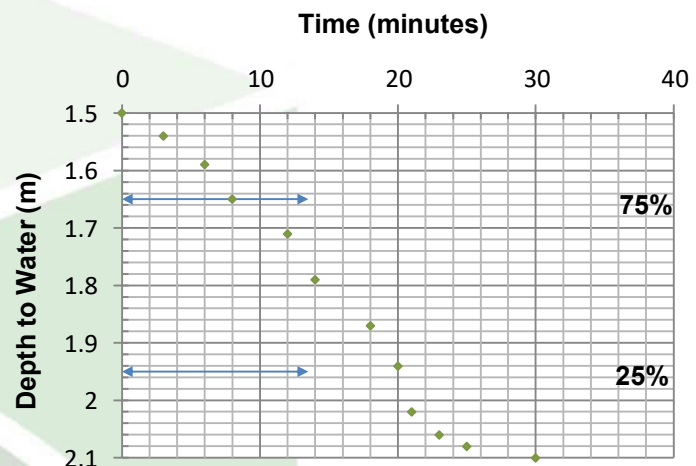
$V_{p75-25}$  0.36 m<sup>3</sup>  
 $a_{p50}$  2.76 m<sup>2</sup>  
 $t_{p75-25}$  12.5 minutes

Soil Infiltration Rate,  $f$  1.74E-04 ms<sup>-1</sup>

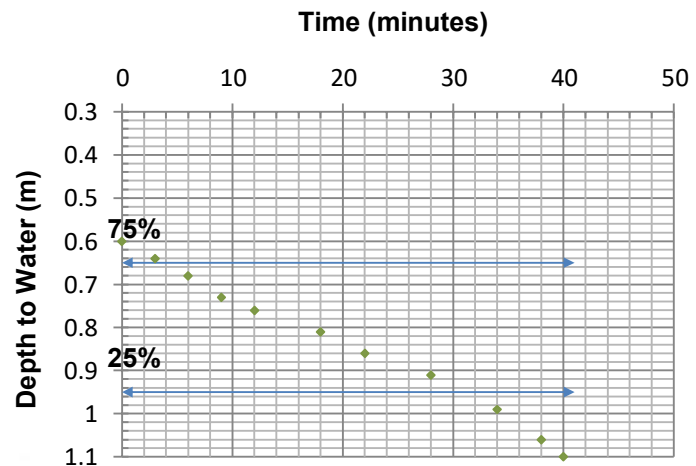
$V_{p75-25}$  0.075 m<sup>3</sup>  
 $a_{p50}$  0.85 m<sup>2</sup>  
 $t_{p75-25}$  27 minutes

Soil Infiltration Rate, f 5.45E-05 ms<sup>-1</sup>

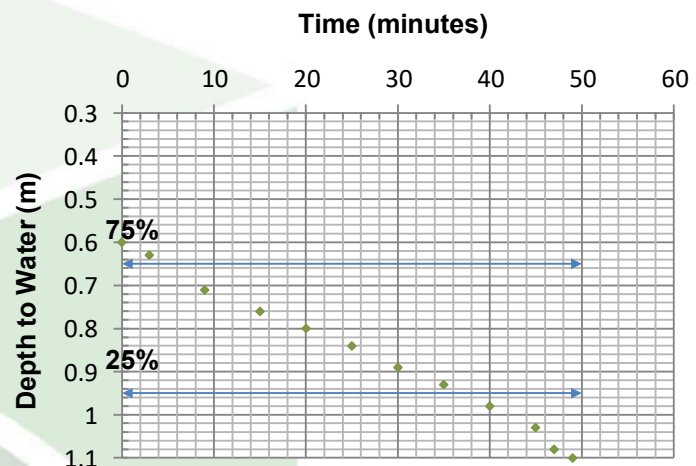
Length 0.50 m  
 Width 0.50 m  
 Depth 1.10 m  
 Fill Level 0.50 m

$V_{p75-25}$  0.075 m<sup>3</sup>  
 $a_{p50}$  0.85 m<sup>2</sup>  
 $t_{p75-25}$  31 minutes

Soil Infiltration Rate, f 4.74E-05 ms<sup>-1</sup>

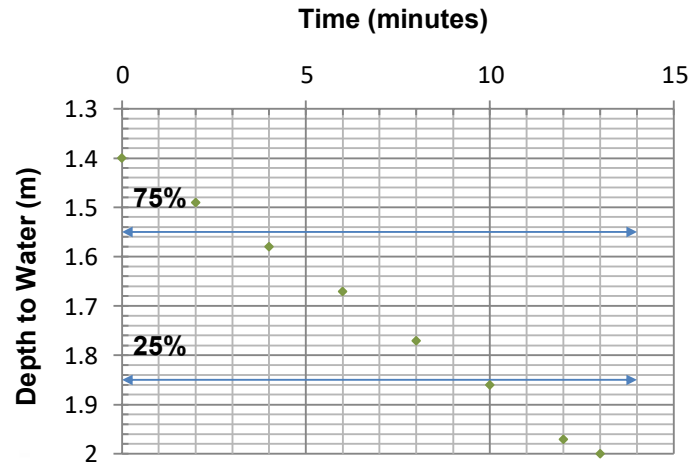
$V_{p75-25}$  0.288 m<sup>3</sup>  
 $a_{p50}$  2.28 m<sup>2</sup>  
 $t_{p75-25}$  6 minutes

Soil Infiltration Rate,  $f$  3.51E-04 ms<sup>-1</sup>

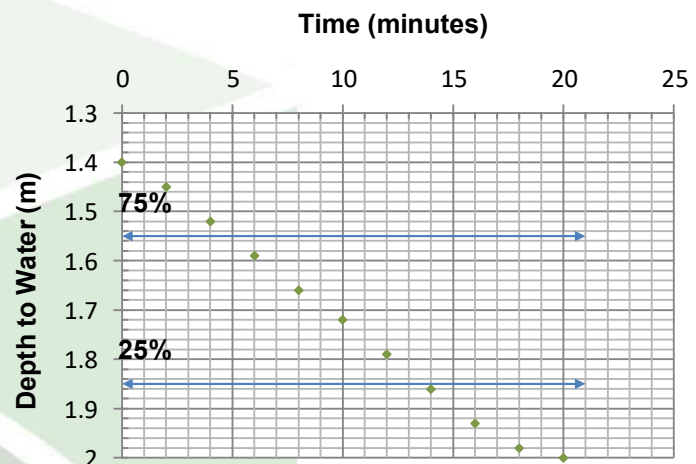
Length 1.60 m  
 Width 0.60 m  
 Depth 2.00 m  
 Fill Level 1.50 m

$V_{p75-25}$  0.288 m<sup>3</sup>  
 $a_{p50}$  2.28 m<sup>2</sup>  
 $t_{p75-25}$  8 minutes

Soil Infiltration Rate,  $f$  2.63E-04 ms<sup>-1</sup>

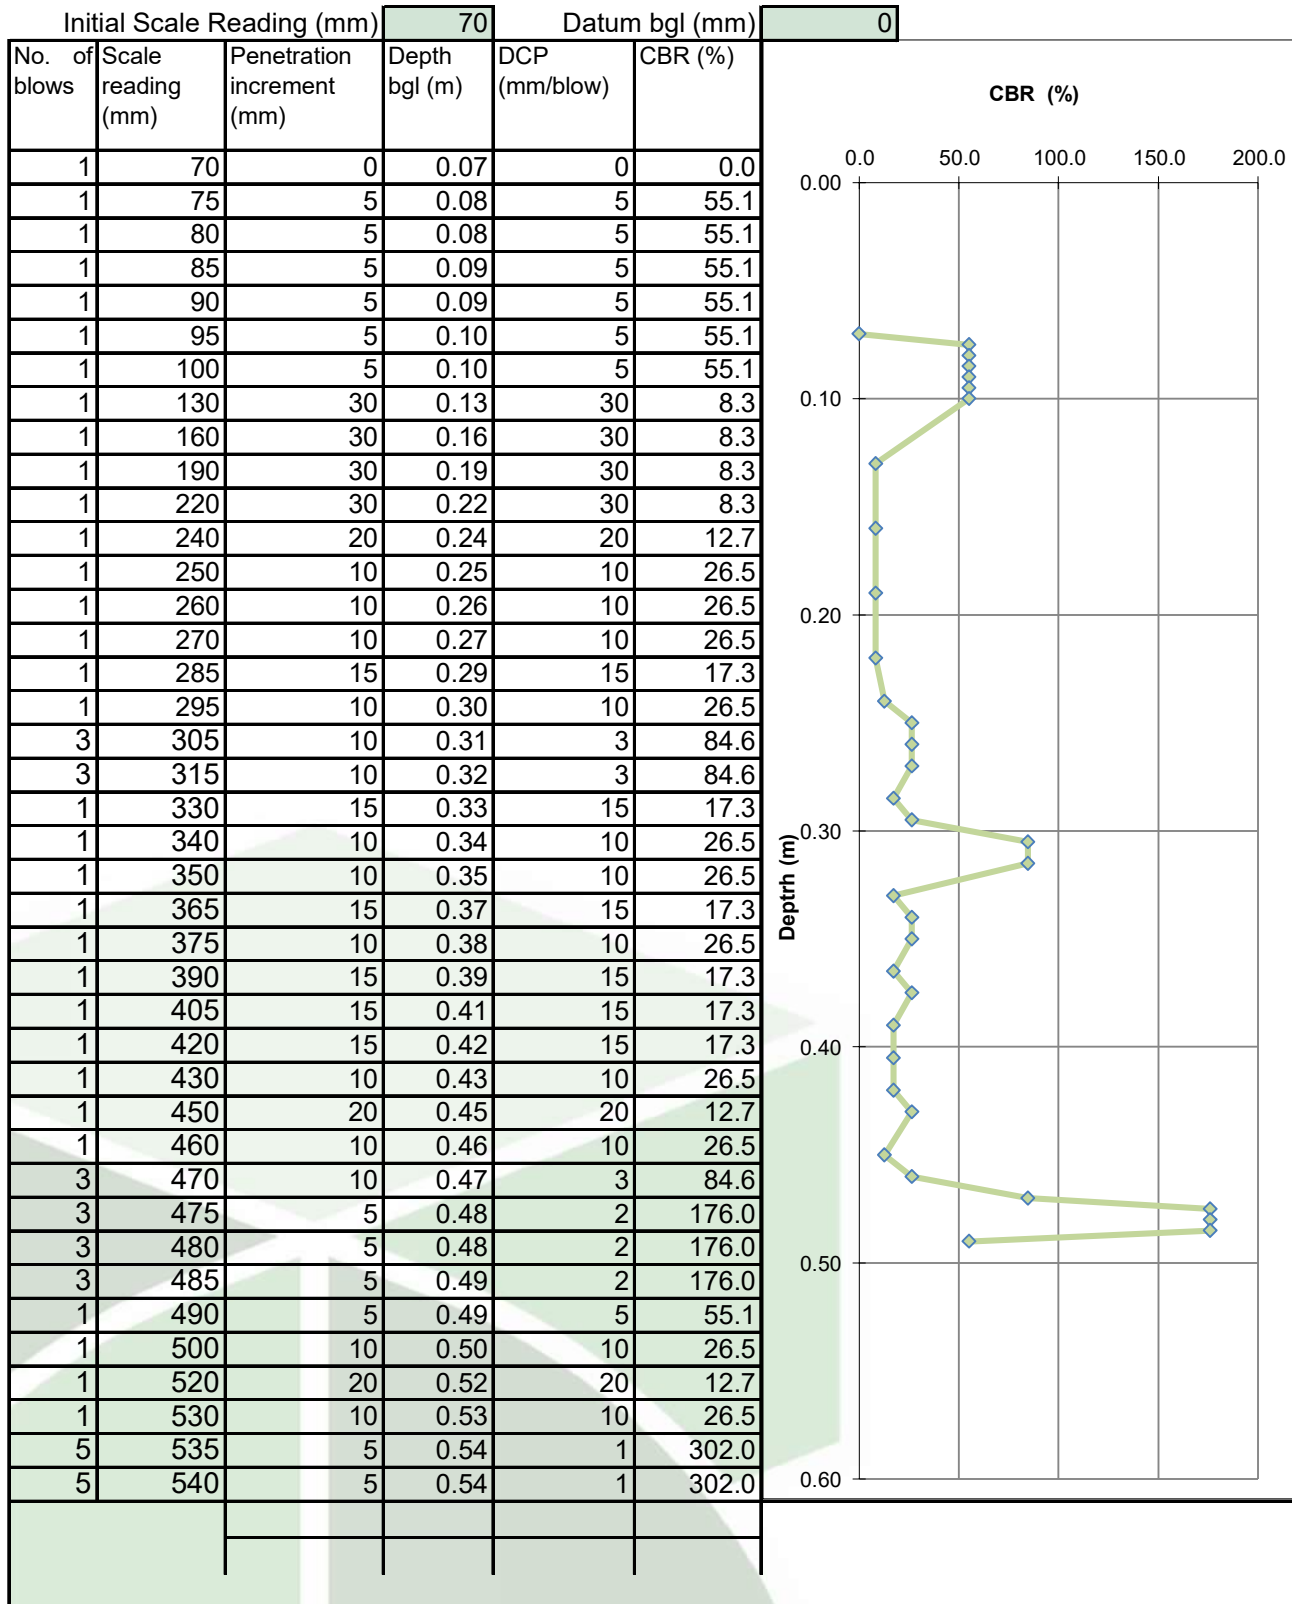
DCP 02

Test carried out in accordance with operating instructions for the dynamic cone penetrometer Model A2465 by CNS Farnell Ltd.  
 CBR correlation based on the relationship  $\text{Log}_{10}(\text{CBR}) = 2.48 - 1.057 * \text{Log}_{10}(\text{mm/blow})$  developed by TRL taken from The

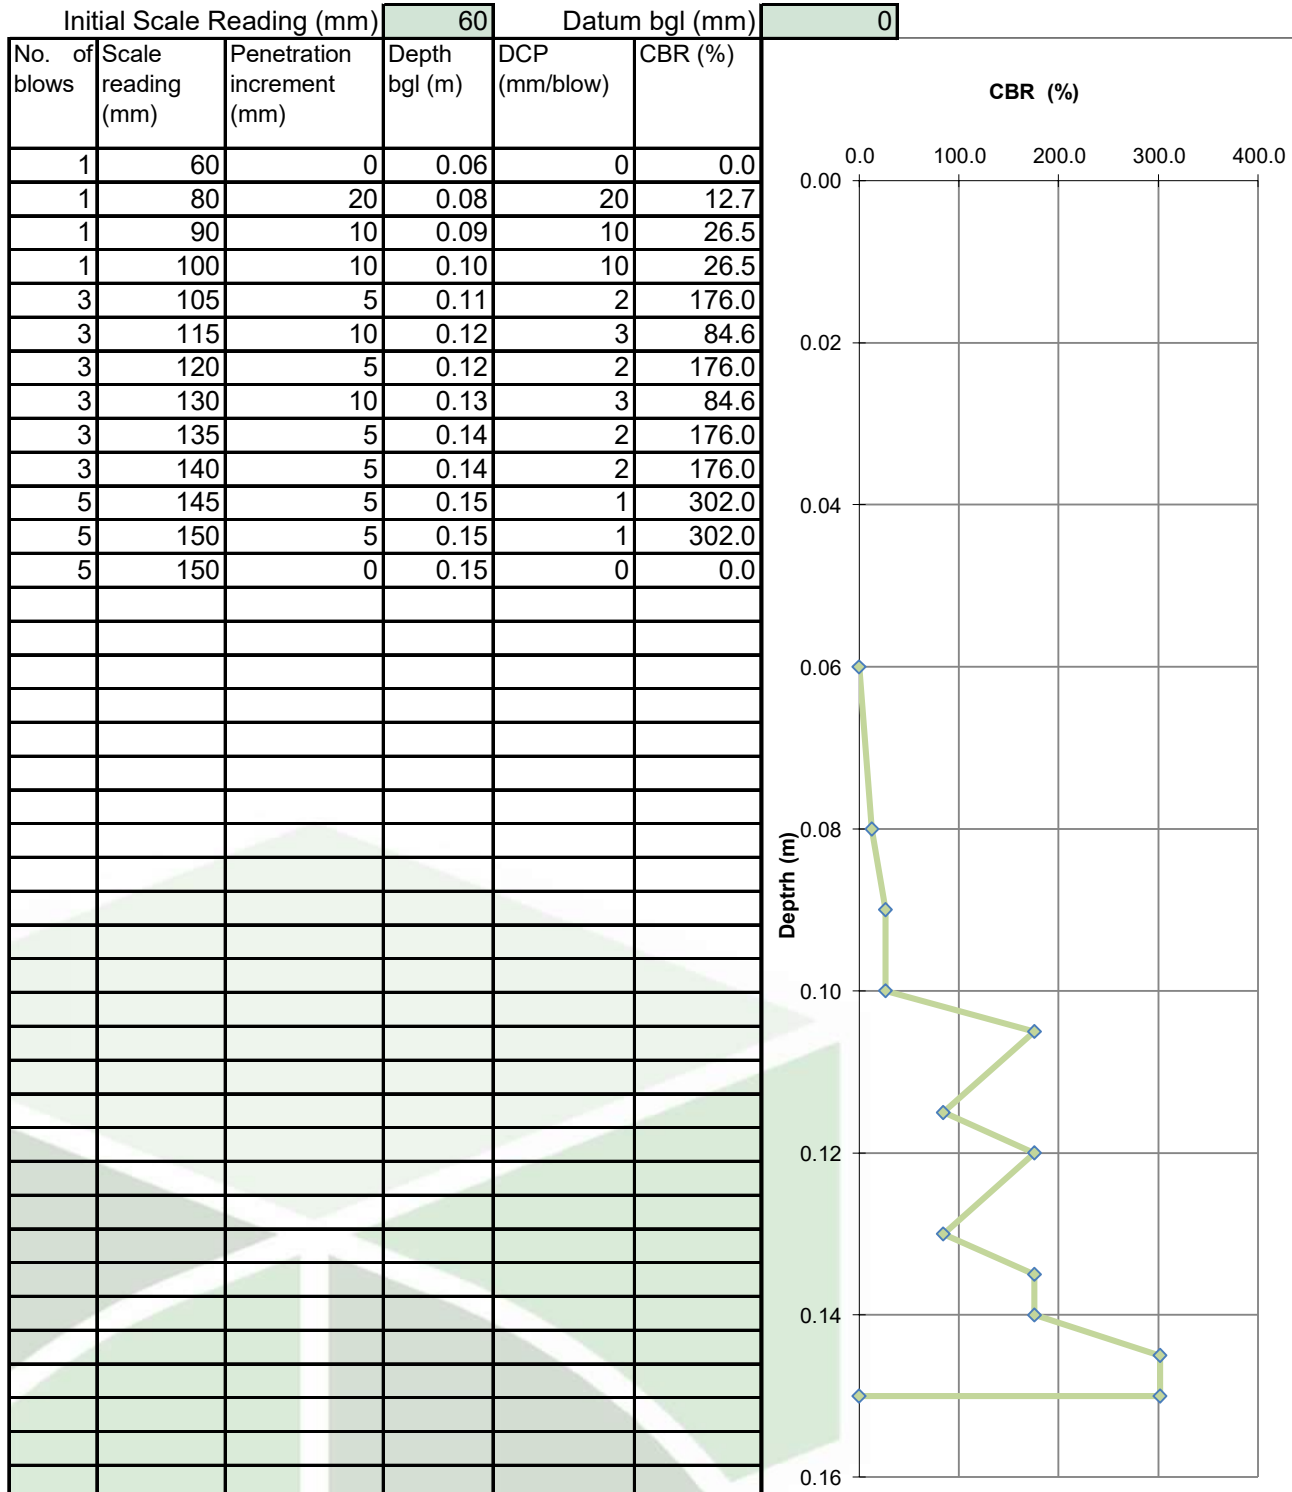
## DCP 13

Test carried out in accordance with operating instructions for the dynamic cone penetrometer Model A2465 by CNS Farnell Ltd.

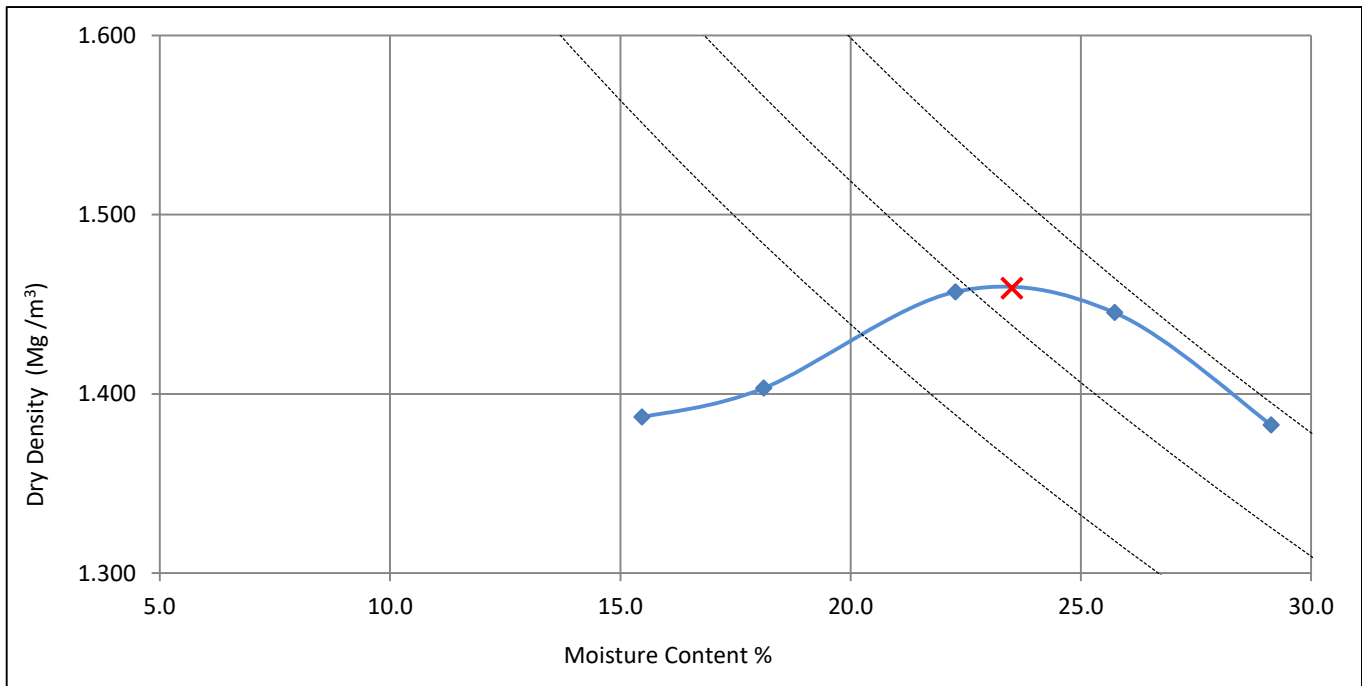
**TEST REPORT**  
**DRY DENSITY / MOISTURE CONTENT RELATIONSHIP**  
**BS1377:Part 4:1990**

| Test Method: | BS 1377: part 4: 1990: clause 3.3, 2.5kg rammer in a 1 litre mould |
| Preparation: | Original sample was oven dried @ 105 oC, separate specimens tested |
